## **Assessment of pre-fabricated bathrooms from the 1990s**

Morelli, Martin; Brandt, Erik

1st International Symposium on Building Pathology (ISBP 2015)

2015

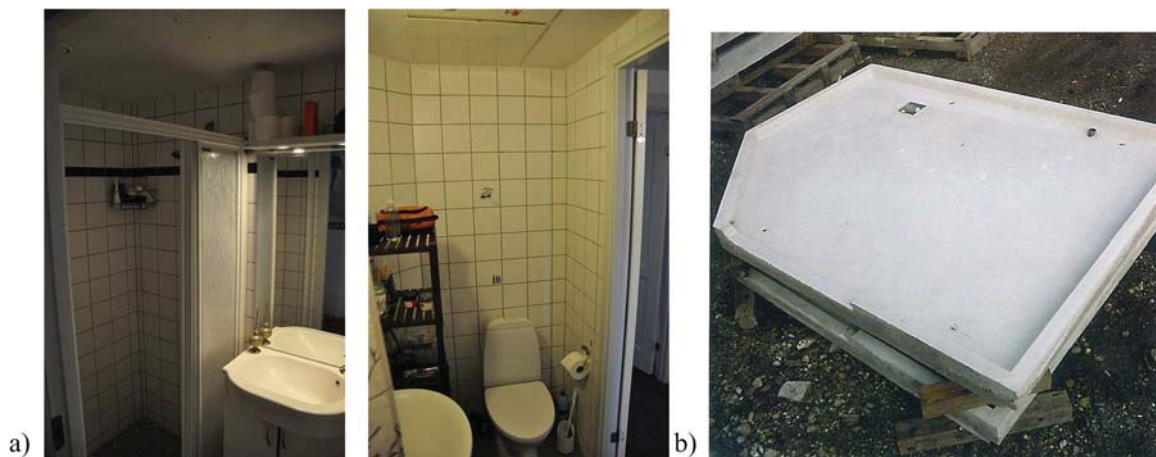
**Figure 4.** Heavy-weight assembly kit with fibre reinforced concrete bottom with dimension:  $2.3 \text{ m} \times 1.2 \text{ m}$ , and b) the fibre reinforced concrete bottom [MHUR 1999b].

Perhaps the most critical failure was registered in the heavy-weight assembly kit of fibre reinforced concrete bottom with a plinth. As the crack was observed on different walls but in the same height in

the three inspected bathrooms, the crack might be related to the plinth on the bottom element (Figs. 4b and 6c). However, the cracks could also be related to movement in the building. As no destructive inspections were conducted, the correct reason for the crack cannot be stated.
