MSE Walls Retrofit

Design and Construction

110th Annual Road School 2024

B-43196 (40 MSE Wall Repair Statewide INDOT) Project Development Process for IDIQ MSE Wall Rehabilitation Projects

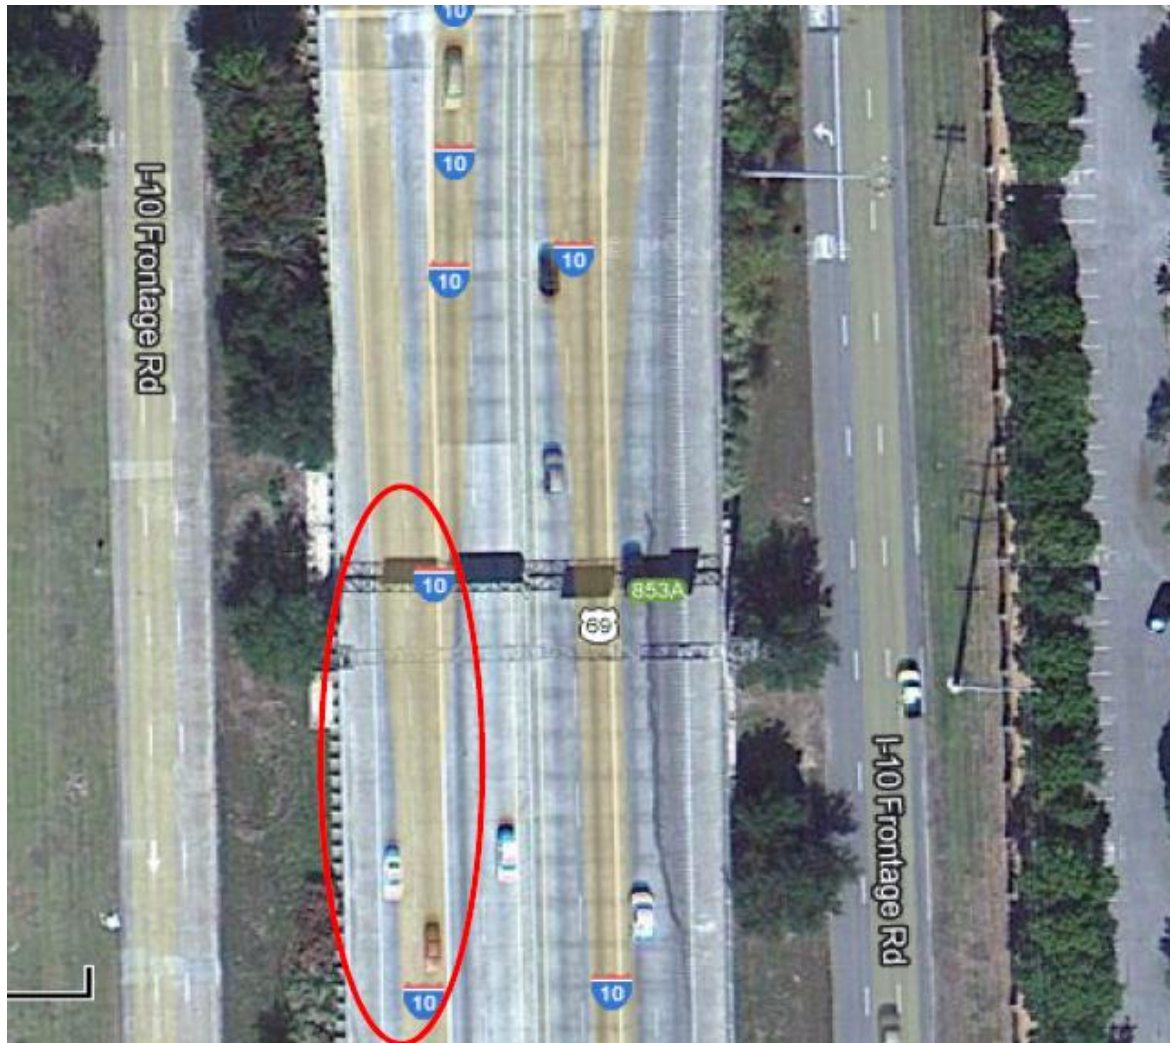
I-10 in Beaumont, Texas - Distressed Portion of the Roadway

The separation ran about 100 ft long and up to 3 inches wide. Cracking was also observed at the connection between the coping/barrier and the MSE wall panels. To prevent the propagation of the settlement and further separation, a retrofit measure was taken by **dowelling the shoulder to the adjacent travel lanes**. After the retrofit, **cracks appeared in the same travel lanes again, but were shifted toward the centerline of the roadway**
