Environmental effects caused by the Mw 7.7, September 19, 2022, Michoacán (Mexico)

Descriptive table

This document presents a collection of Earthquake Environmental Effects (EEEs) triggered by the Mw 7.7 Michoacan earthquake occurred on 19 September 2022. Data derive from original field surveys, published reports and papers, and from a search for EEEs posted online in social media and other websites.

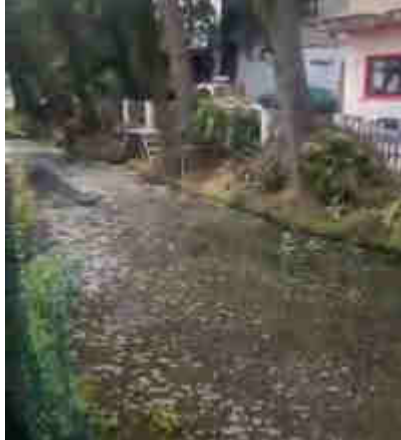
SITE	2
LATITUDE	19.26085964238992
LONGITUDE	-99.07559251806984
DISTANCE FROM EPICENTER	459
CITY	Barrio Xaltocan, Xochimilco, Distrito Federal
EEE TYPE	Anomalous waves
EEE DESCRIPTION	Water violently overflows from small basins and watercourses.
ESI INTENSITY	VI
PHOTOGRAPIC DOCUMENTATION

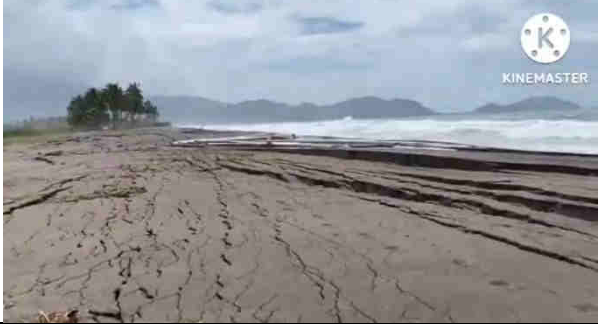
SITE	3
LATITUDE	18.626955053066315
LONGITUDE	-103.68532003545504
DISTANCE FROM EPICENTER	60
CITY	Mezcala, Michoacán
EEE TYPE	Liquefaction processes
EEE DESCRIPTION	Localized lateral spreading and settlements with height of 0 – 30 cm, and with fissuring parallel to waterfront areas
ESI INTENSITY	IX
PHOTOGRAPIC DOCUMENTATION

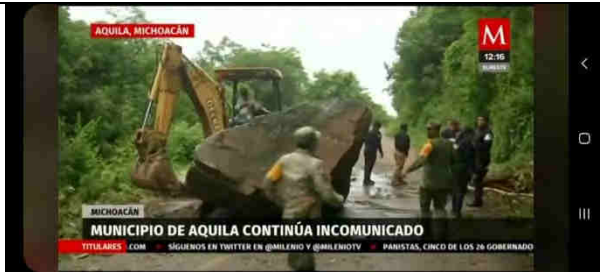
SITE	4
LATITUDE	18.590682569109195
LONGITUDE	-103.50702714641429
DISTANCE FROM EPICENTER	45
CITY	Aquila, Michoacán
EEE TYPE	Slope movements
EEE DESCRIPTION	Slope movement, debris blocked the underlying road. Boulders of more than 1 m of diameter detached from slope
ESI INTENSITY	VII
PHOTOGRAPIC DOCUMENTATION

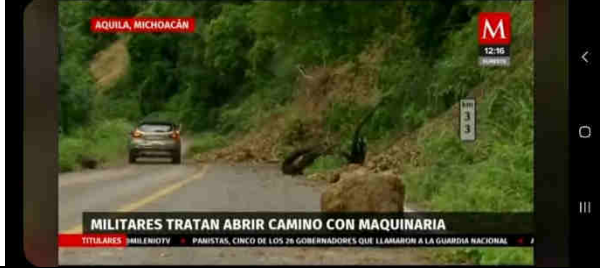
SITE	5
LATITUDE	18.60176461697961
LONGITUDE	-103.5037334784092
DISTANCE FROM EPICENTER	46
CITY	Aquila, Michoacán
EEE TYPE	Slope movement
EEE DESCRIPTION	Modest rock falls 10^3 - 10^5 m ³
ESI INTENSITY	VII
GEOMORPHOLOGICAL ASSET	Slope
PHOTOGRAPIC DOCUMENTATION

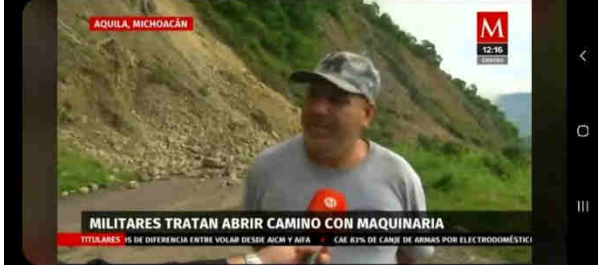
SITE	7
LATITUDE	18.593924668762213
LONGITUDE	-103.49350161004624
DISTANCE FROM EPICENTER	45
CITY	Aguila, Michoacán
EEE TYPE	Slope movement
EEE DESCRIPTION	Modest rock falls 10^3 - 10^5 m ³
ESI INTENSITY	VII
GEOMORPHOLOGICAL ASSET	Slope
PHOTOGRAPIC DOCUMENTATION

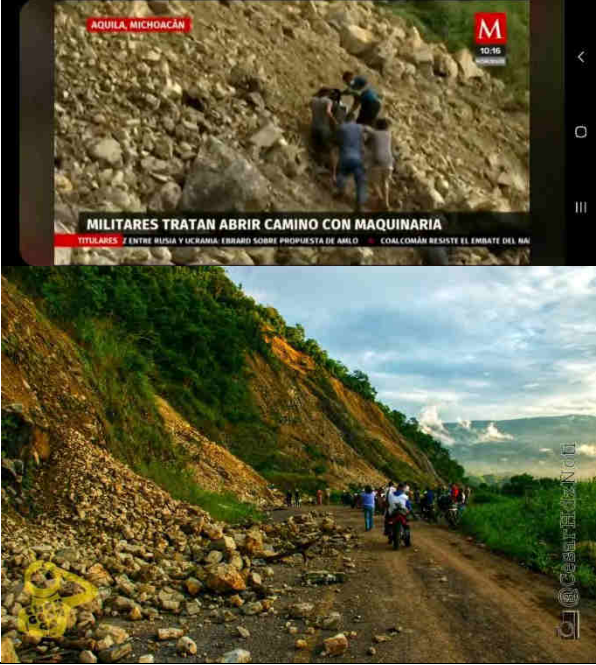
SITE	8
LATITUDE	18.584010391264528
LONGITUDE	-103.51780969584142
DISTANCE FROM EPICENTER	45
CITY	Aguila, Michoacán
EEE TYPE	Slope movement
EEE DESCRIPTION	Rock falls, estimated volume in the order of 10 ⁵ m ³
ESI INTENSITY	IX
PHOTOGRAPIC DOCUMENTATION

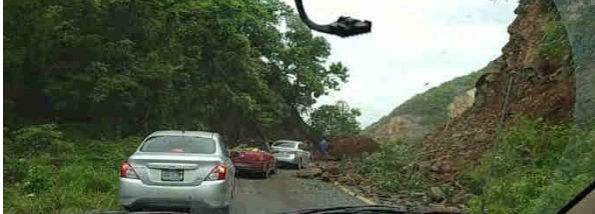
SITE	12
LATITUDE	18.757256515626494
LONGITUDE	-103.61427770644785
DISTANCE FROM EPICENTER	67
CITY	Coahuayana, Michoacán
EEE TYPE	Slope movement
EEE DESCRIPTION	rock falls 10 ³ m ³
ESI INTENSITY	VII
PHOTOGRAPIC DOCUMENTATION

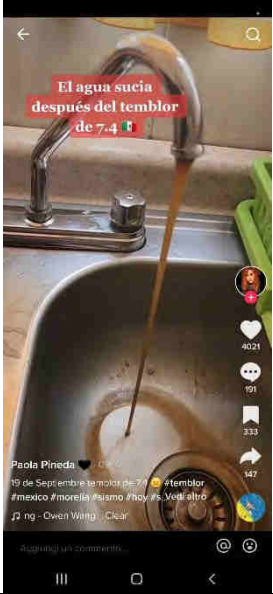
SITE	14
LATITUDE	19.703964823310113
LONGITUDE	-101.19926117221563
DISTANCE FROM EPICENTER	274
CITY	Morelia, Michoacán
EEE TYPE	Hydrogeological anomalies
EEE DESCRIPTION	Variations of chemical-physical: turbidity
ESI INTENSITY	VII
PHOTOGRAPIC DOCUMENTATION

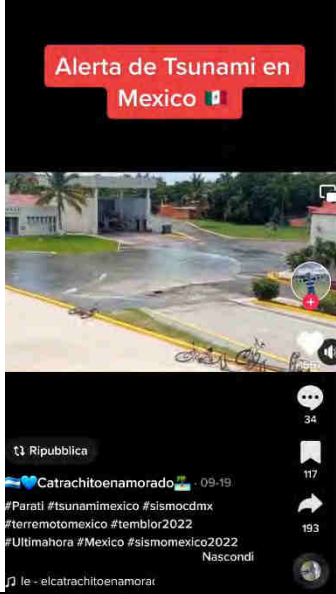
SITE	15
LATITUDE	19.059065096736624
LONGITUDE	-104.29697080660077
DISTANCE FROM EPICENTER	140
CITY	Manzanillo, Michoacán
EEE TYPE	Anomalous waves and tsunamis
EEE DESCRIPTION	Runups of up to several m inland
ESI INTENSITY	IX
PHOTOGRAPIC DOCUMENTATION

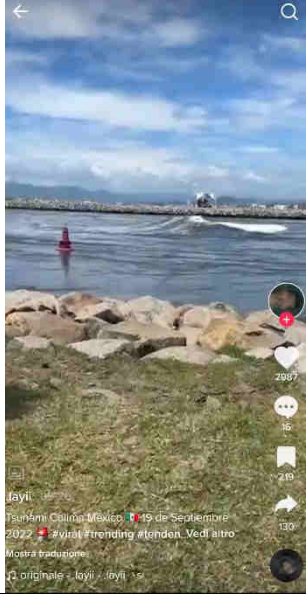
SITE	16
LATITUDE	19.061749027114615
LONGITUDE	-104.30516748469411
DISTANCE FROM EPICENTER	141
CITY	Escollera de las Brisas, Manzanillo, Colima, Michoacán
EEE TYPE	Anomalous waves and tsunamis
EEE DESCRIPTION	Runups of up to several m inland
ESI INTENSITY	IX
PHOTOGRAPIC DOCUMENTATION

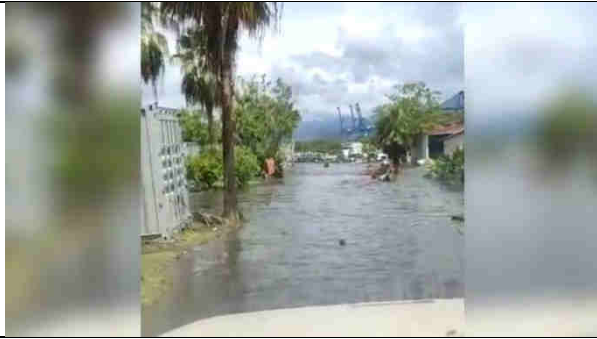
SITE	21
LATITUDE	19.113147305800634
LONGITUDE	-104.3394952569998
DISTANCE FROM EPICENTER	147
CITY	Manzanillo, Michoacán
EEE TYPE	Anomalous waves and tsunamis
EEE DESCRIPTION	Runups of up to several m inland
ESI INTENSITY	IX
PHOTOGRAPIC DOCUMENTATION

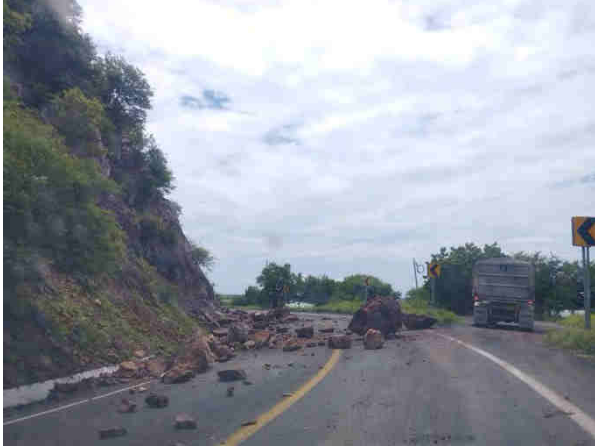
SITE	22
LATITUDE	18.915756200648477
LONGITUDE	-103.84970942522264
DISTANCE FROM EPICENTER	95
CITY	Carretera de Colima, Laguna de Cuyutlan, Colima
EEE TYPE	Slope movements
EEE DESCRIPTION	Landslide of 10 - 10 ³ m ³
ESI INTENSITY	VI
PHOTOGRAPIC DOCUMENTATION

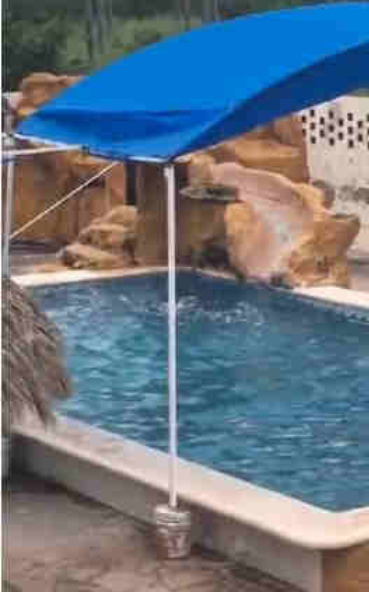
SITE	24
LATITUDE	22.540352942129687
LONGITUDE	-105.7371211538358
DISTANCE FROM EPICENTER	540
CITY	Teacapán, Sinaloa
EEE TYPE	Anomalous waves and tsunamis
EEE DESCRIPTION	Overflows in pools and small ponds
ESI INTENSITY	V
PHOTOGRAPIC DOCUMENTATION

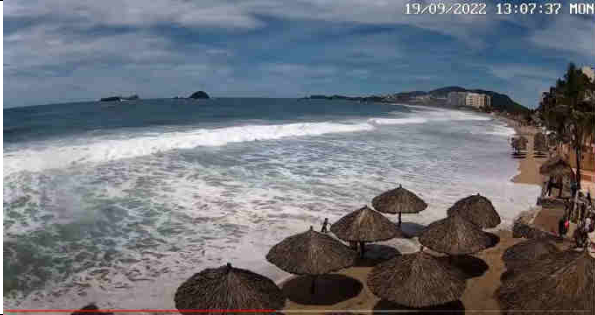
SITE	25
LATITUDE	17.661363454827047
LONGITUDE	-101.6078221879194
DISTANCE FROM EPICENTER	189
CITY	Ixtapa, Guerrero
EEE TYPE	Anomalous waves and tsunamis
EEE DESCRIPTION	Anomalous waves of 0 – several tens of cm
ESI INTENSITY	VI
PHOTOGRAPIC DOCUMENTATION

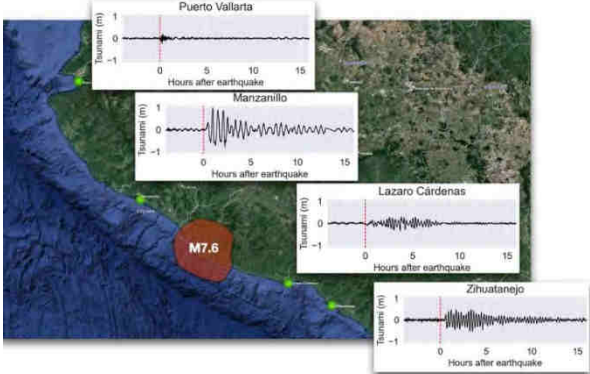
SITE	32
LATITUDE	17.638609114840968
LONGITUDE	-101.55327118250321
DISTANCE FROM EPICENTER	196
CITY	Zihuatanejo, Guerrero
EEE TYPE	Anomalous waves and tsunamis
EEE DESCRIPTION	Anomalous waves of 0 – several tens of cm
ESI INTENSITY	VI
PHOTOGRAPIC DOCUMENTATION

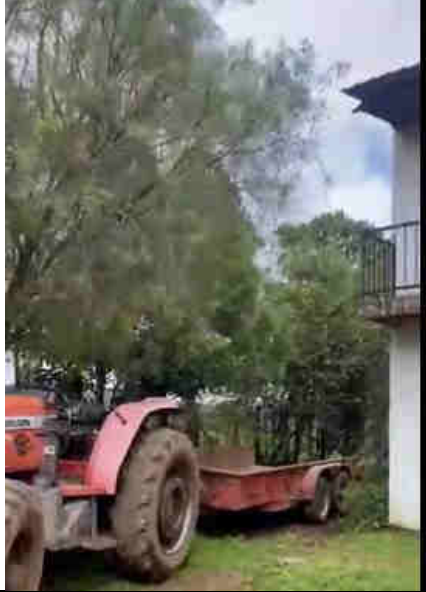
SITE	33
LATITUDE	19.704217655368538
LONGITUDE	-103.46865708428385
DISTANCE FROM EPICENTER	163
CITY	Guzman, Jalisco
EEE TYPE	Tree shaking
EEE DESCRIPTION	Tree limbs shake moderately to strongly Very few tree tops and dead limbs break and fall
ESI INTENSITY	VI
PHOTOGRAPIC DOCUMENTATION

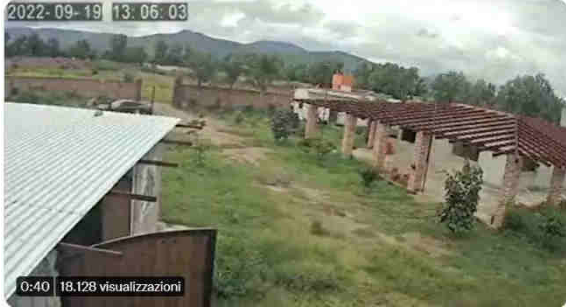
SITE	34
LATITUDE	20.35045149327325
LONGITUDE	-103.6739012514974
DISTANCE FROM EPICENTER	237
CITY	Atotonilco el Bajo, Jalisco
EEE TYPE	Tree shaking
EEE DESCRIPTION	Tree limbs shake moderately to strongly Very few tree tops and dead limbs break and fall
ESI INTENSITY	VI
PHOTOGRAPIC DOCUMENTATION

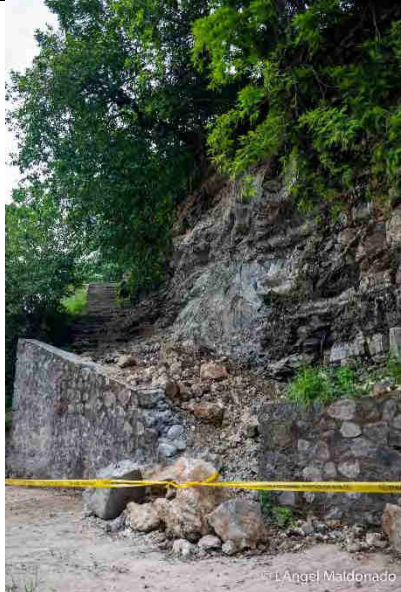
SITE	41
LATITUDE	18.935916382989877
LONGITUDE	-103.96507925763008
DISTANCE FROM EPICENTER	105
CITY	Ciudad de Armeria, Colima
EEE TYPE	Slope movement
EEE DESCRIPTION	landslide of 10 m ³
ESI INTENSITY	VI
PHOTOGRAPIC DOCUMENTATION

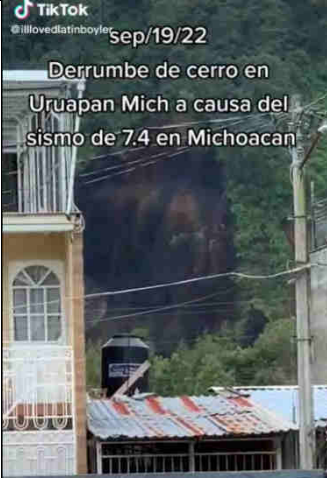
SITE	43
LATITUDE	19.43899214446162
LONGITUDE	-102.05057813760828
DISTANCE FROM EPICENTER	186
CITY	Uruapan, Michoacán
EEE TYPE	Slope movement
EEE DESCRIPTION	Landslide 10 ³ -10 ⁵ m ³
ESI INTENSITY	VIII
PHOTOGRAPIC DOCUMENTATION

<p>TikTok @illlovedlatinboyle sep/19/22 Derrumbe de cerro en Uruapan Mich a causa del sismo de 7.4 en Michoacan</p>
REFERENCES	https://vm.tiktok.com/ZMFPeAwRY/

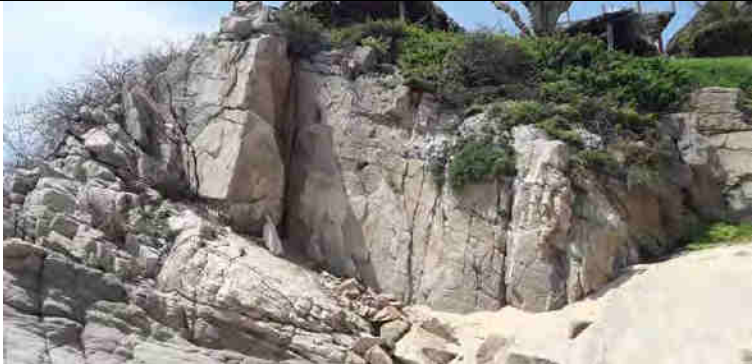
SITE NUMBER	50
LATITUDE	18.3516667
LONGITUDE	-103.51194444444444
DISTANCE FROM EPICENTER	27
CITY	Faro de Bucerias, Michoacán
EEE TYPE	Slope movements
EEE DESCRIPTION	Scattered landslide in prone area
ESI INTENSITY	VII
PHOTOGRAPHIC DOCUMENTATION

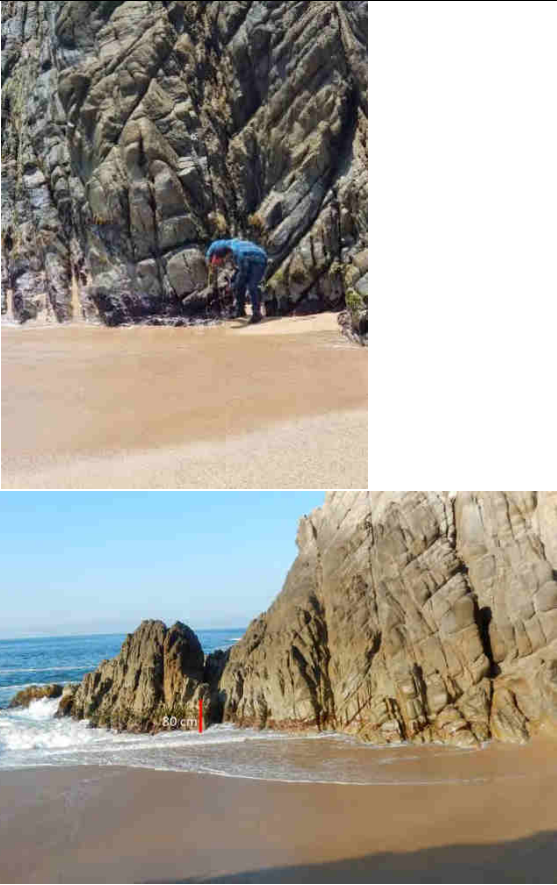
SITE NUMBER	51
LATITUDE	18.3516667
LONGITUDE	-103.51194444444444
DISTANCE FROM EPICENTER	27
CITY	Faro de Bucerias, Michoacán
EEE TYPE	Tectonic uplift
EEE DESCRIPTION	Tectonic uplift of 60 cm indicated by a fresh rock stratum at the base and a layer of organisms exposed to desiccation from the earthquake
ESI INTENSITY	X
PHOTOGRAPHIC DOCUMENTATION

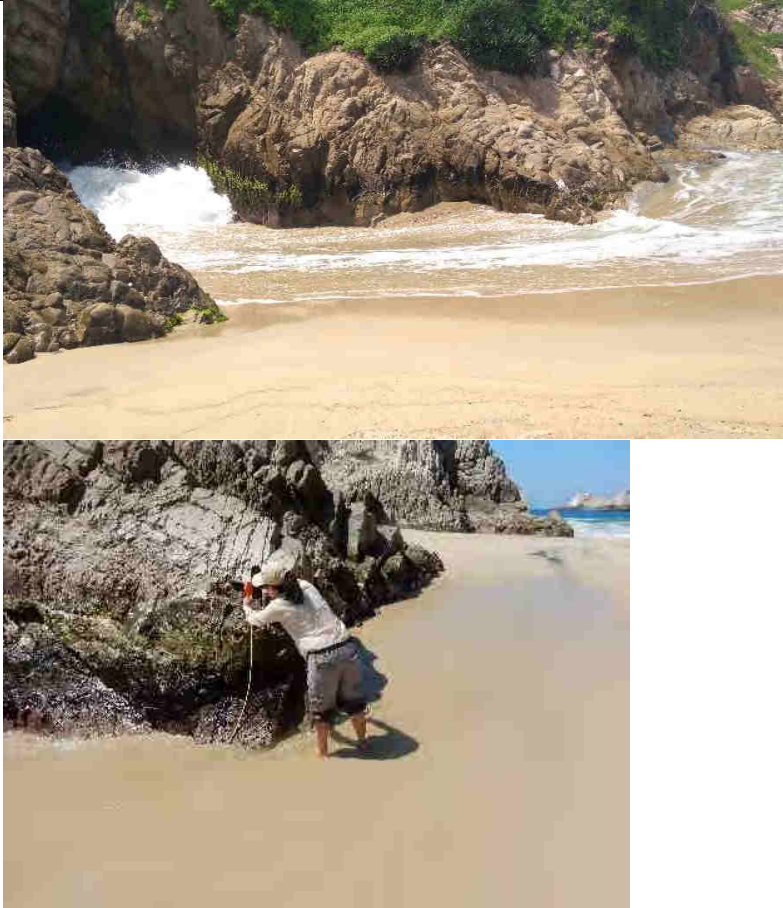
SITE NUMBER	57
LATITUDE	18.267457
LONGITUDE	-103.35083333333333
DISTANCE FROM EPICENTER	7
CITY	Maruata, Michoacán
EEE TYPE	Tectonic Uplift
EEE DESCRIPTION	The elevation reaches in this zone 50-73 cm; with the earthquake, the level (6 months later, green due to the cover of new algae), remained white due to the organisms killed by desiccation.
ESI INTENSITY	X
PHOTOGRAPHIC DOCUMENTATION

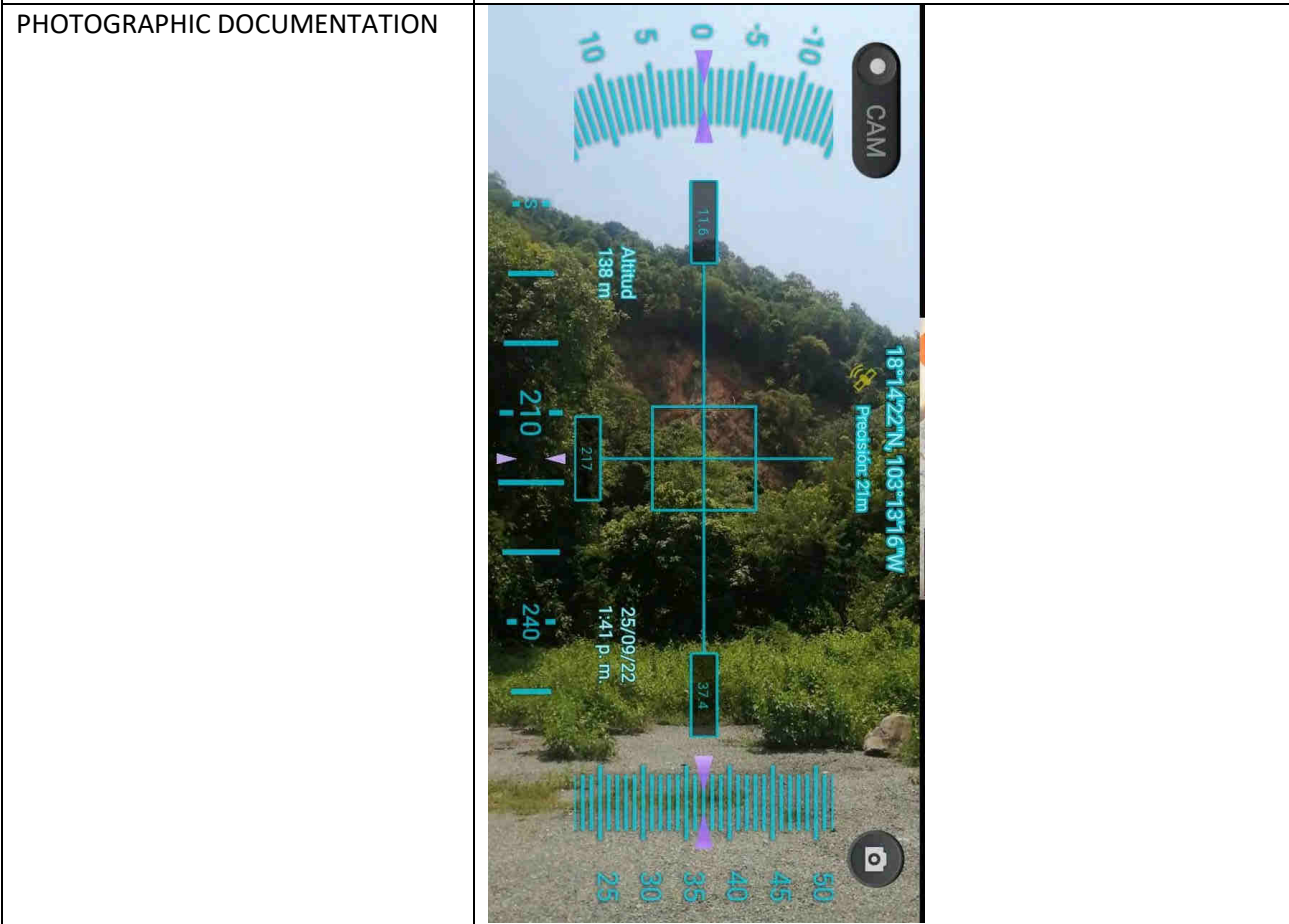
SITE NUMBER	82
LATITUDE	18.2338889
LONGITUDE	-103.22111111111111
DISTANCE FROM EPICENTER	7
CITY	Tecomán - Lazaro Cárdenas road, Aquila, Michoacán
EEE TYPE	Slope movements
EEE DESCRIPTION	Rockfall of 10-10 ³ m ³
ESI INTENSITY	VI

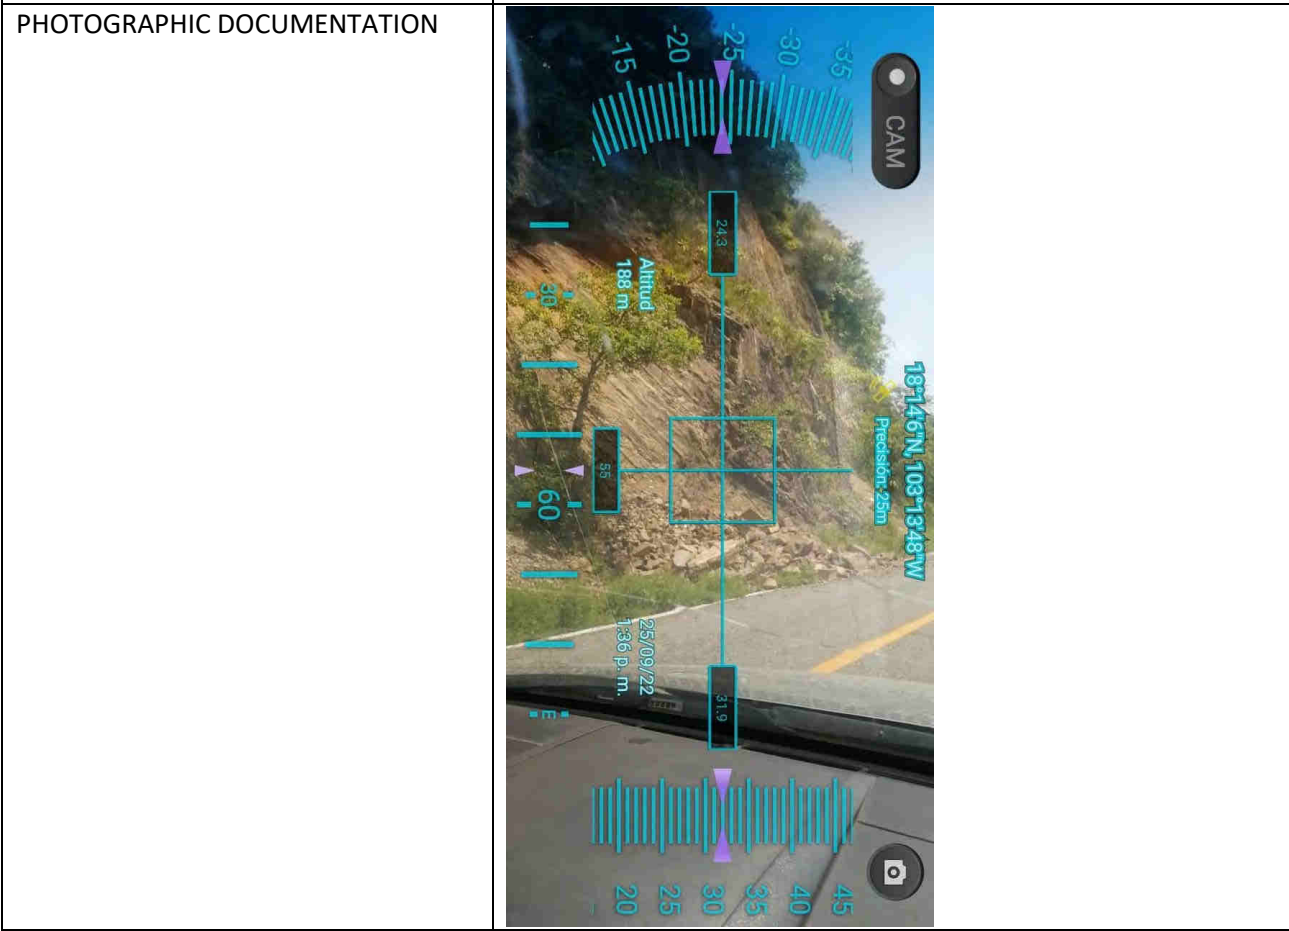
SITE NUMBER	89
LATITUDE	18.235
LONGITUDE	-103.23
DISTANCE FROM EPICENTER	6
CITY	Tecomán - Lazaro Cárdenas road, Aquila, Michoacán
EEE TYPE	Slope movements
EEE DESCRIPTION	Rockfall of 10-10 ³ m ³
ESI INTENSITY	VI

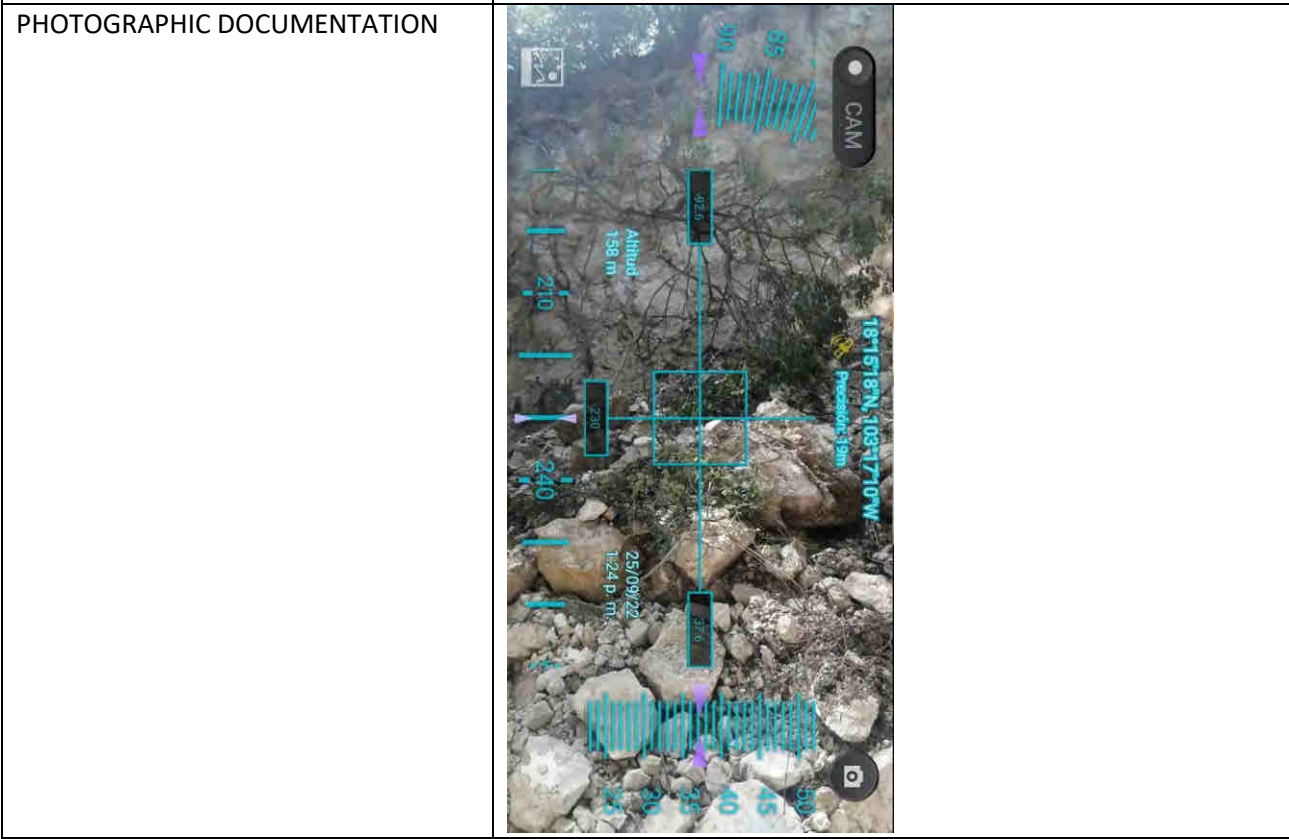
SITE NUMBER	93
LATITUDE	18.255
LONGITUDE	-103.28611111111111
DISTANCE FROM EPICENTER	2
CITY	Tecomán - Lazaro Cárdenas road, Aquila, Michoacán
EEE TYPE	Slope movements
EEE DESCRIPTION	Rockfall of 10-10 ³ m ³
ESI INTENSITY	VI

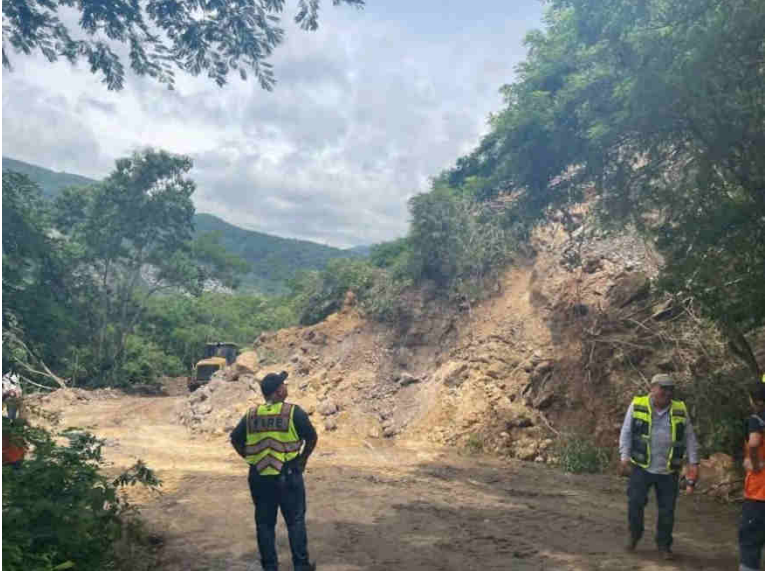
SITE NUMBER	96
LATITUDE	18.233056
LONGITUDE	-103.179278
DISTANCE FROM EPICENTER	12
CITY	Zihuatanejo – Manzanillo road, Aquila, Michoacán
EEE TYPE	Slope movements
EEE DESCRIPTION	Rockfall of 10-10 ³ m ³
ESI INTENSITY	VI
PHOTOGRAPHIC DOCUMENTATION

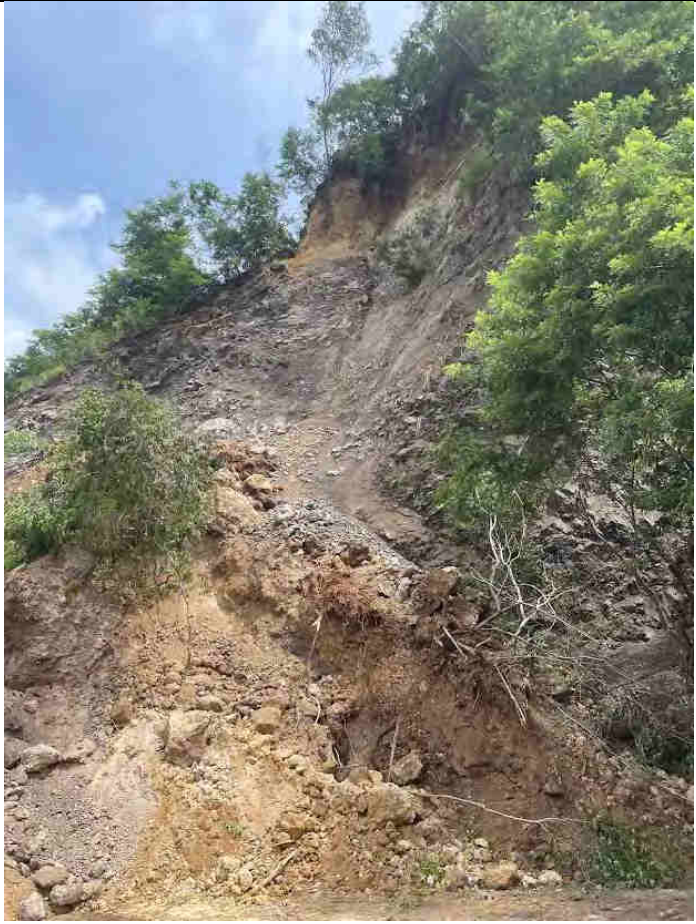
SITE NUMBER	97
LATITUDE	18.233111
LONGITUDE	-103.179222
DISTANCE FROM EPICENTER	12
CITY	Zihuatanejo – Manzanillo road, Aquila, Michoacán
EEE TYPE	Slope movements
EEE DESCRIPTION	Rockfall of 10-10 ³ m ³
ESI INTENSITY	VI
PHOTOGRAPHIC DOCUMENTATION

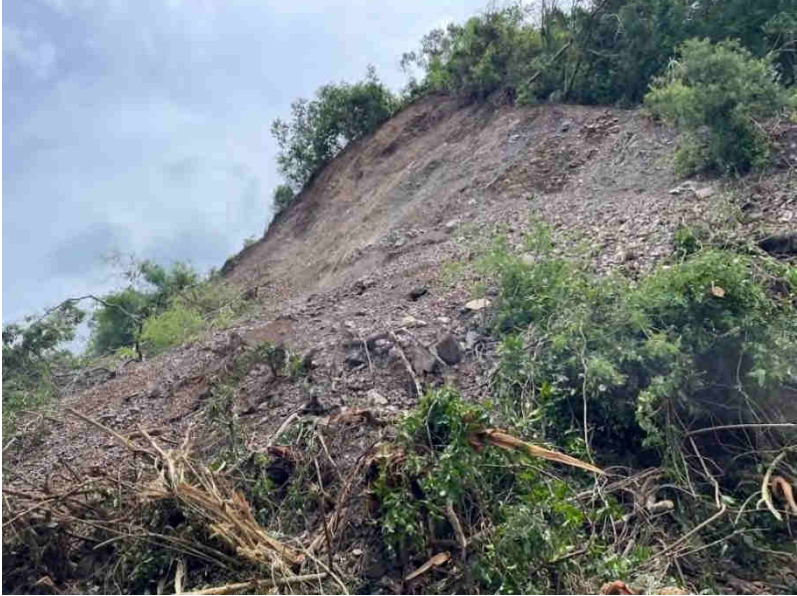
SITE NUMBER	98
LATITUDE	18.235528
LONGITUDE	-103.185778
DISTANCE FROM EPICENTER	11
CITY	Zihuatanejo – Manzanillo road, Aquila, Michoacán
EEE TYPE	Slope movements
EEE DESCRIPTION	Rockfall of 10^3 - 10^5 m ³
ESI INTENSITY	VII
PHOTOGRAPHIC DOCUMENTATION

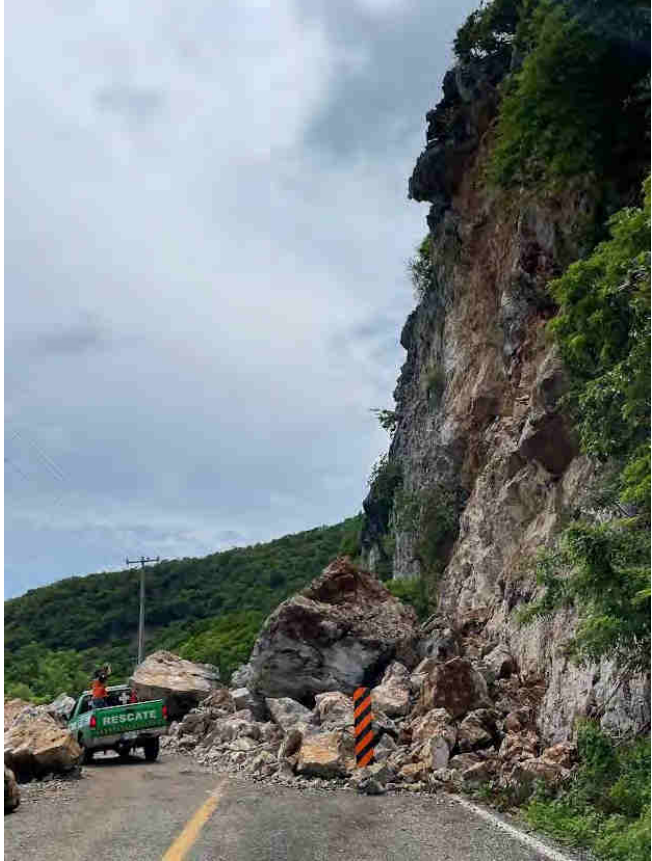
SITE NUMBER	99
LATITUDE	18.229528
LONGITUDE	-103.186806
DISTANCE FROM EPICENTER	11
CITY	Zihuatanejo – Manzanillo road, Aquila, Michoacán
EEE TYPE	Slope movements
EEE DESCRIPTION	Rockfall of 10-10 ³ m ³
ESI INTENSITY	VI
PHOTOGRAPHIC DOCUMENTATION

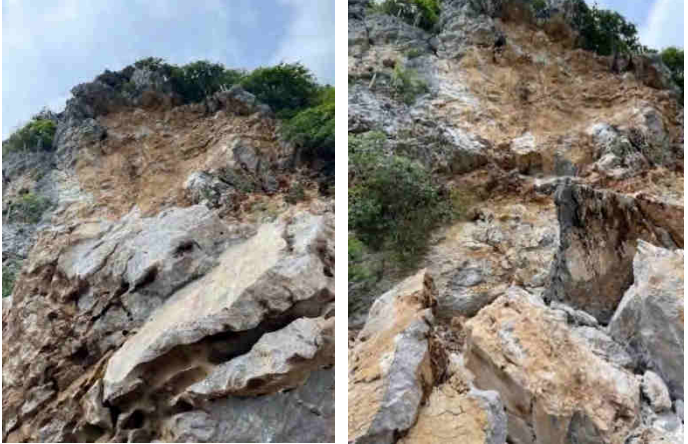
SITE NUMBER	100
LATITUDE	18.229361
LONGITUDE	-103.186972
DISTANCE FROM EPICENTER	11
CITY	Zihuatanejo – Manzanillo road, Aquila, Michoacán
EEE TYPE	Slope movements
EEE DESCRIPTION	Rockfall of 10^5 - 10^6 m ³
ESI INTENSITY	IX
PHOTOGRAPHIC DOCUMENTATION

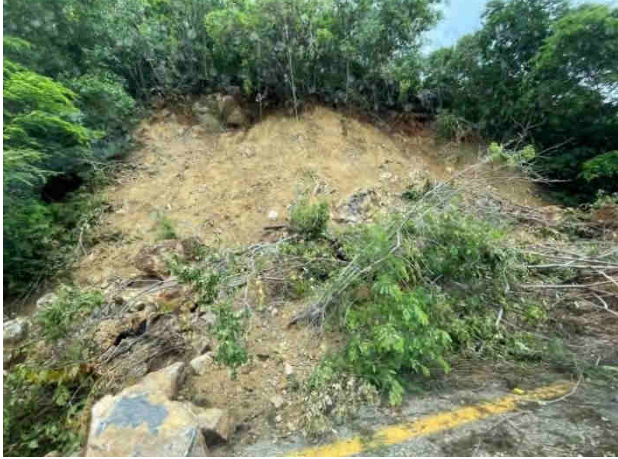
SITE NUMBER	101
LATITUDE	18.227806
LONGITUDE	-103.194361
DISTANCE FROM EPICENTER	10
CITY	Zihuatanejo – Manzanillo road, Aquila, Michoacán
EEE TYPE	Slope movements
EEE DESCRIPTION	Rockfall of 10-10 ³ m ³
ESI INTENSITY	VI
PHOTOGRAPHIC DOCUMENTATION

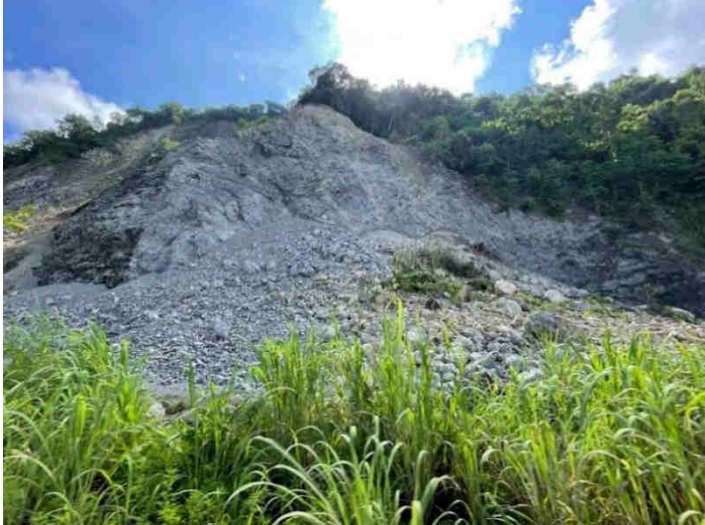
SITE NUMBER	102
LATITUDE	18.609472
LONGITUDE	-103.484222
DISTANCE FROM EPICENTER	46
CITY	Tepalcatepec – Aquila road, Colonia La Ine, Aquila, Michoacán
EEE TYPE	Slope movements
EEE DESCRIPTION	Rockfall of 10^3 - 10^5 m ³
ESI INTENSITY	VIII
PHOTOGRAPHIC DOCUMENTATION

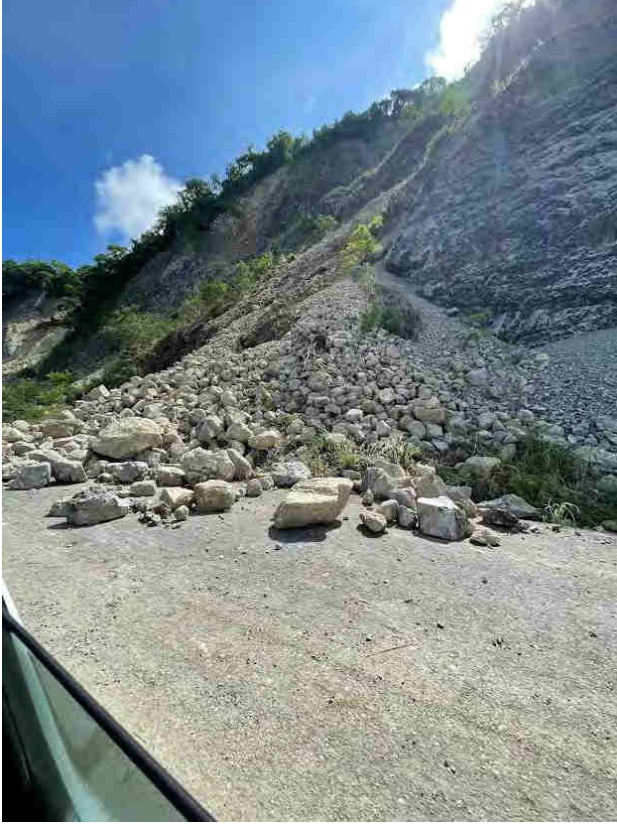
SITE NUMBER	103
LATITUDE	18.609778
LONGITUDE	-103.484111
DISTANCE FROM EPICENTER	46
CITY	Tepalcatepec – Aquila road, Colonia La Ine, Aquila, Michoacán
EEE TYPE	Slope movements
EEE DESCRIPTION	Rockfall of 10-10 ³ m ³
ESI INTENSITY	VI
PHOTOGRAPHIC DOCUMENTATION

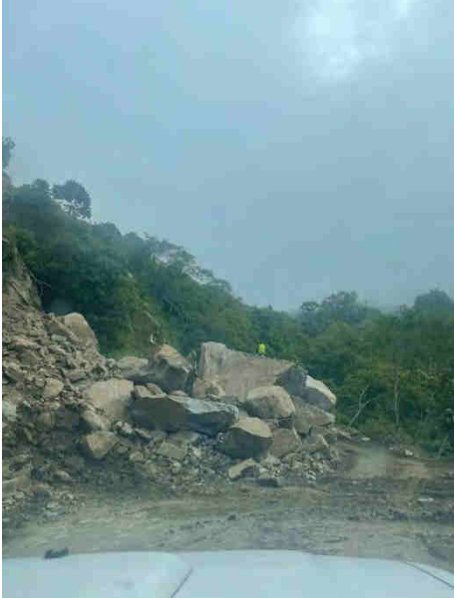
SITE NUMBER	104
LATITUDE	18.668472
LONGITUDE	-103.420889
DISTANCE FROM EPICENTER	49
CITY	Tepalcatepec – Aquila road, Huitzontla, Chinicuilá, Michoacán
EEE TYPE	Slope movements
EEE DESCRIPTION	Rockfall of 10^3 - 10^5 m ³
ESI INTENSITY	VII
PHOTOGRAPHIC DOCUMENTATION

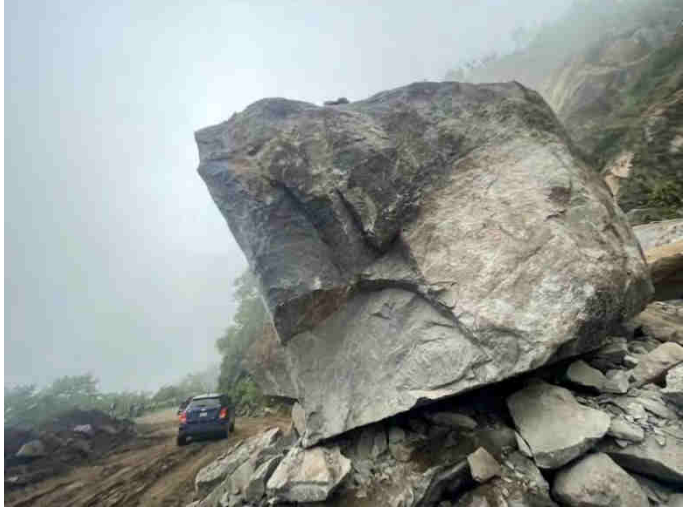
SITE NUMBER	105
LATITUDE	18.668472
LONGITUDE	-103.420889
DISTANCE FROM EPICENTER	49
CITY	Tepalcatepec – Aquila Road, Huitzontla, Chinicuila, Michoacán
EEE TYPE	Slope movements
EEE DESCRIPTION	Rockfall of 10^5 - 10^6 m ³
ESI INTENSITY	IX
PHOTOGRAPHIC DOCUMENTATION

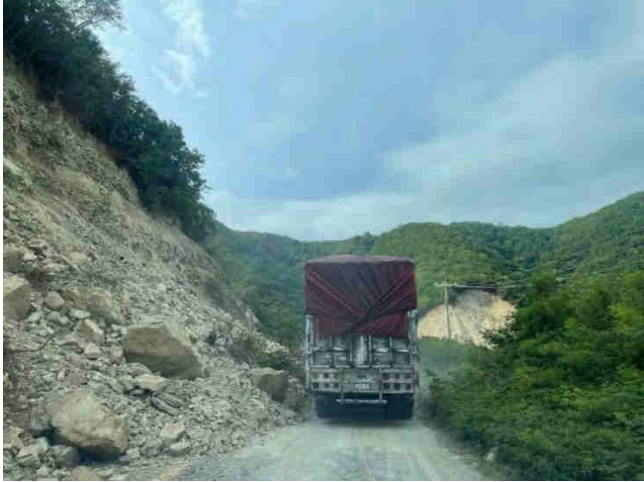
SITE NUMBER	106
LATITUDE	18.235361
LONGITUDE	-103.228889
DISTANCE FROM EPICENTER	6
CITY	Zihuatanejo – Manzanillo road, El Naranjito, Michoacán
EEE TYPE	Slope movements
EEE DESCRIPTION	Landslide of 10^3 - 10^5 m ³
ESI INTENSITY	VIII
PHOTOGRAPHIC DOCUMENTATION

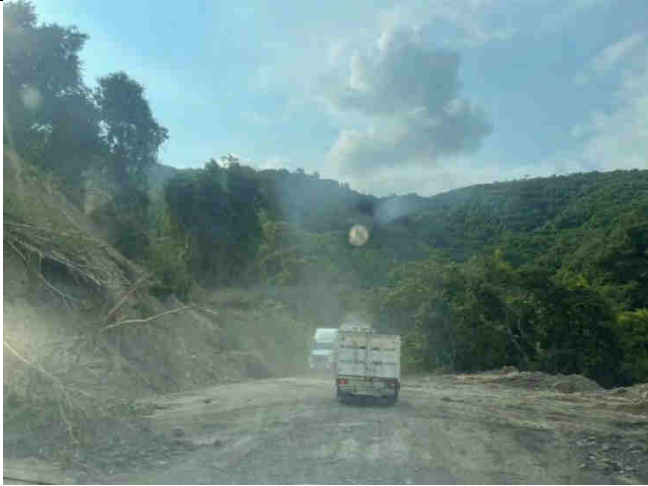
SITE NUMBER	107
LATITUDE	18.235333
LONGITUDE	-103.185500
DISTANCE FROM EPICENTER	11
CITY	Zihuatanejo – Manzanillo road, Aquila, Michoacán
EEE TYPE	Slope movements
EEE DESCRIPTION	Landslide of 10^3 - 10^5 m ³
ESI INTENSITY	VIII
PHOTOGRAPHIC DOCUMENTATION

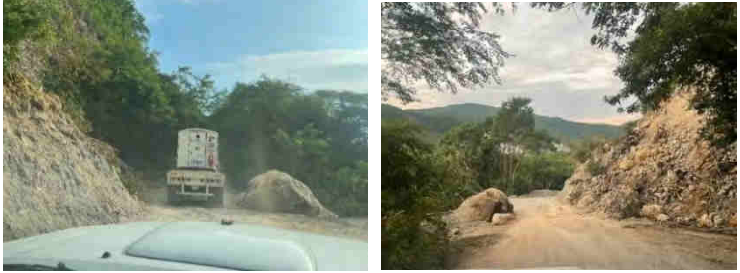
SITE NUMBER	108
LATITUDE	18.233222
LONGITUDE	-103.179167
DISTANCE FROM EPICENTER	12
CITY	Zihuatanejo – Manzanillo road, Aquila, Michoacán
EEE TYPE	Slope movements
EEE DESCRIPTION	Landslide and rockfall of 10-10 ³ m ³
ESI INTENSITY	VI
PHOTOGRAPHIC DOCUMENTATION

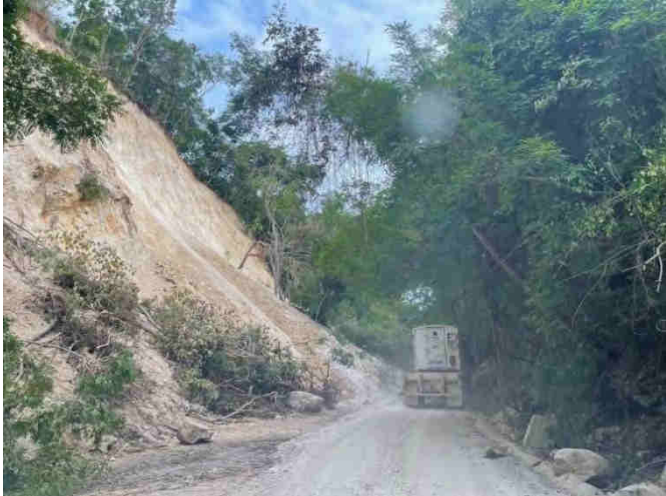
SITE NUMBER	109
LATITUDE	18.2180556
LONGITUDE	103.16777777777779
DISTANCE FROM EPICENTER	13
CITY	Zihuatanejo – Manzanillo road, Aquila, Michoacán
EEE TYPE	Slope movements
EEE DESCRIPTION	Landslide of 10^3 - 10^5 m ³
ESI INTENSITY	VIII
PHOTOGRAPHIC DOCUMENTATION

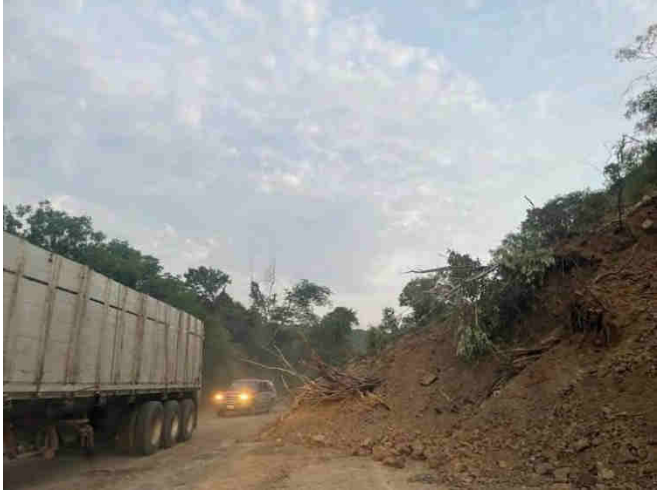
SITE NUMBER	110
LATITUDE	18.235389
LONGITUDE	-103.185694
DISTANCE FROM EPICENTER	11
CITY	Zihuatanejo – Manzanillo road, Aquila, Michoacán
EEE TYPE	Slope movements
EEE DESCRIPTION	landslides of 10 ³ -10 ⁵ m ³
ESI INTENSITY	VIII
PHOTOGRAPHIC DOCUMENTATION

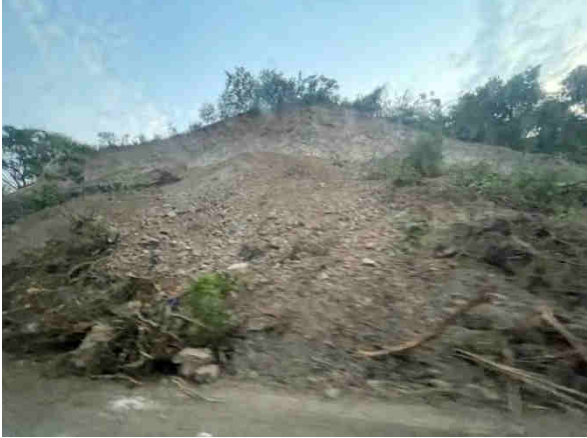
SITE NUMBER	111
LATITUDE	18.235333
LONGITUDE	-103.185472
DISTANCE FROM EPICENTER	11
CITY	Zihuatanejo – Manzanillo road, Aquila, Michoacán
EEE TYPE	Slope movements
EEE DESCRIPTION	landslides of 10 ³ -10 ⁵ m ³
ESI INTENSITY	VIII
PHOTOGRAPHIC DOCUMENTATION

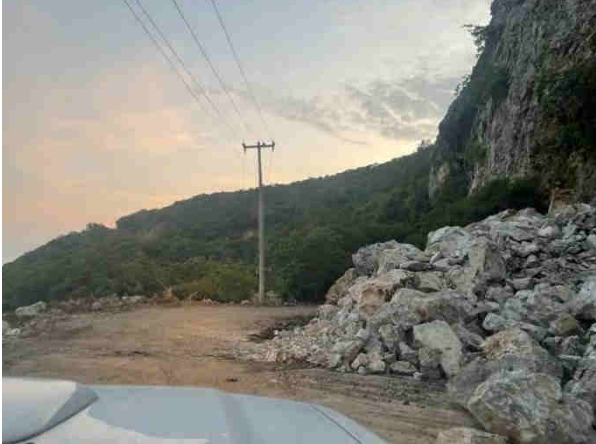
SITE NUMBER	112
LATITUDE	18.229417
LONGITUDE	-103.186861
DISTANCE FROM EPICENTER	11
CITY	Zihuatanejo – Manzanillo road, Aquila, Michoacán
EEE TYPE	Slope movements
EEE DESCRIPTION	rockfall of 10-10 ³ m ³
ESI INTENSITY	VII
PHOTOGRAPHIC DOCUMENTATION

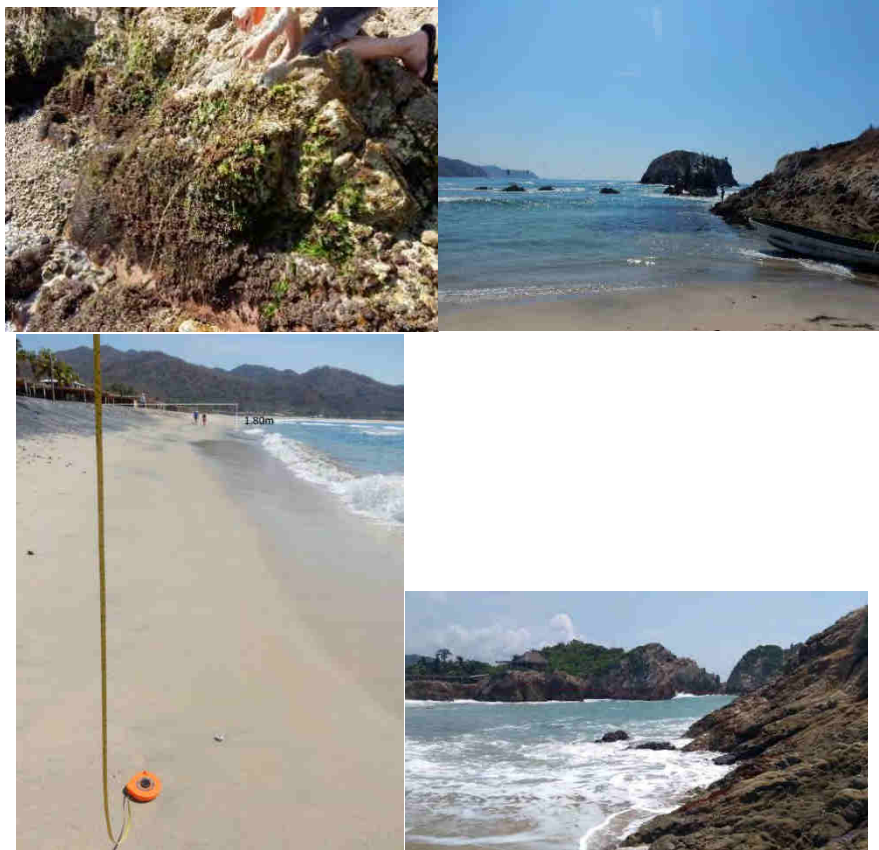
SITE NUMBER	113
LATITUDE	18.268603
LONGITUDE	-103.3475832
DISTANCE FROM EPICENTER	7
CITY	Maruata, Michoacán
EEE TYPE	Tectonic uplift
EEE DESCRIPTION	The elevation reaches in this zone up to 0.94 - 1.70m; The rocks next to the "morro" were normally covered with water before the earthquake, with the earthquake the level, (6 months later, green color), was white due to the organisms that died due to desiccation. The uplift is evident in the color of the rock and in the color of the exposed algae.
ESI INTENSITY	X
PHOTOGRAPHIC DOCUMENTATION

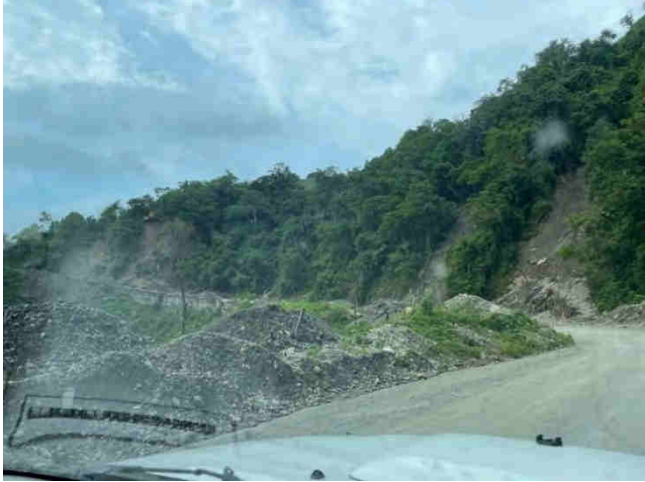
SITE NUMBER	117
LATITUDE	18.6048611
LONGITUDE	-103.48380555555556
DISTANCE FROM EPICENTER	45
CITY	Tepalcatepec – Aquila road, Aquila, Michoacán
EEE TYPE	Slope movements
EEE DESCRIPTION	landslides of 10^5 - 10^6 m ³
ESI INTENSITY	IX
PHOTOGRAPHIC DOCUMENTATION

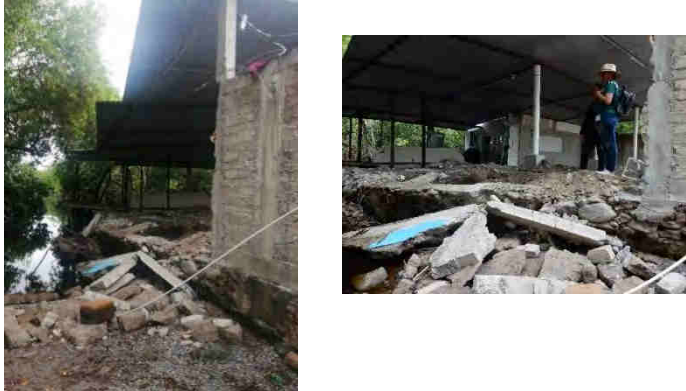
SITE NUMBER	118
LATITUDE	18.685374619093988
LONGITUDE	-103.73377952381449
DISTANCE FROM EPICENTER	68
CITY	Boca de Apiza, Coahuayana, Michoacán
EEE TYPE	Liquefaction processes
EEE DESCRIPTION	Liquefaction, >30 cm localized lateral spreading
ESI INTENSITY	IX
PHOTOGRAPHIC DOCUMENTATION

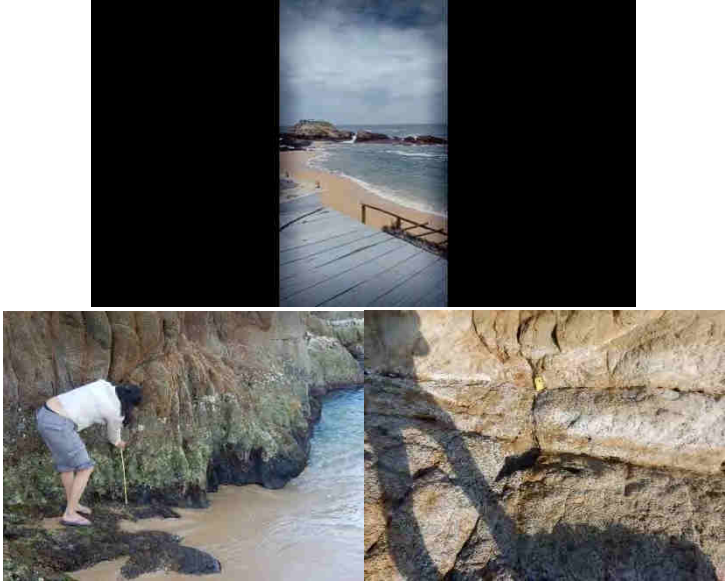
SITE NUMBER	119
LATITUDE	18.347096
LONGITUDE	-103.511218
DISTANCE FROM EPICENTER	26
CITY	Faro de Bucerias, Michoacán
EEE TYPE	Tectonic uplift
EEE DESCRIPTION	Tectonic uplift of 58 - 62 cm indicated by a fresh rock stratum at the base and layer of organisms exposed to desiccation from the earthquake
ESI INTENSITY	X
PHOTOGRAPHIC DOCUMENTATION

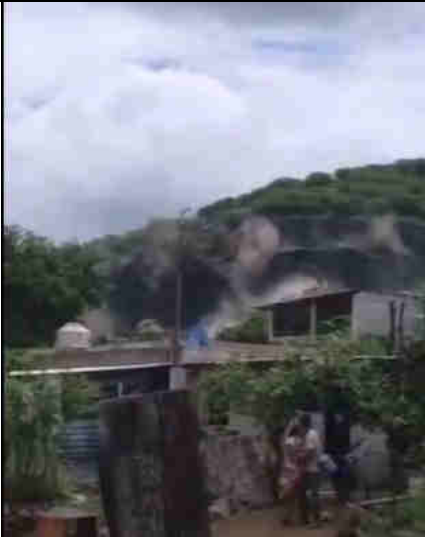
SITE NUMBER	122
LATITUDE	19.04568
LONGITUDE	-102.08593
DISTANCE FROM EPICENTER	155
CITY	Nueva Italia, Michoacán
EEE TYPE	Slope movements
EEE DESCRIPTION	Landslide 10^3 - 10^5 m ³
ESI INTENSITY	VIII
PHOTOGRAPHIC DOCUMENTATION

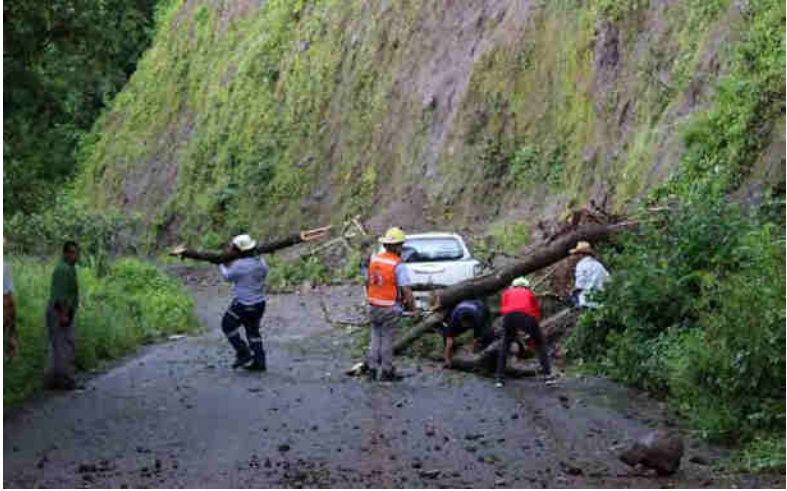
SITE NUMBER	126
LATITUDE	19.35321
LONGITUDE	-103.86038
DISTANCE FROM EPICENTER	137
CITY	Comala - Campo 4 road, Comala, Michoacán
EEE TYPE	Slope movements
EEE DESCRIPTION	landslides of 10^3 - 10^5 m ³
ESI INTENSITY	VIII
PHOTOGRAPHIC DOCUMENTATION

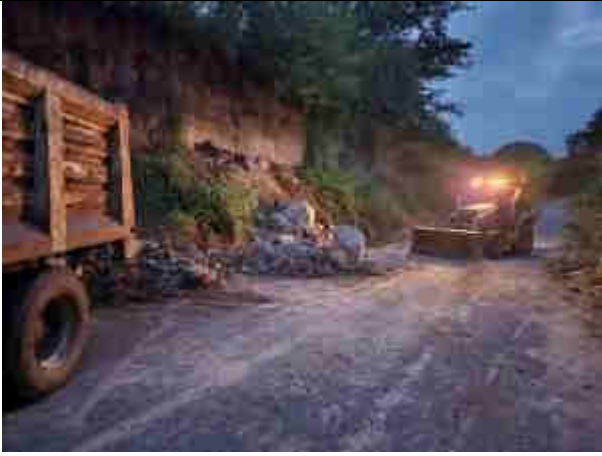
SITE NUMBER	127
LATITUDE	19.34533
LONGITUDE	-103.78555
DISTANCE FROM EPICENTER	133
CITY	Comala - La Caja road, Comala, Michoacán
EEE TYPE	Slope movements
EEE DESCRIPTION	Scattered rockfall, volume of few m ³
ESI INTENSITY	VI
PHOTOGRAPHIC DOCUMENTATION

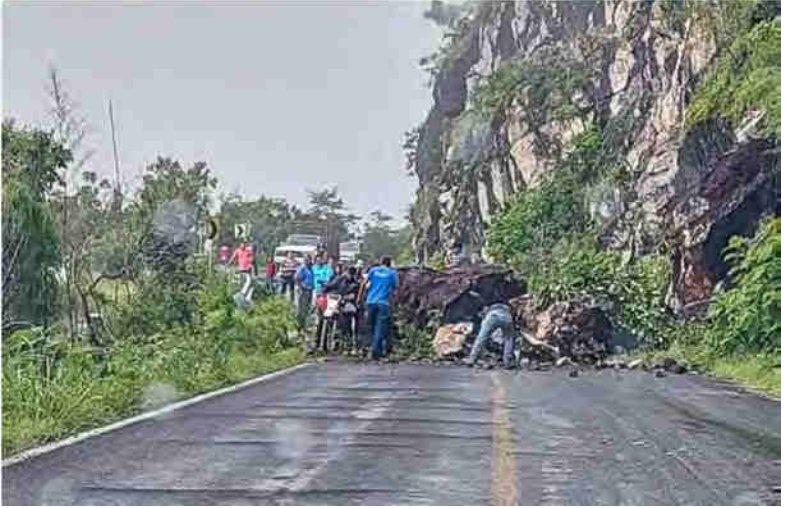
SITE NUMBER	133
LATITUDE	18.9488
LONGITUDE	-103.1099
DISTANCE FROM EPICENTER	81
CITY	Coalcomán-Villa Victoria road, Coalcomán de Vázquez Pallares, Michoacán
EEE TYPE	Slope movements
EEE DESCRIPTION	Stone of > 1 m diameter detached from slope and move away for long distance
ESI INTENSITY	VII
PHOTOGRAPHIC DOCUMENTATION

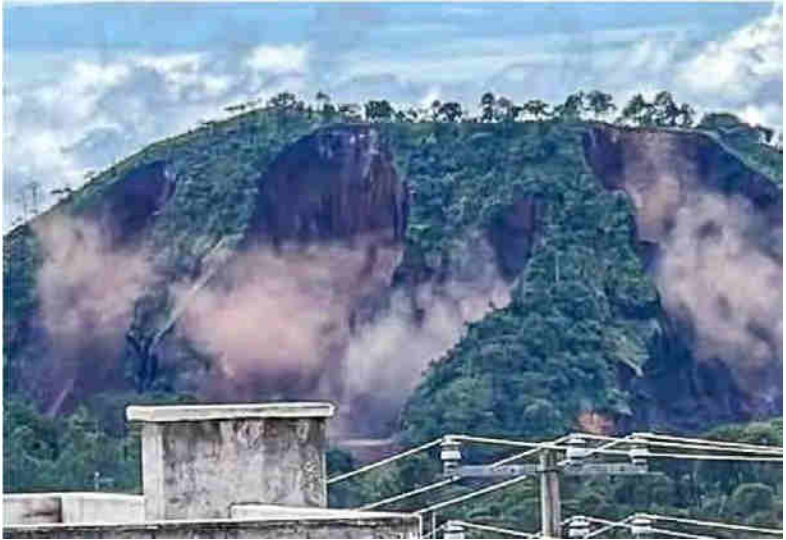
SITE NUMBER	134
LATITUDE	19.2377
LONGITUDE	-103.7740
DISTANCE FROM EPICENTER	122
CITY	Colima, Colima
EEE TYPE	Slope movement
EEE DESCRIPTION	Landslide 10^3 - 10^5 m ³
ESI INTENSITY	VIII
PHOTOGRAPHIC DOCUMENTATION
