Environmental effects caused by the Mw 7.7, September 19, 2022, Michoacán (Mexico)

Descriptive table

This document presents a collection of Earthquake Environmental Effects (EEEs) triggered by the Mw 7.7 Michoacan earthquake occurred on 19 September 2022. Data derive from original field surveys, published reports and papers, and from a search for EEEs posted online in social media and other websites.

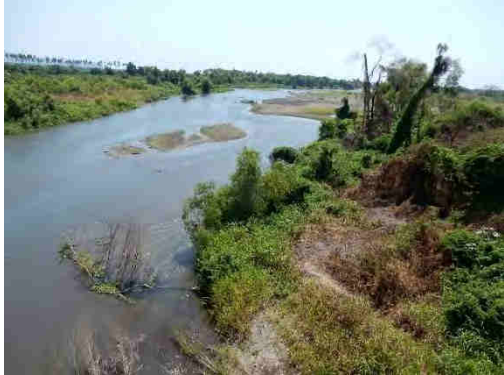
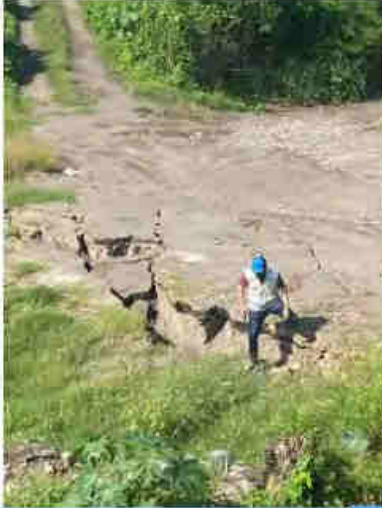
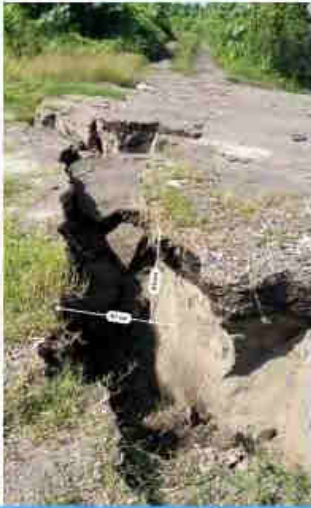
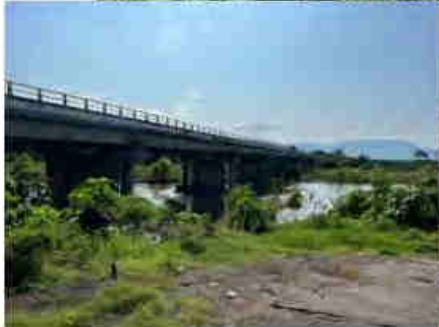
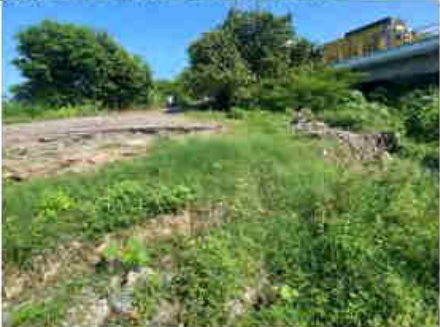
SITE NUMBER	137
LATITUDE	18.717472
LONGITUDE	-103.716876
DISTANCE FROM EPICENTER	69
CITY	La Zapotera, Colima
EEE TYPE	Liquefaction processes
EEE DESCRIPTION	Mud ejection, formation of sand volcanoes and lateral spread a few meters away from the river
ESI INTENSITY	VII
PHOTOGRAPHIC DOCUMENTATION

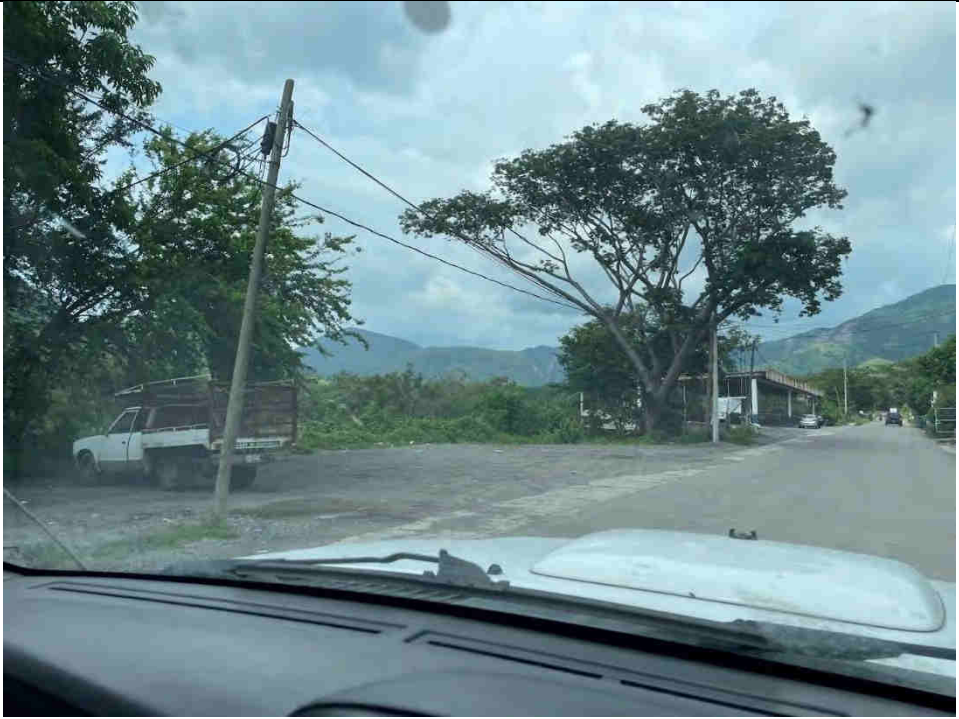
SITE NUMBER	139
LATITUDE	18.589306
LONGITUDE	-103.508933
DISTANCE FROM EPICENTER	45
CITY	Aquila, Michoacán
EEE TYPE	Slope movements
EEE DESCRIPTION	Landslide 10^3 - 10^5 m ³
ESI INTENSITY	VIII
PHOTOGRAPHIC DOCUMENTATION

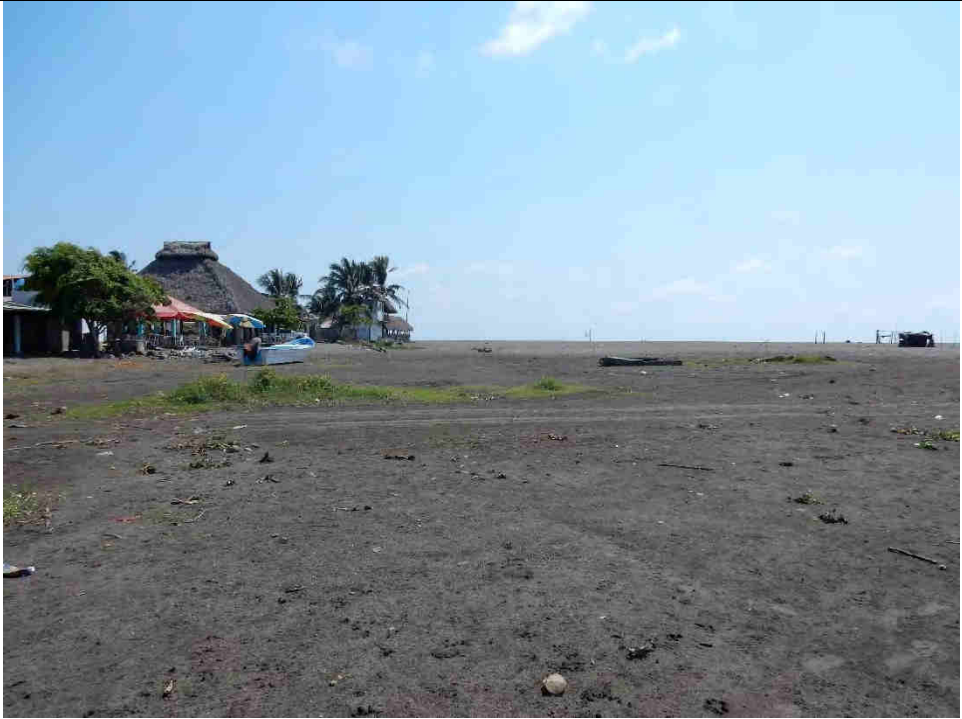
SITE NUMBER	147
LATITUDE	18.6854462
LONGITUDE	-103.736583
DISTANCE FROM EPICENTER	68
CITY	Boca de Apiza, Coahuayana, Michoacán
EEE TYPE	Tectonic uplift
EEE DESCRIPTION	The estuary has dried up, the elevation is about 50 cm.
ESI INTENSITY	X
PHOTOGRAPHIC DOCUMENTATION

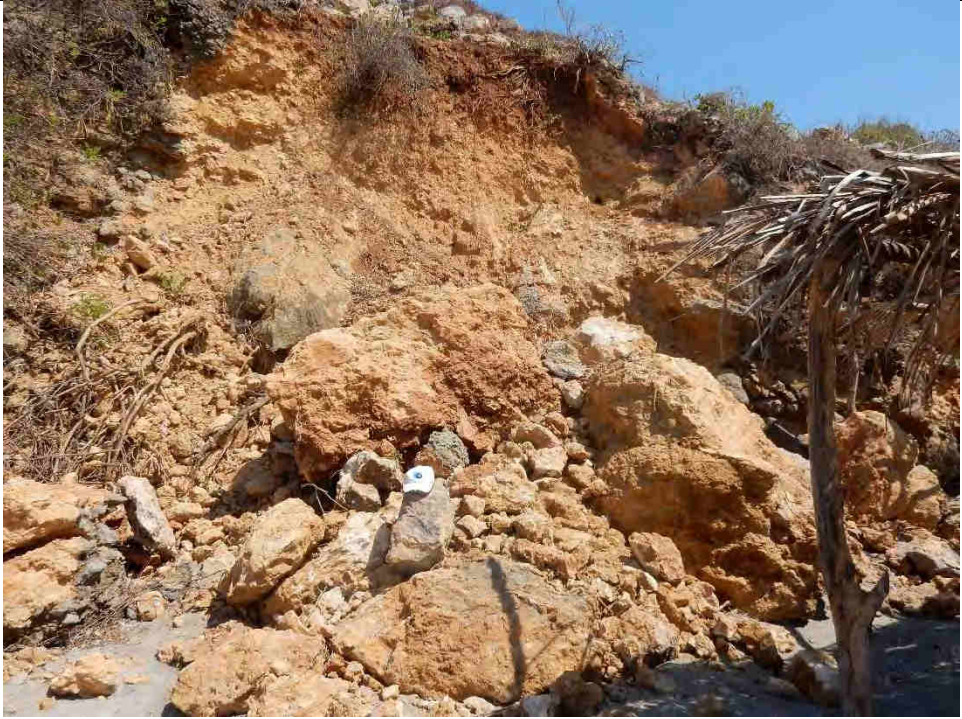
SITE NUMBER	153
LATITUDE	18.558904
LONGITUDE	-103.641948
DISTANCE FROM EPICENTER	51
CITY	Las Brisas, Michoacán
EEE TYPE	Rockfalls
EEE DESCRIPTION	Blocks of varied diameter that reaches up to 3m, with material falling on an unstable slope, on the cliff.
ESI INTENSITY	VII
PHOTOGRAPHIC DOCUMENTATION

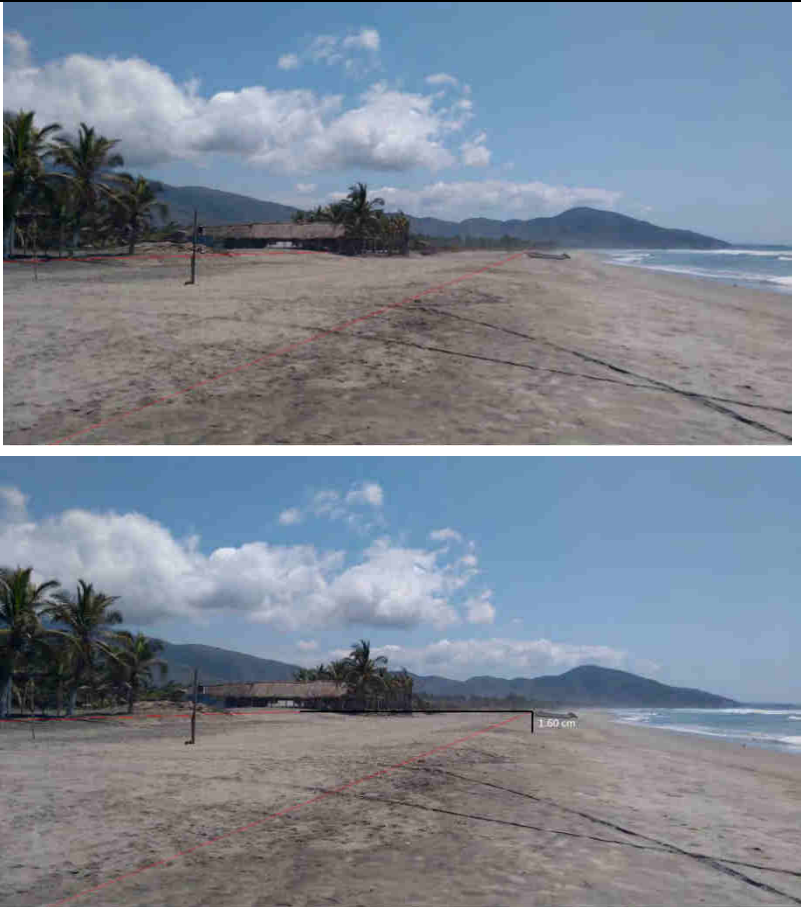
SITE NUMBER	154
LATITUDE	18.5258
LONGITUDE	-103.60178
DISTANCE FROM EPICENTER	46
CITY	La Placita, Michoacán
EEE TYPE	Tectonic uplift
EEE DESCRIPTION	The coastline is 59 cm lower from the earthquake. “15 - 30 minutes after the earthquake the sea entered approximately 80 m inland, the day after the earthquake, it returned but only 30 m and during the following 4 days, it was totally returning, in fact more than normal; From then on, the sea, even at high tide, does not reach as far as it did before the earthquake” (testimony of residents of La Placita).
ESI INTENSITY	X
PHOTOGRAPHIC DOCUMENTATION

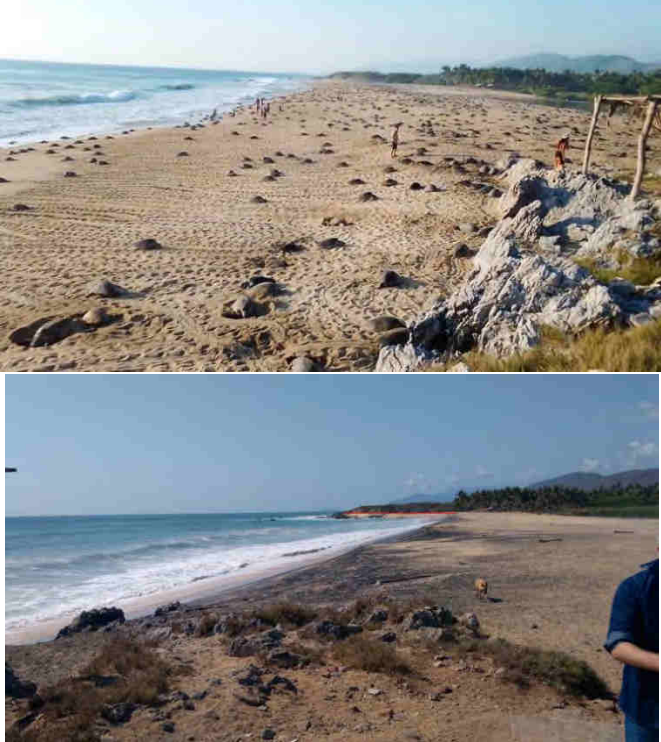
SITE NUMBER	156
LATITUDE	18.413399
LONGITUDE	-103.533096
DISTANCE FROM EPICENTER	32
CITY	Ixtapilla, Michoacán
EEE TYPE	Tectonic uplift
EEE DESCRIPTION	Tectonic uplift of 50 cm approx. The coastline currently marks a step from the earthquake. According to testimonies from the inhabitants "the sea moved several meters inland with the earthquake".
ESI INTENSITY	X
PHOTOGRAPHIC DOCUMENTATION

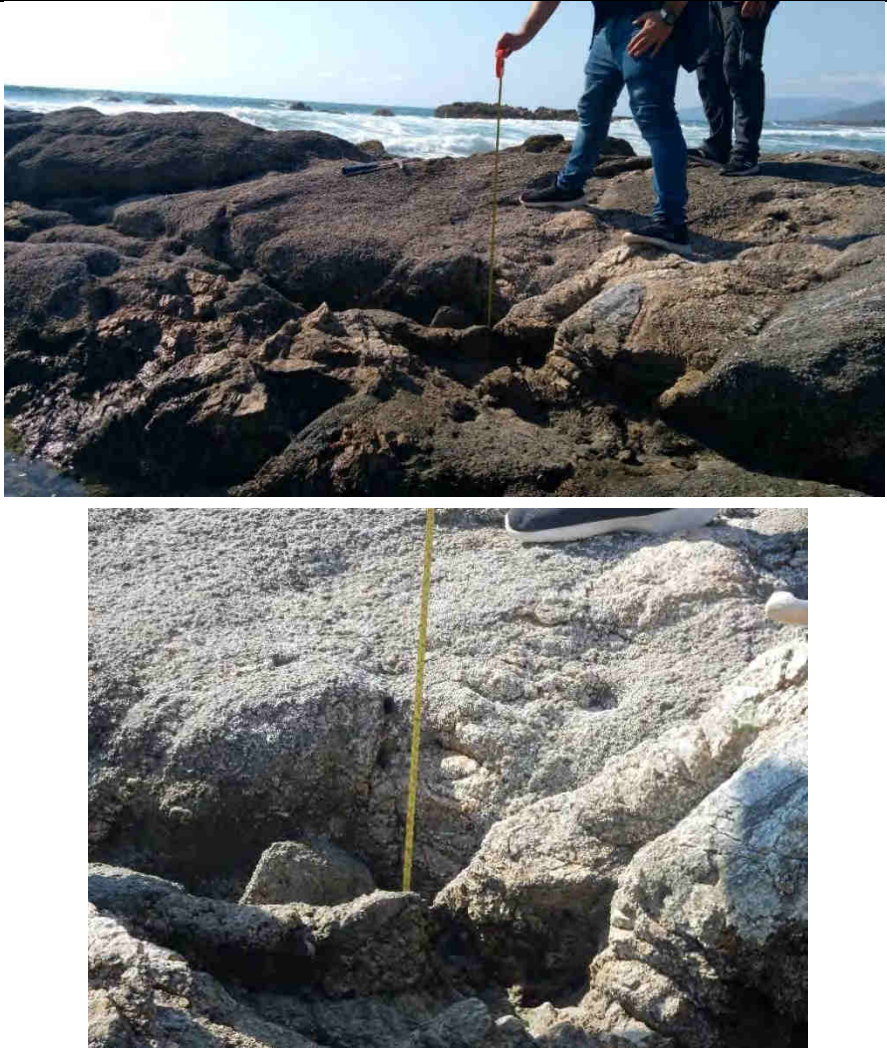
SITE NUMBER	158
LATITUDE	18.402852
LONGITUDE	-103.529276
DISTANCE FROM EPICENTER	31
CITY	Majahuita, Michoacán
EEE TYPE	Tectonic uplift
EEE DESCRIPTION	64-69 cm layer with organisms now white due to death by desiccation.
ESI INTENSITY	X
PHOTOGRAPHIC DOCUMENTATION

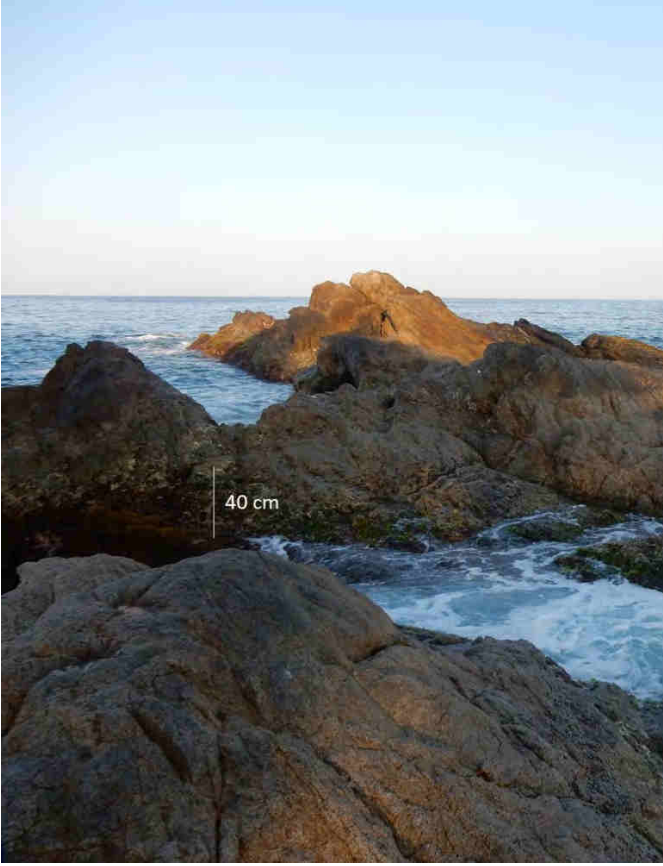
SITE NUMBER	159
LATITUDE	18.355478
LONGITUDE	-103.513137
DISTANCE FROM EPICENTER	27
CITY	La Manzanillera, Michoacán
EEE TYPE	Tectonic uplift
EEE DESCRIPTION	Tectonic uplift that is observable by a stratum, white color from 40 to 50 cm of organisms exposed to desiccation
ESI INTENSITY	IX
PHOTOGRAPHIC DOCUMENTATION

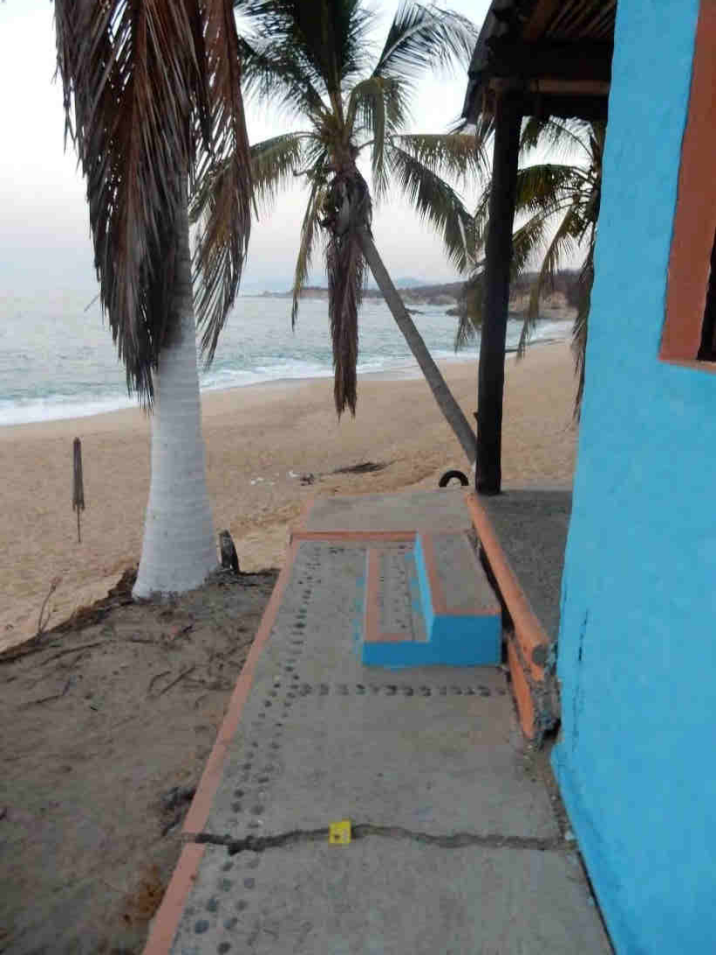
SITE NUMBER	160
LATITUDE	18.355478
LONGITUDE	-103.513137
DISTANCE FROM EPICENTER	27
CITY	La Manzanillera, Michoacán
EEE TYPE	Ground cracks
EEE DESCRIPTION	Cracks in natural beach sandy soil and paved structures, up to 5 cm wide.
ESI INTENSITY	VII
PHOTOGRAPHIC DOCUMENTATION

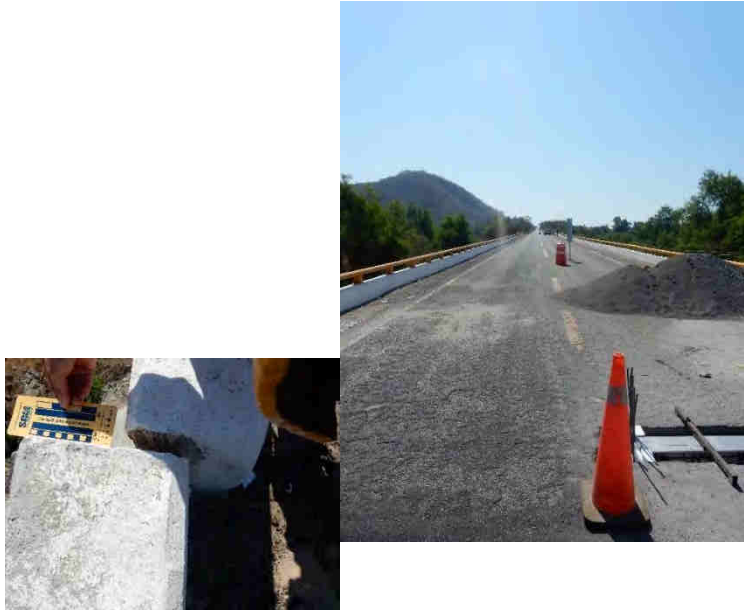
SITE NUMBER	162
LATITUDE	18.278983
LONGITUDE	-103.353613
DISTANCE FROM EPICENTER	8
CITY	Colola-Maruata bridge, Michoacán
EEE TYPE	Ground cracks
EEE DESCRIPTION	The destabilization of the bridge caused cracks along its length in its paved floor and lateral movement of its different parts.
ESI INTENSITY	VIII
PHOTOGRAPHIC DOCUMENTATION

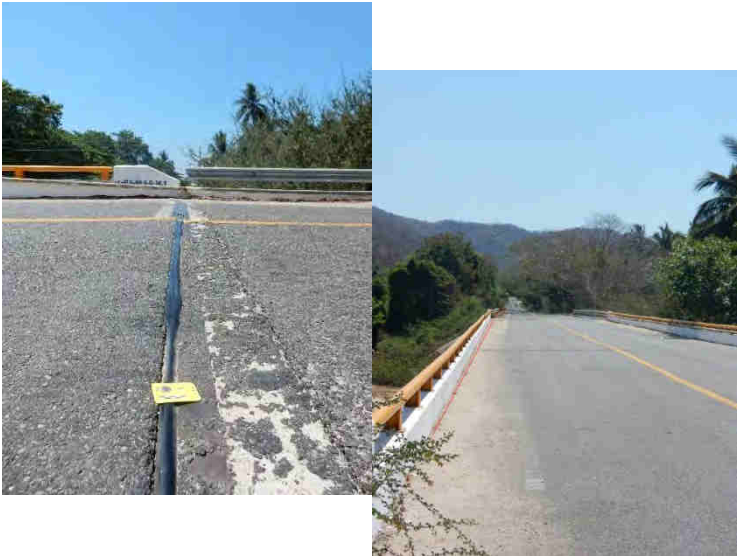
SITE NUMBER	163
LATITUDE	18.297000
LONGITUDE	-103.408051
DISTANCE FROM EPICENTER	14
CITY	Colola bridge, Michoacán
EEE TYPE	Ground cracks
EEE DESCRIPTION	Cracks along the bridge and destabilization of the structure.
ESI INTENSITY	VIII
PHOTOGRAPHIC DOCUMENTATION

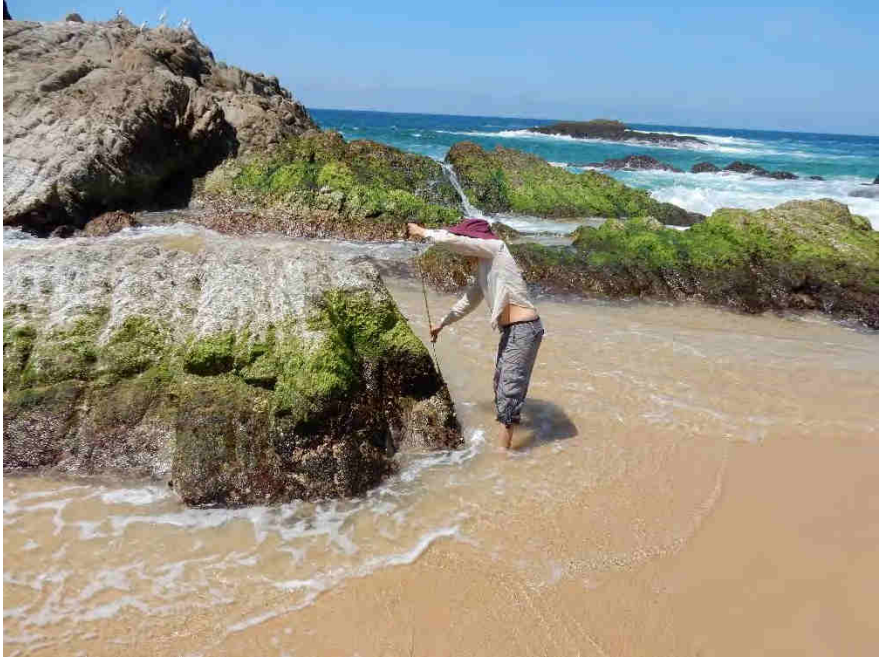
SITE NUMBER	164
LATITUDE	18.292719
LONGITUDE	-103.409405
DISTANCE FROM EPICENTER	14
CITY	Colola, Michoacán
EEE TYPE	Tectonic uplift
EEE DESCRIPTION	Uplift of 0.65m, evident by the layer of organisms that suffered desiccation. 6 months later, the inhabitants of the town comment that "the sea has been covered" and now there is more beach.
ESI INTENSITY	X
PHOTOGRAPHIC DOCUMENTATION

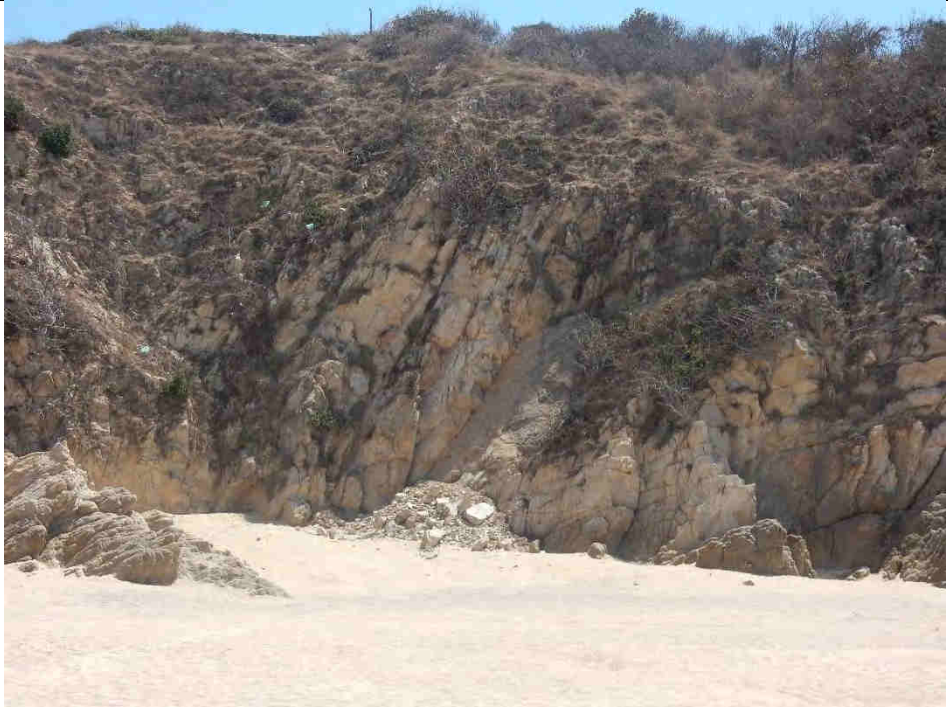
SITE NUMBER	166
LATITUDE	18.292719
LONGITUDE	-103.409405
DISTANCE FROM EPICENTER	21
CITY	Colola, Michoacán
EEE TYPE	Rockfalls
EEE DESCRIPTION	Rockfall and loose material in small volumes, on the cliffs of the beach.
ESI INTENSITY	VI
PHOTOGRAPHIC DOCUMENTATION

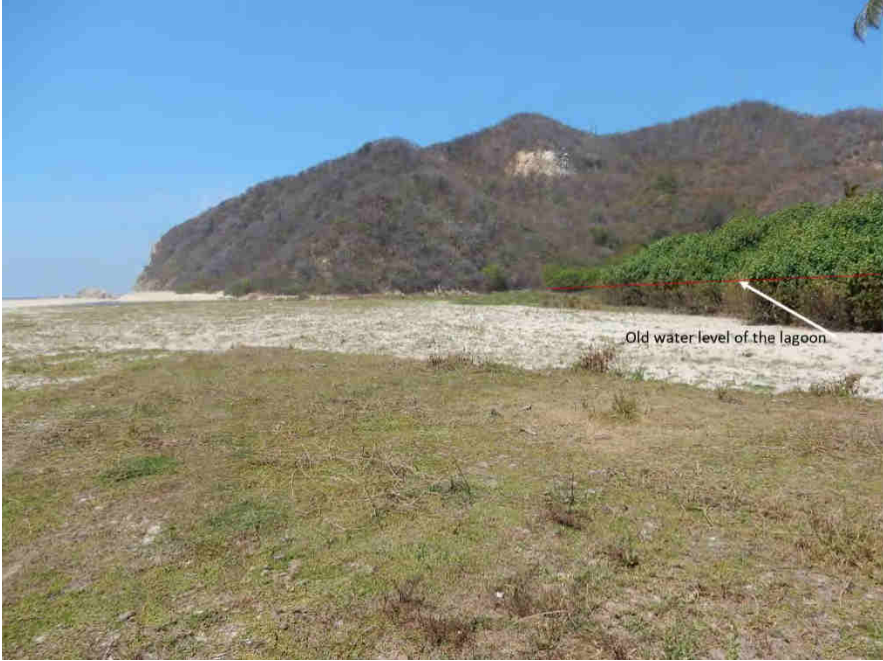
SITE NUMBER	168
LATITUDE	18.322157
LONGITUDE	-103.4712
DISTANCE FROM EPICENTER	21
CITY	Motín del Oro, Michoacán
EEE TYPE	Hydrogeological anomalies
EEE DESCRIPTION	2 of 3 springs dried up and a new one appeared. The lagoon dried up. The water level in the lagoon was about 2m deep before the earthquake. Formation of cracks 15 - 20 cm wide and up to 10 m long. It is about 1mm diameter beach sand.
ESI INTENSITY	X
PHOTOGRAPHIC DOCUMENTATION

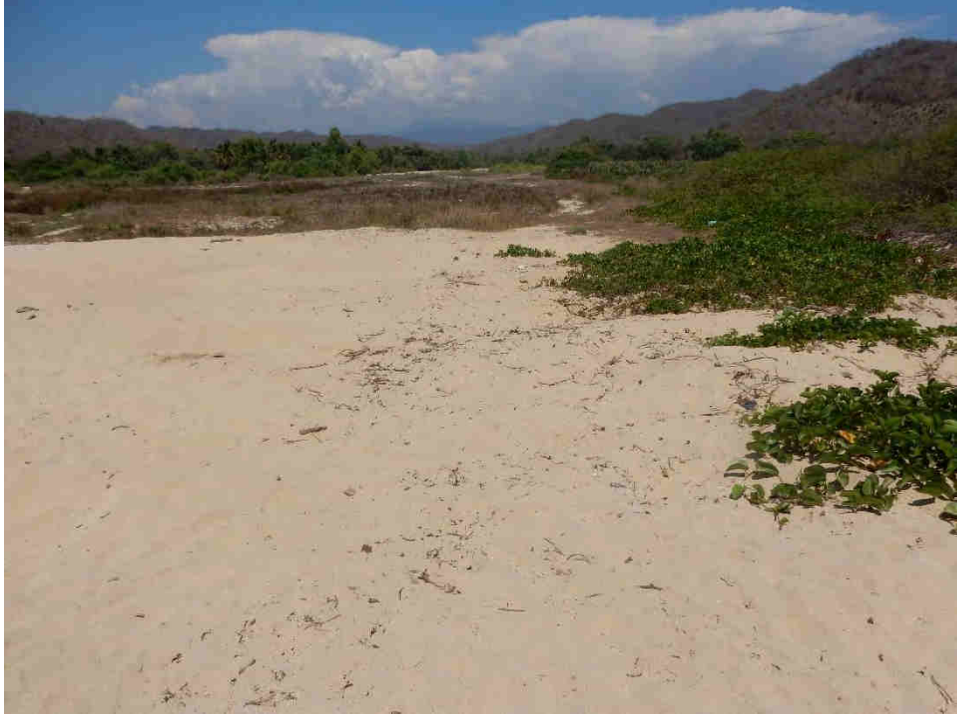
SITE NUMBER	169
LATITUDE	18.3213619
LONGITUDE	-103.4701079
DISTANCE FROM EPICENTER	21
CITY	Motín del Oro, Michoacán
EEE TYPE	Liquefaction processes
EEE DESCRIPTION	Formation of a sand volcano of 1m in diameter approx. and ejection of fresh water and sand near the lagoon that dried up from the earthquake.
ESI INTENSITY	VIII
PHOTOGRAPHIC DOCUMENTATION

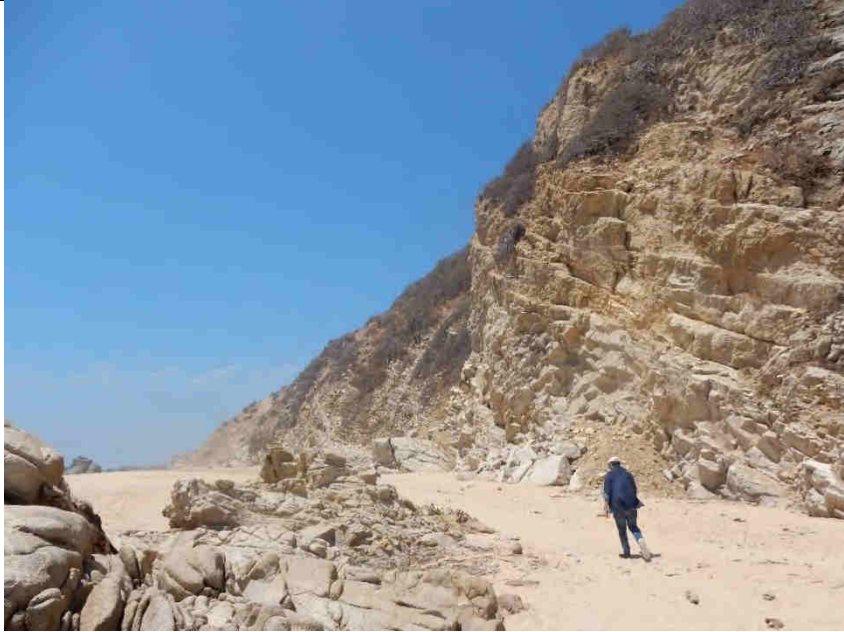
SITE NUMBER	172
LATITUDE	18.322191
LONGITUDE	-103.474452
DISTANCE FROM EPICENTER	22
CITY	Motín del Oro, Michoacán
EEE TYPE	Landslides and rockfalls
EEE DESCRIPTION	Landslides and falls of rocks and material from the coastal cliff, from small volumes up to 10^5 m^3
ESI INTENSITY	VIII
PHOTOGRAPHIC DOCUMENTATION

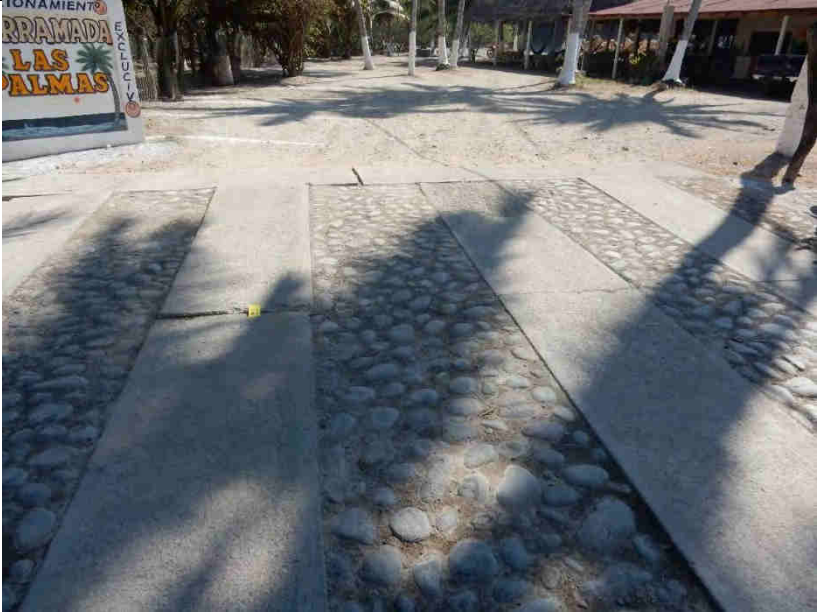
SITE NUMBER	173
LATITUDE	18.3213619
LONGITUDE	-103.4701079
DISTANCE FROM EPICENTER	21
CITY	San Telmo, Michoacán
EEE TYPE	Ground cracks
EEE DESCRIPTION	Cracks that cross the paved and paved street of approximately 4 meters long and up to 5 cm wide.
ESI INTENSITY	VII
PHOTOGRAPHIC DOCUMENTATION

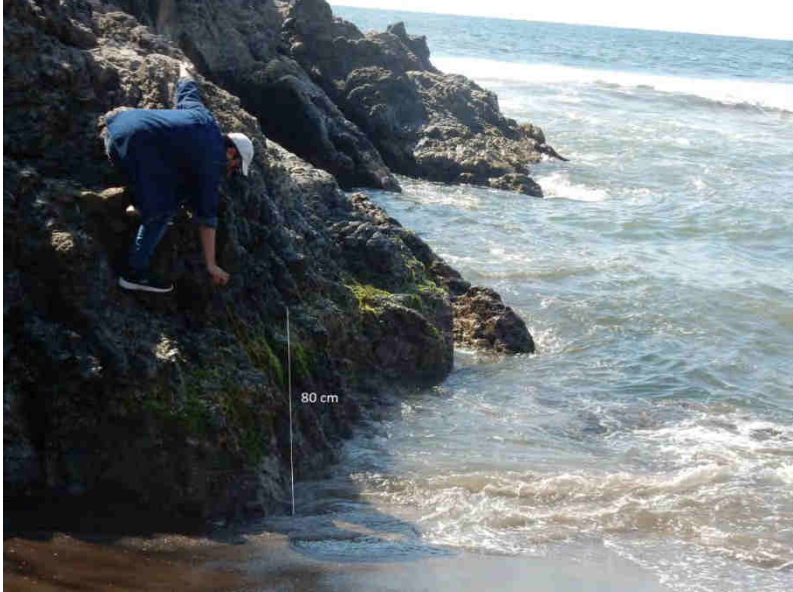
SITE NUMBER	174
LATITUDE	18.3213619
LONGITUDE	-103.4701079
DISTANCE FROM EPICENTER	21
CITY	San Telmo, Michoacán
EEE TYPE	Tectonic uplift
EEE DESCRIPTION	<p>Uplift of 66 - 68 cm evidenced by stratum with white colored organisms due to exposure to desiccation after the earthquake.</p> <p>According to residents, at the time of the earthquake, a sound like a "great waterfall" was heard and waves were seen on the ground. "Since then, the sea level has dropped, before there was not so much beach."</p>
ESI INTENSITY	X
PHOTOGRAPHIC DOCUMENTATION

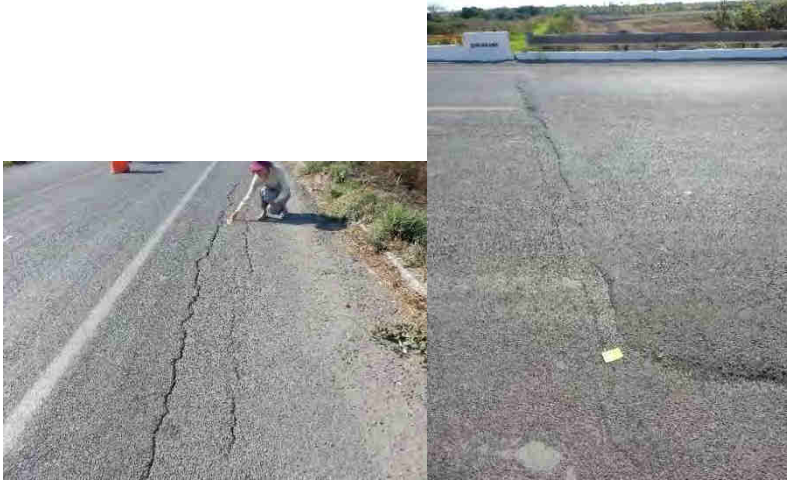
SITE NUMBER	175
LATITUDE	18.624414
LONGITUDE	-103.685008
DISTANCE FROM EPICENTER	60
CITY	Chocoquillo bridge, Coahuayana, Michoacán
EEE TYPE	Ground cracks
EEE DESCRIPTION	Ground cracks in the pavement path traversing the entire width of the road, with displacement of the bridge structure
ESI INTENSITY	VIII
PHOTOGRAPHIC DOCUMENTATION

<p>Photos taken six months after the earthquake</p>
REFERENCES

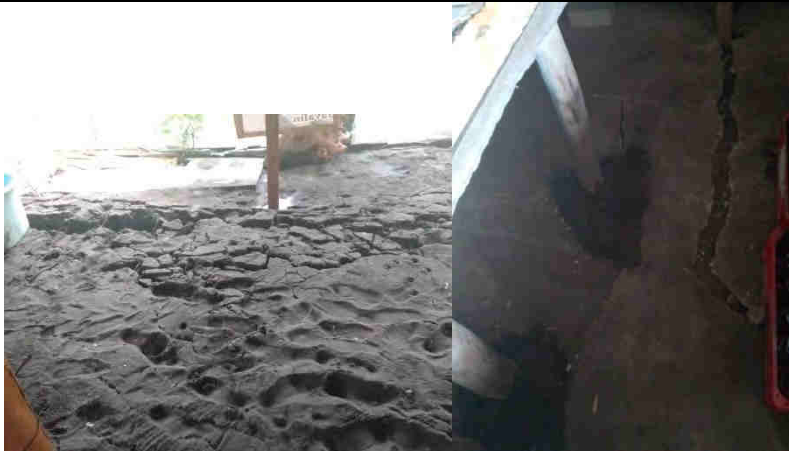
SITE NUMBER	176
LATITUDE	18.8609168
LONGITUDE	-103.966097
DISTANCE FROM EPICENTER	99
CITY	Tecomán, Colima (Boca de Pascuales)
EEE TYPE	Ground cracks
EEE DESCRIPTION	Crack on natural soil with 2-4m in length
ESI INTENSITY	VIII
PHOTOGRAPHIC DOCUMENTATION
