EMERGENCY REHABILITATION OF BROWNSBARN BRIDGE

V.PAKRASHI¹, J.KELLY¹, J.HARKIN² & S.NANUKUTTAN²

¹Roughan & O'Donovan Consulting Engineers, Dublin, Ireland

Abstract

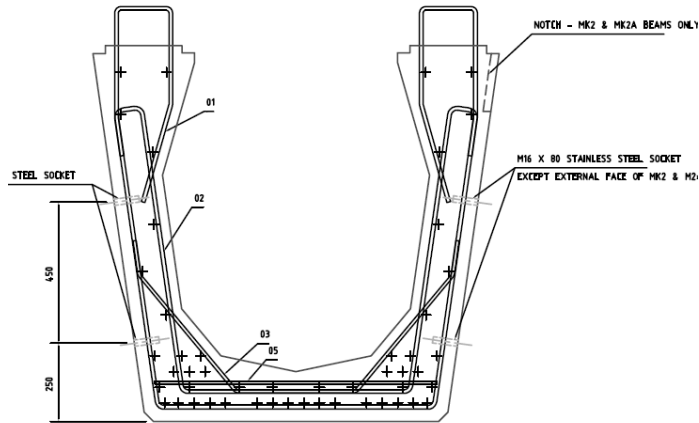
Figure 1 – As Manufactured Tendon Arrangement

The analytical background to the proposed refurbishment works were constrained to a line beam model and a two dimensional finite element model to qualitatively assess the potential stress hotspots, to distinguish non-structural cracks from structural ones with a high degree of confidence and to establish guidance for monitoring of strains during rehabilitation. Under damaged condition, the bridge was deemed safe under Ultimate Limit State (ULS) but was observed to violate Serviceability Limit State(SLS). Figure 1 provides the as-manufactured drawings of the tendons of the prestressed beam obtained from the design archives of Roughan & O'Donovan Consulting Engineers.

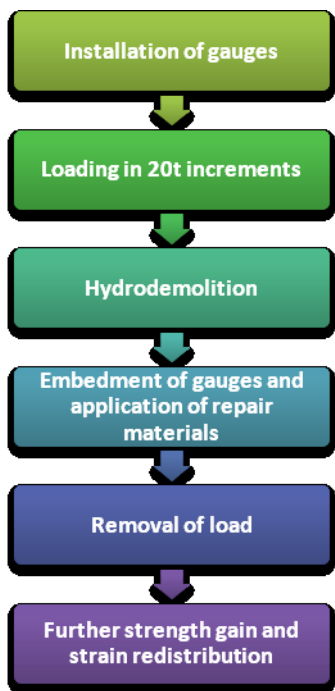
Figure 4 – Brownsbarn Bridge Rehabilitation Flowchart

The emergency rehabilitation process on Brownsbarn Bridge can be divided into seven significant zones of activity distributed chronologically in time. Figure 4 provides a flow chart indicating these stages. The first stage comprises of the installation of gauges. These gauges corresponded to monitoring points of the damaged beam and the two adjacent beams. In total, five monitoring points were selected. Each monitoring point comprised of a number of strain gauges, including sacrificial strain gauges and targets for the measurement of deflection. A vibrating wire strain gauge was used in this regard. The instrumentation and real time remote data logging was provided by Datum Geotechnical and Structural Monitoring.

The two ends of the damage were patch loaded in 20t increments on each side, quasistatically and equally, using bales of concrete blocks. This loading provided the prestrain in the beam. The loading was carried up to 60t on each side. Consequently, the bridge was preloaded to 120t in total before hydrodemolition

was carried out. The organisation of hydrodemolition, including the erection of safety fencing and scaffolding was carried out during this time by Structural Concrete Bonding. Figure 5 shows a photograph of the removal of concrete through hydrodemolition. Although this method is a high risk activity and should only be carried out by experts, the process was chosen to be the best for the current project due to its precision and low impact on the existing strands.

Hydrodemolition was followed by the installation of embedded strain gauges within the existing tendons and the application of high strength repair material. The material was expected to gain adequate strength within 12 hours and can take significant tension as well.

The preload was removed from the top of the bridge after the repair material gained adequate strength and some amount of prestress was reinstated following the removal of prestrain. The repaired section is shown in Figure 6 while the removal of preload is shown in Figure 7. A sample photograph of the traffic management provided by Complete Highway Maintenance throughout the rehabilitation is provided as Figure 8.
