## Full-Scale Tests of a Wood-Frame Structure under Extreme Wind Loads

# Full-Scale Tests of a Wood-Frame Structure under Extreme Wind Loads

Derek A Stedman

Department of Civil and Environmental Engineering  
Faculty of Engineering

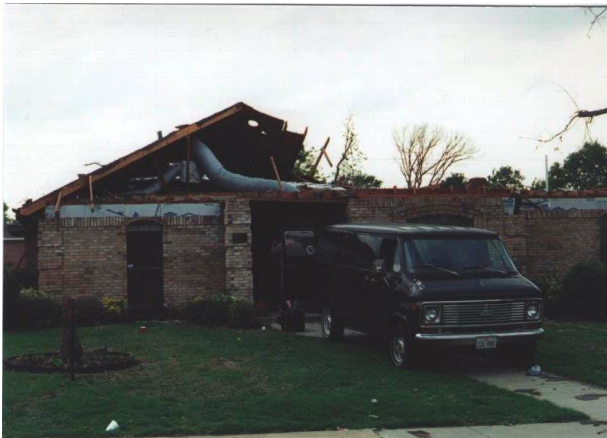
Figure 1.1 - A reference for degree of damage six (from Texas Tech University, 2006).

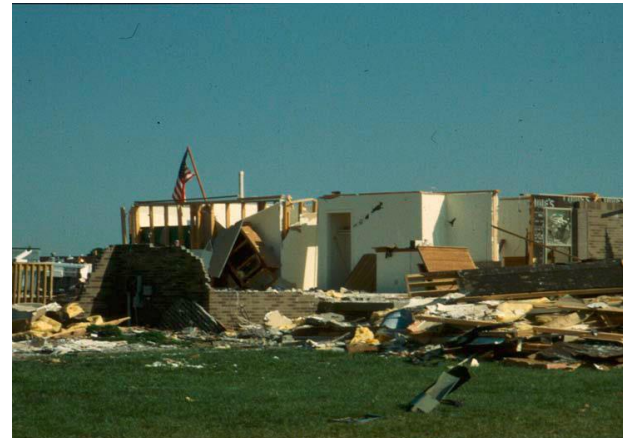
Figure 1.2- A reference for degree of damage seven (from Texas Tech University, 2006).

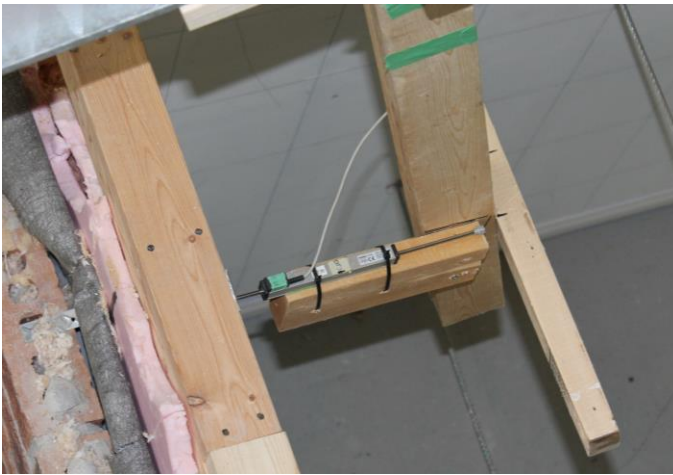
Figure 3.18 - LVDT NE1, with the wood beam from the steel reaction frame.

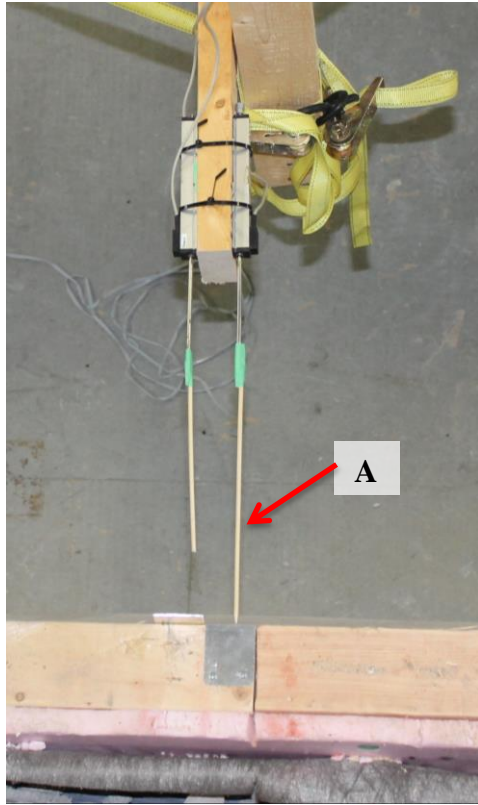
Figure 3.21a - A two LVDT setup (EN8 and EN9) before the experiment.

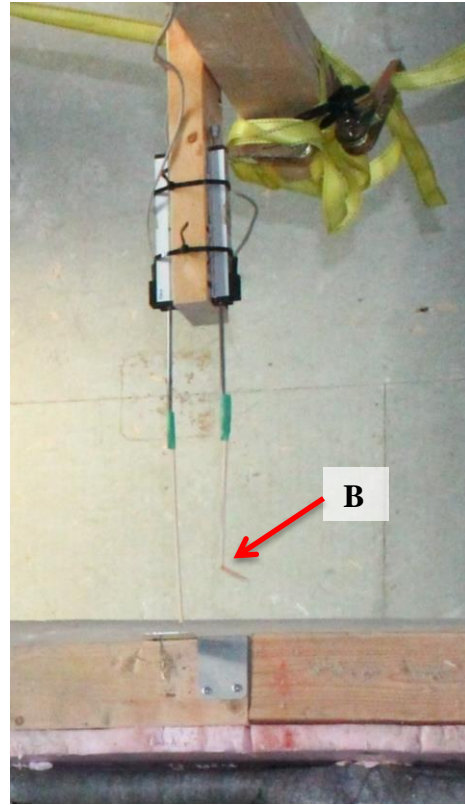
Figure 3.21b - LVDT setup EN8 and EN9 post experiment.

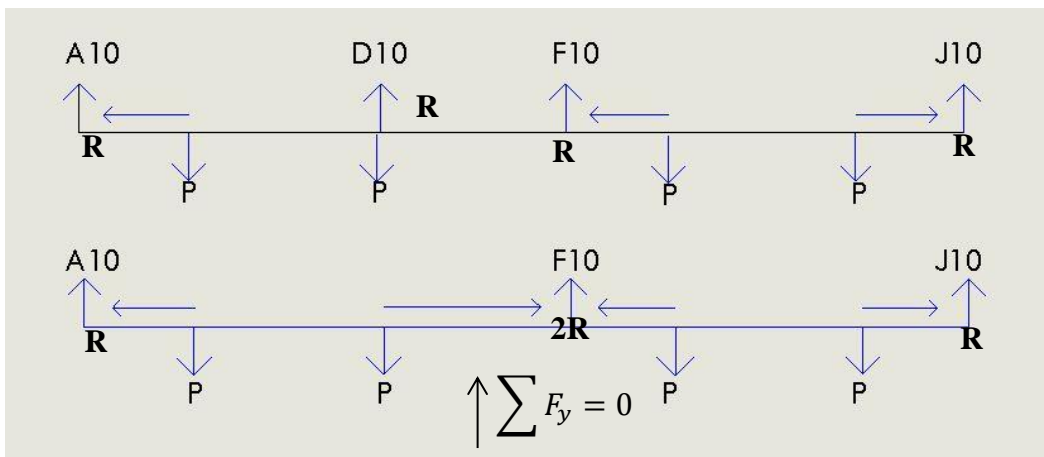
When the connection at D10 fails, the interior wall is no longer providing a restraint at the exterior top plate. Because Wall D10 is perpendicular to the loaded wall it transferred the out-of-plane (shear) forces in the exterior wall into racking forces in the interior wall, which is strong in this aspect. A result of the joint failing is loss of this load path. Following the failure at D10, the loads being applied to the exterior wall between A10 and F10 must be restrained at joint F10 and the corners. This immediately increases the net loads at joint F10, causing this joint to fail and catastrophic failure of the entire wall. A schematic of the change in load path is shown in Figure 5.5, which shows the approximate load path before the failure at D10 (top) and then after the failure at D10 (bottom). The Figure shows a basic approximation of how the reaction forces at the interior-exterior wall connections change when the connection at D10 fails. Thus, the connection strengths at the interior-exterior wall interfaces are extremely important for the strength of the entire exterior wall.

Figure 5.5 – External wall top plate load paths along the wall spanning from A10 to J10 with and without the connection at

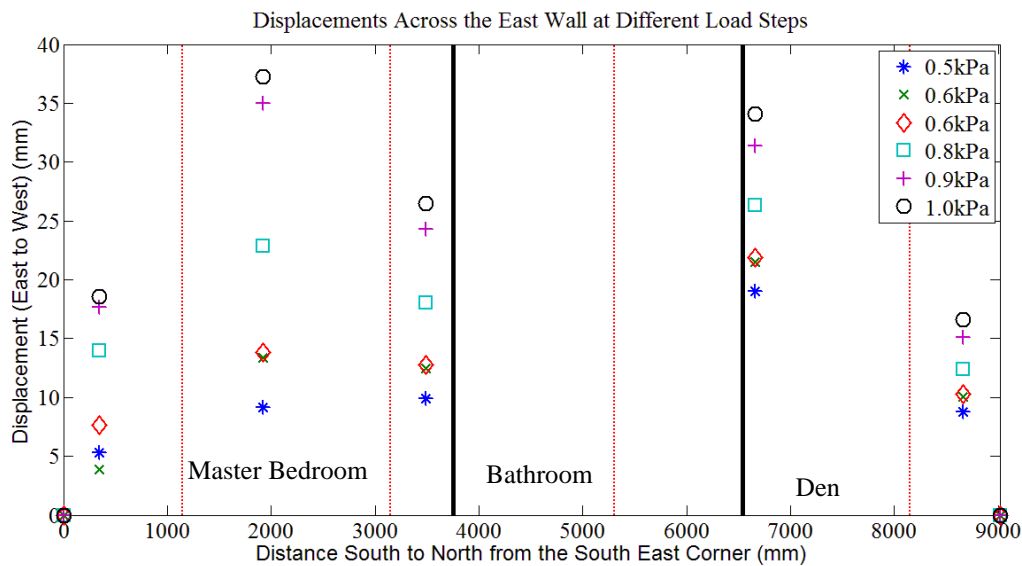
Although no catastrophic failure occurred on the East wall (J1 – J10), displacements of up to 120 mm occurred along J6 – J10 (in the Master Bedroom). The scale of these displacements and the lack of failure was largely affected by the placement of the interior walls. LVDTs were placed at J1, J3, J6, J8/9 and J10 in order to measure the movement of the top plate. The displacement readings at lower load levels – up to 1.0kPa are shown in Figure 5.6, higher load levels are not shown to allow for better illustration of the two different behaviors observed. The zero displacement at the corners is assumed, based on the comparison between the effects of loading the East side on West side deflections, and vice-versa, since there were no noticeable racking effects across the house. In the Figure, the thick vertical black lines represent the locations of interior walls. The thin vertical red lines represent the points where the loads were applied. There were three LVDTs in the master bedroom, and two in the den. No LVDTs were placed in the bathroom due to quantities of available instrumentation.

Figure 5.6- Wall J1 - J10 LVDT readings at increasing loads.

Two patterns can be observed in the data. First, during the early stages of loading (0.5kPa, 0.6kPa and 0.6kPa<sup>3</sup>), more movements of the whole wall are seen. As the load increases, the behaviour changes, showing more local deflections with a maximum occurring near the middle of the Master Bedroom wall segment.

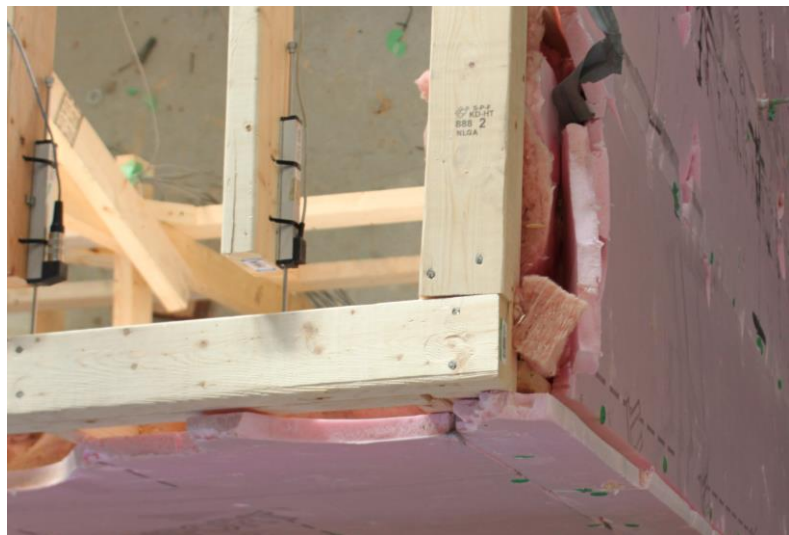
In the tests without brick veneer, the corner was visibly opening (shown in Figure 7.1), which was not observed in the full house tests with brick veneer. Figure 7.2 shows a sketch of how the opening angle was obtained from the wall displacement data. The applied torque on opening angle were calculated using equations 7.1 and 7.2 The total opening angle at the corner was calculated for the test with no brick veneer, as shown in Figure 7.3.

Figure 7.1a - The corner located at A1 with no brick before loading.

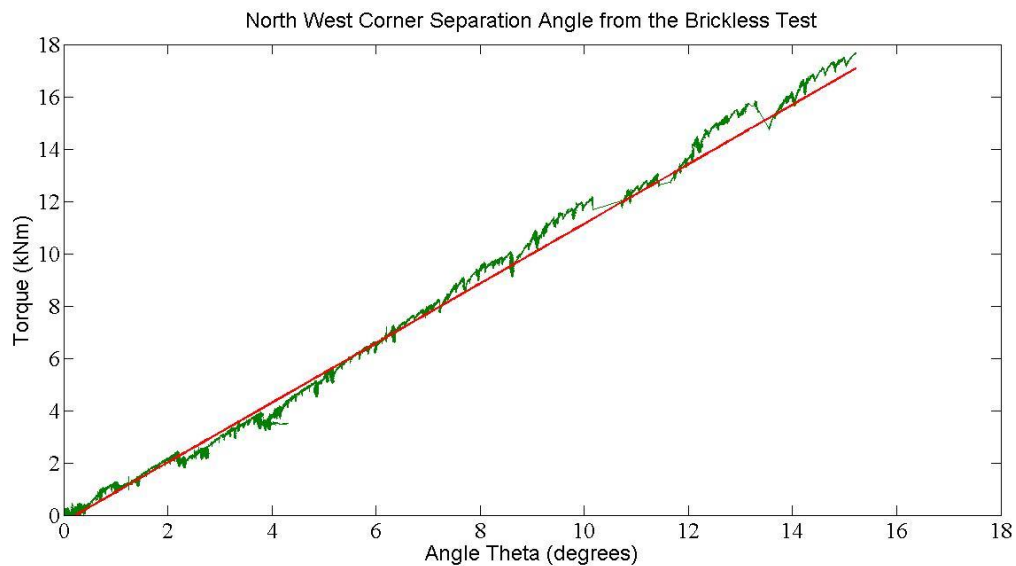
Failure occurred at a load of 17.7 kNm, and an angle of 15 degrees. Most of the

total angle was on one side of the corner, namely, on the wall spanning A1-D1 where the failure occurred (discussed in Section 4.2). The angle of the other wall (A1-A4) at the point of failure was 3.7 degrees, while the angle along wall segment A1-D1 was 11.6 degrees. (The two different angles were calculated using the deflection from each wall based on the assumption that the entire corner did not twist. This observation is supported by the photographs in Figure 7.1.)

Figure 7.3 - The full angle of opening of the North West corner during the test with no brick veneer.

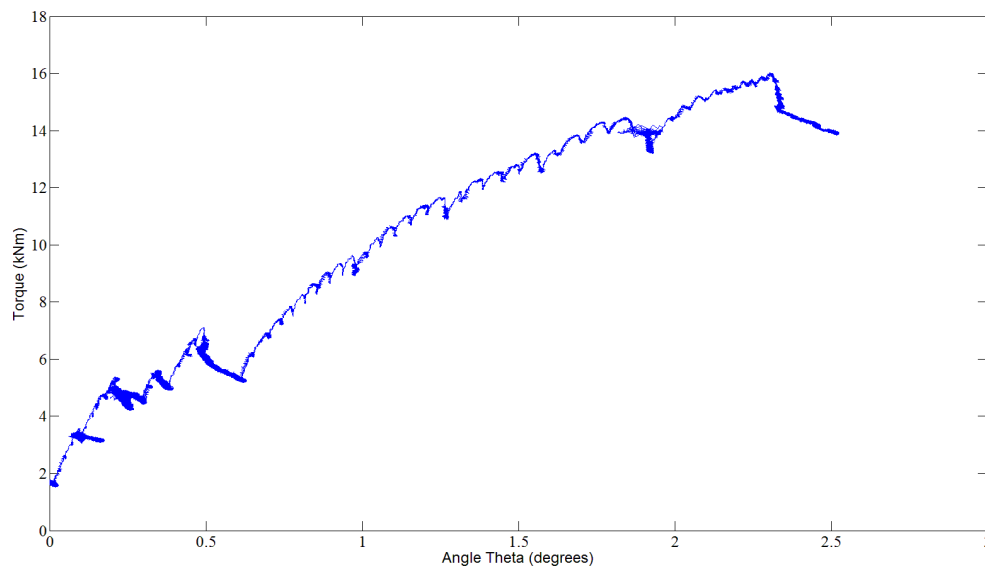
No catastrophic failure of wall A1-A4 occurred during the tests with brick veneer in place; meaning no breaking of the top plate, falling brick or detachment from interior walls. However, the wall failed by the definition of being unable to resist more load. At an applied torque of 16.0 kNm, the load carried by the wall dropped significantly while the angle increased, suggesting the maximum capacity of the wall had been reached - as can be seen in Figure 7.4. Figure 7.4 only shows half of the total angle, the opening of wall A1-A4, the total angle was not calculated due to a malfunctioning strain gauge which rendered accurate total angle calculation impossible. The strain gauge on the North side of the corner (wall A1-D1) malfunctioned and did not produce any useable data, thus the opening angle of that corner could not be calculated.

**Figure 7.4 - Applied torque - opening angle curve for the corner on wall A1-A4 during the full house test.**

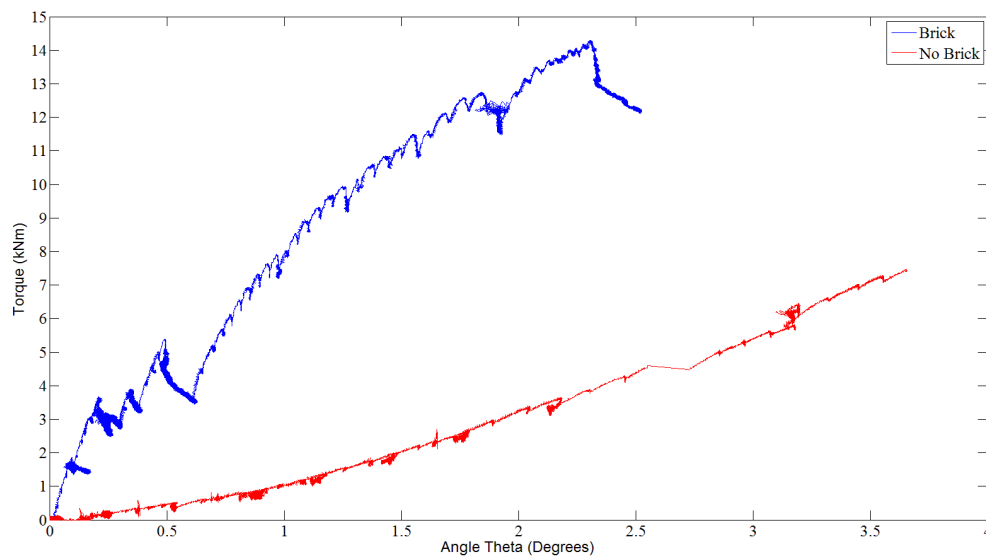
Comparison between the two tests was only performed for the corner at A1 with respect to the wall spanning from A1 – A4 (North end of the West wall). This comparison is shown in Figure 7.5. At the failure load from the tests without brick veneer (7.5 kNm), the angle  $\theta$  was 3.7 degrees. The angle theta for the corner with brick veneer at a load of 7.5 kNm was 1.0 degrees. Thus, the deflection without the brick at that point is 3.8 times greater than the deflection with the brick. It can also be seen that the maximum load resisted by the corner effectively doubled from 7.5 kNm to 16.0 kNm from with no brick veneer to with brick veneer respectively. Thus, the brick veneer adds considerable stiffness to the corner by reducing deflections at equivalent loads. This increase is due to the stiffness of the brick corner, which behaves similar to a fixed corner, allowing little rotation and opening and preventing the wood frame from being able to open.

Figure 7.5 - West side of the North corner response comparison with and without the brick veneer.

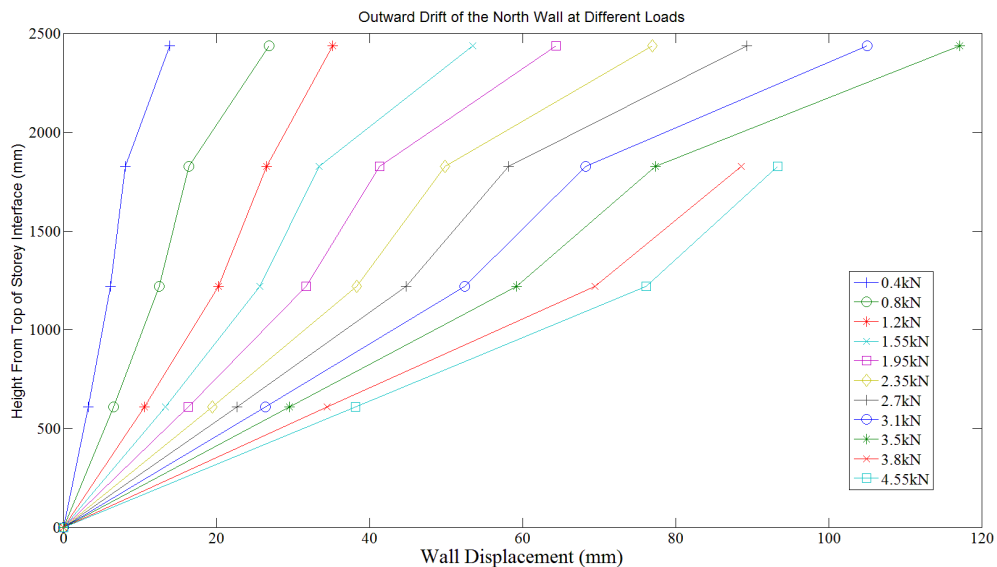
A vertical line of LVDTs was installed at B1 spanning from the second floor to the top plate as indicated by the markers in Figure 8.1; spaced approximately every 600mm up to a height of 2400mm. This line of LVDTs happened to be placed directly in line with the location at which the top plate failed catastrophically in the tests without brick veneer. Analysis of this line of displacement transducers showed the wall to be rotating about the connection between the wall base and the second floor, as shown in Figure 8.1. The responses for 3.8kN and 4.55kN do not show the reading from the displacement transducer at the top of the wall because it ran out of travel and so provides no more useful data past this point. In all cases, 0mm of displacement is assumed at 0mm of height because of the linear response over the bottom half of the wall as well as from experimental observations. The bottom two LVDT readings have an average ratio of 1.98 for the displacement quotient from the LVDT 600mm and 1200mm off the floor. There is very little variation in that ratio, with a standard deviation of 0.03.

Figure 8.1 - Profiles of the North Wall deflection at different loads

The data shows a significant increase in the displacement from the LVDT located at 1800mm to the LVDT on the top plate (2400mm). Because the wall is rotating outwards about the bottom and not bowing outwards with a local maximum in the middle – as it would if the top plate was attached to a firm diaphragm.

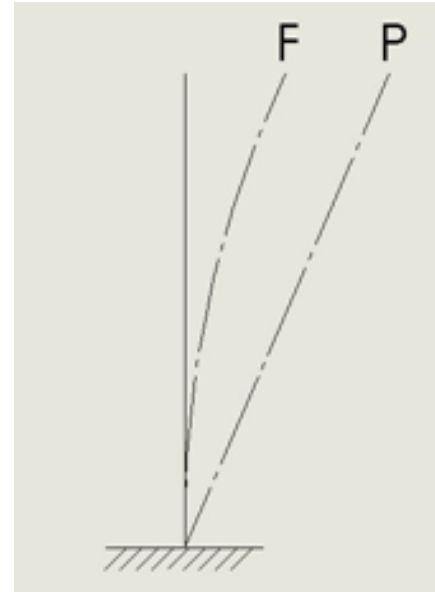
Figure 8.3 - Deflection difference due to fixity.

If rotational resistance was installed, it would decrease the top plate displacements, in a way shown in Figure 8.3, where F represents the deflected shape of a vertical member with a fixed connection, and P represents the deflected shape with a pinned connection. Even partial fixity, which could be provided by something as simple as a Simpson Strong-Tie, would increase the rotational resistance.

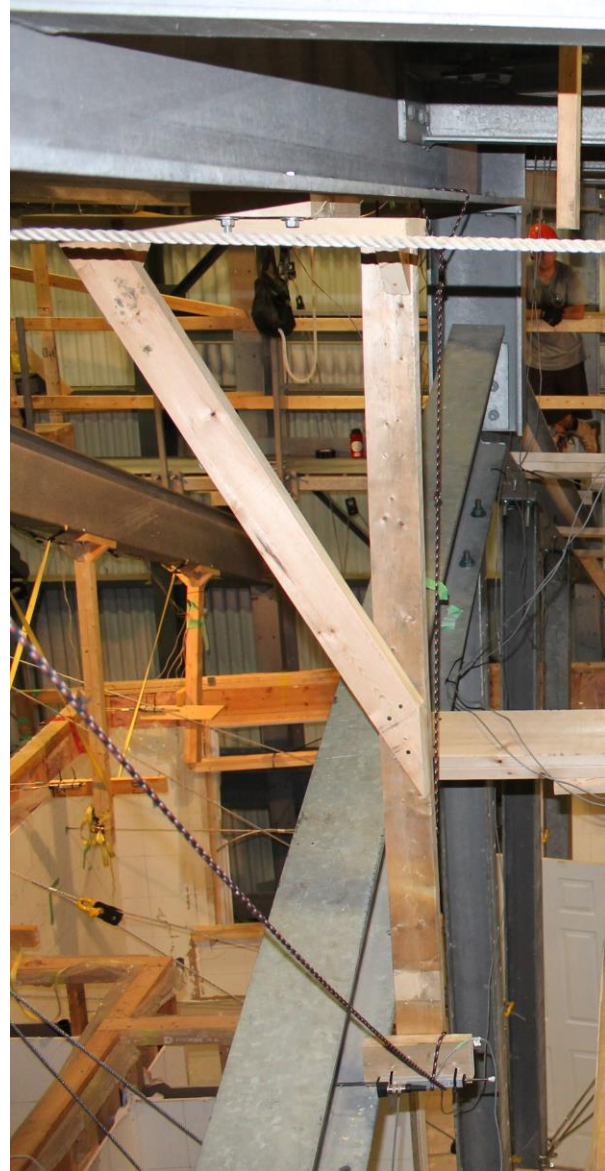
During the experimental setup, it was noted that if the drop down steel beams for the second storey positive whiffle trees moved at all, there was noticeable twisting in the gable beam they were attached to on the reaction frame. This was a potential problem because some of the LVDTs measuring interior wall movements were mounted off of this gable beam and if the beam rotated, it would cause a change in the displacement reading of these LVDTs. To compensate for this, an LVDT was placed at the midspan of the gable beam, measuring any rotation of the beam – Figure E1. Some rotation was measured throughout the experiment (see Figure E2). This rotation requires great care

**Figure E1 - LVDT dropping down from higher up on the reaction frame to record gable beam rotations.**

to be taken when observing the displacements from any LVDTs mounted off of this gable beam. The entire interior wall LVDTs were mounted off of wood frames mounted between the rotating gable and the next gable along (not rotating). Based on the rotation and the lever arm for the drop down wood frame, an estimate of the rotation induced displacement can be made, which makes the interior wall LVDT data usable for analysis. In Figure E3, the gable rotation (in mm) is compared with the interior wall LVDT IS8 reading. This LVDT was located at the top of the

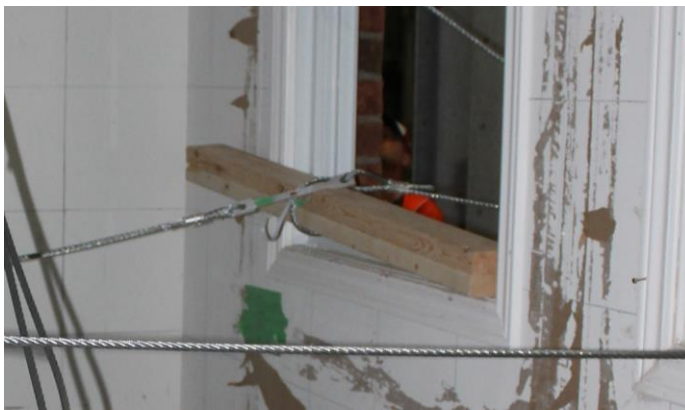
**Figure A6 - East South Lower setup before the morning zeroing**

From the data it would appear that the data from the A side started recording to the B side channel and vice versa. There is no evidence to support this hypothesis. However, notes from the day of the experiment suggest a potential source of the problem. Figure A6 shows

the lower East South strain gauge in its setup before the 09h30 data zeroing. As part of the final setup between the morning zeroing and the next zeroing, the wooden load pad had its location adjusted to remove a geometric problem with the cable rigging. Instead of the load cell passing overtop – as shown in the photo, it was moved to pass underneath the load pad instead. This switch did not change the loading being applied to the walls of the house (0kN). However, it did change the bending stress on the load cell, from one side to the other. When the first zeroing data point is swapped from each side the resulting normalized data is highly sensible compared to the remainder of the strain gauges (see Figure A7). The first zeroing data point is switched to simulate the same bending stress on each side for the 09h30 zeroing as is observed for the 11h40 and 14h30 zeroings. The data shown in Figure A7 has not had thermal strain accounted for, when accounting for thermal strain, the readings have even less variance from the first – last zeroing.

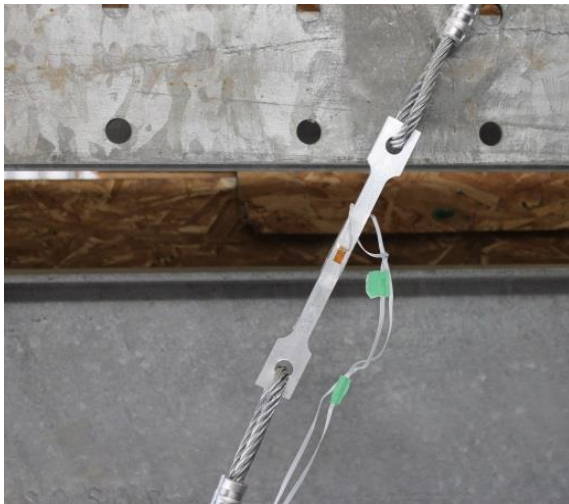
When the strain gauge zeros on the North West Upper load cell are adjusted for temperature, the normalized value from the B side drops from 1.00 at the 09h30 zeroing to 0.81

Figure A8 - North West Upper Load Cell After Adjustment, before PVC fix

and 0.80 at the 11h40 and 14h30 zeroings respectively. The strain gauge on the A side of the North West Upper load cell did not function correctly and so provides no usable readings. A potential explanation for why the zero strain readings trended downwards instead of upwards is a fix which was applied to the load cell at 13h20. This load cell had pulled tight up against a horizontal beam on the react frame (see Figure A8), and it was expected to cause problems during the running of the test. A quick fix solution was performed by encasing the load cell in a PVC tube, which was allowed to slide along the beam while preventing bending of the load cell (Figure A9). This does not explain why the zero changed between 09h30 and 11h40, as the fix

was applied after. It was noted in the experimental log that the North West Upper load cell was giving odd readings at 12h11, before the PVC fix was applied.

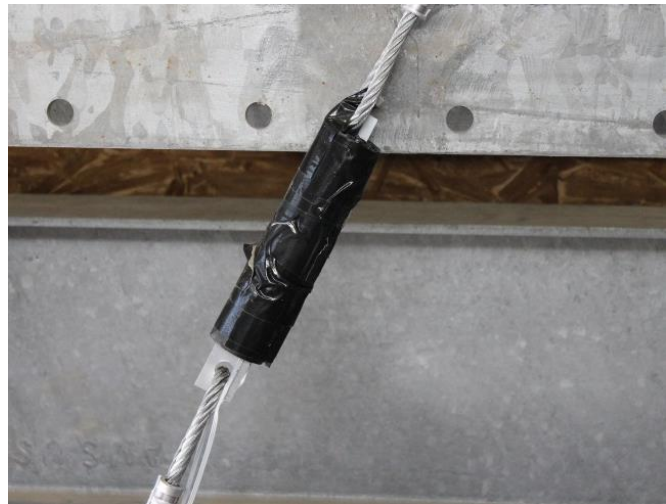
Figure A9 - North West Upper Load Cell After PVC fix

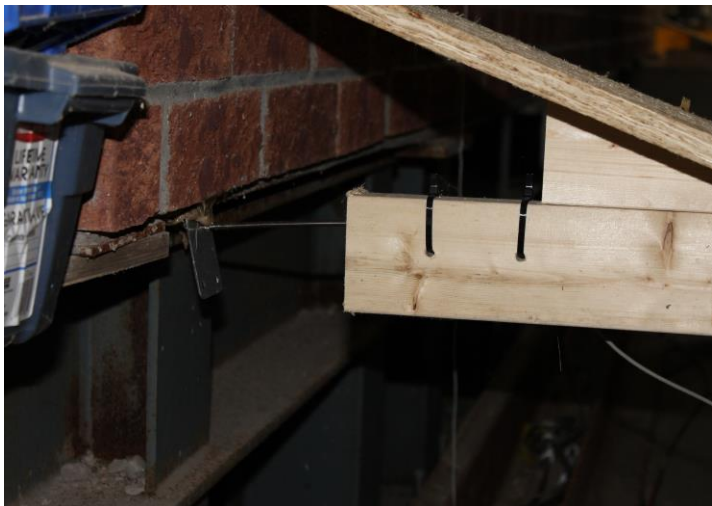
**Figure A13 - Displacement Transducer North East 5**

shown in Figure A14). One explanation for the reading change is that the transducer was adjusted to be level during the final walk around at 10h30, which then would have it contacting the hardened glue, but it slipped off sometime between 11h40 and 14h30.

For this displacement transducer, the final zero point will be used as the zero value. It is important to note that because of this DT's location, its main function is to ensure that there was not movement of the foundation of the house. As the value of read by the displacement

transducer remained constant throughout the experiment and the evidence suggests no drift of the displacement transducer readings over time, the final zeroing value is acceptable to use as a zero for this transducer.

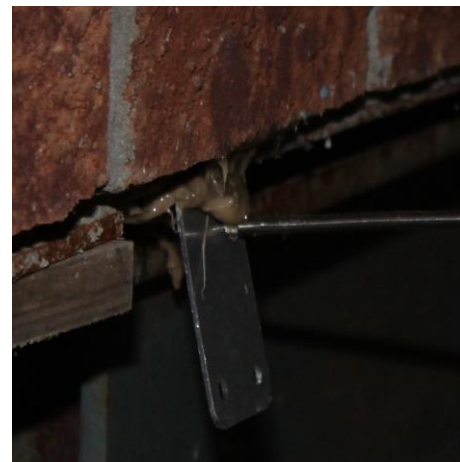
**Figure A14- Close up of the DT connection to the metal plate at the base of the house**

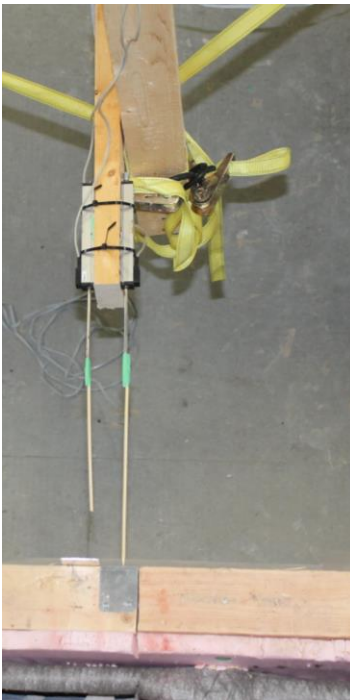
Pictured in Figure A15, the displacement transducer East North 8 was mounted on 2x4” wood members dropping down from the reaction frame. It was located on the East wall of the master bedroom, midway between the corner with the South wall and where the interior wall for the ensuite bathroom connected to the exterior wall. The readings from this DT are shown in table A5. The first two displacement readings are very consistent, however the final reading is not. There is no noted (or observed in photographs) pictures showing changes in the setup or orientation of this displacement transducer. As well, while the react frame is expected to have

**Figure A15 - Displacement Transducers EN8 (right) and EN9 (left) before the test.**

undergone some thermal expansion and contraction throughout the experiment/experiment day, the first two readings are insignificantly different. There was enough change in temperature between the first two zeroing times that if thermal expansion was affecting the DT readings, it would be noticeable. As well, no other DT’s appeared to be significantly effected by thermal expansion/contraction of the reaction frame, so this is likely not the cause of the change in zero reading.

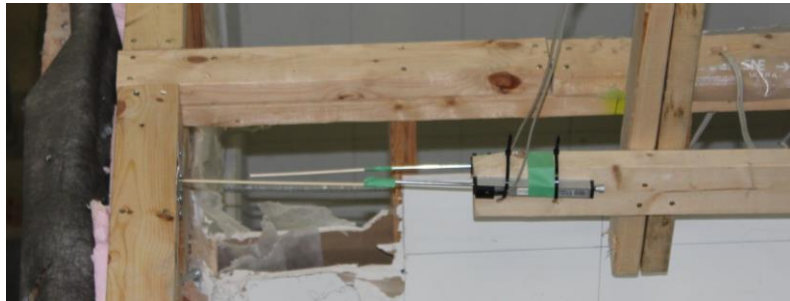
The drift in East North 4 was quite small (~3mm), but still big enough to warrant a more detailed examination. There were no noted adjustments to this LVDT (seen in Figure A16), so that is not the reason for the change in displacement reading.

However, with a drift as small as it was, this is unlikely to be the reason for this drift. One possible explanation for the change in displacement reading is slippage of the skewer attached to the LVDT. The angle of the skewer may have slightly slipped/moved, which would cause a small change in displacement reading. Another explanation is differential expansion of the reaction frame, this is examined in more detail later.

Figure A16 - LVDTs EN4 (closest) and EN5 (farthest away).
