Transgranular Stress Corrosion Cracking of 304L Stainless Steel Pipe Clamps in Direct Use Geothermal Water Heating Applications

Michael F. Hurley
Boise State University

Kent A. Johnson
City of Boise Geothermal Department

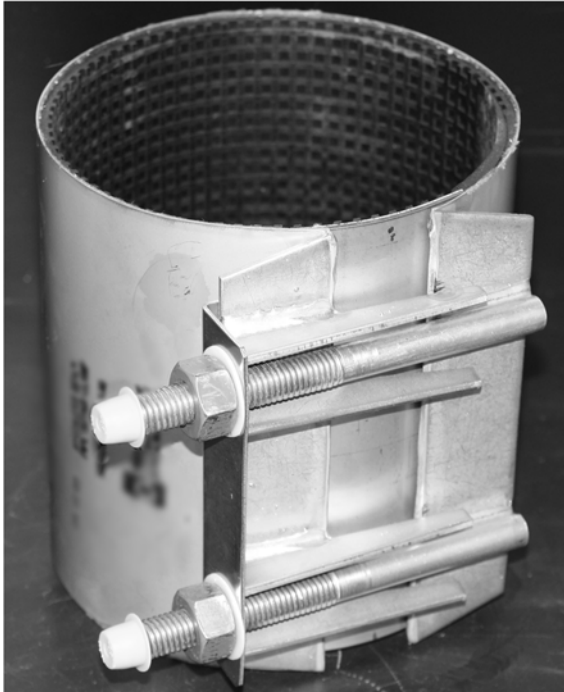
Figure 1. Image of a new 304 stainless steel pipe repair clamp identical to those studied in this investigation. Once a leak in the geothermal system has been excavated and repaired the pipe clamp is placed and sealing pressure is applied via bolt tightening.
