# Expansive rocks in California : an engineering and geologic review

Lauren Jelks Doyel  
*San Jose State University*

**EXPANSIVE ROCKS IN CALIFORNIA:  
AN ENGINEERING AND GEOLOGIC REVIEW**

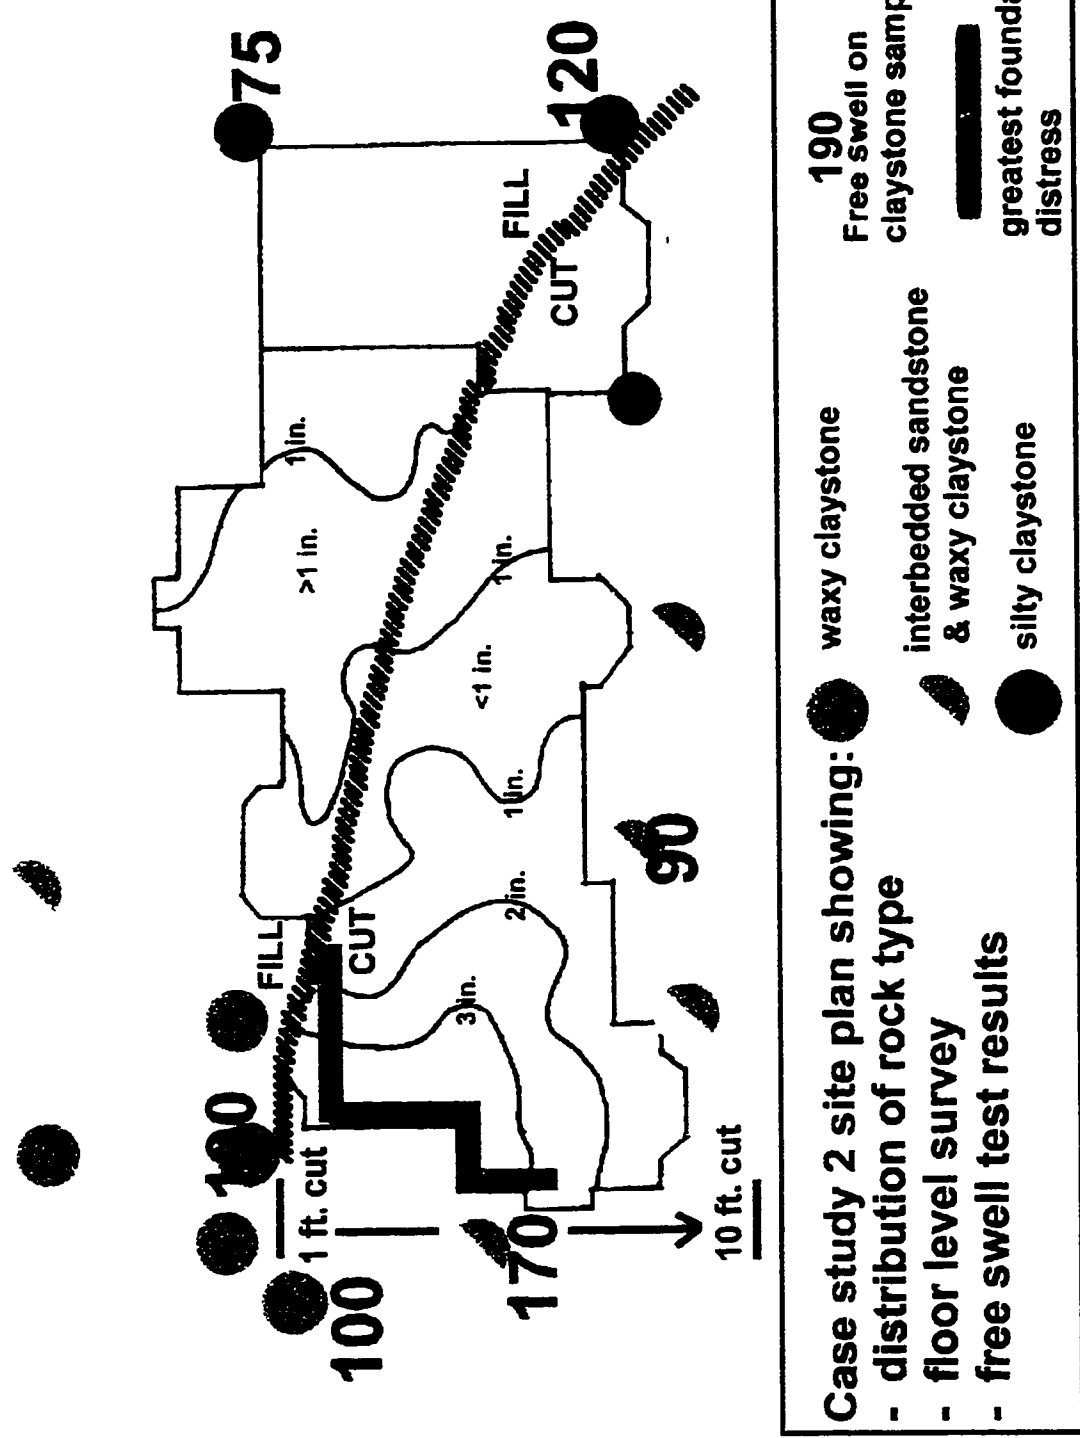
The explanation for this seemingly non-conforming behavior is in local geologic quirks. Subsequent investigations by other geotechnical engineers and geologists revealed, upon examination of the bore holes and comparison with depth of piers, that the area with greatest cut had piers mostly founded in the sandstone inter-layered with siltstone/claystone. The area with greatest heave (and least cut) is claystone throughout the entire depth of piers. Another significant contributing factor is the type of claystone found across the lot. During the investigation of the damage home, careful descriptions were made of the rock across the site, indicating a waxy, fine claystone in the vicinity of heave, and silty claystone elsewhere. Testing of the claystone using the free swell test

Fig. 6. Case study 2 site plan..

also indicated that the claystone in that portion of the lot had the highest values of free swell tests (100 to 190%) compared to the silty claystone (70 to 100%). The difference in physical composition of the claystone as indicated by description (waxy) and testing (high free swell values) explains the seemingly anomalous behavior of the claystone, where the greatest amount of heave occurred in the area of least overburden relief.

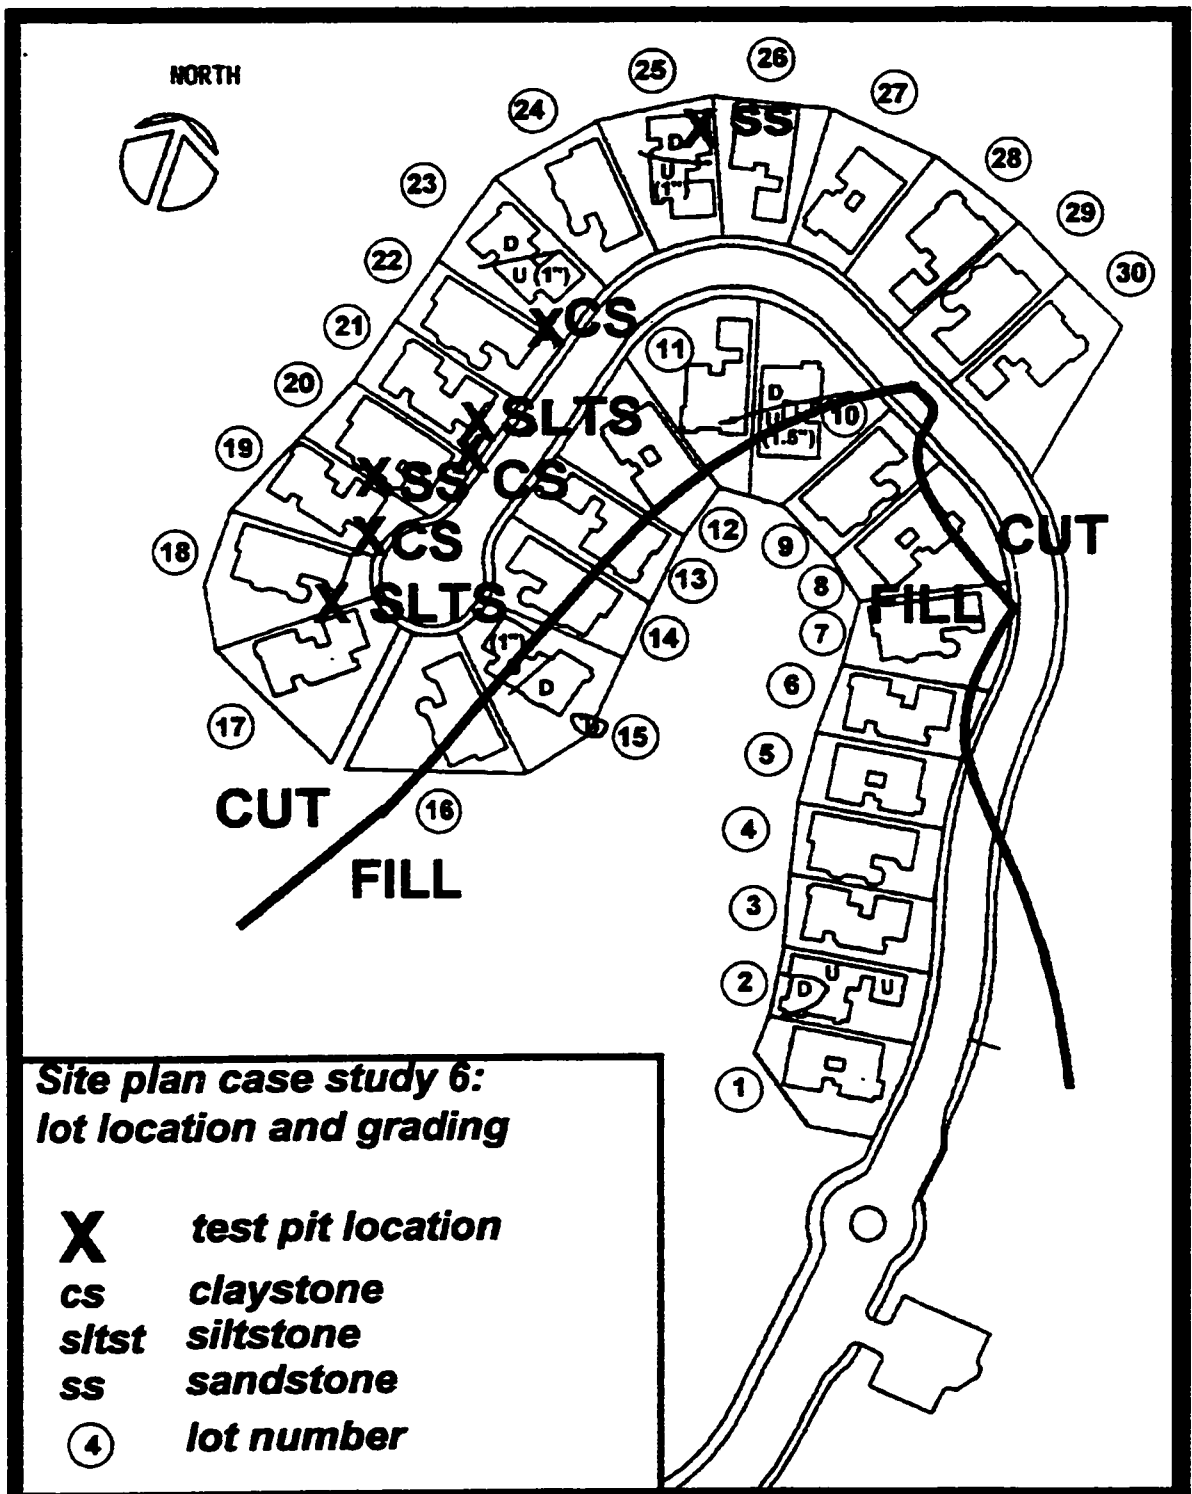
on cut lots and the remaining on deep fill (Fig. 16). During 1982, 1983 and 1986, the slopes behind some of the lots had debris flows occur during the heavy rainstorms (Fig. 17).

Fig. 16. Site plan, case study 6.

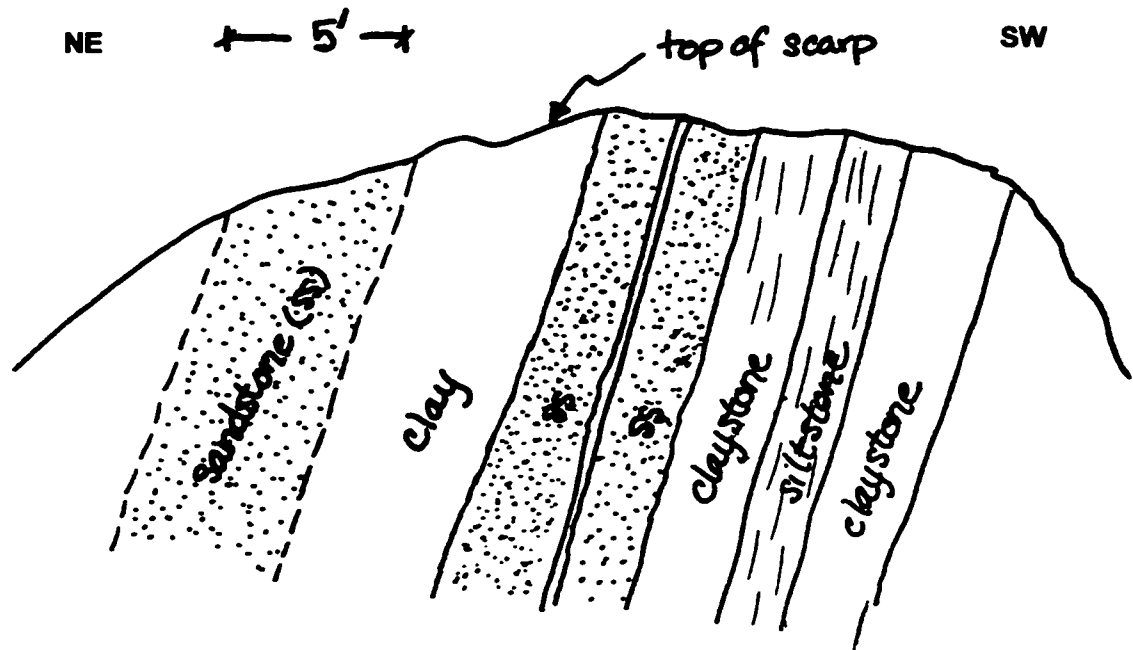
Fig. 19. Log of debris flow scarp showing interbedding of different rock types.

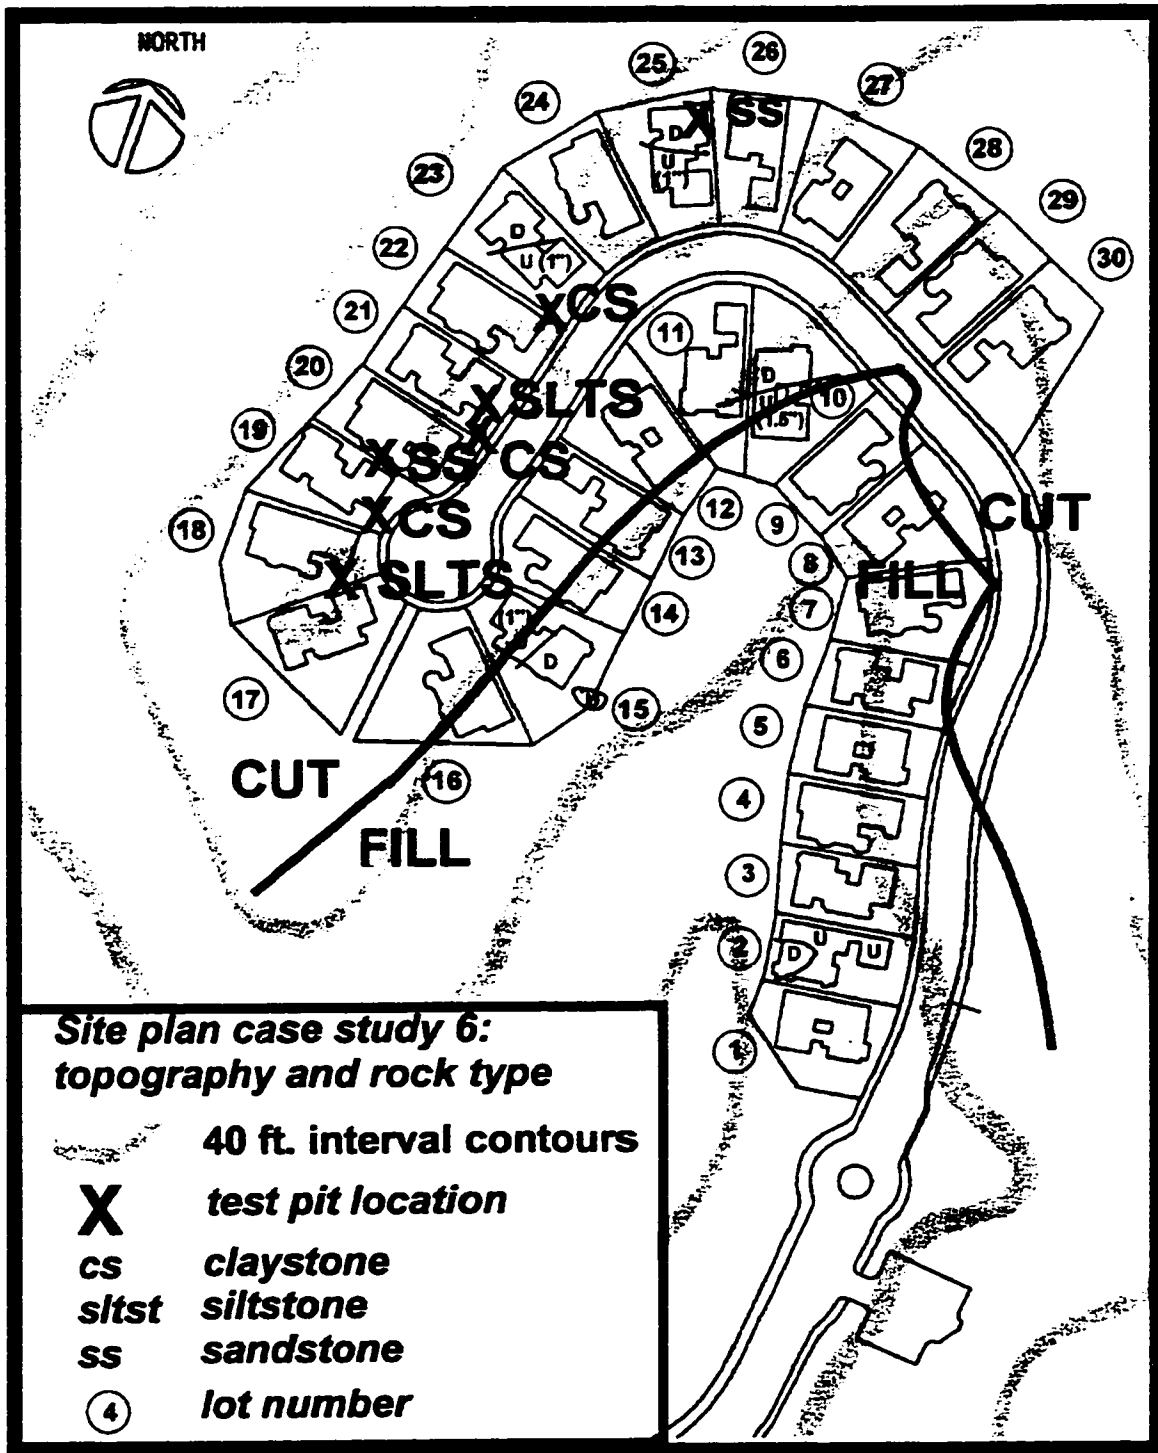
Fig. 20. Case study 6 site plan, showing pre-grading topography and relationship to rock type.

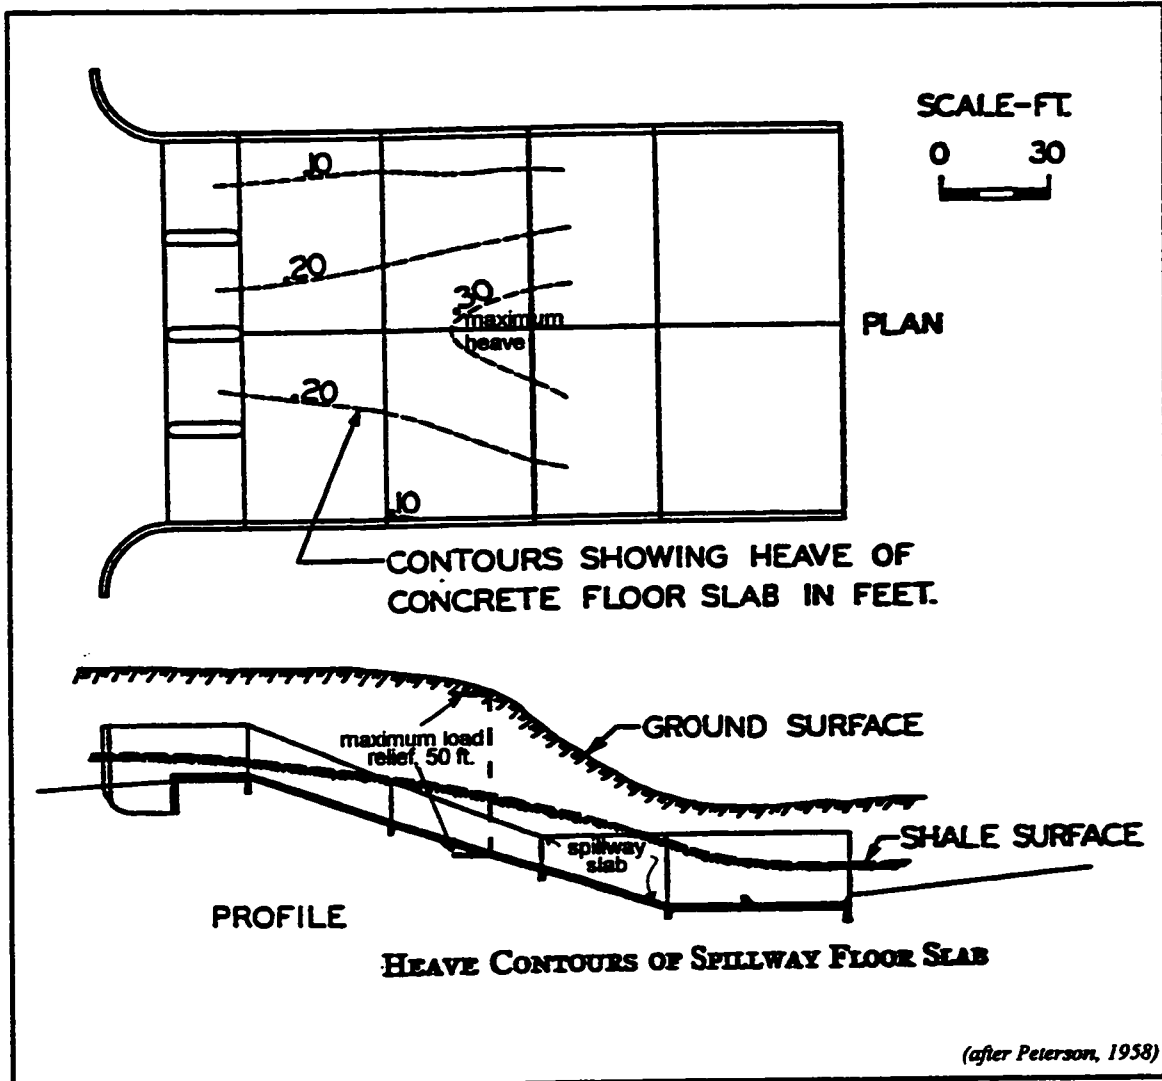
Changes in total stress of rock are caused by tectonism (uplift or burial), erosion, and excavation (removal of confining pressures). When this occurs, claystones tend to rebound or swell in response to this pressure relief. This mechanism is mainly seen in coarse-grained, kaolinitic claystones. Peterson (1958) explains this as part of a two step rebound process: (1) short term immediate elastic rebound and (2) long term "time rebound," or deformational rebound, that takes place over many years. Elastic relief is self-explanatory and is illustrated by Fig. 41 from Peterson. A spillway constructed in the Bearpaw shale, an expansive shale in western Canada, experience heave in the bottom slab, as shown on the upper portion of the figure. The maximum heave of four inches coincided with the deepest excavation of overburden and shale, approximately 45 feet, or about 1 inch of heave for every 10 feet of cut.

**Fig. 41.** Swelling due to load relief in the Bearpaw shale in Canada (modified from Peterson 1958).

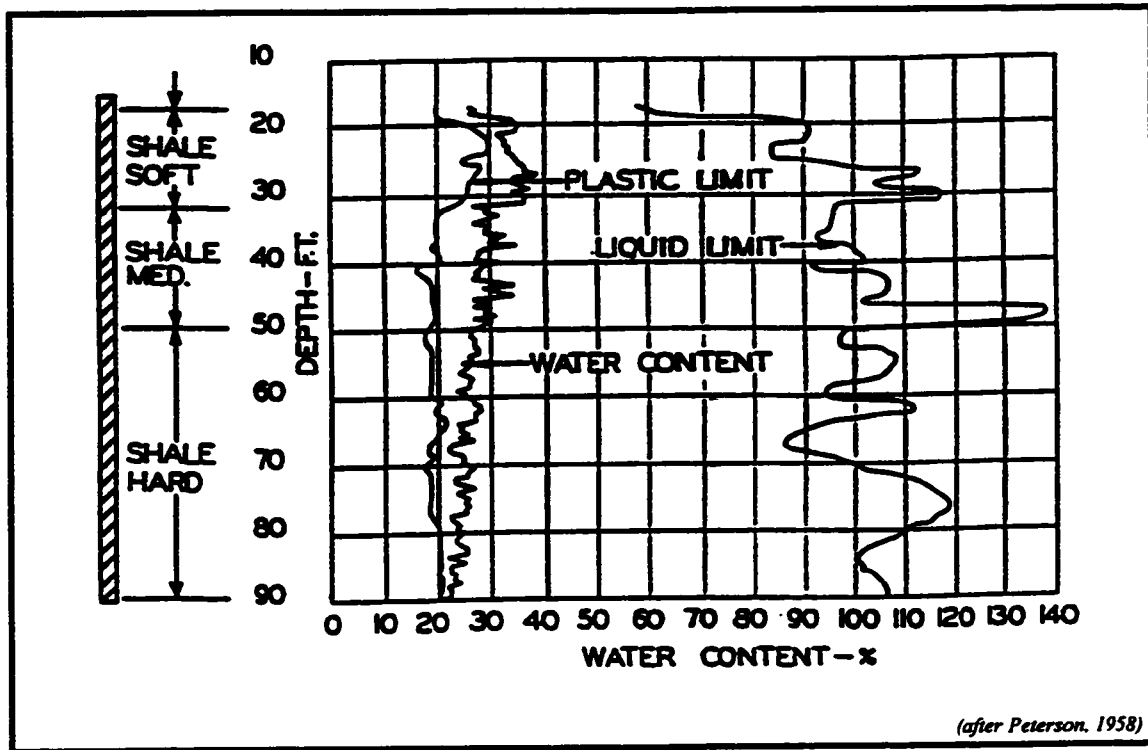
Time rebound is more complicated and involves long term softening of the rock, an increase in natural moisture content and accompanying change in volume. Peterson illustrates this in Fig. 42, which summarizes the hardness and moisture content of the Bearpaw shale from the surface to some depth. The shale has a profile that typically is soft rock near the surface with natural water contents of 30 to 35% and increases in hardness with depth, with a corresponding decreasing natural water content to about 20%. This is demonstrative of the effects of "time rebound" stress relief. During the retreat of the last glacial stage in Canada, it is estimated that approximately 2,000 feet of sediment

Fig. 42. Changes in moisture content and rock durability with depth, Bearpaw shale, Canada (from Peterson 1958).

was removed by erosion from this area along with glacial ice. Peterson estimates a removal of overburden stress equal to 100 to 150 tsf (200 to 300 ksf), or the equivalent of an excavation one-third of a mile deep in material averaging 125 pcf unit weight.
