NBS MONOGRAPH 158

Corrosion and Protection of Steel Piles in a Natural Seawater Environment

This report describes the first eight years of a long term program in which twenty-three coating systems and five cathodic protection systems are evaluated on their ability to protect steel piles in offshore conditions. These systems are made up of nonmetallic coatings, metallic pigmented coatings, nonmetallic coatings on metal filled coatings, nonmetallic coatings on metallic coatings, metallic coatings, and cathodic protection on bare and coated piles.

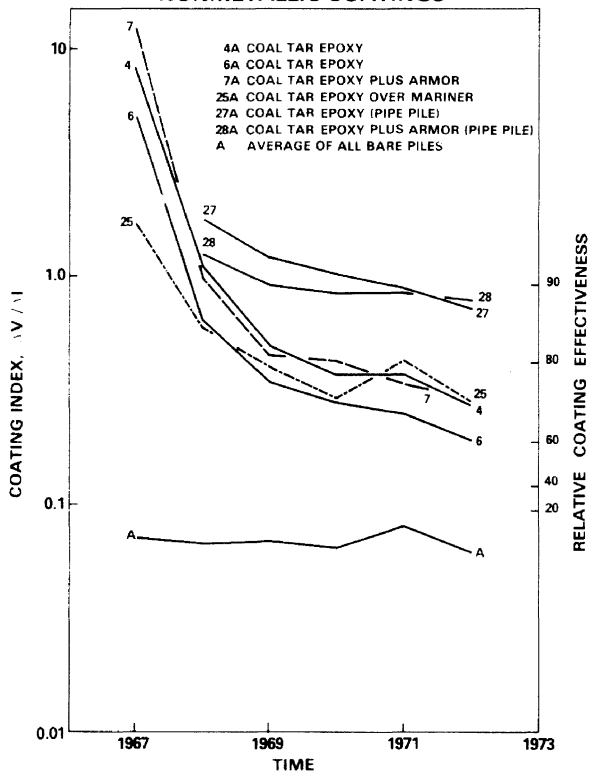
FIGURE 10

The polyamide cured coal tar epoxy Systems 4, 7, and 25 are somewhat better than 6A and have a relative coating effectiveness of 70 in the same period of time as shown in figure 10. It is of interest to note that System 7, which has the aluminum oxide armor in the erosion zone, initially provided the highest degree of protection to the steel as indicated by the elec-

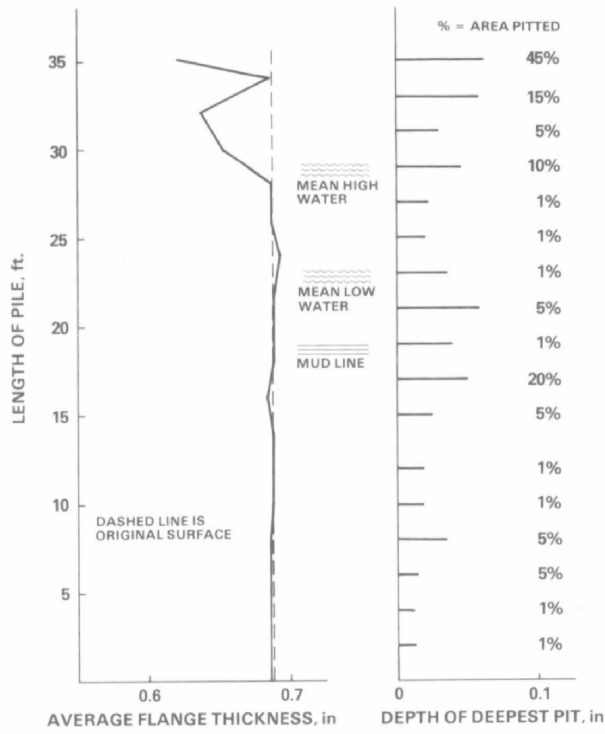
FIGURE 16

trochemical measurements. The physical measurements of these three piles are illustrated in figures 15, 16, and 17. The poor resistance of the coal tar epoxy coatings in the atmospheric and splash zones is well indicated in these drawings. Below the waterline, however, they have performed well. Pile 7A shown in figure 16 indicated that the armor coat did reduce the rate of coating deterioration in the erosion zone. Figure 18 is a photograph of the window in the atmospheric zone of pile 7A. Note the severe undercutting extending half the width of the pile. The window in the tidal zone, that zone between mean high water and mean low water, reveals only a slight amount of undercutting that extends 0.25 in (0.7 cm) as shown in figure 19. Pitting due to coating failure is evident. Below the mud line undercutting resistance is even better as shown in figure 20. Generally the coal tar epoxy looks good in this region.

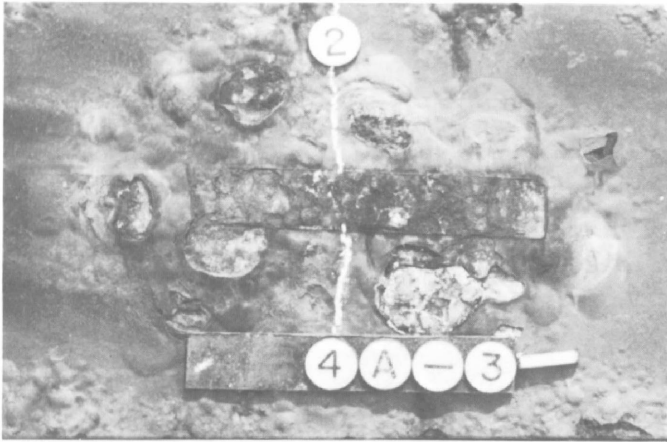
FIGURE 21

Pile 4A shown in figure 21 lacks the armor protection and has developed greater deterioration of the coating in the erosion zone as compared to pile 7A. The appearance of the window

in the atmospheric zone of pile 4A is similar to that of 7A after six years of exposure as figure 21 shows. In the tidal zone, however, the window on 4A has undergone considerable damage not readily seen in figure 22. Undercutting in this area extends almost 1 in (2.5 cm) beneath the coating. General damage to the coating in the surrounding area is also apparent. Below the mud line the coating is in excellent condition with practically no undercutting as shown in figure 23.

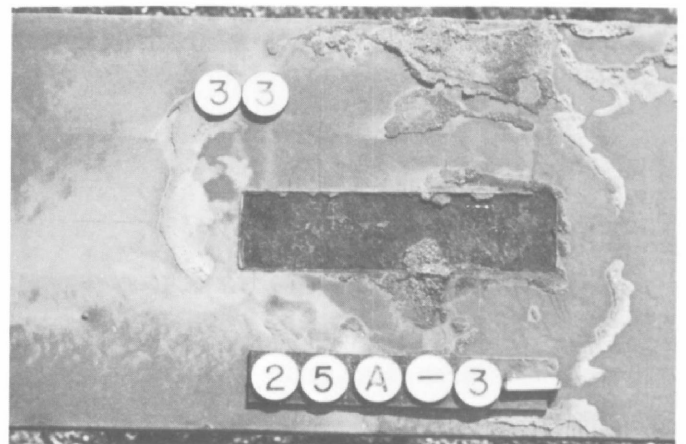
FIGURE 26

In the erosion zone, the coal tar epoxy on mariner steel, System 25, has not fared as well as the same coating on carbon steel (System 4A). Figure 17 indicates loss of metal at the flange in this area. Its pitting resistance below the mud line, however, is far better than any of the other similarly coated piles. Undercutting of the coating in the atmospheric zone is severe as illustrated in figure 24. Coating damage in the tidal zone is also very extensive (fig. 25). Below the mud line, however, figure 26 illustrates that the coal tar epoxy on mariner steel has not been undercut.

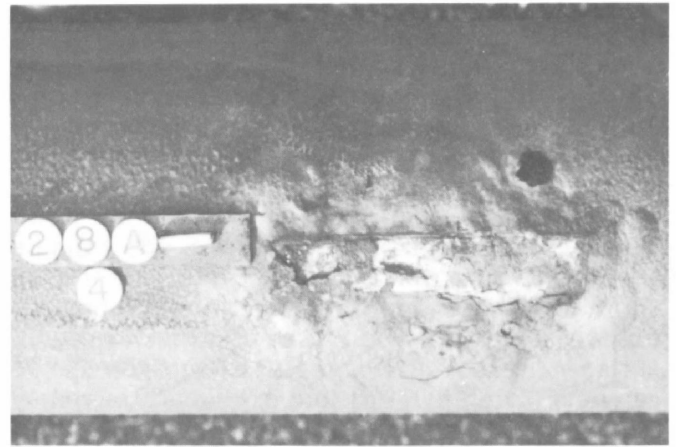
FIGURE 32

mud line, undercutting of the coating has progressed almost 1 in (2.5 cm) from the edge of the window. Coating delamination is also visible in this photograph. The windows in the coating on pile 28A are almost identical in appearance to those on 27A. In the atmospheric zone deterioration is extensive (fig. 32). In the tidal zone undercutting of the coating is moderate (fig. 33) with some mechanical damage visible. Below the mud line undercutting has progressed at least 1 in (2.5 cm) from the edge of the window (fig. 34).

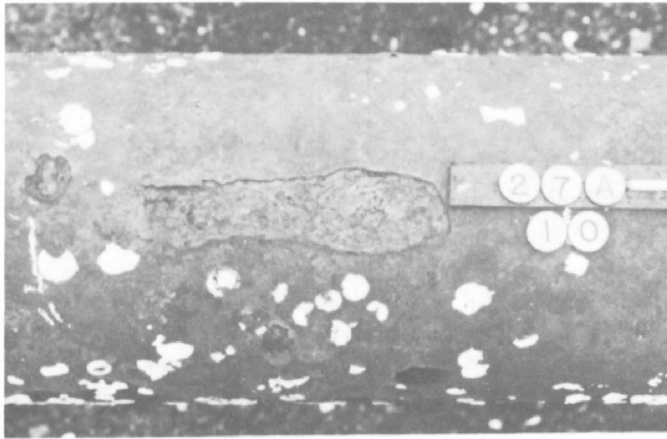
FIGURE 30

The physical measurements on the pipe piles consists only of pit depth measurements (figs. 27 and 28) as meaningful wall thickness measurements were not practical. These observations indicate that though there were fewer coating failures on the pipe piles, (% area pitted) as compared to the H-piles, the resulting pits were deeper on the pipe piles. The deepest pit in the erosion zone of 27A was almost 0.2 in (0.5 cm) deep. Undercutting of the coating on pile 27A extends about 2 in (5 cm) beyond the edge of the window as shown in figure 29, and is considered severe. In the tidal zone undercutting resistance is improved. Undercutting extends 0.5 in (1 cm) at the most (fig. 30). Figure 31 illustrates that below the

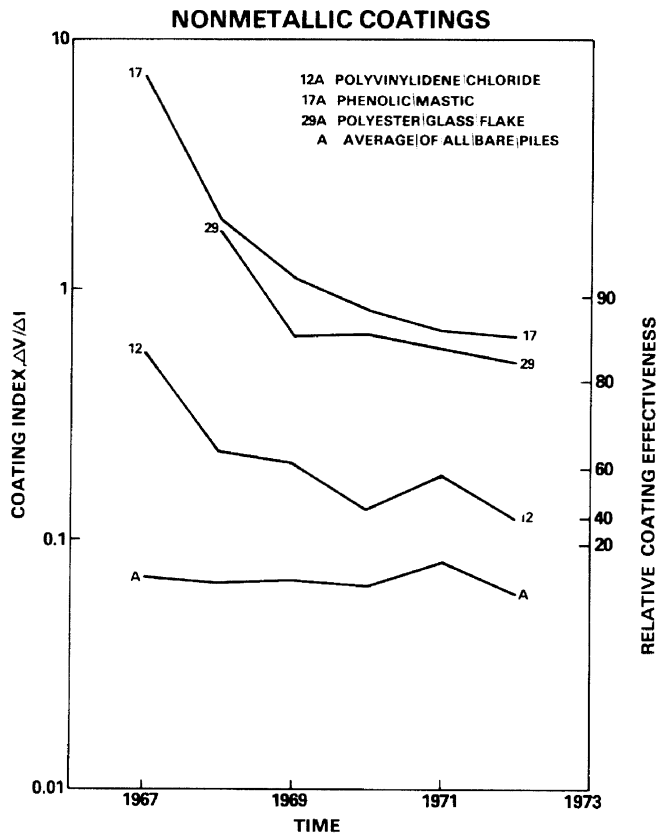
FIGURE 35

The second group of nonmetallic coatings in the program are Systems 12 (Polyvinylidene Chloride), 17 (Phenolic Mastic), and 29 (Polyester Glass Flake). The electrochemical measurements on these piles are given in figure 35. This data reveals the good resistance to deterioration of Specimen 17A. Specimen 29A is almost as good, and both have a coating effectiveness above 80. The physical measurements for pile 17A are illustrated in figure 36. The resistance to deterioration of the phenolic mastic has been very good over the entire surface of the pile in the six years of exposure. Even in the erosion zone the amount of pitting was low with maximum pit depths less than 0.1 in (0.2 cm). The maximum degree of cor-

Figure 35 illustrates the degree of deterioration of polyvinylidene chloride, System 12, as measured by electrochemical means. Without question, this system has given the least amount of protection to the steel. Initially it had a coating effectiveness of slightly more than 80. After five years the effectiveness of the coating dropped to 40. Figure 44 illustrates the data taken from the physical measurements. It is apparent from this figure that while the resulting corrosion of the pile is nowhere near that observed on the bare piles, it is considerably more than that seen on any of the piles protected by other types of non-metallic coatings. The worst area of attack is in the erosion zone with a corrosion rate of 5 mils per year (27 mdd) in this narrow region. The average corrosion rate over the entire pile surface is calculated to be 2.4 mils per year (13 mdd). The deepest pits developed between mean low water and the mud line as shown in the same figure. Photographs taken of the window in the atmospheric zone show considerable deterioration of the polyvinylidene chloride not only in the area immediately adjacent to the window, but also in other surrounding areas. Figure 45 is an example of this observation. The least amount of undercutting is observed in the tidal zone where damage extends 0.3 in (0.8 cm) beyond the window as shown in figure 46. Below the mud line, the

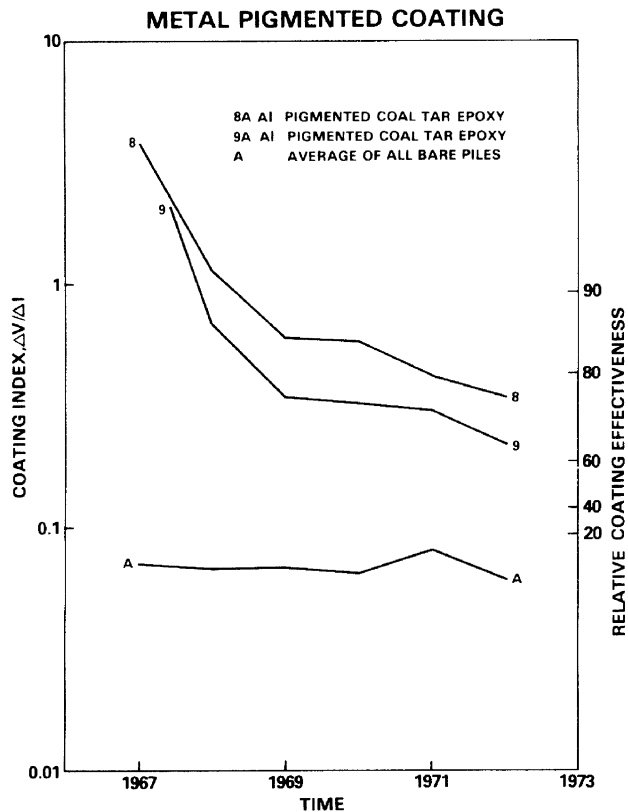
FIGURE 48

Metal Pigmented Coatings—Two aluminum pigmented coal tar epoxy coating systems (Systems 8 and 9) were included in the investigation. The electrochemical measurements on these two piles are illustrated in figure 48. From this figure one can see that the coating system on 8A has a relative coating effectiveness of over 70 while system 9A has slightly more than 60. The electrical resistivity of these two metal filled coatings is so high, that for all practical purposes they are nonconducting in the voltage ranges of our experiments. This is an important consideration as any conductivity through the film will affect the electrochemical measurements as will be pointed out later. The flange thickness measurements for pile 8A are illustrated in figure 49. This figure reveals that very little deterioration of the coating has taken place in the six years of exposure. Most of the damage to the coating has occurred in the erosion zone. The corrosion rate in this region has averaged less than 0.1 mil per year (0.5 mdd). The degree of pitting damage is

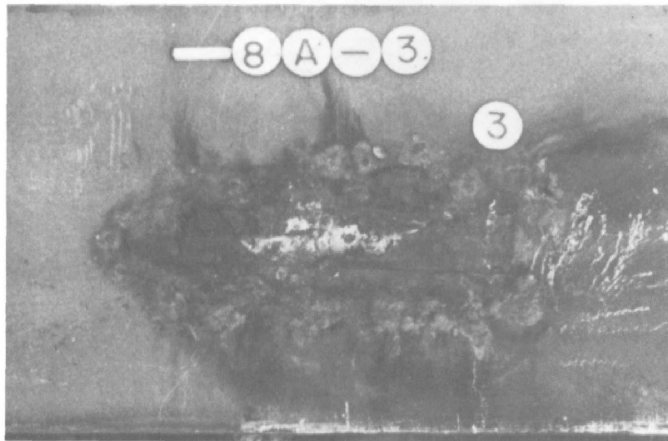
FIGURE 50

minor over most of the pile. In the atmospheric zone, undercutting of the coating extends less than 1.2 in (3 cm) beyond the original edge of the window as shown in figure 50. The same figure shows the otherwise excellent condition of the coating in the surrounding area. Most of the apparent damage is rust staining. In the tidal zone the coating at the edge of the window is in fairly good condition with only 0.1 in (0.2 cm) of undercutting as seen in figure 51. Some coating damage is visible in the surrounding area. Figure 52 is a similar window below the mud line which displays essentially no undercutting and no coating deterioration in the visible area.

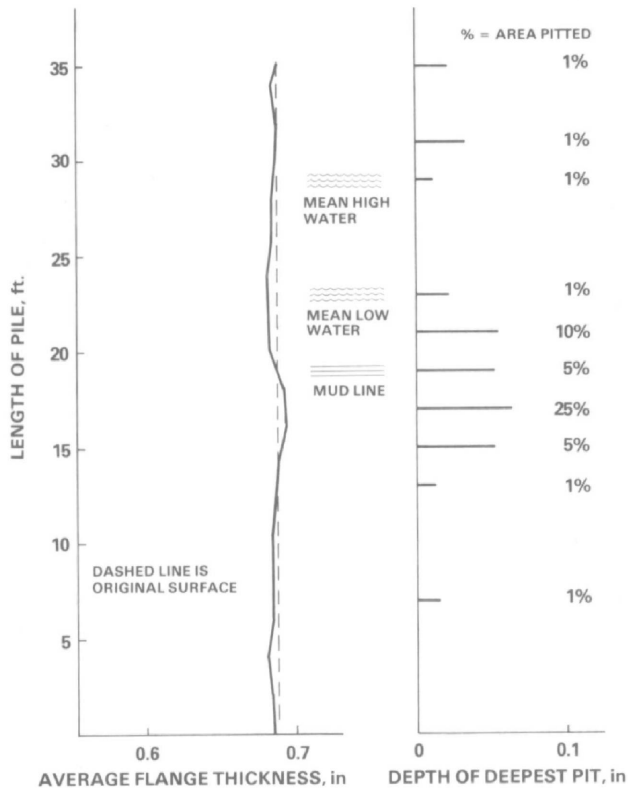
FIGURE 53

The second system of aluminum pigmented coal tar epoxy, System 9, has a film thickness that is 30 percent thinner than System 8. Specimen 9A has undergone more damage as the physical measurements illustrate in figure 53. Incomplete sandblasting of the surface during the cleaning process has caused the flange of specimen 9A in figure 53 to appear thicker in the erosion zone than it really is. The coating 1 in (2.5 cm) from the edge where the flange thickness measurements are made is in

good condition, but two or three inches (5 to 7 cm) from the edge, the coating had deteriorated as indicated by the pitting data in the same figure. The average corrosion rate over the entire surface of the pile is calculated to be slightly less than 0.2 mils per year (1 mdd). In the atmospheric zone, the coating window has produced undercutting extending about 1.5 inches (4 cm) under the coat as seen in figure 54. In the tidal zone, coating damage at the window is minor as can be seen in figure 55. Below the mud line undercutting has extended as much as 2 in (5 cm) under the paint system as shown in figure 56. Coating breakdown at the edge of the flange is also visible in this photograph. In general, both aluminum pigmented coal tar epoxy substrates have performed fairly well, although the thicker film, System 8A, has performed somewhat better in the six years of exposure.

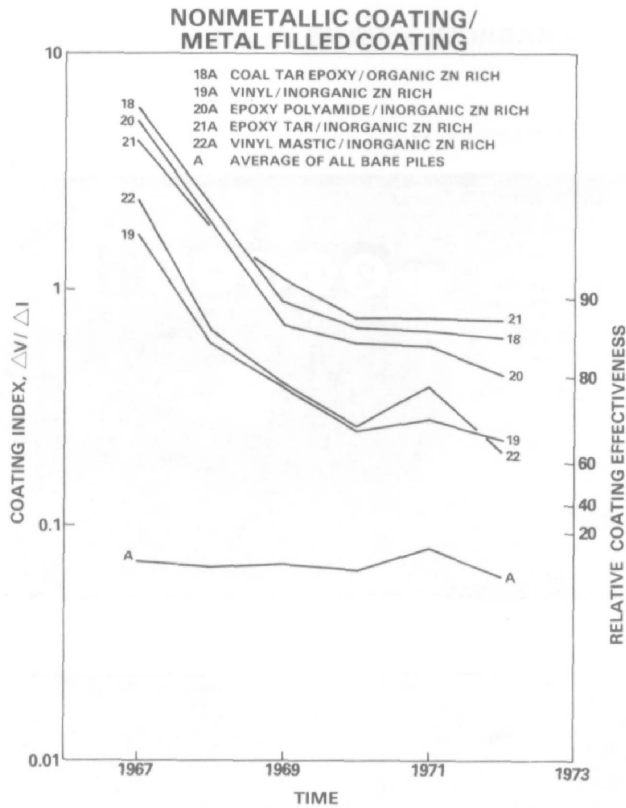
FIGURE 57

Nonmetallic Coatings on Metal Filled Coatings—Metallic Zinc powder has been used in the metal filled undercoats of the five 2-coat systems discussed here. Whereas all of the topcoats are electrically insulating, three of the five metal filled undercoatings are electrically conducting. These three, Systems 18, 20, and 21 will be considered separately from the rest. Figure 57 is a plot of the electrochemical data

of these coatings. System 18, coal tar epoxy over zinc rich organic primer, is maintaining a relative coating effectiveness of 85. At the same time System 20, epoxy polyamide over zinc rich inorganic primer, has a relative coating effectiveness of 80. The coal tar epoxy over zinc rich inorganic primer, System 21, also has a relative coating effectiveness of 85. The relative coating effectiveness of these three systems may actually be slightly better than indicated by the electrochemical data. The reason being that as the overcoat erodes away or fails from some other cause, the electrically conducting metal filled undercoat is exposed. This undercoat may be protecting the steel very well, but because of its low electrical resistance it displays a lower coating effectiveness (coating index) than it really has.

Attention is again directed to figure 57 which illustrates the electrochemical data for the nonmetallic coatings on metal filled coatings. Systems 18, 20, and 21 have been described. The remaining systems in this category are piles 19A (vinyl over zinc rich inorganic primer), and 22A (vinyl mastic over zinc rich inorganic primer).

The electrochemical data indicate that Systems 19 and 22 are very similar in their deterioration and degree of protection as figure 57 illustrates. The relative coating effectiveness

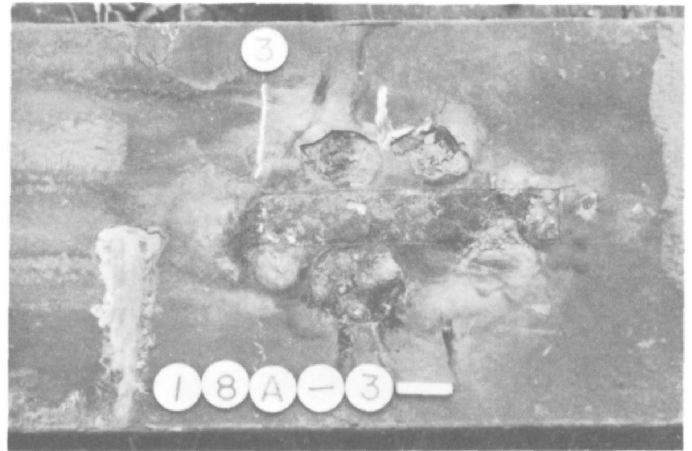
FIGURE 59

The physical measurements on System 18A are illustrated in figure 58. The deterioration of the steel pile has been slight. The coating system has performed well in all of the zones of exposure. Average corrosion rate for the pile has been less than 0.2 mils per year (1 mdd). In the atmospheric zone, damage of the coating at the window has been severe as shown in figure 59. Undercutting of the coating extends almost 2 in (5 cm) beyond the window. Undercutting of the coating in the tidal zone has been

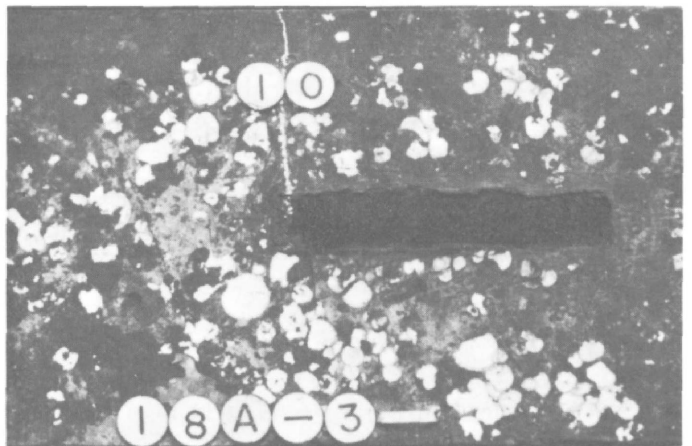
FIGURE 60

minor as shown in figure 60. Below the mud line the effect is negligible as seen in figure 61. Some of the coating damage visible in this photograph is mechanical abrasion due to removal and shipping.

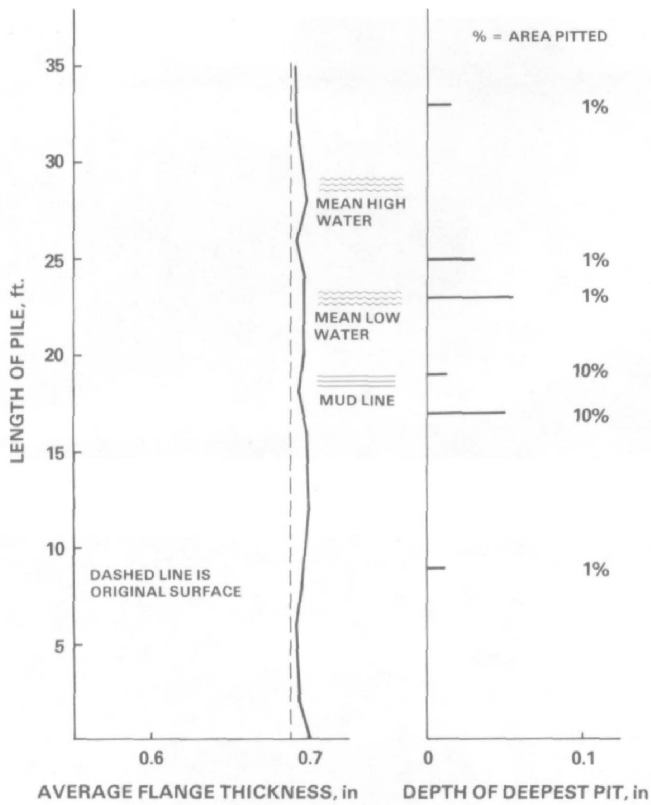
FIGURE 66

System 21 has displayed unusually good resistance to deterioration in the offshore exposure as shown in the physical measurements of figure 66. Incomplete sandblasting has led to the data showing the flange to be thicker than it was originally. As mentioned before, this clearly indicates that there was no metal loss in these areas. Thus, pile 21A is in excellent condition after six years of exposure. The amount of pitting is minor as the same figure shows. Undercutting of the coating in the atmospheric zone has been moderate with damage extending about 0.6 in (1.5 cm) beyond the window as seen in figure 67. The coating in the surrounding area is in excellent condition. In the tidal zone undercutting is of minor consequence and extends less than 0.1 in (0.2 cm) as illustrated in figure 68. Below the mud line there was no measurable undercutting of the coating as shown in figure 69. Mechanical damage to the edge has removed some of the coating.

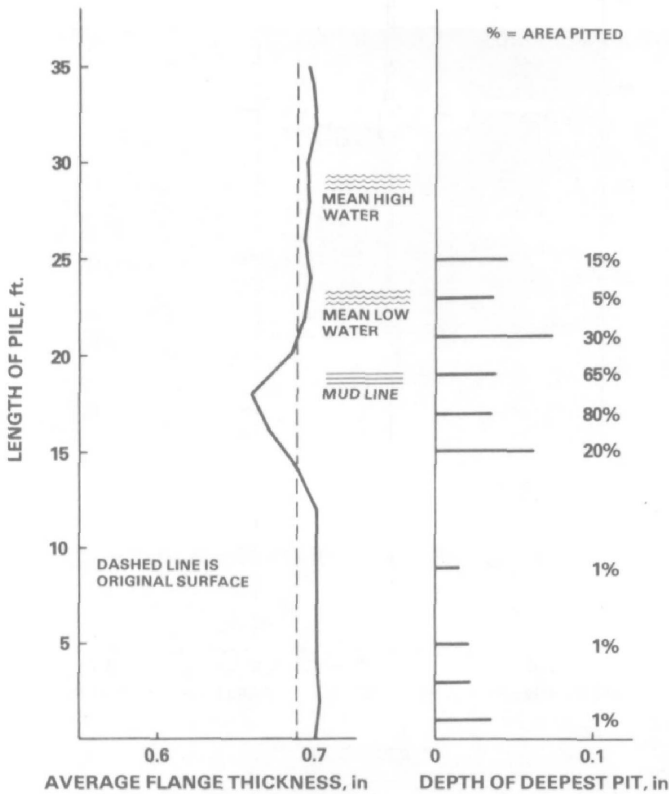
FIGURE 74

Pile 22A, vinyl mastic over inorganic zinc rich, has a relative coating effectiveness slightly above 60 after six years. The flange thickness measurements are illustrated in figure 74.

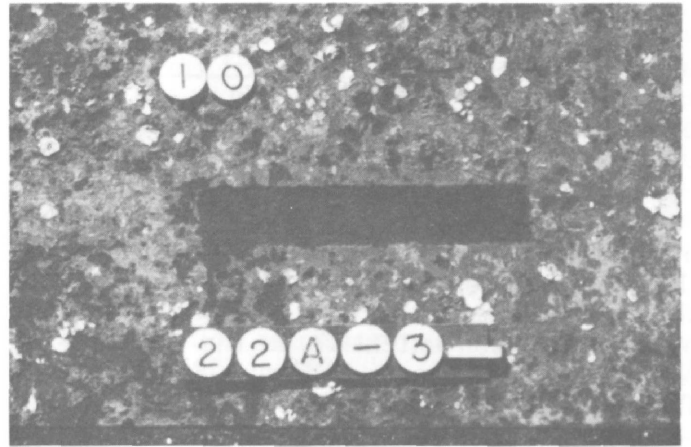
FIGURE 76

There is very little attack in the atmospheric zone. Undercutting in this area is less than 0.1 in (0.2 cm) as shown in figure 75. In the tidal zone general deterioration of the coating has taken place, but with very little actual metal loss. This is illustrated in figure 76. Undercutting here is also less than 0.1 in (0.2 cm). Below the mud line undercutting extends about 0.2 in (0.5 cm) beyond the window as figure 77 shows. Notice the blistering of the coating in the surrounding area. The overall average corrosion rate for pile 22A is less than 0.25 mils per year (1.4 mdd).

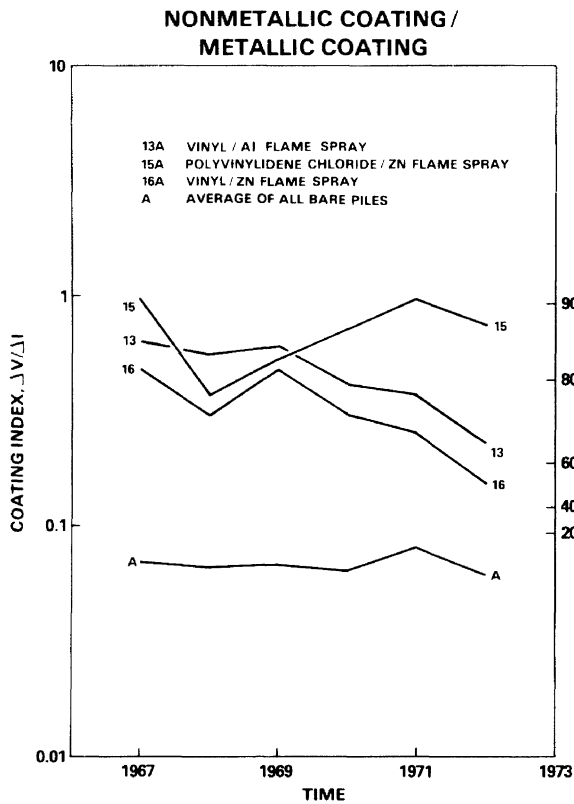
FIGURE 78

The vinyl over zinc flame spray system, pile 16A, has undergone the most deterioration of the topcoated metallic coating systems. The relative coating effectiveness of 16A is about 50 percent as figure 78 illustrates. After the top coat began to fail during the first year of exposure, the flame sprayed zinc protected the piling for a short period. Soon after, however, the system started to deteriorate steadily. It is of interest to note that the total coating thick-

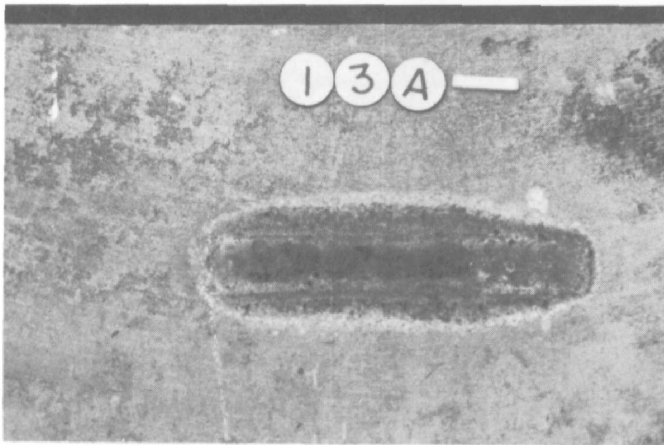
FIGURE 80

been less than 0.05 mils per year (0.3 mdd) for the six years of exposure.. In the atmospheric zone, the coating is in excellent condition. Corrosion damage extends slightly less than 0.5 in (1.2 cm) from the edge of the window as shown in Figure 80. Undercutting of the coating at the window in the tidal zone is too slight to be measurable, however, general coating failure is visible as figure 81 shows. Though the coating has obviously deteriorated below the mud line (fig. 82), there has been little subsequent attack to the steel pile. Damage to the coating at the window extends about 0.1 in (0.2 cm).

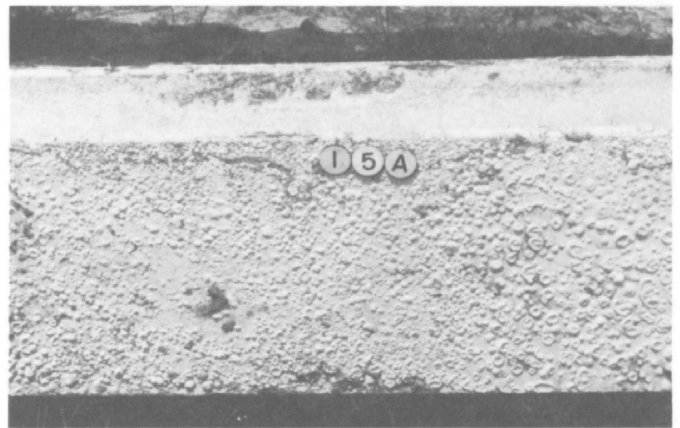
FIGURE 85

loss is small and uniform over the surface of the pile. Similarly, pitting is scattered and of minor consequence. The average corrosion rate for the entire pile is about 0.1 mil per year (0.5 mdd). There were no windows in the coating of this pile. The following photographs are included to display its appearance in areas similar to those seen for the other pilings. The coating in the atmosphere is in very good condition with only minor damage in a few areas. Unfortunately the photograph of this area is of such poor quality that it will not be shown. In the tidal zone the nonmetallic coating is badly blistered as figure 84 shows, but the piling is still being protected by the zinc. Top coat blistering extends into the area below the mud line as figure 85 illustrates, but corrosion damage to the pile is minor.

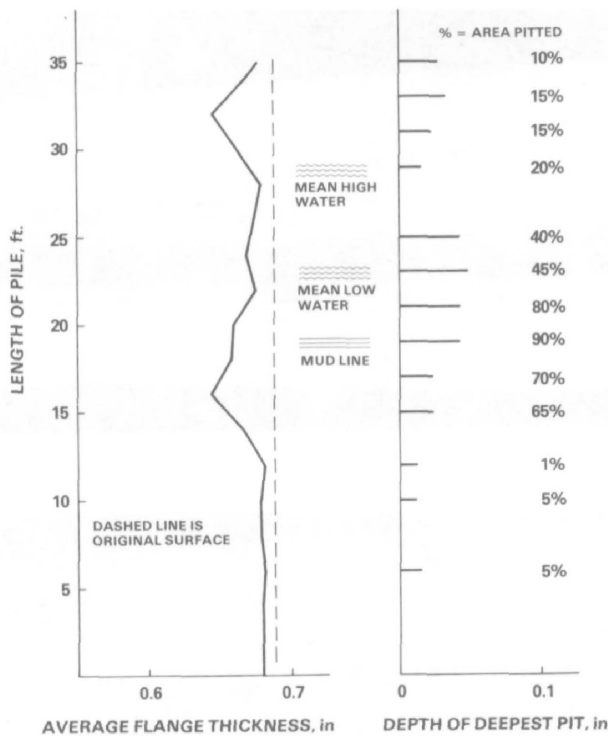
FIGURE 86

ness of this system is about 50 percent less than that of pile 15A. Corrosion damage to the steel pile in the form of general corrosion and pitting has been extensive as the plot of the physical measurements in Figure 86 illustrate. The average corrosion rate for the entire pile is about 1.5 mils per year (8 mdd). In the atmospheric zone coating failure was severe as figure 87 shows. The window in the coating is barely visible. In the tidal zone failure was also extensive as shown in figure 88. Figure 89 illustrates the condition of the piling below the mud line where it has fared somewhat better than in other zones. With such complete failure of the coating, evaluation of the undercutting is of no consequence and, therefore, is not attempted.

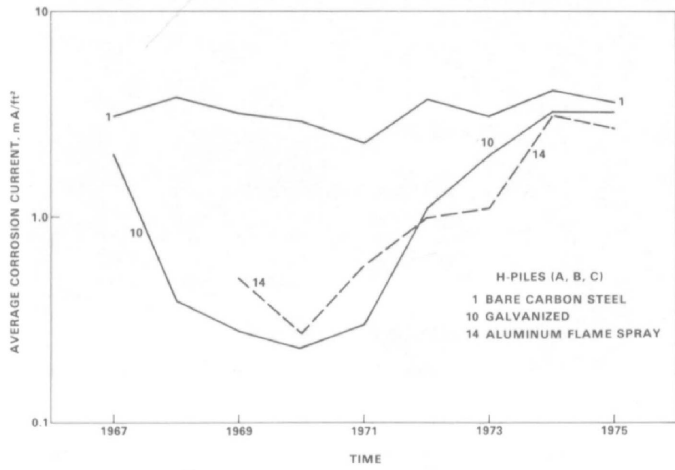
FIGURE 90

The flame sprayed aluminum system, pile 14A, is similar to pile 10A in its electrochemical behavior as indicated in figure 90. It too shows an increase in corrosion which is approaching that of bare steel as the aluminum deteriorates. The flange thickness measurements, figure 95, reveal some metal loss in the erosion zone, and practically no pitting anywhere. In the atmospheric zone the aluminum flame spray coating appears in excellent condition with the exception of the corrosion damage extending almost 1 in (2.5 cm) from the window shown in figure 96. In the tidal zone the coating is also in excellent condition (fig. 97) with minor damage extending from the window. From the mud line down, however, damage is more extensive. Figure 98 illustrates the window in this region with coating damage over most of the visible surface.

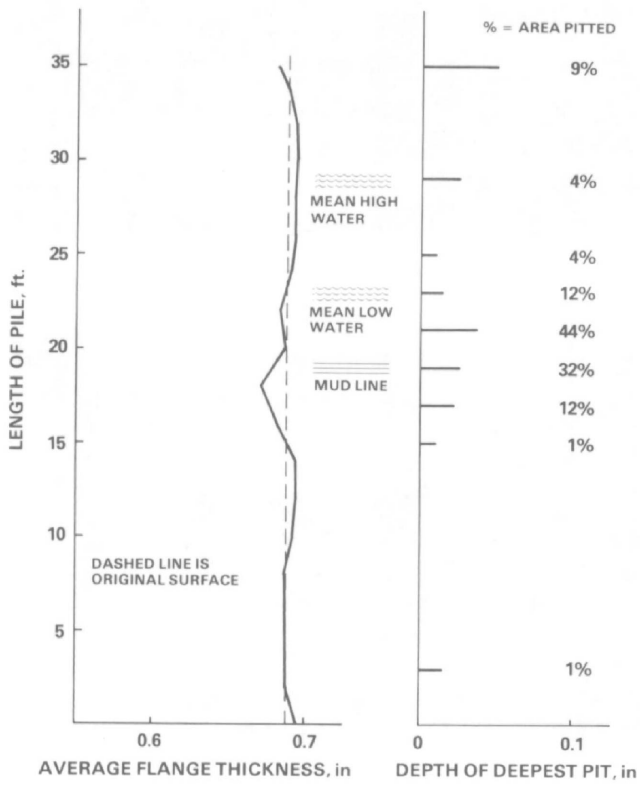
FIGURE 91

The results on the bare carbon steel piles are shown for reference as was done in all illustrations of electrochemical data. The corrosion current indicates that the bare steel corroded at a relatively uniform rate with time while the corrosion of the galvanized pile, 10A, has changed considerably in the same period. During the first three years, the corrosion current decreases by a factor of ten. Thereafter it increased steadily until now, eight years later, it is approaching the corrosion of the bare carbon steel pile. This data on the galvanized steel is made up of information from piles A, B, and C, two of which are still at the offshore site. Figure 91 illustrates the physical measurements on pile 10A. The pile shows some

corrosion in the atmospheric zone and considerable corrosion in the abrasion zone. The average corrosion rate for the pile is less than 0.15 mils per year (0.8 mdd). There are no windows in this system, but photographs are included for information. Above the high water line, coating failure is in the form of pits as figure 92 illustrates. In the tidal zone pitting continues along with some undercutting of the coating. A small section of coating was easily separated from the substrate as figure 93 shows. Below the mud line the coating was very thin or altogether missing in some areas as figure 94 illustrates.

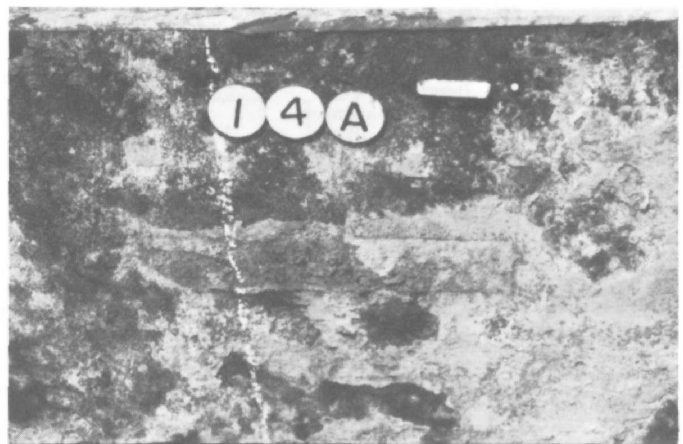
FIGURE 98

Sealed flamesprayed aluminum

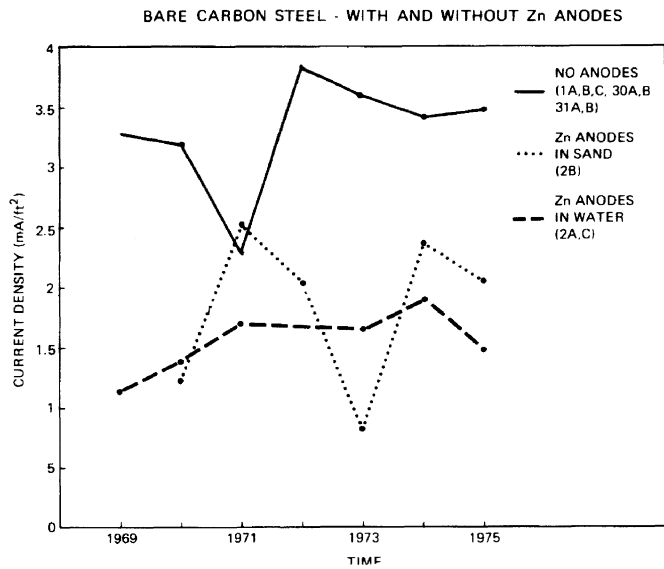
FIGURE 99

The average corrosion current densities of several bare steel piles and the average protective current densities of steel piles with zinc anodes are plotted in figure 99. The protective current density of the protected piles represent both the galvanic current as well as local action current on the anodes. The local action current was not directly determined but it has

As seen in figure 99, the protective current densities of the zinc anode protected systems are less than those of the unprotected piles. It appears that there is not very much difference in the protective current densities provided by the anodes in the water and buried in the sand over the 6 year period (1970 to 1975). More time will be required to determine any real differences.

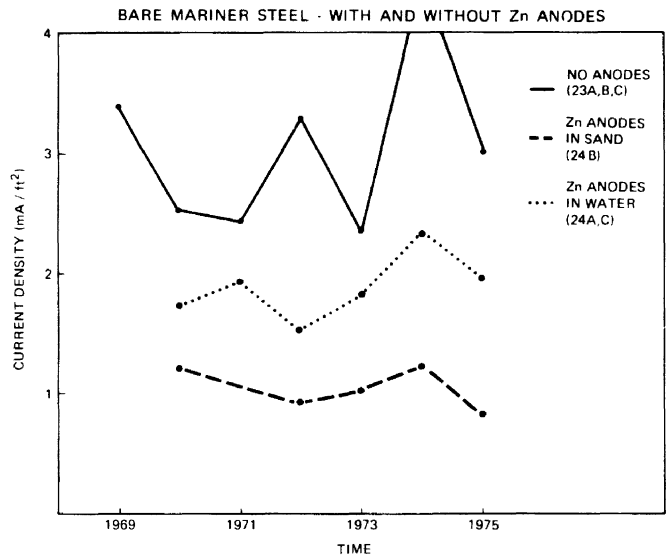
FIGURE 101

In the case of mariner steel, however, the protection current density of the zinc anodes buried in the sand, over the 6 year period, is definitely less than the current density of the zinc anodes exposed to the water (fig. 101).

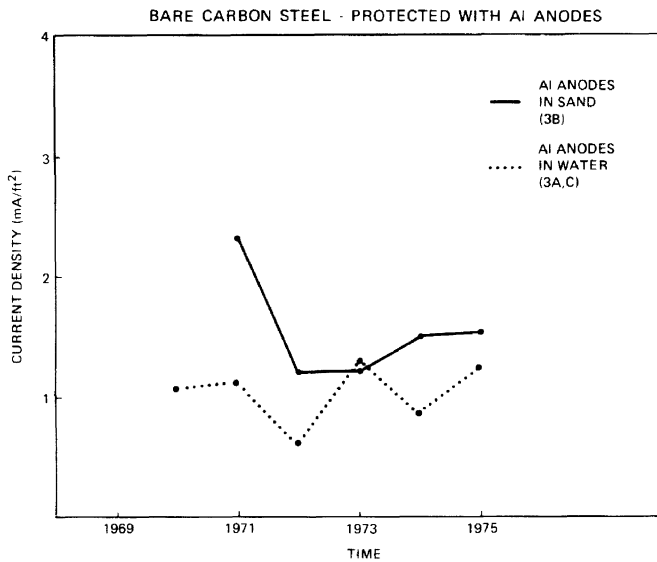
FIGURE 100

Aluminum anodes in the sand appear to be less effective than the anodes in water in protecting the steel (fig. 100).

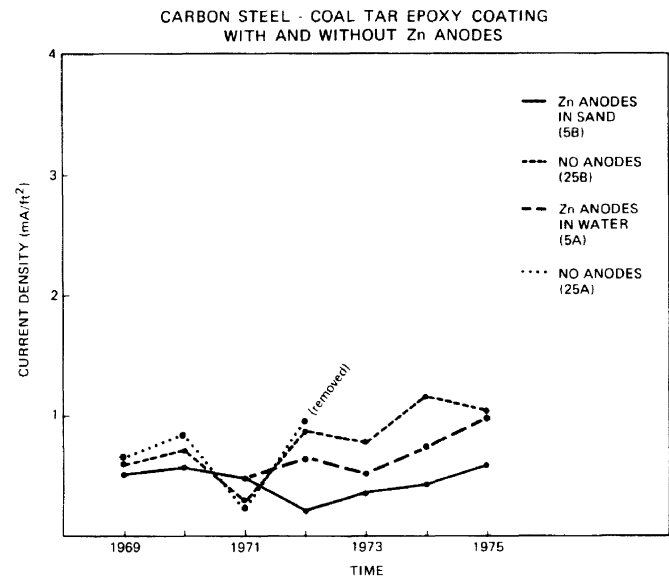
FIGURE 102

The coal tar epoxy coated piles, with zinc anodes in the sand appear to be more effective (from a galvanic current standpoint) than the coated piles without cathodic protection except for one year (1971). For the piles with windows (5A and 25A), there was little discernible differences for two years (1971, 1972) between the piles with anodes in the water and the piles without anodes (fig. 102).

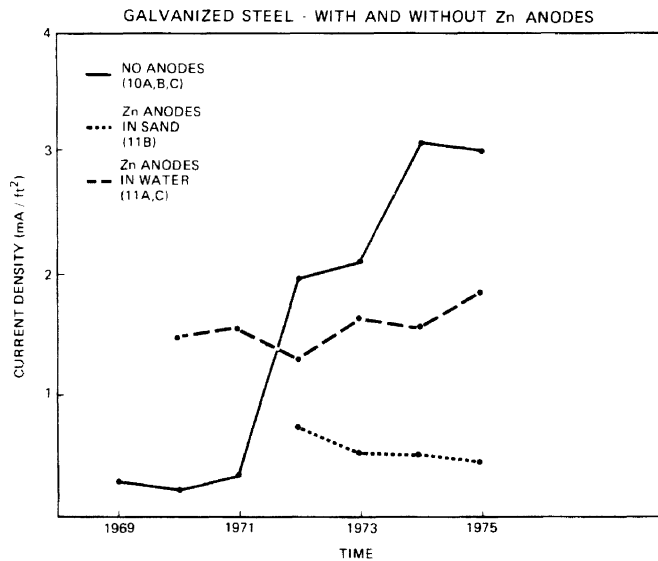
FIGURE 103

A comparison of the galvanized pile, with zinc anodes (System 11) and without zinc anodes (System 10), is shown in figure 103. Only a portion of the curve for the protective current density of the galvanized pile is shown. From 1973 to 1975 the curve represents the averages on piles B and C. Initially (1967) the average corrosion current density on piles A, B, and C was quite high and then decreased to very low values for 1967-1971 (fig. 90). The protective current density is very low for the zinc anodes buried in the sand and appears to be steadily decreasing with the passage of time. The protective current density for the zinc anodes in the water is about 3 times higher and appears to be increasing with time.
