NACA RM E55J04

PRELIMINARY INVESTIGATION OF SEVERAL ROOT DESIGNS FOR  
CERMET TURBINE BLADES IN TURBOJET ENGINE

III - CURVED-ROOT DESIGN

December 28, 1955

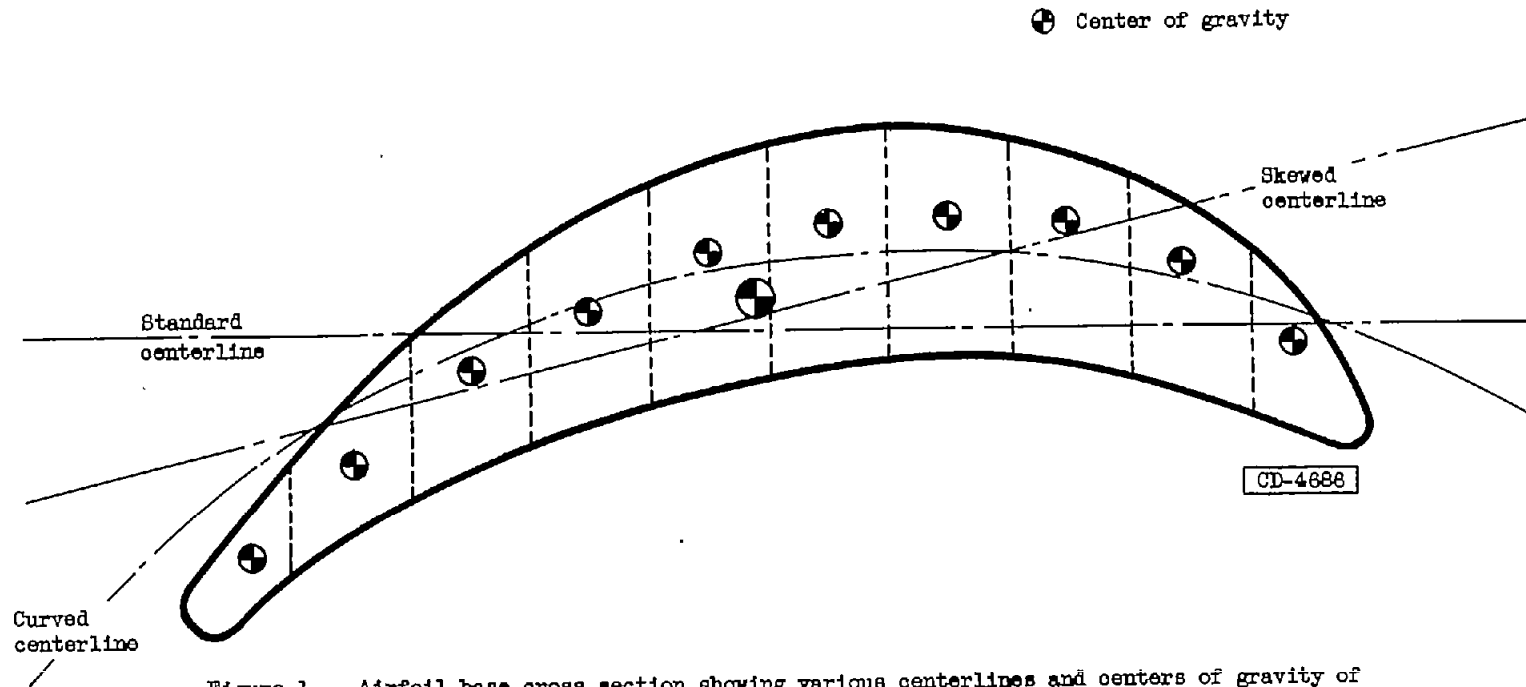
To determine the optimum root centerline for the curved root blade, the airfoil was divided into ten radial columns instead of in halves. The computed center of gravity of each column was plotted on the base cross section of the airfoil (fig. 1).

The optimum centerline of the root would conform to the curve through the centers of gravity, but displaced from it to compensate for gas bending loads. A root developed in this manner, however, could not be assembled in the rotor, because the curve through the centers of gravity has different radii of curvature at the several points. A root with a circular-arc centerline provides a good compromise that can be assembled readily. The radius of the proper arc depends on the camber of the airfoil; a 1.953-inch radius was selected for the airfoil investigated. Figure 1 shows the curved centerline selected, along with the standard and the skewed centerlines from reference 4.

Figure 1. - Airfoil-base cross section showing various centerlines and centers of gravity of whole airfoil and of ten radial columns.
