**Contamination Source Review for Building E5032,
Edgewood Area, Aberdeen Proving Ground, Maryland**

ANL/ESD/TM-102

September 1995

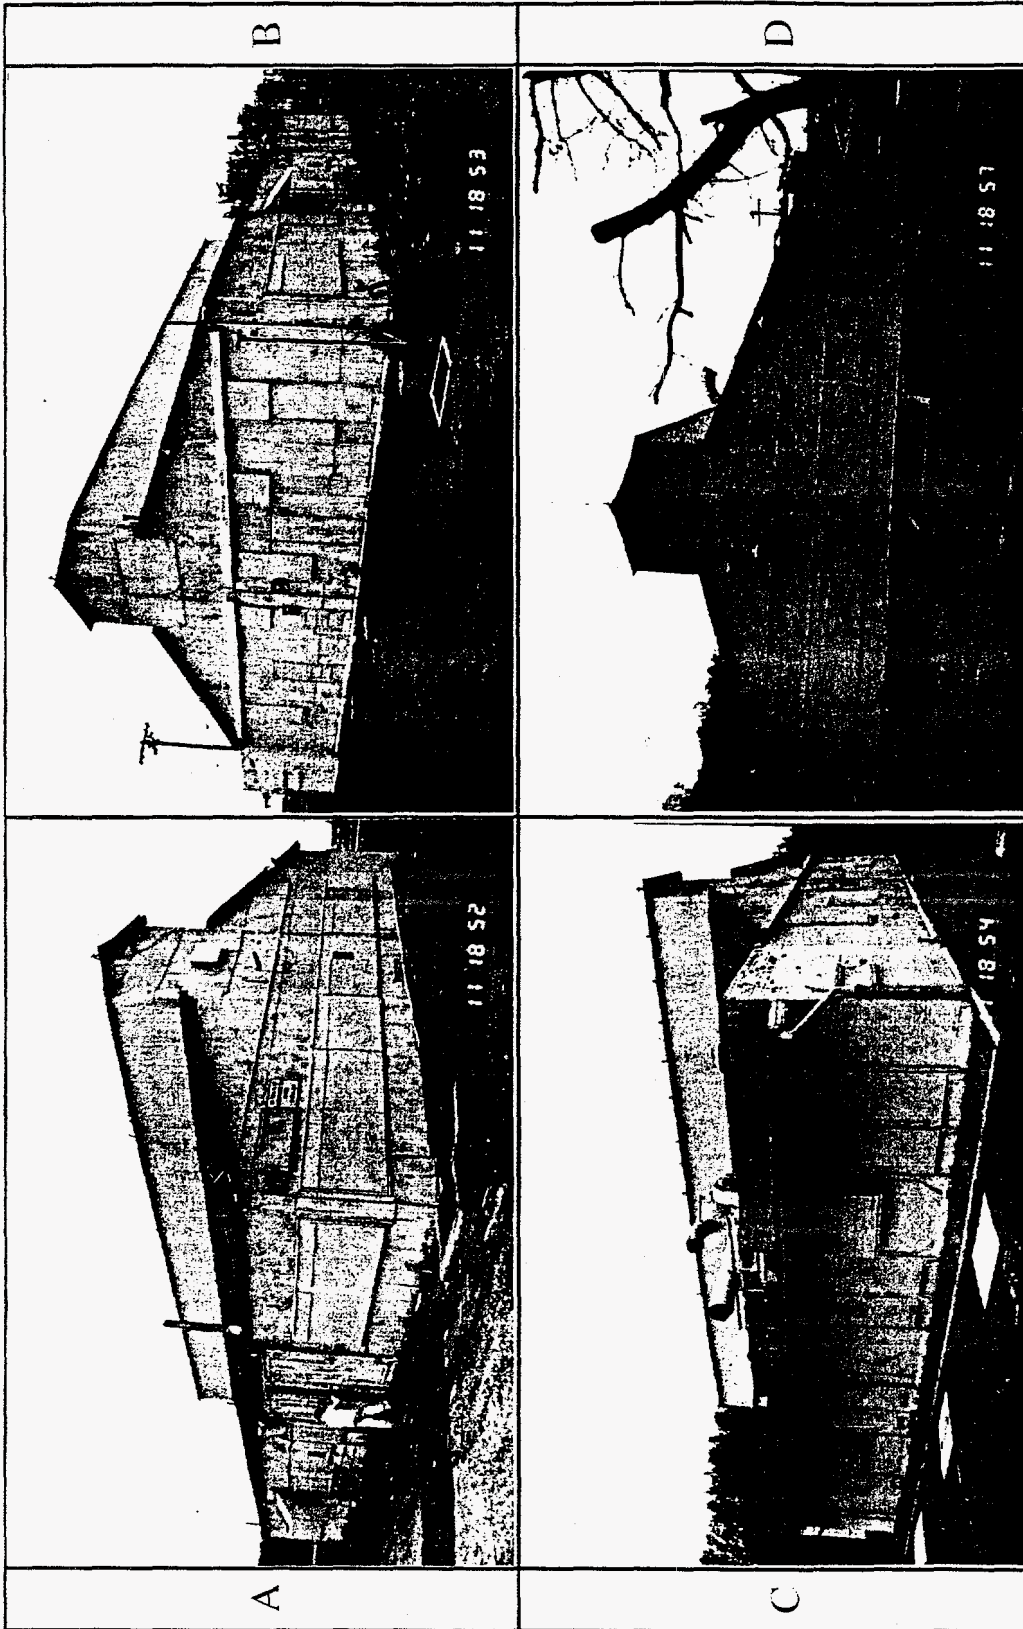
Numerous exterior concrete pads, sumps, aprons, and drainage ditches (troughs) were found near Building E5032. The building shows evidence of several major modifications during its history. The main building is constructed of a vertical I-beam steel structure with steel roof trusses. The exterior of the main building is covered by corrugated sheet metal. Numerous holes of varying sizes indicate that piping once passed through the exterior walls of the building. An addition along the south side of the main building, constructed of cinder blocks, consists of four small cubicles. These cubicles are accessible only through exterior double doors located at the center of each cubicle. Outside of the cubicles, a concrete slab extends approximately 6 ft to the south and 10 ft to the west. A 6-in.-high concrete curb frames the concrete slab on the east and south edges. Figure 3 shows a plot plan of Building E5032 and its vicinity. Figure 4 shows a floor plan of Building E5032, developed at the time of ANL's inspections. Photographs of the building exterior are presented in Figure 5.

Remnants of pipes were observed along the north elevation (Figure 6).

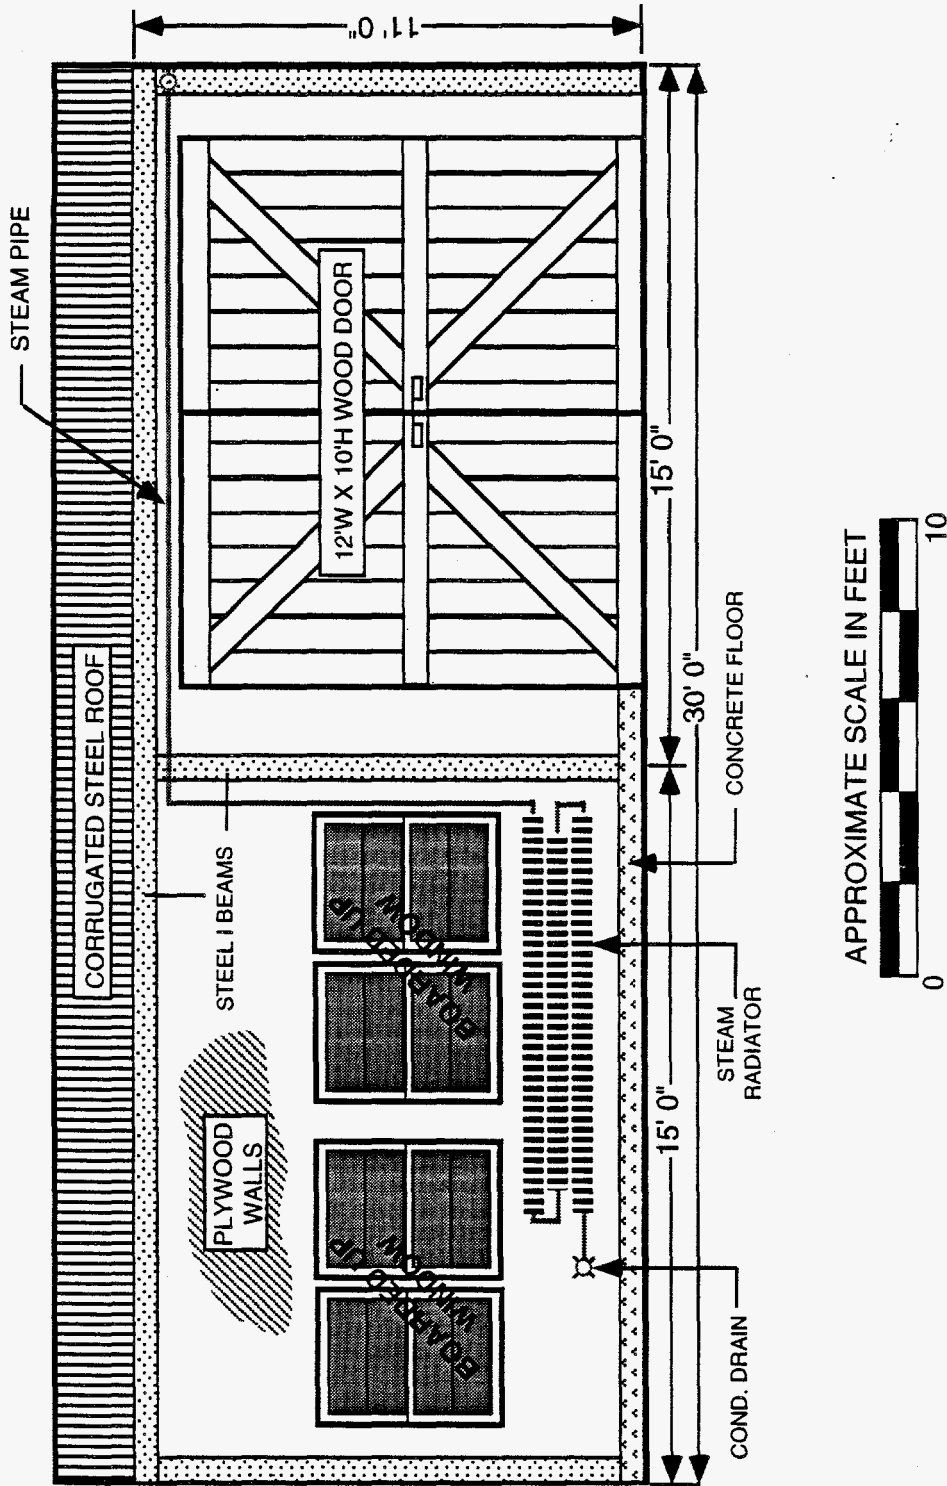
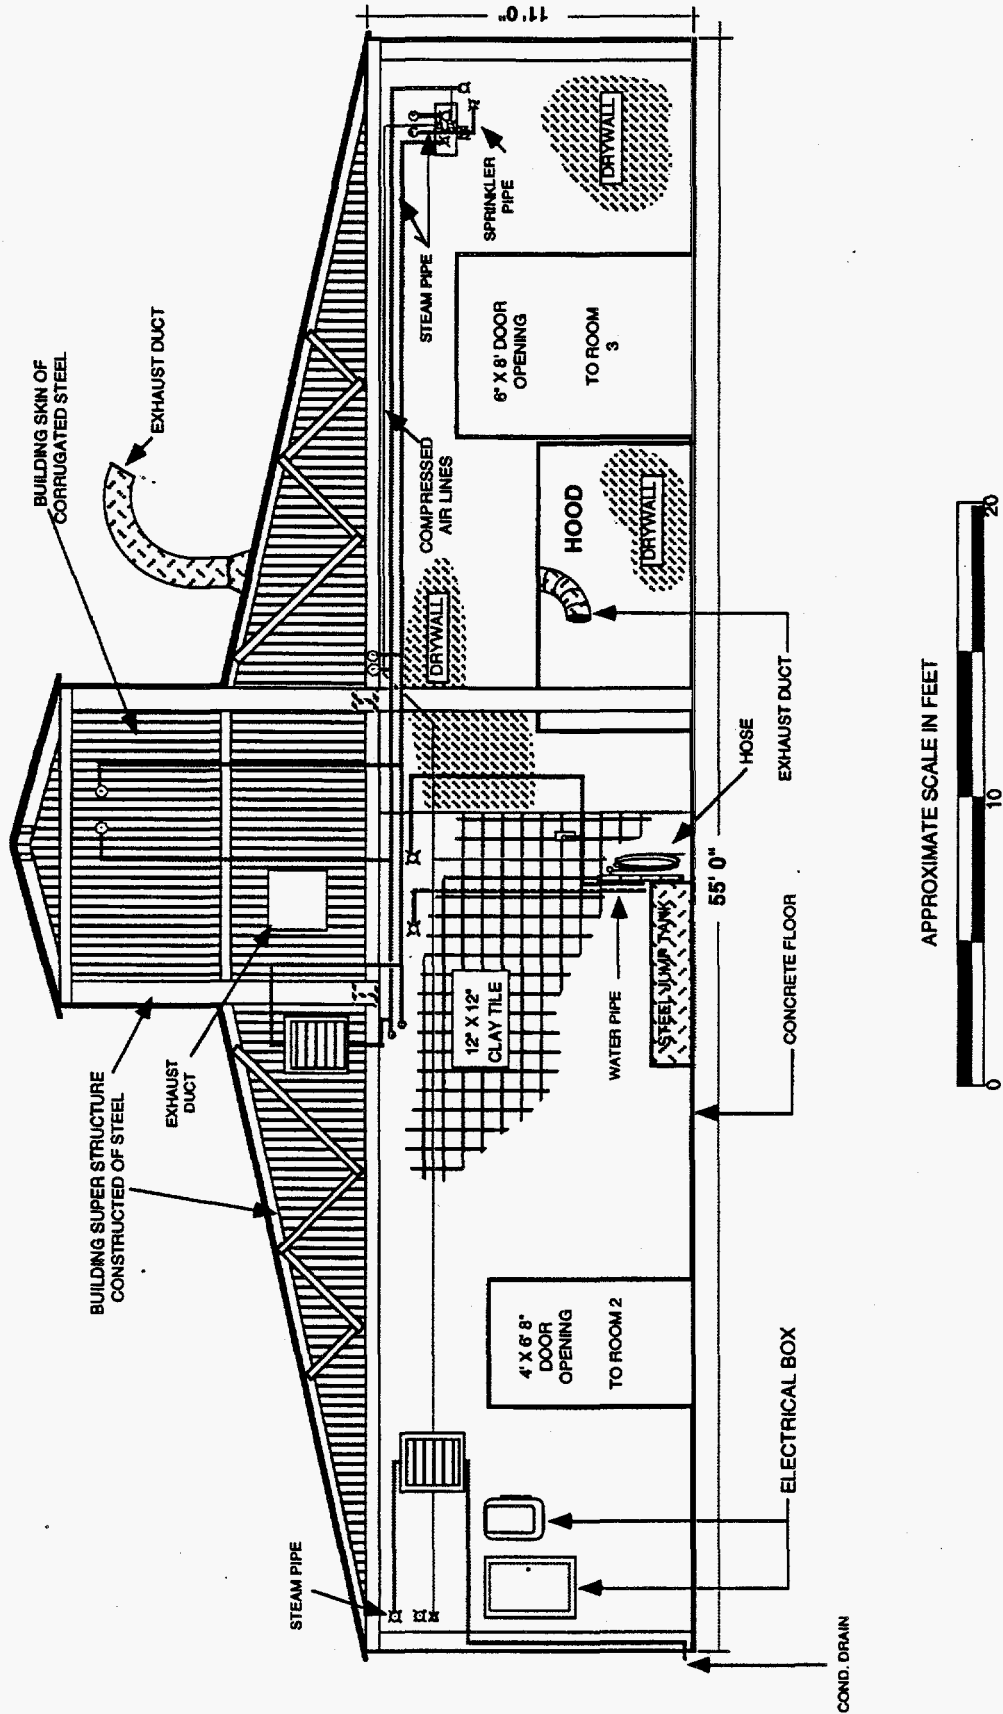
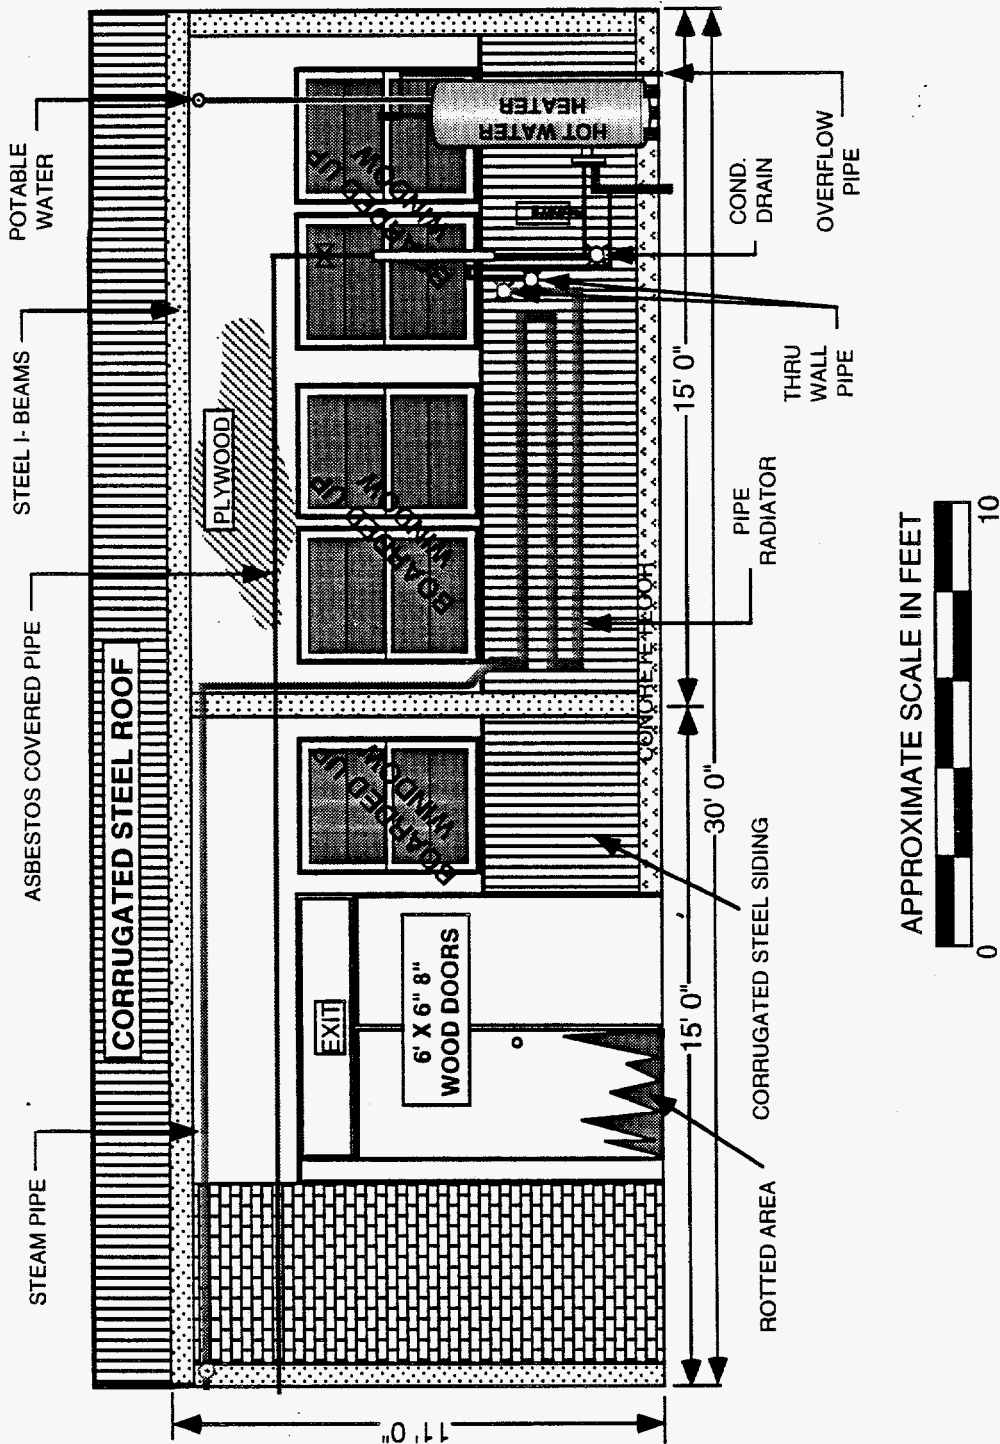
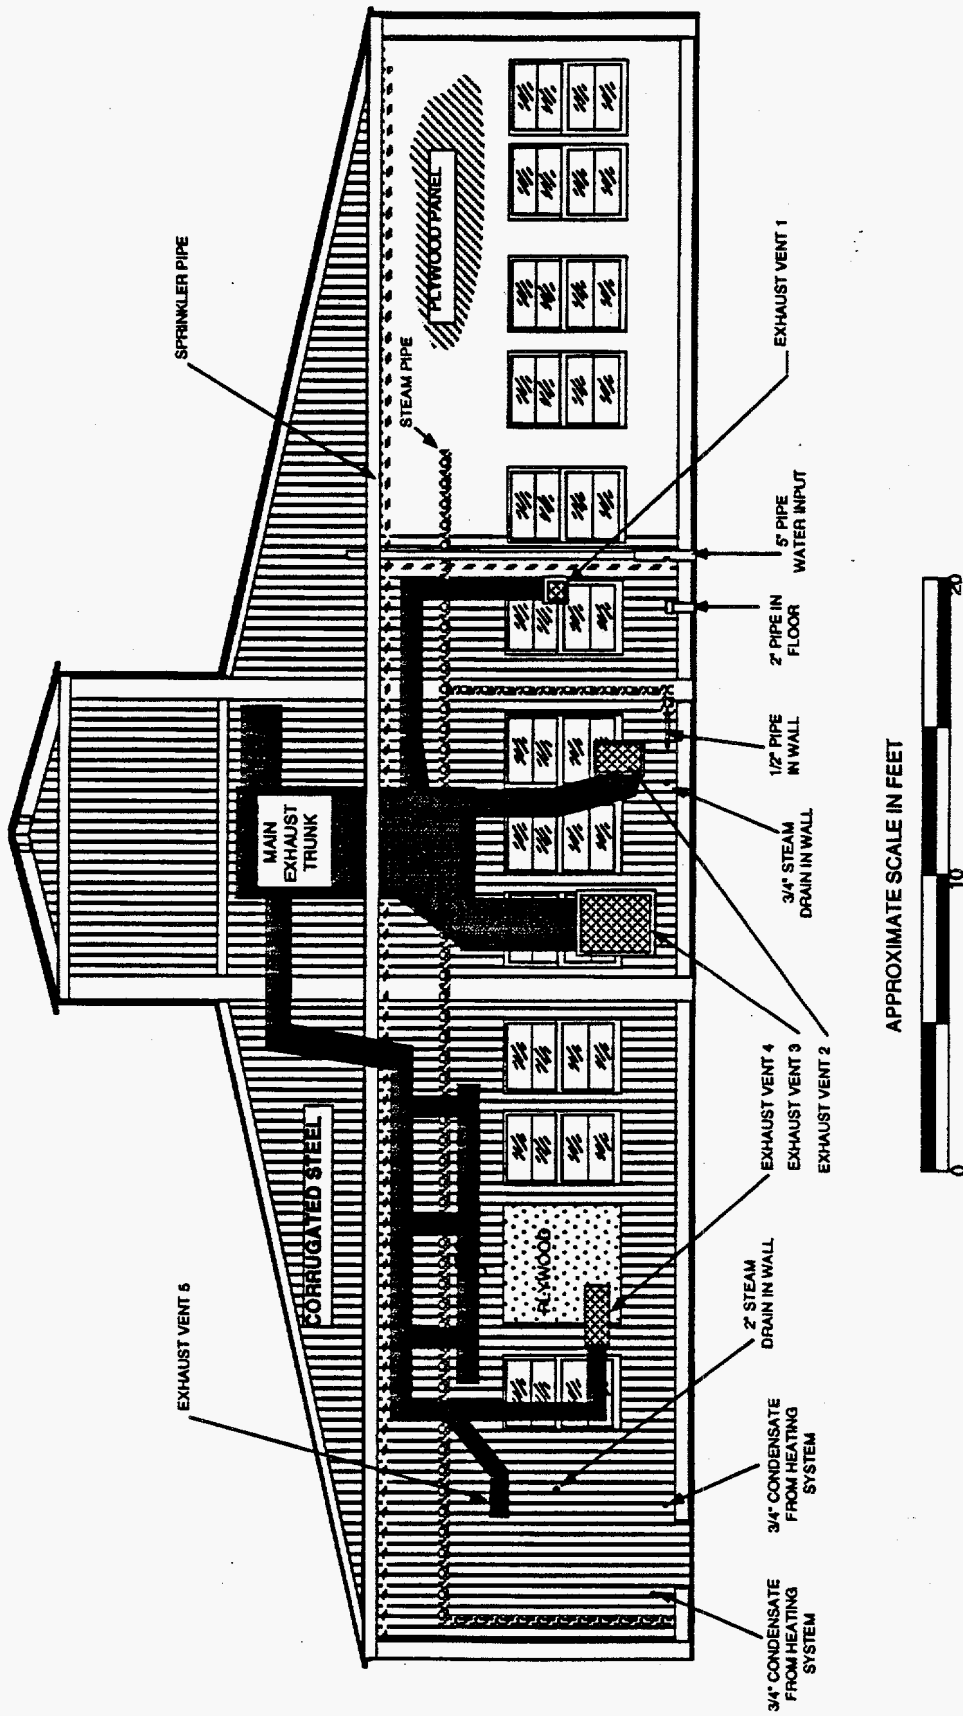
2 ft high, is labeled as a "jump tank" on a wall sign above it. Exhaust pipes are connected to the exhaust system in the room. A pipe covered by suspect asbestos-containing insulation is connected to a hot water heater on the south wall of the building. Numerous other pipes are also present. See Figures 10 through 13 for the locations of these pipes.

The windows on the exterior walls are boarded over with plywood. The only doors accessible from the outside are on the north and south walls. The door on the south wall is boarded shut. See Figures 10 through 13 for wall materials, window locations, and door locations.

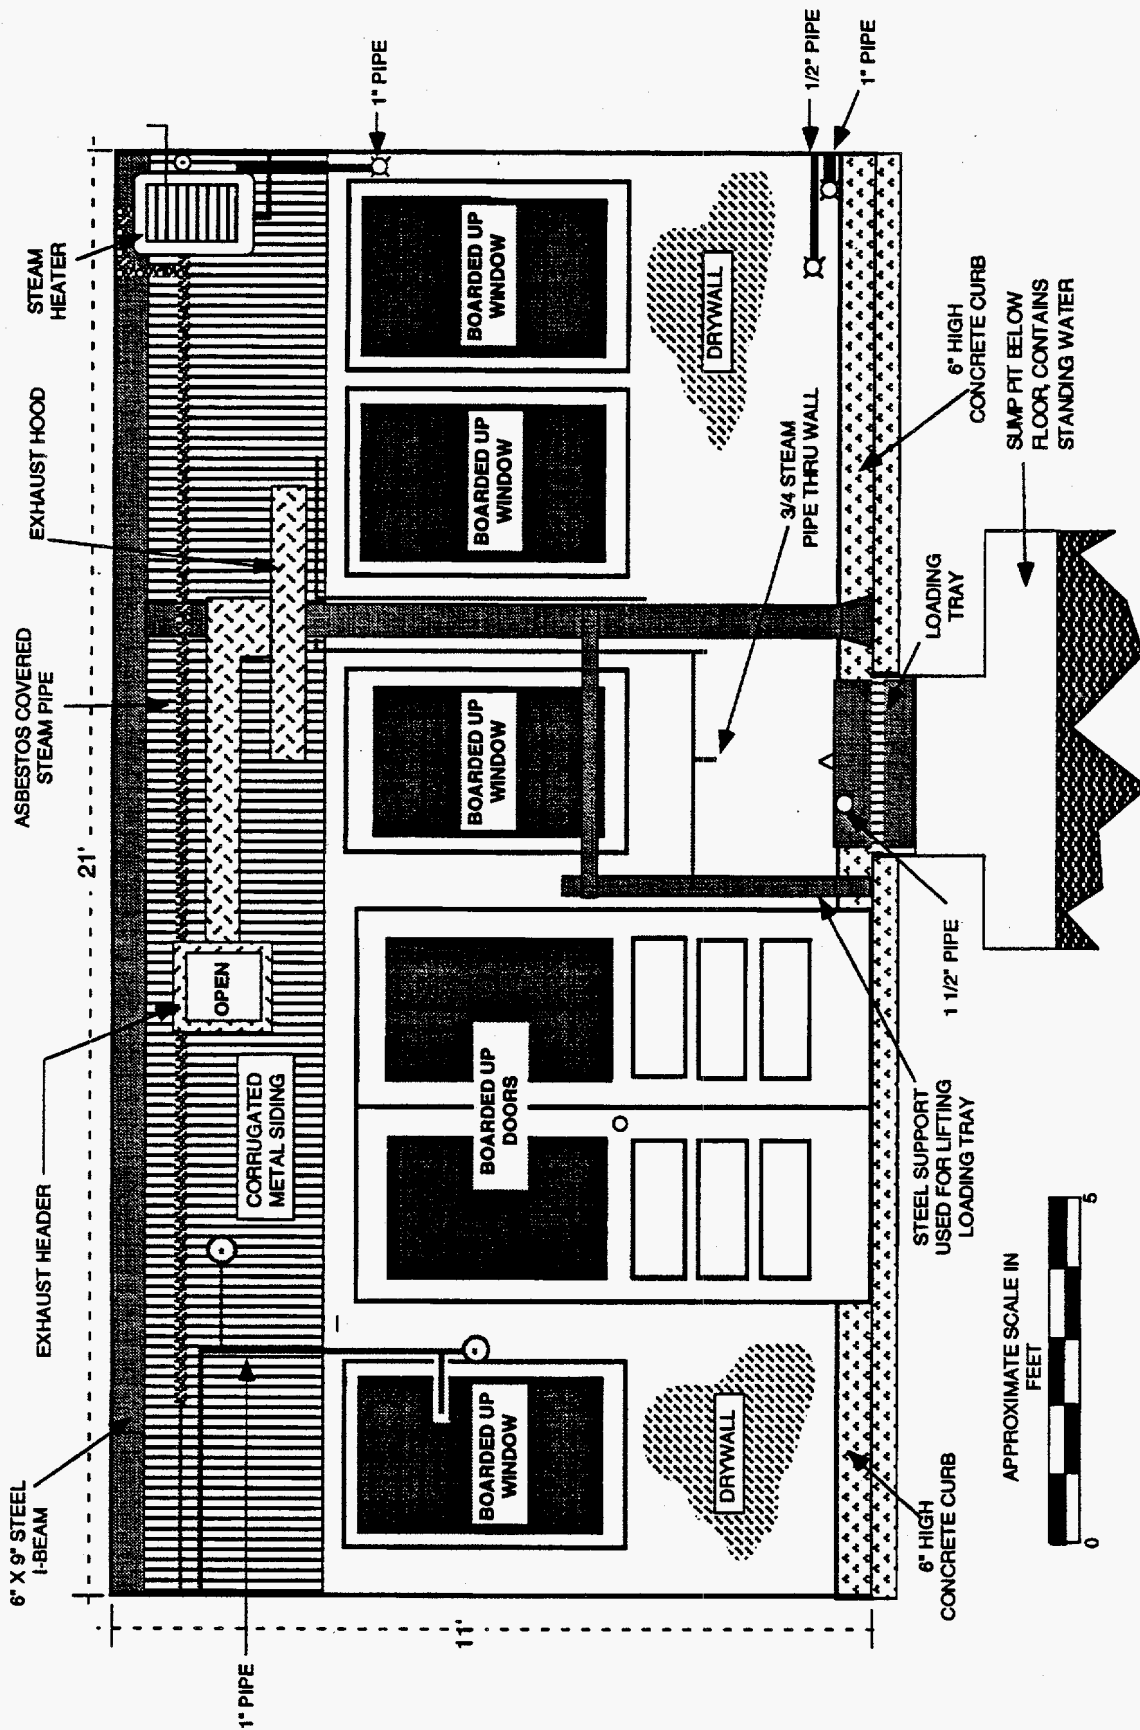
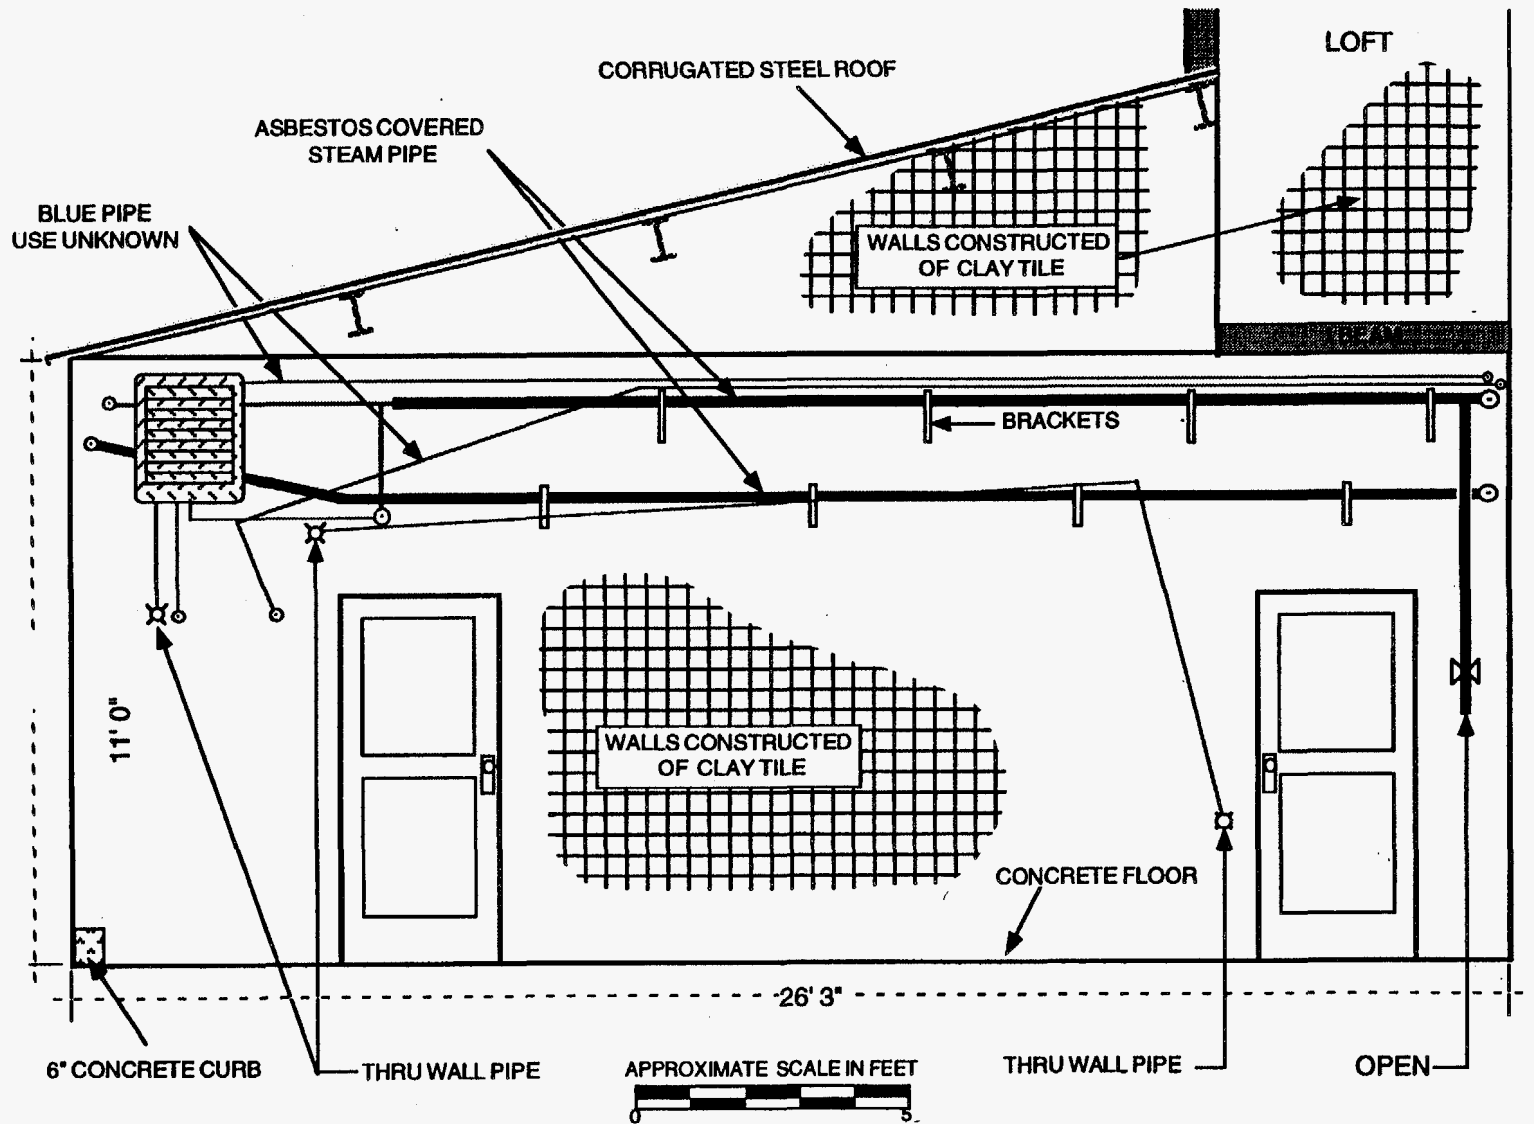
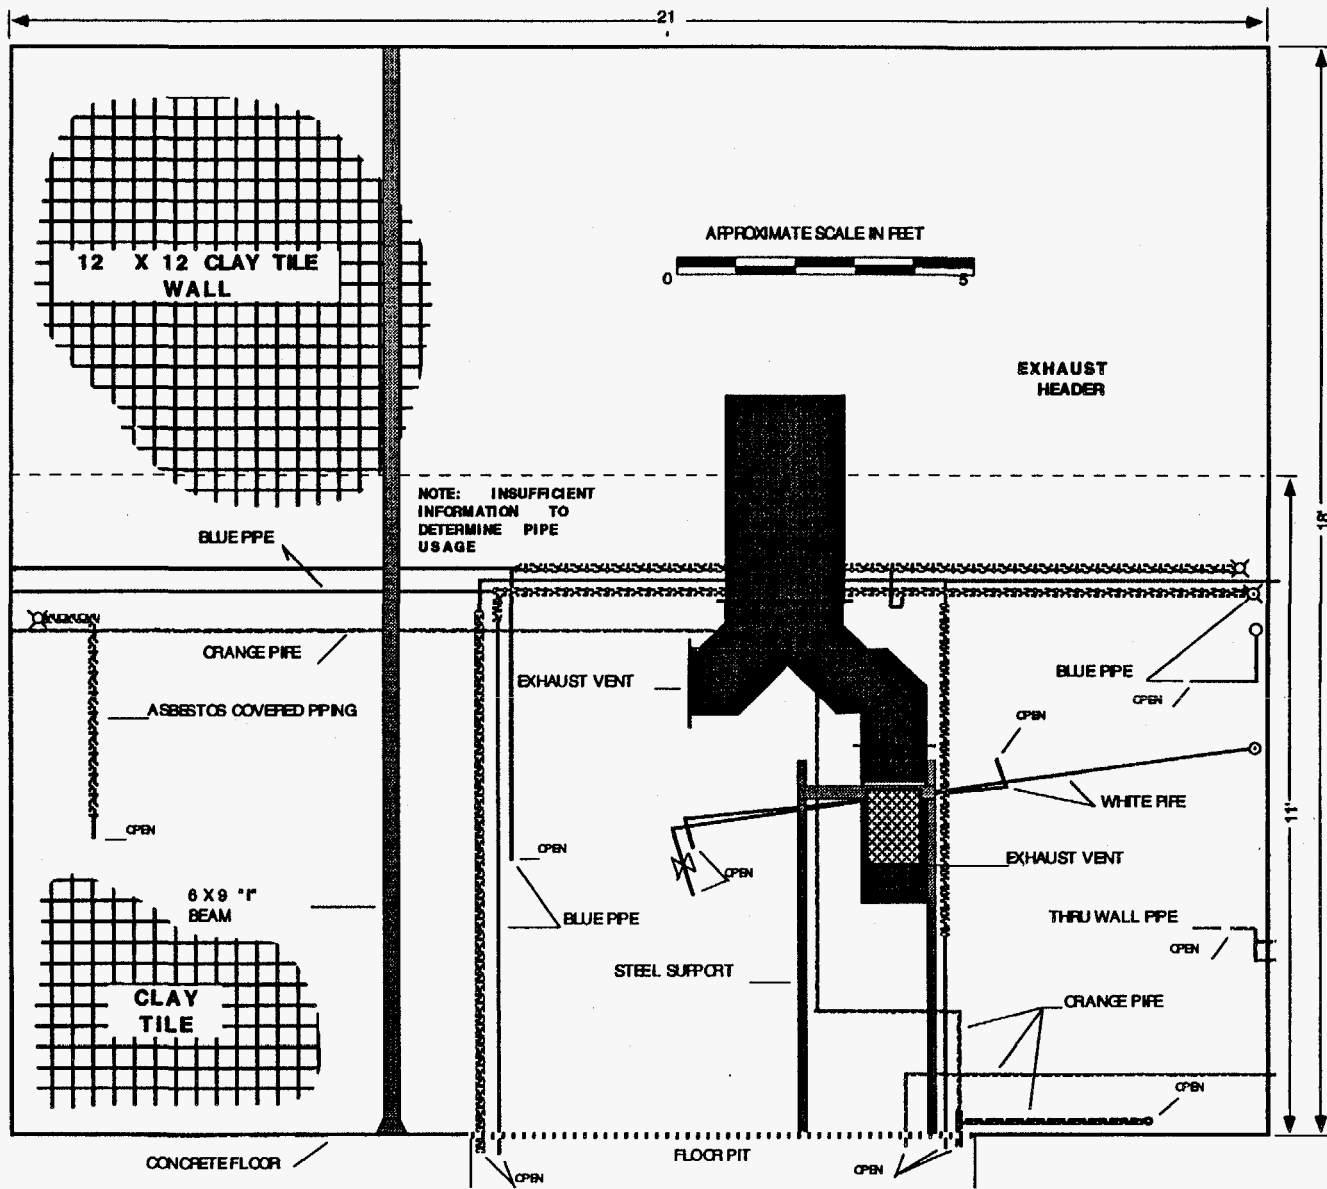
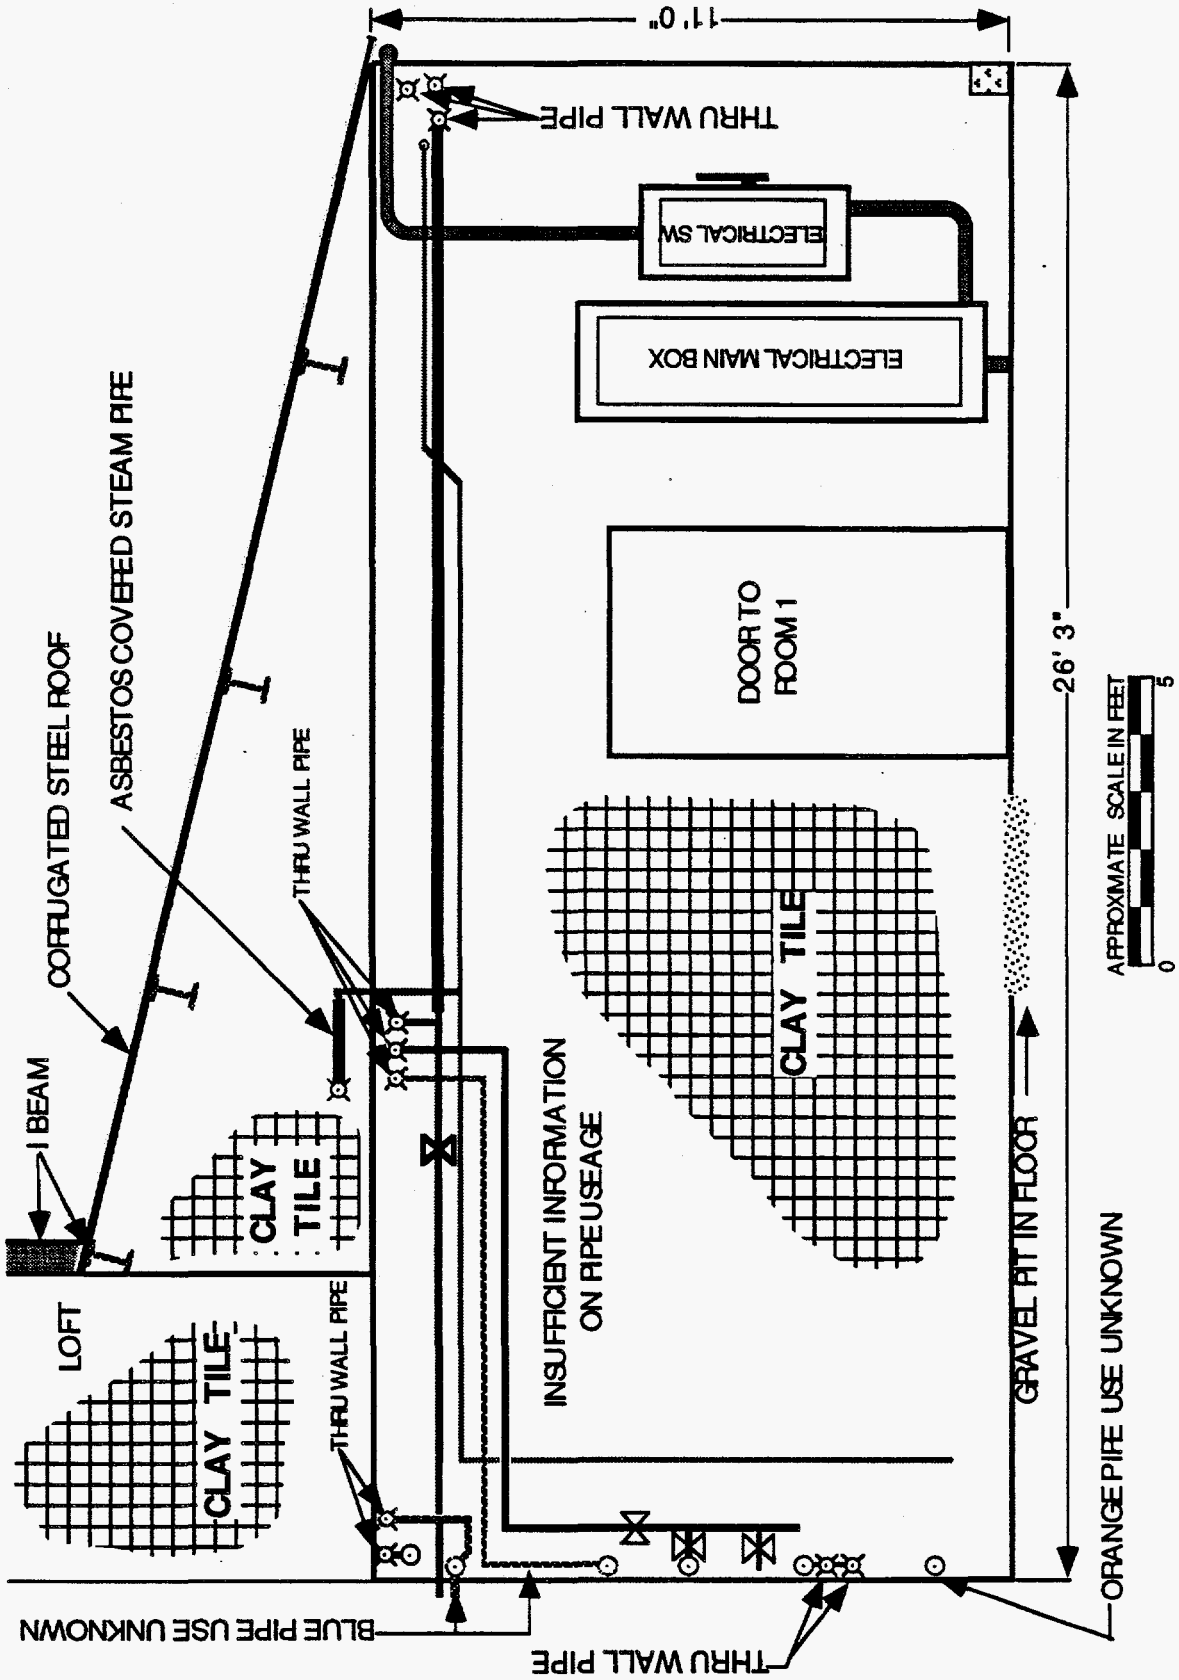
Numerous pipes run along each of the four walls. These pipes are covered by suspect asbestos-containing insulation. Pipes are also present in the collection trench. Figures 16 through 19 show the locations of the pipes.

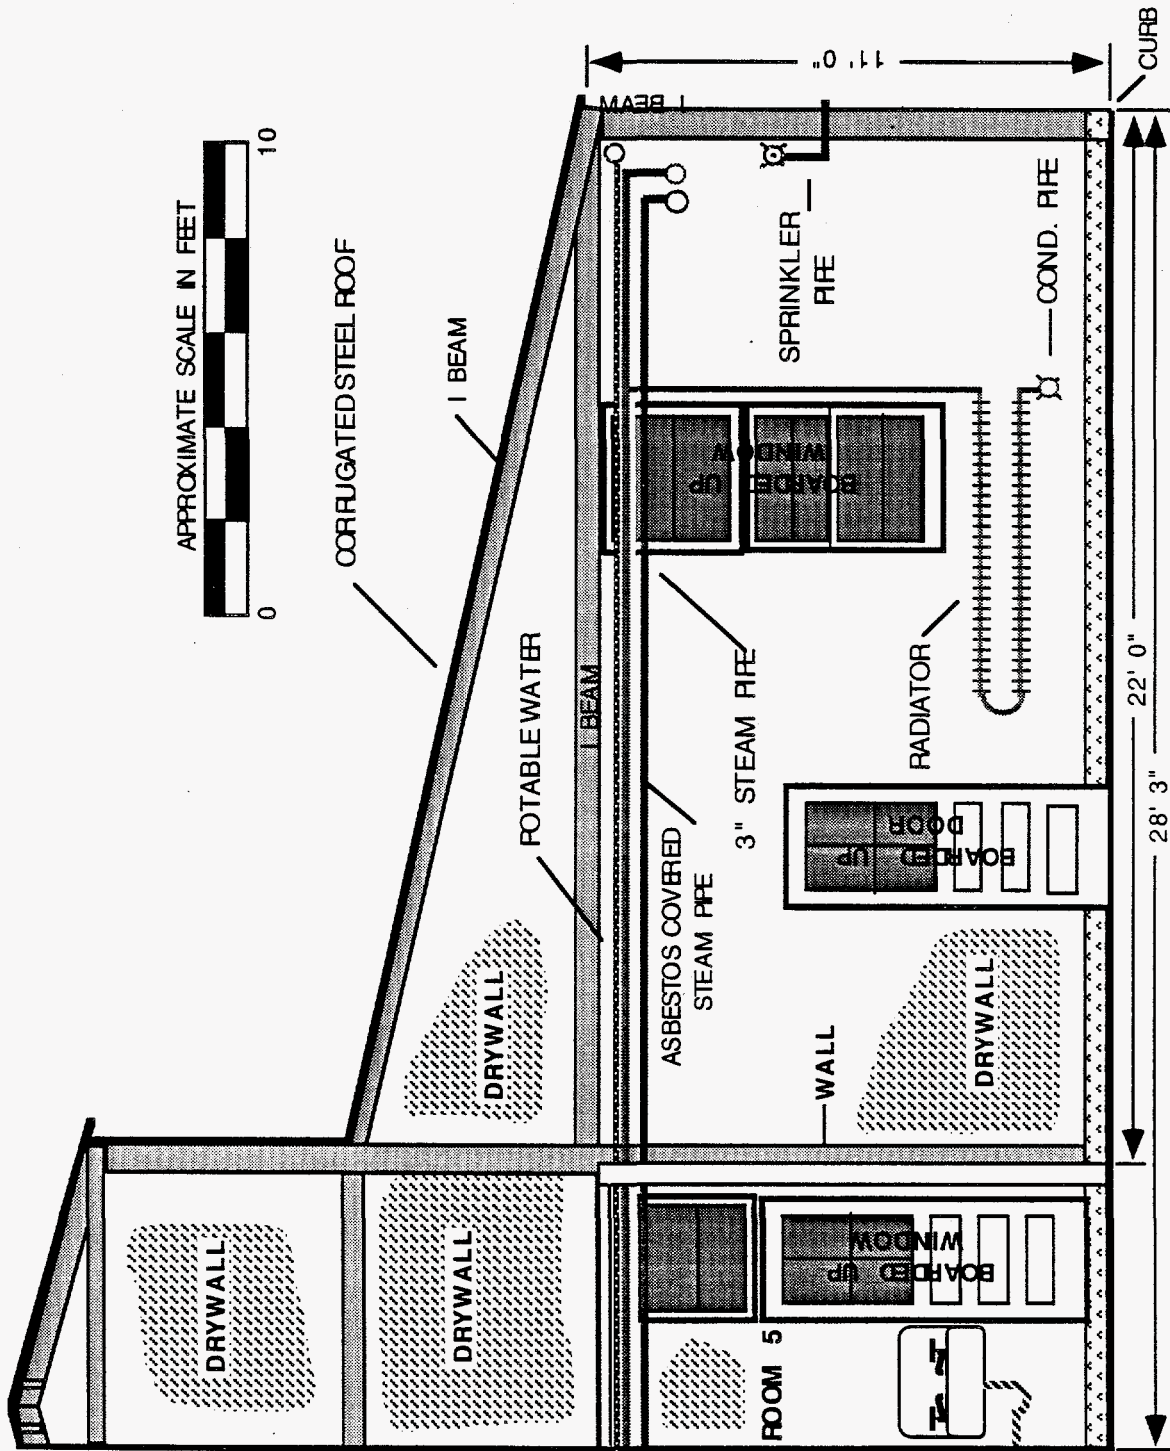
FIGURE 27 Rooms 4 and 5 — East View

The exterior walls are constructed of brick and corrugated metal sheeting. The interior walls are constructed of drywall, clay tile brick, wood, and 12-in. by 12-in. clay tile. A 10-ft-high wire fence separates rooms 3 and 4 (Figure 27).

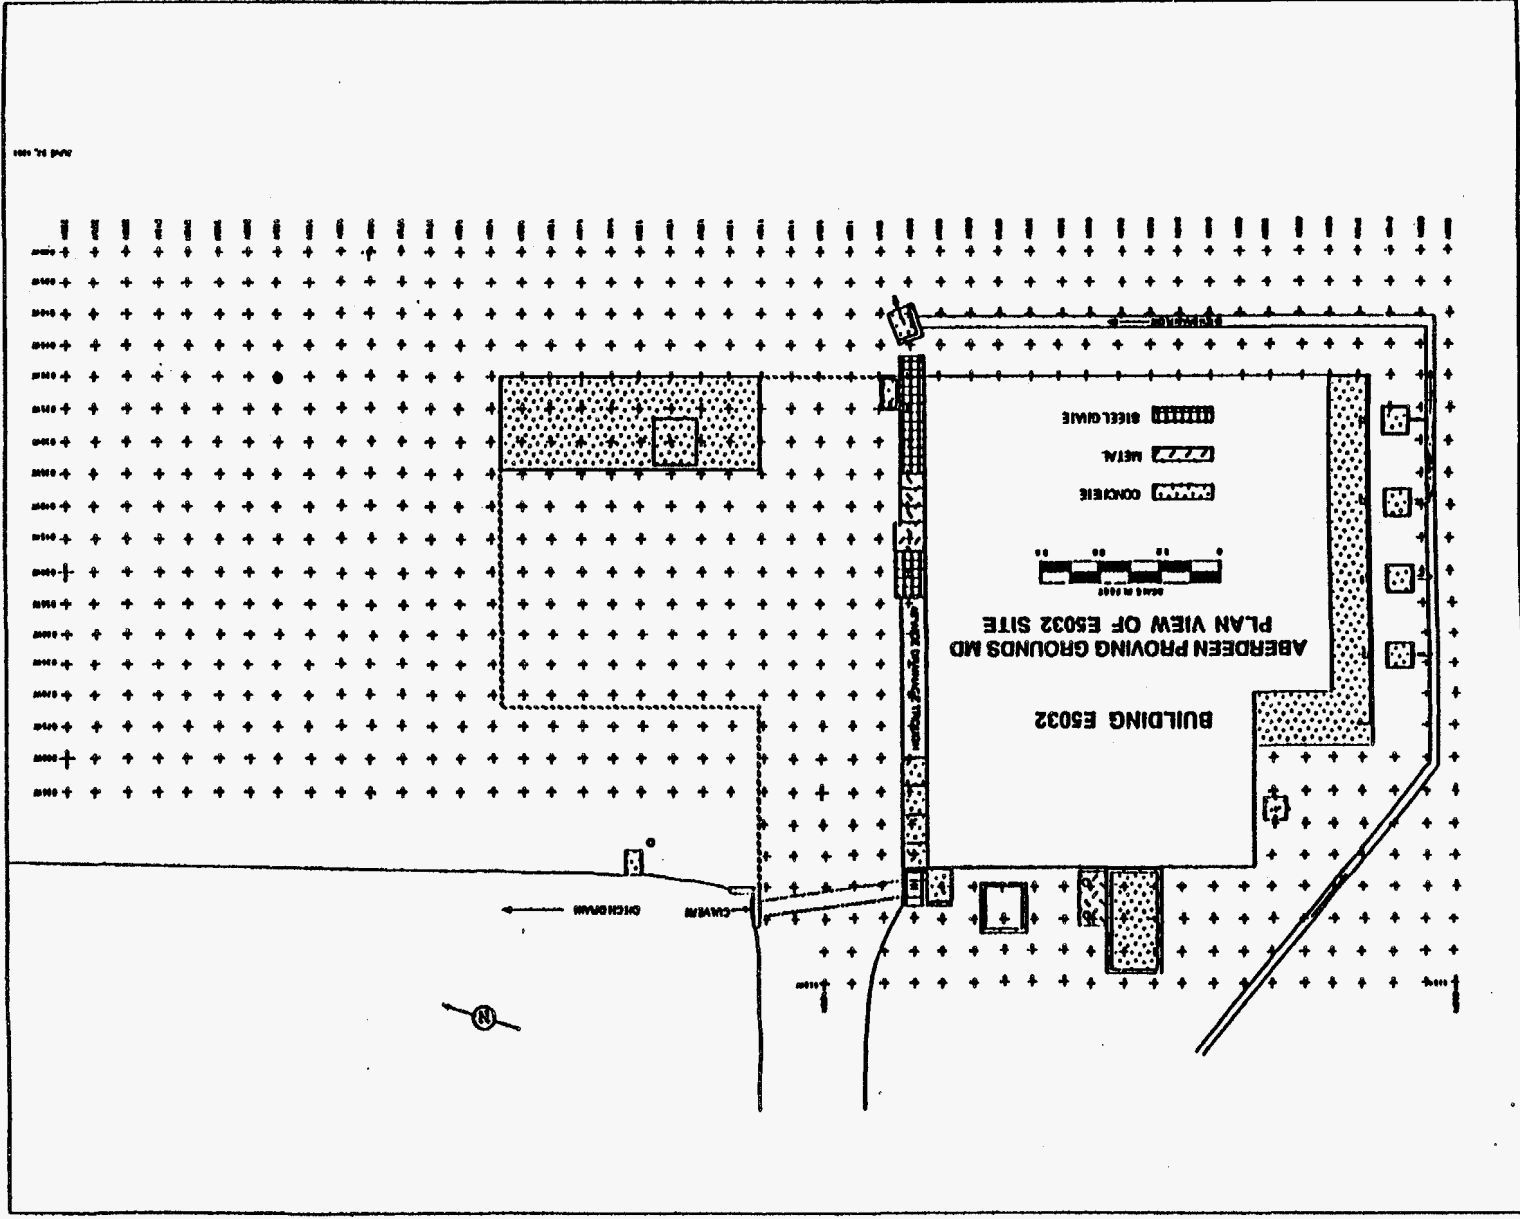
FIGURE 2 Site Map Showing the Outline of Building E-5032 and the Grid Spacing

Geophysical signal quality south, east, and west of the building was generally poor because of the presence of metallic material on the surface. For additional figures and detailed information about field parameters and instrumentation, refer to the McGinnis and Miller report (1991).
