**Contamination Source Review for Building E3642,
Edgewood Area, Aberdeen Proving Ground, Maryland**

Contamination Source Review for Building E3642, Edgewood Area, Aberdeen Proving Ground, Maryland

September 1995

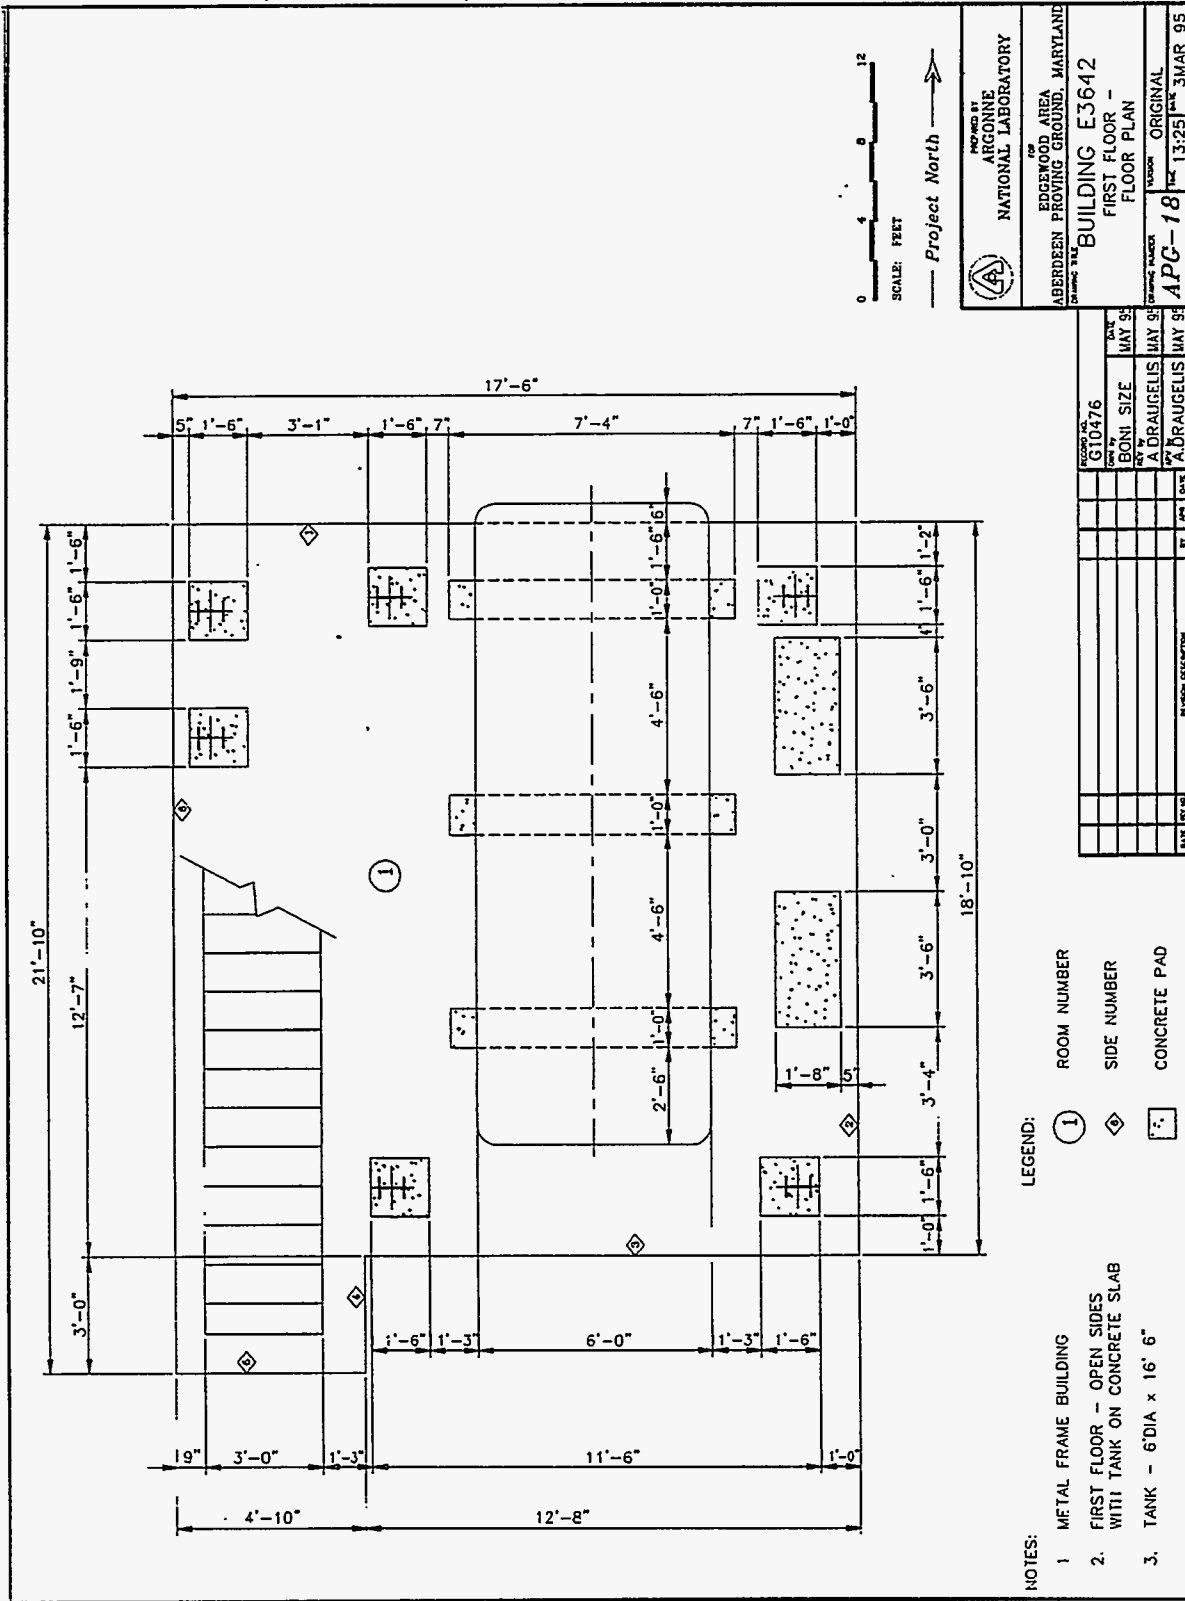
FIGURE 3 Building E3642 First Floor — Floor Plan

The north exterior elevation of Building E3642 measures 17 ft 6 in. long. The second-floor structure measures 11 ft 6 in. long (excluding the staircase) (Figures 3 and 4).

Along the east exterior elevation of Building E3642, the first floor measures 18 ft 10 in. long. The second floor is 15 ft 2 in. long (Figures 3 and 4).

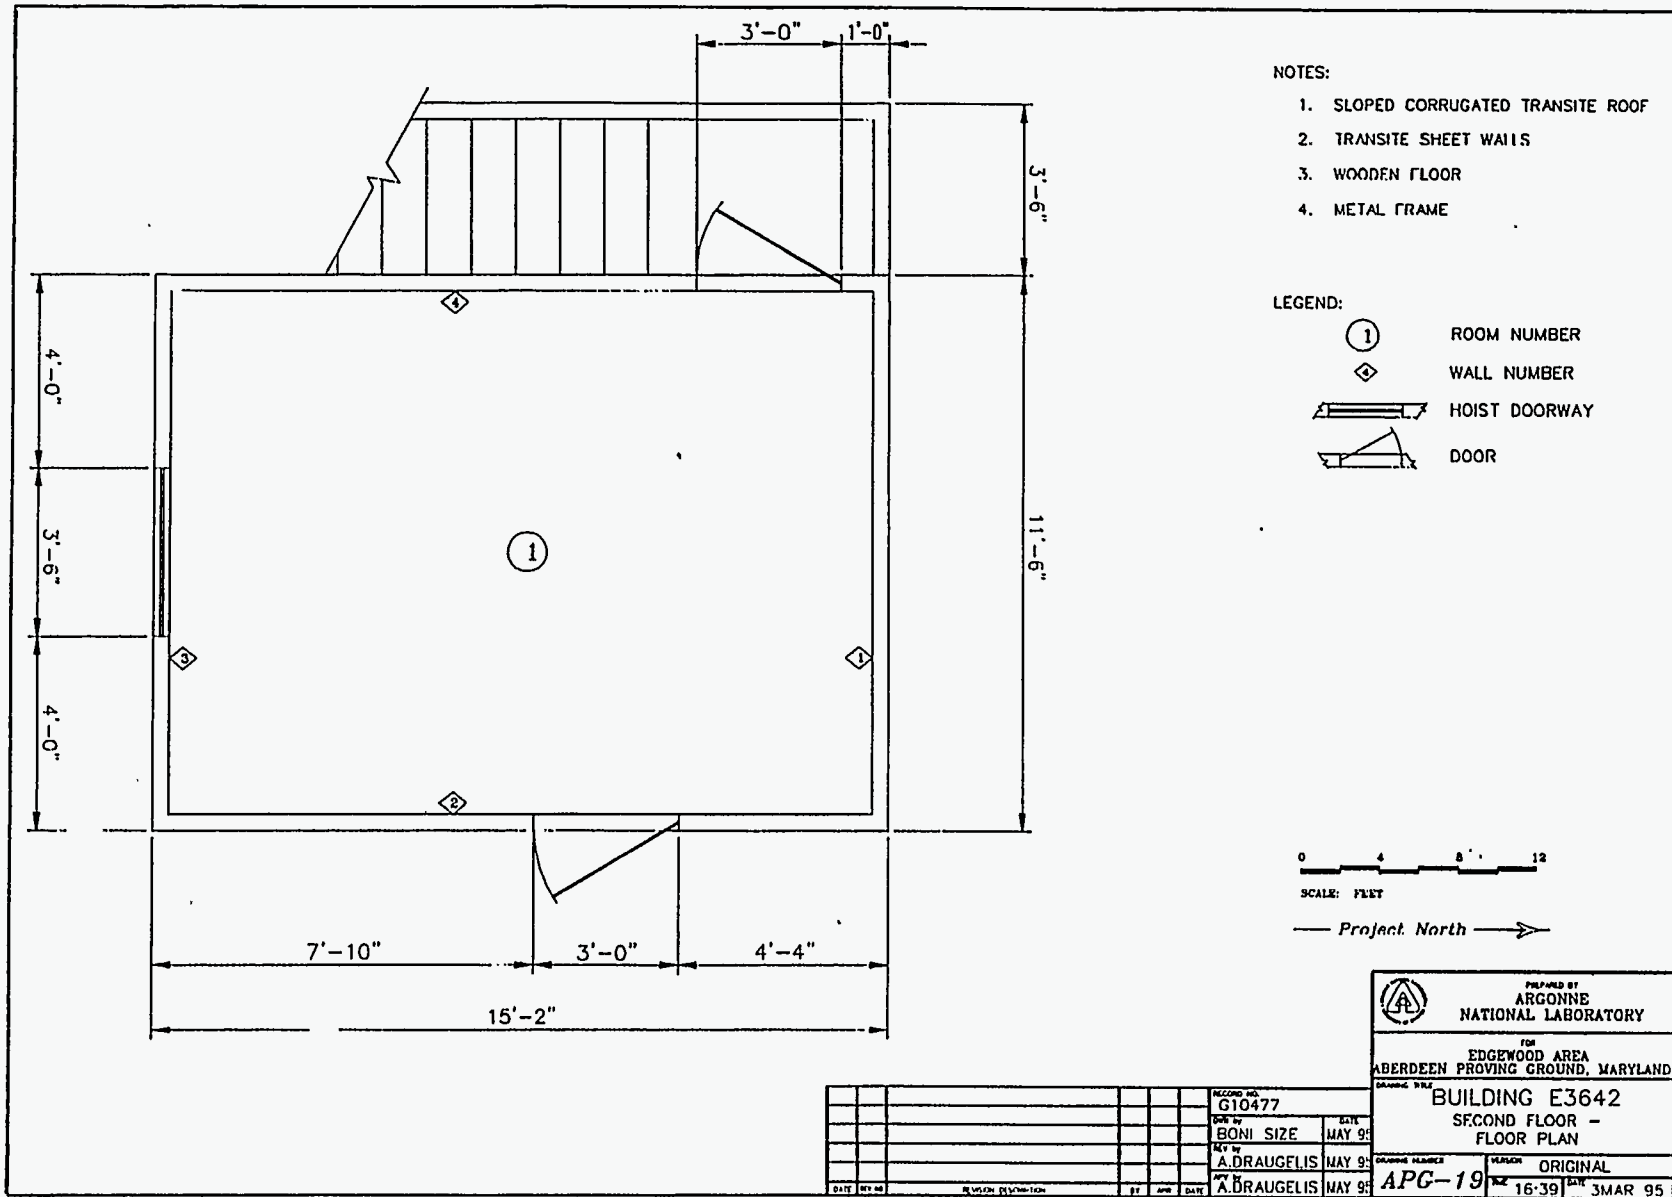
FIGURE 4 Building E3642 Second Floor — Floor Plan

The south exterior elevation of Building E3642 measures 17 ft 6 in. long. The second floor structure measures 11 ft 6 in. long (Figures 3 and 4).

The first floor on the west exterior elevation of Building E3642 measures 18 ft 10 in. long. The second floor is 15 ft 2 in. long (Figures 3 and 4).
