Potential for Hepa Filter Damage From Water Spray Systems in Filter Plenums

W. Bergman
J.K. Fretthold
J.W. Slawski

This paper was prepared for submittal to the
24th DOE/NRC Nuclear Air Cleaning and Treatment Conference
Portland, OR
July 15-18, 1996

POTENTIAL FOR HEPA FILTER DAMAGE FROM WATER SPRAY SYSTEMS IN FILTER PLENUMS*

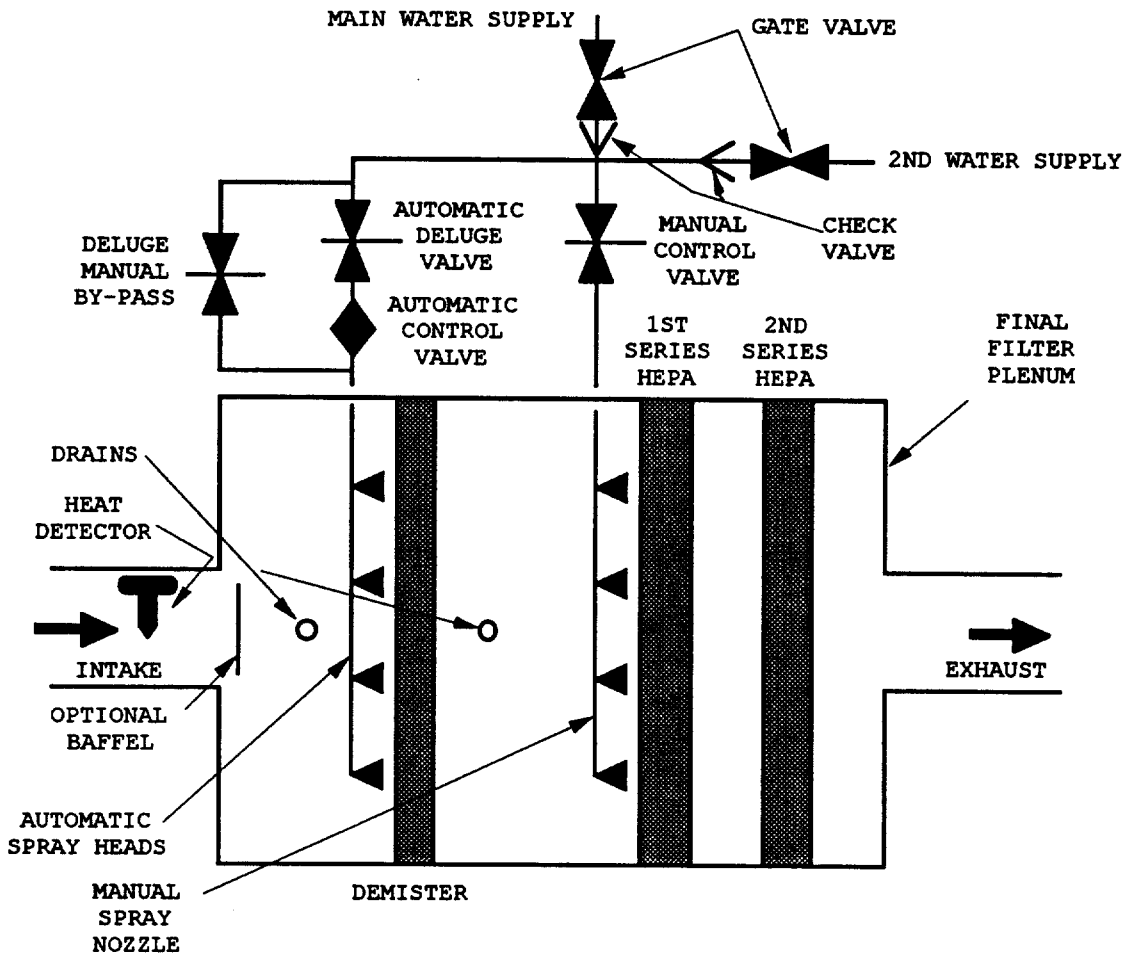
DOE has prepared a standard on Fire Protection Design Criteria in which the water spray system shown in Figure 1 is recommended for use in HEPA filter plenums.⁽⁷⁾ The Design Criteria document formalizes a design that has been used extensively throughout DOE facilities for many years since the 1969 Rocky Flats fire. The fire protection system consists of a heat detector at the plenum inlet, an automatic deluge spray head followed by a demister stage, and manual spray nozzles directed at the first of a two-stage HEPA filter bank. The function of the

Figure 1 Diagram of the fire protection system for HEPA filter plenums widely used in DOE facilities and specified in DOE Standard on Fire Protection Design Criteria, DOE-STD-1066-XX ⁽⁷⁾

The 1980 filter plenum fire and the German studies on filter plugging with water sprays raise serious questions about the effectiveness of the water spray system shown in Figure 1 for protecting HEPA filter plenums from fires. The omission of key experiments in the early studies that led to the present fire protection system for filter plenums have perpetuated the belief that the system will work as designed. The early studies showed that water sprays followed by

The available studies on HEPA filter performance under fire conditions suggest there are problems with the current fire protection systems in filter plenums. Unfortunately there are no studies to confirm that the current fire protection system shown in Figure 1 will prevent the extensive filter blow-out seen in the 1980 Rocky Flats fire. German studies on filter blow out suggest that smoke and moisture can rapidly plug the filter plenum system in Figure 1 and result in filter rupture. We recommend an experimental study to confirm that the existing water spray system will work in protecting HEPA filters from rupturing during fires. Until this study is completed, we recommend that 0% efficiency be assumed for each filter stage exposed to a water spray if the blower has at least 10 inches of vacuum, disregarding the presence of a demister. This recommendation had been previously made in our guide for determining HEPA filter efficiency under accident conditions.⁽⁵⁾

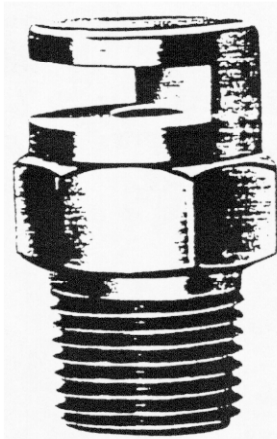
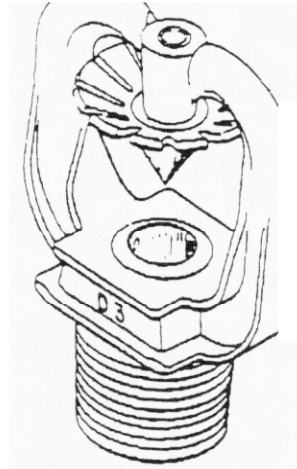
automatic deluge spray is to provide a uniform sheet of water over the entire cross section of the plenum in order to cool hot intake air. Figure 2 shows the typical spray nozzles used for the deluge spray (Figure 2A) and for the HEPA filter spray (Figure 2B). The deluge nozzle directs a flat, 180° fan-shaped spray pattern toward the floor where the water enters a drain, whereas the HEPA filter spray nozzle directs a 360° cloud of fine mist against the face of HEPA filters. Figure 3 shows a photograph of a deluge spray nozzle mounted on the ceiling of a 4x4 HEPA filter plenum and located close to the inlet of the metal mesh demisters. A second deluge spray nozzle is not seen in the photograph. The deluge spray is generated at 0.25 gpm per square foot of filter area, or 16 gpm for the 16 2'x2' demisters in Figure 3. Any water droplets carried in the air stream are removed by the demisters.

Figure 2. Drawings of typical spray nozzles used for (A) the deluge spray and (B) the HEPA filter spray. The deluge spray nozzle generates a flat, 180° fan-shaped spray pattern. The HEPA filter spray nozzle generates a 360° cloud of fine mist.

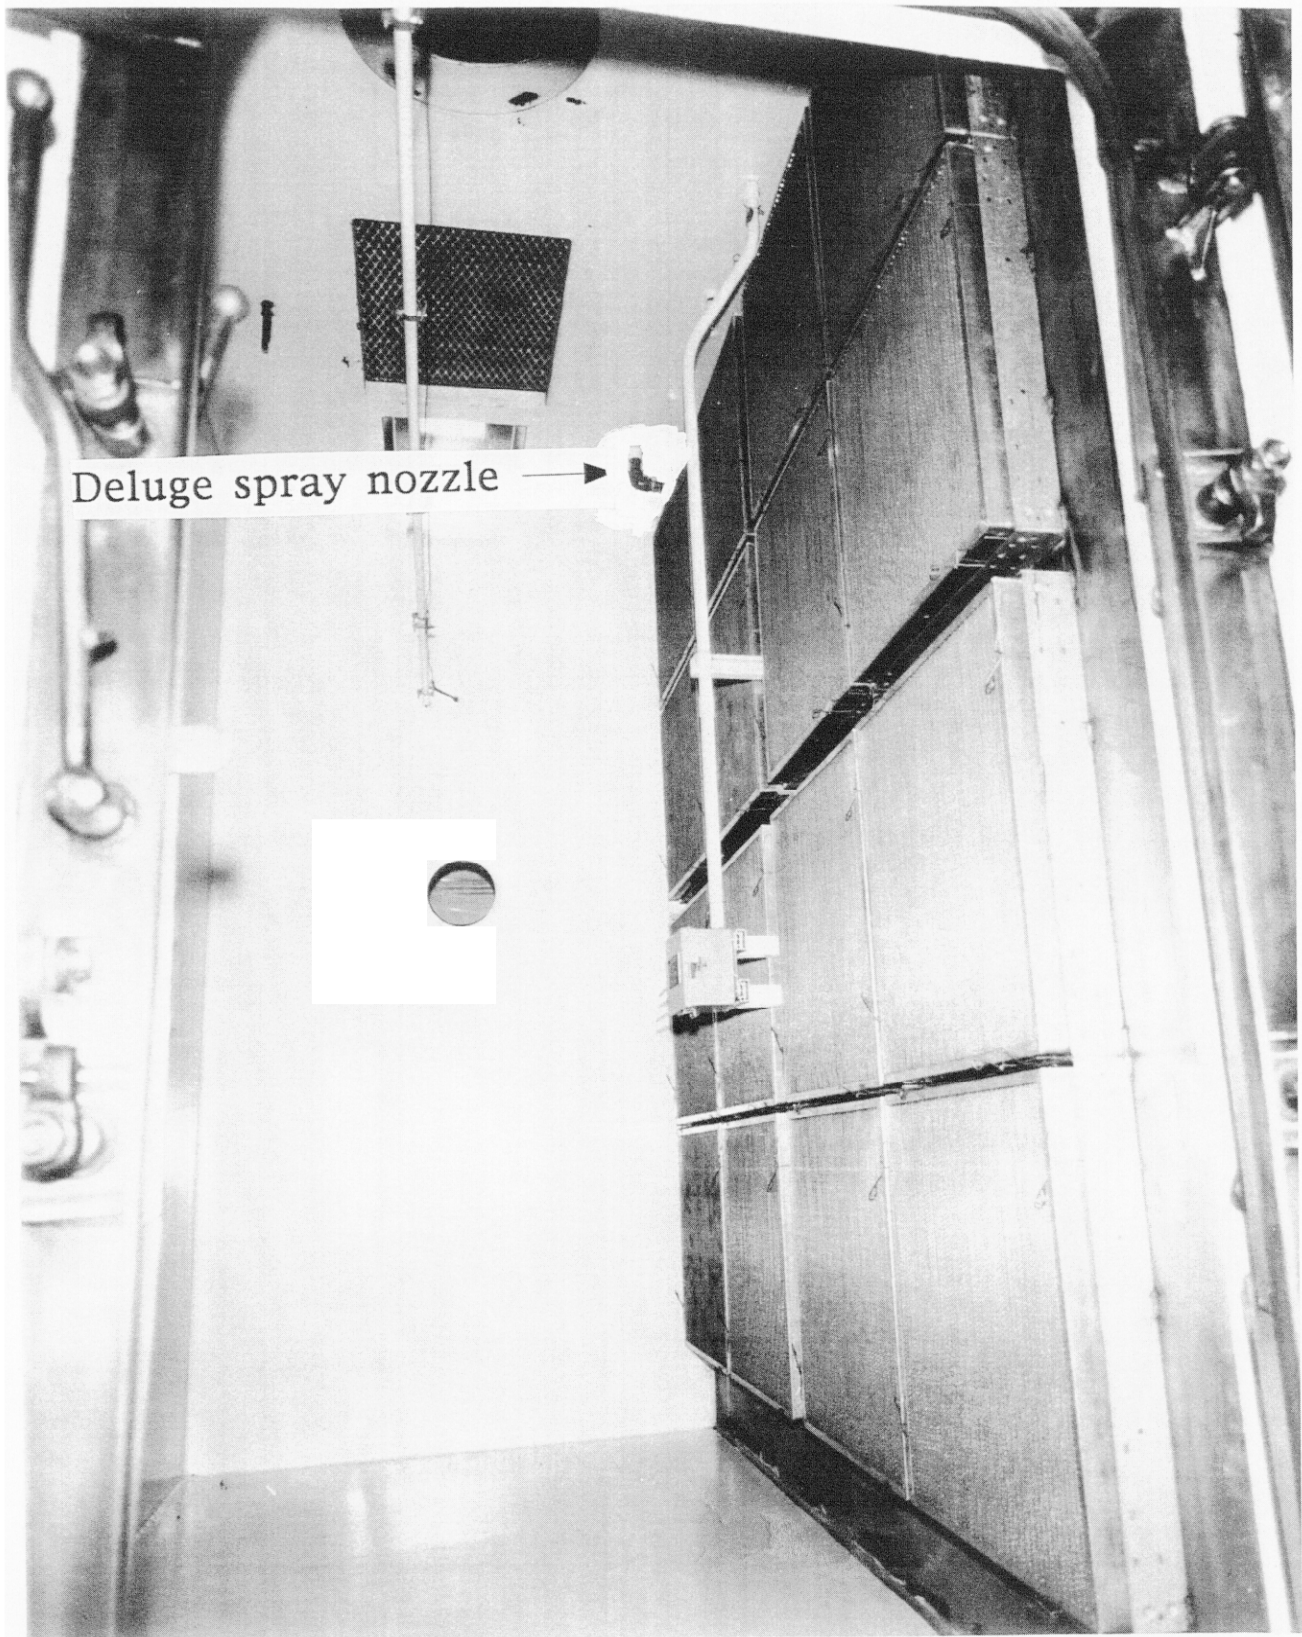
Figure 3. Photograph of a deluge spray nozzle mounted on the ceiling of a 4x4 HEPA filter plenum and located close to the inlet of the metal mesh demisters. The access door to the demister stage was opened for the photograph.

Although the use of a metal demister, as shown in Figures 1 and 3, improves the reliability of the fire protection system by cooling the air and removing water droplets, the HEPA filters can still be blown out because of smoke and water plugging. Ruedinger et al showed that HEPA filters can rupture due to absorbed water even when protected by demisters.⁽¹²⁾ Ricketts et al demonstrated that if a HEPA filter has particle deposits, it can rupture at relative humidities less than 100%.⁽¹³⁾ Since smoke aerosols can easily pass through demisters, the smoke and high humidity can result in rapid HEPA plugging and subsequent rupture.

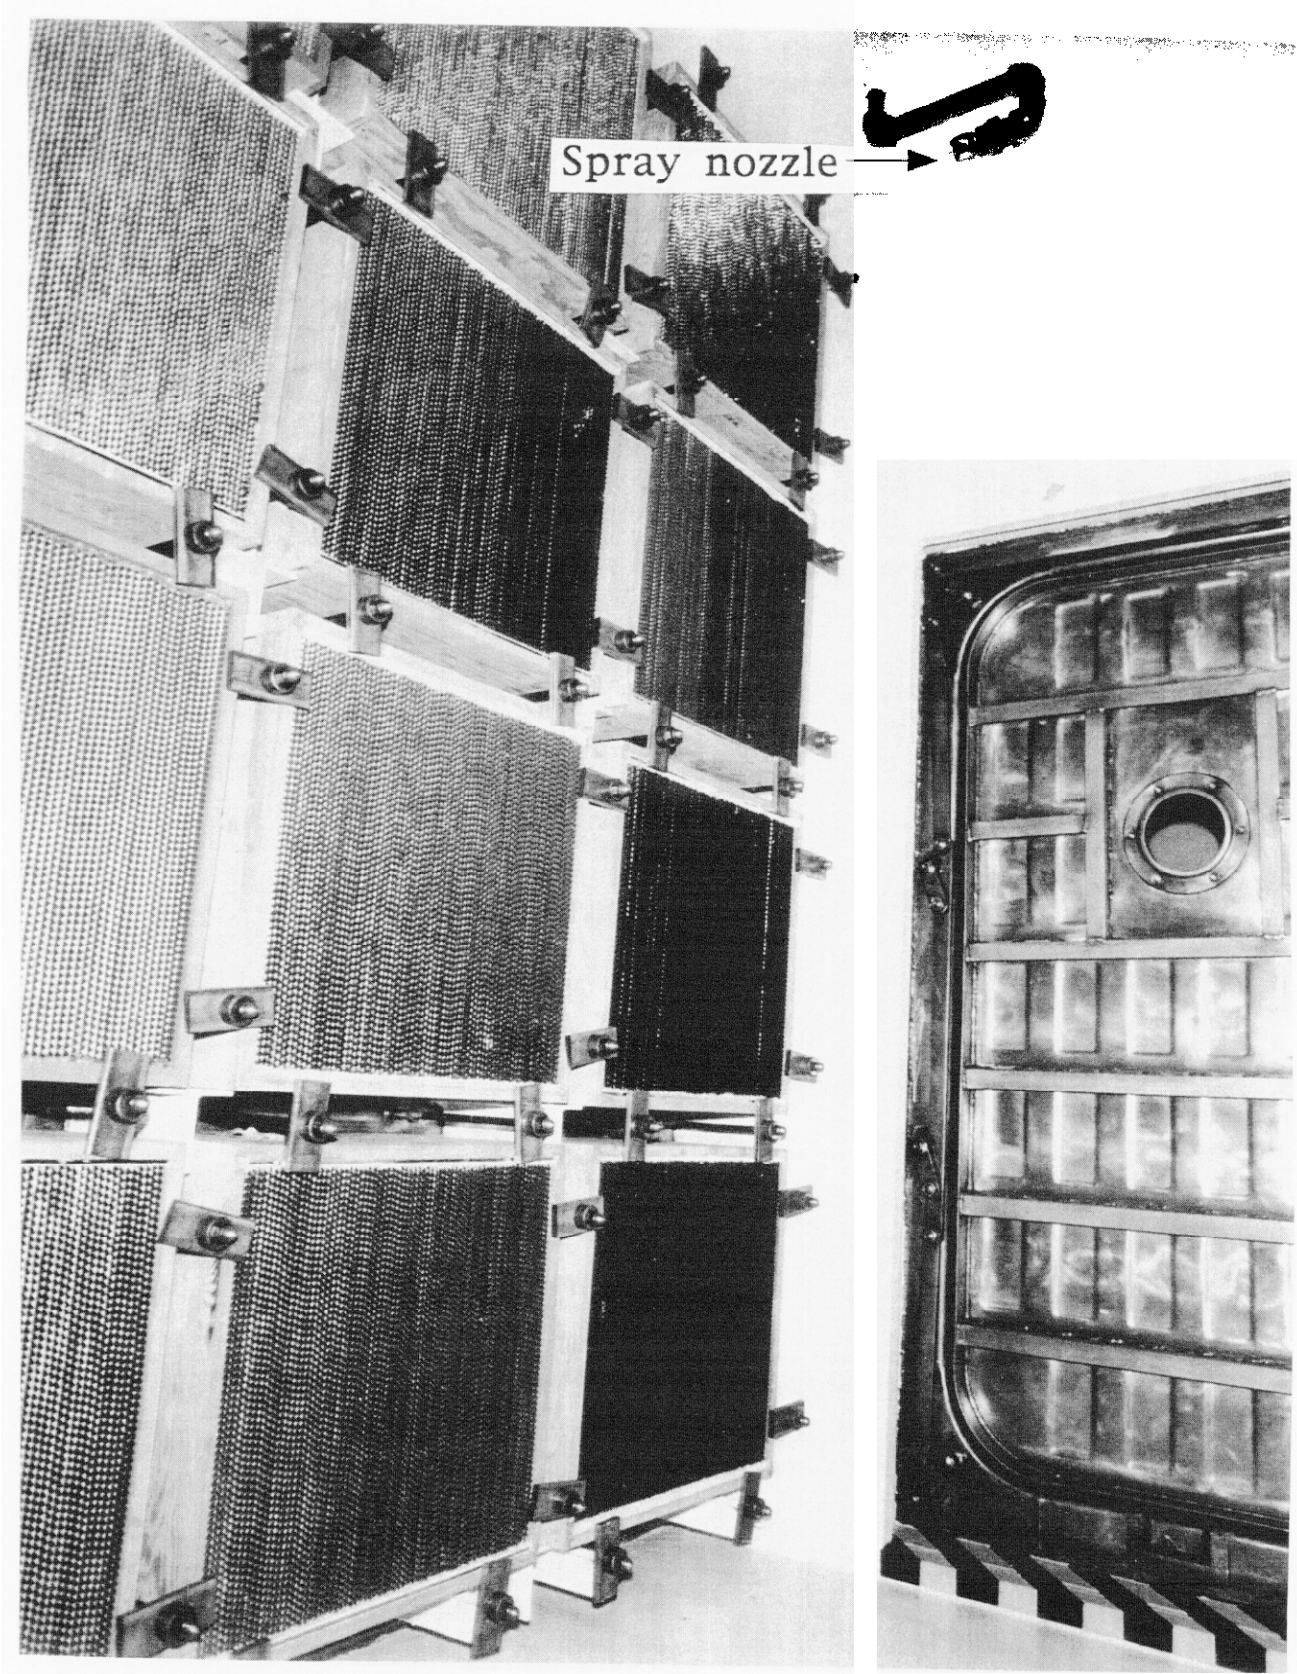
Manual spray nozzles, like the one shown in Figure 2(B), are directed at the first stage HEPA filters to put out potential fires should they occur. However, since the HEPA filters are easily damaged by direct water sprays, the selected nozzles must generate a fine water mist. Figure 4 shows a photograph of a manual spray nozzle mounted on the ceiling of the filter plenum with the spray nozzle directed against the first stage HEPA filters. A second spray nozzle is not seen in the photograph. The water flow through both nozzles is 0.25 gpm per square foot of filter area, or 16 gpm for the 16, 2'x2' HEPA filters. Some facilities periodically test the water spray and unavoidably wet the HEPA filters. This practice reduces the strength of the HEPA media as described later in this report and should be avoided.

Figure 4. Photograph of a manual spray nozzle mounted on the ceiling of the filter plenum with the spray nozzle directed against the first stage HEPA filters.

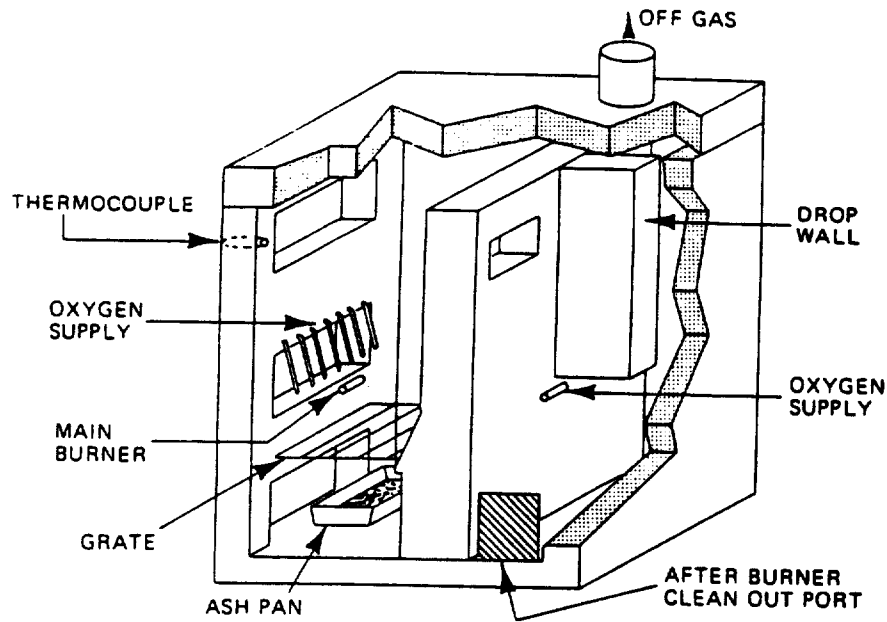
Fretthold described the results of a fire in a HEPA filter plenum at Rocky Flats that occurred on July 2, 1980.⁽²⁾ The fire occurred in a HEPA filter plenum that filtered the exhaust from an incinerator shown in the drawing in Figure 5. The exhaust from the incinerator is treated in an off-gas system in which the hot exhaust gas is first sprayed with a caustic solution to cool the gas and to neutralize the acid gases and then passed through a wet cyclone to remove suspended particles. Figure 6 shows the off-gas system. The treated exhaust then passes through a booster blower and into the incinerator filter plenum, as shown in Figure 7. A deflector cone at the plenum inlet deflects the incoming air to distribute the air more uniformly over the HEPA filters mounted 3 high and 4 across. Note that only 600 cfm passed through the plenum that had a filter capacity of 12,000 cfm. Although the filter plenum contained 4 stages of HEPA filters, the stages were incorrectly mounted back-to-back. The incinerator plenum did not have an automatic deluge spray system or a demister stage in front of the first HEPA bank. The exhaust from the incinerator plenum then enters the main building plenum.

Figure 5. Drawing of the Rocky Flats incinerator.

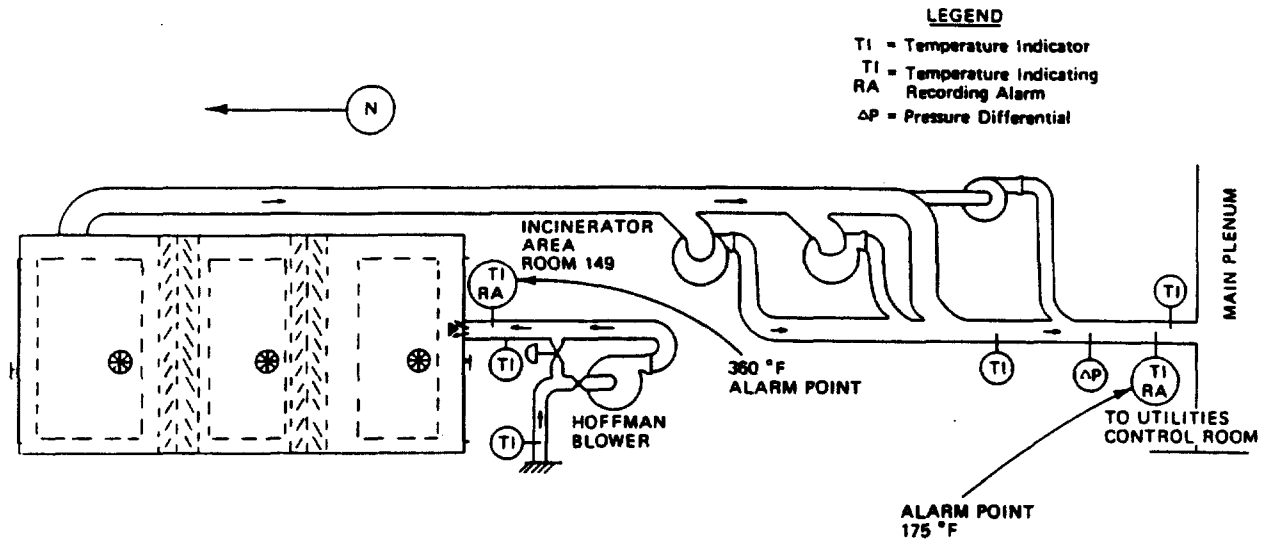
Figure 7. Incinerator filter plenum system

On July 2, 1980, a fire had occurred in the incinerator filter plenum and had extensively damaged the first three stages of HEPA filters and caused the fourth stage to severely bow.⁽²⁾ A continuous recording of the plenum inlet temperature showed the temperature was constant at 100°C for several hours prior to 11:00 A.M.. At that time the inlet temperature increased linearly with time until it reached a maximum 180°C at about 12:40 A.M.. At 11:30 A.M., the production foreman inspected the filter plenum and noted the plenum inlet temperature was 70° C, the differential pressure across the HEPA filters was 0.7 inches of water, and the plenum vacuum was 7 inches of water. These were normal readings. (The automatic temperature recording at 11:30 A.M. showed the inlet temperature was 110°C, not 70°C.) At 12:34 P.M., the alarm for the incinerator filter plenum sounded as well as the main filter plenum. The deluge spray also was automatically activated in the main plenum. Responding to the incinerator fire alarm, the utilities manager observed a red glow within the incinerator plenum and then activated the manual deluge sprinklers. Shortly thereafter, firemen arrived and also noticed a red glow in the plenum and that the manual water spray had been activated. They then attempted to enter the plenum with building water hoses, but could not open the airlock doors due to the high vacuum. After reducing the air flow, the firemen entered the incinerator plenum and sprayed the HEPA filter banks with a fine water mist. Photographs of the filter plenum in Figures 8-14 showed extensive HEPA damage.
