The Effect of Humidity on the Reliability of a Surface Micromachined Microengine

Danelle M. Tanner, Jeremy A. Walraven, Lloyd W. Irwin, Michael T. Dugger, Norman F. Smith, William P. Eaton, William M. Miller, and Samuel L. Miller

Sandia National Laboratories, P.O. Box 5800, MS 1081, Albuquerque, NM 87185-1081
<http://www.mdl.sandia.gov/Micromachine>
 email: tannerdm@sandia.gov

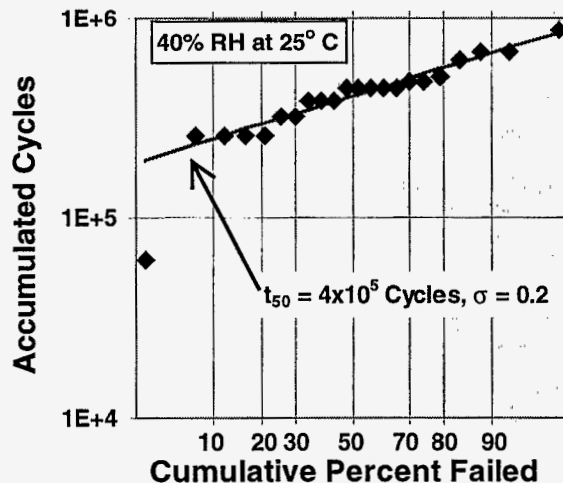
The data from each of the experiments could be described by a simple unimodal distribution such as seen in Figure 3. The regression analysis yielded a median of 4×10^5 cycles to failure with a correlation coefficient of 0.98. The shape parameter, σ , was determined to be 0.2. The above analysis was completed for each experiment and a value for the median and sigma of each distribution was calculated. We performed nine experiments during which a total of 262 parts failed. A larger number of experiments were performed with the FTS process simply because of their greater availability.

Figure 3. Lognormal distribution of accumulated cycles to failure for the 40% RH stress. The early failure, with less than 10^5 cycles, was omitted from the regression analysis.

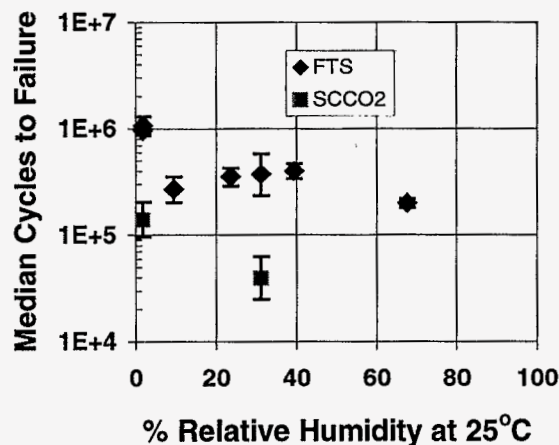
Table 2 has the results of lognormal fits to all of the humidity experiments. The data is also graphically represented in Figure 4 with 95% confidence bounds represented by error bars. The figure shows a rather flat dependence on humidity for the FTS-coated microengines with the exception near 0%. The $SCCO_2$ data shows the failure roughly an order of magnitude earlier, indicating a less reliable microengine.

Figure 4. The effect of humidity on the lifetime of the microengines shows a rather flat distribution with the exception near 0%. The y error bars represent 95% confidence bounds. The microengines were stressed with large forces to accelerate failures in these experiments.

The values shown in Figure 4 are comparable to previous data used in the development of a predictive reliability model based on the fundamental principles of wear coupled to a resonating system [7, 9]. In this work, the stickiness of the gear motion was attributed to the interaction of asperities on the rubbing surfaces. Asperities could break off causing wear debris or adhere which would result in a seized gear.

The behavior of the microengines tested at levels near 0% was quite different. In this low humidity case, there was a dramatic increase in the amount of wear debris, regardless of the coating method. We first noticed the formation of wear debris after accumulation of roughly 10^5 cycles. The debris was typically thrown out from the hub and collected on the gear face and surrounding substrate. In general, the gear hubs were worn down and the gears exhibited severe wobble during operation. In 55% of the failures (31% for SCCO_2), the pin joint actually wore down and severed. We suspect that the large wear rate removes any asperities that would cause the gear to seize in the same manner as the higher humidity levels. Therefore, wear of polysilicon would continue until the pin joint is worn away, causing failure at a much higher number of cycles. The increase in median cycles to failure observed at 1.8% RH in Figure 4 resulted from this change in failure mechanism and was not a true indication of increased reliability.

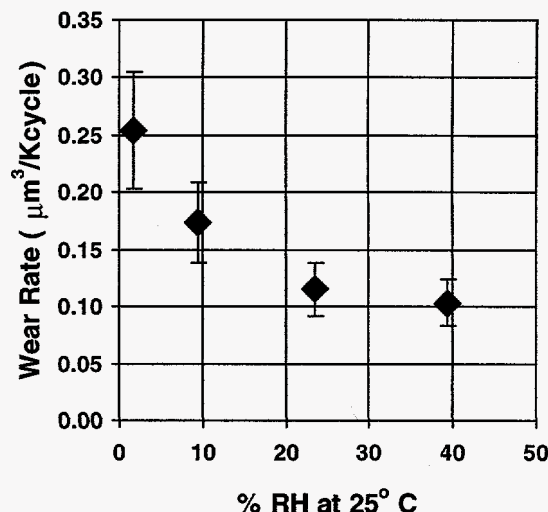
The locations exhibiting the most wear were the hub and pin joint areas so we made our estimates there. Measurements of the diameter of worn hubs, gears, and pin joints were made. The cross sectional area was calculated and compared to the control to yield a value for worn area. This value was then multiplied by the thickness to yield the volume of the material worn away. The technique assumes that the wear is symmetrical around the hub and pin joint. We estimated the error in the technique as $\pm 20\%$ of the calculated worn area. The wear volume was normalized by the total number of cycles to failure to yield wear rate which is shown in Figure 13 as a function of % RH at 25°C.

The wear rate shown in Figure 13 agrees with studies of a SiC/SiC system [20] where the decrease in wear rate has been attributed to a tribochemical reaction leading to the formation of a protective film of hydrated amorphous silica. Silicon nitride sliding on silicon nitride was also investigated [21] and the main mechanism of wear was the tribochemical oxidation of the silicon nitride to form silicon oxide. The wear rate increased in drier conditions in the silicon nitride case also.

Figure 13. This plot of wear rate of FTS-coated microengines as a function of humidity shows the increase in wear rate as humidity decreases. (FTS)
