Failure Analysis for Micro-Electrical-Mechanical Systems (MEMS)

Kenneth A. Peterson, Paiboon Tangyunyong, and Daniel L. Barton

Sandia National Laboratories MS1081 P.O. Box 5800 Albuquerque, NM 87185-1081

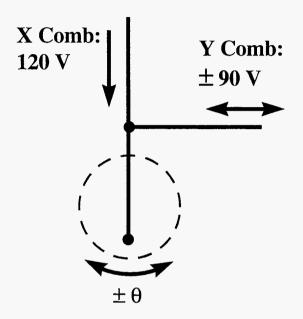
In an attempt to generate wear, a sample was run in a rocking mode, illustrated in Figure 19. The X comb was used to push unusually hard in one direction against the hub, while the Y comb was reciprocated to create a rocking motion, without completing a revolution. The rocked and not-rocked bearing surfaces were then separated in the FIB and examined for signs of wear. Not only did the opposite sides of the gear lack signs of wear but, as Figure 20 shows, the hub surfaces examined in the SEM showed no differences in wear when examined at a high tilt angle. Other edges were examined as well, to cover the possibility of contact resulting from tilting of the gear during actuation, but no wear was observed.

Figure 19. Schematic of rocking experiment.
