Morphologies of Laser-Induced Damage in Hafnia-Silica Multilayer Mirror and Polarizer Coatings

F. Y. Génin
C. J. Stolz

This paper was prepared for submittal to the
Third International Workshop on Laser Beam and Optic Characterization
Quebec, Canada
July 8-10, 1996

August 22, 1996

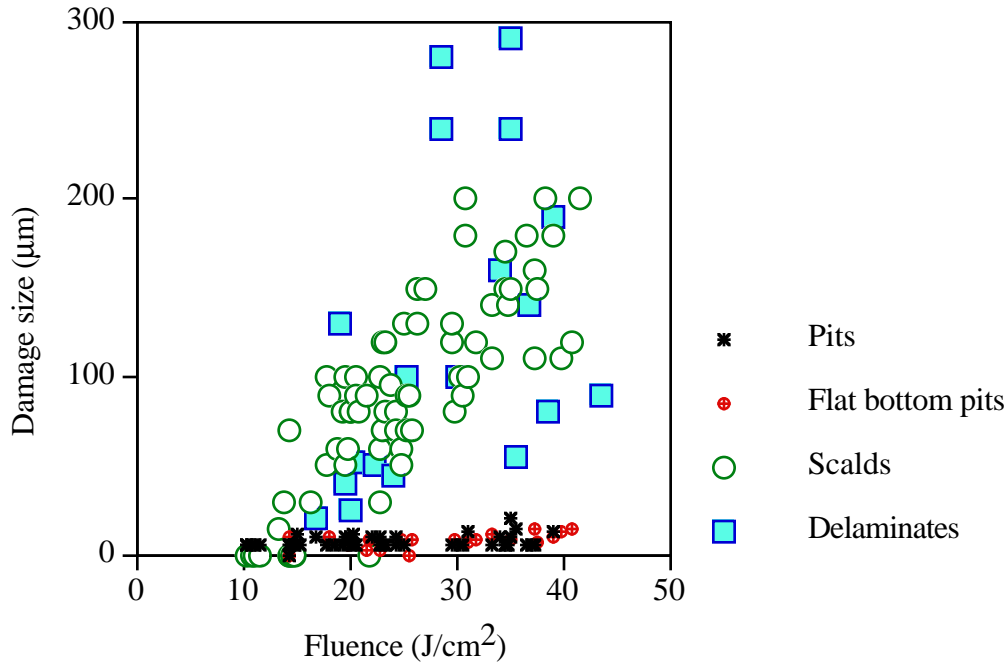
expands during the shot and may lead to very high temperatures on the surface. The diameter of the scald increases almost linearly with the fluence (see Fig. 5). Other experiments⁴⁶ have also shown that their size increases with longer pulse lengths.

Delaminates (i.e. removal of the overlayer) are very similar in size and shape to scalds. They are also found above 13 J/cm² when plasmas are observed to ignite and their size increases with higher fluences and longer pulse lengths (see Fig. 5). Like scalds, only the overlayer is damaged. However, while the silica overlayer remains attached to the coating for scalds, it is removed for delaminates. Fig. 4 shows a typical delaminate morphology. A pit is often found within the delaminated region. The failure mechanism is likely related to large gradients of temperature and stress in the top layers. Lowdermilk et al.³⁴ and other authors¹⁵ have reported that the addition of a silica half-wave overcoat can substantially increase the damage threshold of HRs. A future article⁴⁷ will show that these findings also apply to polarizers and that the main factor contributing to such improvement is the prevention of delamination.

pit	flat bottom pit	scald	delaminate
typical number of layers affected	between 2 and 50	2,4, or 6	1	1
typical maximum diameter (μm)	20	30	300	400

Fig. 5: Maximum damage size of the pit, flat bottom pit, scald, and delaminate morphologies as a function of fluence after a single shot. The measurements for the mirrors and polarizers of various origins (OCLI, S-P, LLNL) tested at 45 and 56° are plotted on this graph.
