## Common Causes of Material Degradation in Buried Piping (U)

A document prepared for ASME PRESSURE VESSEL & PIPING CONFERENCE at Orlando, FL, USA from 7/27/97 - 7/31/97.

**Common Causes of Material Degradation in Buried Piping**  
by  
**Charles F. Jenkins**

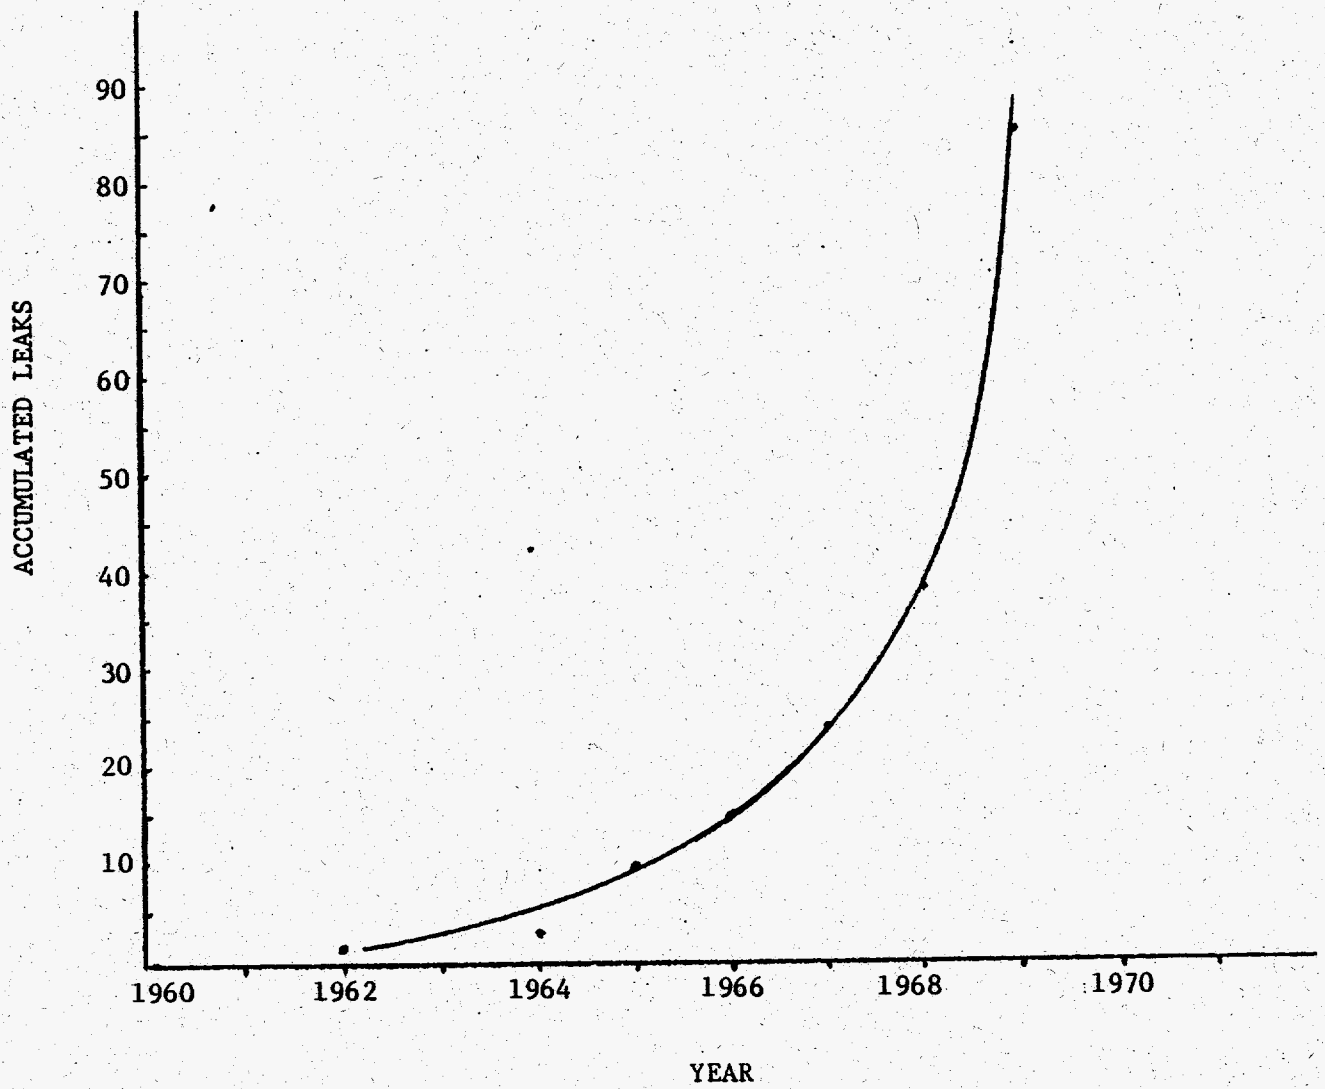
General experience with underground corrosion indicates that once leaks start to occur, an increase in the rate of development of leaks can be anticipated. The accumulated number of leaks typically follows an exponential curve with time (Fig. 1, after Ref. 1). As suggested in the graph in Fig. 1, a normal leak-free infancy can be expected. However, the natural tendency to corrode or oxidize eventually leads to some leaks.

Figure 1. Leak history of an underground pipeline. The curve is prototypical and exponential. Reference 1.
