Effect of Conductivity
Between Fasteners and Aluminum Skin
On Eddy Current Specimens

David G. Moore
Sandia National Laboratories
Federal Aviation Administration
Airworthiness Assurance NDI Validation Center
Albuquerque, New Mexico 87185
(505) 844-7095

M. C. Hutchinson ^{950 3821}
Boeing Commercial Airplane Group
P.O. Box 3707
M/S 9U-EA
Seattle, Washington 98124-2207
(206) 234-8392

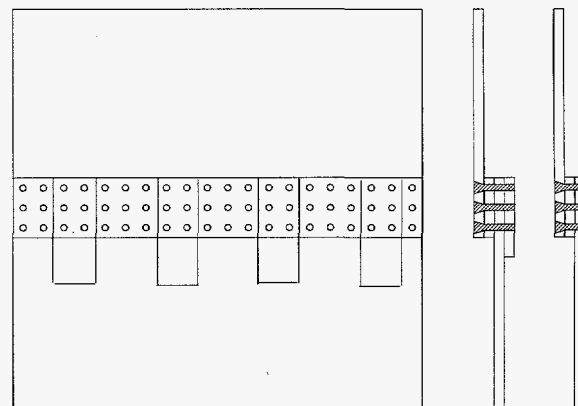
Figure 2. Panel design to simulate Boeing lap joint.

The specimens were designed to model pertinent aspects of an in-service 737 lap splice. Each test specimen consists of one mock doubler, four mock tear straps and two aluminum skins riveted together with a 76.2 mm (3") overlap (Figure 2). Programmed fatigue cracks were grown in aluminum sheets and placed as the lower skin. The spacing of the tear straps was varied to simulate manufacturing tolerances. Since the tear straps create a major source of noise for the eddy current inspection, the number of tear straps per unit length of lap splice was doubled. This gives an inspector a larger number of tear strap inspection sites with a minimum number of samples. The eddy current inspection is also effected by the skin thickness of the lap splice. Therefore, the top two layers of the specimens (upper skin and doubler) had two thickness values - 1.83 mm (0.072") and 2.03 mm (0.080"). The programmed fatigue cracks were created from starter notches at select locations. The lower skin panels were then cycled until the desired length of fatigue crack was reached. Starter notches were removed by drilling the final holes for fastener installation.
