**FAILURE ANALYSIS OF MARK IA
LITHIUM/IRON SULFIDE BATTERY**

**V. M. Kolba, J. E. Battles,
J. D. Geller, and K. Gentry**

ARGONNE NATIONAL LABORATORY, ARGONNE, ILLINOIS
Prepared for the U. S. DEPARTMENT OF ENERGY
under Contract W-31-109-Eng-38

October 1980

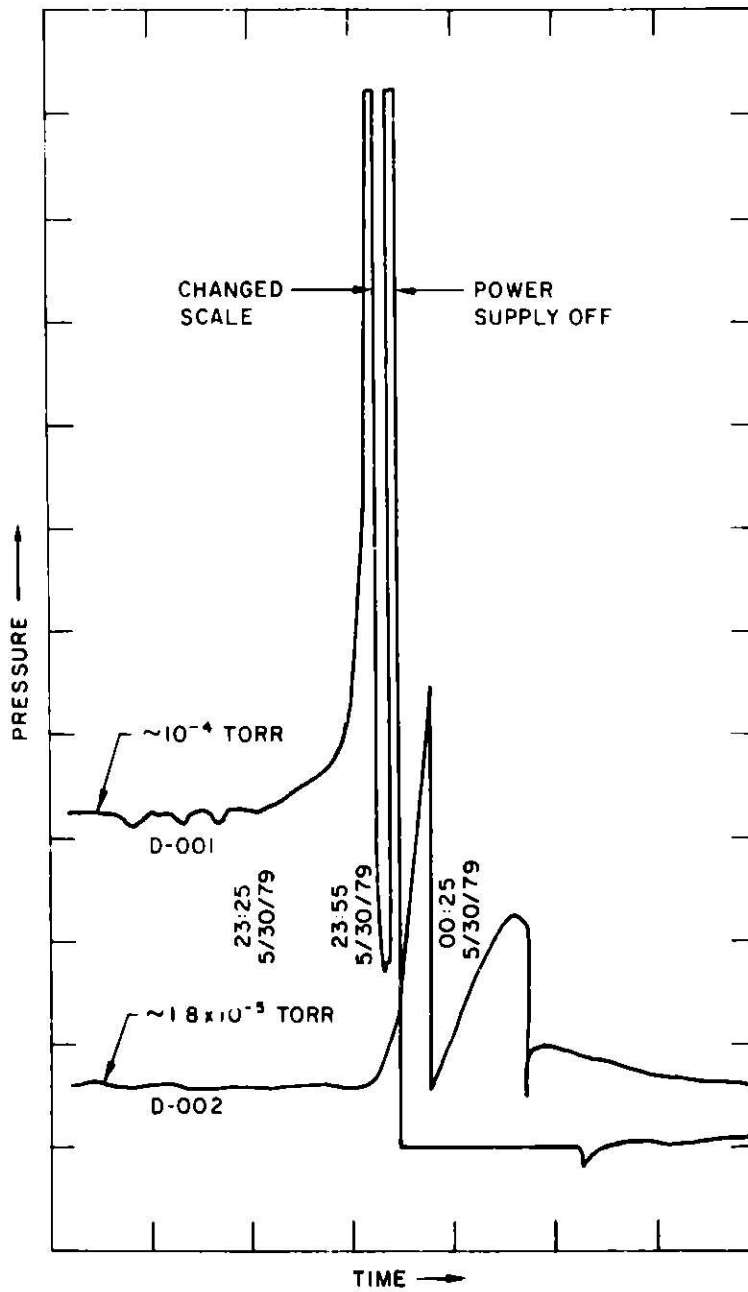
Fig. III-4. Pressure in Vacuum Annulus of Insulating Containment Vessels

At this time, an argon flowmeter on the exit line from the cell chamber was off-scale on the maximum, 85 L/hr (3 cfh); however, the flow was readily decreased to the desired value of 68 L/hr (2.4 cfh). This high reading could have resulted from a change in gas volume due to a temperature increase or a minor pressure surge in the cell chamber. At the same time, the pressure in the vacuum annulus rose from 1.2×10^{-2} to 1.5×10^{-2} Pa (9.0×10^{-5} to 1.1×10^{-4} torr), as shown in Fig. III-4. The vacuum annulus of D-001 was connected via a manifold to an 11 L/sec ion pump. The annulus of D-002 was connected to the same manifold, but it was valved off from the manifold. The

annulus pressure in D-002, however, showed a slight increase, which was attributed to a slight leak in the isolation valve. The voltage declines for Cells 22 through 31 are shown as a group in Fig. III-5, and those for Cells 24 through 27, which were the first cells to exhibit voltage decline, are shown individually in Fig. III-6. At about 2327, the voltages of Cells 24 through 37 began to drop significantly, and this effect progressed to the other cells. Between 2316 and 2333, the battery voltage had dropped from 173 to 90 V. The progression of cell-voltage decline (in 0.25-V increments) and temperature changes is shown in Fig. III-7. The decline in voltage of the entire Mark IA battery during the failure is given in Fig. III-8. There appear to be at least three major sections in this curve between 28 and 32 minutes. The slopes of the curve at approximately 28 and 32 minutes appear to be the same while the slope at 30 minutes is about one-half of the other two.

At 2340 the gas from the vacuum annulus was checked on the mass spectrometer, which showed a peak at Mass No. 40 (argon), thereby indicating a leak from the cell chamber into the vacuum annulus. The ion pump on the annulus stopped operating as a result of the rising pressure, and the sorption pump on the system was activated. At this same time, the thermocouple at location #3 had exceeded the temperature scale (maximum 999.9°C) on the digital meter. The air blower on the concentric cooling tube was activated, and air fans were directed on the outside of the battery.

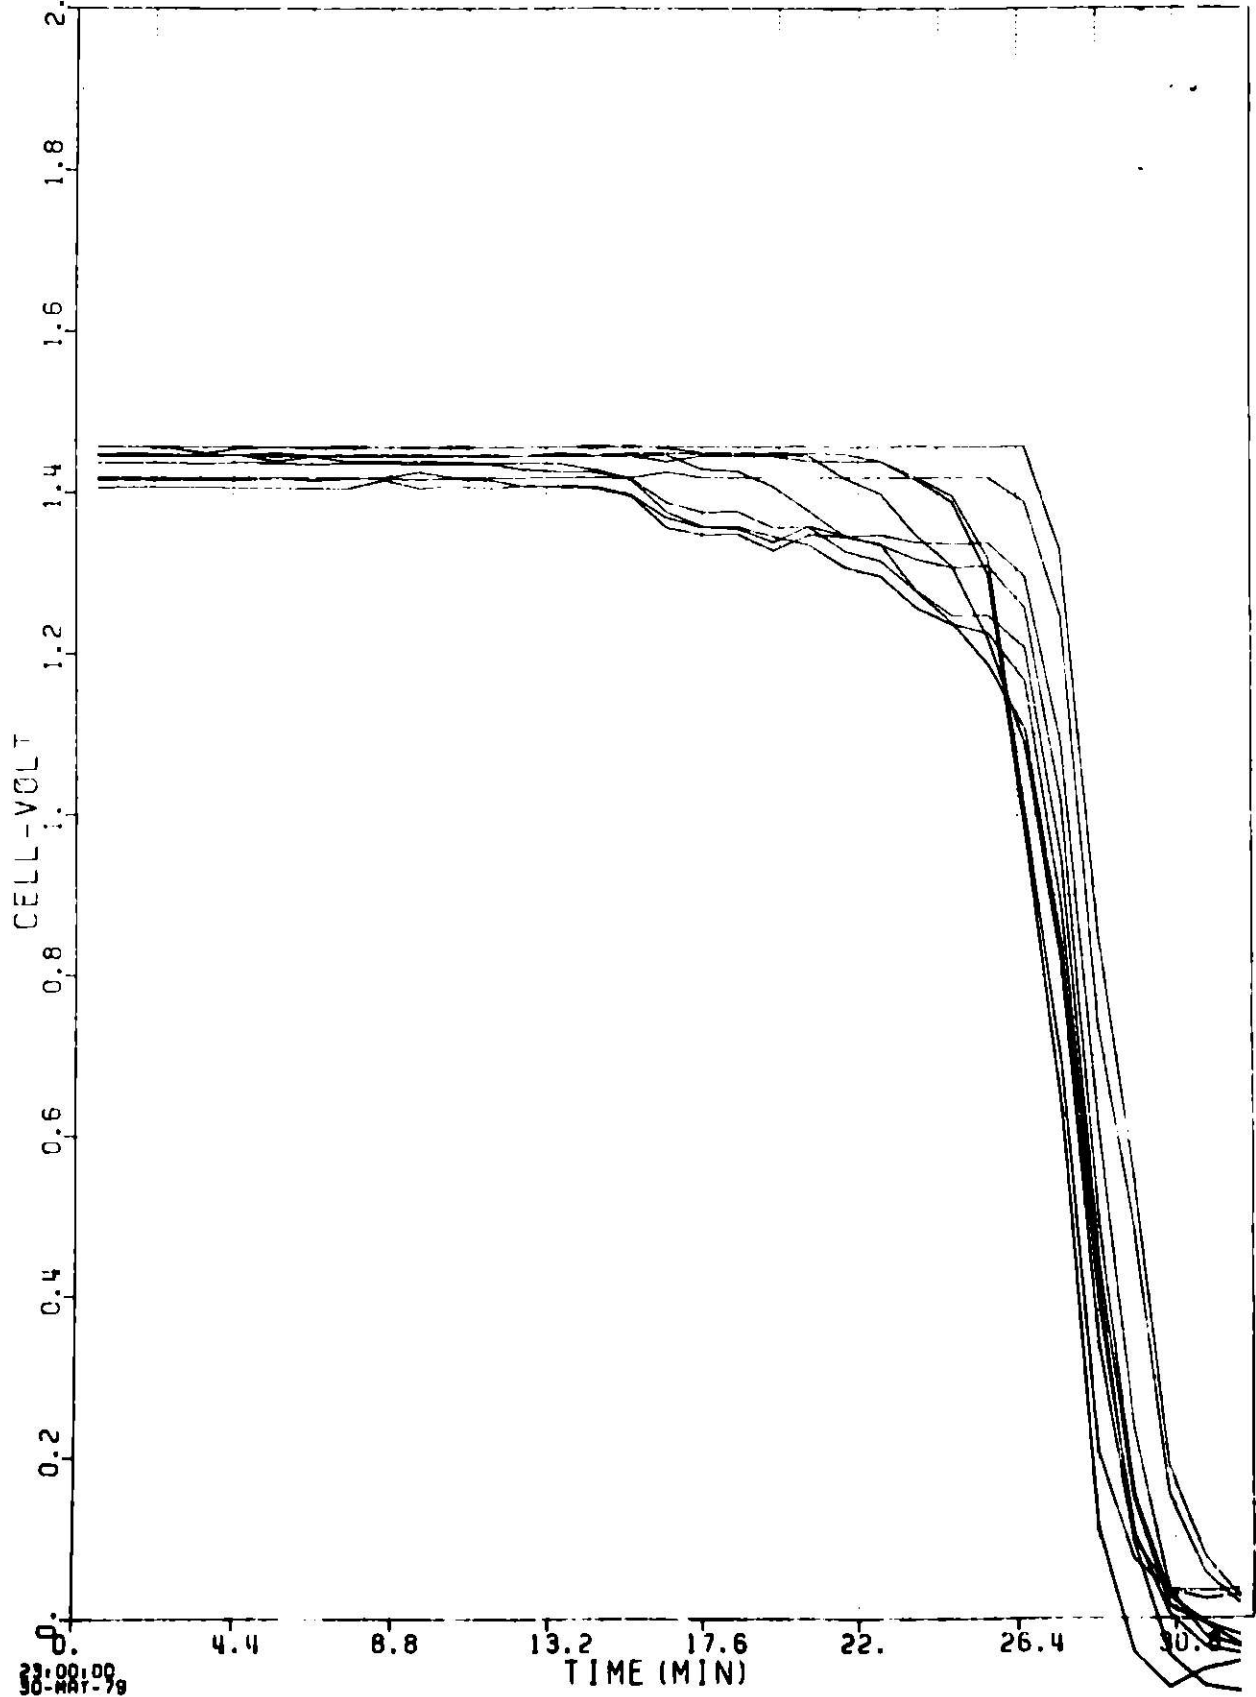
Fig. III-5. Voltage Decrease with Time for Cells 22-31 in Module D-001

Until 2316, May 30, the temperatures, cell voltages, annulus vacuum pressure, argon flow rate to the cell chamber, and other readings for both modules were normal. At that time, however, a small decrease (0.1-0.2 V) was noticed in the voltages of Cells 24 through 27 on the CRT terminal.

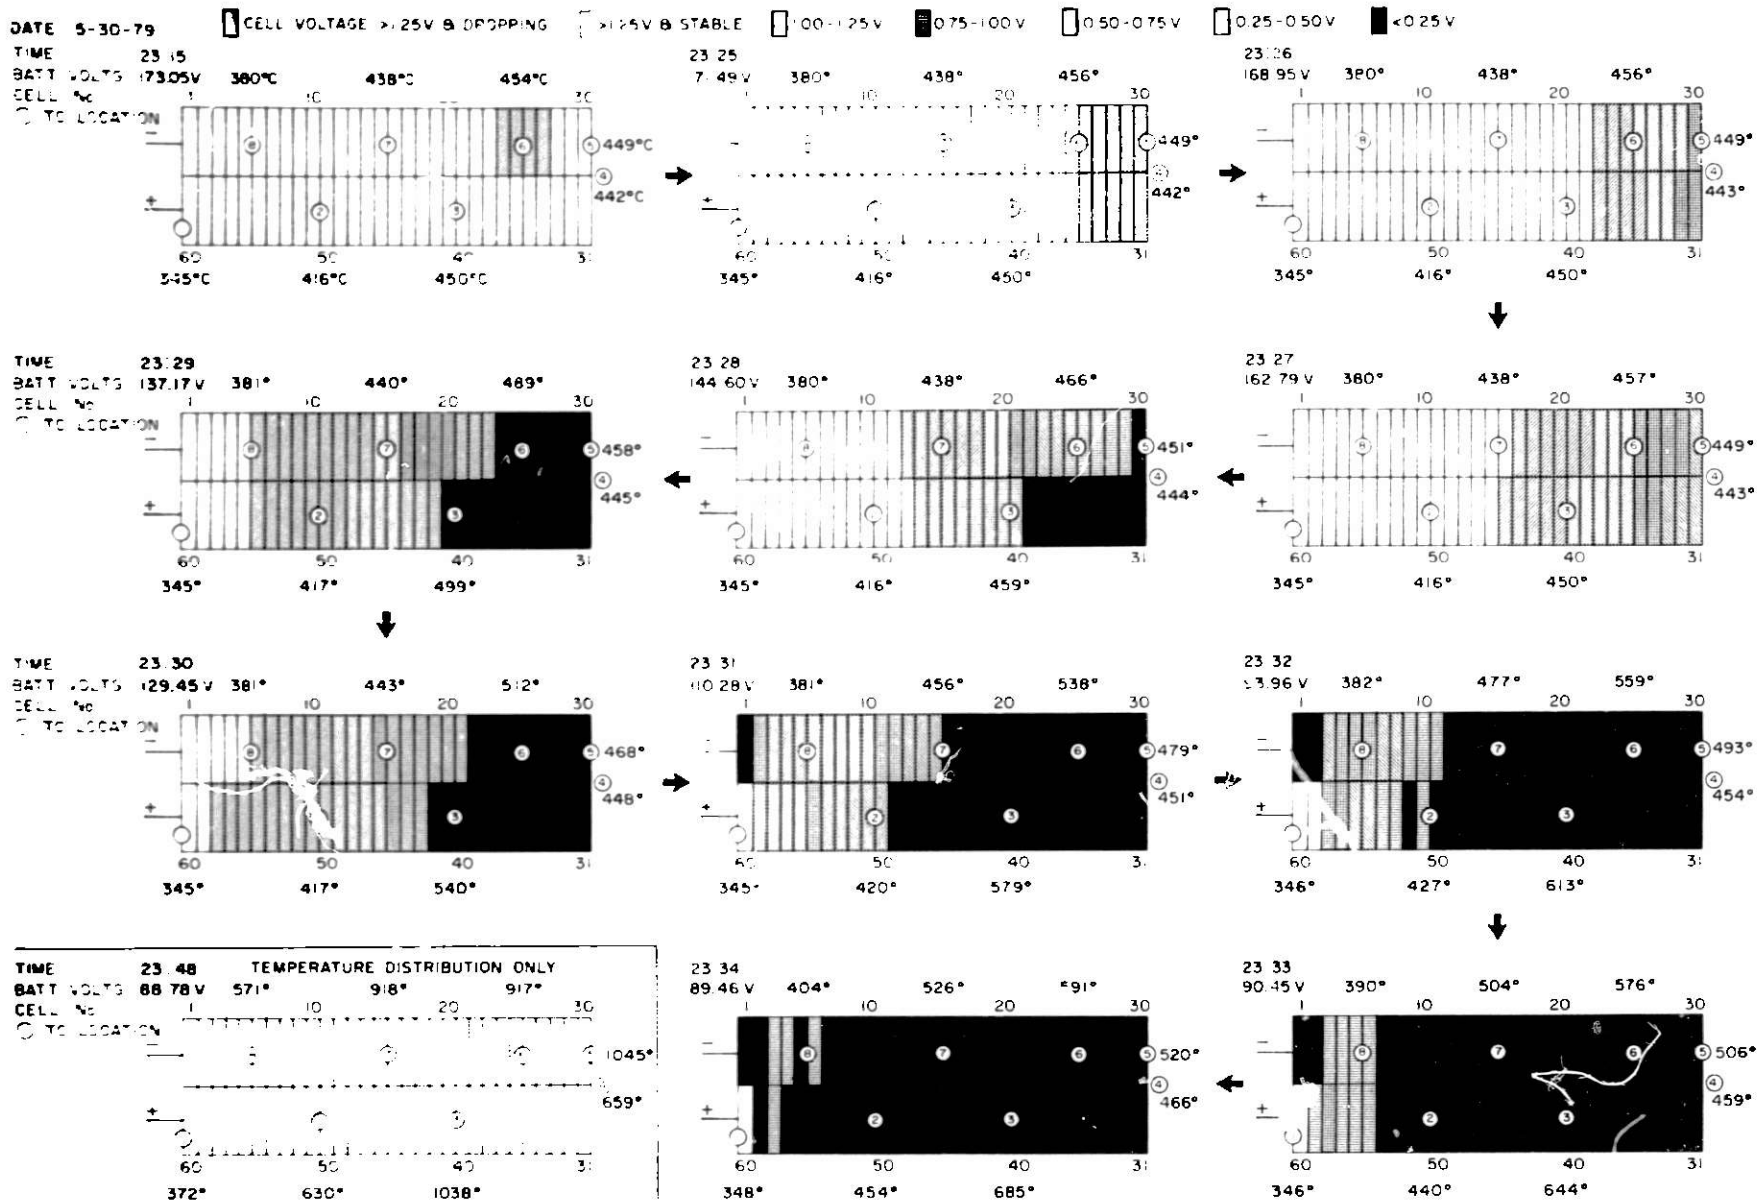
Fig. III-7. Change of Cell Voltages and Temperature with Time in Module D-001

The data in Fig. III-7 indicates that the temperature rise lagged behind the voltage decay of the cells in the vicinity of the thermocouples at locations #2, 4, 8, 9, 10, 11, and 12 (Table III-1). Temperature versus time curves for four thermocouples near the region where the first declines in cell voltage occurred are shown in Fig. III-9. The cause of the abrupt temperature rise at thermocouple locations #4, 9, and 10 and the generally erratic behavior of these thermocouples is not fully understood, but it may have been due to pickup of spurious voltages or intermittent contacts with molten materials.

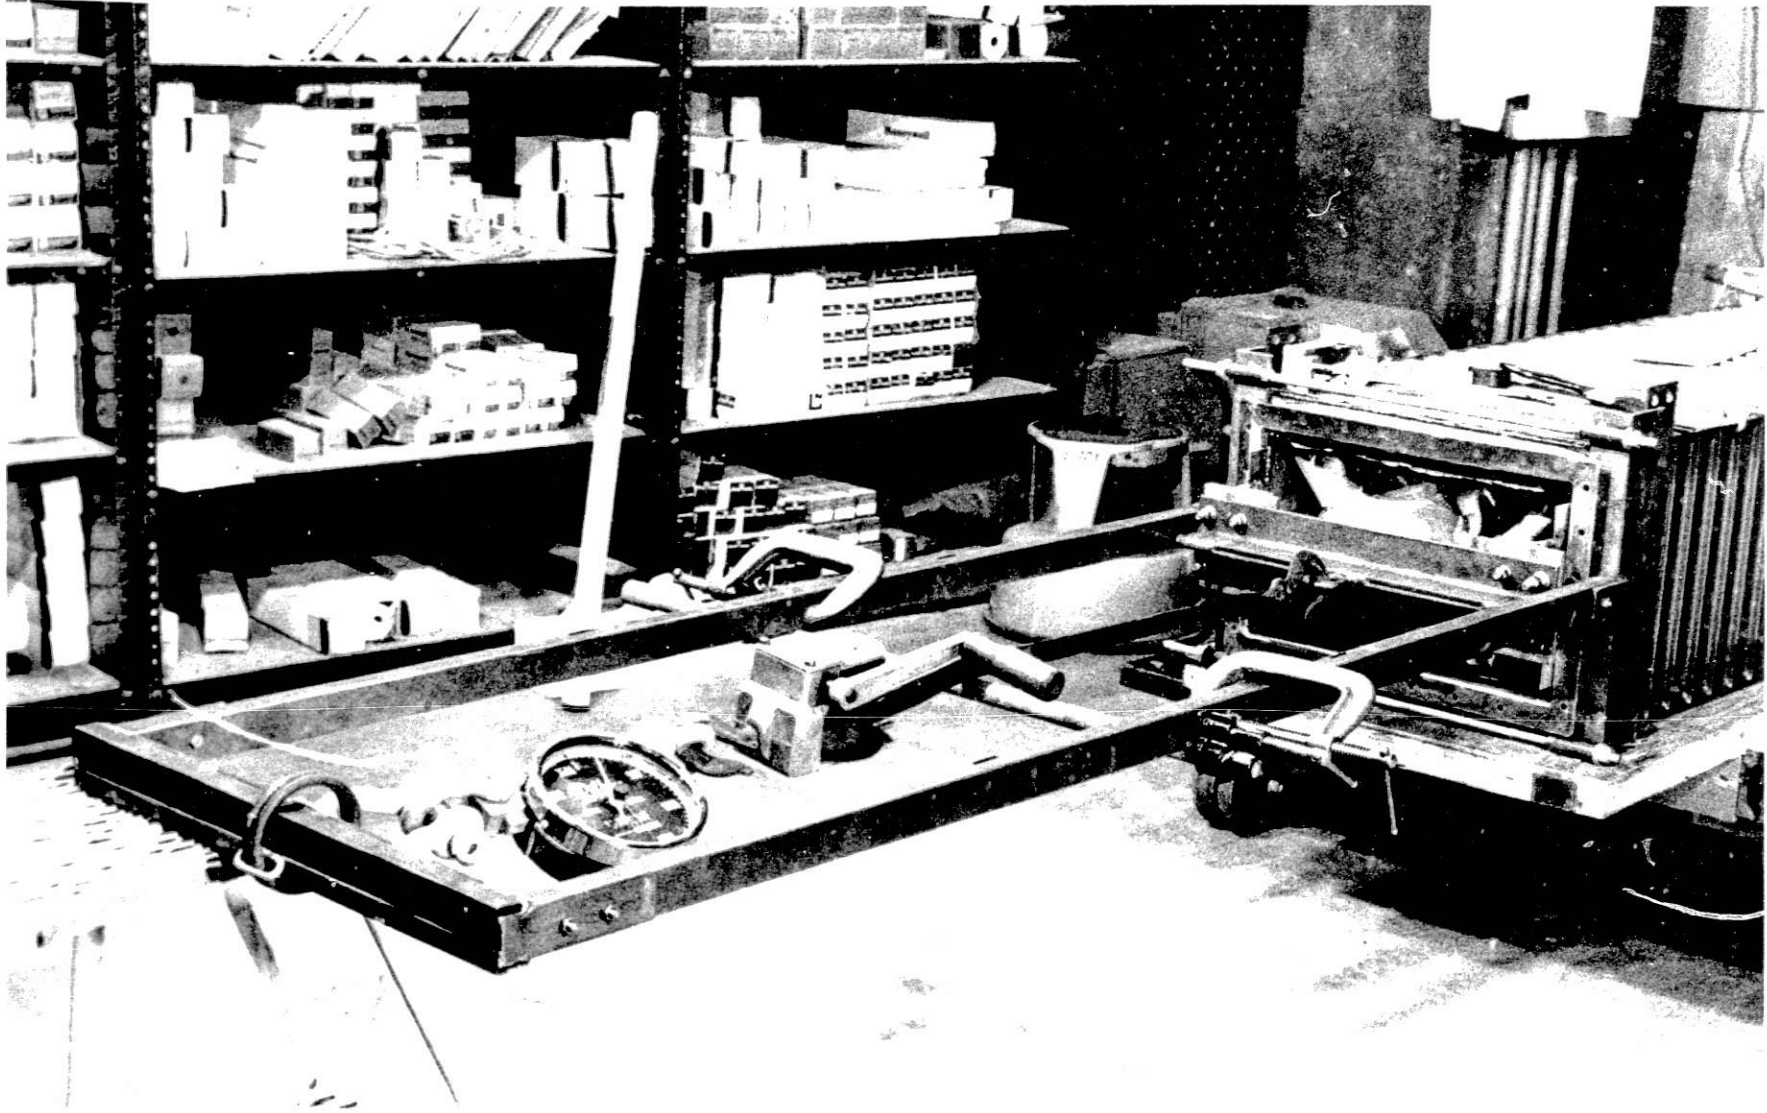
Fig. IV-1. Fixture for Tray Removal

Three options were proposed for the disassembly of Module D-001. The first option was to pull the cell tray out of the front of the module, as it was designed to be removed; however, attempts to do this, even with a pulling force of up to 680 kg (1500 lb), failed. The next option was to remove the liner (added to the inside of the containment vessel to correct a difficult-to-repair leak) and the cell tray as a single unit. The seal weld attaching the liner to the containment vessel was ground off, and appropriate pull tabs were welded on the liner (Fig. IV-1). This option also failed, even at pulling loads in excess of 900 kg (2000 lb). The final option was to sacrifice the module case by cutting it apart. A selective procedure was developed and was reviewed at each successive step. This procedure allowed examination of the foil, inner case, liner, cells in the tray, etc., as the disassembly progressed.

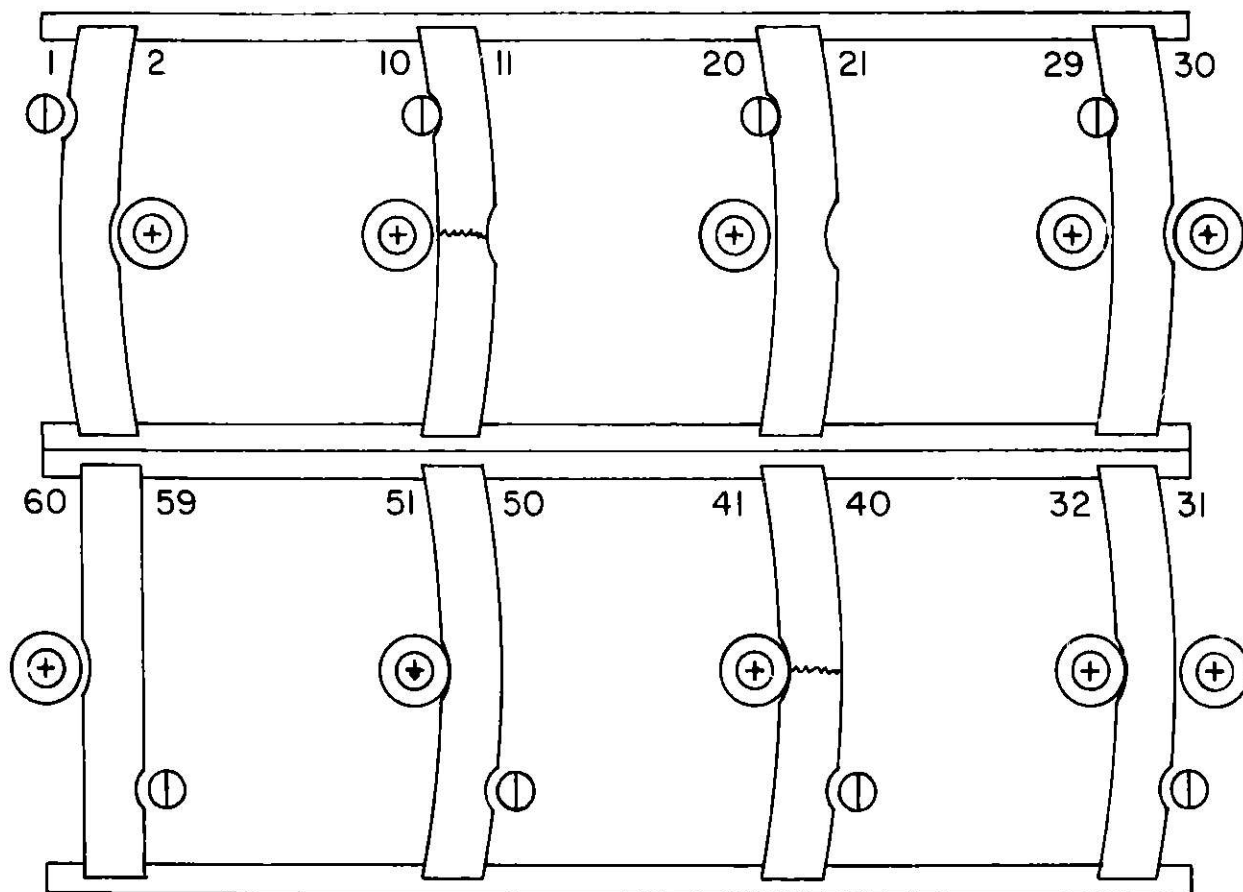
Fig. IV-7. Schematic Representation of Displacement of Cross-over Straps

Observations indicated that some movement of the cells with respect to the tray had occurred. This movement was caused by cell expansion brought about by rapid discharge and/or high internal temperatures. Figure IV-6 is a photograph of the module and shows the shift in position of the cells relative to the intercell connectors and to the cross-over straps (employed to restrain the sides of the cell tray at the top). Figure IV-7 indicates schematically the observed movements. Little or no swelling of Cell 59 occurred; this may be because Cell 60 did not discharge until approximately 2.5 hr after the event. The cross-over straps had contacted the fill tubes at Cells 10, 20 and 29 (Figs. IV-8 and IV-9) and had contacted the feedthrough housing of Cells 41 and 51 (Fig. IV-10). Evidence of arcing was observed between the strap and fill tube of Cell 29 and between the strap and feedthrough housing of Cell 41. Straps by Cells 10 and 41 were broken, having the appearance of a brittle fracture.

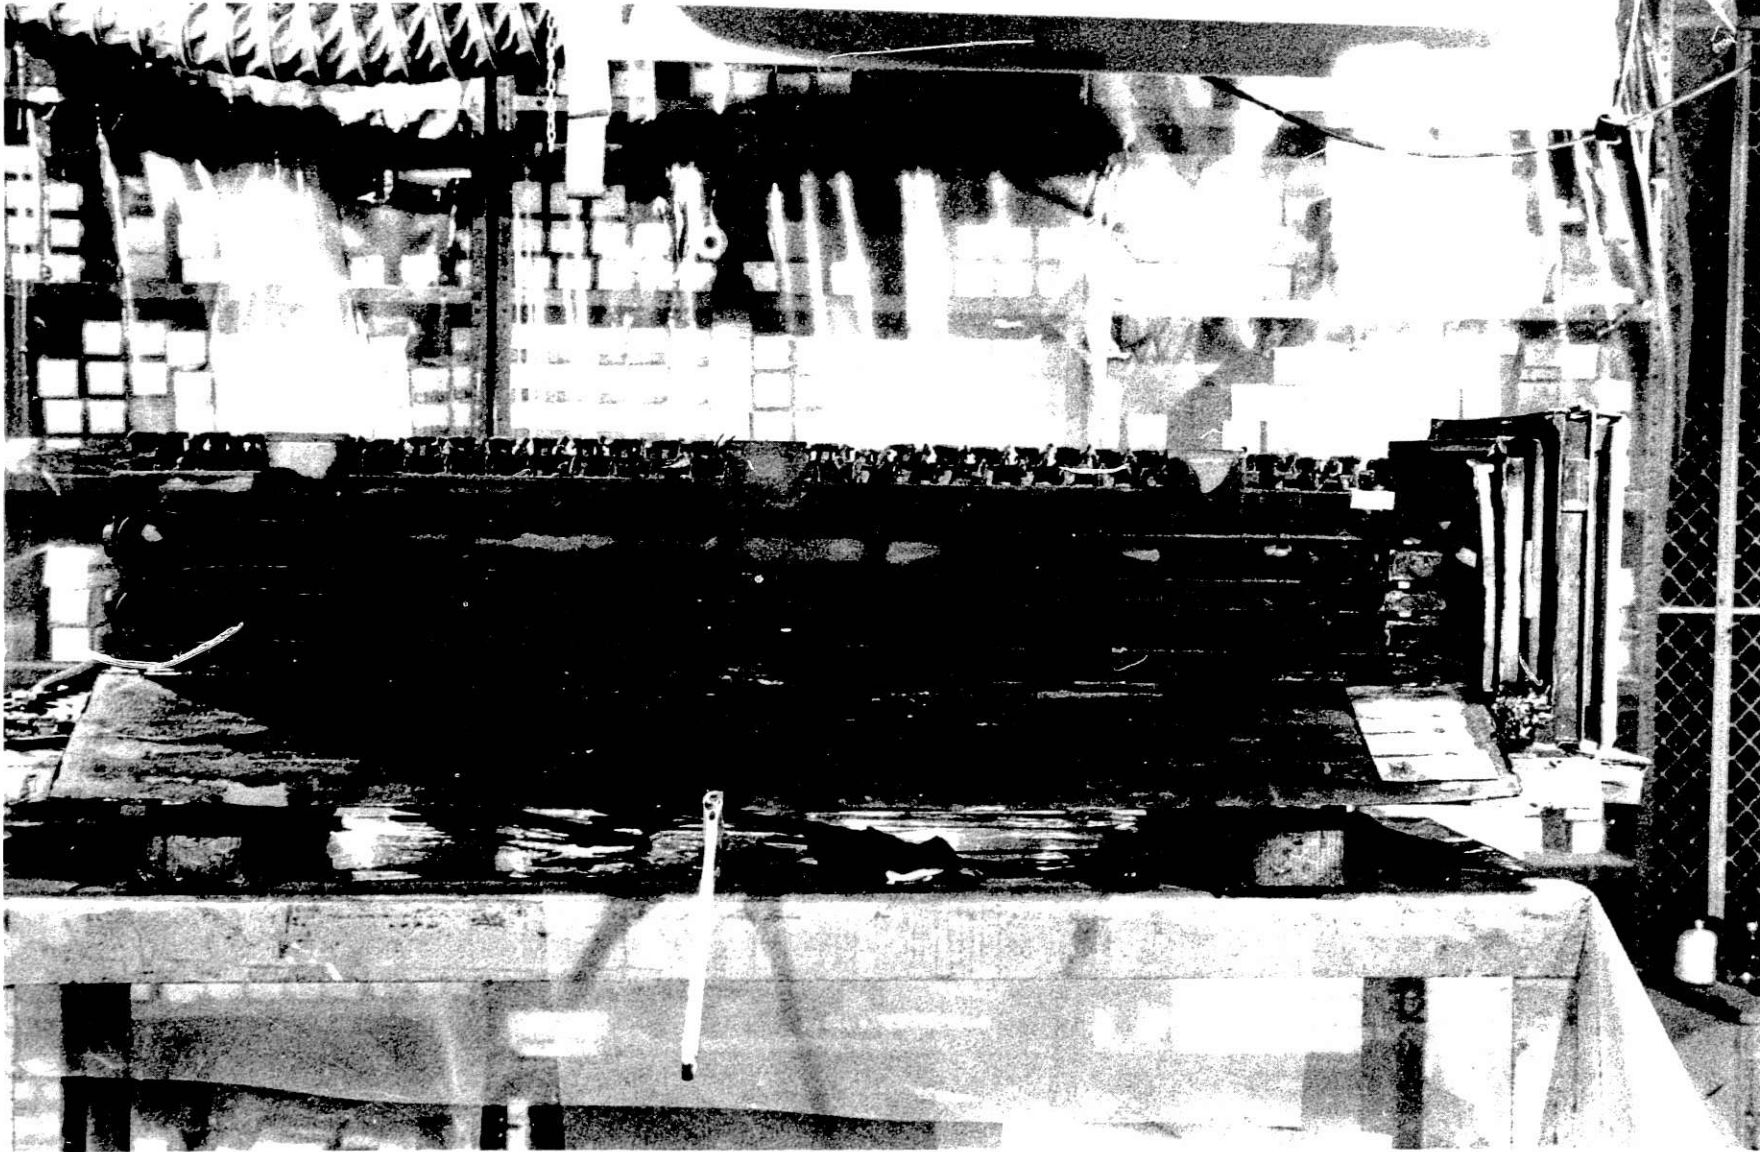
Fig. IV-24. Battery Heaters and Tray (Cells 1 to 30)

Overheating in a local area caused by a faulty heater was investigated as a potential initiation mechanism. Because of observations that cell-to-tray contact had occurred in the region of Cell 28, localized external heating was suspected. Examination of the rod-type heater in this region gave no visual evidence of local hot spots (Fig. IV-24), and resistance measurements of the heater itself showed no evidence of short circuits between the heating elements and c'adding of the heater rod. There is, at present, insufficient information concerning the possibility of internal arcing through argon gas within the heater element tube to reach a definite conclusion, but this is considered unlikely to be an initiator of the failure.
