ORNL/TM-13442

OAK RIDGE  
NATIONAL  
LABORATORY

## Composite Tube Cracking in Kraft Recovery Boilers: A State-of-the-Art Review

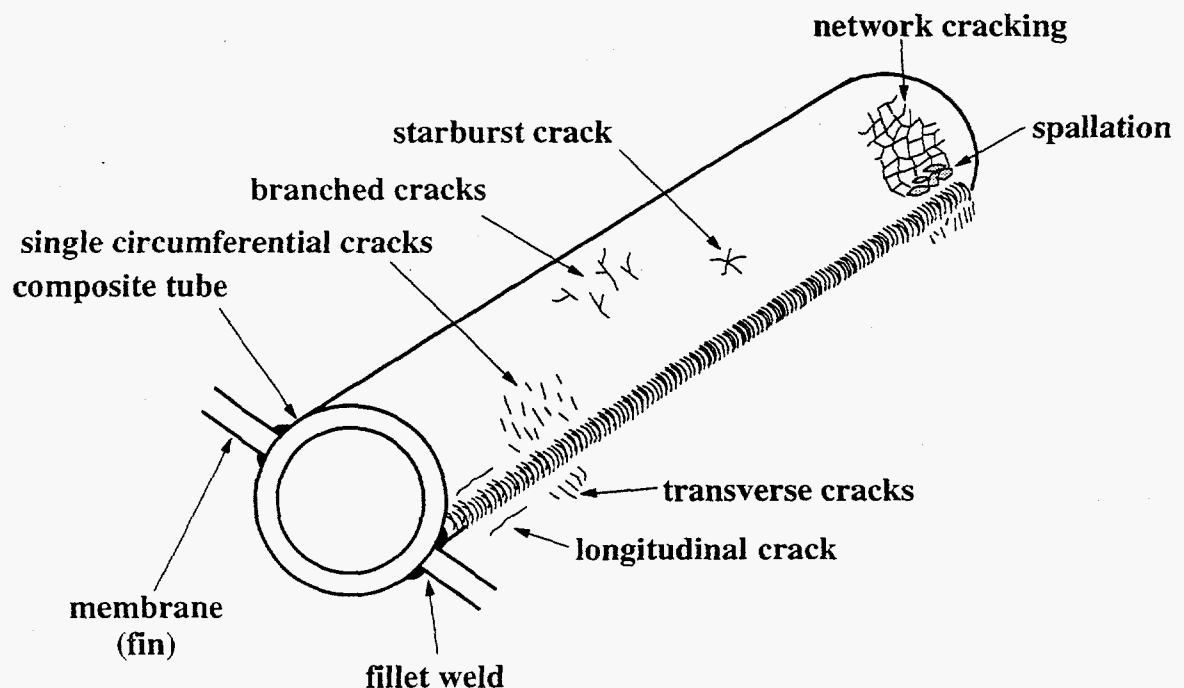
Regardless of whether cracking is observed in air-port, spout-opening, or floor tubes, a number of common features link many of the cracks. Cracking of coextruded tubes is most easily detected by penetrant testing (PT) on a carefully prepared surface. A "composite" example of the types of crack patterns generally observed on the surface of tubes is shown schematically in Fig. 10. Cracking may be located in or adjacent to the membrane, or may be spread across the tube surface. Cracks may be oriented either transversely or longitudinally to the tube. Cracking at the crown of the tube is less common at air-port or spout openings but has been found on numerous occasions in floor tubes.

In the early stages of degradation, short, unconnected cracks may be detected. More severe damage is characterized by longer, branched cracks or cracks that appear to meet and cross over one another. Sometimes cracks radiate in several directions from a central point, often described as "star-burst" cracking. A more severe stage of degradation shows itself as an interconnected network of cracks. This has been described as "craze cracking," "spider's-web cracking," "snake-skin cracking," or "crocodile-skin cracking." In extreme cases, chunks of stainless steel may completely lose contact with the tube when this form of cracking occurs.

Fig. 10. A "composite" drawing showing the manifestations of the various forms of cracking found on the surface of coextruded tubes.

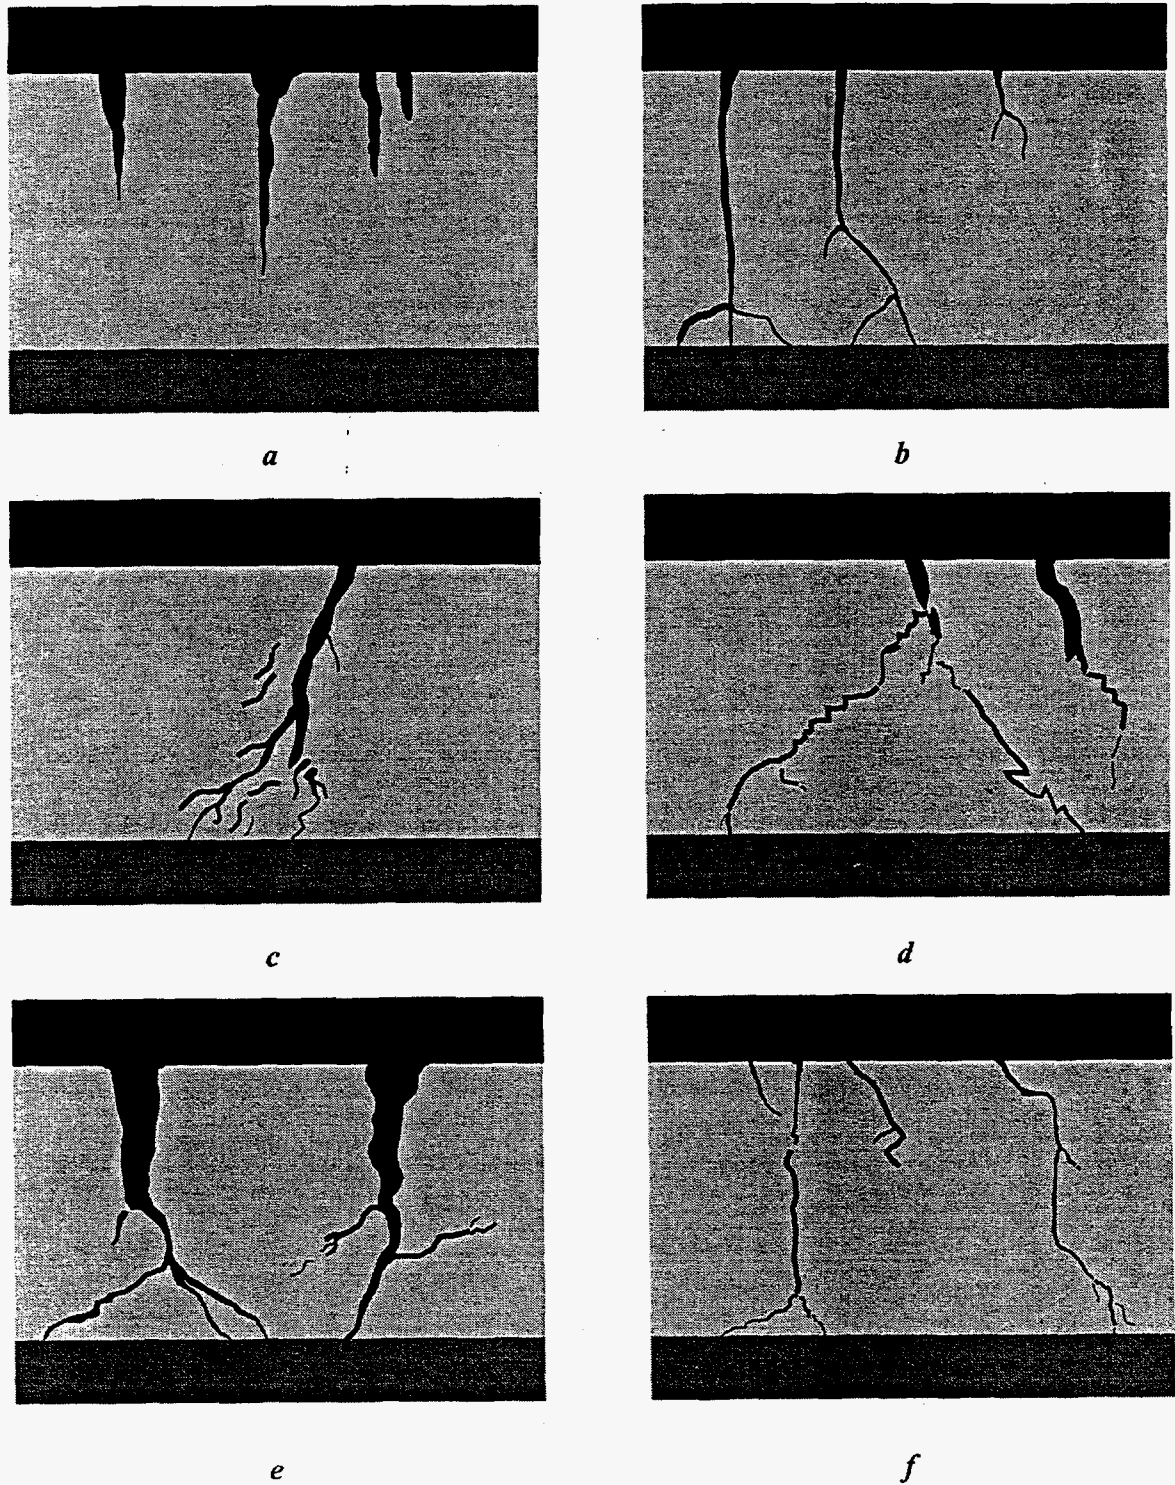
With fortuitous timing of an inspection, the cracks may be detected before they have penetrated through the outer layer of stainless steel cladding. The cracks are almost always initiated at the outer stainless steel surface and generally propagate perpendicularly to the surface. Sometimes single cracks are observed; in other cases, multiple cracks close together or craze cracking is found. They are mostly wedge-shaped or tapered with sharp, rather than blunt, tips. They may contain corrosion products or deposits from the boiler environment. Short cracks are usually straight and unbranched (Fig. 11*a*), but after they have penetrated some distance into the stainless steel layer, there may be signs of branching (Fig. 11*b*). The branches are generally finer than the original crack. They frequently show signs of further branching and may exhibit a multibranching morphology or "river delta" pattern (Fig. 11*c*). These cracks tend to be transgranular, rather than intergranular, but sometimes follow certain crystallographic features with frequent changes of direction giving rise to stepped crack morphologies (Fig. 11*d*).

Type 304L stainless steel is generally considered to have good corrosion resistance in a recovery boiler atmosphere. However, cases have been reviewed in which crack formation in coextruded tubes was accompanied by corrosion of the outer layer. In some cases, corrosion of the outer stainless steel layer was significant, but in other cases, it was manifested by a slight roughening and staining of the surface. There have been instances in which cracks appear to have been widened by the action of the corrosive environment (Fig. 11*e*), perhaps becoming filled with corrosion product. In contrast, highly branched cracking can sometimes initiate without developing from a wider initial crack (Fig. 11*f*).

The first method, and perhaps most common, is that the path of the crack turns and proceeds along the interface between the stainless steel and the carbon steel (Fig. 11*g*). Metallography has shown cracks that proceed along the interface for distances of 2 cm (0.79 in.). In extreme cases, the loss of the bond associated with this mode of crack propagation leads to delamination and spalling of chunks of the outer stainless steel layer, exposing the carbon steel core to the boiler atmosphere.

Several examples show how corrosion of the carbon steel can occur at the point where the crack meets the interface. The cracks allow access of corrosive species that attack the carbon steel at a faster rate than they attack the stainless steel. Damage may show itself as small spots of corrosion at the crack tips (Fig. 11*h*), which eventually grow into pits of considerable size (Fig. 11*i*). The region of active corrosion can spread along the interface (Fig. 11*j*), or can produce broad corrosion pits in the carbon steel (Fig. 11*k*). There are also cases in which intergranular attack of the carbon steel has been noticed in the vicinity of the crack tip (Fig. 11*l*).

Fig. 11. Schematic drawing showing the various types of crack morphology found in coextruded tubes as cracks propagate to the interface between the carbon steel and the stainless steel.

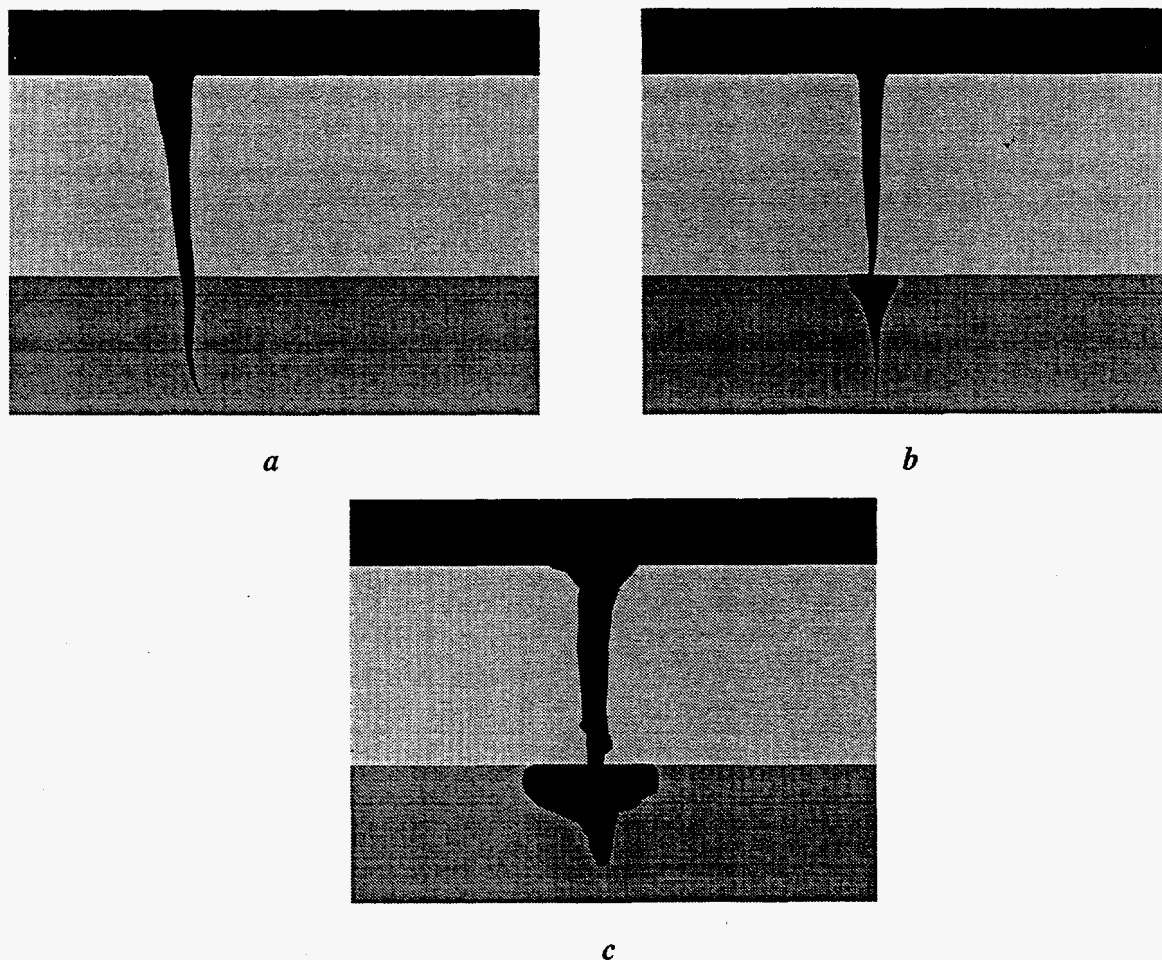
The evidence reviewed suggests that the cracks that cross the interface are chiefly the straight, wide, unbranched, or carrot-shaped cracks (Fig 12*a*); however, network cracking from the crown of a spout-opening tube that penetrated into the carbon steel have been reported. Although sometimes the crack may pass directly through the interface, there have also been cases in which corrosion and widening of the crack take place at the point where it enters the carbon steel (Figs. 12*b* and 12*c*).

Fig. 12. Schematic drawing showing the morphologies of cracks progressing through the interface into the carbon steel core.
