Final Results of Double-Shell Tank 241-AN-105 Ultrasonic Inspection

Key Words: ultrasonic, tank integrity, examination, 241-AN-105, 105-AN, inspection, wall thinning, UT testing, tank wall, UT, integrity assessment, ultrasonic inspection

FINAL RESULTS OF DOUBLE-SHELL TANK
241-AN-105
ULTRASONIC INSPECTION

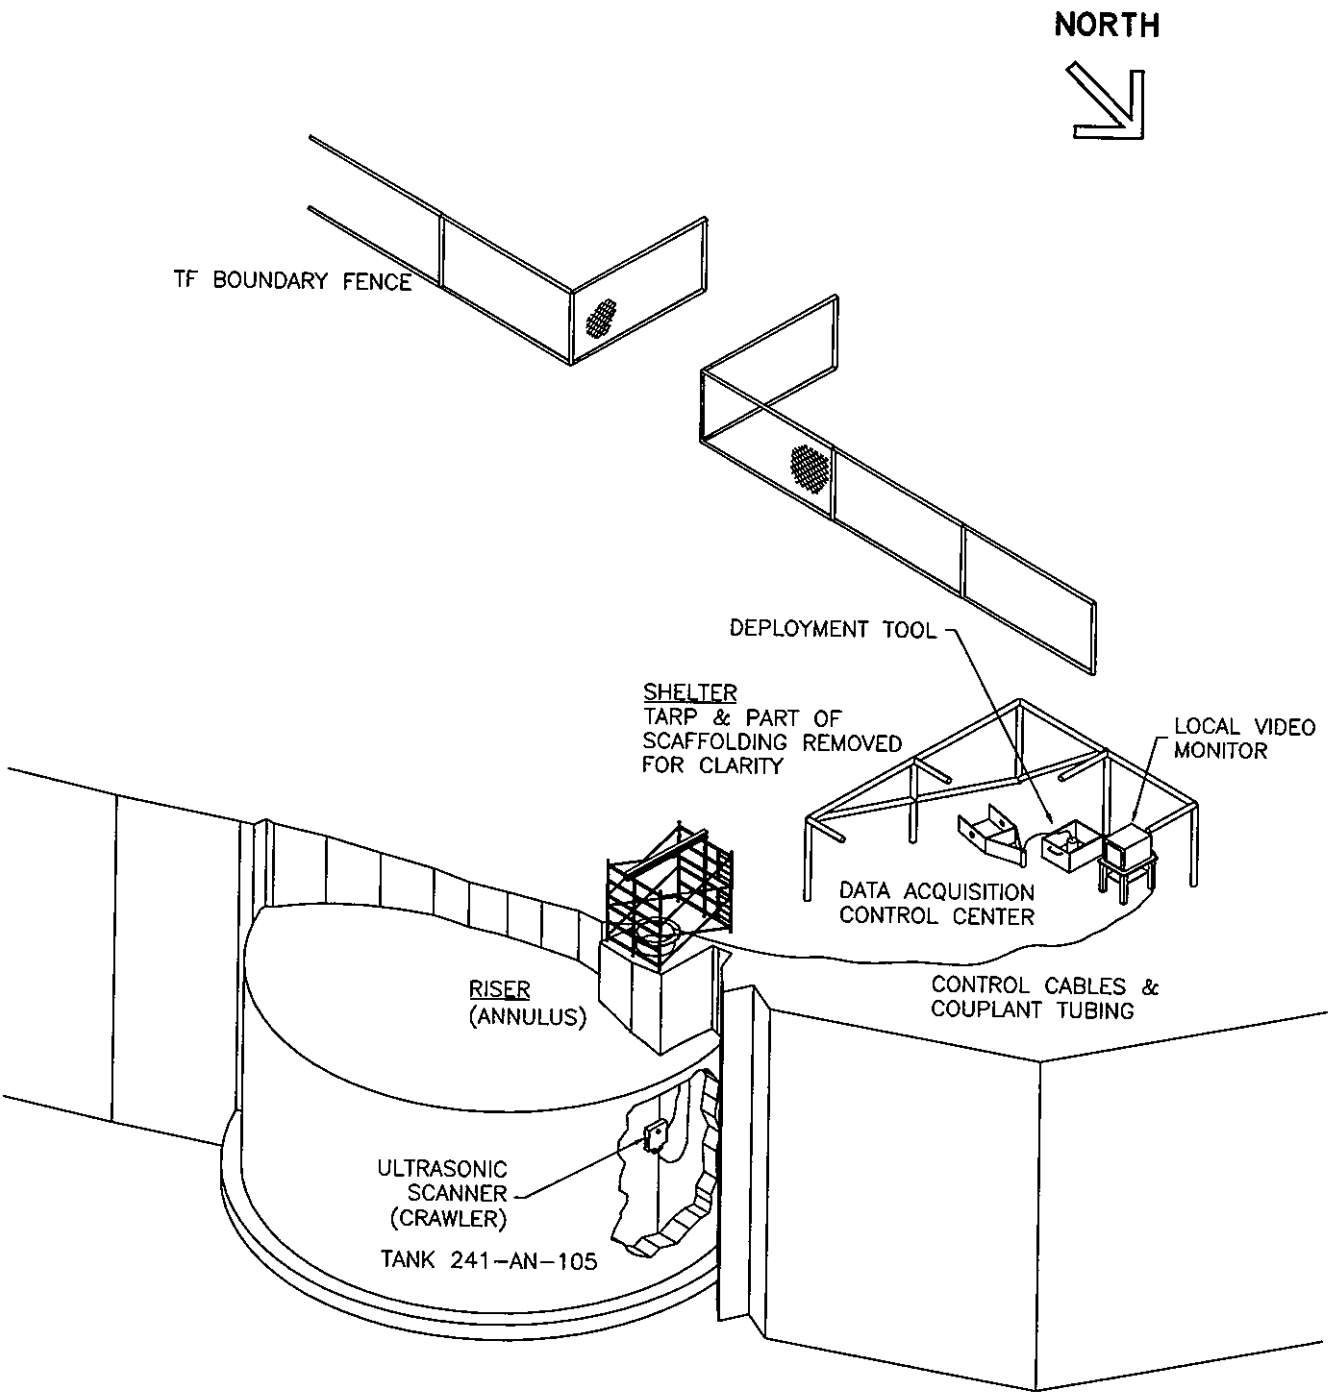
Figure 2 - Schematic of Inspection Set-up 241-AN-105

A temporary structure, constructed of scaffolding, was erected around the riser to provide the means for deploying the UT equipment (Figure 2). A central I-Beam was secured to the top of the scaffolding and supported a single-line sheave. A manual cable winch was secured to the base with the cable running up to the sheave in a single-line hoisting method for maneuvering the equipment into position. The weather during the entire examination was cold to moderate. Some initial control center heating problems caused the equipment to malfunction but were addressed immediately. Once heat was restored, no further cold-weather problems were encountered. Due to the weather, a temporary structure was erected near the inspection riser. This "tent" was constructed of round tubing and covered with weather resistant material and housed the inspection overview video equipment, deployment tool and video monitor (Figure 2). The tent was used as the control center and provided adverse weather protection for the equipment and crew. The control cables were run along the ground to the equipment located at the riser. The cable was sleeved with plastic to prevent possible contamination
