Energy Retrofit Field Study and Best Practices in a Hot-Humid Climate

J. McIlvaine, K. Sutherland, and E. Martin
*Building America Partnership for Improved
Residential Construction*

March 2013

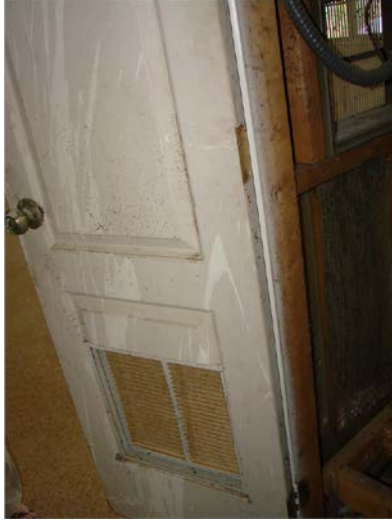
Figure 26. Interior closets that served as return plenums had louvered doors or door-mounted return grilles.

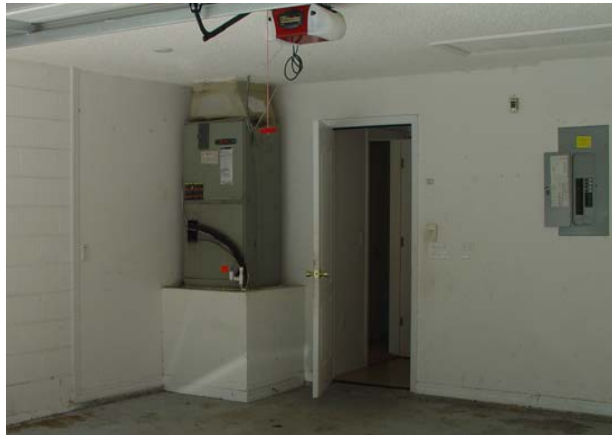
Figure 27. Upflow AHUs on framed platforms in garage with a wall-mounted filter-back grille were ducted directly into the platform cavity.

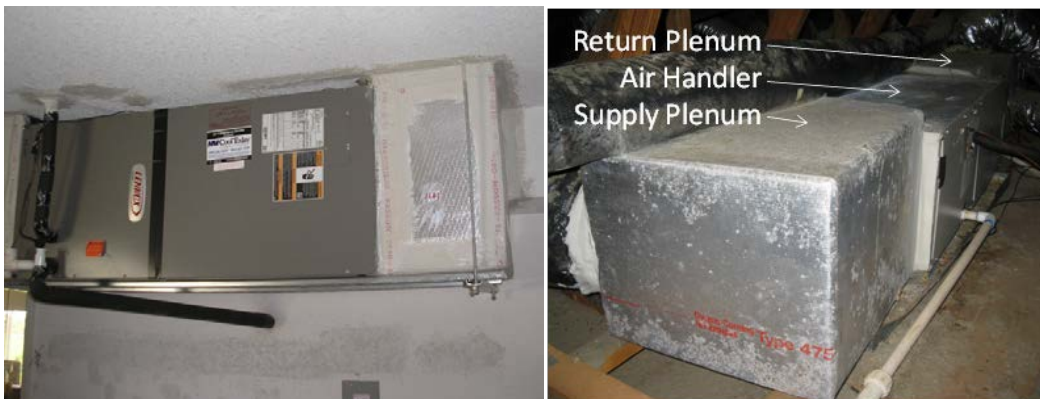
Figure 28. Horizontal flow AHUs mounted at ceiling of garage (left) and in the attic (right)

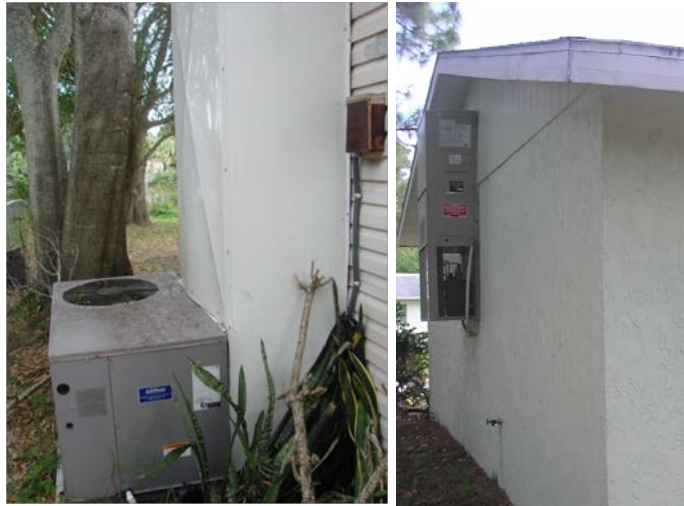
- **Six homes.** Attic-mounted horizontal flow AHU (Figure 28, right) with duct board supply and return plenums. The return air path is through a ceiling-mounted filter-back grille.
- **Three homes.** Package unit exterior to house with return air path through a wall-mounted filter-back grille. Two were units typical of manufactured housing (Figure 29, left) and one unit was typical of portable classrooms (Figure 29, right). In all three homes, systems were put together haphazardly with ill-fitting parts, which makes airtight assembly challenging.

Figure 29. Exterior package units with return air path through a wall-mounted filter-back grille. Ground mounted unit with metal shroud housing main return and supply ducts (left) and wall-hung unit with attic-mounted ducts (right).
