Wyandotte Neighborhood Stabilization Program: Retrofit of Two Homes

A. Lukachko, A. Grin, and D. Bergey
Building Science Corporation

April 2013

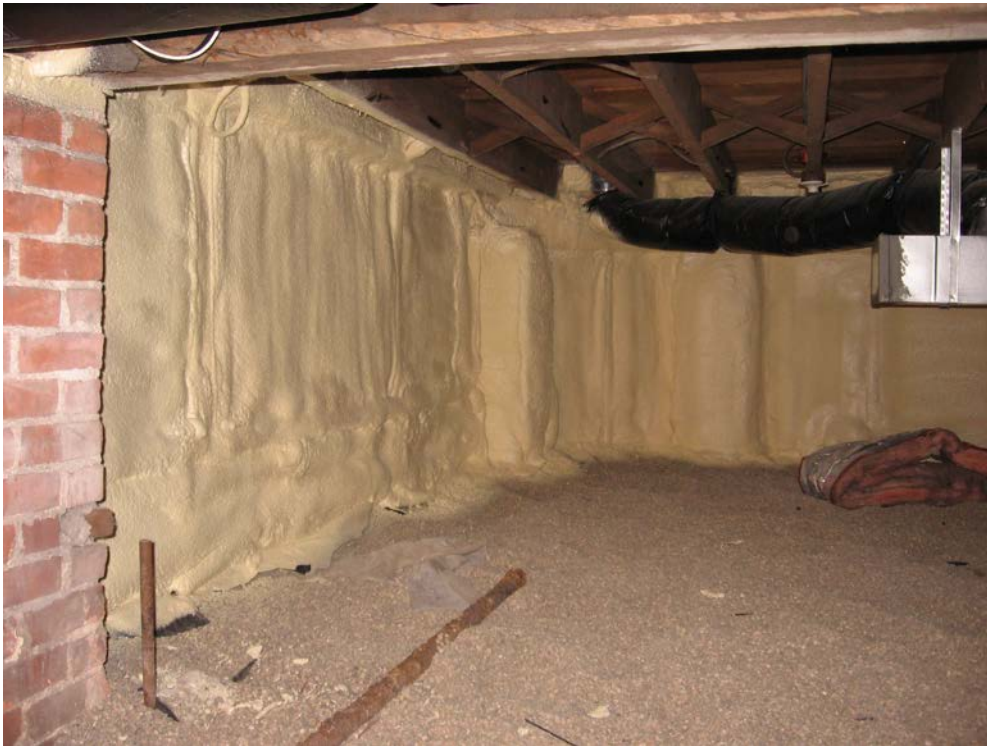
Figure 13. Spray foam installation in conditioned crawlspace at Cedar 1

The foundation existing pre-retrofit at Cedar 1 was a combination of an uninsulated basement accessed from the exterior at the rear of the house, and an un-insulated, vented crawlspace at the front of the house. The strategy for the crawlspace was to seal, insulate, and condition this area as a conditioned crawlspace. A polyethylene sheet was placed on top of the ground and overlapped by the spray foam as a complete air barrier.

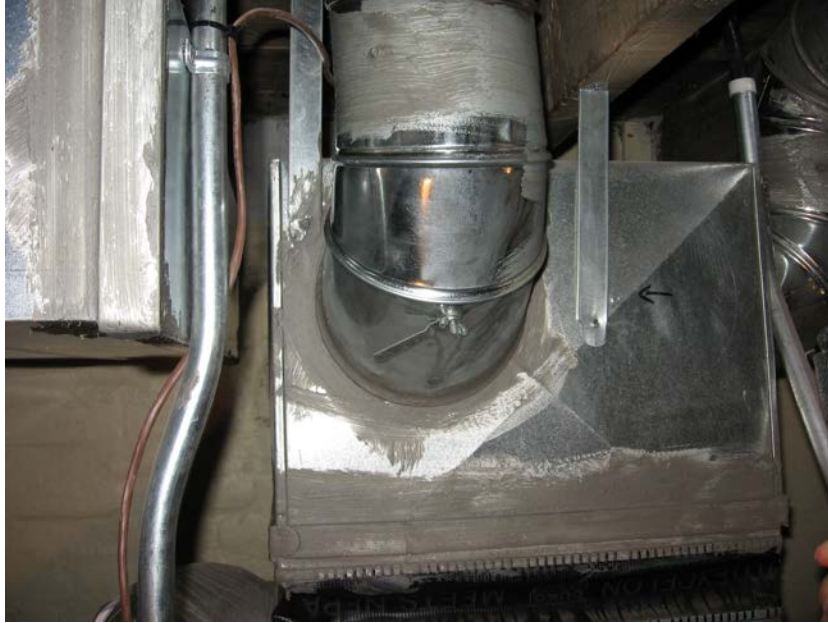
Figure 14. Typical ductwork sealing at takeoff from trunk; elbow to the site is sealed

The HVAC equipment—a GSHP, hot water tank, and air handler—were installed and commissioned by the installer in Cedar 1 but not Cedar 2 at the time of this report. As specified, all ductwork joints and seals have been sealed with mastic (see Figure 14 below). Pressure testing of the ductwork system has not been completed. All ductwork has been installed inside the thermal enclosure as specified.

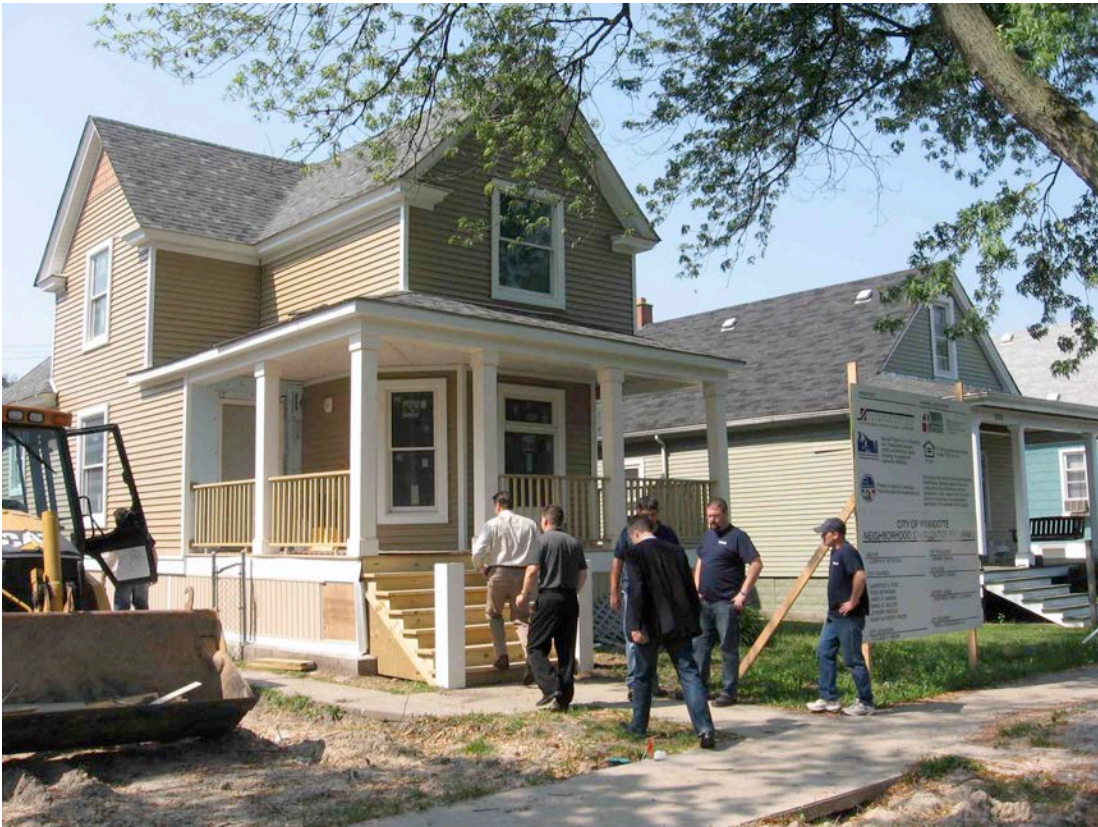
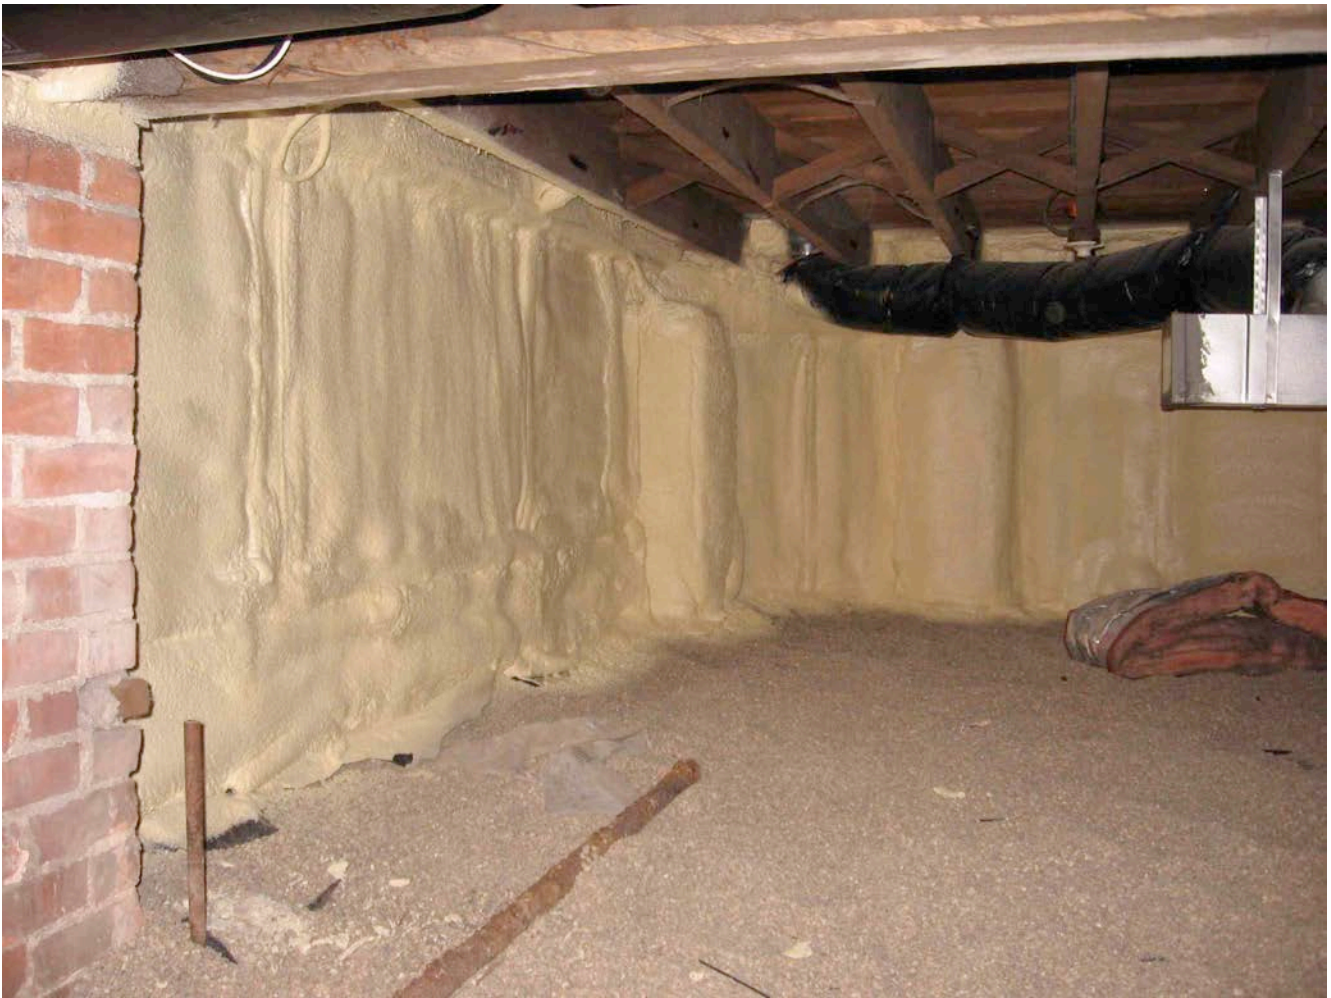
213 CEDAR STREET

This is a Bid Pack 1 retrofit project. Briefly, the house was gutted and refinished on the inside – full depth ccSPF in stud cavities. New mechanical including GSHP. The crawlspace was covered to a conditioned crawlspace. The attic was insulated as a conditioned attic. The roofing was new and left as found. The building was reclad with 1” of XPS and new vinyl. This house is ready for us to test on June 27 but we do not have pre-retrofit data on this house because construction was started during our funding gap.

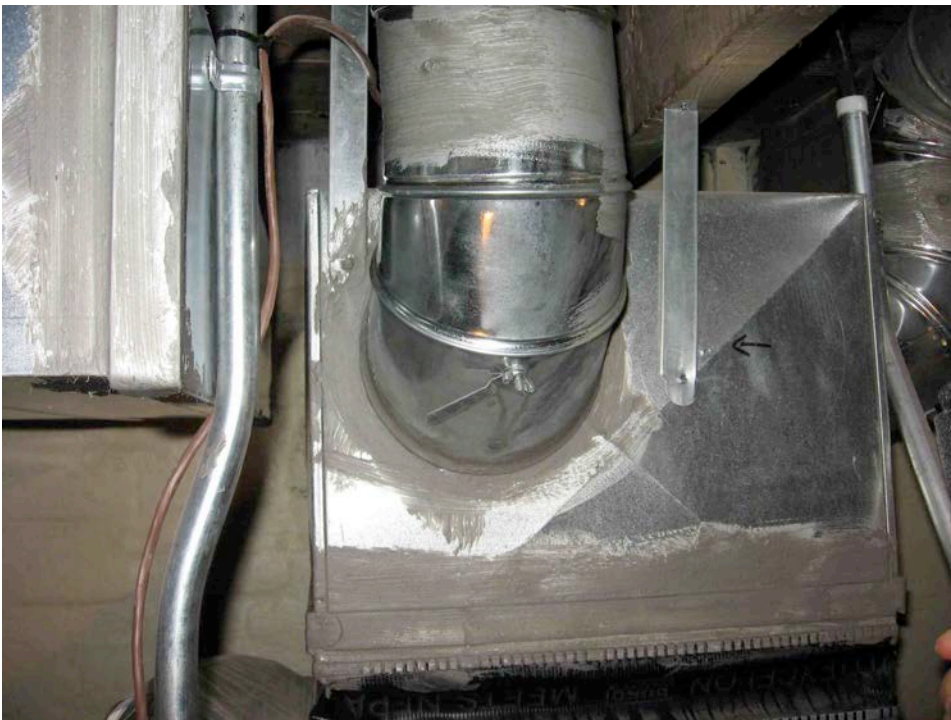
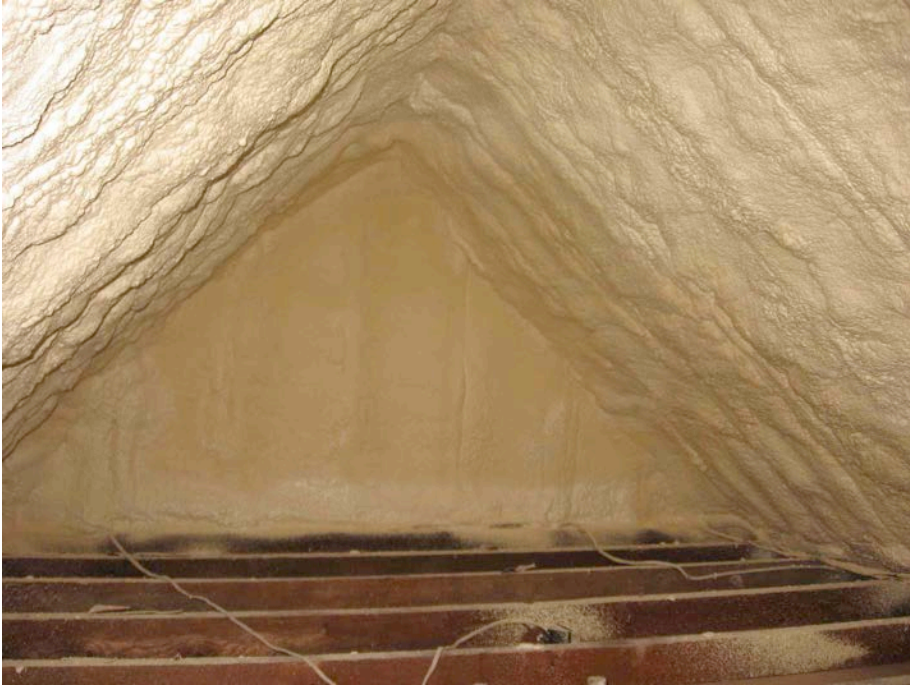
There is a sheet of polyethylene under the pea gravel.

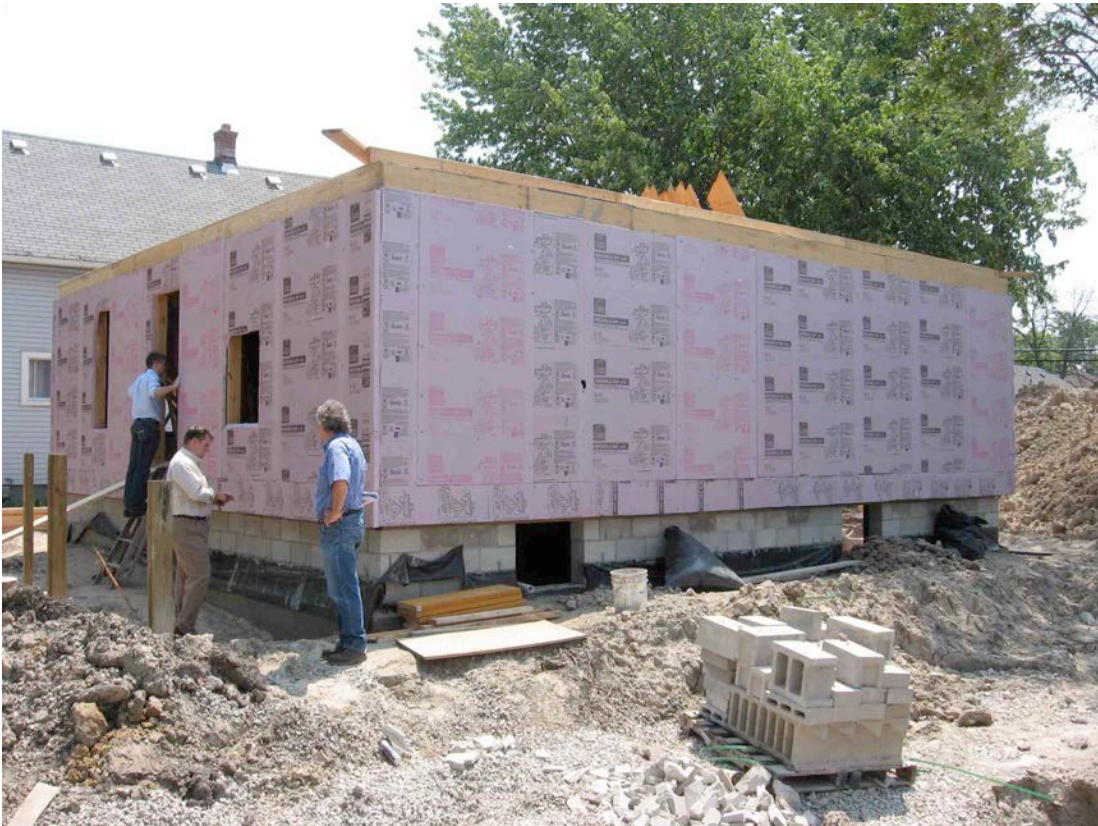
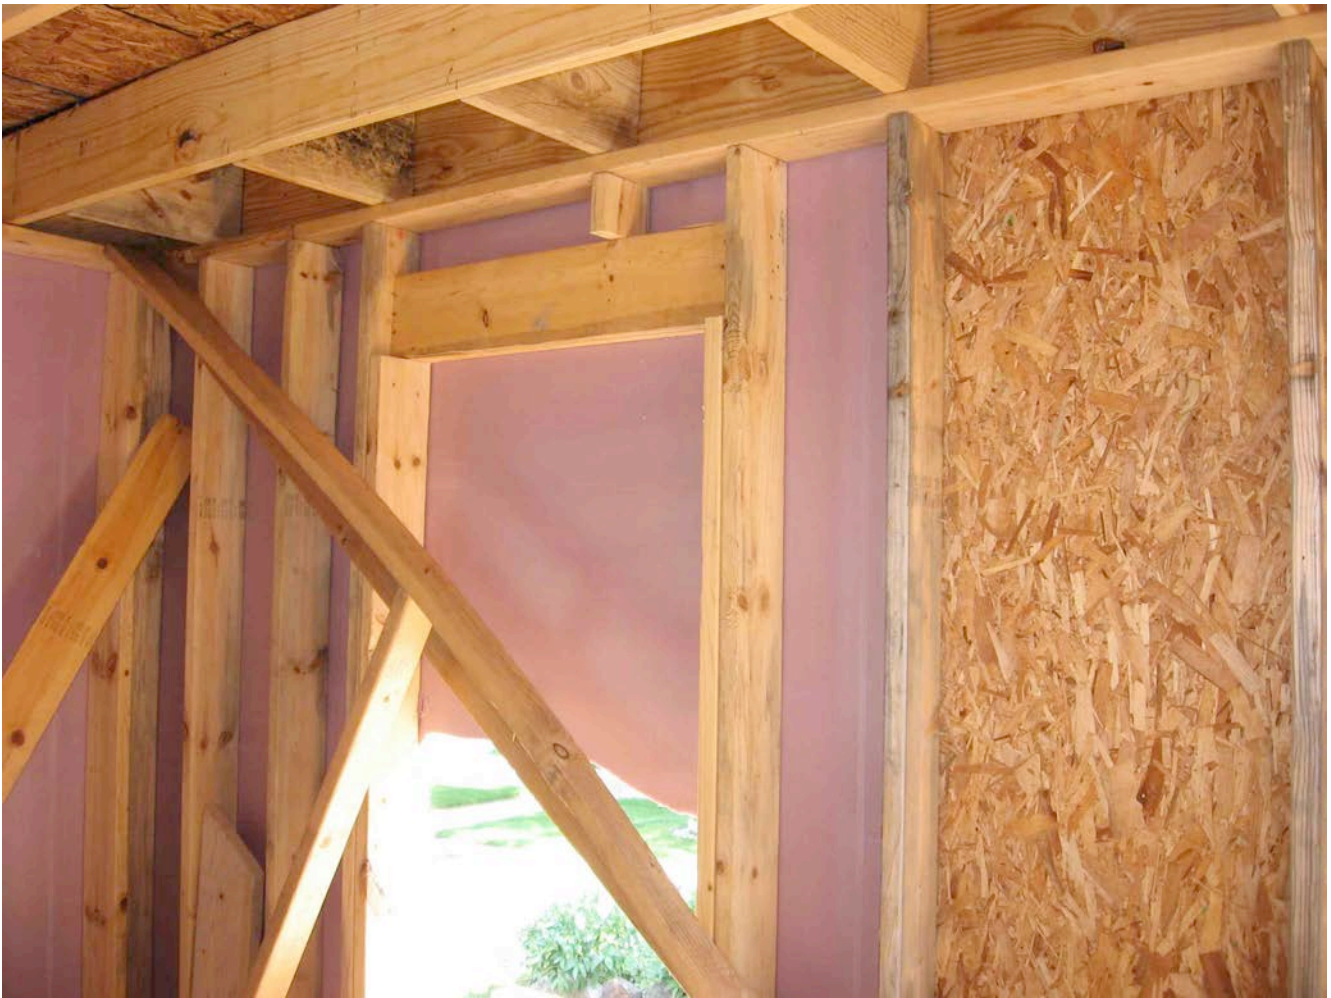
247 & 257 WALNUT STREET

These are the first two new houses in the NSP2 project. There were a number of changes made to the framing on the first one. Framing of the second house should be smoother. The above-grade portion of the basement foundation wall will be finished with brick and insulated with Thermax on the interior. 2" XPS as insulating sheathing and 3-4" ccSPF on the interior.

The window opening framing will be corrected. They were having some issues with alignment of the framing between walls and floors. This has been largely corrected by the architect. The meeting on-site included the GC, the framing crew, the lumber supplier, the mason, the architects and the City project manager. We talked through all of the details and gave them some guidance on corrections that need to be made. Aaron will issue a brief report to the architect with photos to help them with their site review. A major issue was that no framing drawings were produced. We discussed the value of this and it seems that everyone now understands what level of planning is required for these houses.

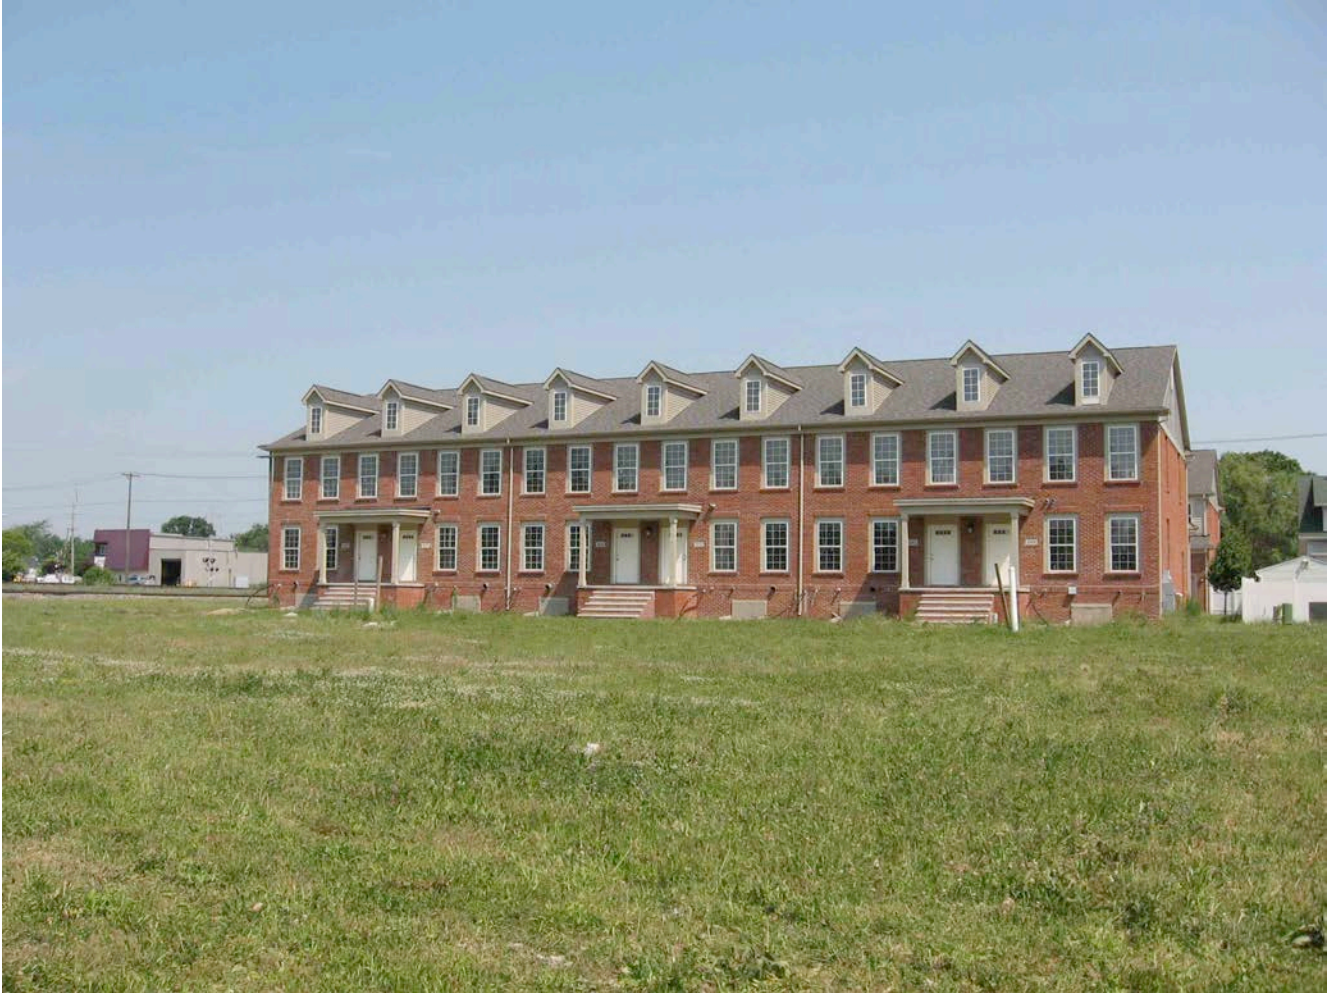
BID PACK 3 HOUSES

This is the unfinished project that the City purchased. There are two rows of attached houses. The row facing the street (behind this block) is ready for sale with only minor work. The pictured block is finished on the exterior but is completely open to the framing on the inside so significant work can be done on these buildings. Another 4 units will be built on the field in the foreground as part of Bid Pack 3. BSC could include these projects as part of the new construction task.

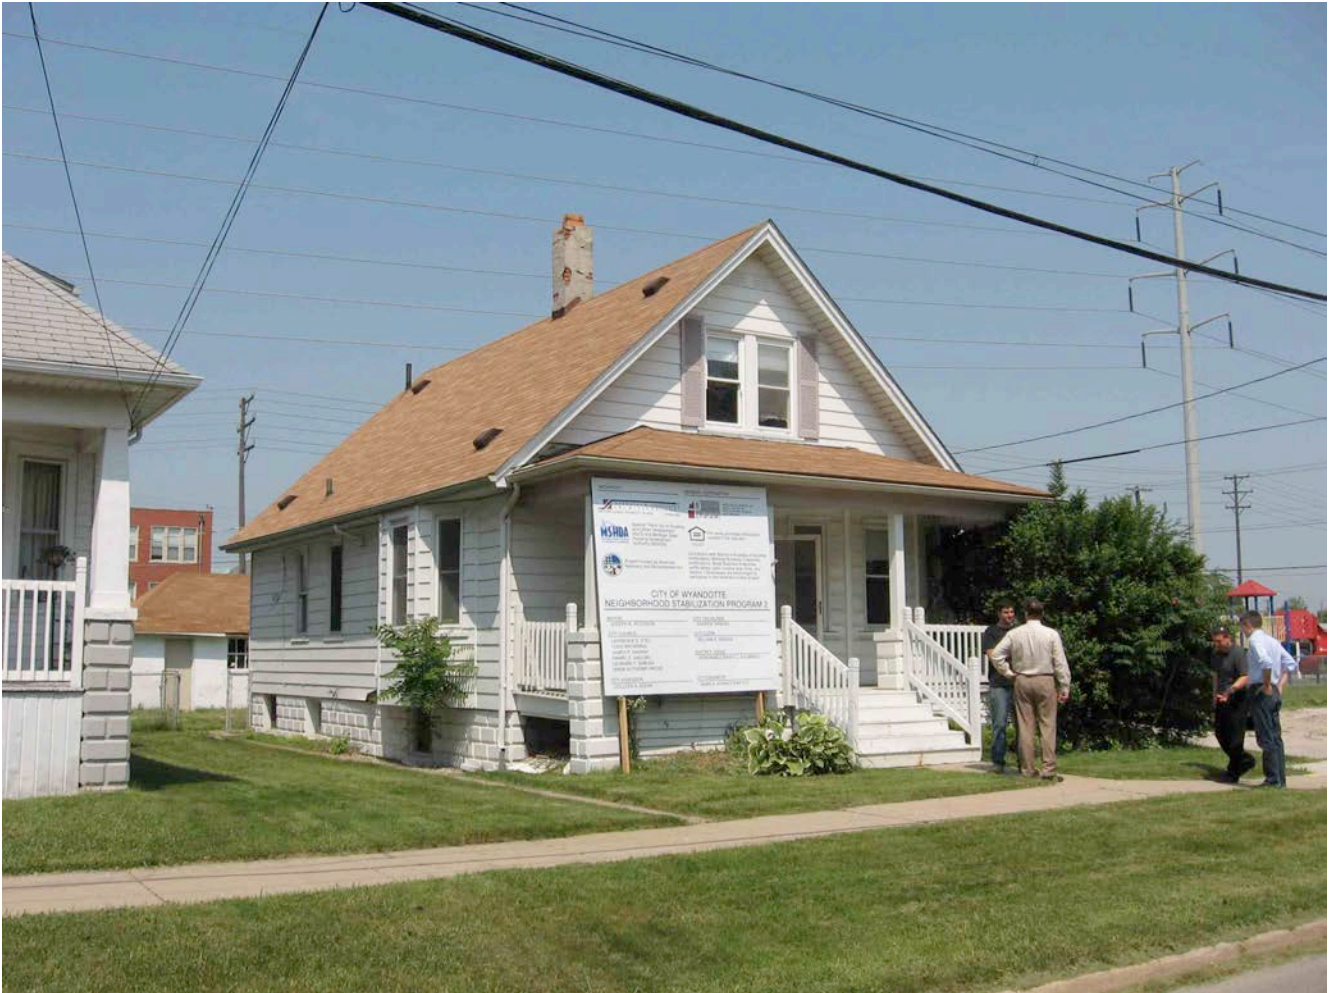
BID PACK 2 RETROFIT

This house has been assigned as part of Bid Pack 2, which was awarded to the builder who is completing work on the first houses mentioned in this report. This house will be a full rebuild from the interior with minor repairs to the exterior cladding. The basement has obvious water intrusion issues and the City is considering both trenching the exterior to install damproofing and replacing the concrete floor slab to install insulation and a capillary break.

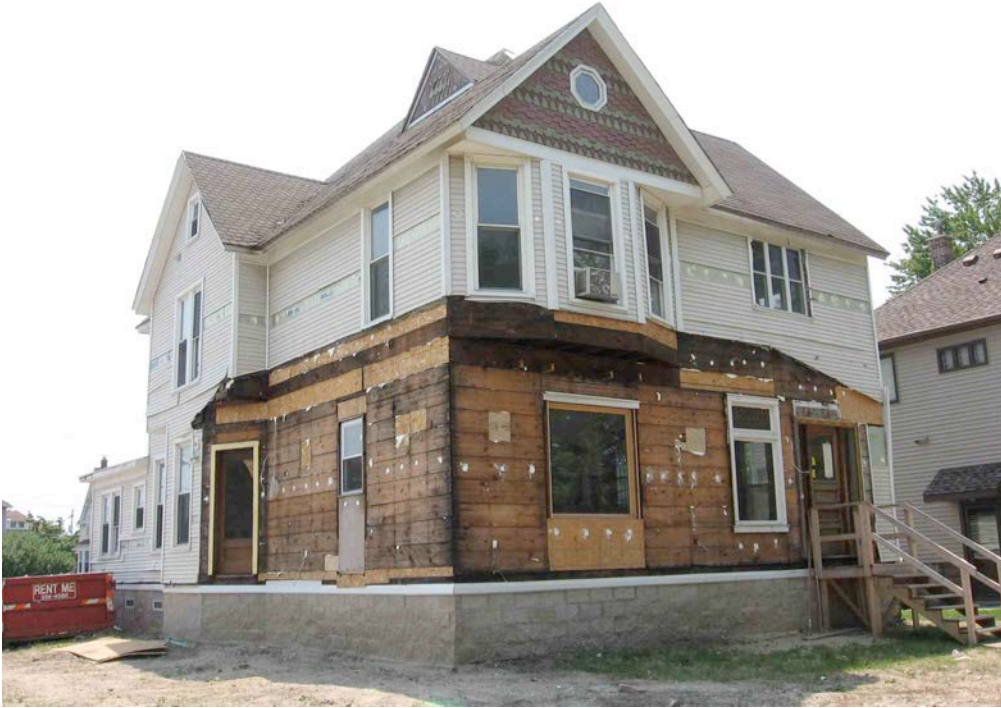
NSP1 RETROFIT HOUSE

This house is not part of the NSP2 project. It is being completed with NSP1 funds and other funding available to the City of Wyandotte and a local non-for-profit development group. The house was moved through the city to this location. It was owned by an important member of the community and has historical significance for the City. 3,500 sq ft plus basement and conditioned attic.

The retrofit work on the interior is largely complete (finishing gypsum board). A new concrete block foundation and floor slab was provided. Insulation of the basement will depend on funding availability. Two ground source heat pump systems were installed, one to service an AHU on the third floor.

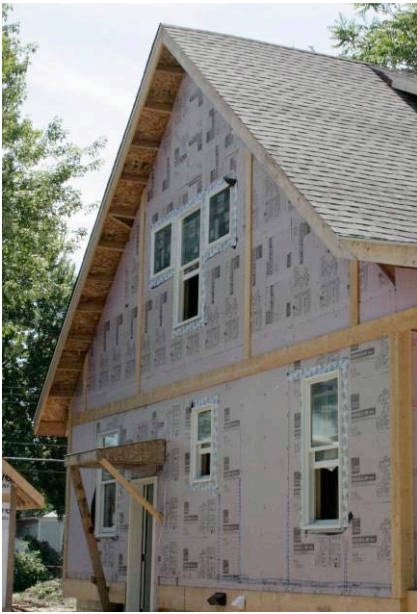
Areas where flashings below the windows need to be removed

Water management details at the windows need some improvement - flashing was observed to be sealing the bottom of the window, rather than being drained. It was recommended that the flashing across the bottom of the window be slit or removed completely. BSC also recommended back dams on window openings. As recommended the flashing across the bottom of the window was removed in most areas. The east facing windows of the home on the first and second floor still require that the flashings along the bottoms of the windows be removed. There also areas within the field of the wall where the joints between the sheets of XPS must be sealed as the primary drainage plane. The windows above the front porch also require attention to repair the flashings.

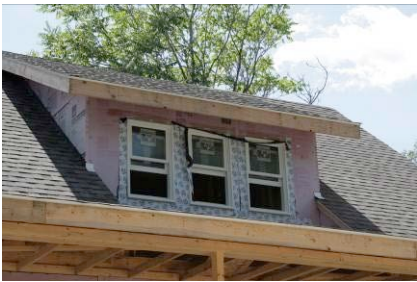
Windows above front porch requiring remediation

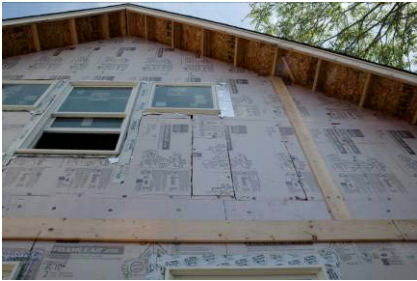
Areas in the field of the wall that require tape sealing

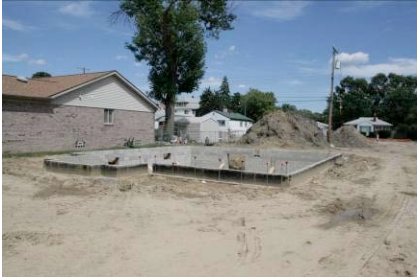
2011-08-22 – Foundation complete, capillary break not apparently present

During the August 22nd site visit it was found that the block foundation was complete for this house. Exterior parging and damproofing were complete but a footing capillary break did not appear to be present.

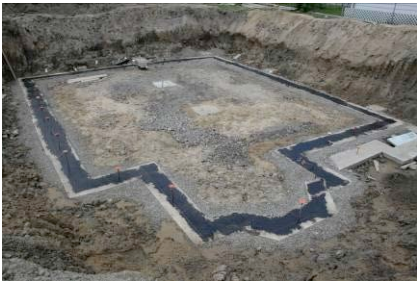
2011-08-22 – Footings complete with capillary break

During the August 22nd site visit it was found that the footings were complete for this house. A capillary break was adequately installed in the form of a roller applied product.

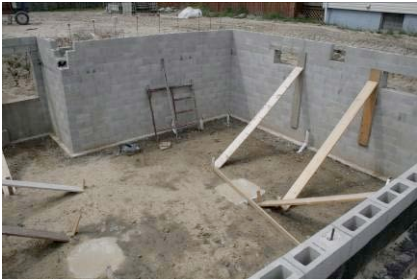
2011-08-22 – Foundation complete, missing capillary break

During the August 22nd site visit it was found that the block foundation was complete for this house. Exterior parging and damproofing were complete but a footing capillary break did not appear to be present.

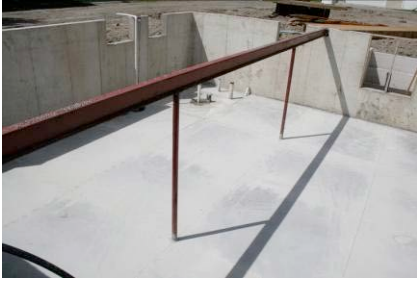
2011-08-22 – Foundation and basement floor complete. The status of the capillary break is unknown

During the August 22nd site visit it was found that the poured foundation was complete for this house. Exterior damproofing was complete but it could not be determined if a footing capillary break was installed as the basement slab was already poured.

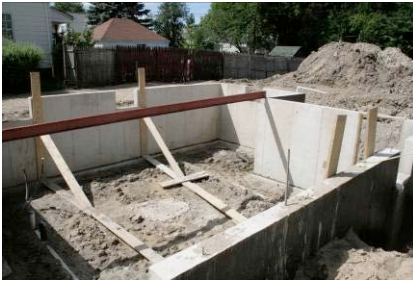
2011-08-22 – Foundation and basement floor complete. It appears that the capillary break was not properly installed between the footing and the foundation.

During the August 22nd site visit it was found that the poured foundation was complete for this house. Exterior damp-proofing was complete but it appeared that the footing capillary break was improperly installed at the inside joint between the footing and the foundation rather than between the footing and the foundation before the foundation was poured. The crack appears to be due to the fact that the foundation was back filled before the floor of the house was installed and, as reported by Ralph Hope, before shoring was installed.

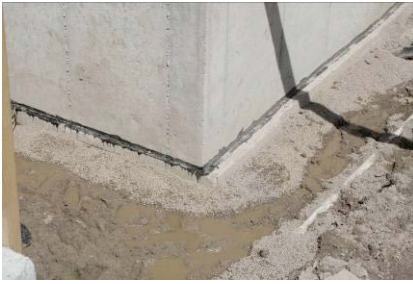
2011-08-22 – Foundation crack

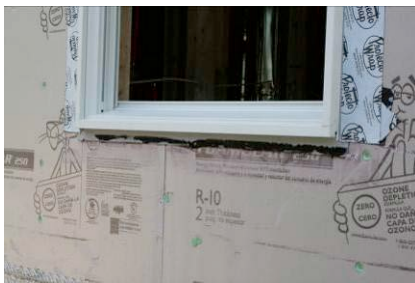
Water management details at the windows need some improvement - flashing was observed to be sealing the bottom of the window, rather than being drained. It was recommended that the flashing across the bottom of the window be slit or removed completely. BSC also recommended back dams on window openings. As recommended the flashing across the bottom of the window was removed in most areas. The east facing windows of the home on the first and second floor still require that the flashings along the bottoms of the windows be removed. There also areas within the field of the wall where the joints between the sheets of XPS must be sealed as the primary drainage plane. The windows above the front porch also require attention to repair the flashings.

Flashing at the bottom of the window removed

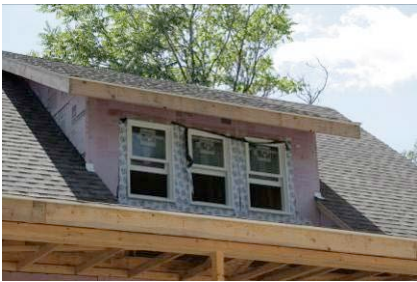
Windows above front porch requiring remediation

The flashing issues on the second floor bathroom windows reported on during the August visit still require repair.

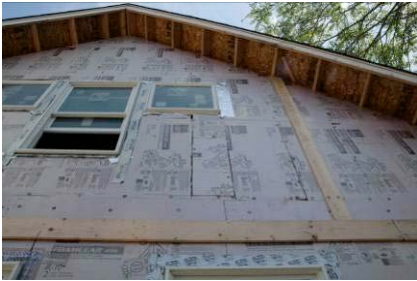
Areas in the field of the wall that require tape sealing

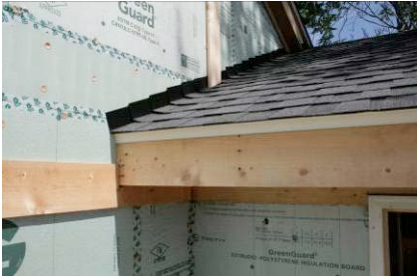
<p>Step flashing requiring integration to the drainage plane. Details to finish this flashing with a regletted cap flashing and tape can be found at:</p> <p>http://www.buildingscience.com/documents/information-sheets/common-flashing-details/files/bsc_info_303_common_flashing.pdf</p>

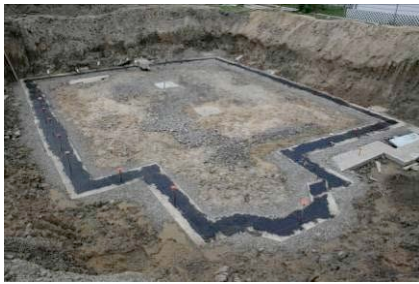
2446 8th Street (South, west side of the road)

2011-08-22 – Footings complete with capillary break
2011-10-06 – Foundation complete, nothing else to report

During the August 22nd site visit it was found that the footings were complete for this house. A capillary break was adequately installed in the form of a roller applied product. It was observed during the October visit that the foundation for this house was installed.

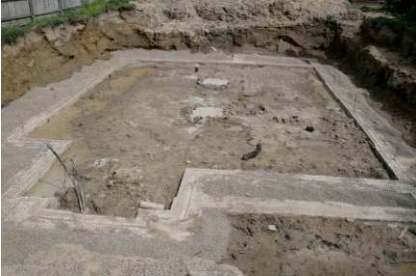
2325 8th Street (North, east side of the road)

<p>2011-08-22 – Footings complete missing capillary break 2011-10-06 – Foundation complete, nothing else to report</p>

During the August 22nd site visit it was found that the footings were complete for this house. A capillary break not installed for this footing. This information was relayed to Ralph Hope for remediation. It was observed during the October visit that the foundation for this house was installed.

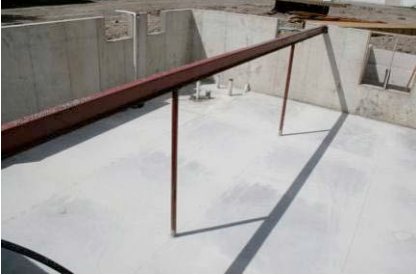
234 Chestnut

<p>2011-08-22 – Foundation and basement floor complete. The status of the capillary break is unknown 2011-10-06 – Site not visited during this trip</p>

During the August 22nd site visit it was found that the poured foundation was complete for this house. Exterior damproofing was complete but it could not be determined if a footing capillary break was installed as the basement slab was already poured. This site was not visited during the October site visits.

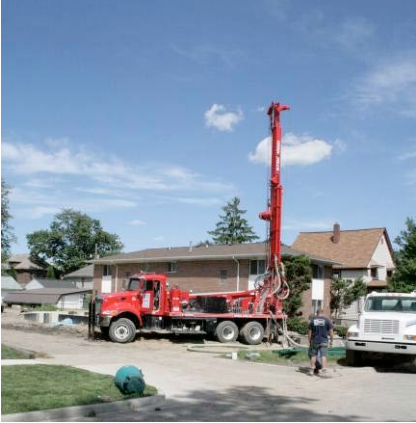
<p>2011-08-22 – Drilling of the geothermal wells in progress</p>

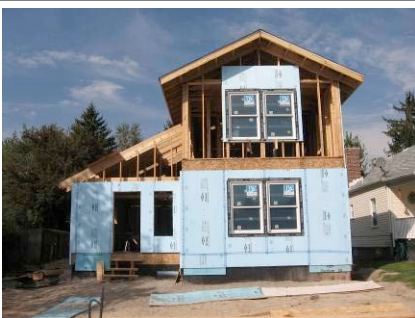
2011-10-06 – Framing substantially complete. Insulated sheathing was removed in locations to determine fastening pattern for SIS.

During the October site visit this site seemed to be in a state of disassembly and repair. Sections of roofing were left uninstalled. Areas of the exterior insulation and SIS had been removed while the electrical and mechanical was at rough-in.

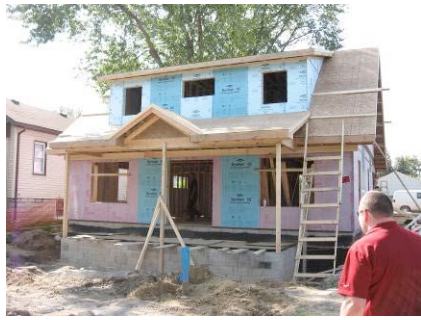
2250 Cora Street

2011-10-06 – Foundation complete, framing nearing completion.

During the October site visit this house was found to be nearing framing completion. This was a first try for the framer on-site and overall there were very few issues with the home. Some design issues were determined on-site, but do not require major repair. 1" of exterior insulation is used on this home because the design created for this home was developed during the initial design process with the city of Wyandotte when it was unclear how much funding would be available for energy saving upgrades. During the construction process it was found that the construction would be significantly simplified and increase the available headroom on the second floor if the two planned dormers became one large dormer as shown in the photo above. This framing package is the first completed that has a hung main floor framing system to minimize the rise of the first floor from grade allowing this unit to be fully wheelchair accessible.

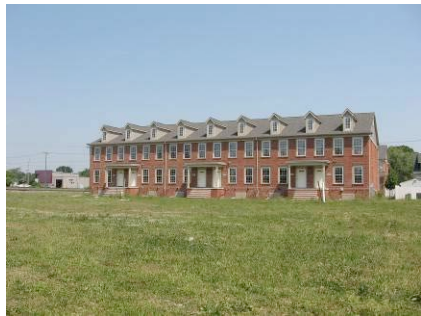
Vinewood Condos

2011-10-06 – Preliminary walk through completed of units without drywall or insulation. Blower door test completed of a single interior unit which was substantially complete.

A finished blower door test was completed on October 6th. The results of this blower door test showed an estimated leakage rate of 1803 CFM at 50Pa. This correlates to an approximate 5 ACH at 50Pa. Areas of leakage found included the window to window rough framing where it appears no sealant is provided and interior partitions on the second floor which connect to the attic space. The windows should be sealed with low expansion foam while the partitions intersecting the attic space should be sealed with closed cell spray foam from the attic side. It is likely that the rim joists are also sources of leakage, but to seal this area would require removal of interior drywall to properly seal.
