# **TMI-2 – A Case Study for PWR Instrumentation Performance During a Severe Accident**

Joy L. Rempe  
Darrell L. Knudson

March 2013

**Prepared for the  
U.S. Department of Energy  
Office of Nuclear Energy  
Under DOE Idaho Operations Office  
Contract DE-AC07-05ID14517**

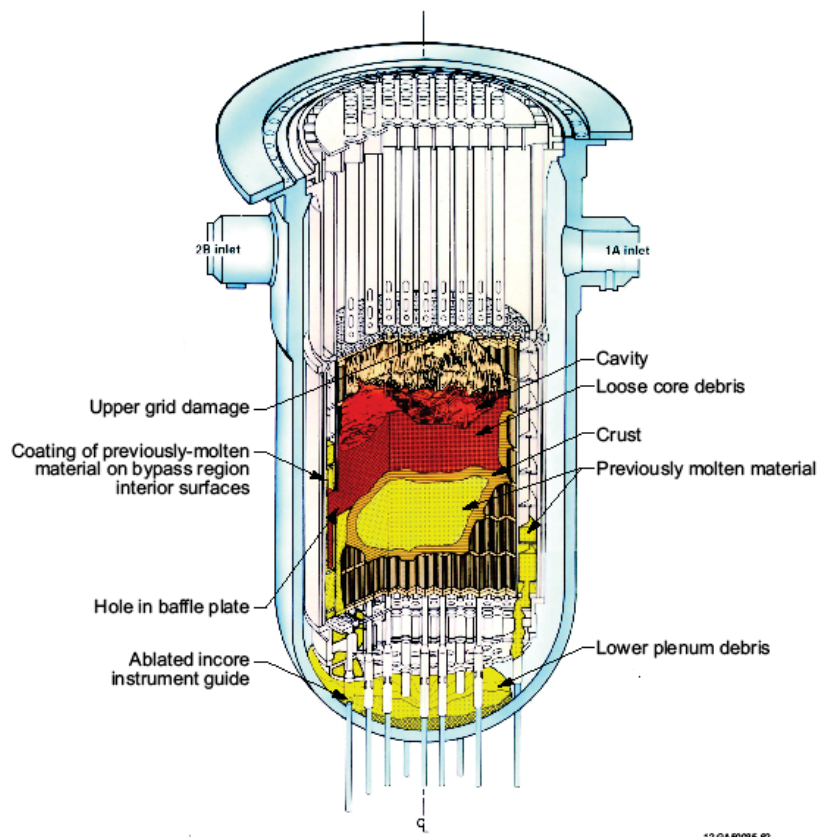
**Figure ES-4.** Postulated final state of materials within the TMI-2 vessel.

- Based on the end-state core and CSA configuration and supporting analysis of core heatup, it is believed that the crust (or resolidified molten material) surrounding the relocated core material failed near the top of the molten core region in the southeast quadrant of the reactor vessel. Limited damage to the CSA occurred as the core material flowed to the lower plenum. Figure ES-4 illustrates the final state of materials within the TMI-2 vessel.

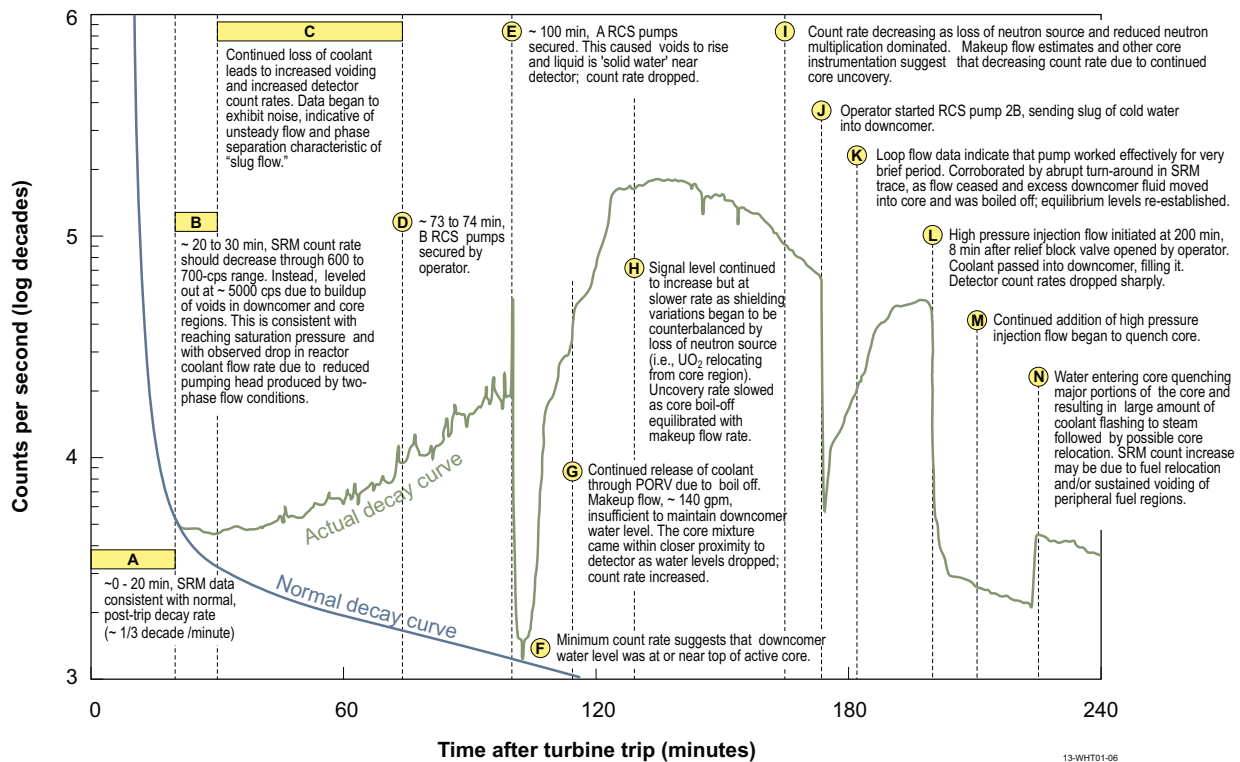
**Figure ES-11.** TMI-2 SRM response during the first 4 hours of the accident.

- Qualitative insights can be obtained by considering sensor response for alternate applications, e.g., ex-core source-range detector signals provide insights about real-time RCS water levels, in-core

SPNDs provide insights about RCS temperature and water levels. However, such interpretations often require detailed analyses and assumptions related to the status of the core, the RCS and containment (as evidenced from efforts to interpret SRM data in Figure ES-11).

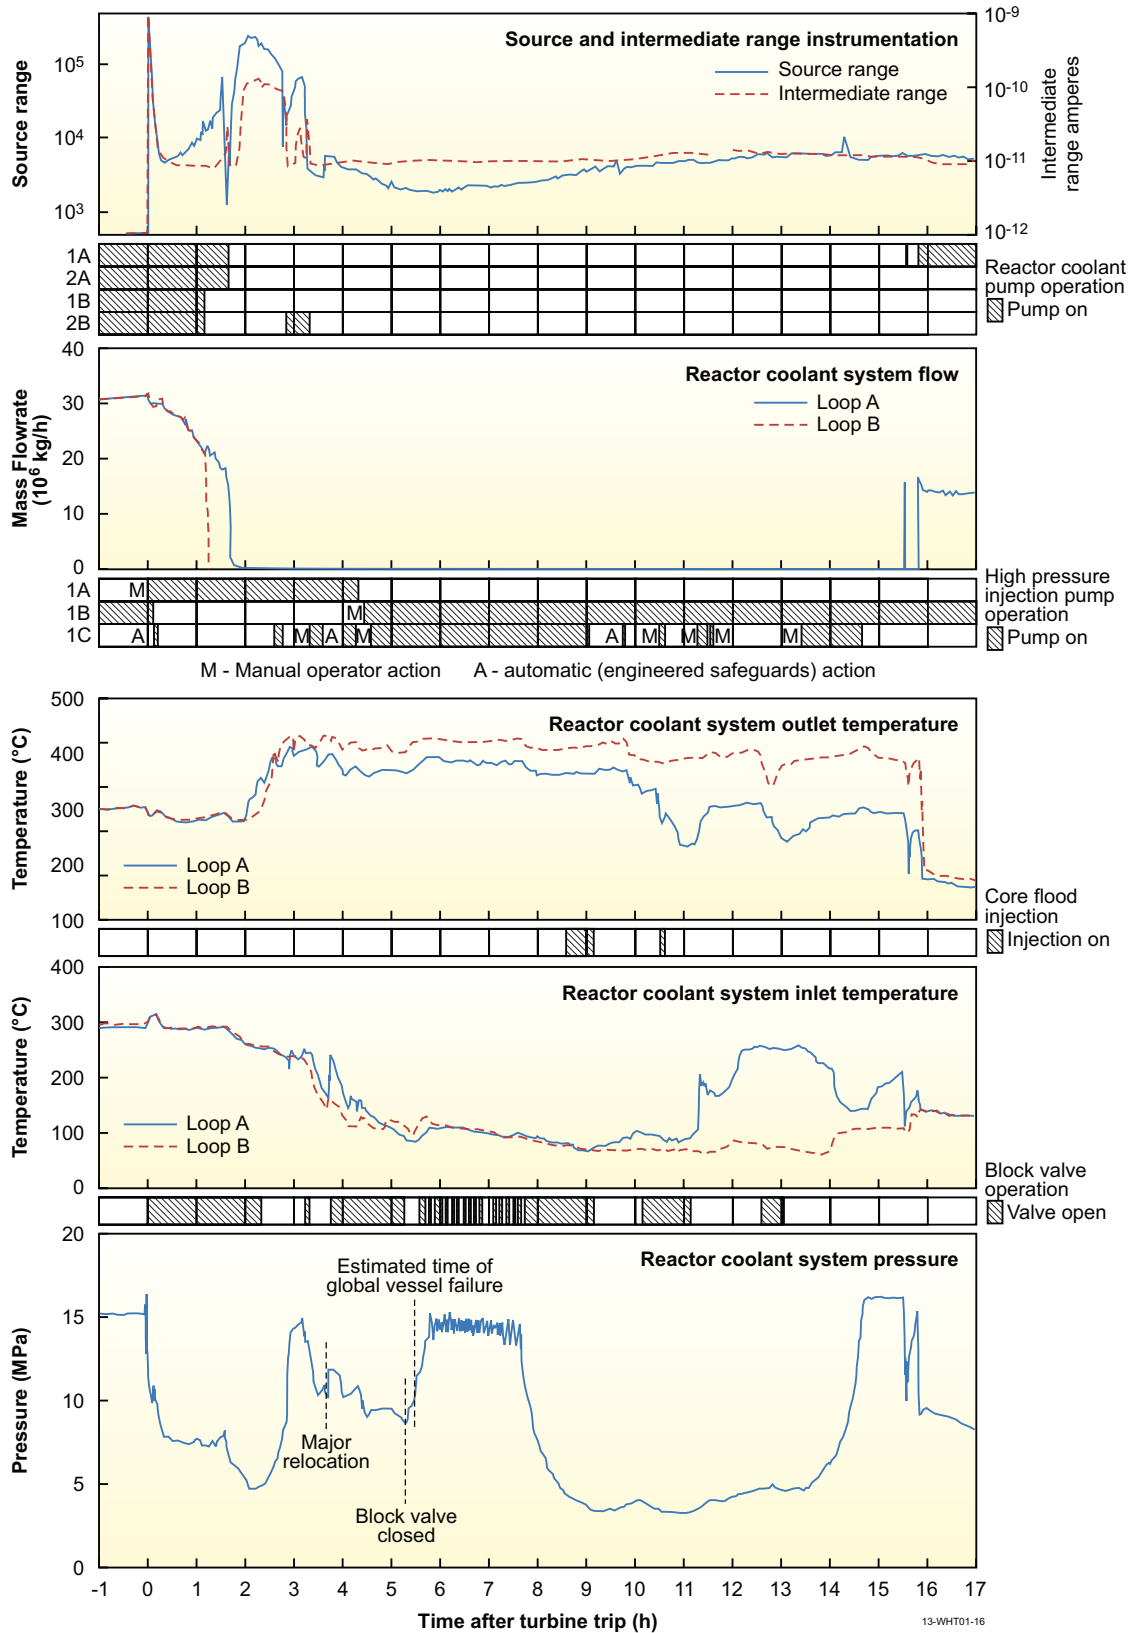
**Figure 2-3.** TMI-2 data from March 28, 1979.<sup>6</sup>

At the time that pump operation ceased (see Figure 2-3), increases in Source Range Monitor (SRM) count rate and coolant system temperature and pressure, suggest that the reactor vessel liquid level had decreased. Studies correlating the response of the SRMs with the core liquid level suggest that core uncover began between 114 and 120 minutes and that the liquid level had dropped to the core midplane by approximately 140 minutes.<sup>6,7</sup> Insufficient decay heat removal associated with core uncover is estimated to have led to upper regions of the core heating to temperatures that caused the cladding to overheat, balloon, and rupture.<sup>7,11</sup> Such cladding failure, which results in the release of gaseous fission products, was substantiated by significant increases in containment radiation levels at 140 minutes. When operators finally realized that the PORV was failed in the open position, they closed the pressurizer block valve upstream of the PORV, terminating coolant loss and the release of fission products to the containment.

In-core self powered neutron detector (SPND) output and RCS pressure data (see Figure 2-3) indicate that core temperatures continued to increase between 150 and 165 minutes. Subsequent analysis of the SPND output indicated that temperatures probably reached 1077 °C.<sup>12</sup> Insights gained from materials interaction and severe accident testing (e.g., see References 13 and 14) suggest that Zircaloy-steam exothermic reaction initiated, producing large amounts of hydrogen and dramatically increasing the core heatup rate. Zircaloy melting temperatures were exceeded, resulting in relocation of the molten Zircaloy and

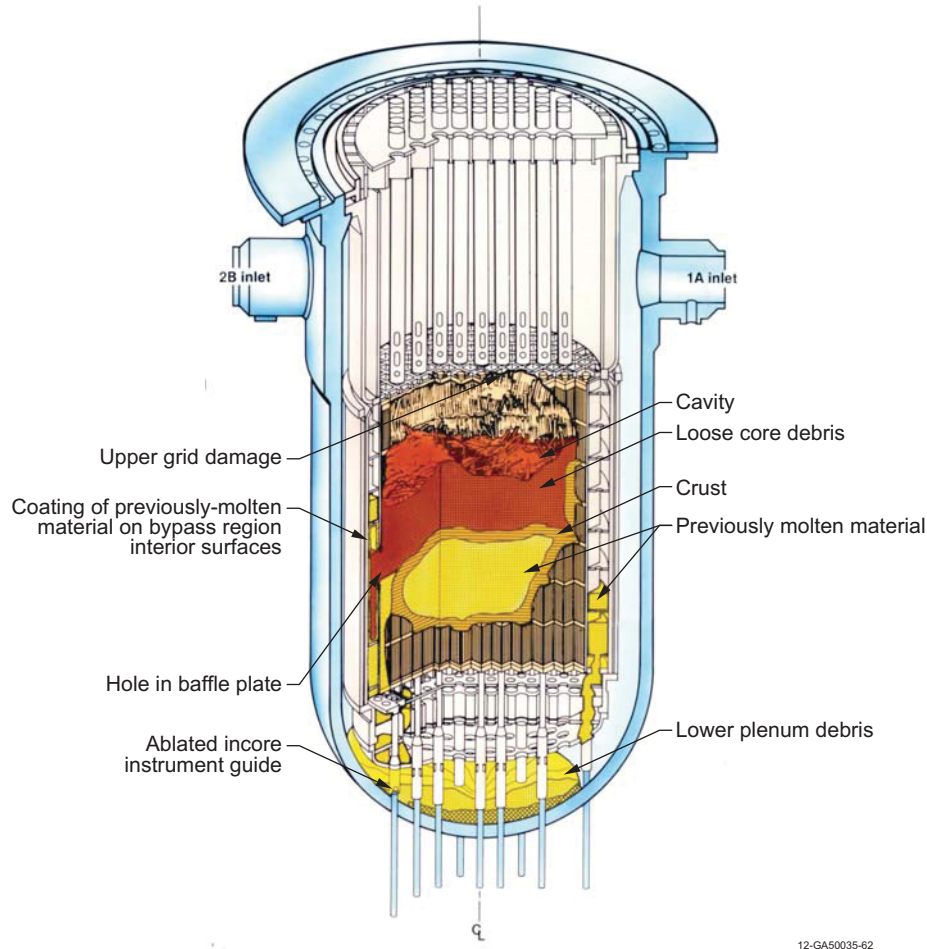
**Figure 2-4.** Postulated final state of materials within the TMI-2 vessel.<sup>6</sup>

- Based on the end-state core and CSA configuration and supporting analysis of core heatup, it is believed that the crust (or resolidified molten material) surrounding the relocated core material

(see Section 2.2) failed near the top of the molten core region in the southeast quadrant of the reactor vessel. Limited damage to the CSA occurred as the core material flowed to the lower plenum. Figure 2-4 illustrates the final state of materials within the TMI-2 vessel based on available instrumentation, analyses, and post-accident examinations.<sup>7</sup>

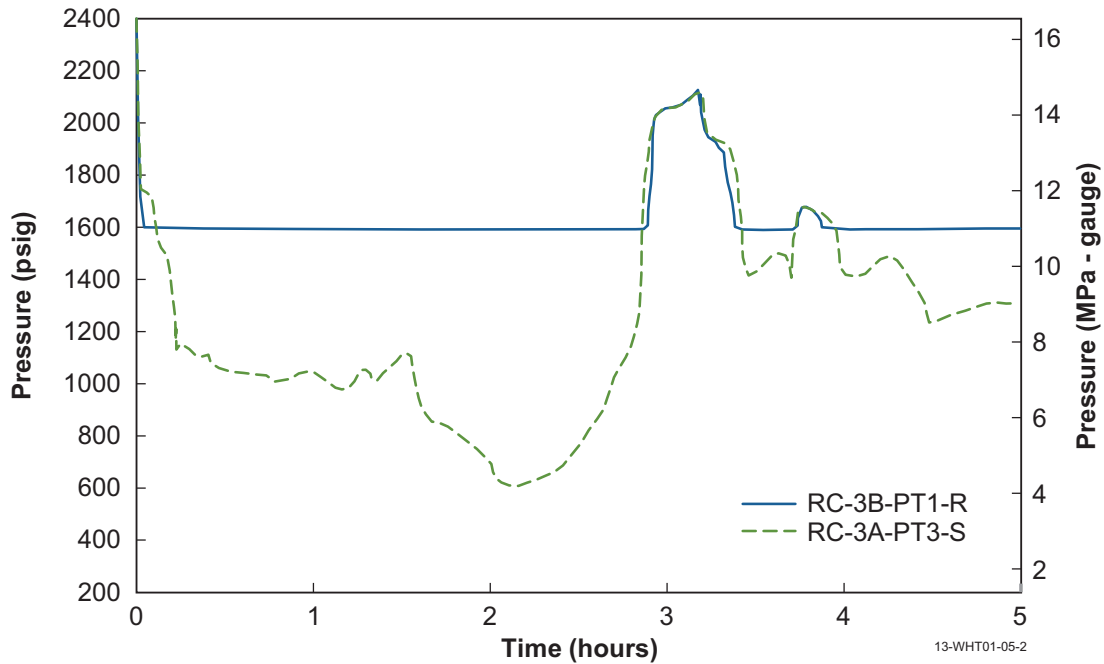
**Figure 4-4.** Comparison of A-loop wide range pressure recorded on the strip chart and the B-loop narrow range pressure on the reactimeter.

The system pressure prior to the accident initiation (initial condition) was 14.8 MPa-gauge. Output from one of the narrow range pressure transmitters in the B-loop (RC-3B-PT1-R)<sup>†</sup> was recorded on the reactimeter at a sample rate of one sample every 3 seconds. These data (see Figure 4-4) were considered to be the best available TMI-2 RCS pressure data.<sup>49</sup> Following the reactor trip, the primary system pressure quickly dropped below the minimum range for this measurement (by 2.2 minutes). With the exception of certain periods in which the system pressure increased to within the range of this transmitter (approximately 2.8 hours), other data sources were required for obtaining the primary system pressure.

\* Although the narrow range measurement was set-up for a range of 11.7 to 17.2 MPa-gauge, the measurement continued to produce readings slightly below 11.0 MPa-gauge. Therefore, the reactimeter data down to 11.0 MPa-gauge was used in the composite pressure.

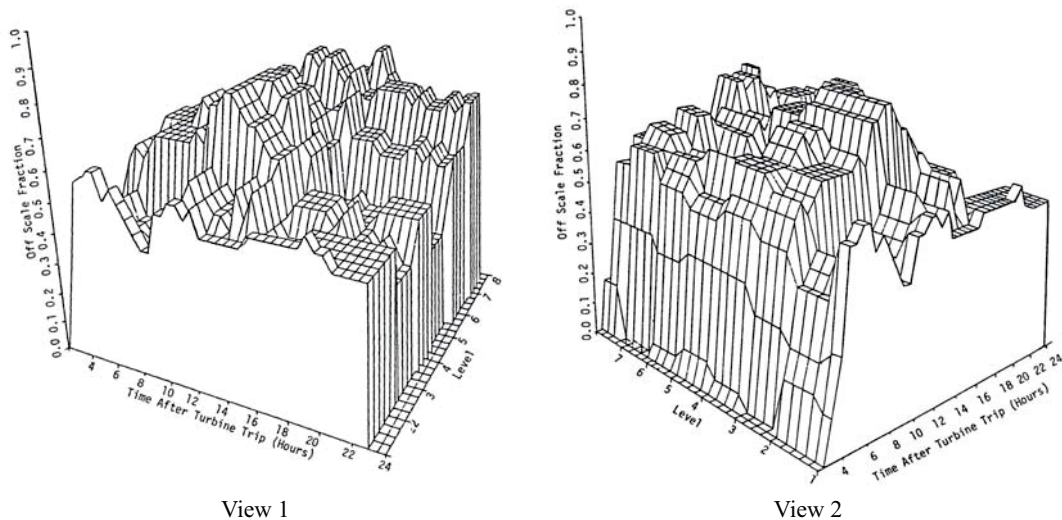
**Figure 4-6.** SPND Activity - Core Center.

At 226 minutes into the accident, the Nuclear Science Advisory Committee (NSAC) report indicated that 51 SPNDs went offscale (see Figure 4-6). At this time, all or nearly all of the seven levels of SPNDs in locations G9, F7, F8, E7, G6, G5, H5, and M9 went off scale. This behavior suggests that something was happening along the full length of the fuel element. Since the SPNDs were individually sheathed and sealed, it is unlikely that a fault would propagate from one to another. Thus, the effect must have been external to the instrument tube. Subsequent furnace evaluations suggest that such behavior is consistent with a rapid temperature increase.

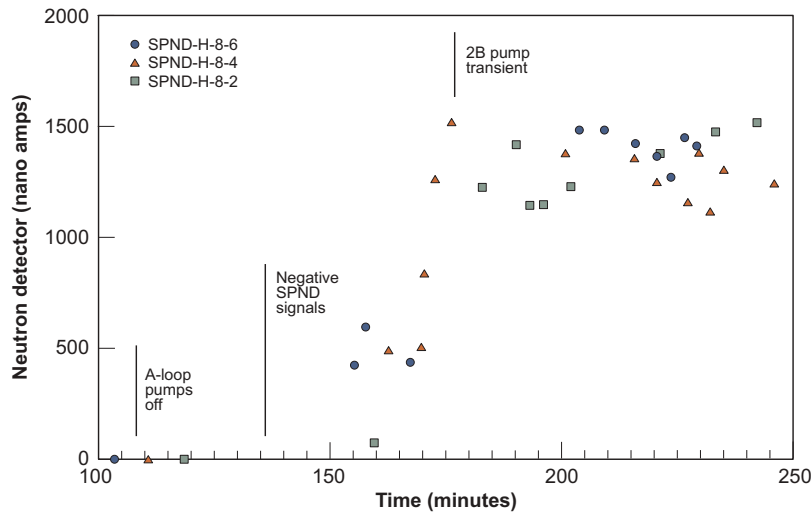
Thirty-six SPNDs (at the 2, 4, and 6 levels; see Figure A-3 in Appendix A.1) were monitored and recorded on two backup multipoint recorders (18 channels on each recorder). A data point for each channel was printed every 2.5 minutes with a channel identification number. Later, it was discovered that Backup Recorder 2 data could not be used due to inadequate pen ink. The data on Backup Recorder 1 had to be decoded and tabulated before it could be placed in a database (so it was not readily accessible during the accident). The data indicate that just prior to the accident, with the reactor at 97% power, the SPND signals ranged from +500 to +850 nA. When the reactor scrammed during the initial stages of the accident, the SPNDs responded with their signals dropping to a few nanoamperes within 5 minutes. The first anomalous signals were produced 135 minutes into the accident when at least two SPND channels became negative (e.g., currents less than -20 nA). However, at 155 minutes, most of the SPND signal channels became positive, some in excess of 1000 nA. Figure 4-7 illustrates this behavior by providing data from the H-8 SPNDs at the 2, 4, and 6 levels.

**Figure 4-7.** Signals from the H-8 SPNDs at the 2, 4, and 6 levels.

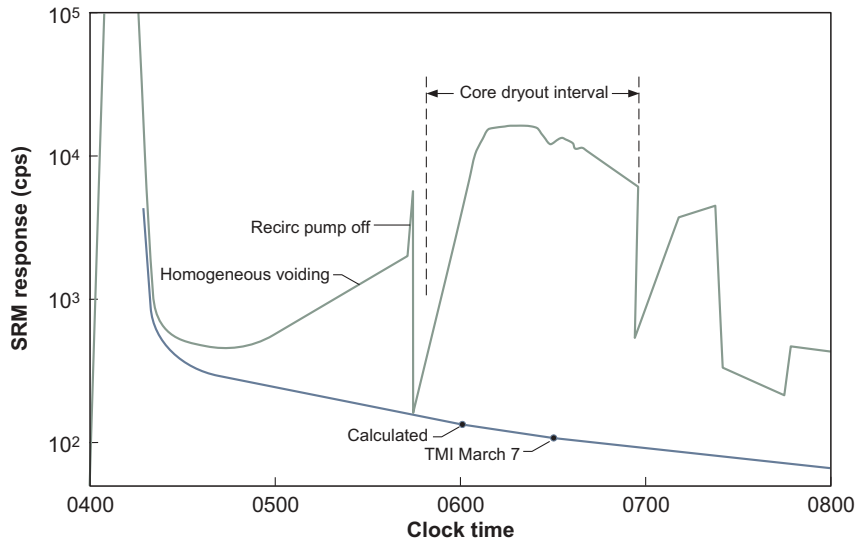
Reference 54 reports results gained by performing a number of neutronics calculations for postulated conditions and comparing calculation results with the available data. One-dimensional ANISN<sup>68</sup> neutronics calculations revealed that the increase in SRM response before the RCS coolant pumps stopped could be explained by homogeneous core voiding (e.g., the core is estimated to be 35% voided and peaked at 50% voiding when the pumps stopped at approximately 100 minutes after turbine trip). Figure 4-11 compares the measured SRM N 1-2 output on March 7, 1979 and expected response (in blue) and calculated accident response (in green).

**Figure 4-11.** Observed response (in green), and “normal” following reactor shutdown that occurred at TMI-2 on March 7, 1979 and calculated (in blue).<sup>54</sup>

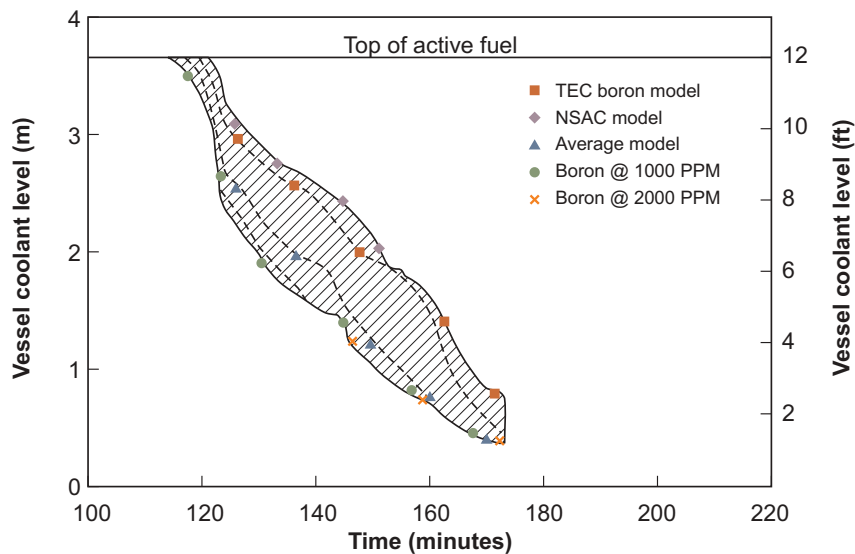
Two-dimensional calculations<sup>69</sup> evaluated the effects of phenomena, such as decreased core coolant levels, coolant mixing assumptions, and boron concentration. Results indicate that the onset of core uncov-  
 erage occurred between 114 and 120 minutes after turbine trip (see Figure 4-12). Calculations suggest that the relocation of fuel containing fission products could lead to the observed abrupt upward shift in the SRM response at 227 minutes (3.8 hours), associated increases in primary system temperatures and pressures, and increased core-wide SPND activity. Analyses also indicated that the gradual rise in SRM response at six hours was consistent with the release of I-135 (See Figure 4-13). However, these earlier analyses assumed an intact core geometry. Reference 70 suggested that a partial absence of control material in the core region would cause neutron multiplication to increase and water level to lower, leading to an increase in SRM response. Sensitivity study results presented in Reference 70 indicate that nearly 80%

**Figure 4-12.** Core water level estimate sensitivity to boron concentration model assumptions.<sup>54</sup>

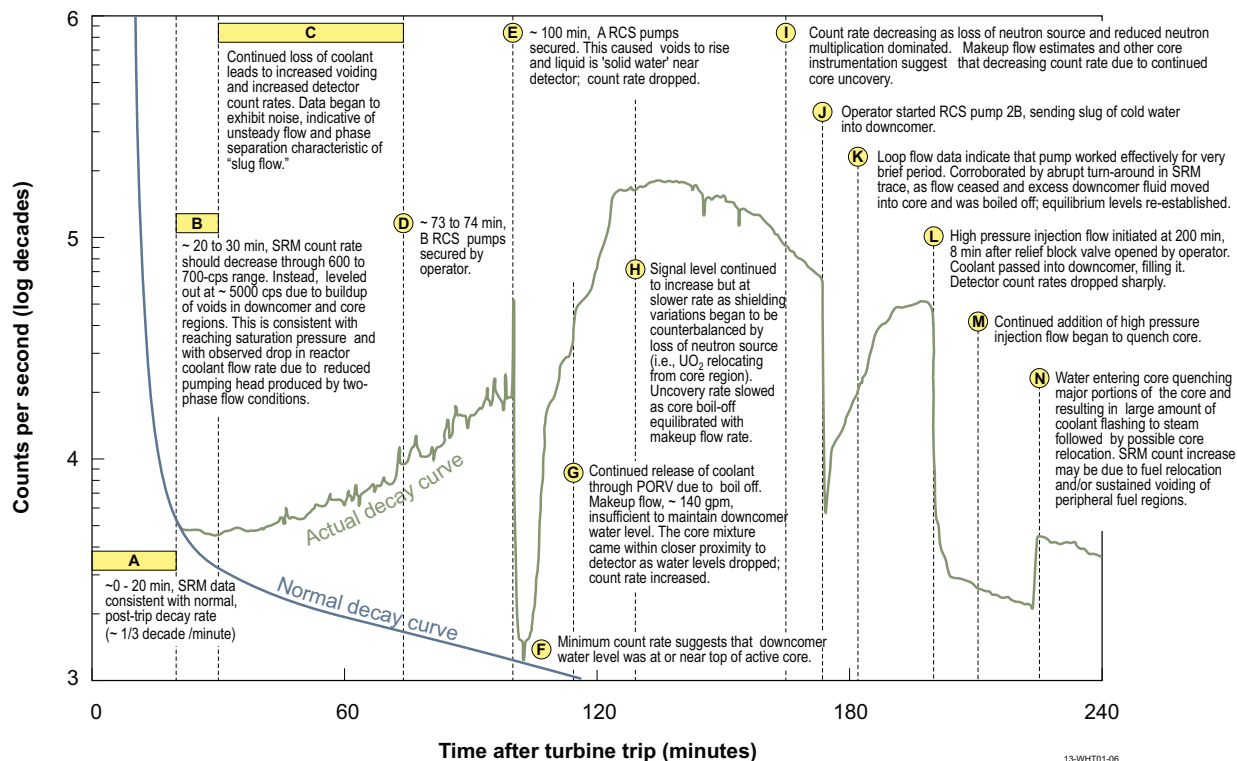
Events attributed to changes in the SRM response are shown in the annotated plot in Figure 4-14. For the first 20 minutes (A), SRM behavior was consistent with a normal post-trip decay rate of about one-third decade per minute. Between 20 to 30 minutes (B), the SRM count should be decreasing through the 600 to 700 cps range. However, the curve leveled out at around 5000 cps due to voiding (steam bubbles) in the downcomer and core regions. This hypothesis was consistent with the fact that the pressure had reached saturation and there continued to be outflow through the open PORV. Void formation is also con-

sistent with the observed drop in reactor coolant flow rate. Continued loss of coolant from the primary system (C) led to increased voiding and detector count rates. At approximately 73-74 minutes (D), the B reactor pumps were secured by the operators. At 100 minutes (E), the A pumps were secured. This caused a flow transient and voids separating to the upper regions of the RCS. The coolant filled lower regions of the RCS and caused an abrupt drop in the detector count rate (F). Continued release of fluid out of the PORV was not offset by available makeup flow, leading to an increase in count rate (G). Competing effects (H) caused the count rate to increase at a slower rate until the count rate started to decrease (I). Startup of RCS 2B pump (J) filled the downcomer. At 200 minutes, high pressure injection flow initiated (L) filling the downcomer and causing the detector count rate to drop. Relocation of core materials (N) may have led to an increase in count rate.

**Figure 4-14.** TMI-2 SRM response during the first 4 hours of the accident.

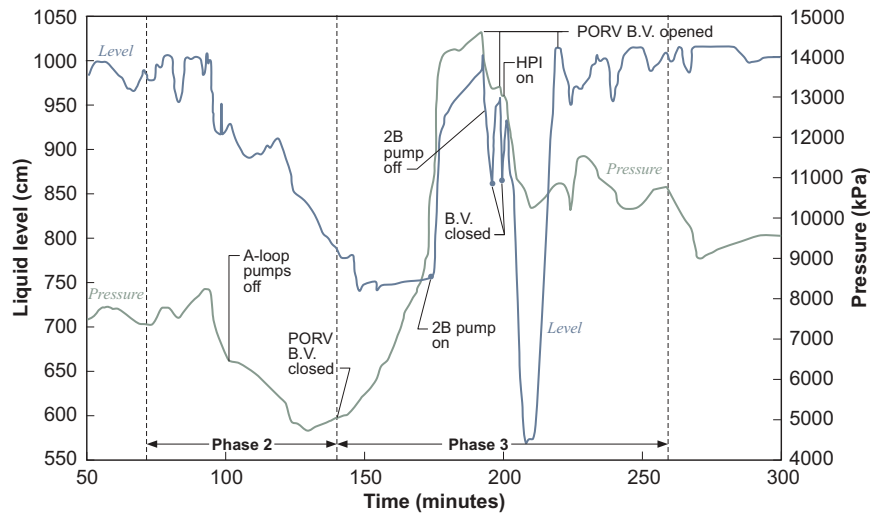
**Figure 4-18.** TMI-2 pressurizer liquid level and primary system pressure (50 to 300 minutes).

At 139 minutes, the operators closed the PORV block valve (see Figure 4-18). Between the time that core uncovering began (at about 125 minutes) until the PORV block valve was closed at 139 min, the pressurizer water level decreased at a rate of 4.6 cm/min (1.8 in./min). Heater operation at a power of 1386 kW would account for a rate of 2.0 cm/min (0.8 in./min). The remainder of the steam flow out the PORV would have been from steam generated in the core and entering the pressurizer through the surge line. Since part of the steam flowing out the PORV was generated in the pressurizer, the reduced steam velocities in the surge line probably allowed some liquid to drain out of the pressurizer.

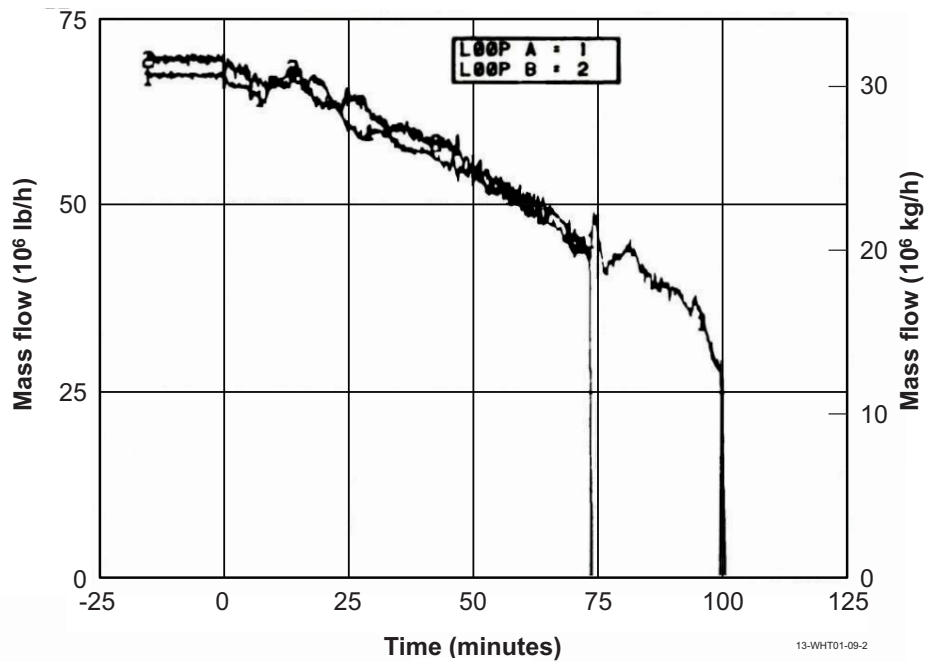
The mass flowrate and temperature in the primary coolant system were recorded on the reactimeter prior to and during the accident, which was set to sample each channel on a 3 second interval. As shown in Figure 4-21, the mass flowrate data are somewhat noisy.

The flowmeter was designed to operate near the normal reactor full power conditions. During the accident, the flowmeter continued to indicate mass flowrate but was using an erroneous coolant density when the RCS depressurized and the coolant voided. Hence, the mass flowrate data from each hot leg had to be corrected for the error caused by calculating the liquid density using the flowmeter electronic circuits. Although it was known that the reduction in liquid density was due to the increased void fraction in the liquid, there was no way of knowing the time-dependent void fraction. A method was devised to estimate the maximum and minimum possible void fractions in the hot leg liquid. From these values, lower and upper densities were calculated. The recorded mass flowrate data were then corrected using the upper and lower density limits to yield a maximum and minimum probable mass flowrate. The mean value between the upper and lower limits was used as a substitute for the expected value. The actual expected value was thought to be between the mean value and the upper flowrate bound. Figure 4-22 shows the qualified mass flowrate data but with error bands. The error bands show calculated uncertainties, and qualified mean val-

**Figure 4-21.** Recorded hot leg mass flow rate.

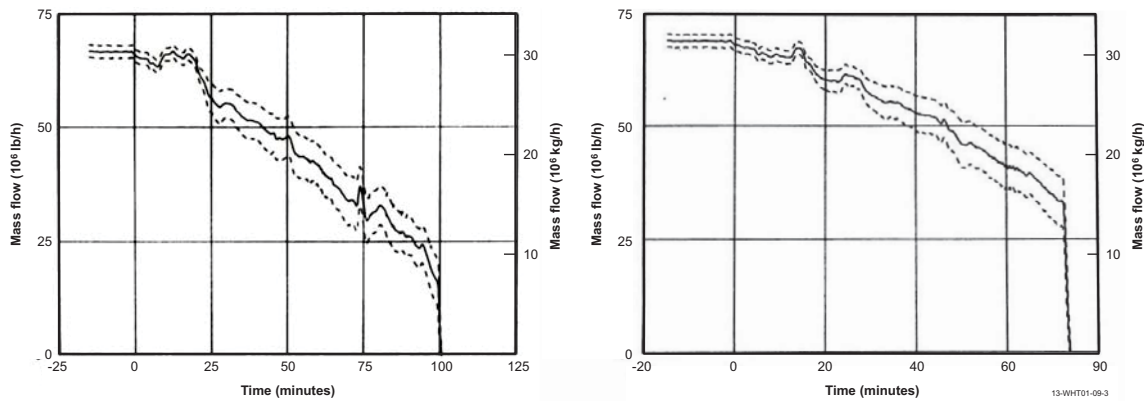
**Figure 4-22.** Qualified hot leg mass flow rates and uncertainties.

ues have been corrected for all known errors. As documented in Reference 80, the mass flowrate data were classified as “Qualified.”

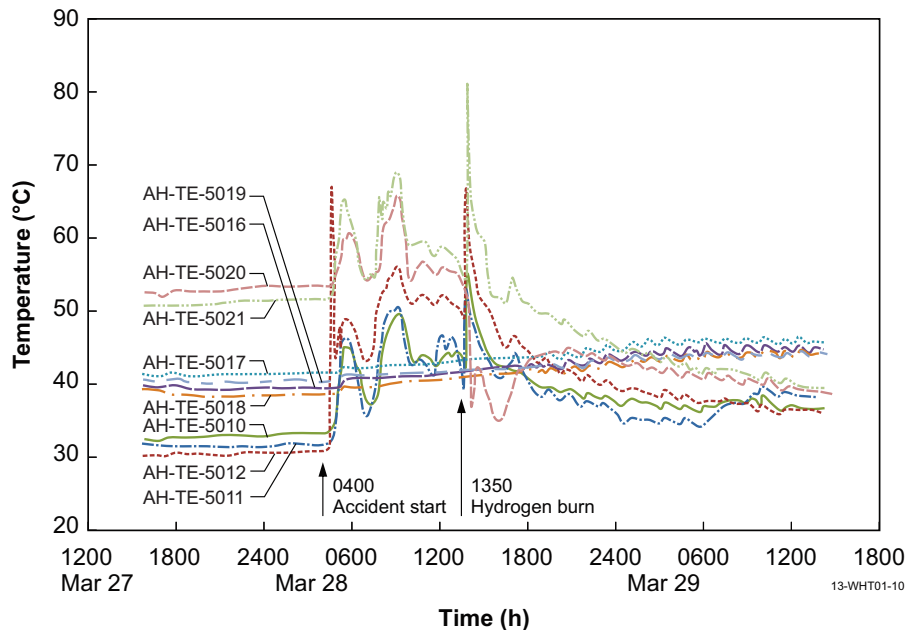
Figure 5-2 shows selected RTD data. Certain locations, such as the reactor coolant drain tank room (RTD 5012), experienced many temperature changes. Other locations showed no temperature change, such as the primary shield (RTDs 5016 through 5019). None of the 16 RTDs indicated a peak temperature greater than 90 °C. However, during the hydrogen burn, the top ceiling RTD 5020 behaved unexpectedly

and recorded a negative trending trace, probably because of spray activity. Most other locations, including the other top ceiling RTD recorded a positive-trending trace during this time.

**Figure 5-2.** Reactor building temperatures at selected locations.

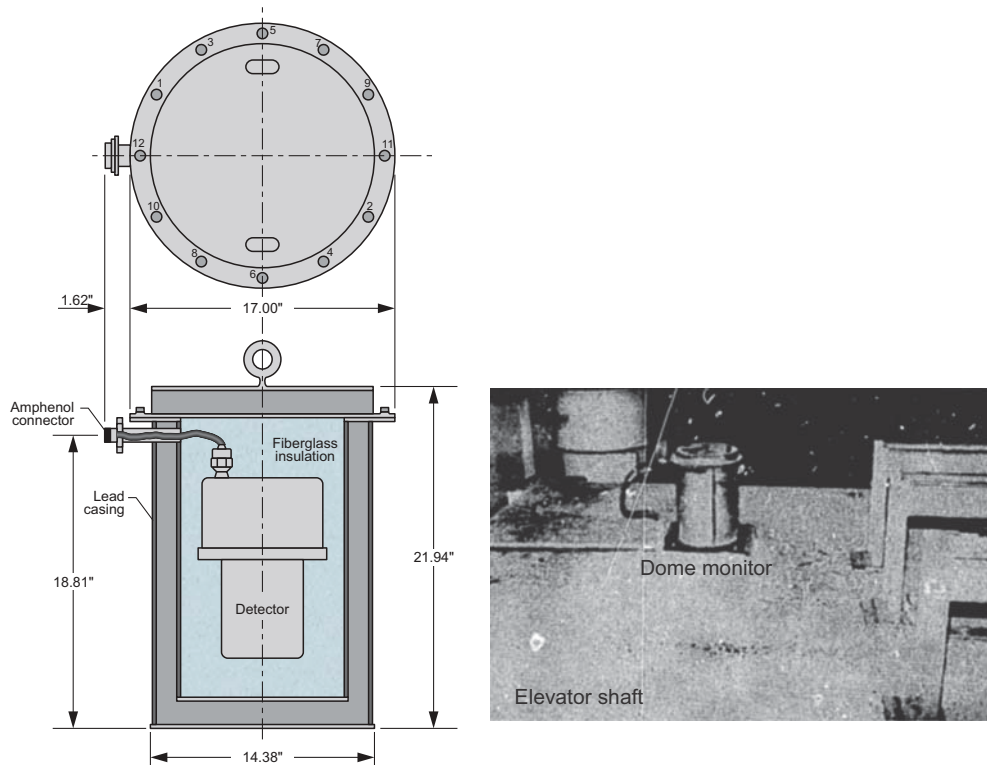
**Figure 5-5.** Photo and schematic of TMI-2 HP-R-214 dome monitor in stainless steel container.

Field measurements were performed on the HP-R-212, HP-R-213, and HP-R-214 monitors.<sup>94-96</sup> The field measurements included evaluations of the current radiation signal from each unit, passive measurements (e.g., time domain output waveforms, high frequency spectrum analysis) and active measurements (resistance, capacitance, impedance, and TDR tests). Evaluation results indicated that by the time that

these measurements were taken, all three monitors had failed although the cause of the failures were not discerned from these field measurements.

During the accident at TMI-2, operators used the Dome Monitor readings as required and declared a General Emergency based on an 8 R/hr high alarm. However, because of a low Containment Building pressure of only 7 kPa-gauge and concerns about the accuracy of the 40 R/hr calculation associated with this detector and its shielding, the supervisor ordered radiation surveys to be made around the plant boundary prior to recommending an evacuation. Radiation surveys revealed that no significant levels of radioactivity had been detected.

Reference 102 examinations of the Dome Monitor revealed that, while the declaration of a General Emergency was proper, the radiation levels measured were probably inaccurate at that time. Much later in the accident, they were certainly inaccurate. Reference 102 concluded that circuit failures occurred in the HP-R-214 monitor at various times during and following the first days of the accident. Failures in the detector electronics package and preamplifier circuits occurred within the first 3 hours of the accident due to moisture intrusion from the containment atmosphere. Radiation levels degraded transistors within the ion chambers in the Dome Monitor. As noted previously, the accuracy of the dome monitor was also decreased because of uncertainties associated with the recording scale and by the presence of a thick lead and stainless steel shield used to protect the detector and its electronics.

Reference 102 concluded that the accident at TMI-2 demonstrates the need for improving radiation measurements during a loss-of-coolant accident. The Dome Monitor failures indicate that similar systems should be reconsidered. Reference 102 provided several recommendations for design improvements, such as better seals that are periodically leak tested, use of radiation resistant components and placing electronics outside the containment so that the lead shield could be removed. Finally, accident analysis indicates that equipment used in containment should undergo more extensive environmental testing prior to installation.

- Post-accident evaluations emphasized the need for more robust containment radiation measurement instrumentation. Identified Dome Monitor failures and data uncertainties led to several recommendations for design improvements, such as better seals that are periodically leak tested, the use of moisture and radiation resistant components and cabling, and relocating electronics outside the containment so that the lead shield could be removed.

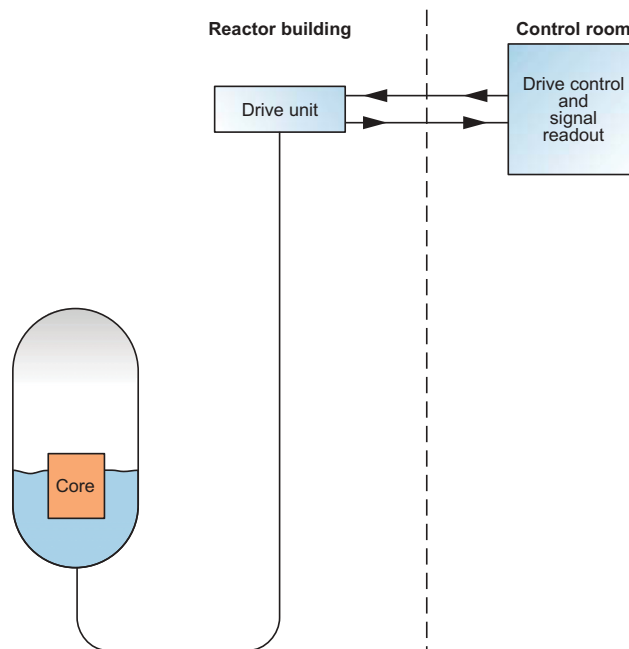
**Figure A-5.** Moveable in-core detection system.

The normal parking position for the detector was approximately 3 m below the active section of the core. It could normally be inserted to a point a few centimeters above the active length of the core. During the early hours of the accident, an attempt was made to make a traverse of the core with the MIDS. The detector could not be moved from the parking location. A second attempt to move the detector was also unsuccessful. However, on the third attempt on April 11, the detector moved away from the parking posi-

tion toward the core. After the detector moved only a foot or two into the core, it encountered resistance. Finally, when the unit was inserted approximately three feet into the core, it became stuck and could no longer be either inserted or withdrawn. From these observations, one may conclude that debris had been driven through the tube and deposited around the detector, and that this debris was dislodged after several attempts to insert the detector. After finally getting the detector underway, it encountered an obstruction at the three-foot level. This suggests that the guide tube was damaged and had admitted debris, and that the damage was enough to distort the tube down to the three foot level.

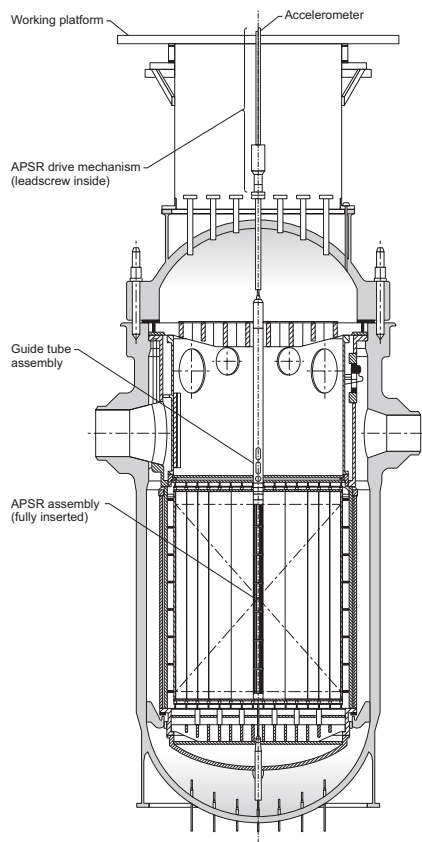
**Figure A-7.** Cross section of TMI-2 reactor vessel, showing typical axial power shaping rod assembly.

As noted in Reference 104, the position indicators for the APRs survived the accident. However, as noted in References 104 and 105, initial attempts (June 23 to 25, 1982) to insert the APSRs encountered blockages in certain core positions. Although nearly half of the APSRs could be entirely (or almost entirely) inserted into the core [at locations 62(F-4), 65(N-10), 66(L-12), and 67(F-12)], APSRs encountered blockages that precluded much (or any) additional movement at other locations [e.g., 63(L-4), 64(N-6), 68(D-10), and 69(D-6)]. Reference 105 noted that the locations where APSRs could be fully inserted correlated with locations where severe damage was observed in the initial “Quick Look” video inspections of the TMI-2 core. It was speculated that nearly complete insertion was possible because there was nearly total breakup of fuel assemblies and APSR assemblies at these locations. In addition, Reference 105 hypothesized that limited or no APSR movement at other locations was due to interference from core debris or distorted upper plenum support plates. Although qualitative insights were possible, no definitive information related to the physical condition of the TMI-2 core was obtained from the APSR evaluations.
