Final Report for the Erosion and Corrosion Analysis of Waste Transfer Primary Pipeline Sections from 241-SY Tank Farm

J. S. Page
R. B. Wyrwas
G. A. Cooke
Washington River Protection Solutions LLC

Date Published
September 2012

Prepared for the U.S. Department of Energy
Office of River Protection

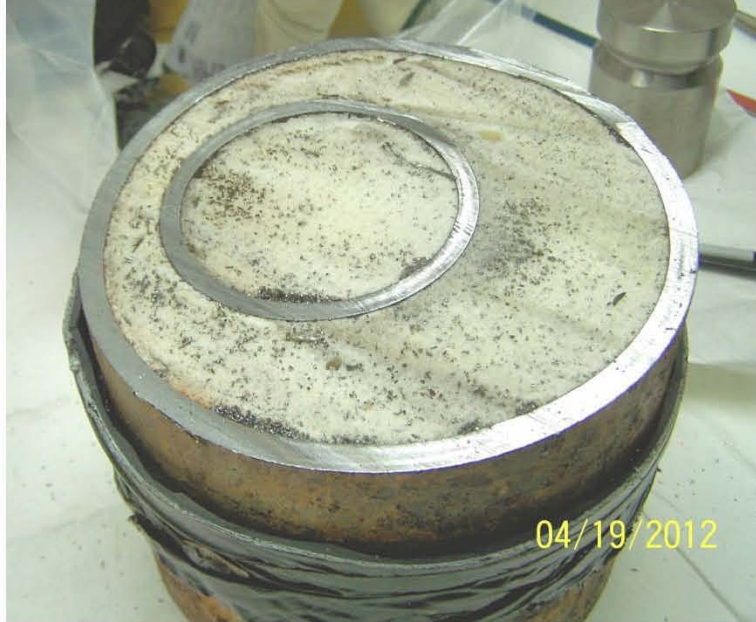
rubber matting. The pipeline was filled with urethane foam (Handi-Foam^{®1} Quick Cure II-205) before cutting to reduce the spread of radioactive contamination. This foam can be seen in Figure 1 along with metal shavings on the foam surface from the cut in the field.

Figure 1. Photograph of the SN-278 Pipe-in-Pipe Section during Sample Unpacking.

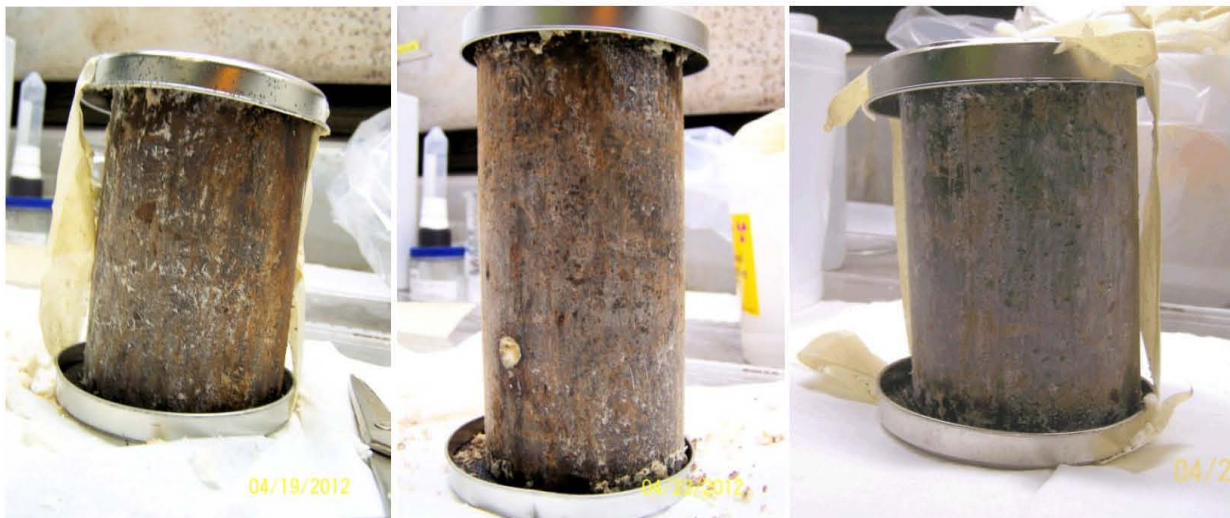
Figure 3. Photographs of the Cleaned Primary Pipes for Pipe Sections SN-285, SN-286, and SN-278.

It is important to note that all three pipe sections contained a hole, as seen on SN-286 in Figure 3, which was used to inject the inner pipe with the foam, and this foam was still present in the pipe throughout the analysis until the coupons were cut from the pipe sections (the foam did not degrade the UT thickness measurements).

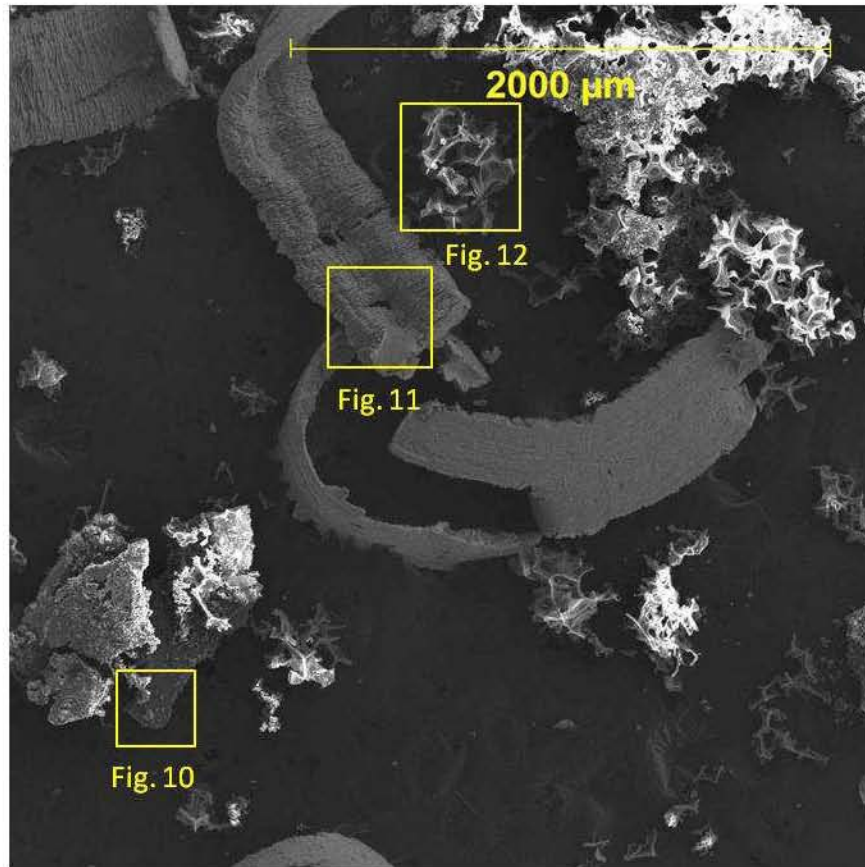
EDS analysis of the elemental composition of the particles. The three types of particles tended to be (1) tank waste associated sub particles and corrosion particles aggregated together and/or embedded in foam, (2) metal shavings from the cutting/scraping of the pipe, and (3) particles of foam.

Figure 9. Scanning Electron Microscopy Image of Particles Scraped from the Inside Surface of Pipe SN-285.

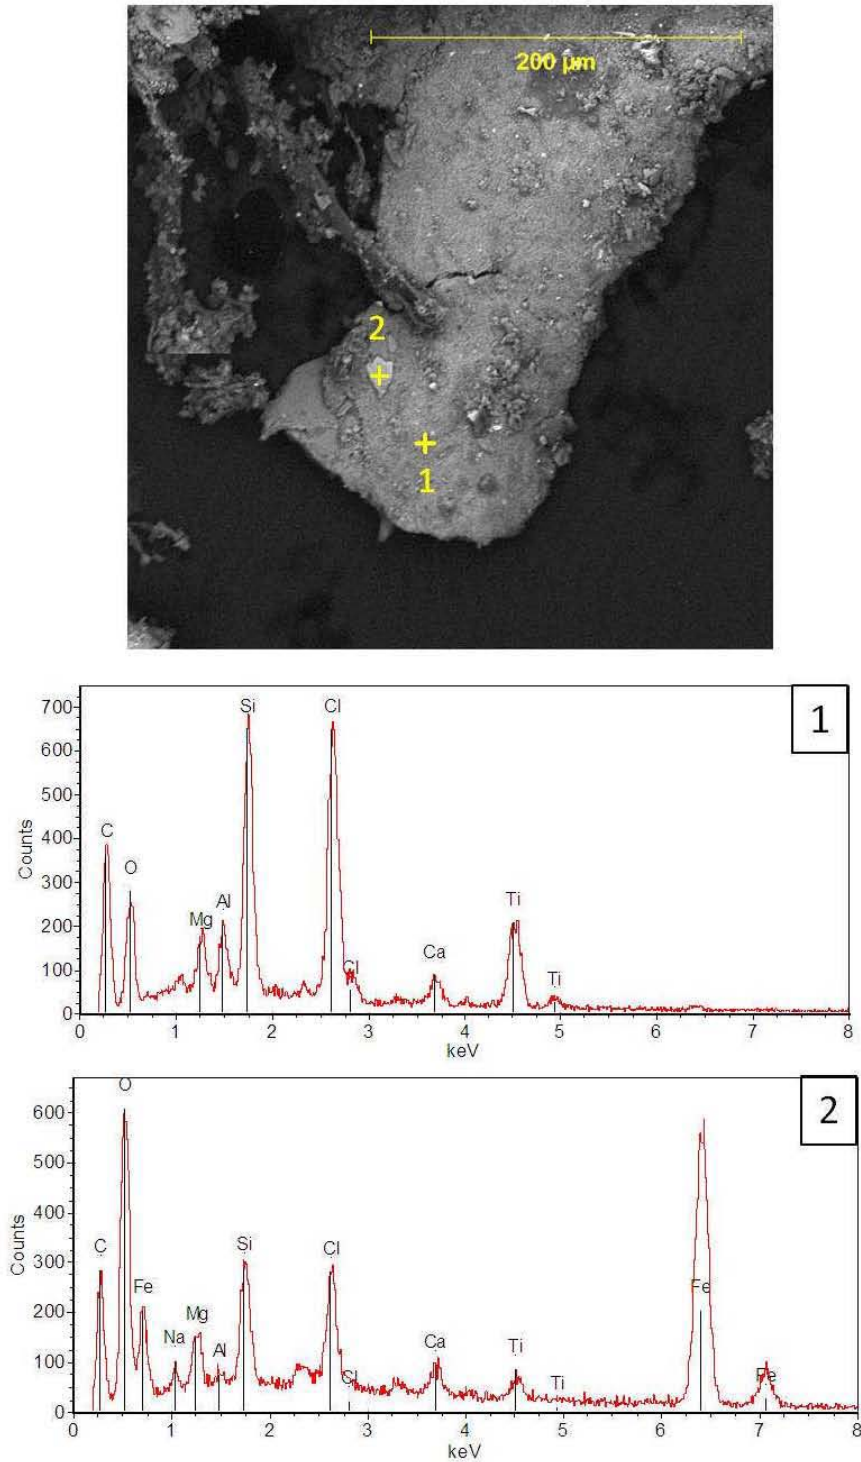
Figure 10 shows larger particles, such as iron oxide at point 2, embedded in a background matrix of aggregated smaller particles, point 1, rich in silica, chloride, oxygen, titanium, aluminum, and magnesium.

Figure 10. Scanning Electron Microscopy Image and Energy Dispersive Spectrometry Spectra of Aggregated Particles in the SN-285 Scrapings.

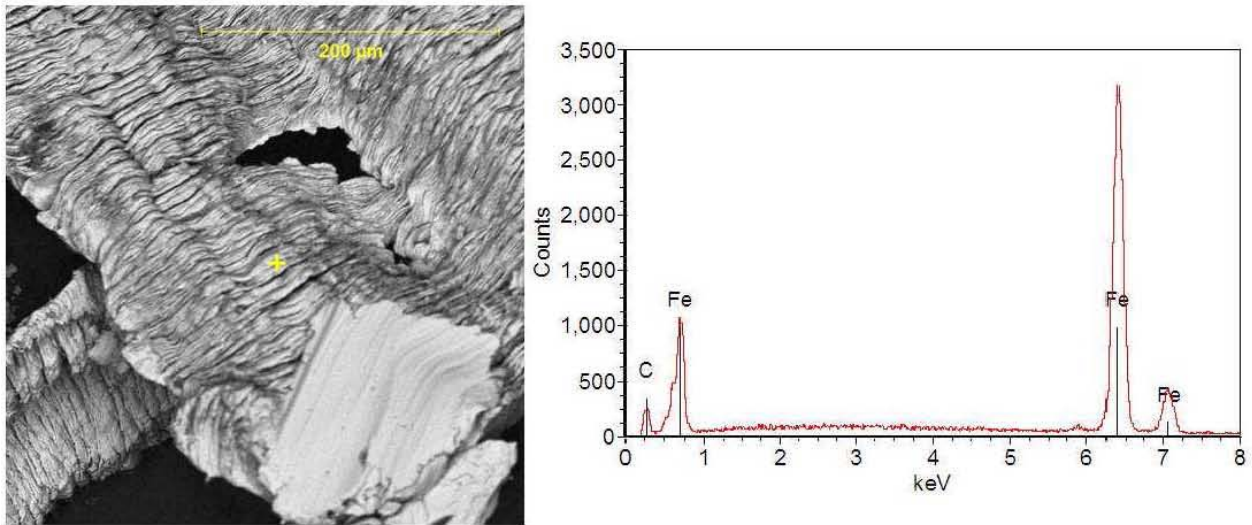
Figure 11 is an example of particles in the scrapings that were metal shavings from the cutting and scraping of the pipe, and Figure 12 shows that other particles were from the foam which was injected into the pipe for the in-field removal. In summary, most of the scrapings were not from

Figure 11. Scanning Electron Microscopy Image and Energy Dispersive Spectrometry Spectrum of Metal Scrapings in the SN-285 Pipe Scrapings.

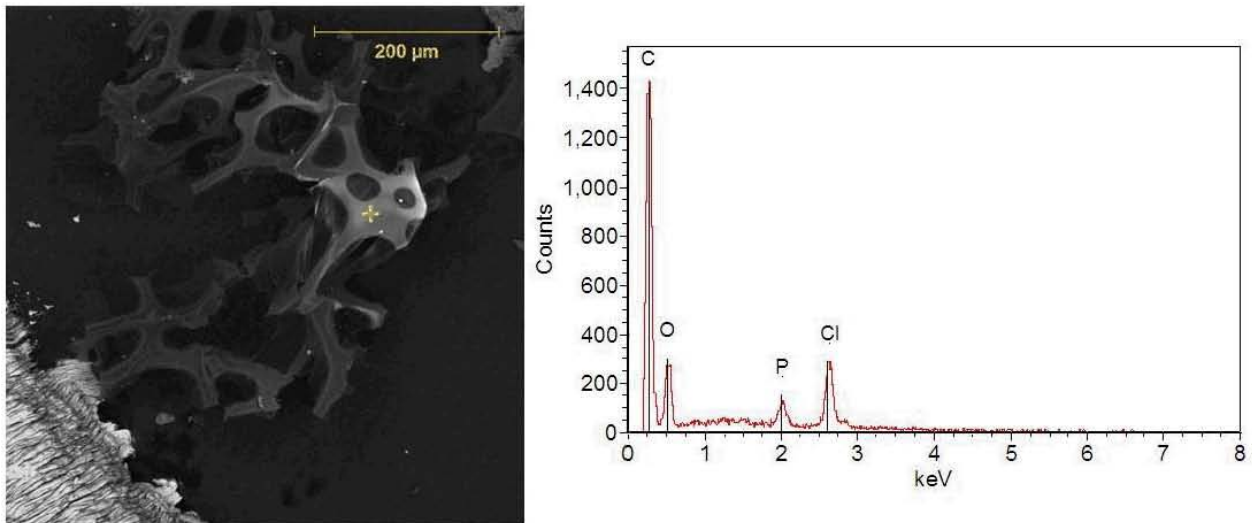
Figure 12. Scanning Electron Microscopy Image and Energy Dispersive Spectrometry Spectrum of Foam Particles in the SN-285 Pipe Scrapings.

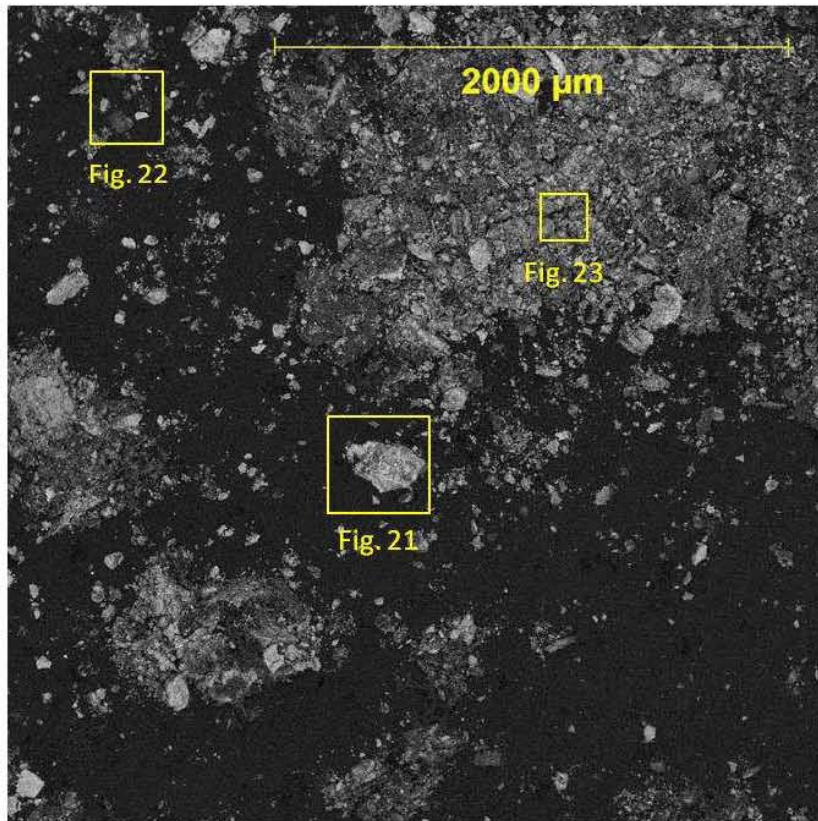
Figure 20 shows a general area on the specimen stub and reveals that the scrapings came off the pipe as isolated and aggregated small particles. Three different areas were chosen for further analysis indicated by the three yellow boxes which refer to following figures where the areas are shown under a higher magnification and with the subsequent EDS analysis of the elemental composition of the particles.

Figure 20. Scanning Electron Microscopy Image of a General Area on the Pipe Scraping Specimen Stub.

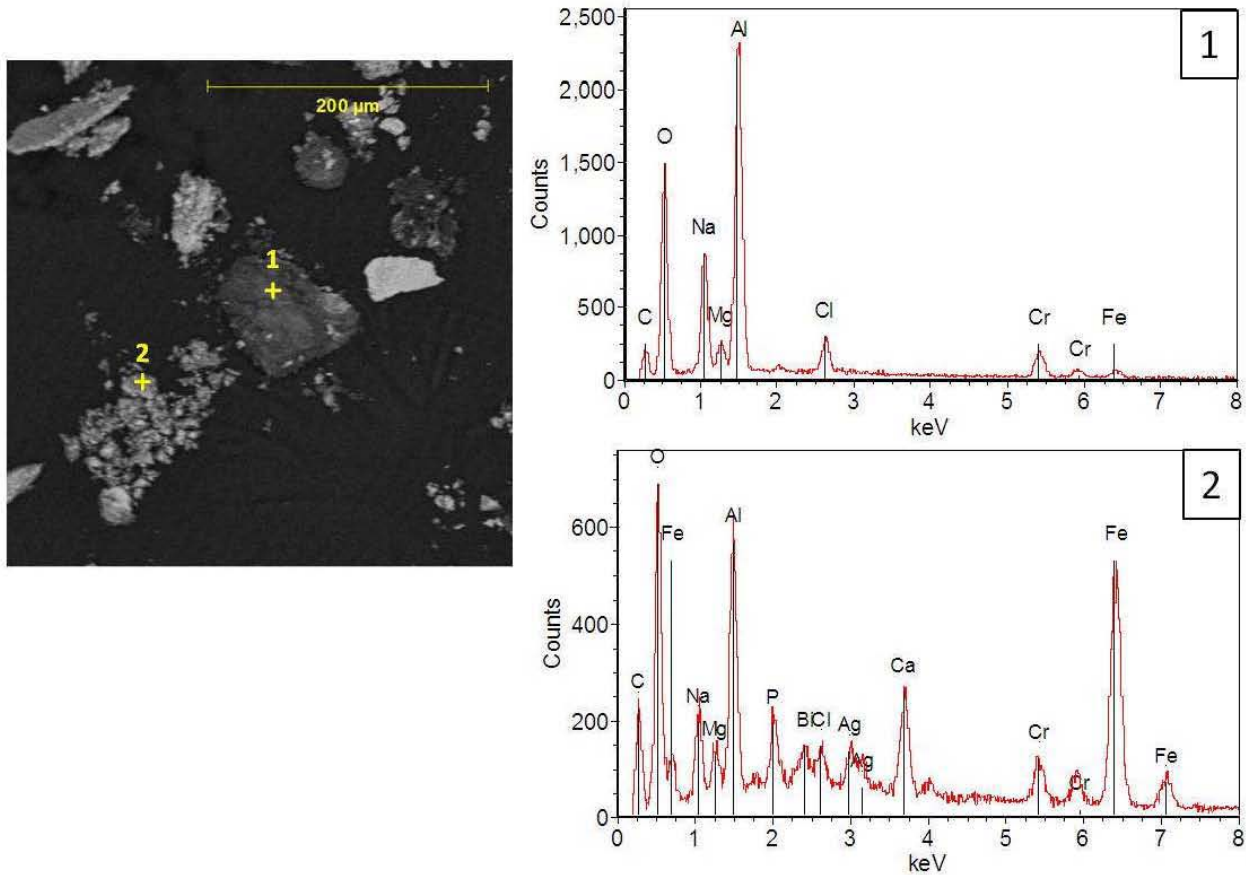
At least two different phases of tank waste were seen in the pipe scrapings. One phase was assigned sodium aluminate and is seen at the EDS analysis spot 1 in Figure 22. An amorphous phase is also present which is rich in iron, aluminum, calcium, sodium, chromium, and phosphorus, and is located at spot 2.

Figure 22. Scanning Electron Microscopy Image and Energy Dispersive Spectrometry Spectrum of Tank Waste Particles Scraped from SN-286.

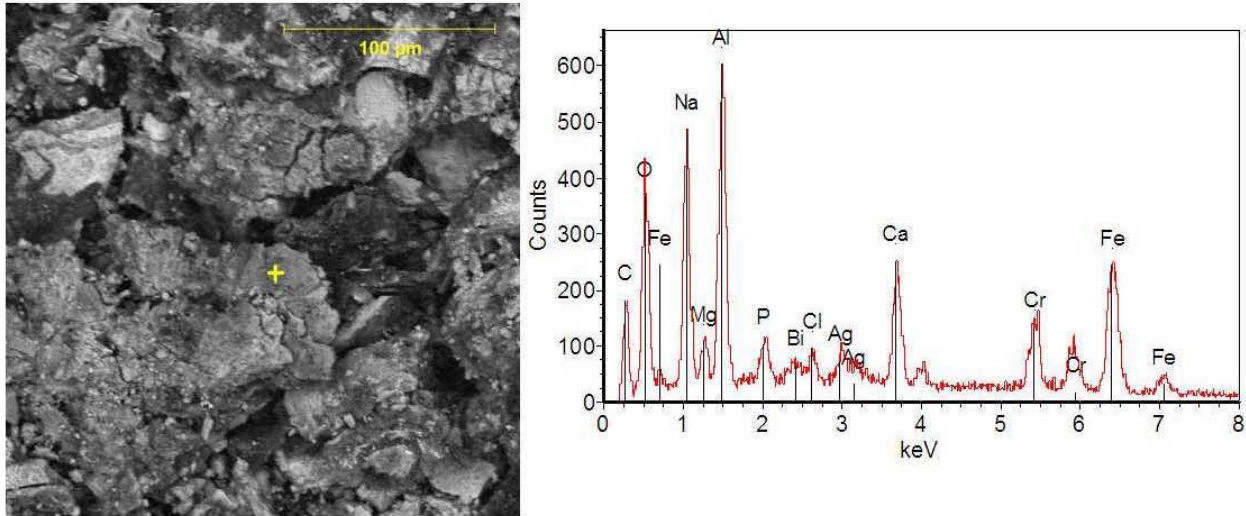
This amorphous phase was the major component in the scrapings from the SN-286 primary pipe section. The chemical variability can be seen in Figure 23 where the levels of the major elements are dissimilar from the EDS analysis in Fig. 22. In addition, the lower level elements are confirmed to be associated with this phase which includes magnesium, silver, bismuth, and chlorine.

Figure 23. Scanning Electron Microscopy Image and Energy Dispersive Spectrometry Spectrum of the Majority of the Particulate in the Pipe Scrapings of SN-286.

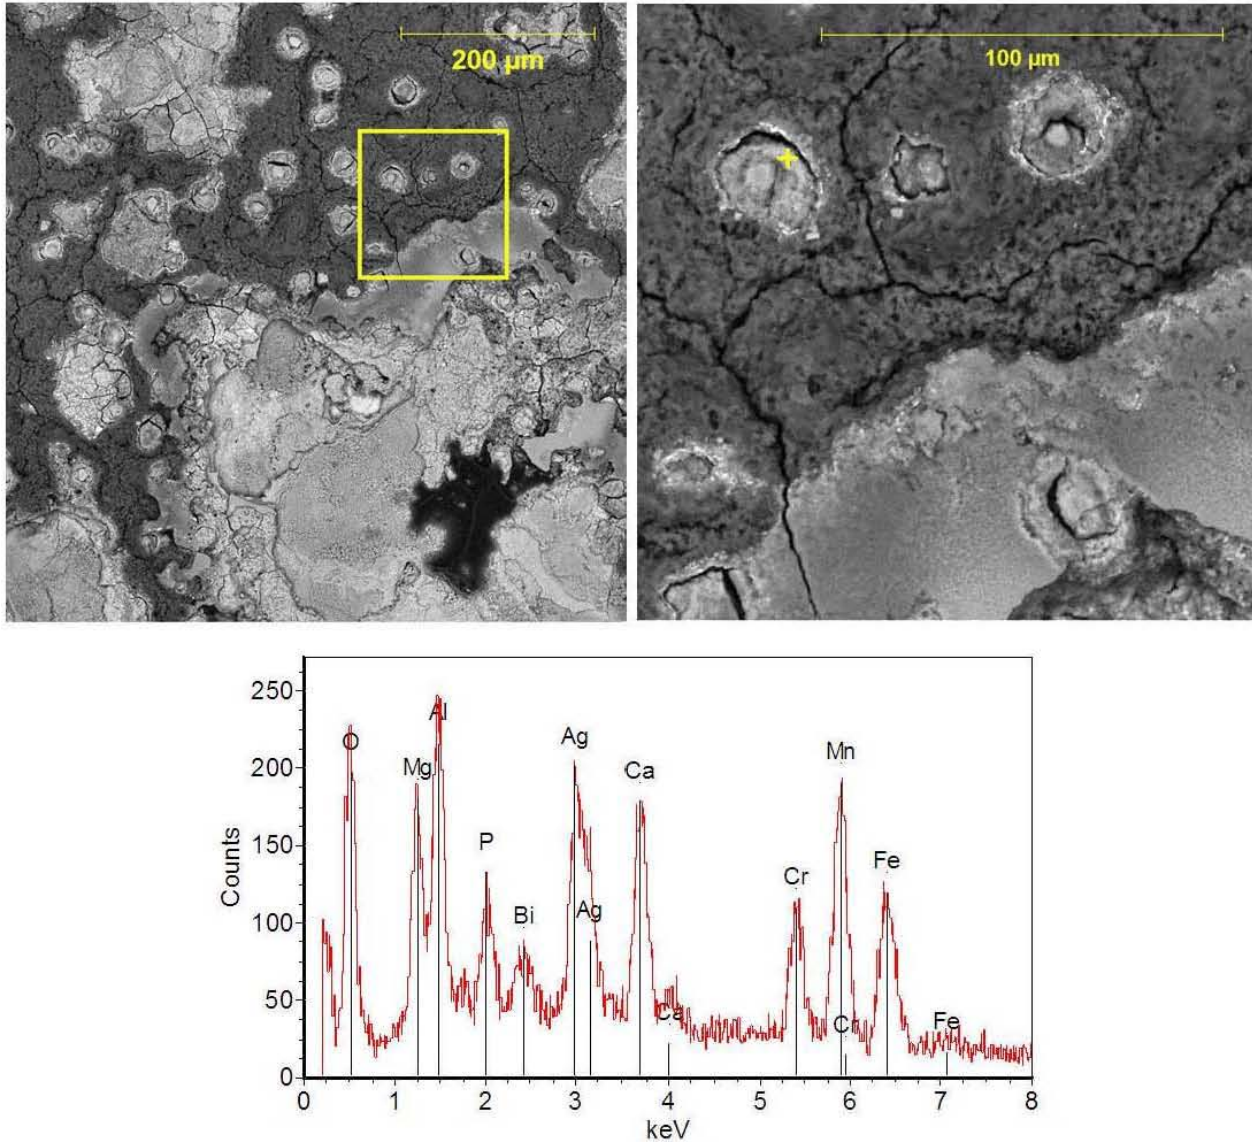
In some parts of the aluminum oxide patches, nodules of an amorphous phase were detected (see Figure 25). These contained a large variety of elements as indicated in the labels on the EDS spectrum.

Figure 25. Scanning Electron Microscopy Image and Energy Dispersive Spectrometry Spectrum of an Area on the Inner Surface of Pipe Section SN-286.

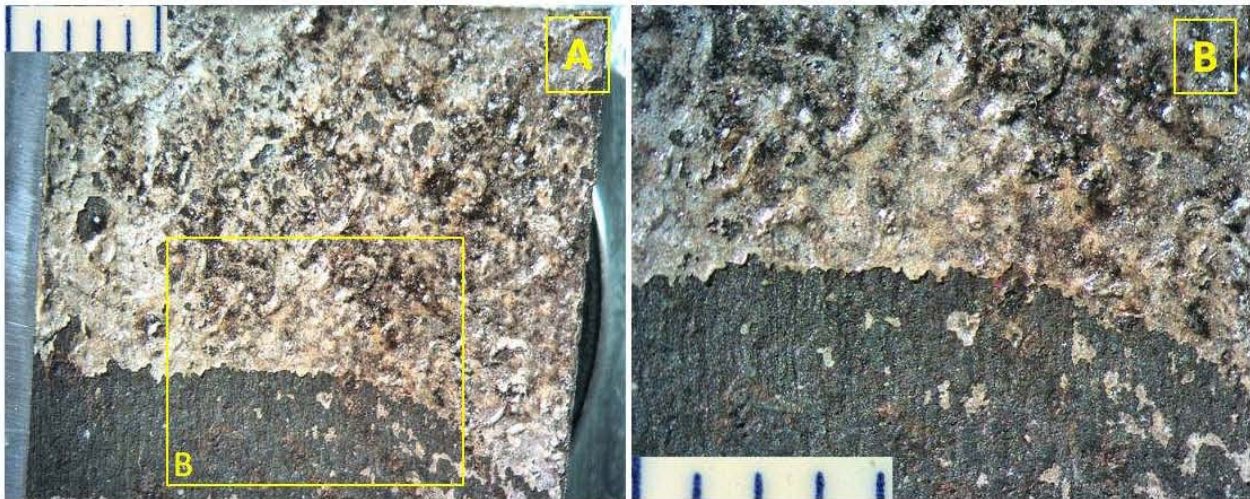
A smaller piece of pipe was cut from the lower left-hand part of the coupon in Figure 29B to better fit in the SEM. Before being loaded in the SEM, photomicrographs were obtained using a Nikon® reflected light stereo microscope. Figure 30 shows the resulting photomicrographs at two different magnifications with a 1 mm scale bar in the images. The right image is a magnified area of the section in Figure 30A indicated by the yellow box. Overall, the surface displayed a thin, flaky layer that easily scraped off. This layer appeared detached in some locations in Figure 30B. Under the layer, where the scrapings occurred, the pipe surface looked furrowed with lines running along the pipe length.

Figure 30. Photomicrographs of a Subsection of the SN-278 Coupon.

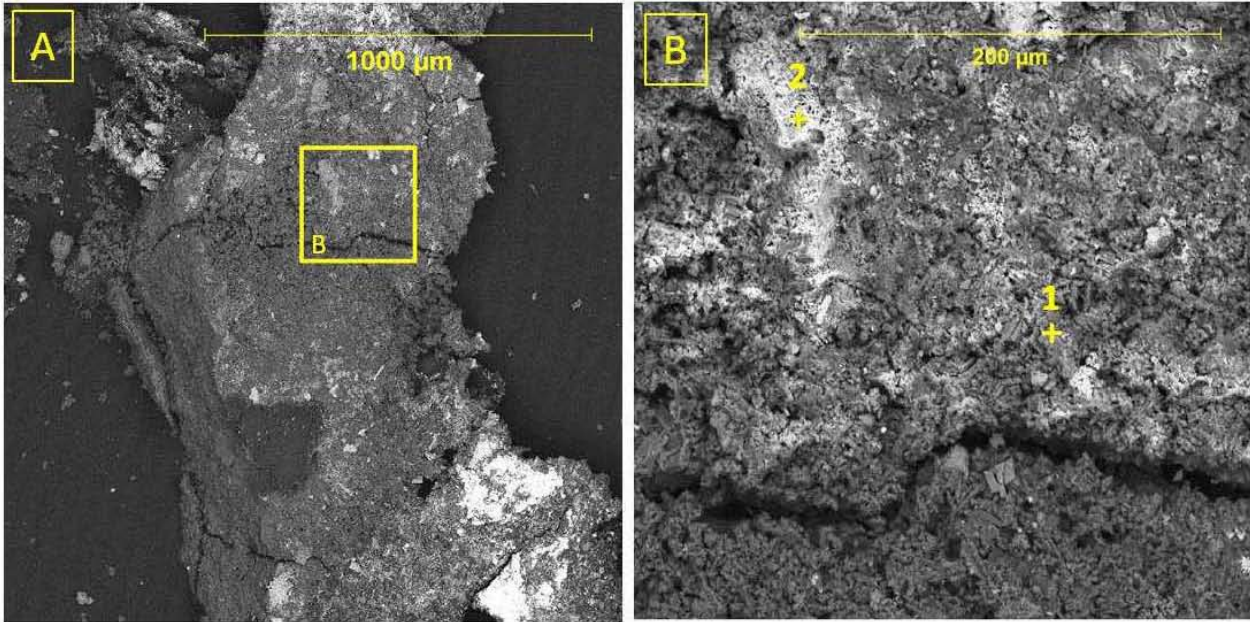
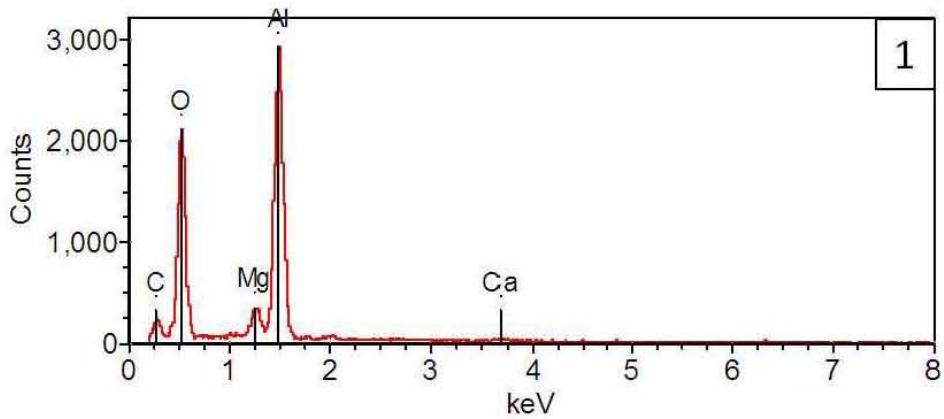
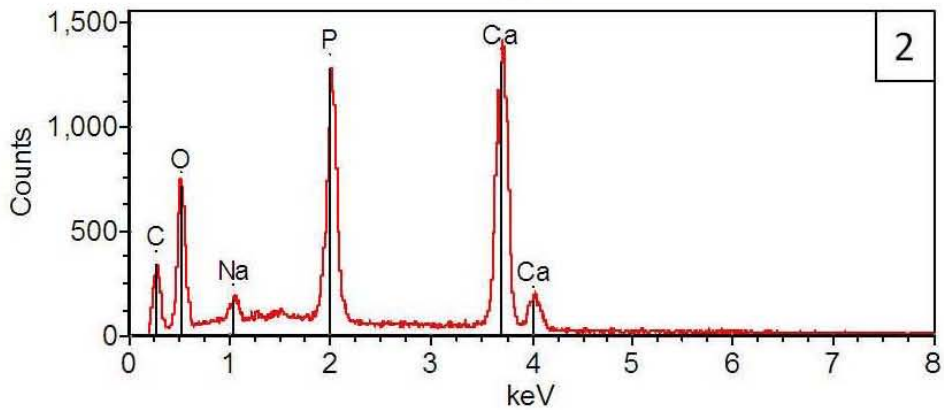
Figure 31 shows a general area on the specimen stub and shows one of the large, thin flakes scraped from the inside surface of the pipe section. The flake appeared to be an aggregate of fine-grained aluminum oxide particulate (possible gibbsite) as indicated by the EDS spectra from spot 1. The brighter area in the BEI shows the presence of a calcium phosphate residue on this aluminum oxide layer.

Figure 31. Scanning Electron Microscopy Image of a General Area on the SN-278 Pipe Scraping Specimen Stub.

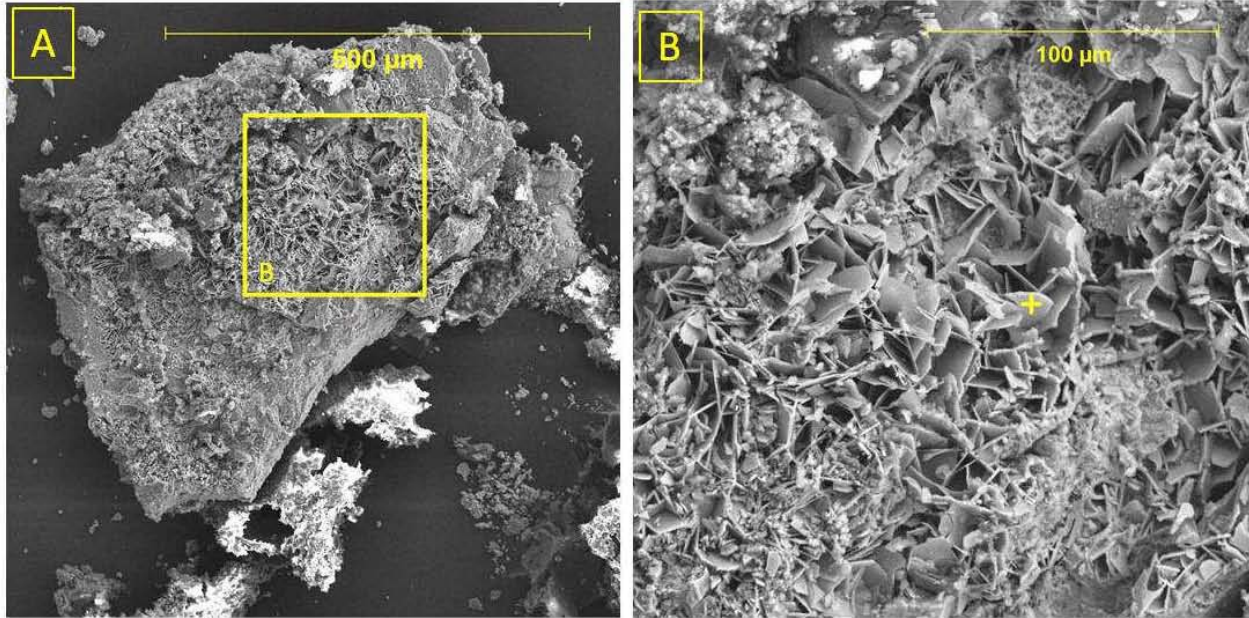
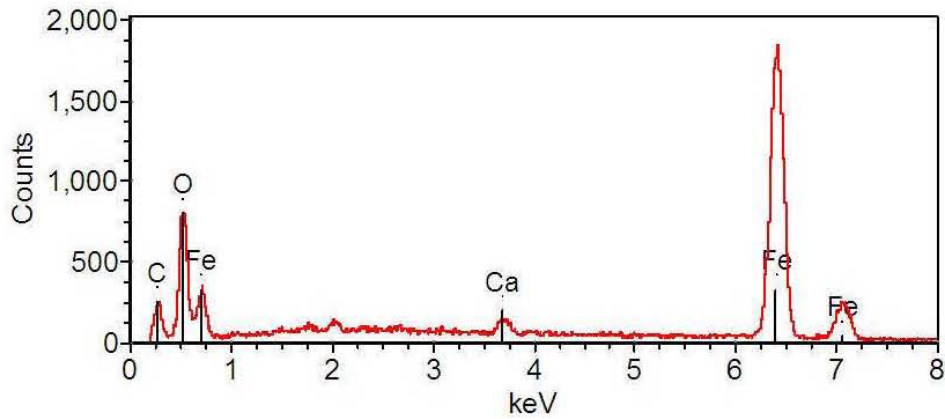
Another flake is shown in Figure 32, which is possibly the underside of the particle, as there is a platy, iron oxide phase which could have been pulled from the pipe wall.

Figure 32. Scanning Electron Microscopy Image and Energy Dispersive Spectrometry Spectrum of a Flake Scraped from the SN-278 Pipe Section.

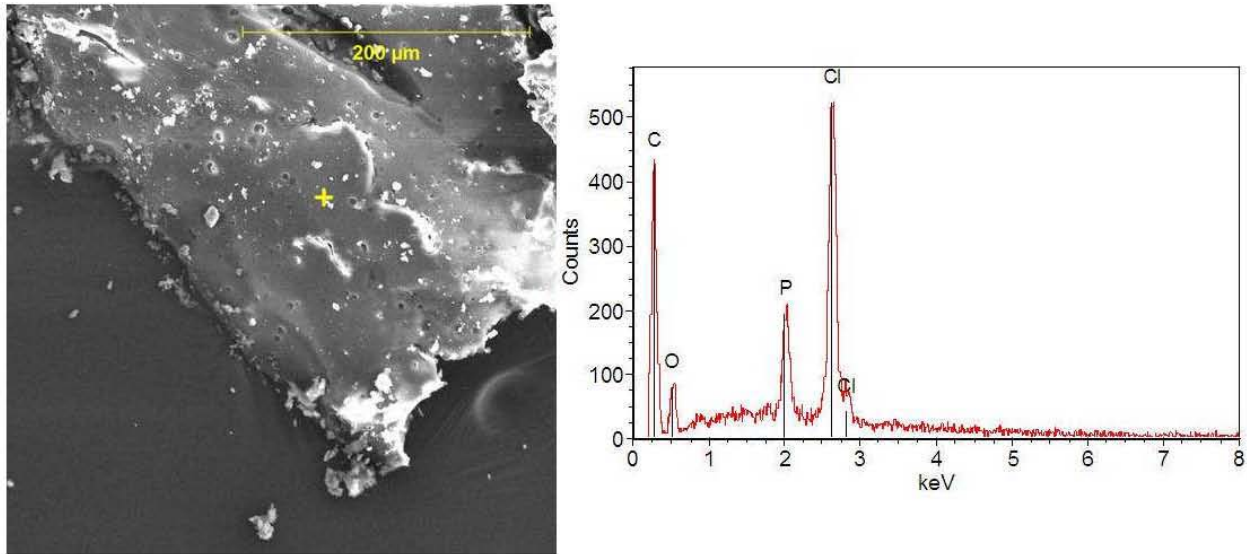
Another type of flaky particle scraped from the pipe surface is shown in Figure 33. This particle contained carbon and chloride, and this could represent the top side of the flakes as its appearance is similar to the images in the following section which show the SEM results of the intact inside surface of the pipe.

Figure 33. Scanning Electron Microscopy Image and Energy Dispersive Spectrometry Spectrum of Another Flake Scraped From SN-278.

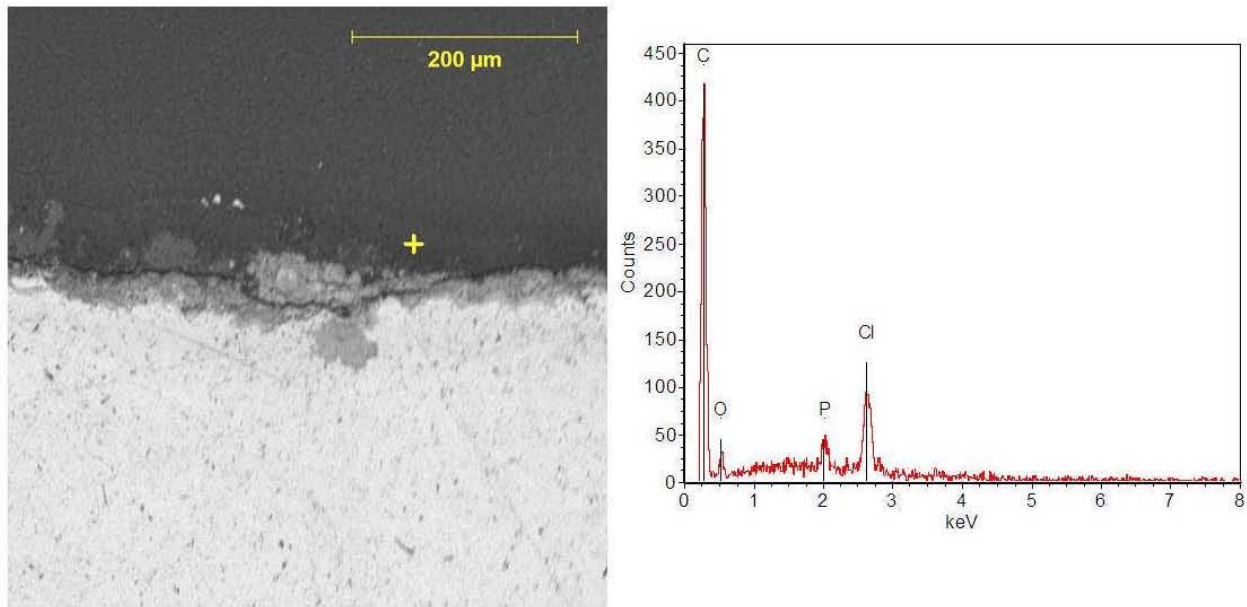
The layered carbon, chlorine, and phosphate phase seen in the analysis of the scrapings was also seen in the cross-section analysis. Figure 39 shows this phase as the topmost layer above the aluminum oxide and iron oxide layers.

Figure 39. Scanning Electron Microscopy Image and Energy Dispersive Spectrometry Spectrum of the Carbon and Chlorine-Rich Layer on the Cross-Sectioned Coupon of SN-278.
