Hanford Single-Shell Tank Leak Causes and Locations - 241-A Farm

Washington River Protection Solutions

Abstract: This document identifies 241-A Tank Farm (A Farm) leak causes and locations for the 100 series leaking tanks (241-A-104 and 241-A-105) identified in RPP-ENV-37956, Hanford A and AX Farm Leak Assessment Report. This document satisfies the A Farm portion of the target (T04) in the Hanford Federal Facility Agreement and Consent Order milestone M-045-91F.

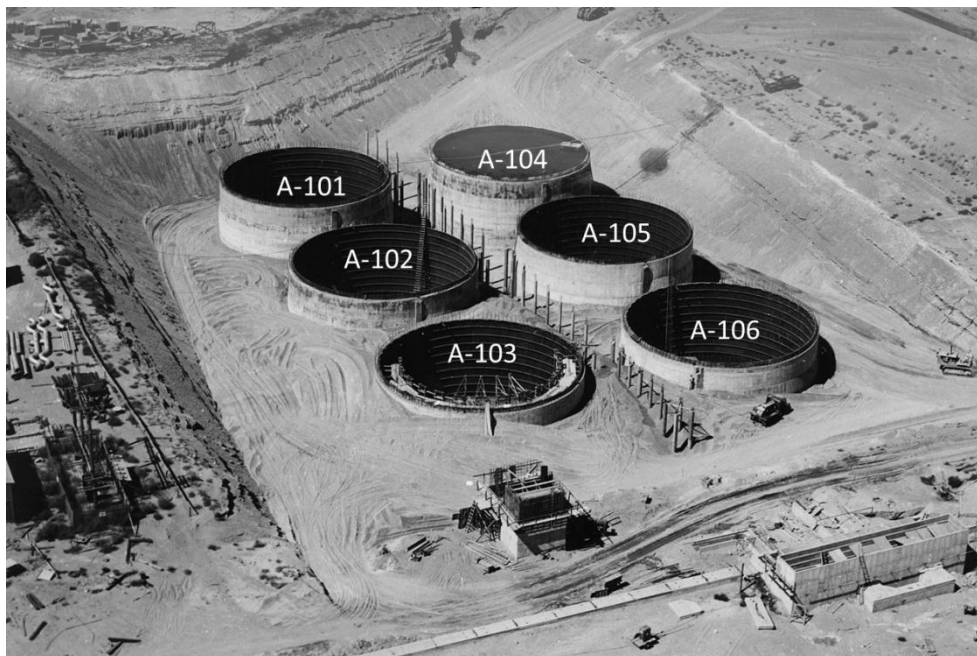
**Figure 3-4. A Farm Construction Photograph August 30, 1954
(Photograph #N1D0057755)**

The A Farm construction temperatures were examined to determine if the tank liner fabrication occurred at or below the metal ductile-to-brittle temperature transition. The photograph in Figure 3-4 shows the A Farm under construction on August 30, 1954.

Below the transition temperature, the metal loses its ability to absorb forces such as induced loads, or the impact of falling objects without fracturing. In this circumstance it is possible for micro-fissures or hairline cracks to be created. Later, when the metal is subjected to high stress, it might be possible for the cracks to propagate through the metal, or possibly subject the weakened areas to increased corrosion.

Any low temperatures experienced during construction at or less than the 18°F allowable temperature where impact loading (e.g. a dropped tool or piece of equipment from scaffolding) had the potential for creating micro-fissures may have triggered fissures in the steel liner (see Sections 4.3.2 and 5.3.2).

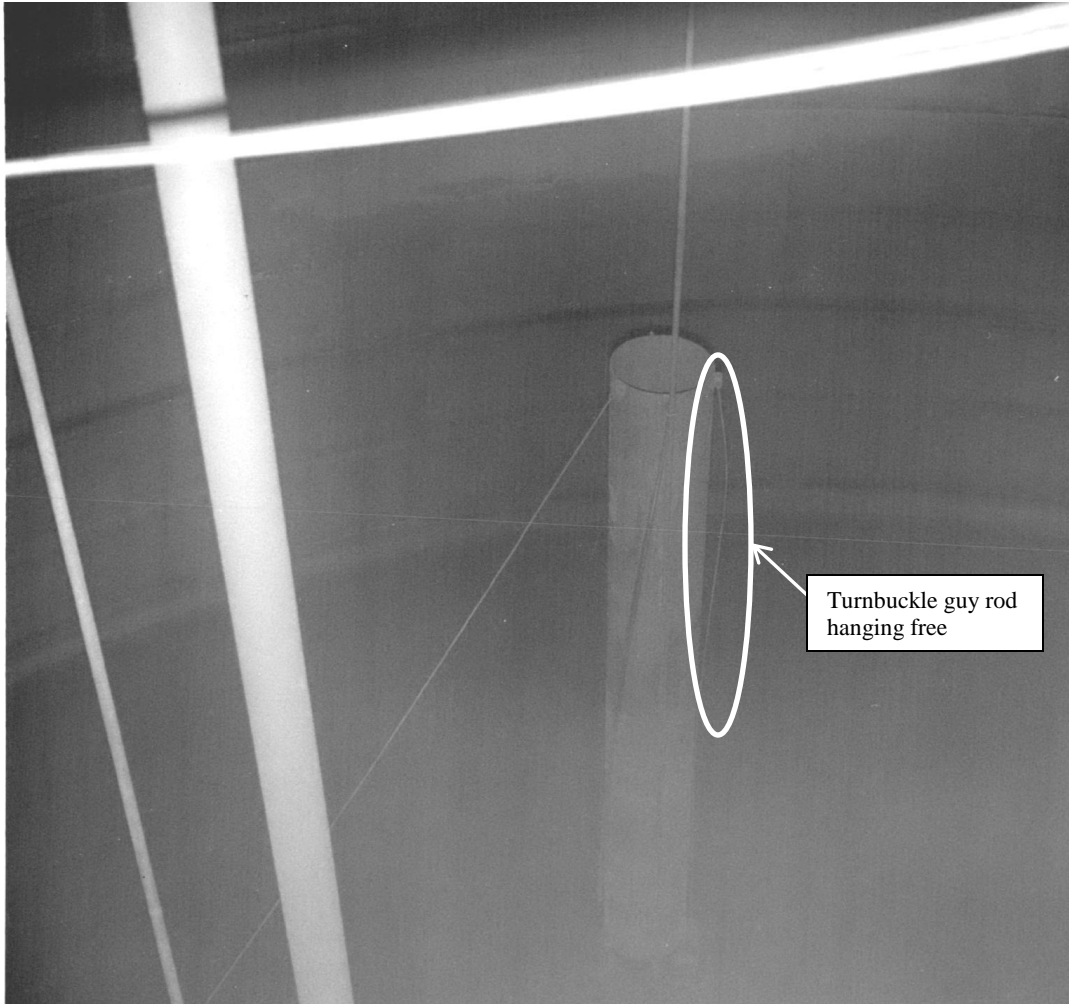
**Figure 4-4. Tank A-104 ALC #1 Photograph 0694459-34
October 7, 1969**

Earliest available photographs of tank A-104 taken on October 7, 1969 were reviewed. However, it is difficult to determine if a bulge was present at this time due to poor lighting and the waste surface is liquid. There are two ALCs (ALC #1 and ALC #2) that have bent piping and turnbuckle guy rods hanging free and are shown in Figure 4-4 and Figure 4-5. The next available sets of photographs were taken April 29, 1975 and May 14, 1975, shortly after tank A-104 was declared a confirmed leaker. However, it is difficult to determine if a bulge is present from these photographs due to the cloudiness of the photographs.

No records were found in available documents for a liner bulge occurring in tank A-104, and it remains unclear if a liner bulge once existed in the tank during its operation. After reviewing available in-tank photographs, there is a possibility of a liner bulge as indicated by ALCs #1 through #4 (see Section 4.4.5). However, a liner bulge remains inconclusive for tank A-104.

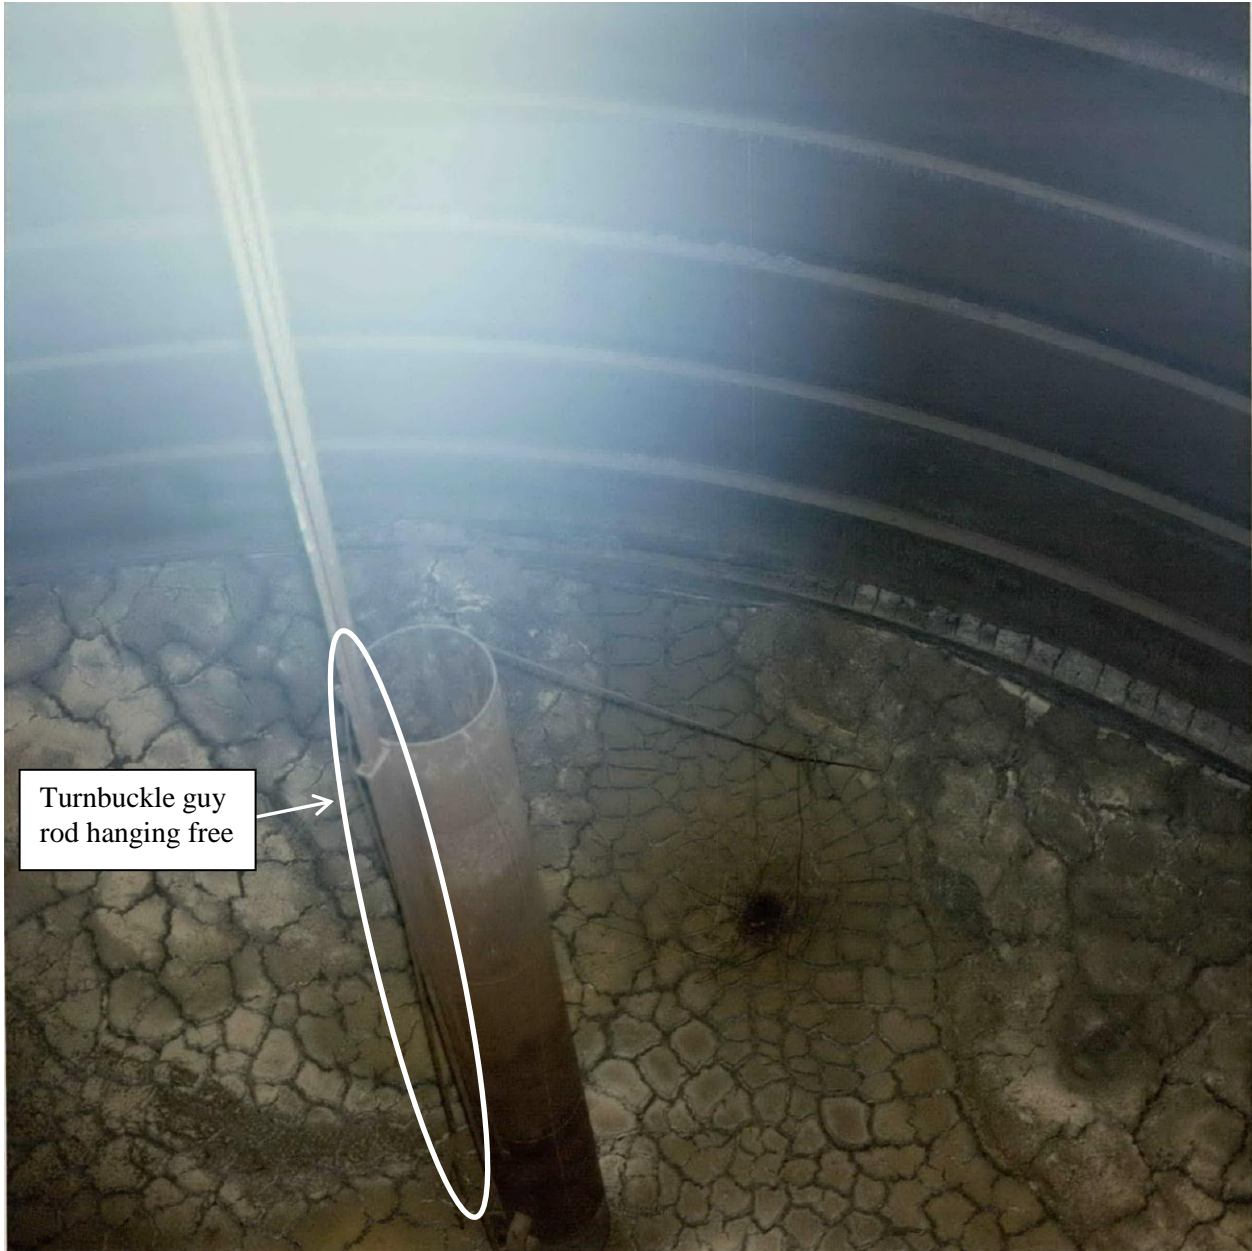
**Figure 4-6. Tank A-104 ALC #3 Photograph 8604129-22CN
June 25, 1986**

All available photographs of tank A-104 were reviewed. Photographs of tank A-104 taken June 25, 1986 show ALC #3 (see Figure 4-6) and ALC #4 (see Figure 4-7) with turnbuckle guy rods hanging free. This may be an indication of a liner bulge that could have resulted in failure of the turnbuckle guy rod bottom liner attachment. However, it remains unclear from the available photographs if the bottom liner of tank A-104 bulged.

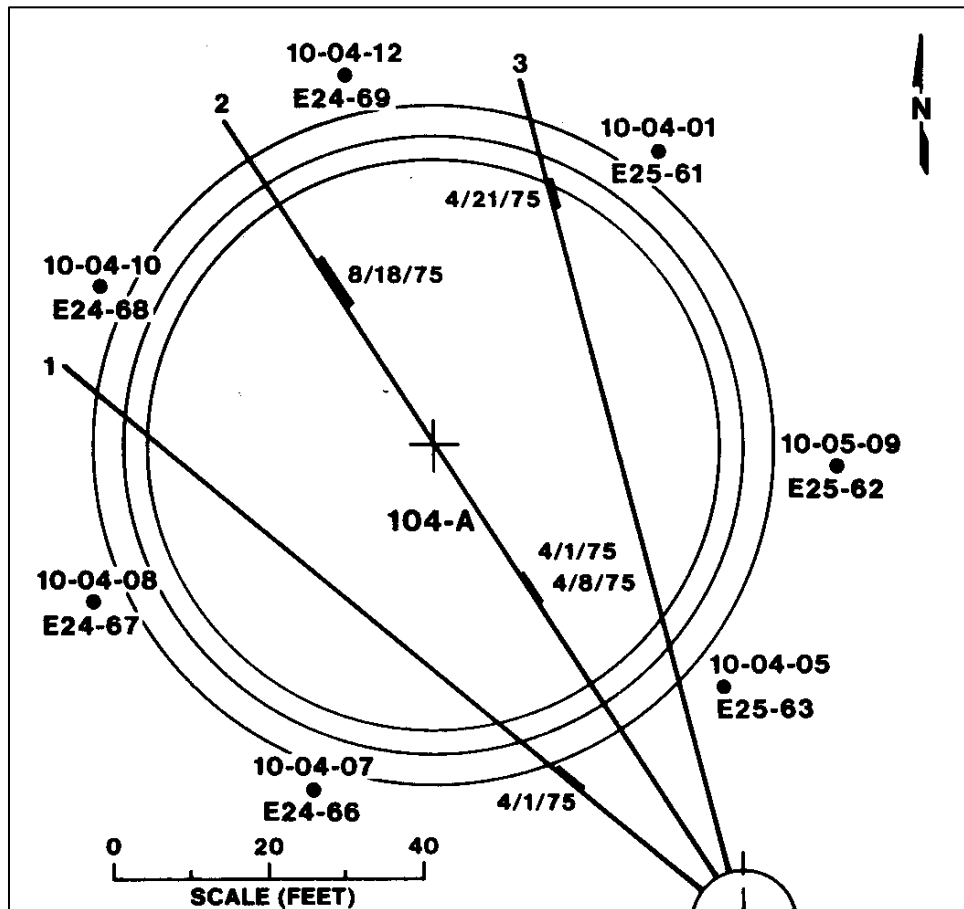
**Figure 4-8. Tank A-104 Historical Lateral Radioactivity
December 1975 (ARH-LD-120)**

additional radiation peaks were recorded, one in lateral 14-04-02 and one in lateral 14-04-01, both along the southeast edge of the tank (see Figure 4-8). Radiation readings were monitored daily in April 1975 for all three laterals and data are shown in Appendix C1. Radiation readings continued to increase in laterals 14-04-01 and 14-04-02 throughout April 1975. The first indication of radioactivity in lateral 14-04-03 occurred on April 21, 1975 at a reading of 95 cpm along the northeast edge of the tank and increased to 480 cpm by May 2, 1975. Tank A-104 was declared a confirmed leaker in April 1975 and supernatant was pumped out of tank A-104 from April 9 through April 19, 1975.

Beginning on May 1, 1975 a new peak was recorded in lateral 14-04-02 at 47-ft from the caisson at 1,200 cpm. A new peak was also recorded in lateral 14-04-01 on May 19, 1975 at 45-ft from the caisson. Gross gamma scans of the drywells around tank A-104 did not indicate radioactivity above background during this time (ARH-LD-120, *Nuclear Waste Tank and Pipeline External Leak Detection Systems*). Radiation readings remained relatively stable through 1976 and lateral scans from 1977 are shown in Figure 4-9, which show similar peaks when compared to the 1975 data. See Appendix C1 for lateral data from July 1974 through June 1986.

Note: There appears to be conflicts with the dates reported on this figure compared to the lateral data recovered in Appendix C1

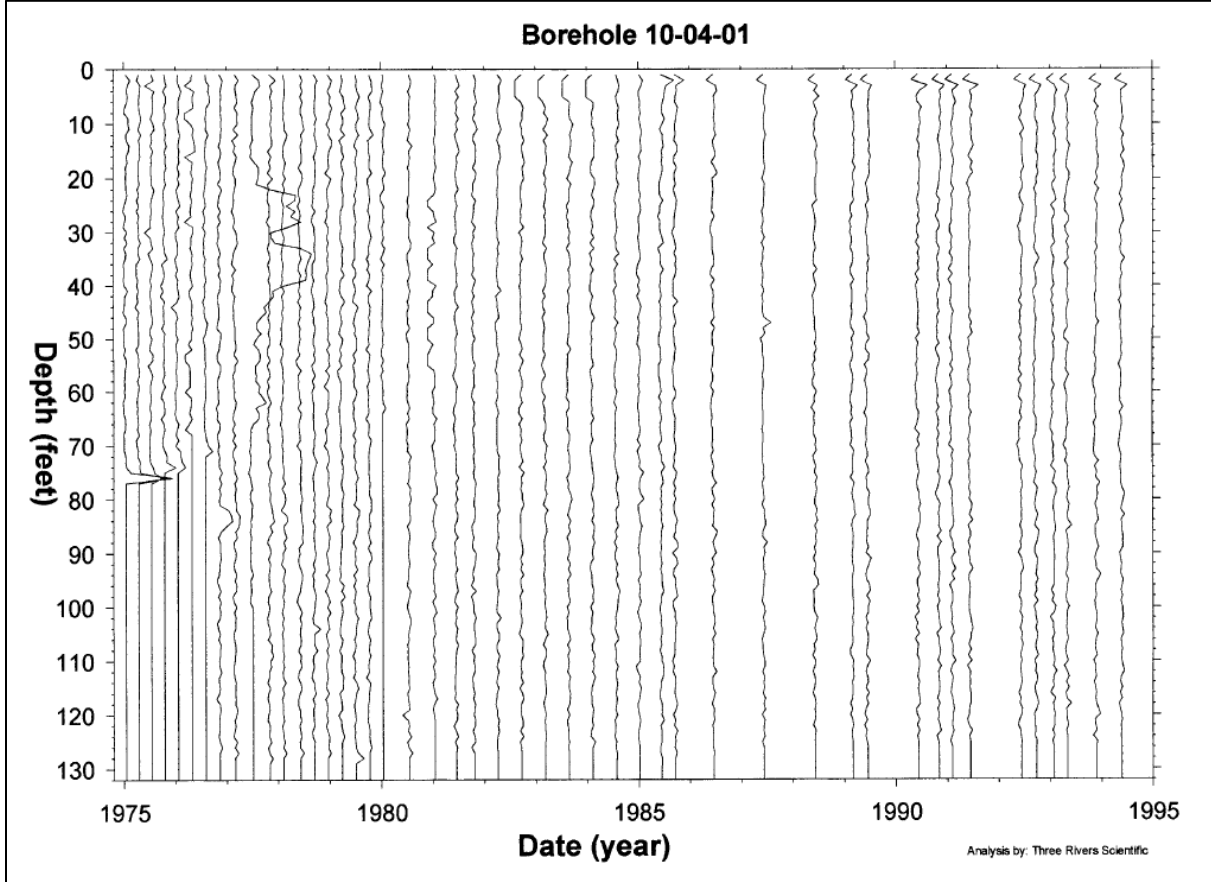
Figure 4-12. Tank A-104 Drywell 10-04-01 (RPP-8820)

In August 1998, Cs-137 was the only man-made radionuclide detected in drywell 10-04-01 with the maximum concentration of 8 pCi/g detected at 1-ft BGS (GJ-HAN-109). At 51-ft BGS, Cs-137 concentration was reported just above the minimum detectable limit at ~0.2 pCi/g. Document GJ-HAN-109 reports, "The near-surface anomalous activity was evident on the earliest available log (January 1975), which implies that the radionuclide contamination was in place before that time. There is no indication of anomalous activity in the borehole below the operating level of the tank." Therefore, drywell 10-04-01 is not included as part of the leak location for tank A-104. Figure 4-12 shows the depths of radioactivity from 1975 to 1995 (RPP-8820, *Analysis and Summary Report of Historical Dry Well Gamma Logs for the 241-A Tank Farm- 200 East*).

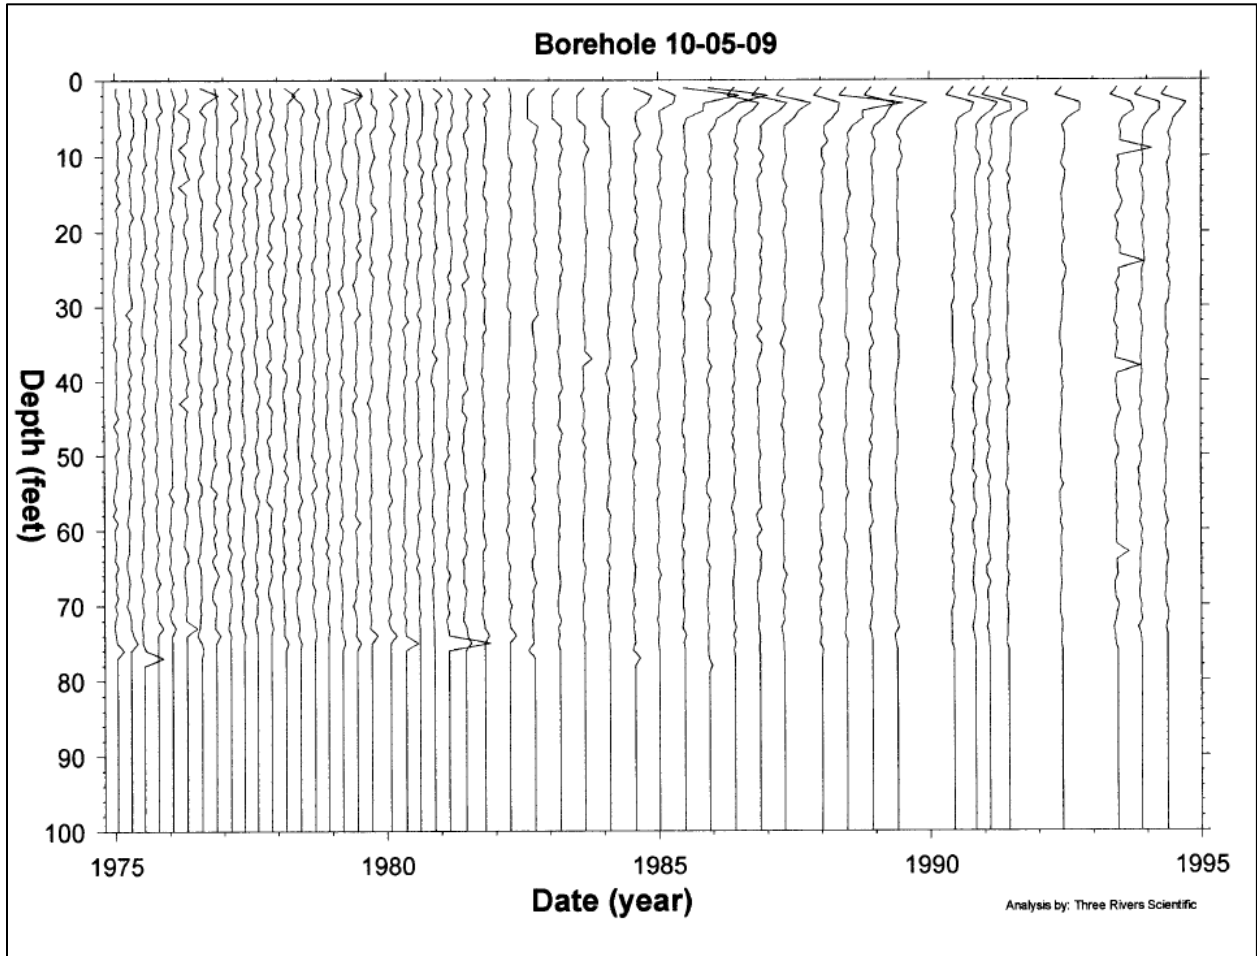
Figure 4-13. Tank A-104 Drywell 10-05-09 (RPP-8820)

Therefore, drywell 10-05-09 is not included as part of the leak location for tank A-104. Figure 4-13 shows the depths of radioactivity from 1975 to 1995 (RPP-8820).

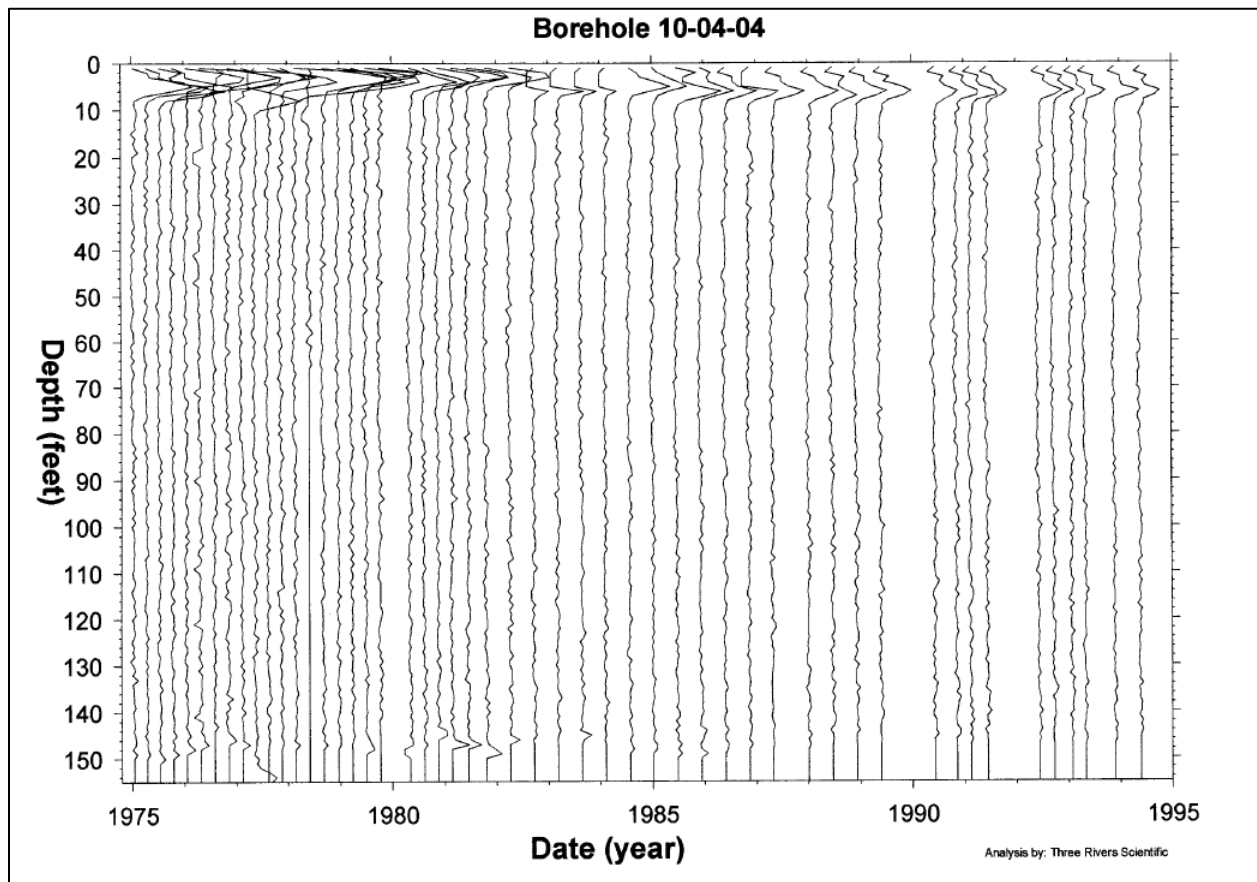
Figure 4-14. Tank A-104 Drywell 10-04-04 (RPP-8820)

In August 1998, Cs-137 and Eu-154 were the only man-made radionuclides detected in drywell 10-04-04 (GJ-HAN-109). From the ground surface to 6.5-ft BGS, Cs-137 was detected continuously at concentrations ranging from 0.5 to 20 pCi/g and was detected at the bottom of the drywell at approximately 0.6 pCi/g. From 4.5 to 6.5-ft BGS, Eu-154 was detected continuously at concentrations ranging from 0.5 to 0.8 pCi/g. Document GJ-HAN-109 reports “Shape factor results support the interpretation that the man-made contaminants detected from the ground surface to 6.5 ft resulted from a surface spill, a nearby pipeline, or a combination of these. The contamination at the bottom of the borehole is most likely particulate matter that has fallen into the borehole from the ground surface.” Therefore, drywell 10-04-04 is not included as part of the leak location for tank A-104. Figure 4-14 shows the depths of radioactivity from 1975 to 1995 (RPP-8820).

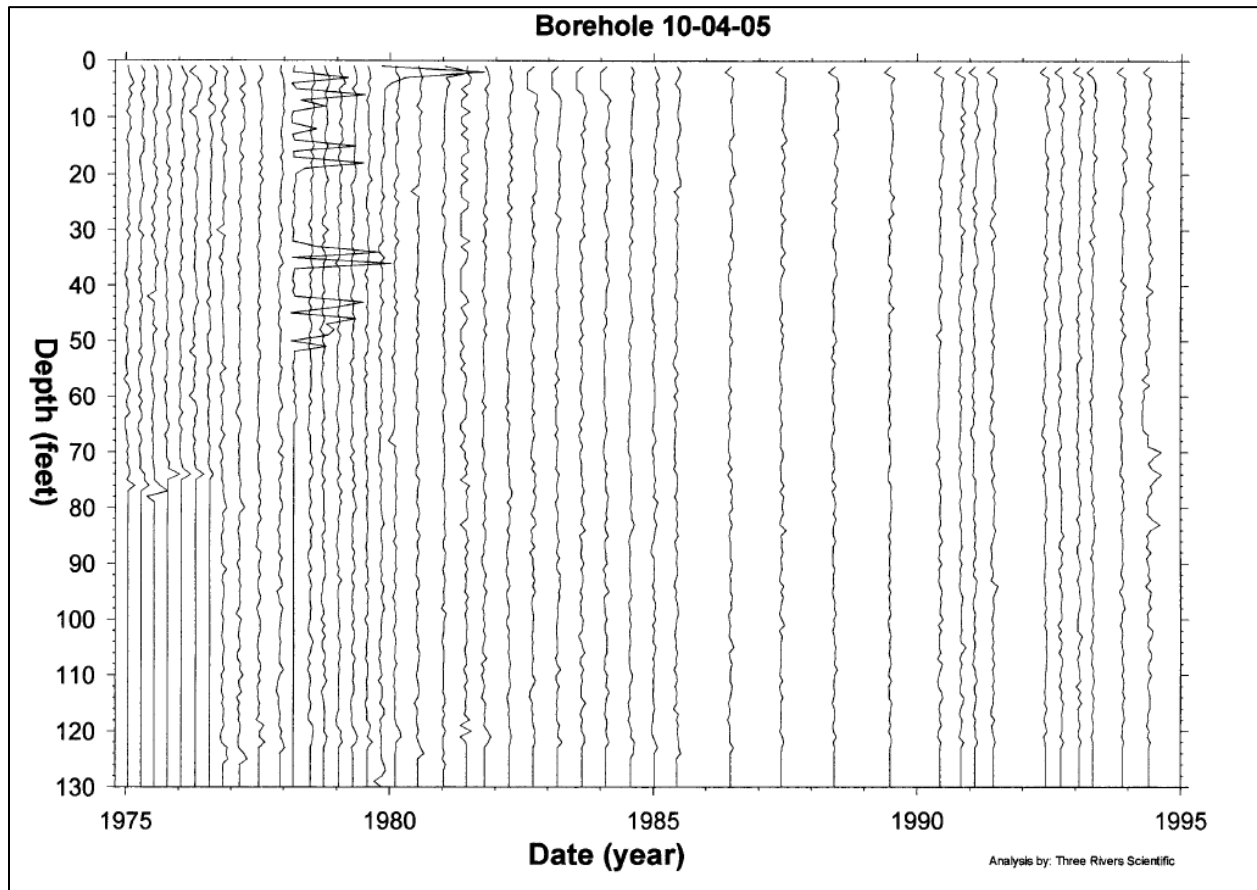
Figure 4-15. Tank A-104 Drywell 10-04-05 (RPP-8820)

In August 1998, Cs-137 was the only man-made radionuclide detected in drywell 10-04-05 and was detected continuously from the ground surface to 15-ft BGS at concentrations ranging from 0.2 to 5 pCi/g (GJ-HAN-109). Low-level Cs-137 contamination was also detected from 24 to 28-ft BGS, from 49 to 75-ft BGS, and at the bottom of the drywell from 121.5-ft to 123-ft BGS. The maximum Cs-137 concentration was 5 pCi/g at 1-ft BGS. Document GJ-HAN-109 reports, “Shape factor results support the interpretation that the Cs-137 contamination detected between the ground surface and 5 ft probably resulted from a surface spill that migrated down into the shallow backfill surrounding the borehole. The contamination from 5 to 15 ft and 41 to 75 ft was probably dragged down during the borehole extension activities.” Therefore, drywell 10-04-05 is not included as part of the leak location for tank A-104. Figure 4-15 shows the depths of radioactivity from 1975 to 1995 (RPP-8820).

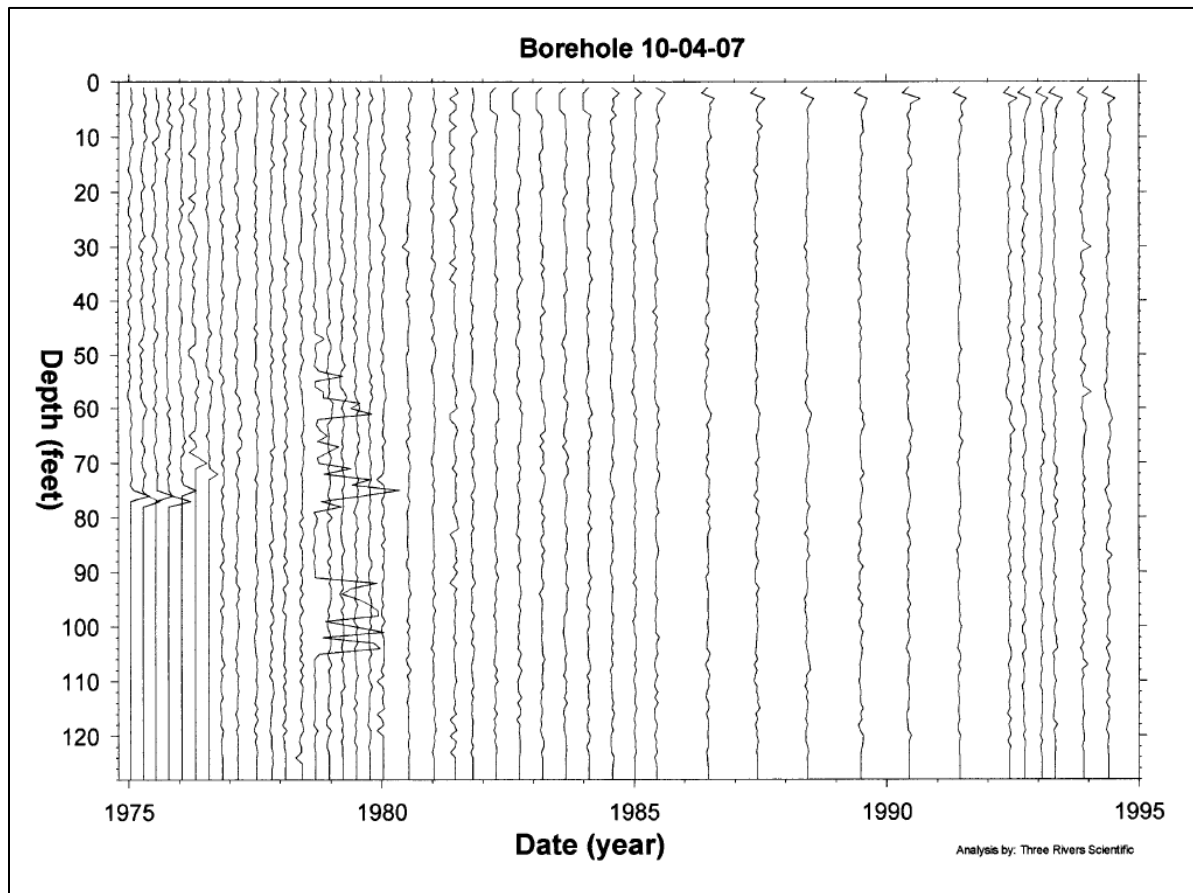
Figure 4-16. Tank A-104 Drywell 10-04-07 (RPP-8820)

In August 1998, Cs-137 was the only man-made radionuclide detected in drywell 10-04-07 (GJ-HAN-109). From the ground surface to 6-ft BGS, Cs-137 concentrations were recorded continuously at concentrations between 0.3 to 10.5 pCi/g, intermittently from 14 to 19-ft BGS at concentrations just above the minimum detection limit (MDL), at an isolated occurrence at 34-ft BGS at MDL, and intermittently from 120 to 125-ft BGS at concentrations below 1 pCi/g. Document GJ-HAN-109 reports, “The Cs-137 concentration detected between the ground surface and 5-ft probably resulted from a surface spill that migrated down into the shallow backfill surround the borehole. The majority of the contamination detected below this zone was probably dragged down during the borehole extension activity.” Therefore, drywell 10-04-07 is not included as part of the leak location for tank A-104. Figure 4-16 shows the depths of radioactivity from 1975 to 1995 (RPP-8820).

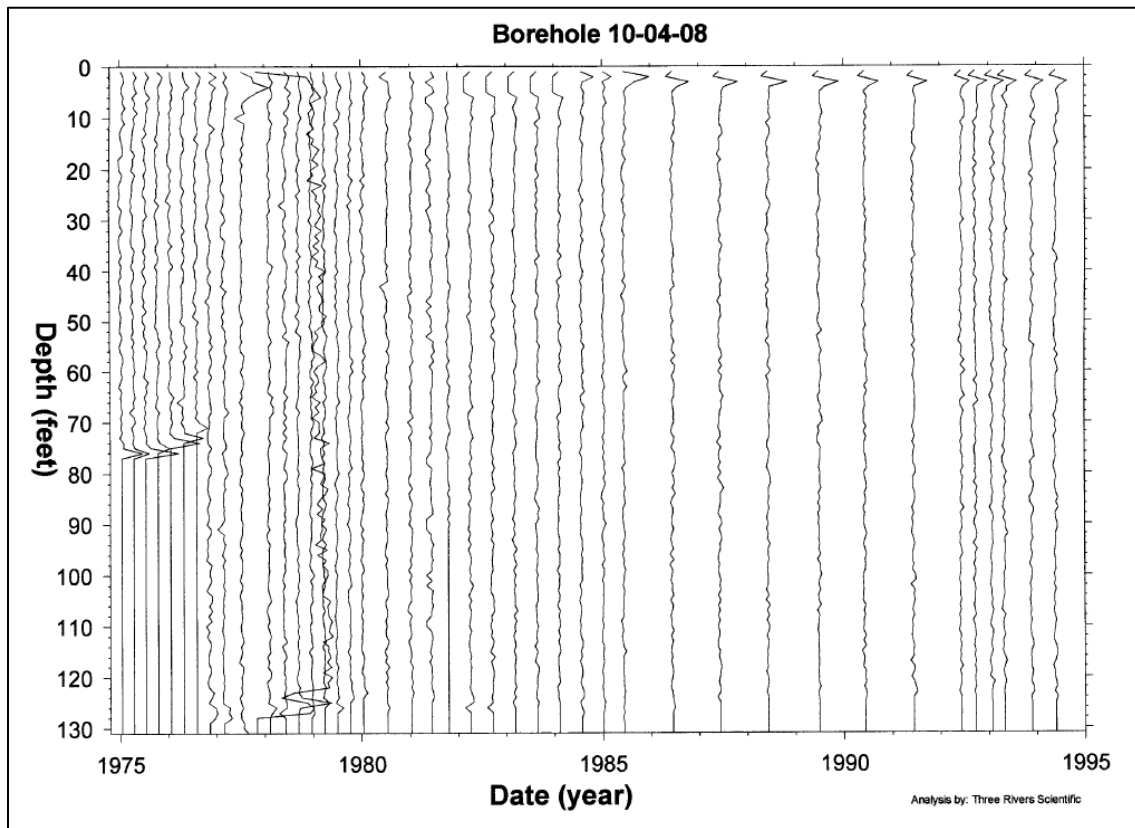
Figure 4-17. Tank A-104 Drywell 10-04-08 (RPP-8820)

In August 1998, Cs-137 was the only man-made radionuclide detected in drywell 10-04-08 (GJ-HAN-109). From the ground surface to 19-ft BGS and from 20 to 30.5-ft BGS, Cs-137 concentrations were detected. From 1 to 4-ft BGS, Cs-137 concentrations ranged from 1 to 20 pCi/g, approximately 1 pCi/g from 4 to 19-ft BGS, 0.3 to 5 pCi/g from 26 to 28-ft BGS, and 0.2 pCi/g from 55 to 70.5-ft BGS and 81 to 81.5-ft BGS. Document GJ-HAN-109 reports, “the Cs-137 contamination detected between the ground surface and 10 ft probably resulted from a surface spill that migrated down into the backfill material surrounding the borehole. The majority of the contamination detected below this zone was probably dragged down during the borehole extension activity” ...and, “The Cs-137 contamination detected from 55 to 70 ft occurs at the base of the tank; this contamination may be the result of a tank leak, but the Cs-137 concentration is too low to interpret this with confidence.” Therefore, drywell 10-04-08 is not included as part of the leak location for tank A-104. Figure 4-17 shows the depths of radioactivity from 1975 to 1995 (RPP-8820).

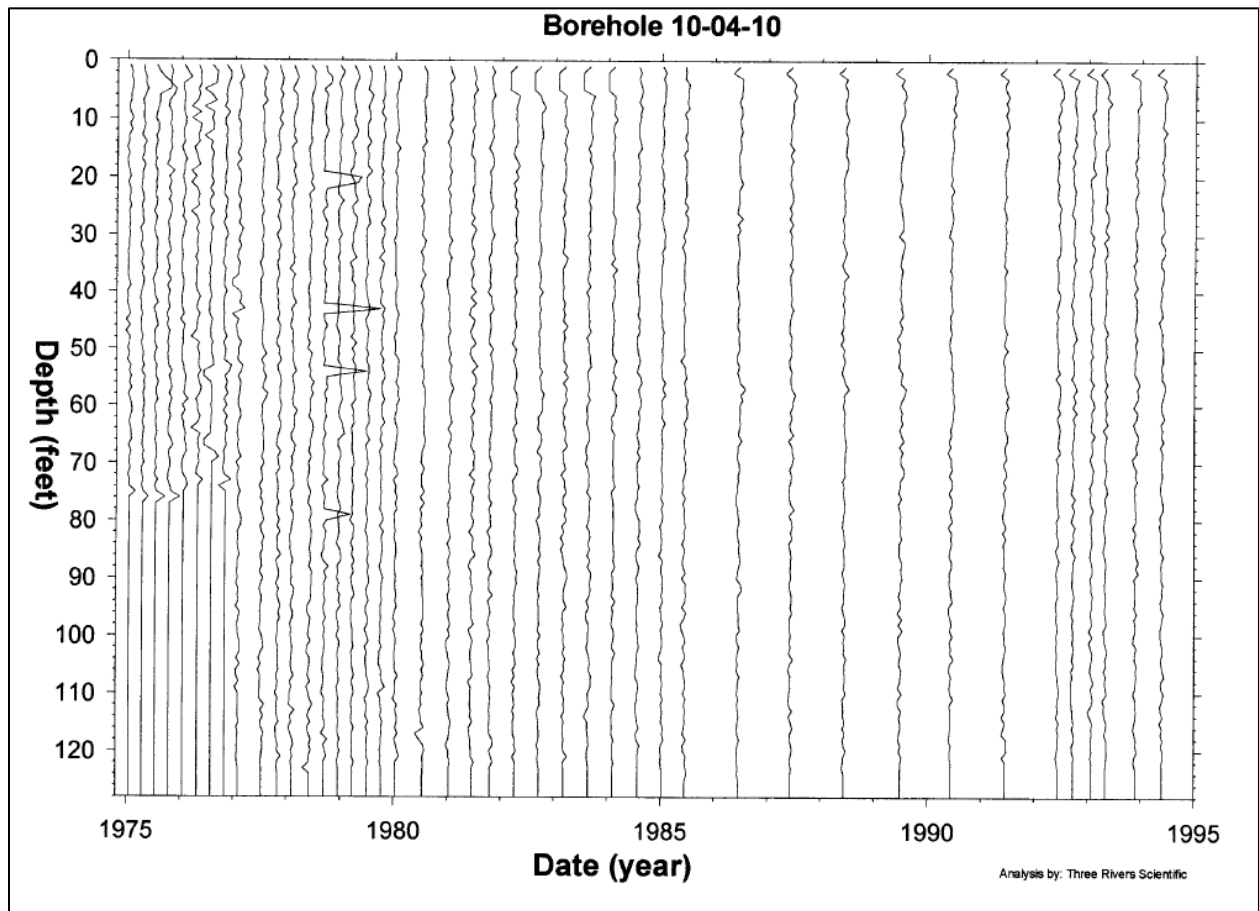
Figure 4-18. Tank A-104 Drywell 10-04-10 (RPP-8820)

In August 1998, Cs-137 was the only man-made radionuclide detected in drywell 10-04-10 (GJ-HAN-109). From the ground surface to 6-ft BGS, Cs-137 concentrations were detected continuously at concentrations ranging from 0.3 to 1.5 pCi/g and intermittently from 6 to 9.5-ft BGS at approximately 0.2 pCi/g. Isolated detections occurred at 50.5-ft BGS and at the bottom of the drywell at 0.3 pCi/g. Document GJ-HAN-109 reports, “The Cs-137 contamination detected between the ground surface and 6 ft probably resulted from a surface spill that migrated down into the shallow backfill surrounding the borehole, and at least some of the contamination was dragged down during the borehole extension activity.” Therefore, drywell 10-04-10 is not included as part of the leak location for tank A-104. Figure 4-18 shows the depths of radioactivity from 1975 to 1995 (RPP-8820).

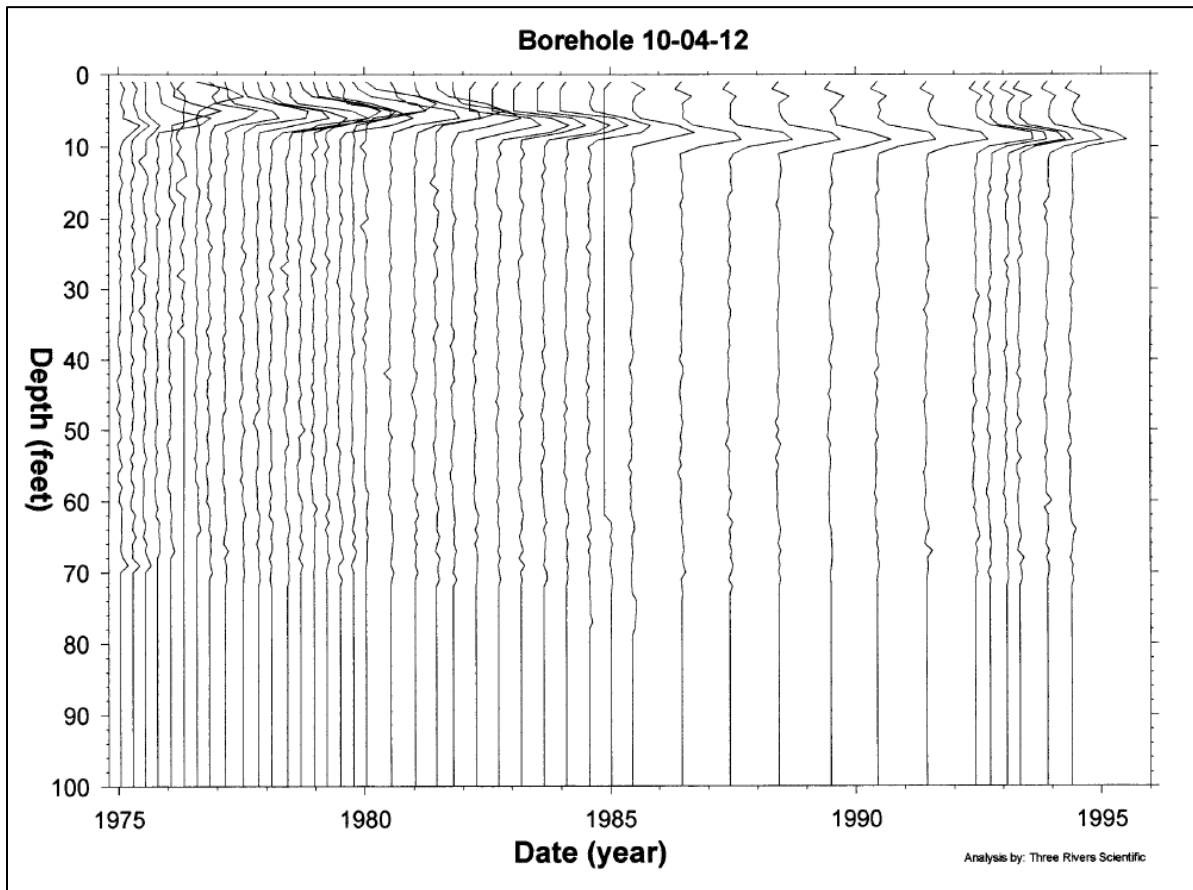
Figure 4-19. Tank A-104 Drywell 10-04-12 (RPP-8820)

In August 1998, Cs-137, Co-60, and Eu-154 were the only man-made radionuclides detected in drywell 10-04-12 (GJ-HAN-109). From the ground surface to 9-ft BGS, Cs-137 contamination was detected continuously at concentrations ranging from 0.3 pCi/g to 16 pCi/g. From 9 to 15.5-ft BGS, Cs-137 was also detected intermittently at concentrations just above the minimum detection limit and from 70.5 to 72.5-ft BGS at concentrations less than 0.3 pCi/g. From 7.5 to 8.5-ft BGS, Co-60 was detected continuously at concentrations ranging from 0.1 to 0.3 pCi/g. From 7 to 8.5-ft BGS, Eu-154 was detected continuously at concentrations ranging from 0.5 to 1.5 pCi/g. Document GJ-HAN-109 reports, “There is no indication of elevated gamma readings in data collected from this borehole that could be attributed to subsurface contamination.” Therefore, drywell 10-04-12 is not included as part of the leak location for tank A-104. Figure 4-19 shows the depths of radioactivity from 1975 to 1995 (RPP-8820).

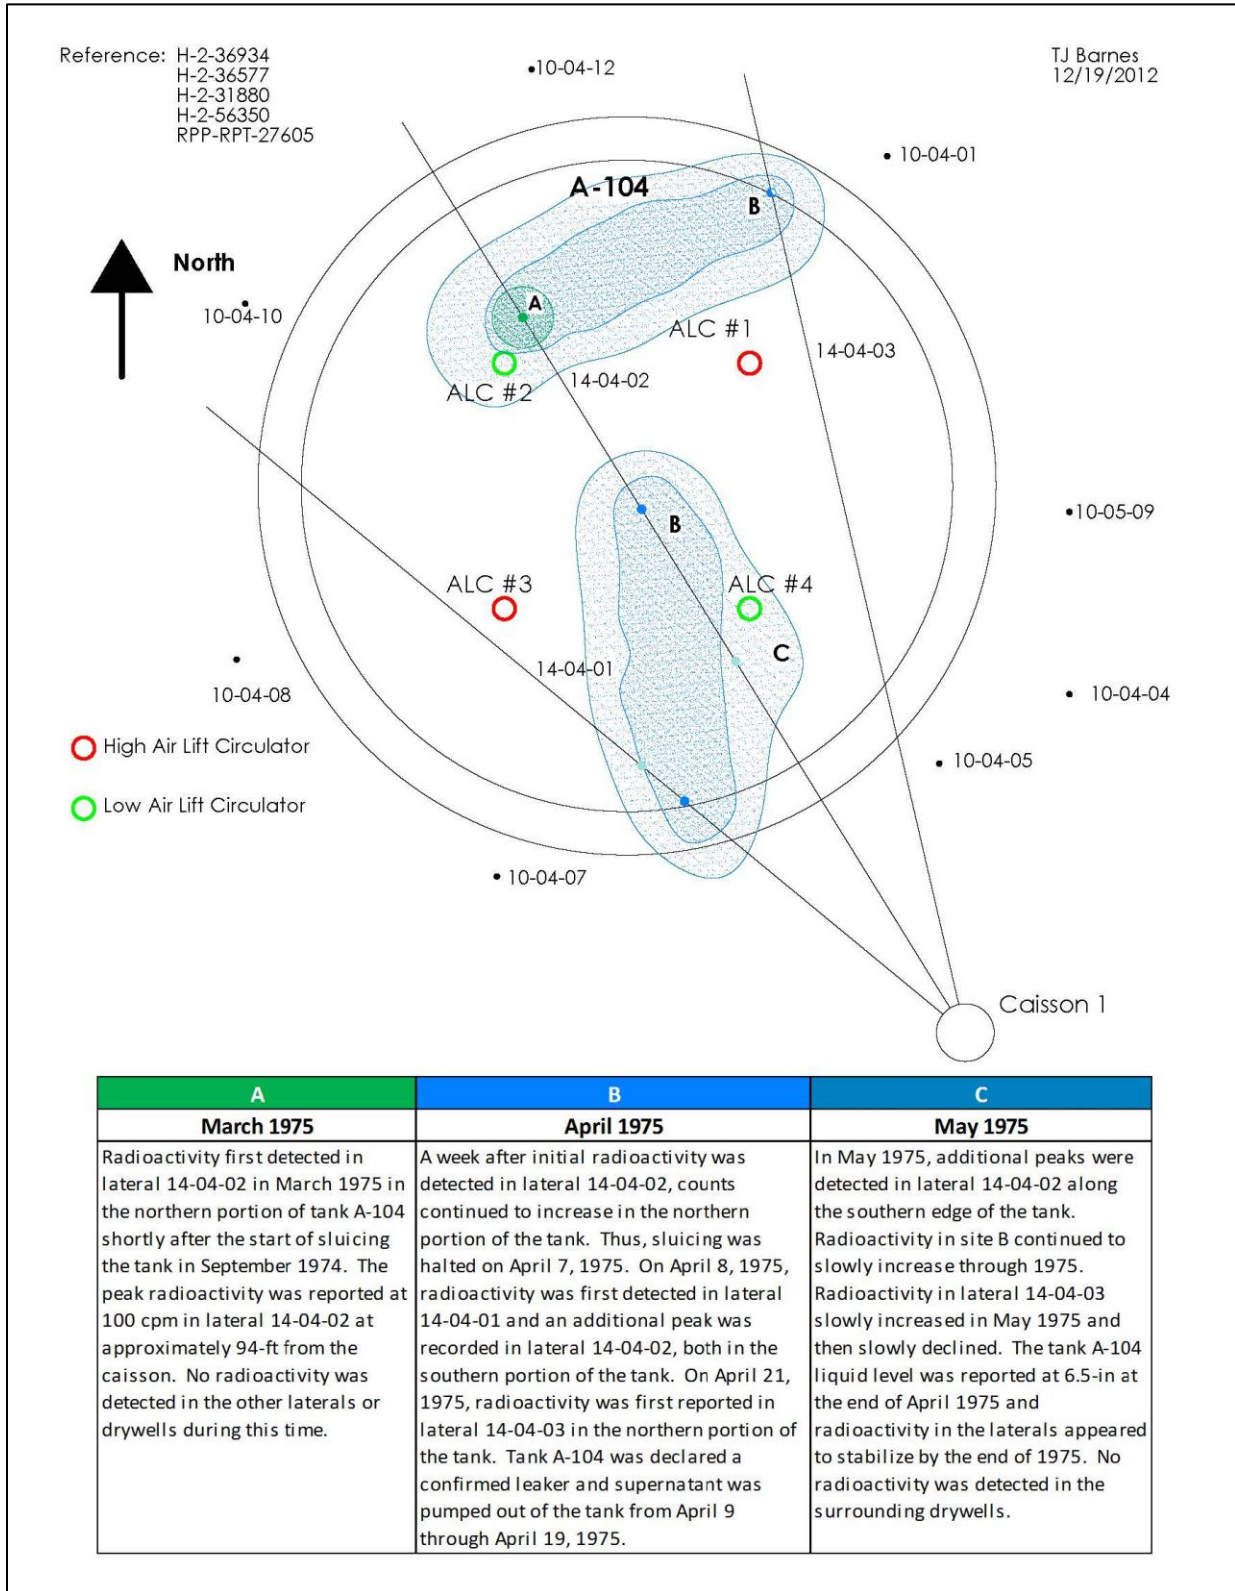
Figure 4-23. Tank A-104 Possible Radial Leak Locations and Indicators
 Tank inner ring is steel liner; outer ring is outer edge of tank footing

Leak locations in Figure 4-23 are based on peak readings and are a representation of possible initial and subsequent boundaries of radioactivity. It is likely the leak site or sites are located below the 31-in waste level as the tank A-104 liquid level was reported at 31-in at the end of February 1975, shortly before the tank was first suspected of leaking.

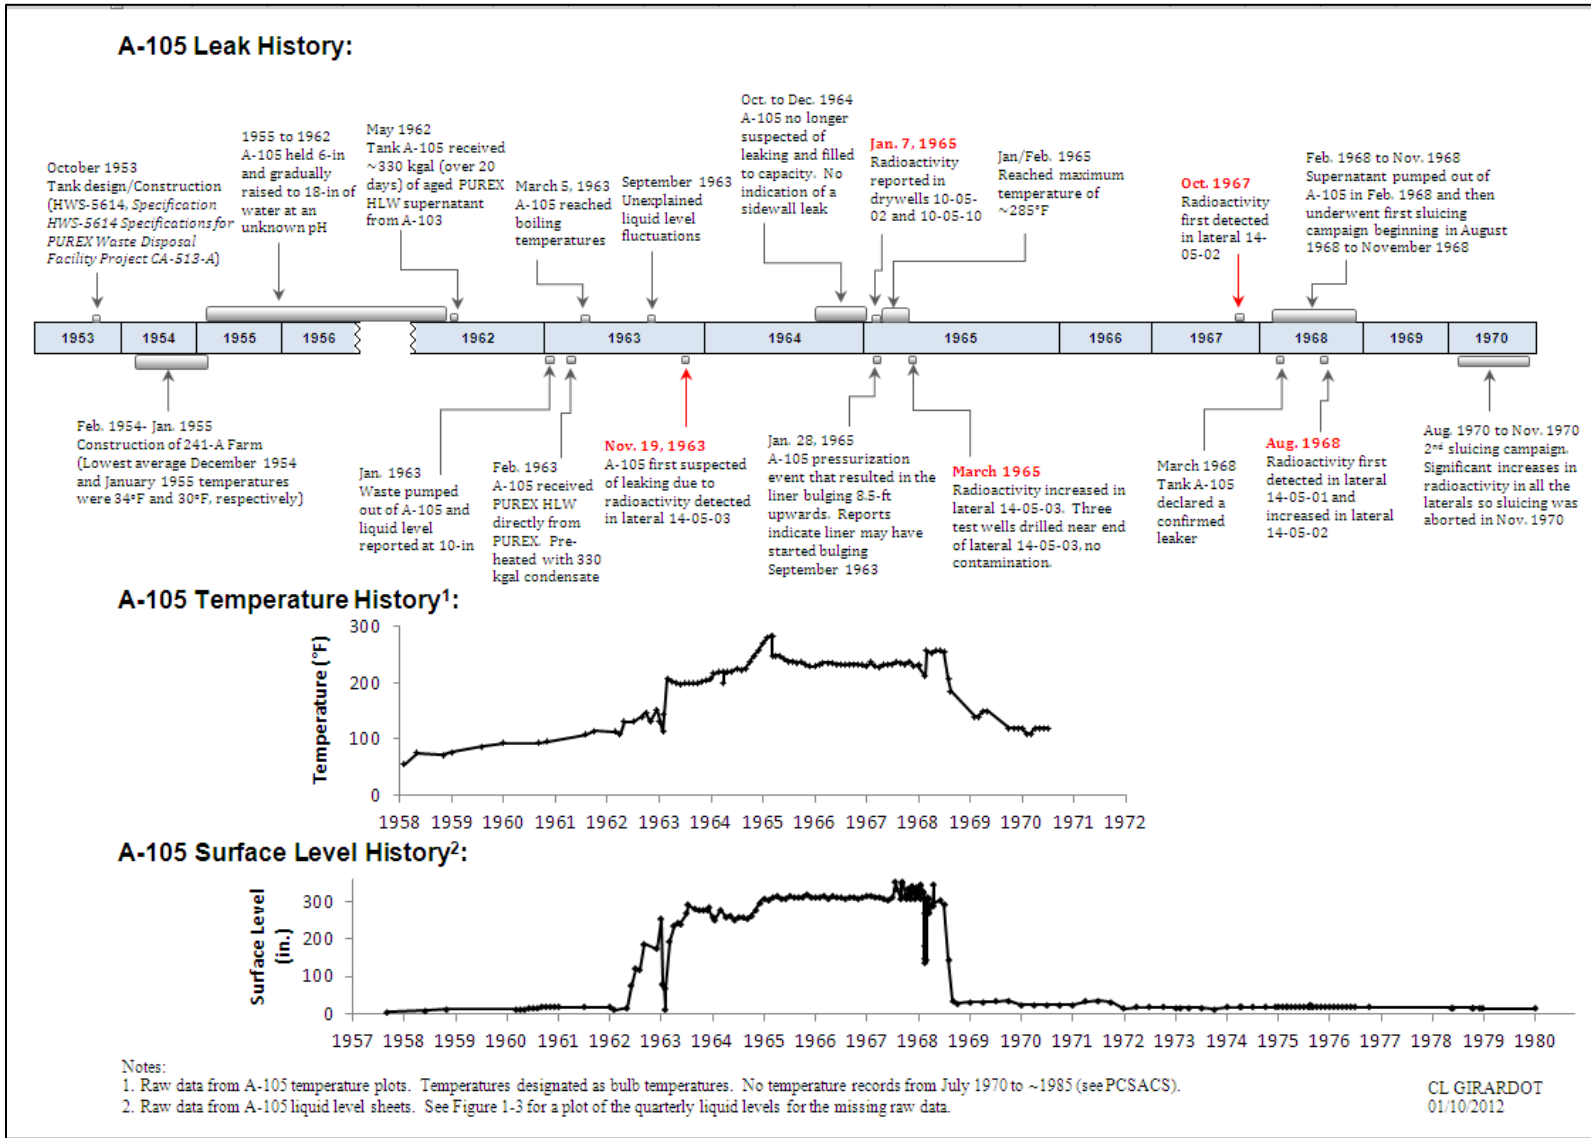
Figure 5-2. Operational Leak History of Tank A-105

Tank Thermal Histories, pages B-39 to B-45). It was reported in RPP-ENV-37956 that the maximum waste temperature was approximately 320°F in March 1963 for tank A-105. However, it appears this was a reporting anomaly as temperatures were below 275°F during this period and waste temperatures never reached above 300°F during operation (see Figure 5-2).

On January 28, 1965, tank A-105 experienced a rapid pressurization event that resulted in the tank liner bulging. During this time, waste temperatures increased from 270°F to the maximum temperature of approximately 285°F in January and February 1965 (see Figure 5-2). On March 11, 1965, when the bulb thermocouple was replaced, temperatures were reported to be approximately 250°F and remained relatively stable through June 1968. Temperatures then started to decline after removal of the tank A-105 supernatant in preparation for the sluicing with a temperature of 120°F recorded in June 1970. Waste temperatures for tank A-105 were recovered from May 1958 through June 1970 (see Appendix B2); however, no temperature data were recovered after June 1970 until 1985 (see Figure 5-2).

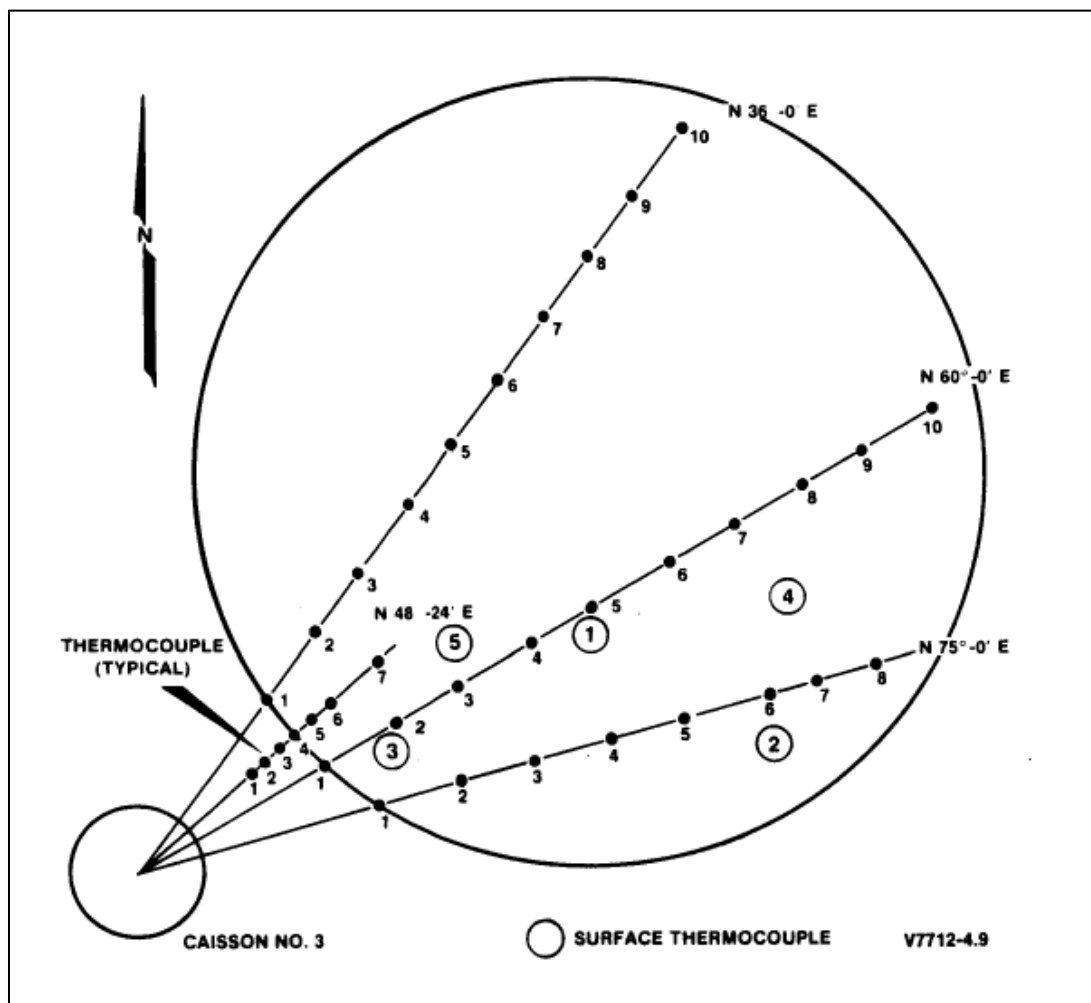
Figure 5-4. Tank A-105 Caisson #3 Temperature Laterals (RHO-CD-255)

Four temperature laterals were later drilled 2-ft under tank A-105 with fixed thermocouples from caisson #3 located southwest of the tank (see Figure 5-4). Readings began in 1968 two years after the lateral temperatures mentioned above with the highest temperature of 332°F observed in both the number 8 and 9 thermocouples of lateral N 36°0'E. This indicates that the temperatures two feet under the tank were probably much higher in 1965 and 1966 which would have far exceeded the concrete temperature limit of 325°F (RHO-CD-255, *Tank 105-A Stabilization Progress Report*).

These thermocouples were no longer the hottest when the report was written in 1978 when the highest reading in lateral N 36°0'E was reported at thermocouple number 3 at 215°F. Temperatures were later found to be higher beneath the bulged area of the tank and highest beneath the sludge pile above the liner.
