Hanford Single-Shell Tank Leak Causes and Locations - 241-A Farm

Washington River Protection Solutions

Abstract: This document identifies 241-A Tank Farm (A Farm) leak causes and locations for the 100 series leaking tanks (241-A-104 and 241-A-105) identified in RPP-ENV-37956, Hanford A and AX Farm Leak Assessment Report. This document satisfies the A Farm portion of the target (T04) in the Hanford Federal Facility Agreement and Consent Order milestone M-045-91F.

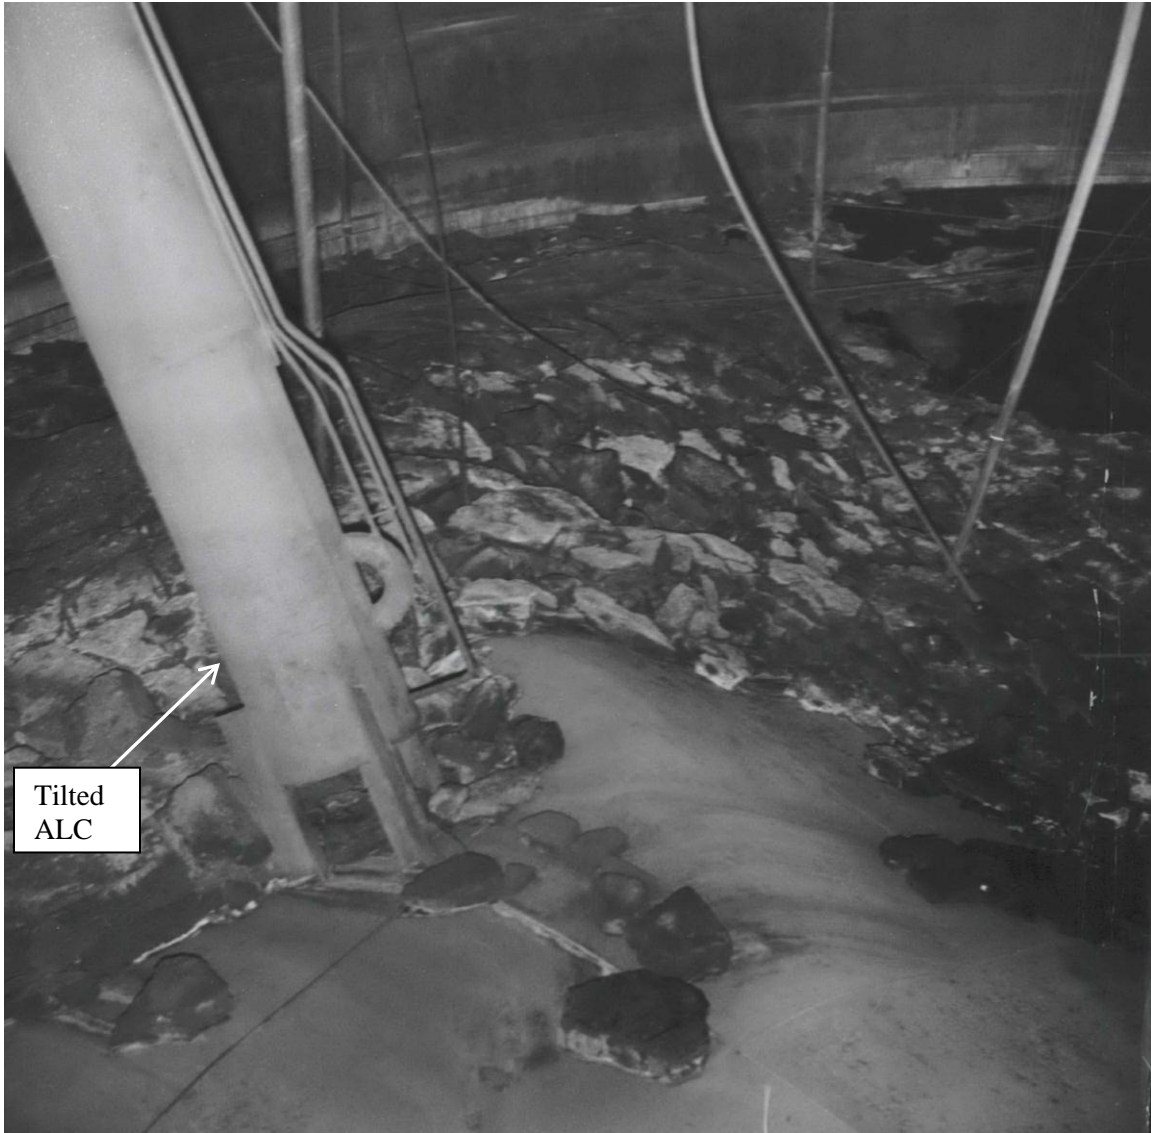
**Figure 5-6. Tank A-105 ALC #3 Photograph 0691646-21
April 16, 1969**

Earliest available photographs of tank A-105 taken on August 28 and 29, 1968 were reviewed. The steam eruption and resulting liner bulge of 8 ½-ft occurred in January 1965 and no photographs were taken during this time. One photograph of a bent ALC with the bottom liner raised beneath the ALC is shown in Figure 5-6 that was taken in April 1969. As a result of the steam eruption, it appears two of the ALCs were tilted off vertical significantly questioning their efficiencies after 1965. However, the ALCs may have been affected during the 1963 liquid level fluctuations which may have indicated periodic bulging of the bottom liner. Air flow to the ALCs was increased to the maximum and waste temperatures were apparently controlled as they remained below 300°F (see Figure 5-2).

Tilted
ALC

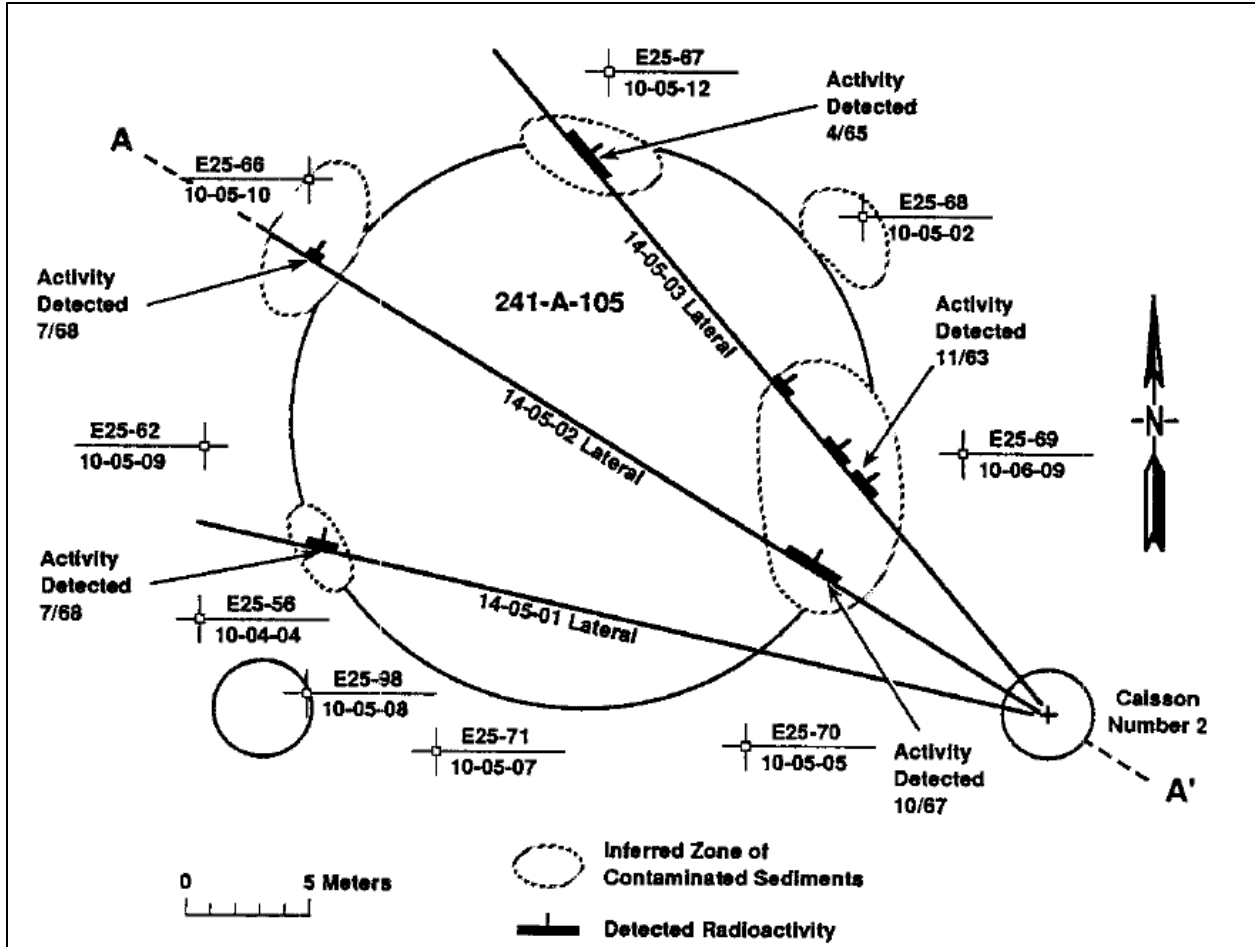
Figure 5-8. Tank A-105 Historical Lateral Radioactivity Location (WHC-EP-0412)

The first indication of a tank A-105 leak occurred in November 1963 when elevated gross gamma levels were measured over a small segment in lateral 14-05-03 (see Appendix C2) on the southeast side of the tank as shown in Figure 5-8. Initial readings were 17K cpm and continued to increase to 150K cpm a week later. Subsequently, radiation readings decreased to approximately 50K cpm by March 1965 indicating that the predominant gamma-emitting radionuclides were short-lived (ARH-78). During this time it was assumed radioactivity detected in lateral 14-05-03 was due to a sidewall leak between 260-in and 280-in (see Section

5.4.1). However, after additional waste was added in 1964 bringing the waste level above 280-in, no recurrence of contamination was detected in lateral 14-05-03. If a sidewall leak had occurred, it apparently self-healed. No radioactivity was detected in the other laterals or drywells during this time.

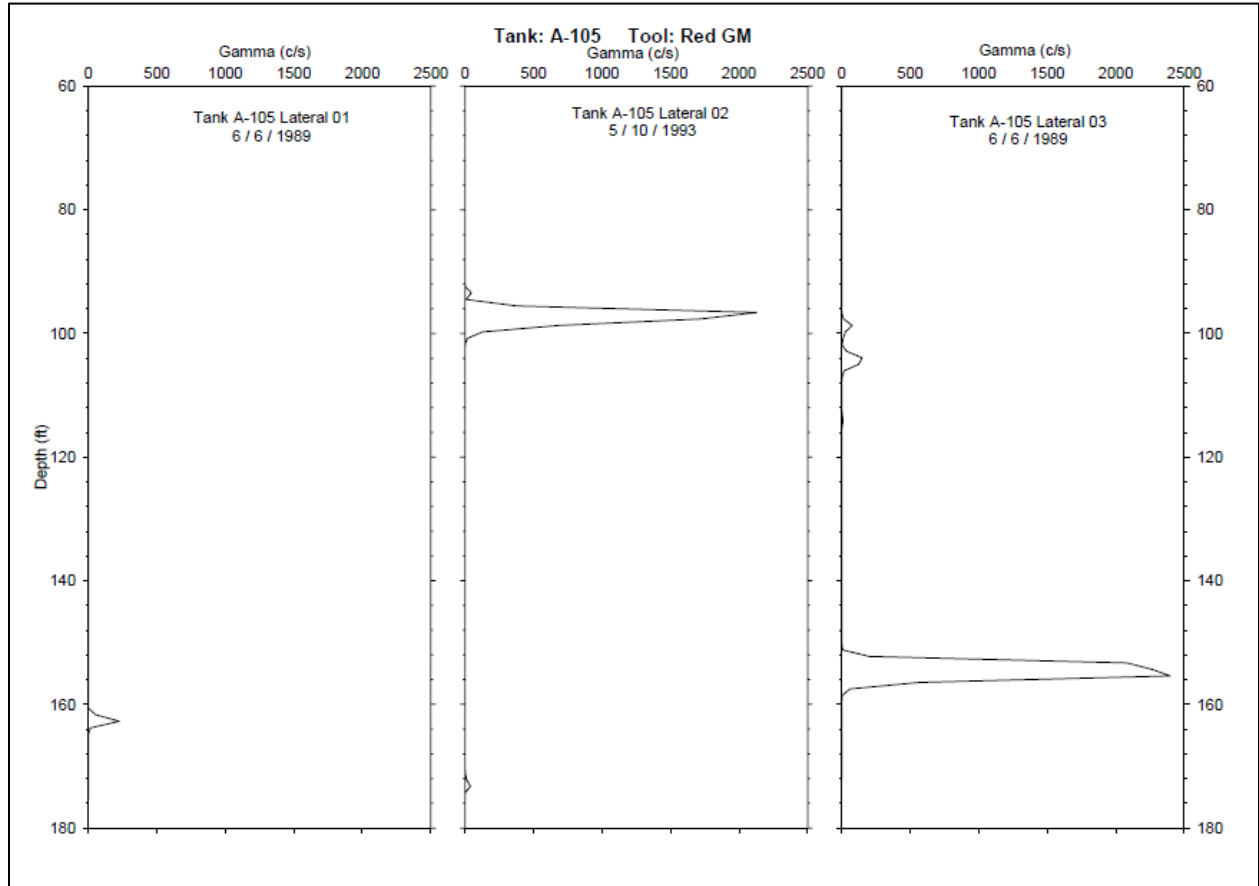
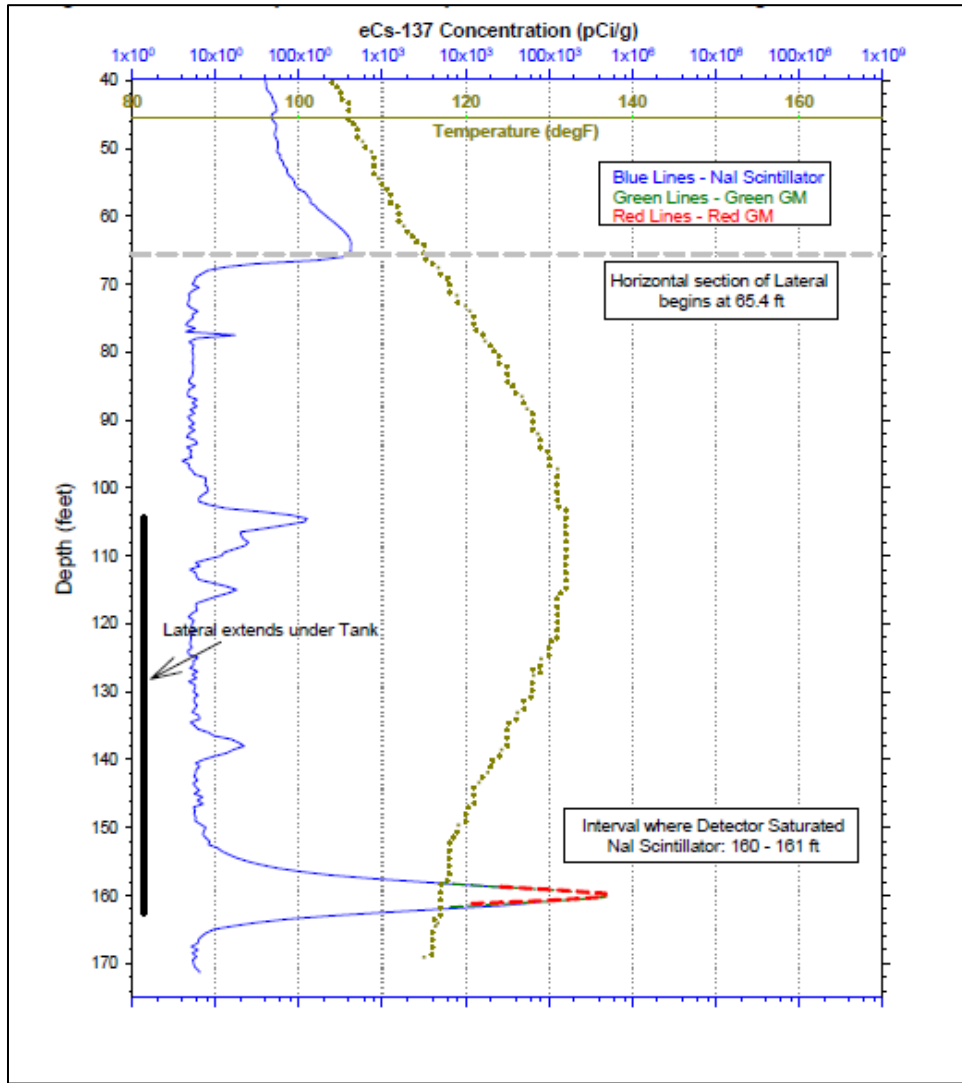
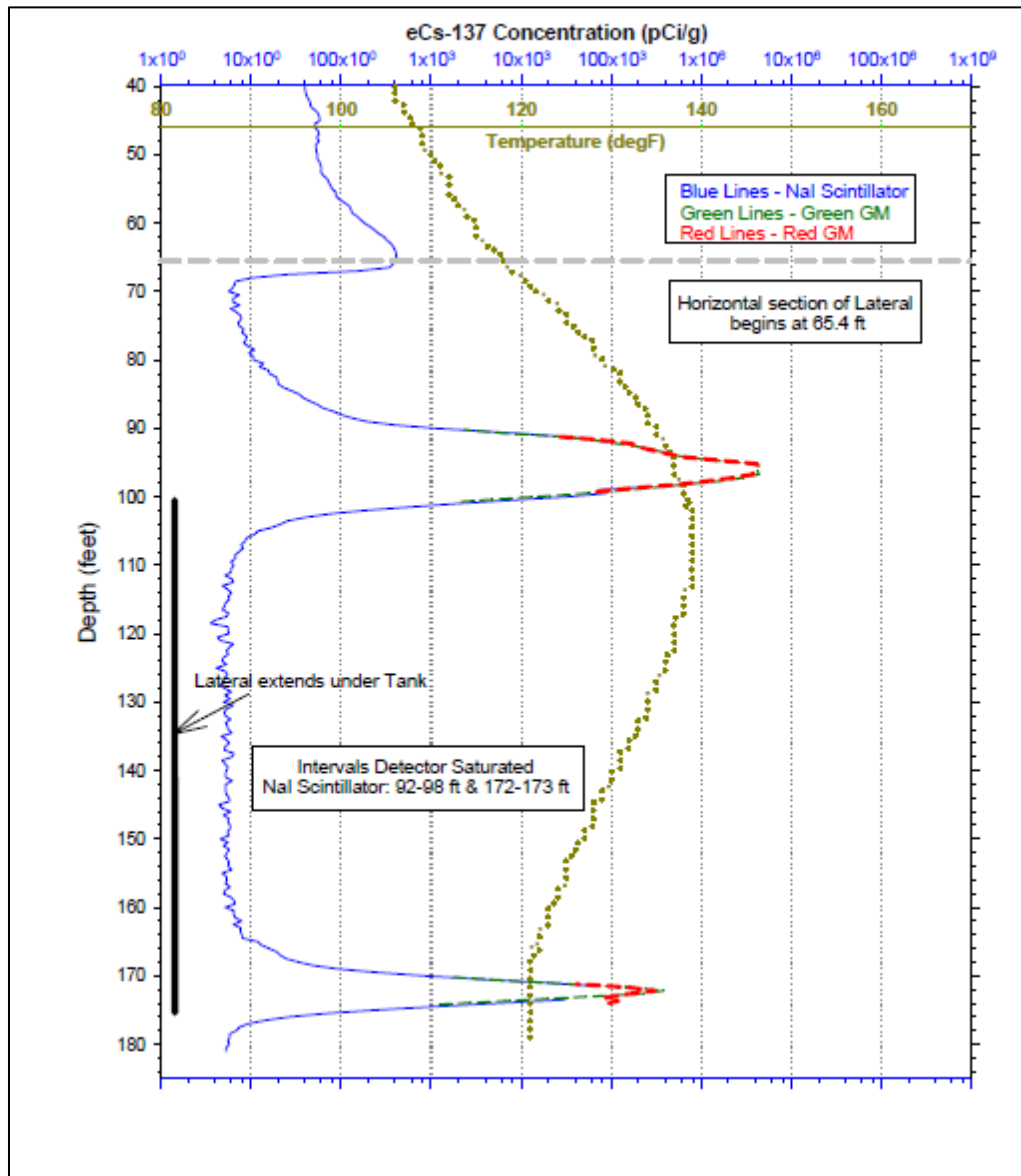
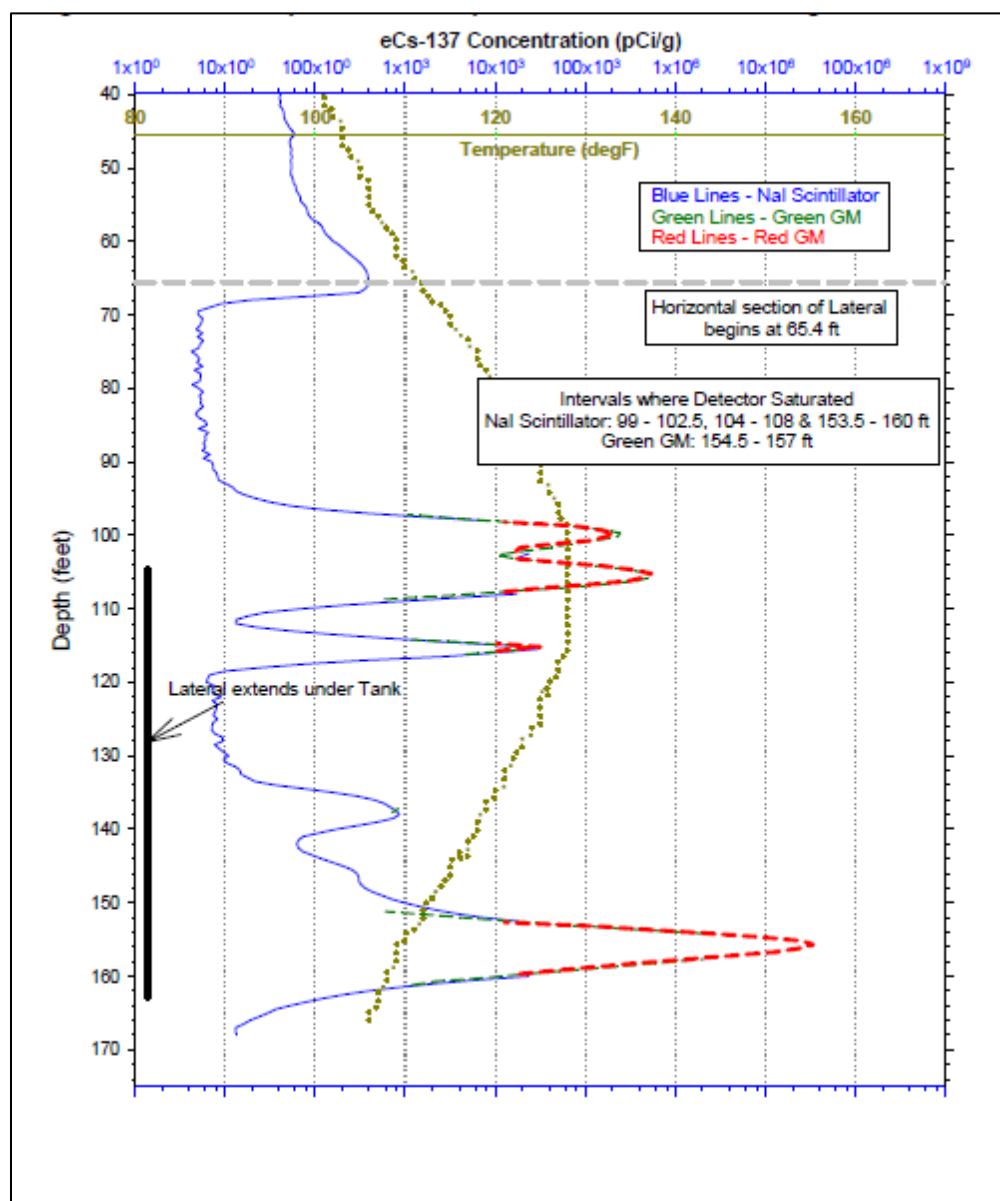
The second sluicing campaign for tank A-105 began August 25, 1970 and ran until November 1970. In August 1970, all laterals showed increased readings compared with the October 1968 readings. Radioactivity increased to 40K cpm in lateral 14-05-01, 375K cpm in lateral 14-05-02, and 960K cpm in lateral 14-05-03. These fluctuations indicated that leaks were active and since readings remained high, the sluicing operation was aborted on November 17, 1970 (WHC-MR-0264). In May 1978, a radiation spike from 516K cpm to 1,080K cpm occurred in lateral 14-05-03 (see Appendix C2). A large nearby water line spill in February 1978 of 60 kgal that redistributed mobile gamma-emitting contaminants already present in the vadose zone appears to have been the most likely cause of this contamination increase. See Figure 5-10 through Figure 5-12 for the most recent lateral scans, which the locations correlate well with the historical data.

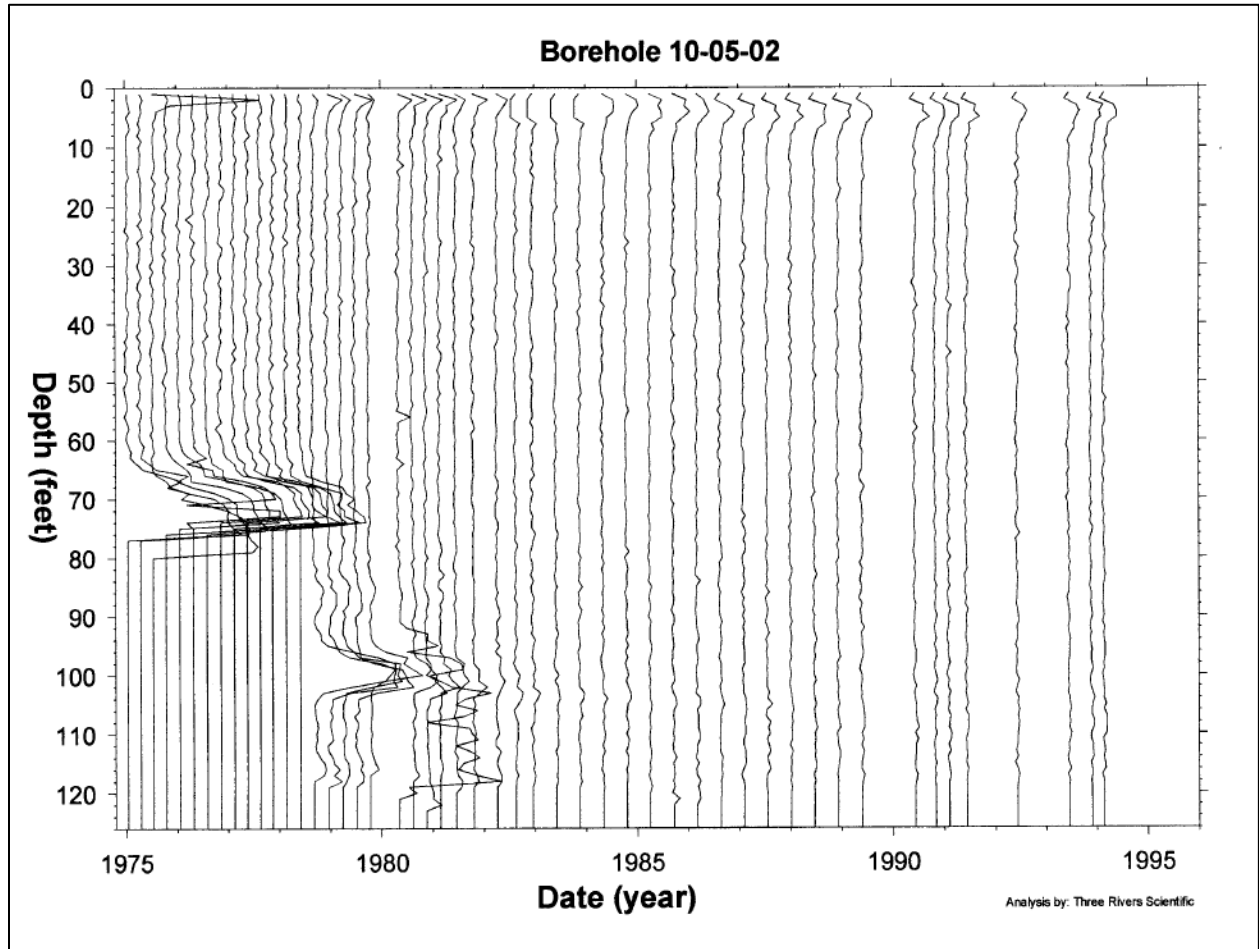
Figure 5-13. Tank A-105 Drywell 10-05-02 (RPP-8820)

By October 1998, Cs-137 was the only man-made radionuclide detected in drywell 10-05-02 with the maximum concentration of 10 pCi/g detected at 4-ft BGS (GJ-HAN-110). Deeper down in the drywell, Cs-137 concentration was reported as less than 1 pCi/g. Document GJ-HAN-110 reports, "The source of anomalous activity in the historical gross gamma-ray logs from 1975 to 1978 is questionable. The contaminants in this depth range may have accumulated and concentrated on the outside or inside of the casing near the original bottom of the borehole. It is possible that this concentrated material was detected by the gross gamma-ray device, but the residual contaminants in the formation were at too low a concentration to be detectable." Since Cs-137 levels were reported to be small in drywell 10-05-02, it is likely the historical radioactivity detected was short-lived, such as RuRh-106 (see Figure 5-14). The source of radioactivity detected in this drywell may have been migration of mobile RuRh-106 from a tank A-105 leak. Figure 5-13 shows the depths of radioactivity from 1975 to 1995 (RPP-8820).

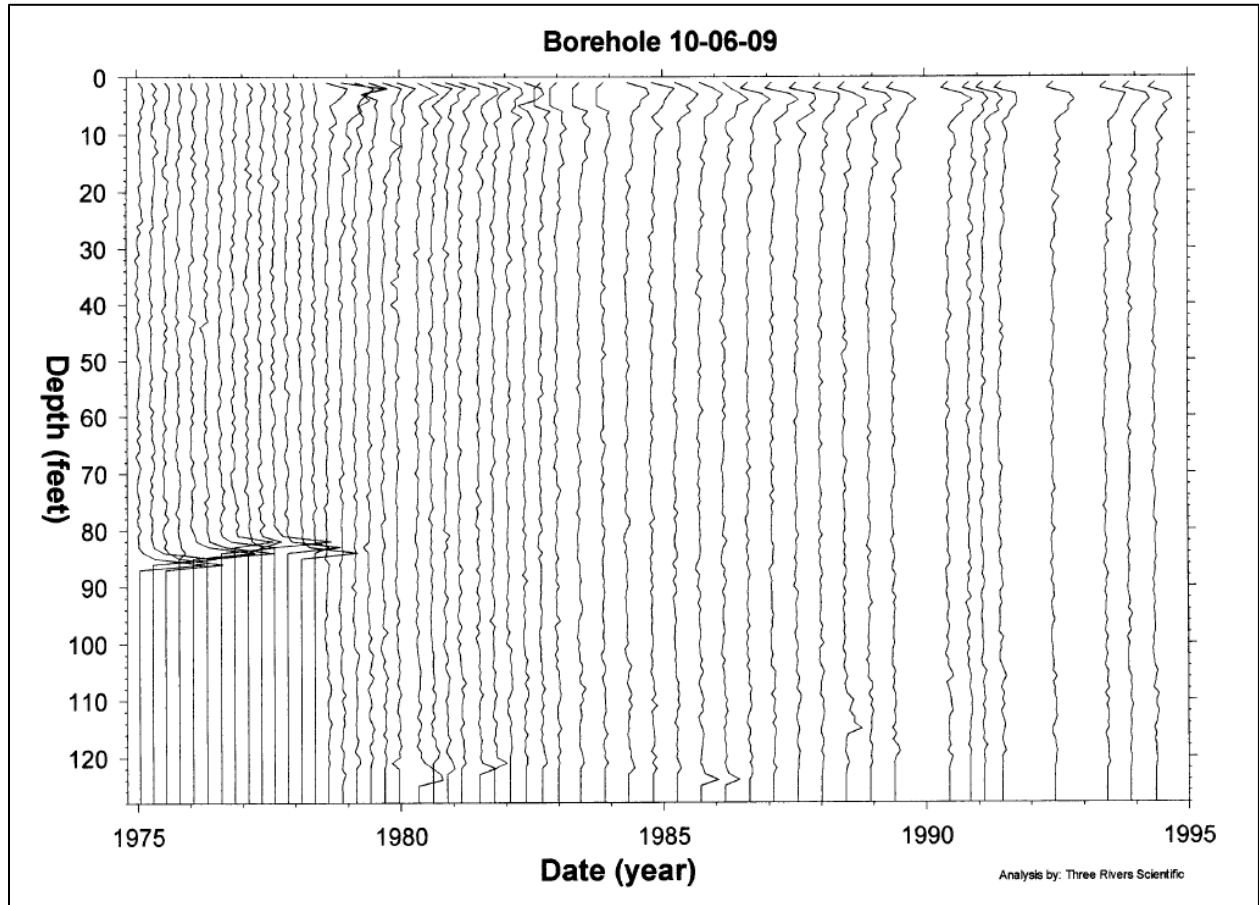
Figure 5-15. Tank A-105 Drywell 10-06-09 (RPP-8820)

Drywell 10-06-09 was drilled in April 1962 with the first recoverable readings on January 3, 1965 with two peaks of 45K cpm reported at 18-ft and 83-ft BGS. Radioactivity levels remained relatively stable at these two depths through August 1966. The next recoverable reading was on September 13, 1972 and reported as less than values at this time through 1986 (see Appendix D2).

In October 1998, Cs-137 was the only man-made radionuclide detected in drywell 10-06-09 (GJ-HAN-110). From the ground surface to 15-ft BGS, Cs-137 was detected continuously at concentrations ranging from 5 to 20 pCi/g. Document GJ-HAN-110 reports, "The Cs-137 contamination detected between the ground surface and 20 ft probably resulted from the borehole extension activities. The contamination in this interval was first recognized after completion of the borehole extension and was most likely placed around the borehole when the temporary 8-in starter casing was installed." Therefore, drywell 10-06-09 is not included as part of the leak location for tank A-105. Figure 5-15 shows the depths of radioactivity from 1975 to 1995 (RPP-8820).

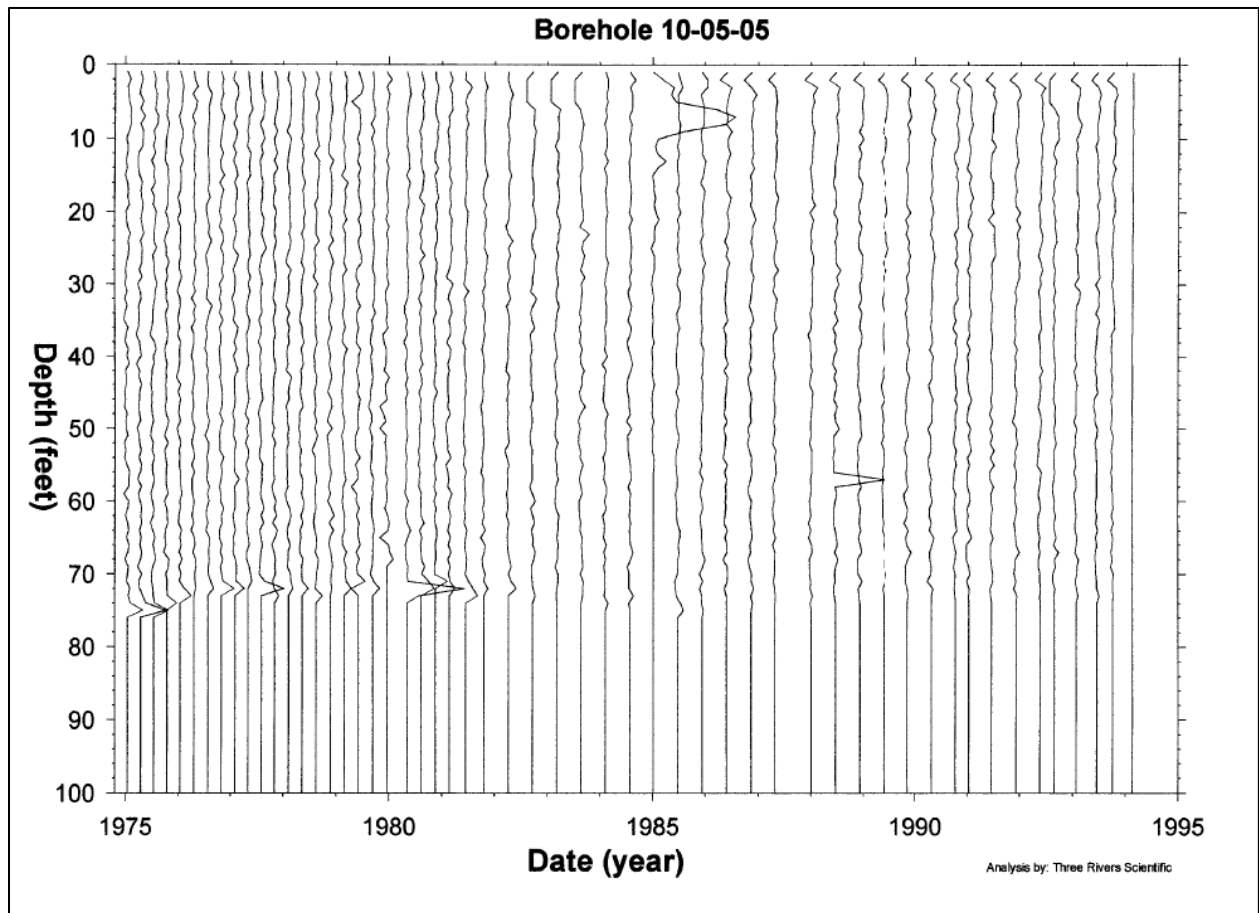
Figure 5-16. Tank A-105 Drywell 10-05-05 (RPP-8820)

In October 1998, Cs-137 was detected nearly continuously from the ground surface to 74.5-ft BGS (GJ-HAN-110). From 6-ft to 55-ft BGS, Cs-137 concentrations were about 1 pCi/g or less and between 1 and 3 pCi/g at depths below 55-ft BGS. Document GJ-HAN-110 reports, "Shape factor results for the rest of the borehole have been interpreted to indicate a contaminant distribution that is local to the borehole casing, indicating that the contamination was probably carried down from the contaminated interval near the top of the borehole during the drilling operation." Therefore, drywell 10-05-05 is not included as part of the leak location for tank A-105. Figure 5-16 shows the depths of radioactivity from 1975 to 1995 (RPP-8820).

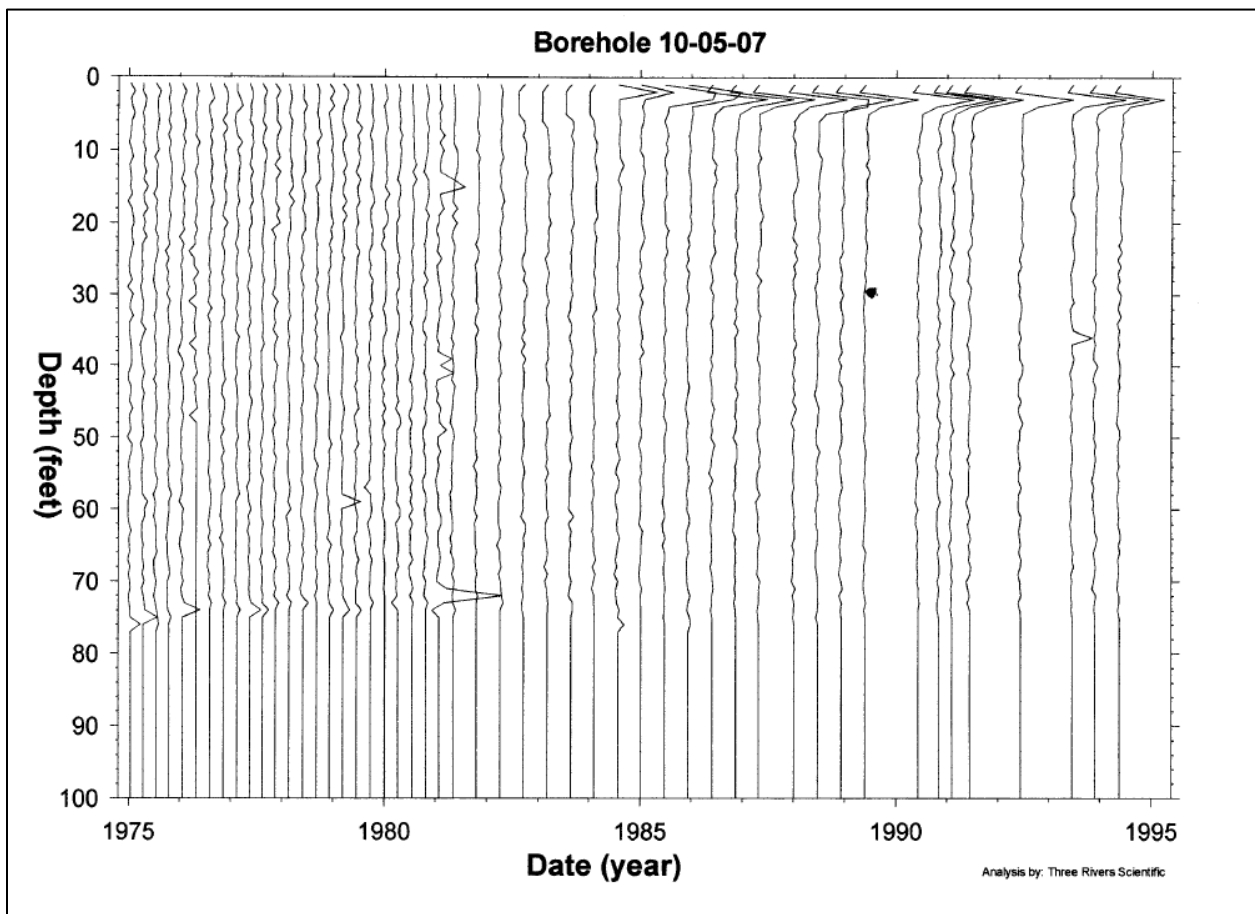
Figure 5-17. Tank A-105 Drywell 10-05-07 (RPP-8820)

In October 1998, Cs-137 was the only man-made radionuclide detected in drywell 10-05-07 (GJ-HAN-110). From 6-ft to 32-ft BGS, Cs-137 concentrations were recorded intermittently at concentrations between 0.15 pCi/g (just above the minimum detection limit) to about 1 pCi/g. From 32-ft to 57-ft BGS, Cs-137 was also noted sporadically at concentrations just above the minimum detection limit and from 57 to 75.5-ft BGS at concentrations between 0.3 pCi/g to about 1 pCi/g. Document GJ-HAN-110 reports that the Cs-137 concentration detected in this drywell was likely caused by dragdown from a surface spill. Therefore, drywell 10-05-07 is not included as part of the leak location for tank A-105. Figure 5-17 shows the depths of radioactivity from 1975 to 1995 (RPP-8820).

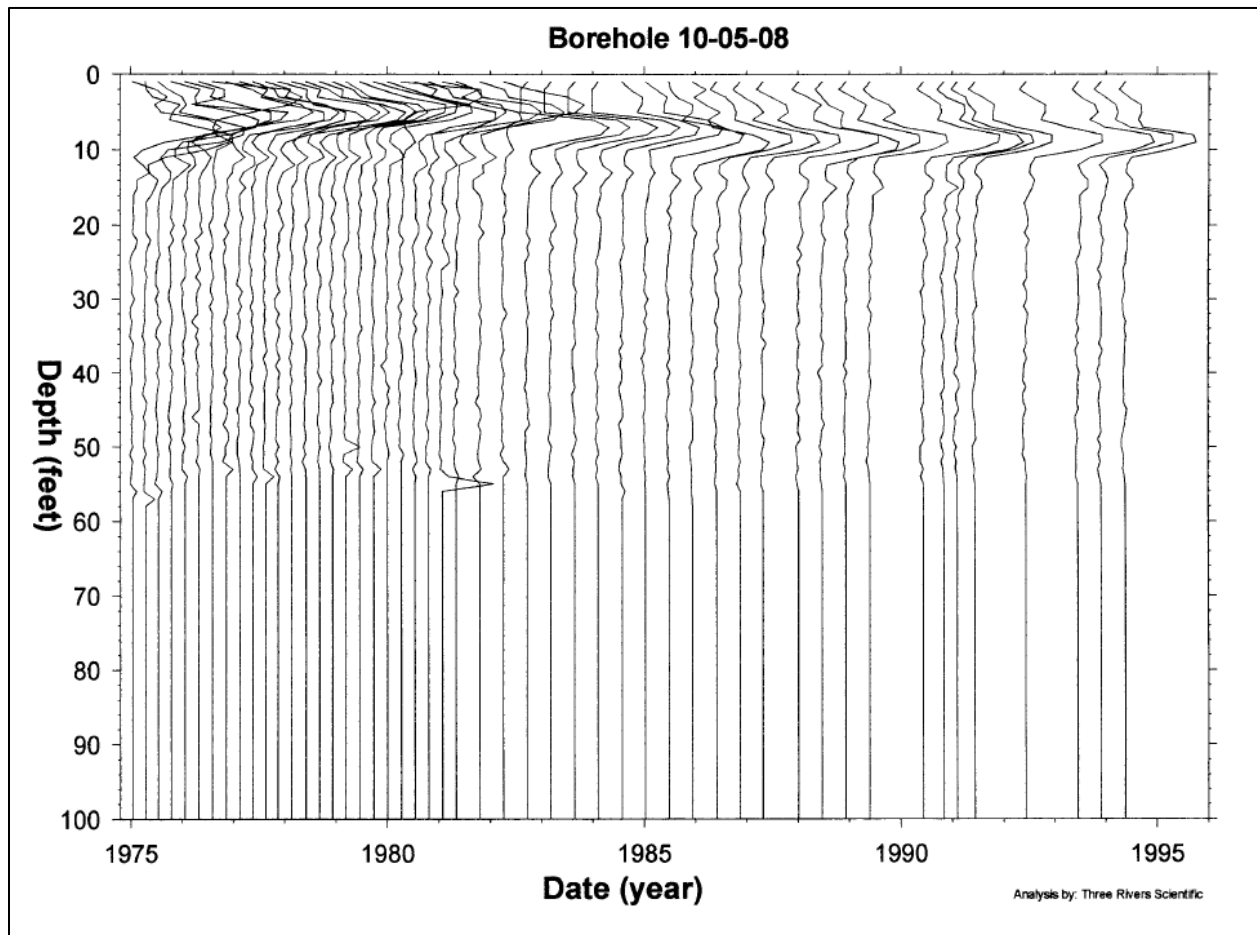
Figure 5-18. Tank A-105 Drywell 10-05-08 (RPP-8820)

In October 1998, Cs-137 was the only man-made radionuclide detected in drywell 10-05-08 (GJ-HAN-110). From the ground surface to 21-ft BGS, Cs-137 concentrations were detected at concentrations less than 1 pCi/g below a depth of 15-ft. At 3.5-ft BGS, a Cs-137 peak was recorded at approximately 25 pCi/g, at 7.5-ft BGS at about 130 pCi/g, and at 13.5-ft BGS at 6 pCi/g. Document GJ-HAN-110 reports, “The Cs-137 contamination detected between the ground surface and 15 ft probably resulted from a surface spill or a leak from a near-surface pipeline that migrated down into the shallow backfill surrounding the borehole.” Therefore, drywell 10-05-08 is not included as part of the leak location for tank A-105. Figure 5-18 shows the depths of radioactivity from 1975 to 1995 (RPP-8820).

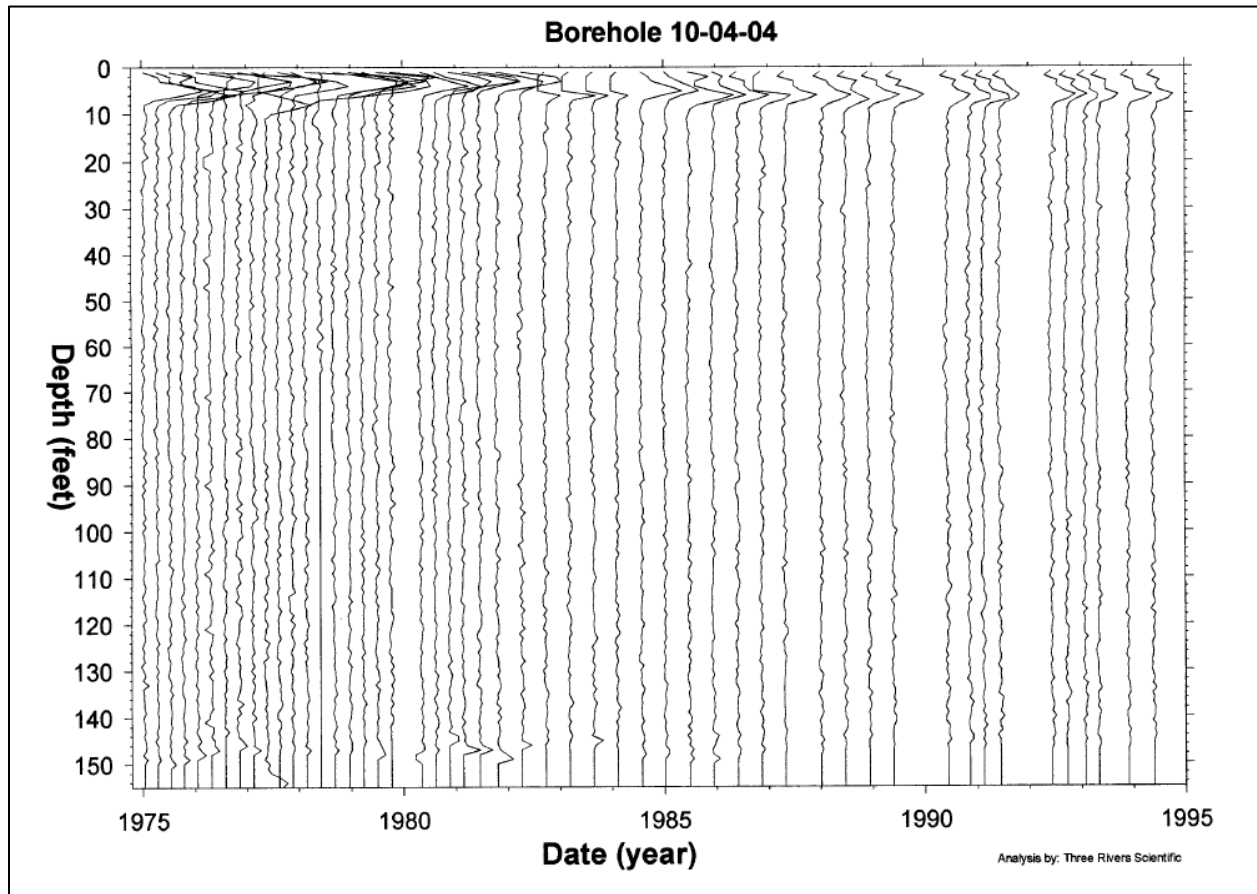
Figure 5-19. Tank A-105 Drywell 10-04-04 (RPP-8820)

In October 1998, Cs-137 and Eu-154 were the only man-made radionuclides detected in drywell 10-04-04 (GJ-HAN-110). From the ground surface to 6.5-ft BGS and at the bottom of the drywell, Cs-137 was detected continuously. The maximum Cs-137 concentration was 20 pCi/g at about 1-ft BGS and concentrations decreased to 2 pCi/g or less below this depth. Eu-154 contamination was detected from 4.5 to 6.5-ft BGS at concentrations less than 1 pCi/g. Document GJ-HAN-110 reports, “The man-made contaminants detected from the ground surface to 6.5 ft probably resulted from a surface spill that migrated into the backfill surrounding the borehole. The shape factor analysis suggests that some of the contamination occurs as a linear source, such as a pipeline.” Therefore, drywell 10-04-04 is not included as part of the leak location for tank A-105. Figure 5-19 shows the depths of radioactivity from 1975 to 1995 (RPP-8820).

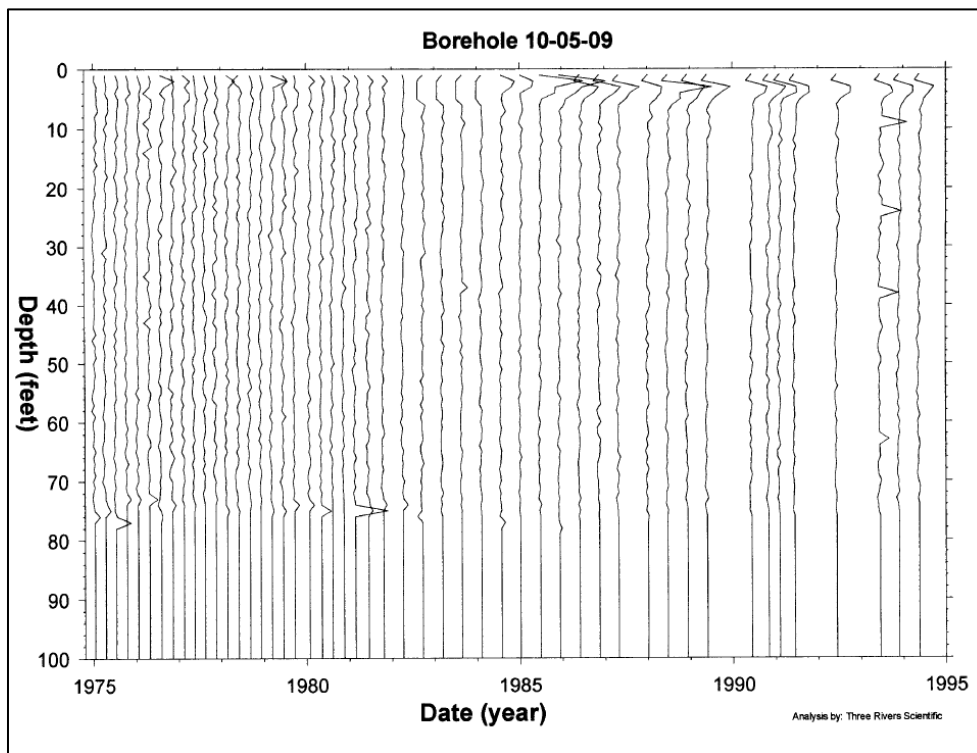
Figure 5-20. Tank A-105 Drywell 10-05-09 (RPP-8820)

Therefore, drywell 10-05-09 is not included as part of the leak location for tank A-105. Figure 5-20 shows the depths of radioactivity from 1975 to 1995 (RPP-8820).

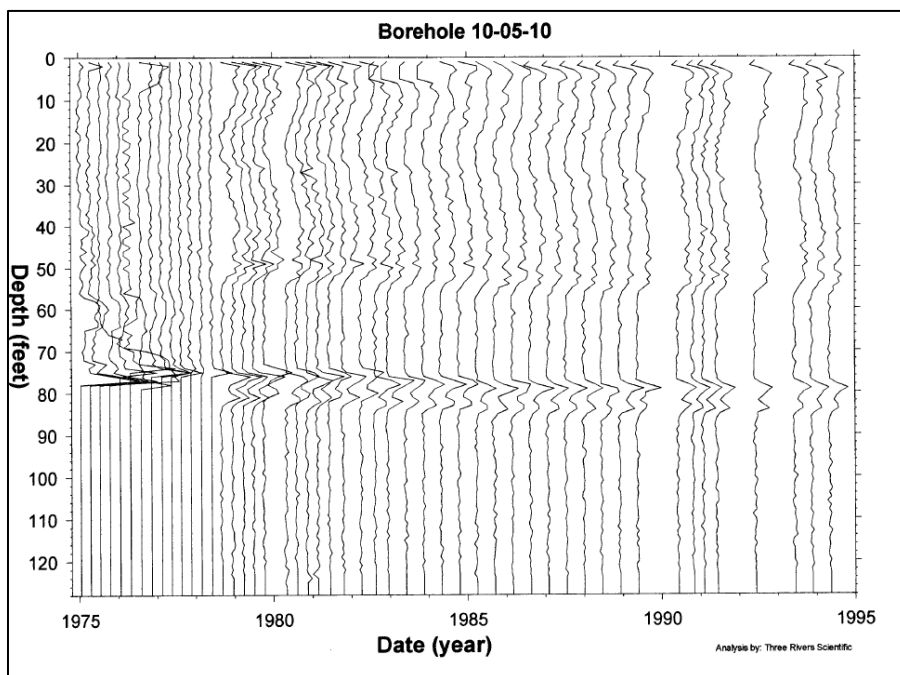
Figure 5-21. Tank A-105 Drywell 10-05-10 (RPP-8820)

Document GJ-HAN-110 reports, “The zones of anomalous gamma-ray activity indicated on the historical gross gamma logs and the Cs-137 contamination detected by the SGLS from 58 to 64 ft and 76 to 86 ft appear to correlate with activity detected in lateral 14-05-02 at 170 ft. The lateral logs for this borehole indicate the presence of a fairly long-lived contaminant at this location. It appears that a plume from a leak near the northwest side of tank A-105 intercepted borehole 10-05-10 from 58 to 64 ft and 76 to 86 ft and lateral 14-05-02 at 170 ft. However, the mechanism by which the contamination arrived at these locations is not clearly understood.” However, with the quantity of water and supernatant used for cooling and leaching tank A-105 waste that some leakage occurred that provided a transport mechanism for some of the radionuclides. Figure 5-21 shows the depths of radioactivity from 1975 to 1995 (RPP-8820).

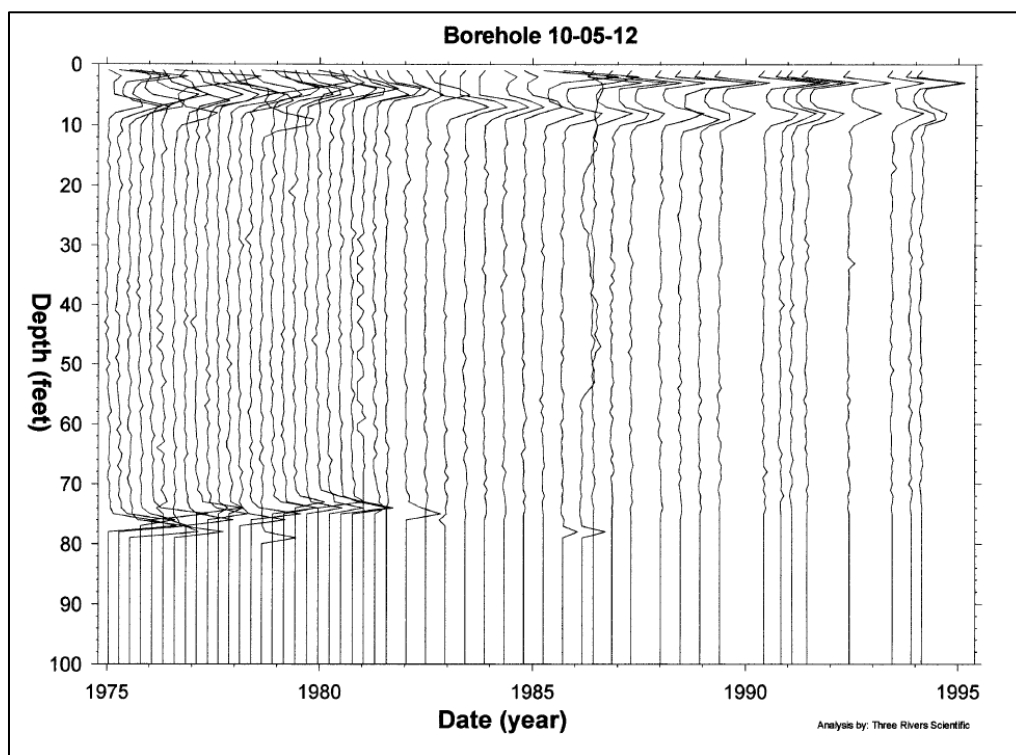
Figure 5-22. Tank A-105 Drywell 10-05-12 (RPP-8820)

Document GJ-HAN-110 reports, “It is most likely that the contamination in the entire interval from 13 ft to the bottom of the borehole is restricted to the borehole casing, and was probably carried downward from the near-surface contaminated zone during the drilling operation.” Document GJ-HAN-110 also stated that radioactivity reported from the ground surface to 13-ft BGS likely resulted from surface spills that have migrated into the backfill sediments. Therefore, drywell 10-05-12 is not included as part of the leak location for tank A-105. Figure 5-22 shows the depths of radioactivity from 1975 to 1995 (RPP-8820).

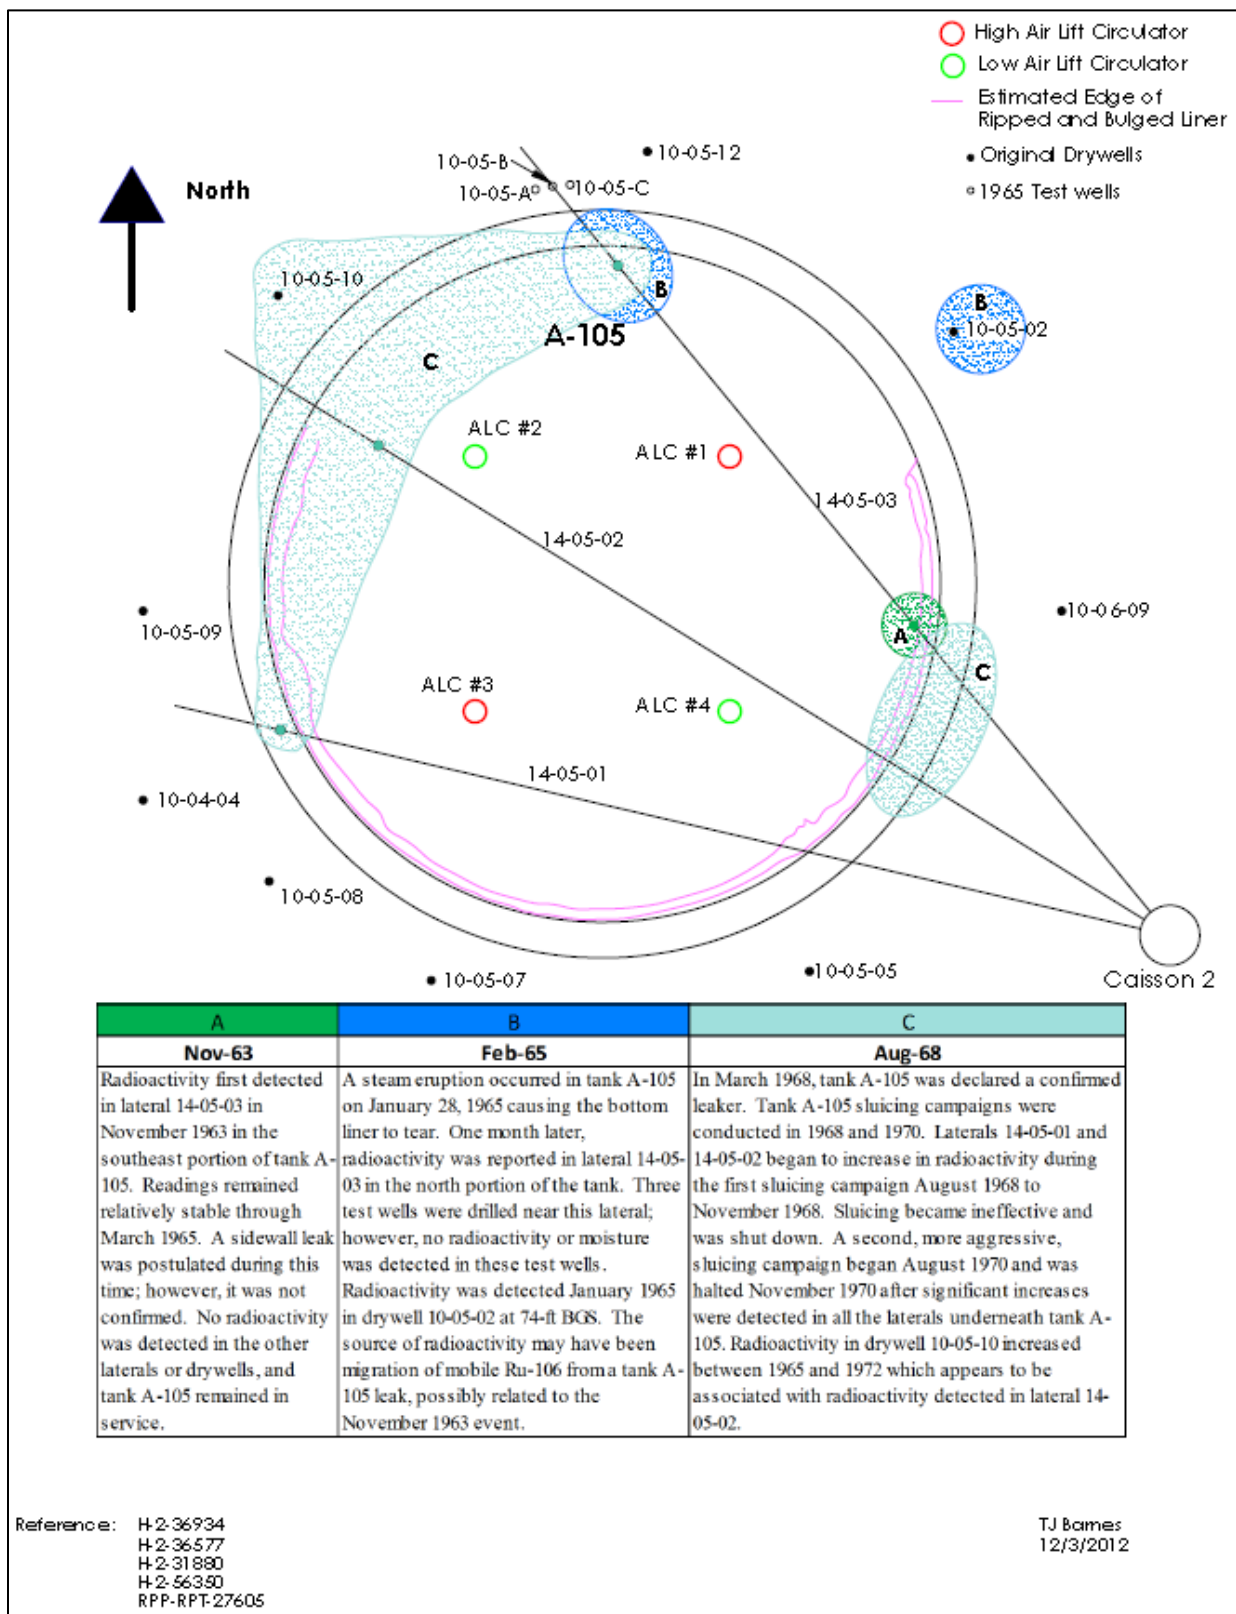
Figure 5-26. Tank A-105 Possible Radial Leak Locations and Indicators

Tank A-105 was first suspected of leaking in November 1963 due to radioactivity being detected in lateral 14-05-03 in the southeast portion of the tank (see site A in Figure 5-26). It was postulated that a sidewall leak occurred during this time as the waste liquid level was raised from 260-in to 280-in four months earlier. After the liquid level was reduced to 260-in, radiation readings in the lateral slowly decreased leading to the observation that a sidewall leak was minor and had self-healed. However, a sidewall leak remains inconclusive. No radioactivity was detected in the other laterals or drywells, and tank A-105 remained in service. Radioactivity remained relatively stable through March 1965 in lateral 14-05-03.

On January 28, 1965, a steam eruption occurred in tank A-105 causing the bottom liner to tear approximately $\frac{3}{4}$ around the perimeter of the tank. One month later, radioactivity was reported in lateral 14-05-03 in the north portion of the tank (see site B in Figure 5-26). Three test wells were drilled near the end of this lateral; however, no radioactivity or moisture was detected in these test wells indicating the leak was likely small and localized. Radioactivity was detected in drywell 10-05-02 at 74-ft BGS. The source of radioactivity may have been migration of mobile RuRh-106 from a tank A-105 leak, possibly related to the November 1963 event (see site A in Figure 5-26). However, there was no indication of radioactivity in nearby drywell 10-06-09 and the radioactivity detected in drywell 10-05-02 could have been from another source. No other drywells or laterals showed indications of radioactivity during this time.

Approximately three years after the steam eruption, tank A-105 was declared a confirmed leaker in March 1968. Two sluicing campaigns were conducted on tank A-105 in 1968 and 1970. During the first sluicing campaign in August to November 1968, radioactivity began to increase in laterals 14-05-01 and 14-05-02 near the end of these laterals along the northwestern edge of tank A-105 (see site C in Figure 5-26). Sluicing became ineffective and the first sluicing campaign was shut down in November 1968. A second, more aggressive, sluicing campaign began August 1970 and was halted in November 1970 after significant increases in radioactivity were detected in all the laterals underneath tank A-105.

A liner bulge of approximately 8 $\frac{1}{2}$ -ft was detected after the January 1965 steam eruption near the center of the tank. The liner tore approximately $\frac{3}{4}$ along the tank perimeter as a result of the steam eruption as shown below in Figure 5-26. The location of the ripped liner is superimposed on Figure 5-26 in relationship to the tank leak locations and leak indicators. It is likely that the potential liner bulge indicated in 1963 started in the south east portion of the tank as the first detection of radioactivity was at the location in lateral 14-05-03 and the most severe portion of the January 1965 liner bulging was near that portion of the tank.

Leak locations in Figure 5-26 are based on peak readings and are a representation of possible boundaries of radioactivity under the tank. The radioactivity detected in drywell 10-05-02 stands alone as there is not enough information to depict the likely specific path to the source. It should be noted that the estimated edge of the ripped and bulged liner indicates that there were various leak paths through the grout, asphaltic membrane, concrete base and soil to the actual points of detection.
