Hanford Single-Shell Tank Leak Causes and Locations - 241-C Farm

C.L. Girardot, D.G. Harlow

Washington River Protection Solutions

Key Words: leak location, leak cause, tank, integrity assessment, C Farm, C-101, C-105, leak assessment

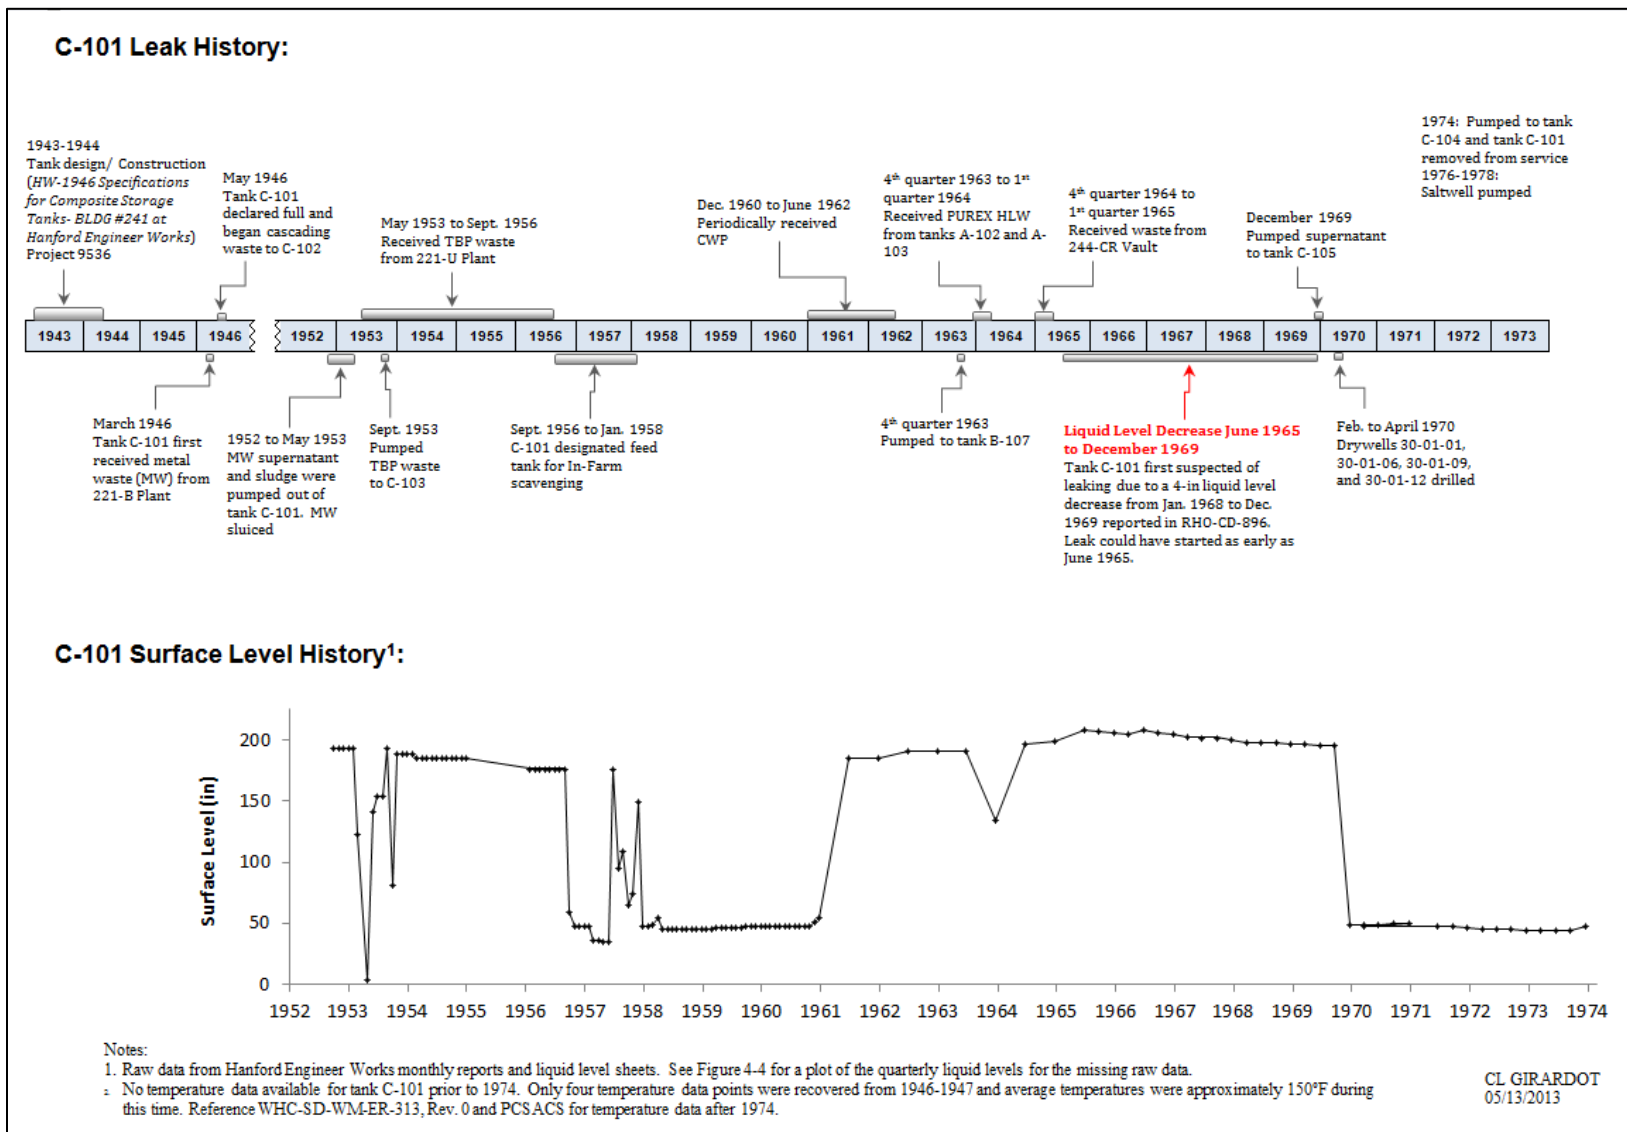
Figure 4-2. Operational Leak History of Tank C-101

The operational history of tank C-101 leak related details including temperature and liquid level is charted in Figure 4-2.

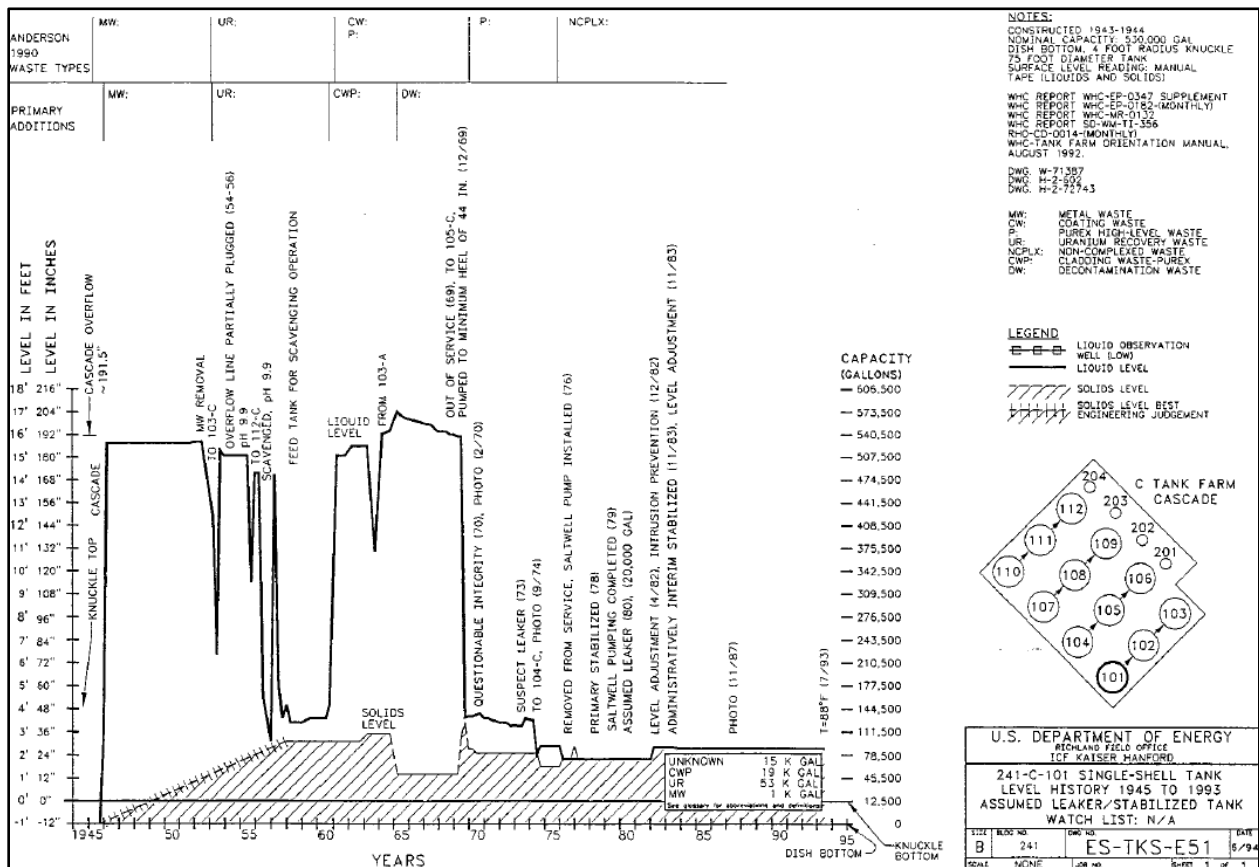
Figure 4-4. Tank C-101 End of Quarter Surface Level

The liquid level plot in Figure 4-4 indicates the transfer activity into and out of tank C-101. The liquid levels are end of quarter levels so this figure may not reflect all transfers into and out of the tank that occurred during the operational history. See Figure 4-2 for historical monthly liquid level readings.

Tank C-101 was first suspected of leaking based on a liquid level decrease of 4-in between approximately January 1968 and December 1969 and the supernatant was pumped to tank C-105 (RHO-CD-896, January 1980, *Review of Classification of Nine Hanford Single-Shell "Questionable Integrity" Tanks*). The RHO-CD-896 document review of the 1968-1969 liquid level decrease, radioactivity detected in drywells drilled in 1970, and potential liquid level decrease January 1970 to October 1973 recommended tank C-101 be reclassified as a Confirmed Leaker. The reclassification was based primarily on the 1968-1969 liquid level decrease with

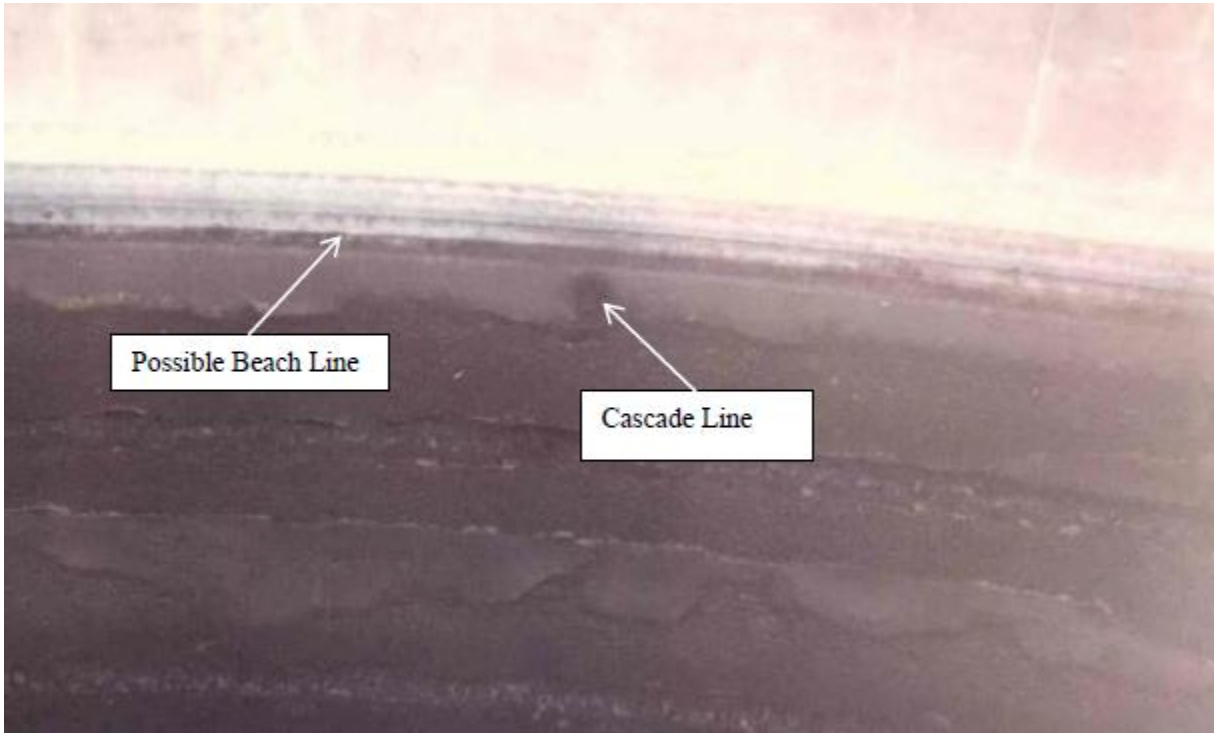
Figure 4-6. Tank C-101 Photograph February 13, 1970 (700695-13 CN)

Tank C-101 photographs taken in February of 1970 show a beachline covering the cascade line penetration (see Figure 4-6). The February 1970 set of photographs was taken about 3 months after pumping the supernatant to tank C-105.

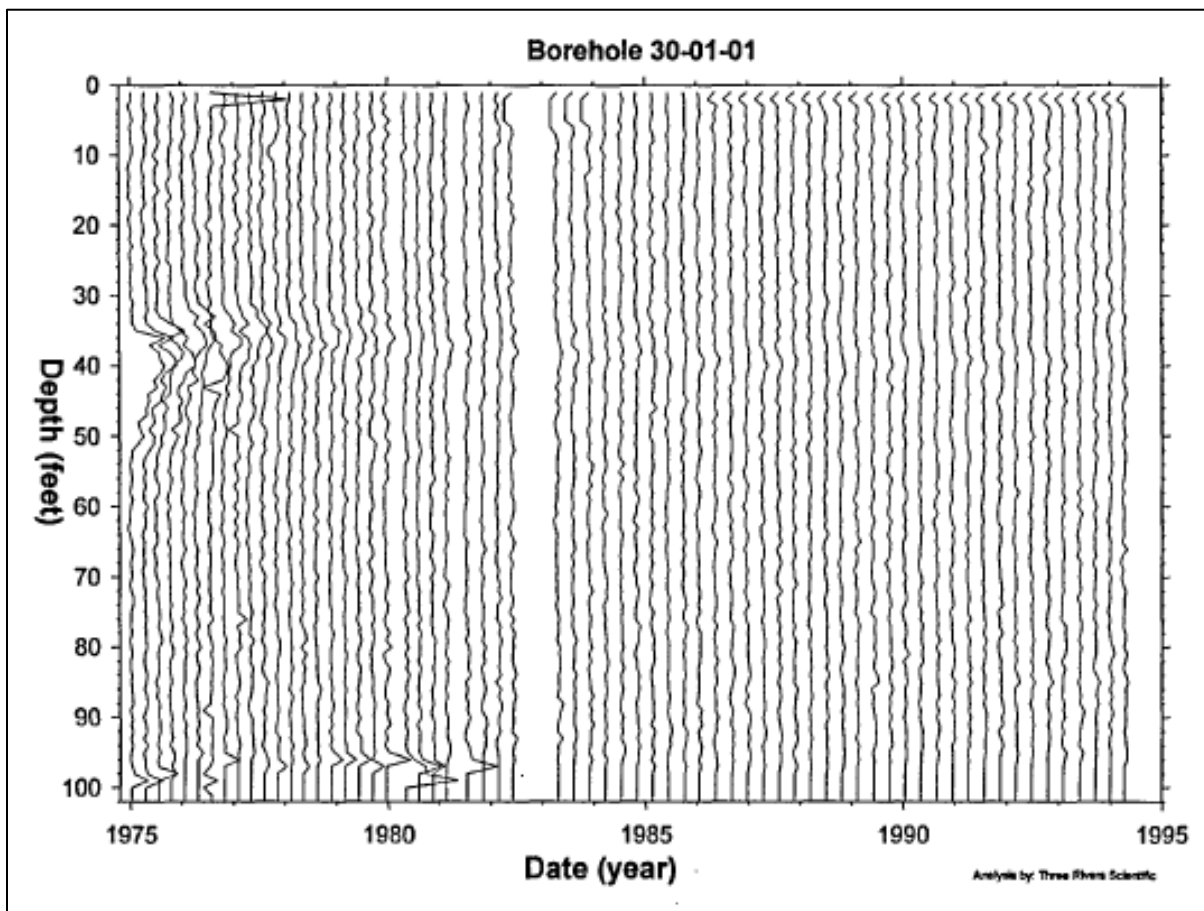
Figure 4-9. Tank C-101 Drywell 30-01-01 (RPP-8321)

drywell or location was not specified in the driller's log. Figure 4-9 shows the depths of radioactivity from 1975 to 1995 (RPP-8321).

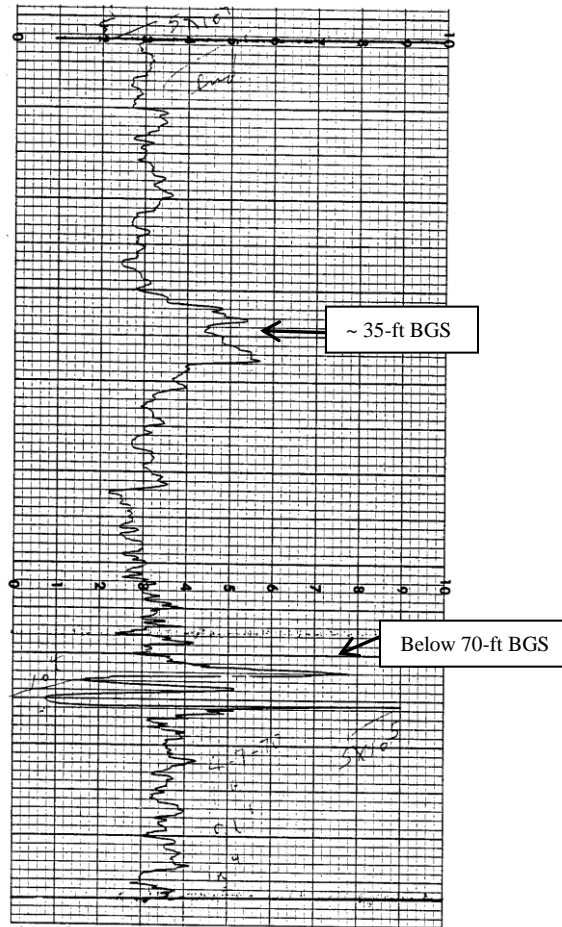
**Figure 4-10. Drywell 30-01-06 Historical Gross Gamma Logging
April 7, 1970**

Drywell 30-01-06 was drilled on April 1970 with the first recoverable reading on April 7, 1970 (see Figure 4-10). This plot from 1970 indicates there are two peaks located at approximately 35-ft BGS at lower radioactivity levels and one larger peak below 70-ft BGS. The next recoverable reading was July 31, 1972 which reported a peak of ~100K cpm at 78-ft BGS (see 01). Readings declined quickly to half this value a year later and continued to decline to less than 10K cpm by February 1976. An additional peak was first reported May 4, 1978 at 3.2K cpm at 34-ft BGS. From April 11, 1979 through June 1986, the peak at the 34-ft BGS level was the only peak recorded for drywell 30-01-06 and readings remained relatively stable between 6 to 7K cpm.

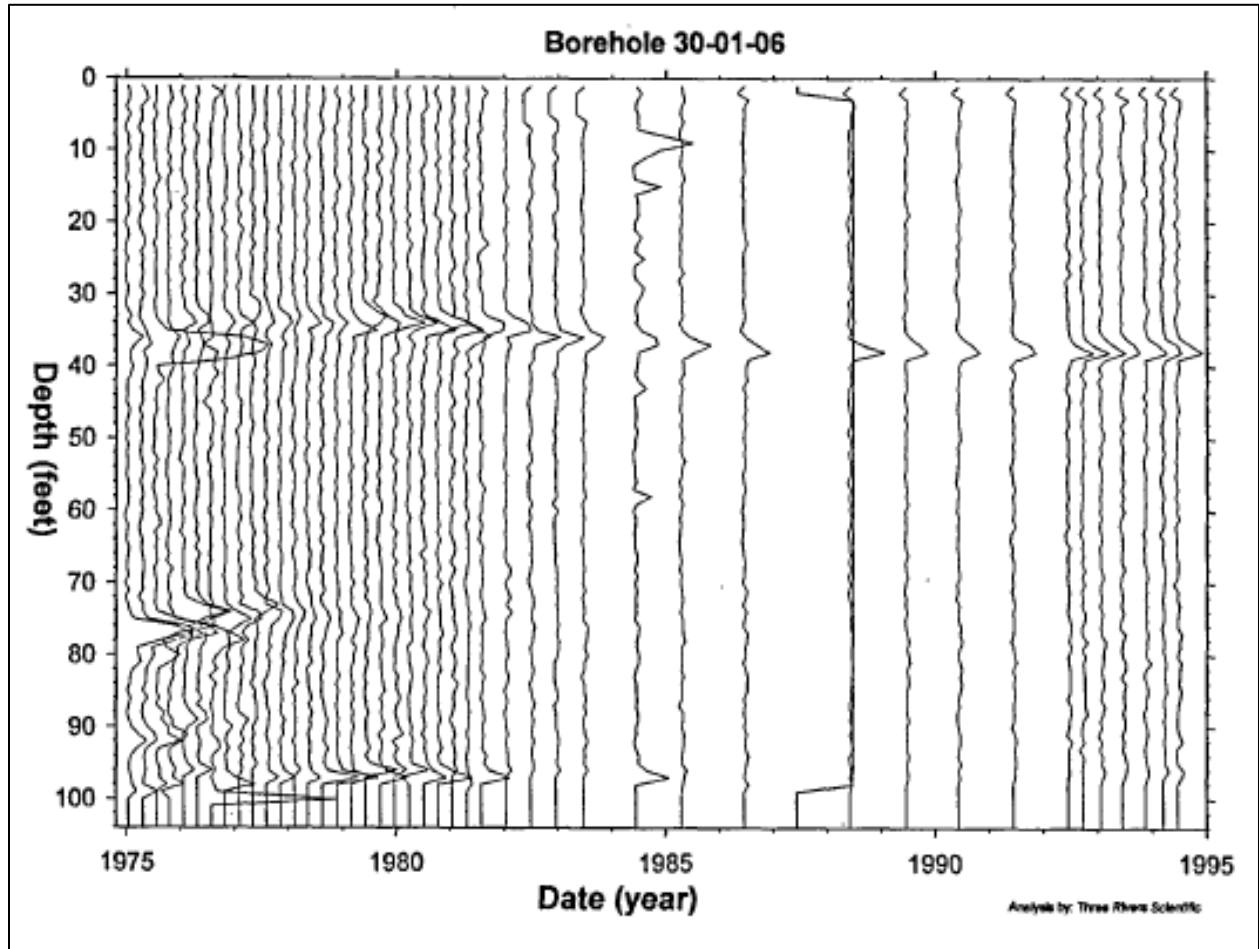
Figure 4-11. Tank C-101 Drywell 30-01-06 (RPP-8321)

maximum concentration of 48.6 pCi/g at 37-ft BGS. The Co-60 contamination was detected only at 37-ft BGS with a concentration of 0.1 pCi/g. Document GJ-HAN-85 states, "The Cs-137 contamination from 35 to 38.5 ft probably migrated from a tank leak and accumulated at the base of the tank farm excavation." Figure 4-11 shows the depths of radioactivity from 1975 to 1995 (RPP-8321).

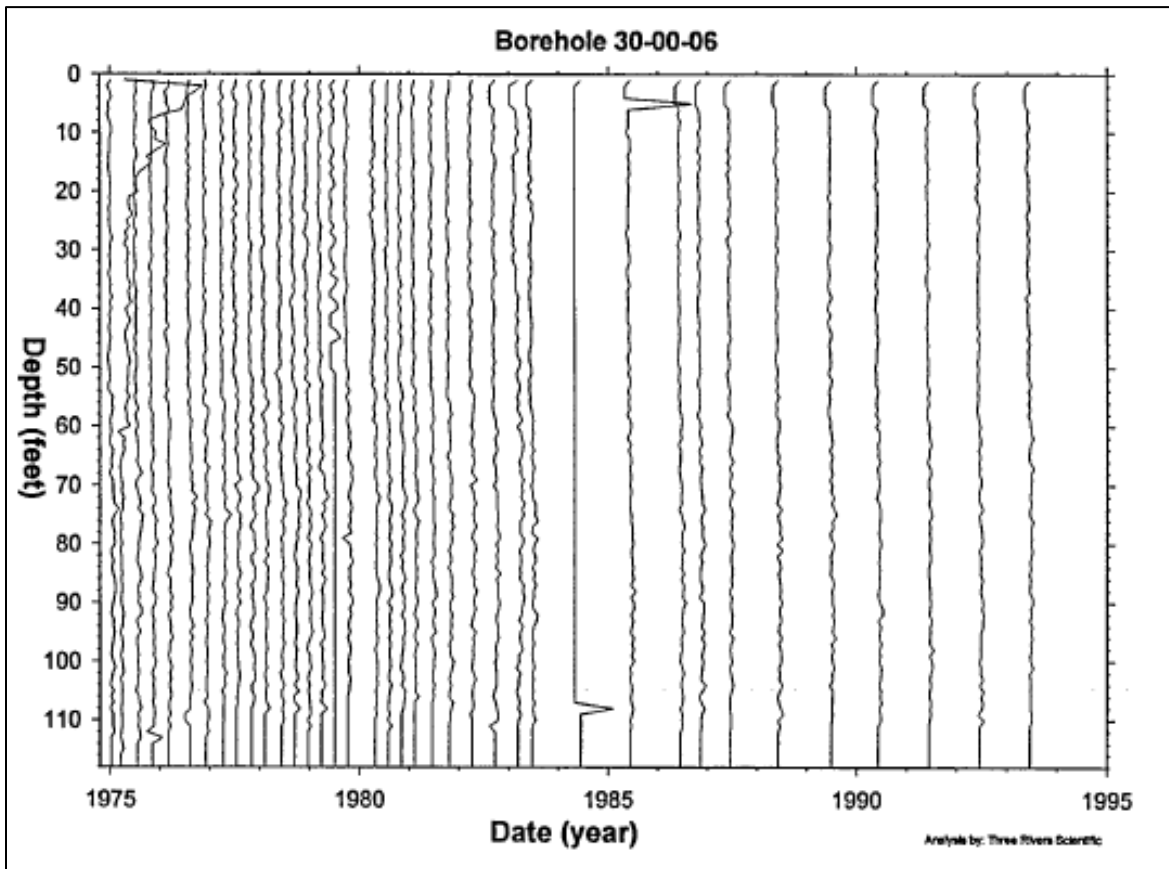
Figure 4-12. Tank C-101 Drywell 30-00-06 (RPP-8321)

In September 1997, Cs-137 and Co-60 were the only man-made radionuclides detected in drywell 30-00-06 (GJ-HAN-58). From the ground surface to 5-ft BGS and from 57 to 111-ft BGS, Cs-137 was detected intermittently. Only at 77.5-ft BGS was Co-60 detected. The maximum concentrations of Cs-137 and Co-60 could not be measured in this drywell due to the double casing. Therefore, the origin of the Cs-137 concentration below 56-ft BGS cannot be determined (GJ-HAN-58). Since historical records report little radioactivity in this drywell and contamination at unknown concentrations were found below 56-ft BGS, drywell 30-00-06 is not being included as part of the leak location for tank C-101. Figure 4-12 shows the depths of radioactivity from 1975 to 1995 (RPP-8321).

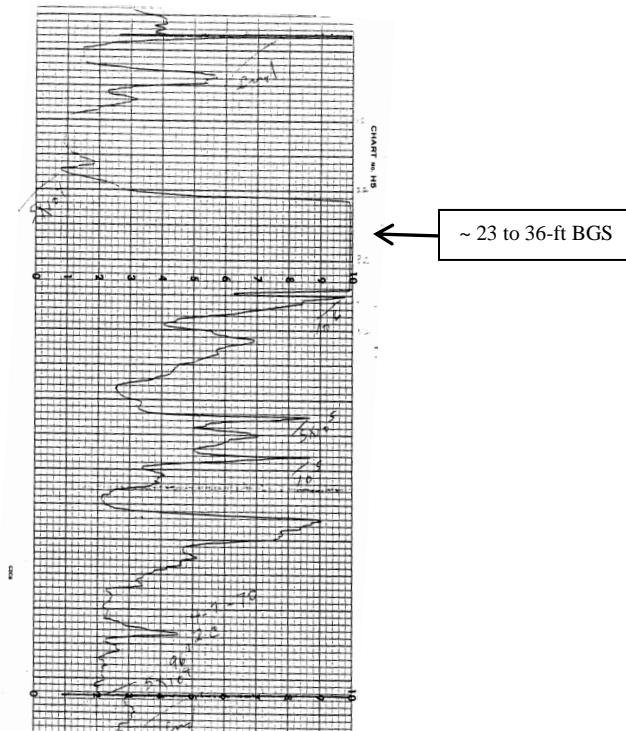
**Figure 4-13. Drywell 30-01-09 Historical Gross Gamma Logging
April 7, 1970**

Drywell 30-01-09 was drilled on February 10, 1970 with the first recoverable reading on April 7, 1970 which indicated a saturated zone between ~23 and 36-ft BGS with multiple smaller peaks down to 87-ft BGS (see Figure 4-13). The next recoverable reading on July 31, 1972 reported a peak of ~1,000K cpm at 30-ft BGS. Readings remained relatively stable at this level through June 1986 (see 01).

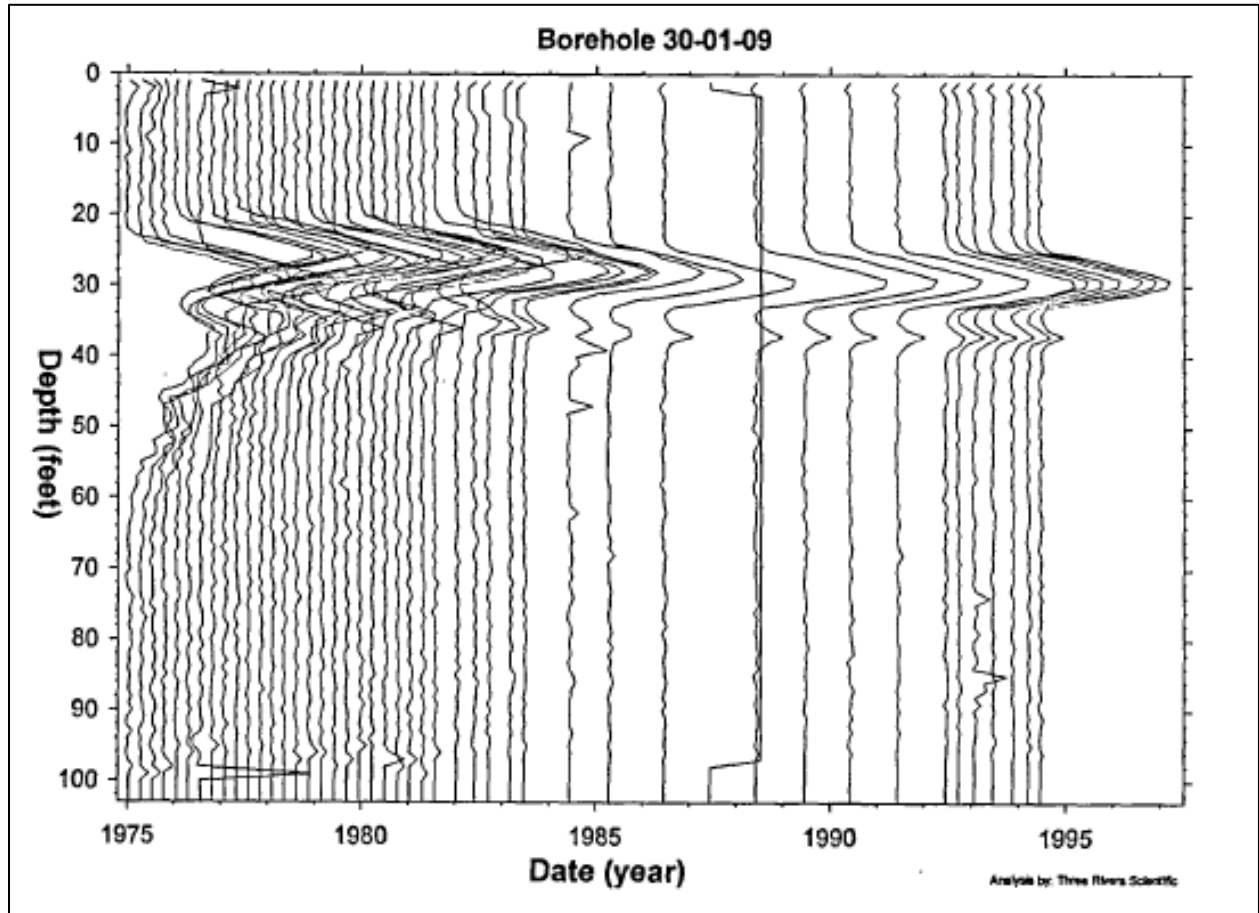
Figure 4-14. Tank C-101 Drywell 30-01-09 (RPP-8321)

Document GJ-HAN-58 reported, “The Cs-137 contamination from 24.5 to 32 ft and the Eu-152 and Eu-154 contamination at 27.5 ft is probably the result of a tank leak at approximately this depth.” However, a leak from the inlet lines is also a possibility as discussed in Section 4.4.1. Figure 4-14 shows the depths of radioactivity from 1975 to 1995 (RPP-8321).

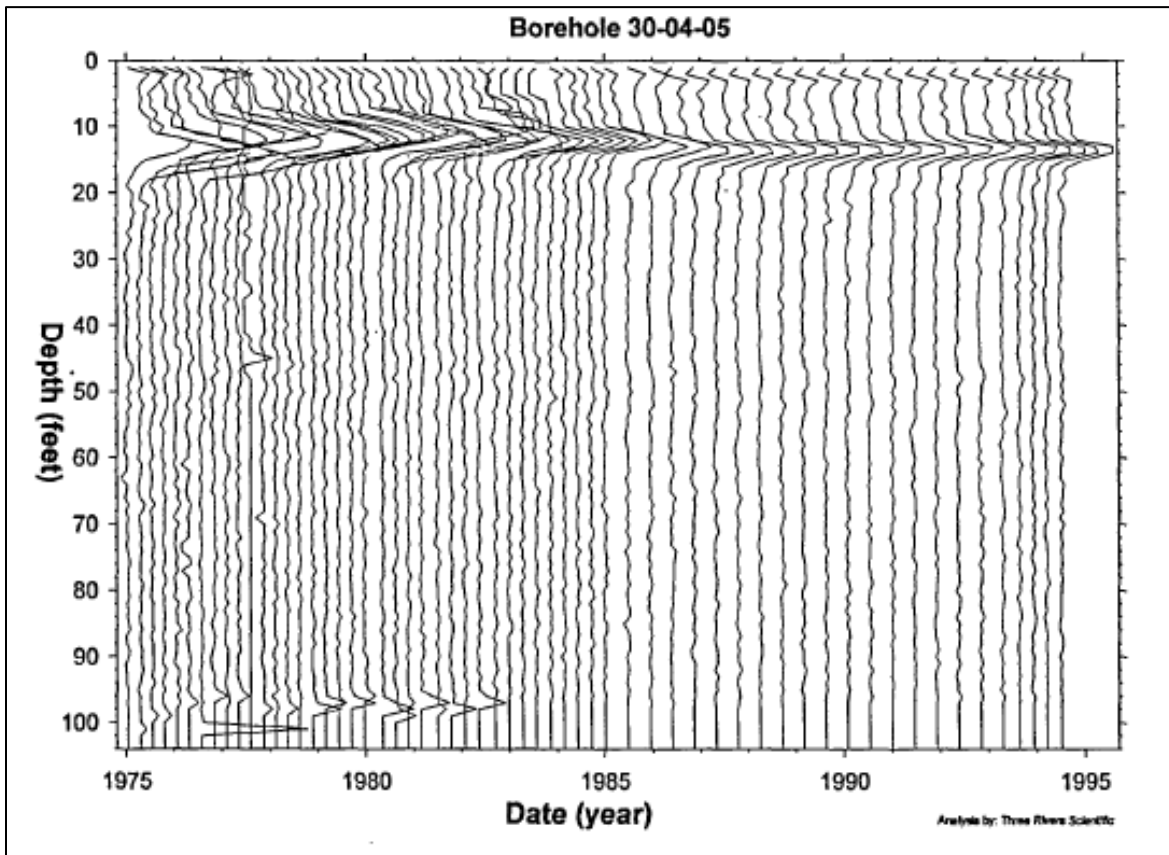
Figure 4-15. Tank C-101 Drywell 30-04-05 (RPP-8321)

In September 1997, Cs-137 was the only man-made radionuclides detected in drywell 30-04-05 (GJ-HAN-85). From the ground surface to 57.5-ft BGS and from 94.5 to 98.5-ft BGS, Cs-137 was detected almost continuously with the maximum concentration of 91.5 pCi/g measured at 12.5-ft BGS. From 69.5 to 91.5-ft BGS, Cs-137 was detected intermittently. Document GJ-HAN-85 reported, "The Cs-137 contamination from 11 to 38 ft is probably the result of a surface spill that migrated into the backfill material around the borehole" and "The Cs-137 contamination from 45 to 57.5 ft is probably from a tank leak that migrated into the Hanford formation sediments beneath the tank farm excavation." The Cs-137 contamination from 45 to 57.5-ft BGS is below 10 pCi/g and could be migration from the leak site near drywell 30-01-09. Figure 4-15 shows the depths of radioactivity from 1975 to 1995 (RPP-8321).

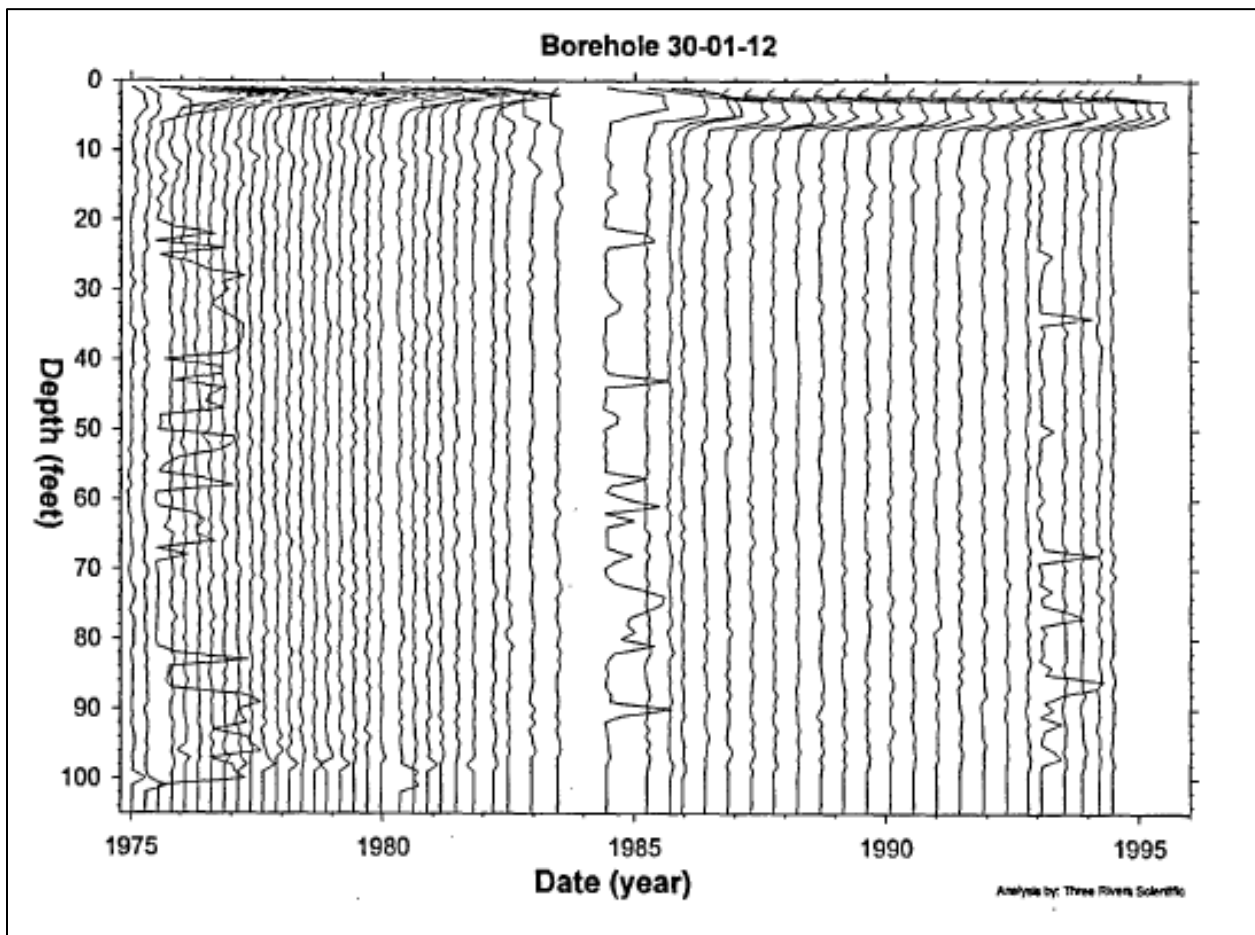
Figure 4-16. Tank C-101 Drywell 30-01-12 (RPP-8321)

In September 1997, Cs-137 was the only man-made radionuclides detected in drywell 30-01-12 (GJ-HAN-58). From the ground surface to 40.5-ft BGS, Cs-137 contamination was detected almost continuously with the maximum concentration of 85.2 pCi/g detected at 4.5-ft BGS. Isolated occurrences of Cs-137 were also detected at 45, 60, 66.5, and 99.5-ft BGS. Document GJ-HAN-58 indicates that radioactivity detected in this drywell is likely associated from surface spills or a pipeline leak that migrated down into the backfill around this drywell and/or dragdown. Therefore, drywell 30-01-12 is not included as part of the leak location for tank C-101. Figure 4-16 shows the depths of radioactivity from 1975 to 1995 (RPP-8321).

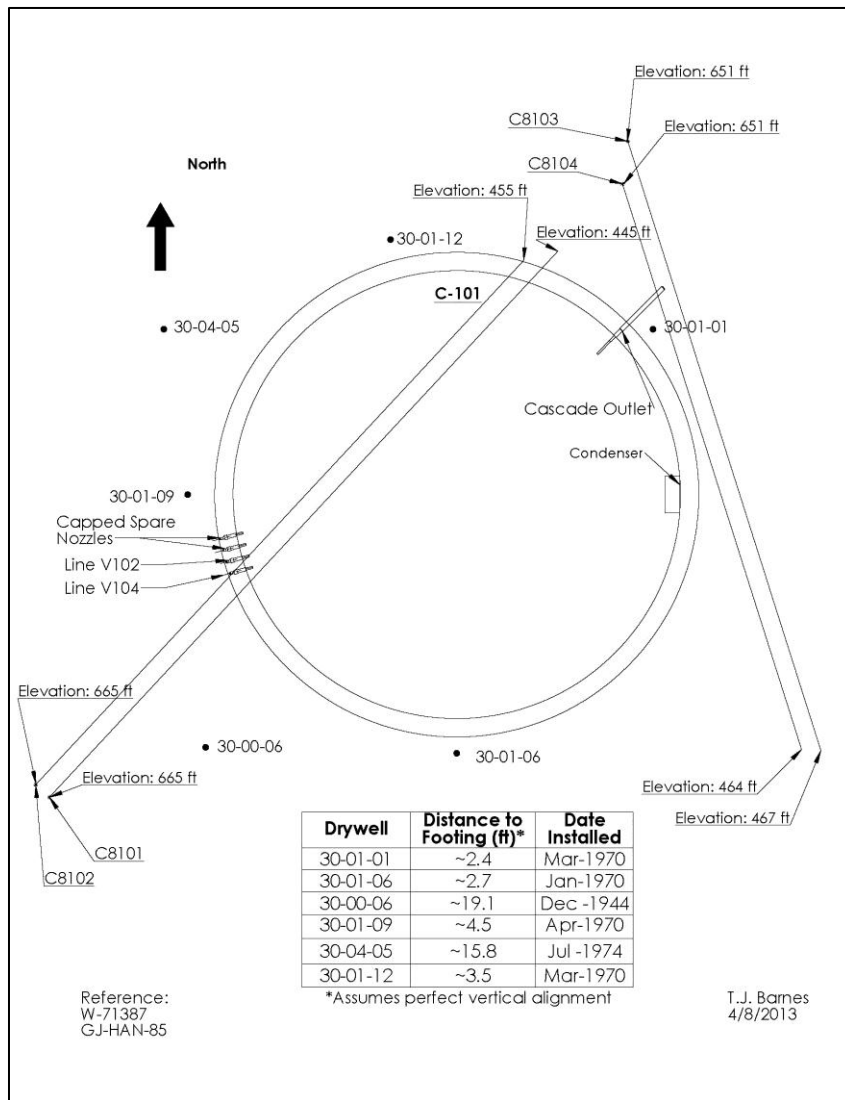
Figure 4-17. Tank C-101 Direct Push Location

In 2011, four direct push slant holes (C8101, C8102, C8103, and C8104) were installed near tank C-101 (see Figure 4-17). Gross gamma logging was conducted in direct pushes C8101 and C8103 while direct pushes C8102 and C8104 were used for sampling.

Results indicate low gamma activity throughout the logged profile in both direct push C8101 and C8103. Sample results showed low nitrate concentrations and Tc-99 was not detected except at low concentrations deep in direct push C8104. Therefore, the direct pushes installed in 2011 do not provide additional information for the leak location of tank C-101 (RPP-RPT-50581, *Completion Report for the C Tank Farm, C-101 Angle Push Characterization*).

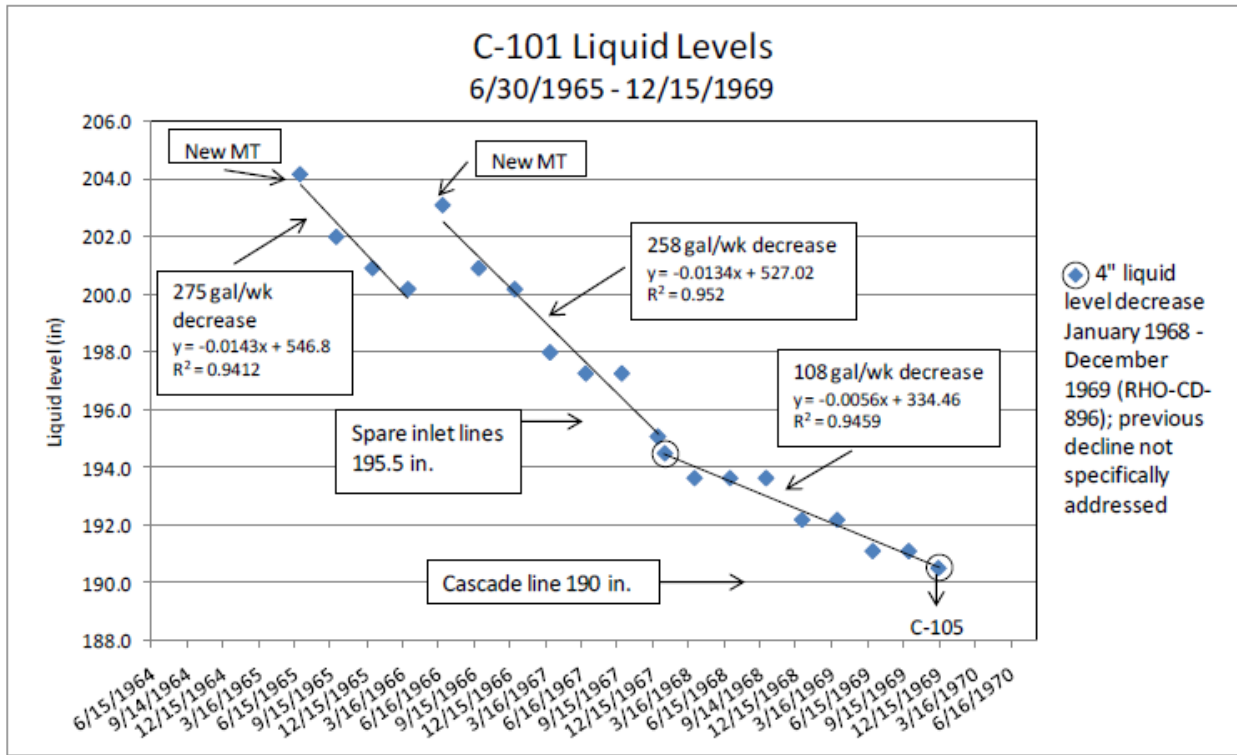
Figure 01-2. Tank C-101 LL 6/30/1965 - 9/30/1969

The first four quarterly volumes including the initial high at 574,000 gallons were considered separately when a comparison was made with the new MT data starting with June 30, 1966. No transfers were reported in this one year period, however for some unexplained reason the MT was changed out. The overall revised initial segment from June 30, 1966 to January 15, 1968 provided a linear waste volume decrease of 258 gallons/week with an interesting reduction in the rate at the approximate level of the spare inlet lines (see Figure 01-2). This could mean that the spare inlet lines were leaking at a rate of about 150 gallons/week (~28 ml/min each) if the following segment at 108 gallons/week was attributed to only the cascade line (seepage to tank C-102 or leakage through the packing) and the effects of reduced head and other parameters were disregarded.

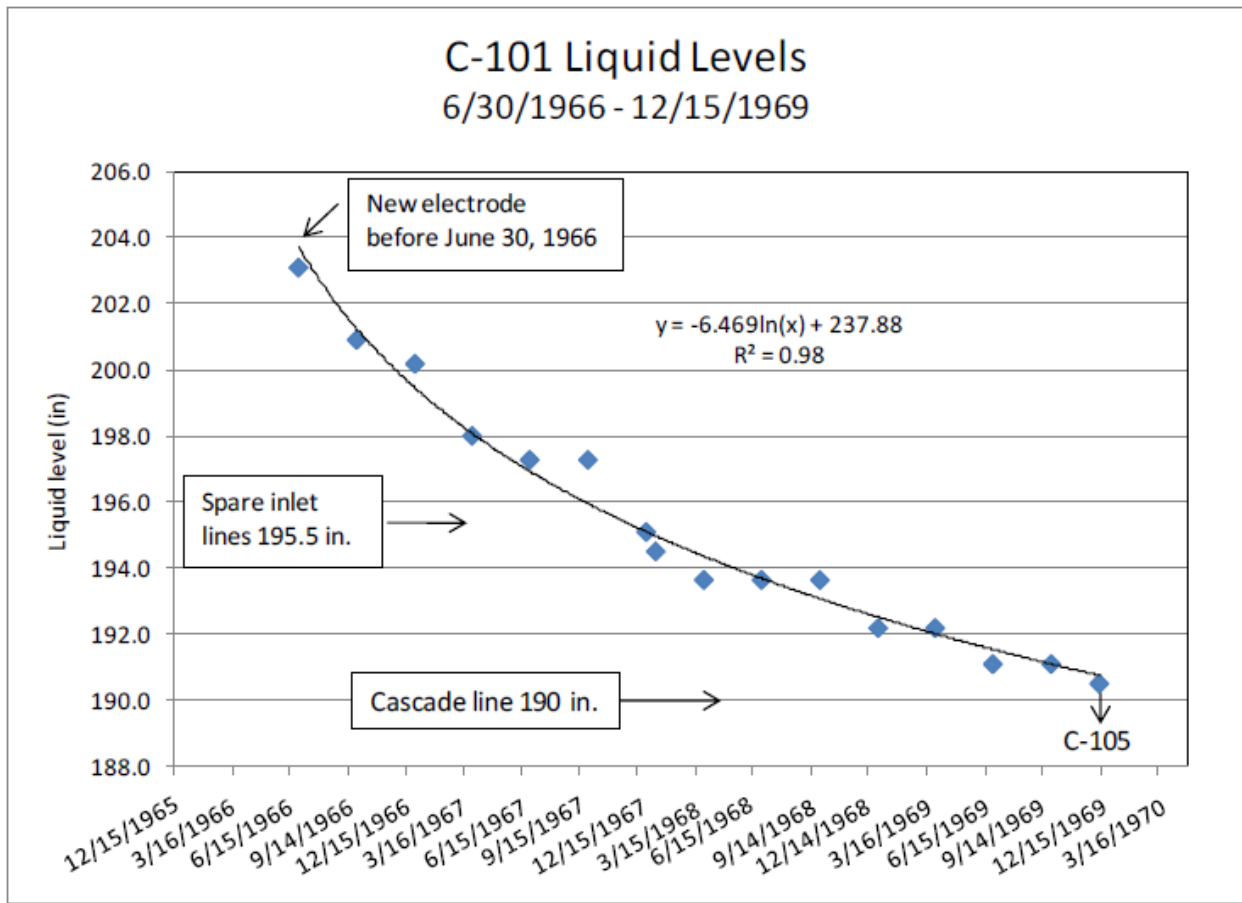
Figure 01-3. Tank C-101 LL June 30, 1966 to December 15, 1969

A separate curve was developed (Figure 01-3) to explore a potentially decreasing rate scenario that may be possible with a reduction in head above spare inlet line leakage and some flow through a partially plugged cascade line. The cascade line was reported to be partially plugged in June 1954 (HW-32389) and up to the second quarter 1956 (RHO-LD-79), however, there is no record that waste cascaded from tank C-101 to tank C-102 during the review time period. A review of the tank C-102 liquid level in WHC-SD-WM-ER-349 and attendant quarterly reports for the period indicated there were numerous transfers in and out of tank C-102 which could mask any slow seepage through a partially plugged cascade line from tank C-101. Not to be

The Cs-137 content of the waste in tank C-101 at the LL of ~204 inches provided the potential for evaporation of ~2,550 gallons/ month assuming no heat losses to the tank structure or surrounding soil, RPP-ENV-33418, Rev. 1, or reduction with decreasing LL. The condensers were reported to be “adequate for the waste temperatures and vapor loads encountered in original operations (Approximately 180 °F (82°C) for sludge and supernatants)”, WHC-MR-0132. There is no direct tank C-101 temperature information available for this time frame. RPP-ENV-33418, Rev. 1, contains temperature ranges of the waste from the source tanks which indicates that tank C-101 waste may have been near the point where the condenser may not have been 100% adequate. An estimate of 95% efficient was postulated for the atmospheric condensers which may not have produced significant ground contamination but would result in ~128 gallons/month (11 ml/min) of water as a vapor escaping into the atmospheric. This would diminish with the reduction in the LL as the supernatant with cesium was decreasing. This by no means comes close to the point experienced in other tank farm condenser operations where contaminated water was actually ejected from the condenser and contaminated the surrounding ground. However, it can be assumed some water vapor probably escaped the atmospheric condensers.

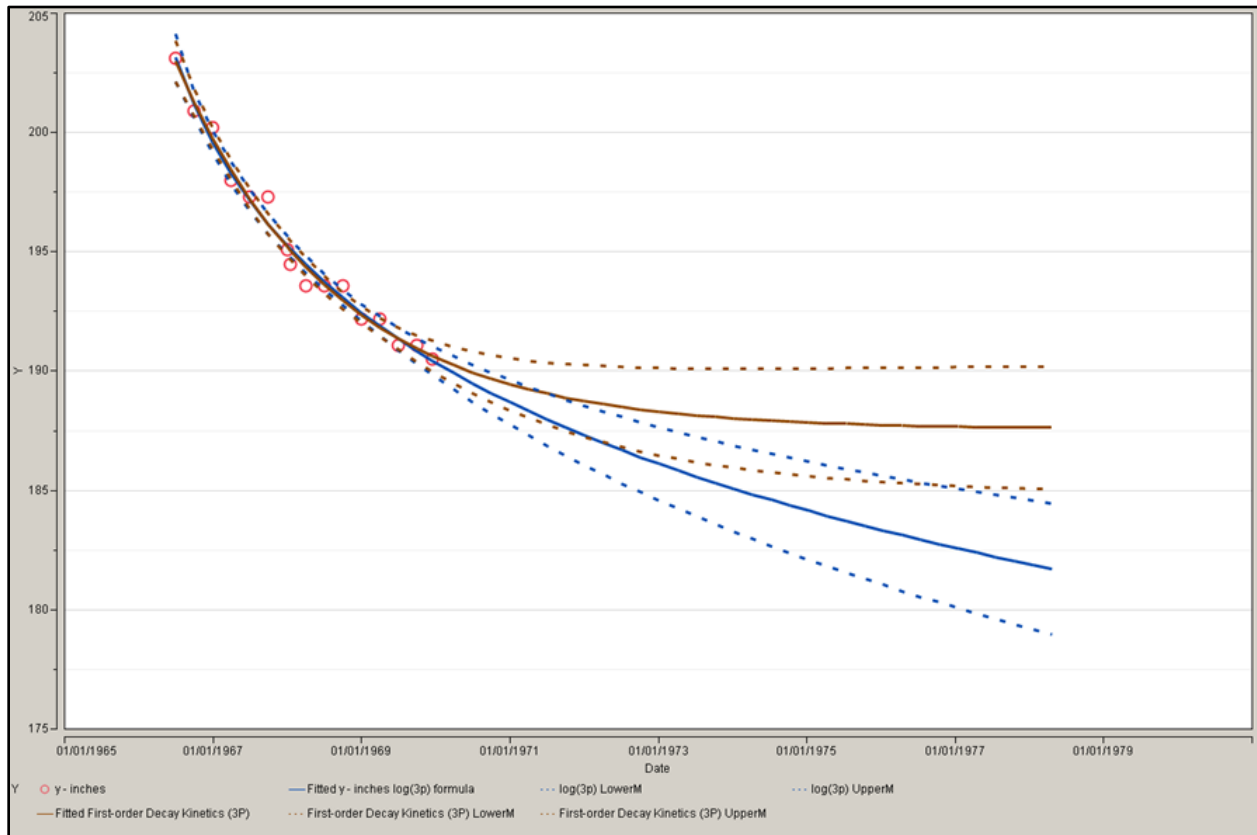
Figure 01-4. Tank C-101 1969 Projected LL Decrease

A projection of the curve in Figure 01-4 after pumping to tank C-105 was made to determine the possible termination of what appears to be a decreasing rate. Four nonlinear regression models were fitted to the waste height data from tank C-101 from the time period of June 30, 1966 through December 15, 1969. Three of the fitted models project that the waste height would have reached a stable level of approximately 188 inches around 1973. Although these three models appear to fit the data well, two of the three models have an extremely large uncertainty in the future projections, rendering them not useful. The fourth model predicts that the waste height would continue to decline, although at a slowing rate. For the two useful models, there is little to suggest picking one model over the other (Figure 01-4) as the performance relative to the confidence levels are similar. This suggests that the choice of one model over the other would be based more on the reasonableness of match to other technical considerations, rather than statistical considerations.

The above discussion indicates that the previously reported partially plugged cascade line could be seeping to tank C-102 or leaking through the packing, or potentially leaking through two capped spare inlet lines or packing of the two active inlet lines, or possible water vapor exiting the atmospheric condenser, or a tank leak were gradually causing the liquid level to decrease at what may be a declining rate as the liquid level decreased at least to the level of the cascade line. A decreasing rate could be a result of the reduction in head above the cascade line, spare inlet lines or a tank leak location as well as the reduction in heat content resulting in a more effective atmospheric condenser. The possible decreases from the cascade line and spare inlet lines would be eliminated when the liquid level decreased below these two points. Evaporation past the condenser and condenser gasket leakage could have continued but at a much lesser degree when the tank waste was pumped.

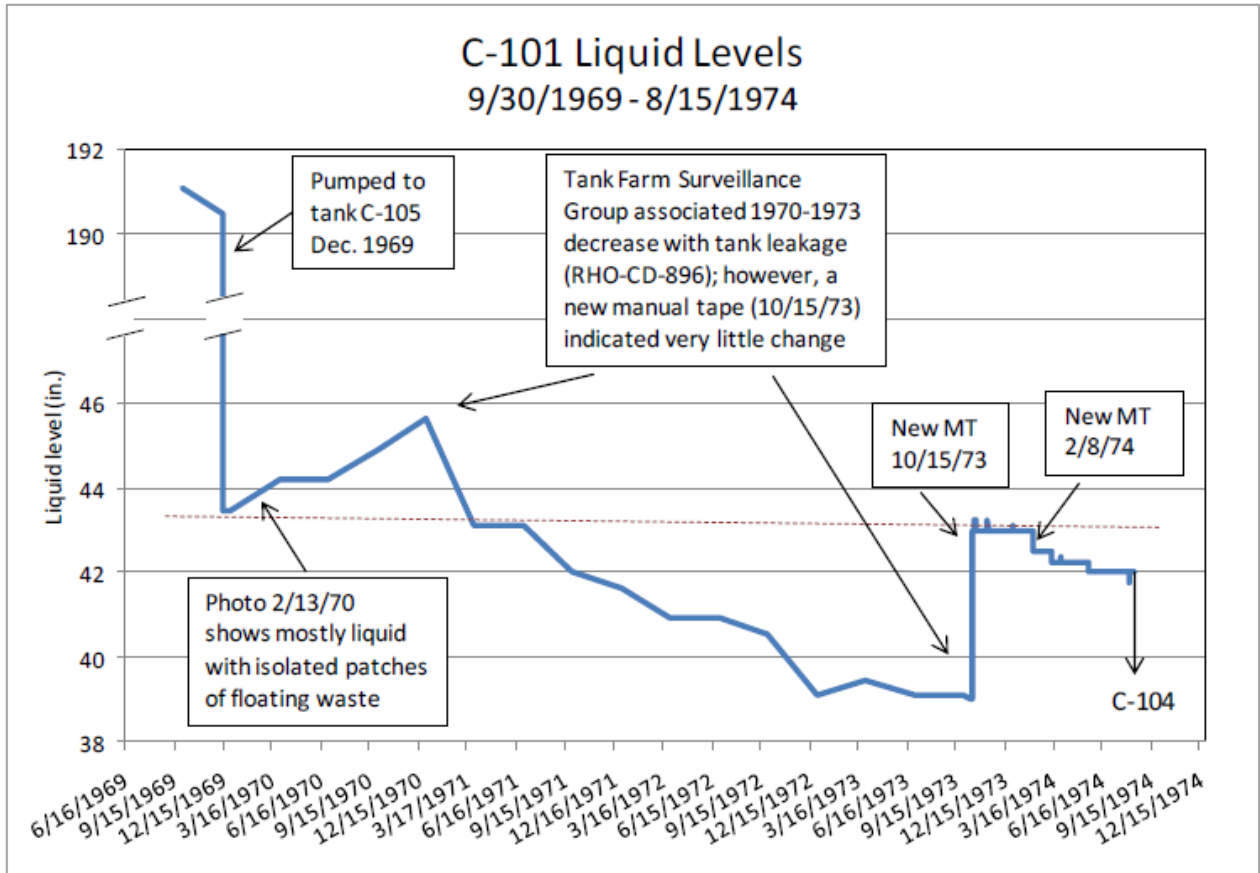
Figure 01-5. Tank C-101 LL September 30, 1969 to August 15, 1974

The December 30, 1969 to August 15, 1974 period starts with pumping tank C-101 to tank C-105 and ends with pumping to tank C-104 (see Figure 01-5). Quarterly report LL data was used to plot the tank C-101 LL until the new MT was installed October 15, 1973. The LL plot after that time used data from C Tank Farm Liquid Level Readings Data Sheets dayshift entries. The period begins with an unexplained volume increase over four quarterly report periods from 43.5 inches to 45.6 inches on December 30, 1970 (see Figure 01-5). The waste volume abruptly decreased to 43.1 inches in the next quarterly report, March 31, 1970; no explanation was found for the decrease. This appears to be a pattern similar to installation of a new MT. A waste volume then decreased from 43.1 inches, on March 31, 1970 to 39.1 inches on September 30, 1973, after which time a new tape was installed October 15, 1973 and the reading returned to the original 43.1 inches indicating that there may have been no decrease in liquid level. The possibility exists that the 43.5 inches of LL at the end of pumping, December 30, 1970, may not be a true reading when viewed with the unexplained subsequent increases and decrease to 43.1 inches with collaborating return to nearly the same 43.1 inch LL more than two years later with a new MT October 15, 1973. The later LL remained steady for more than four months when a new MT was installed February 8, 1974 which indicated a ½-in. decrease from the four month steady period. The base line was decreased ½-in. five days later without explanation and the tank was pumped to tank C-104 February 15, 1974 after another unexplained decrease of ½-in. over two separate time frames. It should also be noted the MT was replaced multiple times during this period which could account for these LL discrepancies.

Questionable Integrity indicated that the estimated leakage volume was “approximately 10,000 gallons based on LL decrease from the 194 inch level”, with no mention of the alleged decrease March 31, 1970 to June 30, 1973. The TFPC entry in RHO-CD-896 stated, “The volume of liquid estimated to have leaked from Tank 101-C is 10,000 to 24,000 gallons.” The final edited and approved document January 25, 1980 (two weeks later) did not include the letter statement or an explanation of the difference.

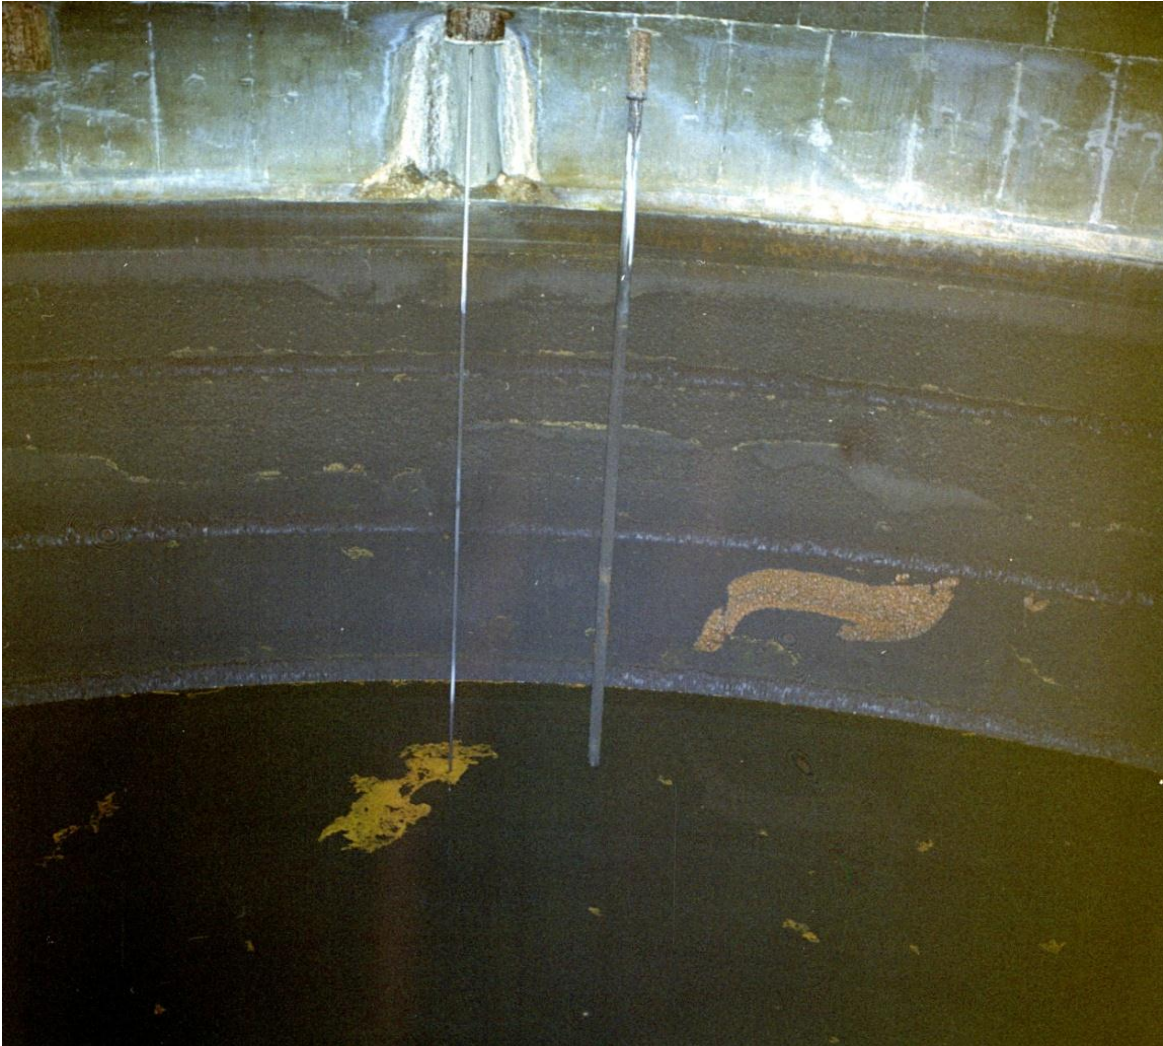
Figure 01-6. Tank C-101 Photograph February 13, 1970 (700695-20)

Photos of the waste surface February 13 1970 indicates a mostly liquid surface with isolated small patches of floating waste (Figure 01-6).
