Hanford Single-Shell Tank Leak Causes and Locations - 241-C Farm

C.L. Girardot, D.G. Harlow

Washington River Protection Solutions

Key Words: leak location, leak cause, tank, integrity assessment, C Farm, C-101, C-105, leak assessment

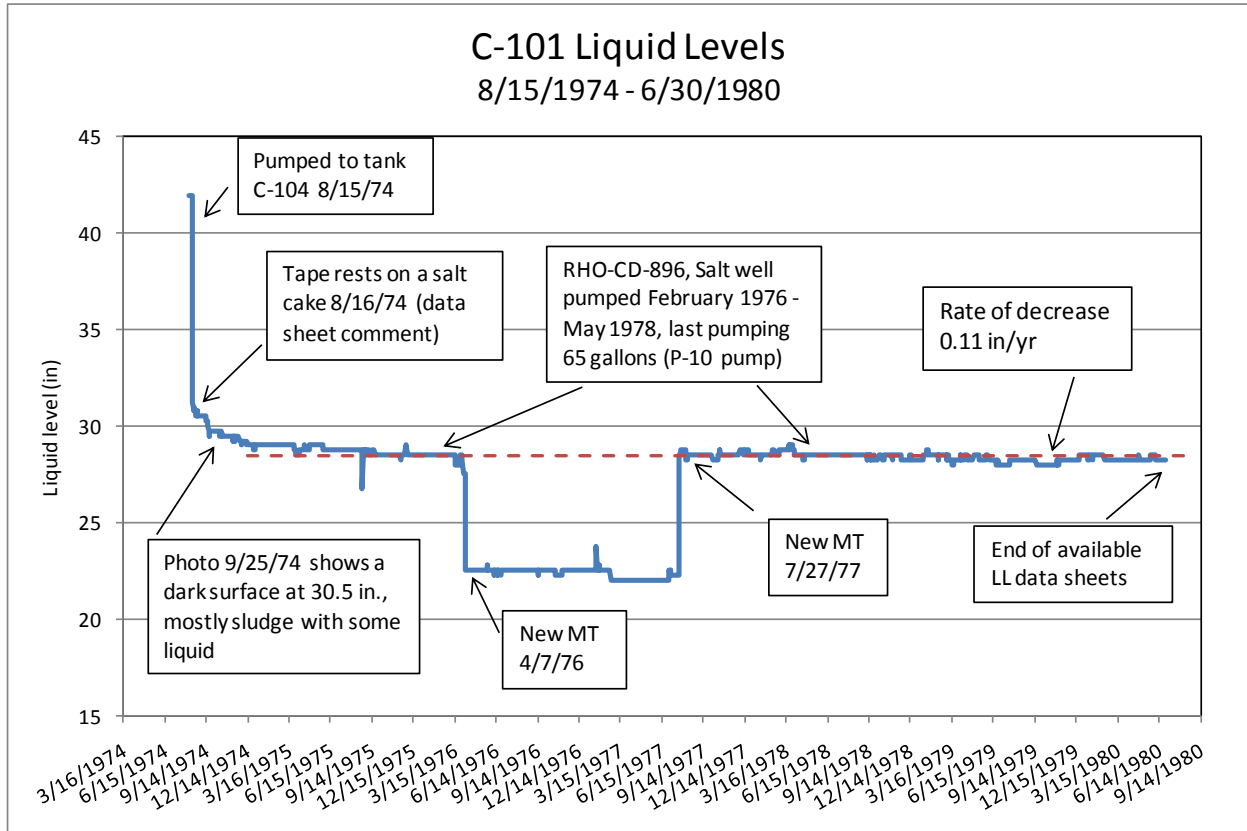
Figure 01-7. Tank C-101 LL 8/15/1973 - 6/30/1980

Tank Farm Liquid Level Readings Data Sheets and graphs covering C-Farm tank LLs are available for the July 1, 1974 to June 30, 1980 (see Figure 01-7). There is very little if any decrease in liquid level that cannot be explained by a change-out of the manual tape or the manual tape resting on reported “salt cake”. The rate of decrease after salt well pumping is 0.11-in/yr.

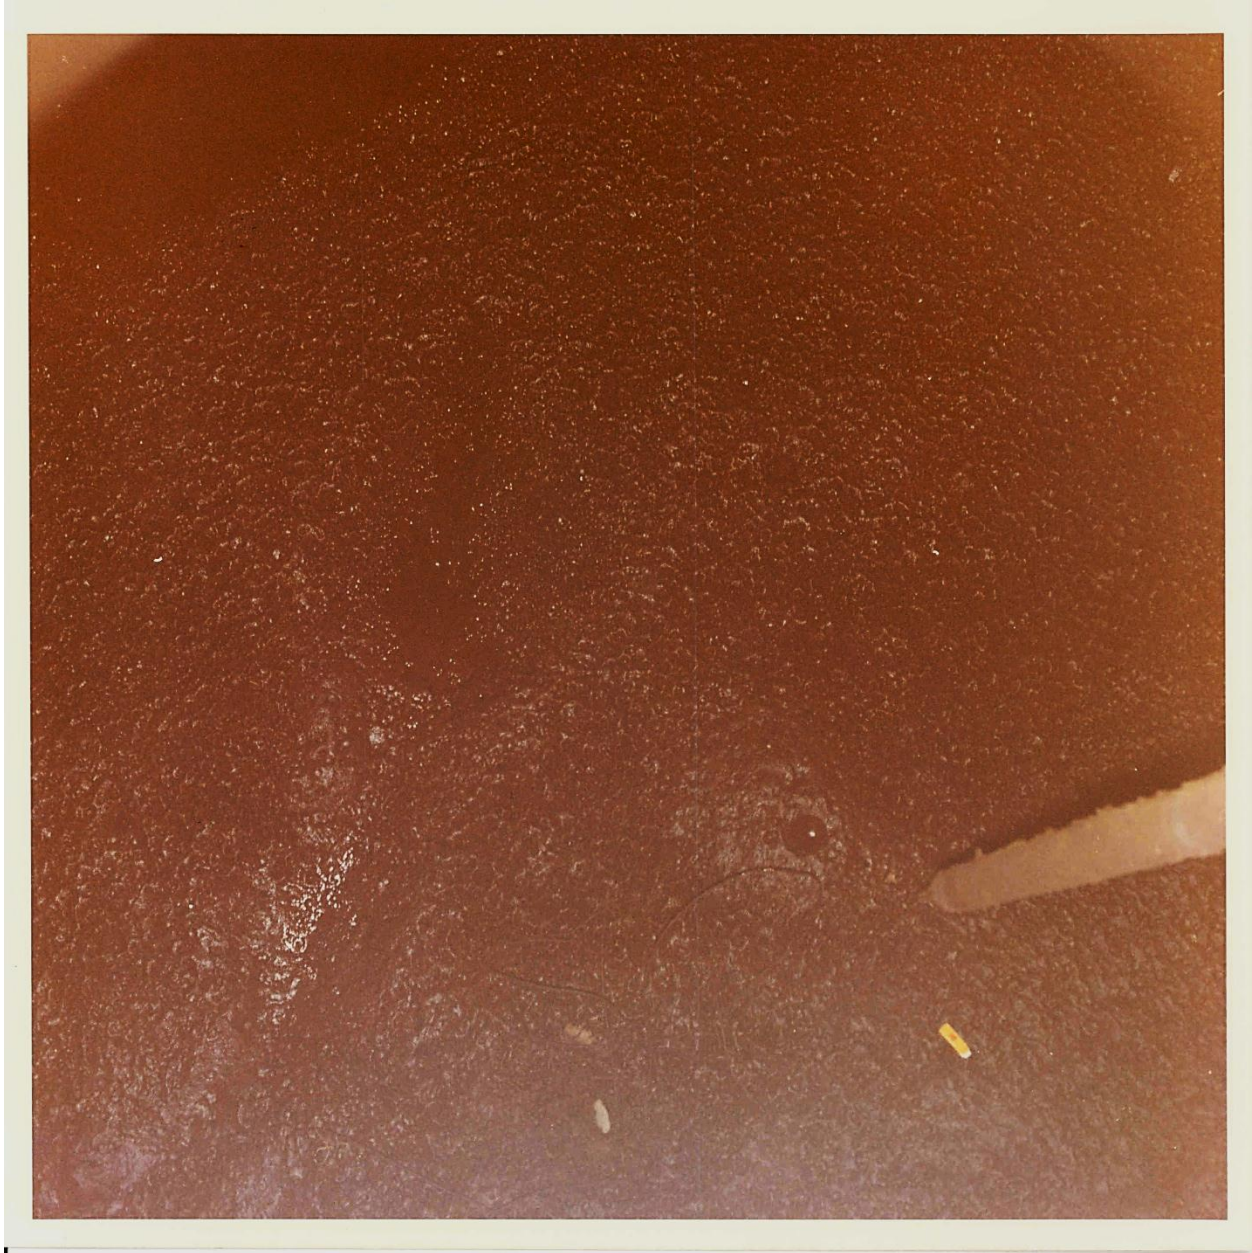
**Figure 01-8. Tank C-101 Surface at the Thermocouple and Manual Tape Location
Photograph September 25, 1974 (745590-24CN)**

The tank C-101 September 25, 1974 photos indicate a mostly sludge surface with some pools of liquid (745990-1 through 4CN). Figure 01-8 shows the waste surface at the location of the thermocouple and the manual tape at Nozzle R2, South PP-241-CR-01C.

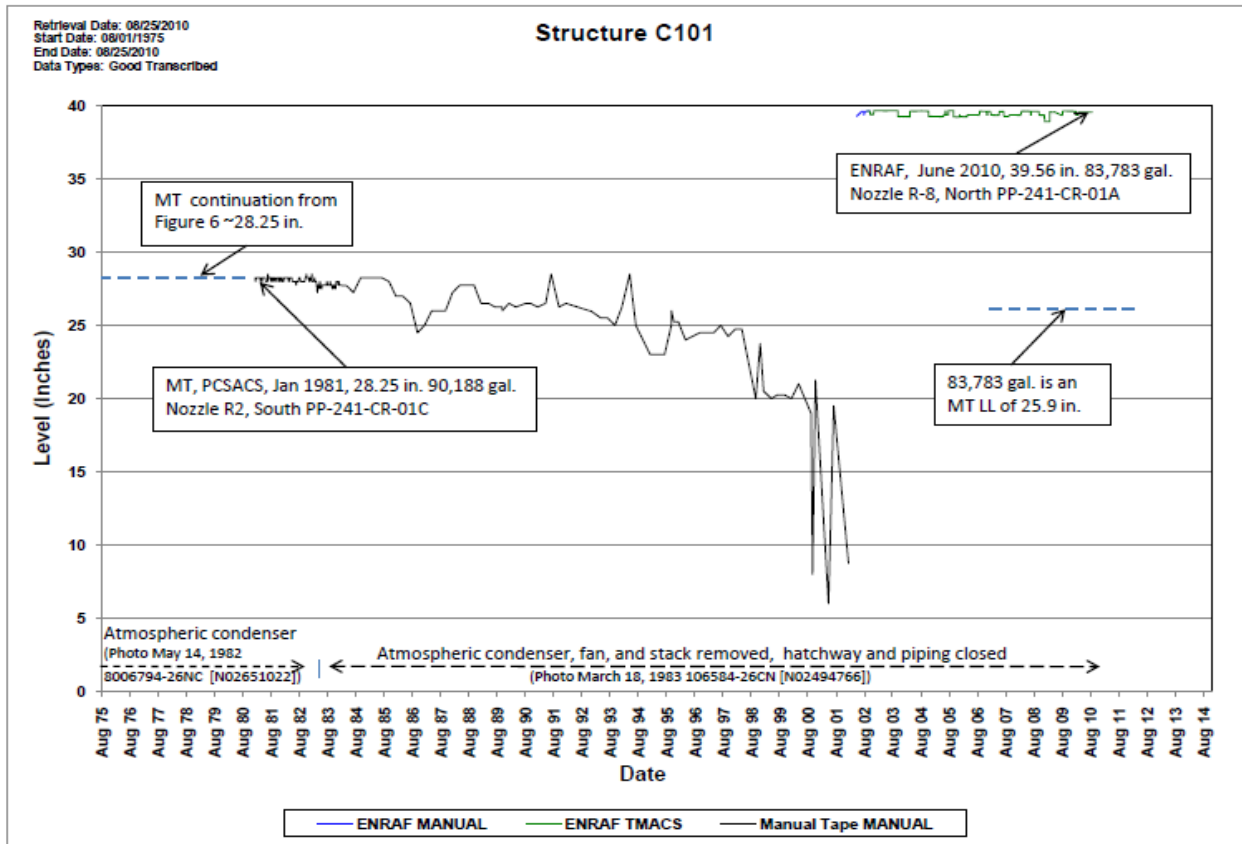
Figure 01-9. Tank C-101 PCSACS LL January 5, 1981 – August 25, 2010

The final period of the tank C-101 LL review in Figure 01-9 comes from the PCSACS program and covers the period from January 5, 1981 to August 25, 2010. The period begins with the MT plot on January 5, 1981 which ends on January 11, 2002 then continues with the ENRAF LL probe readings on April 24, 2002 to August 25, 2002. Photographs in Figure 01-10 and Figure 01-11 indicate that the atmospheric condensers as well as the exhaust fan stack (fan is not visible) were removed with the hatchway and piping blanked between May 14, 1982 and March 18, 1983. The plot indicates that the liquid level was continuing to be more stable between January 5, 1981 and the removal of the atmospheric condenser with a rate of decrease of ~0.0015-in/year. After the removal of the atmospheric condenser there is an apparent decreasing liquid level probably caused by atmospheric breathing and then instability as the MT comes into contact with solids.

The manual tape decrease from June 1982 to 1997 (when the manual tape contacted solids) is estimated to be roughly 6400 gallons or 530 gallons/year to 430 gallons/year respectively. A 1994 tank C-101 sample provided an estimated atmospheric breathing rate liquid removal of 430 gallons/year (HNF-3588, Rev. 1).

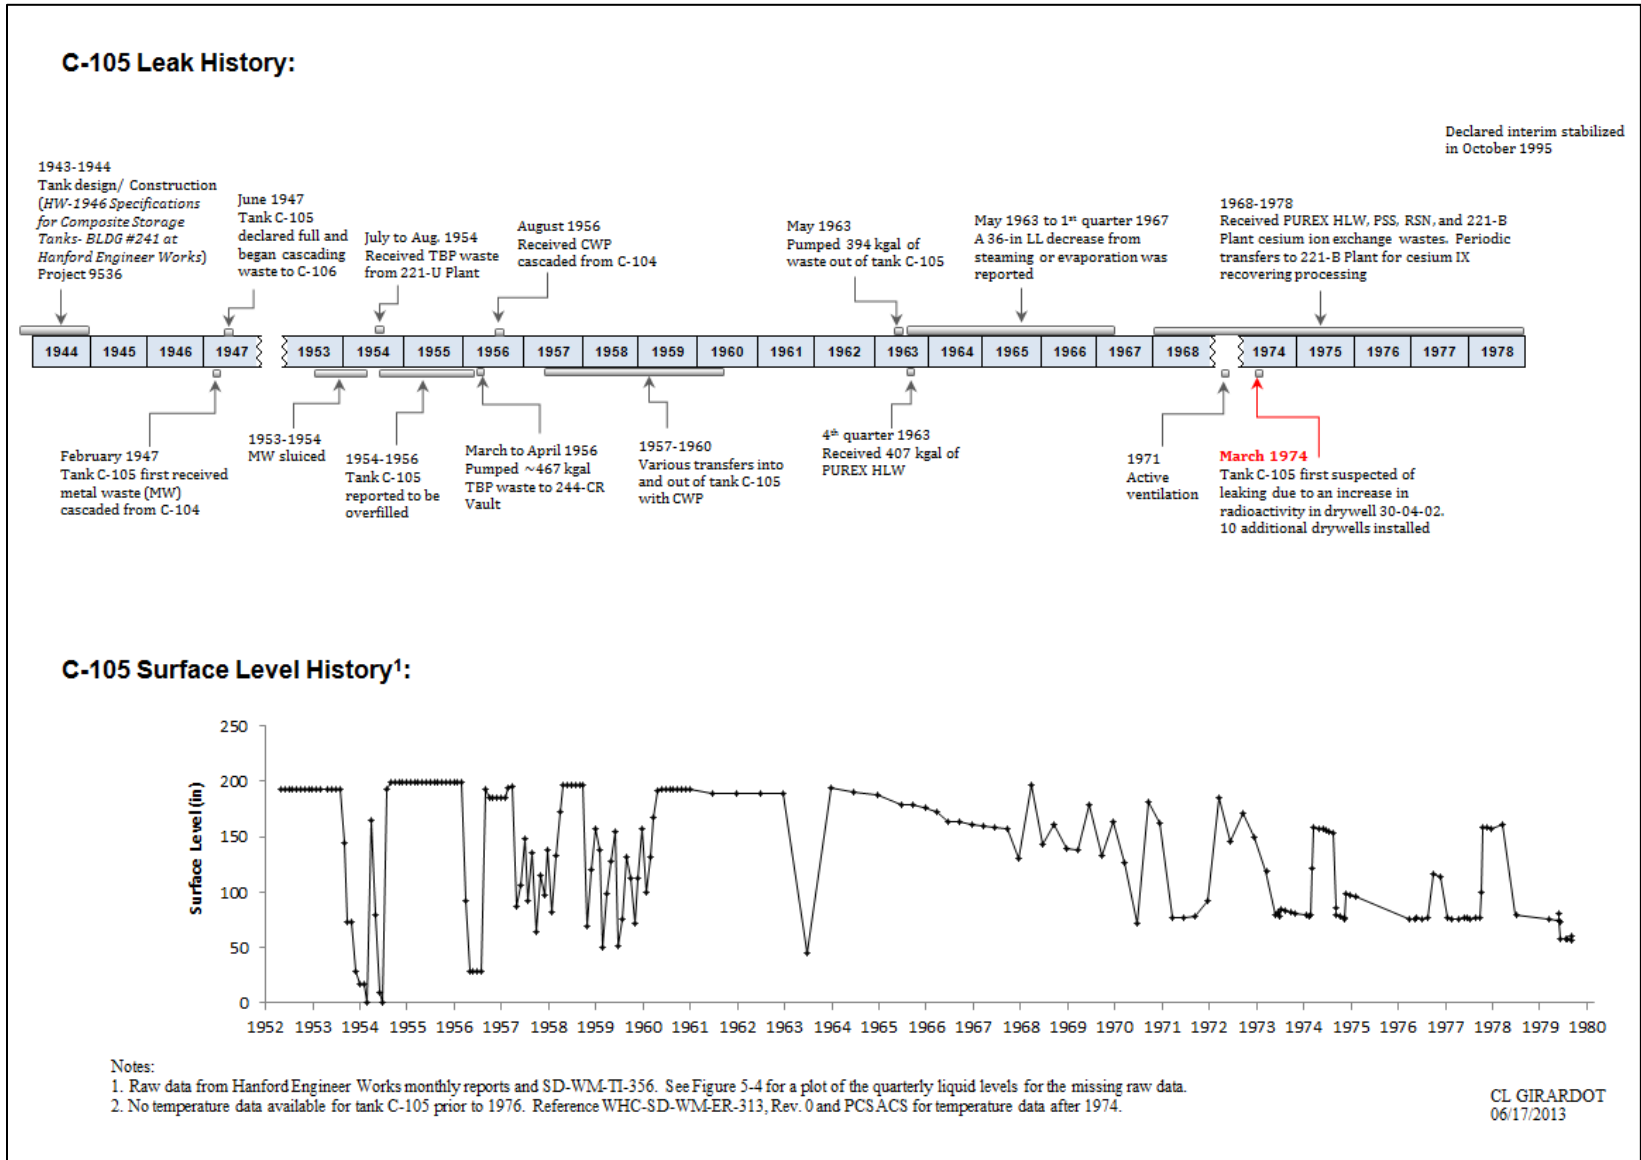
Figure 5-2. Operational Leak History of Tank C-105

The operational history of tank C-105 leak related details including the liquid level is charted in Figure 5-2.

- Response: Added words to acknowledge a 6 kgal material balance discrepancy with the new LL measurement.
12. Figure 5-2: The March 1974 entry appears related to C-101, not C-105. Please check and correct as needed.

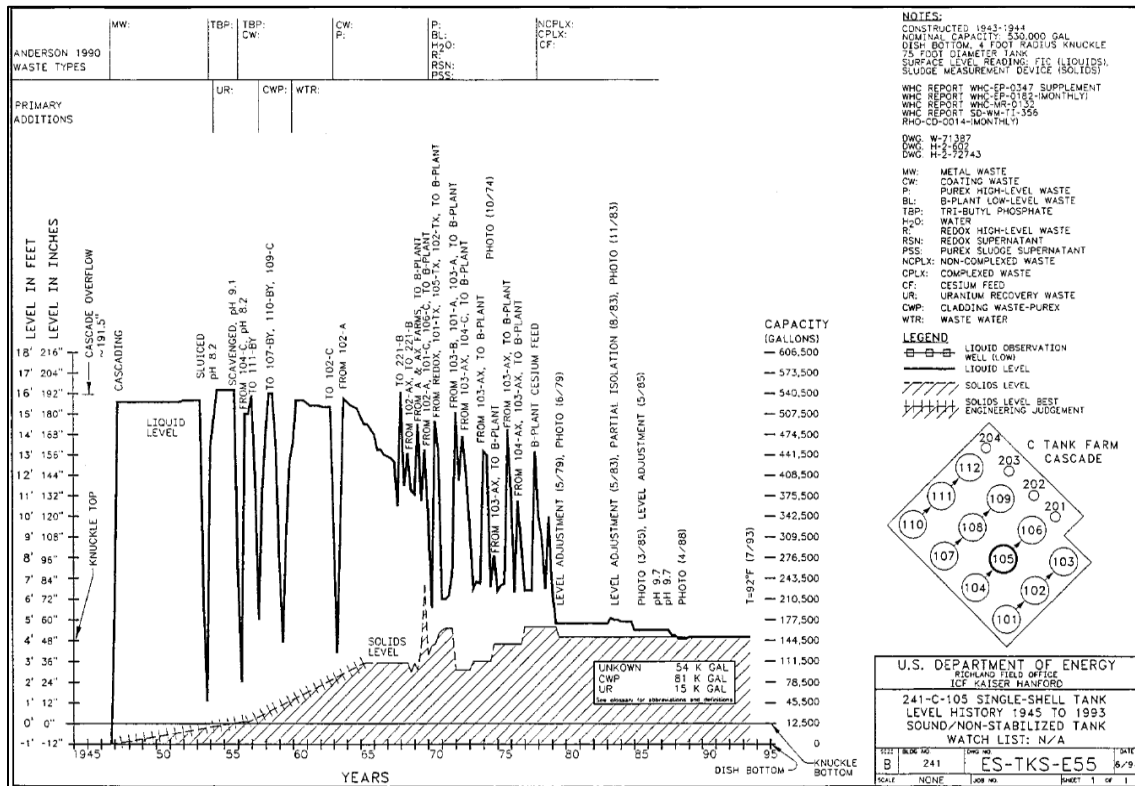
Figure 5-4. Tank C-105 End of Quarter Surface Level

Tank C-105 first received waste in February 1947 and was reported to be overfilled from August 1954 through February 1956 (see Figure 5-4). No unexplained liquid level decreases were reported until May 1963 to the 4th quarter 1967 when a 36-in liquid level decrease was reported in tank C-105, equivalent to a loss of approximately 101 kgal (RPP-ASMT-39801, Rev. 1). Records state the loss was due to "steaming" or "evaporation" (see Section 5.4.2). Tank C-105 was kept in service with no future unexplained liquid level decreases and drywells were not installed until 1972-1974.

The liquid level plot in Figure 5-4 indicates the transfer activity into and out of tank C-105. The liquid levels are end of quarter levels so this figure may not reflect all transfers into and out of the tank that occurred during the operational history. See Figure 5-2 for historical monthly liquid level readings.

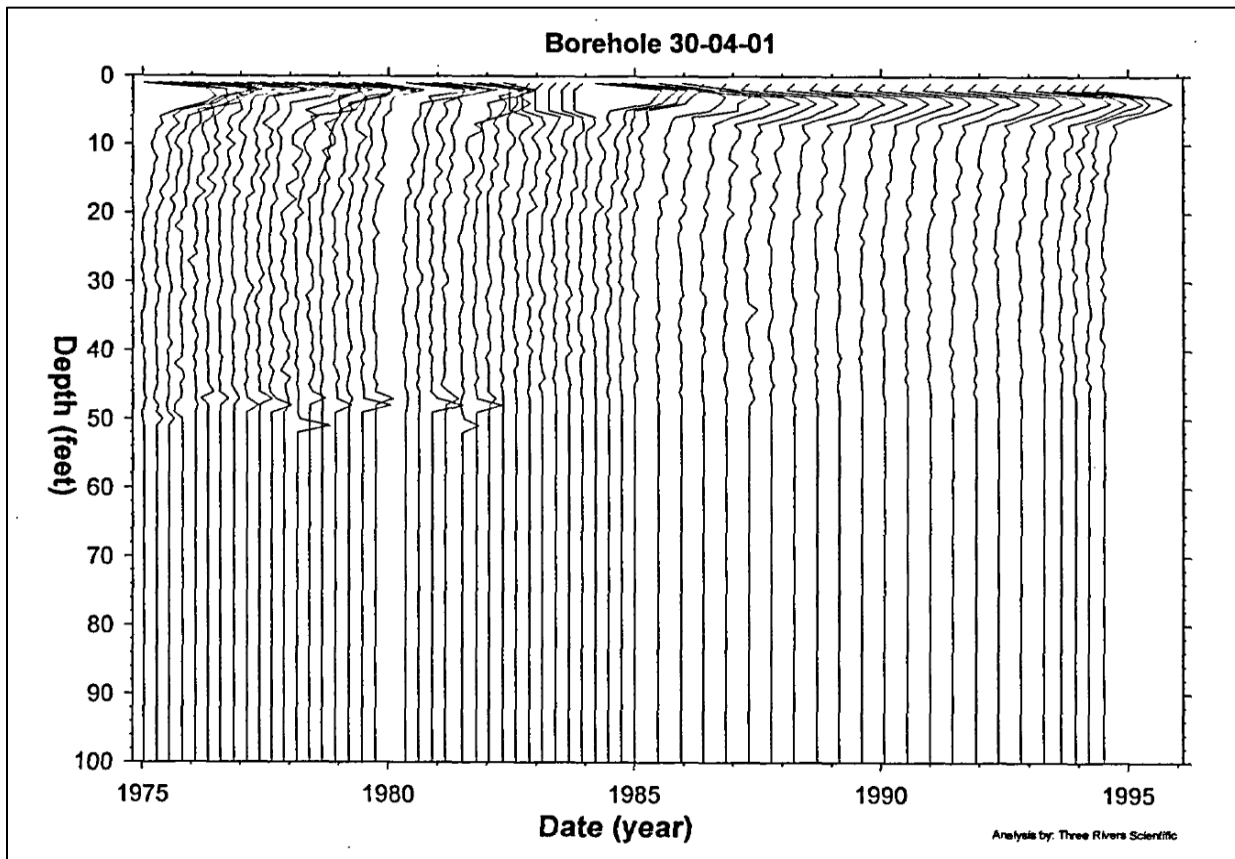
Figure 5-7. Tank C-105 Drywell 30-04-01 (RPP-8321)

Historical radioactivity in this drywell is very low and RPP-ASMT-39801 reports that radioactivity reported in this drywell does not support a tank C-105 liner leak. Therefore, drywell 30-04-01 is not being included as part of the leak location for tank C-105. Figure 5-7 shows the depths of radioactivity from 1975 to 1995 (RPP-8321).

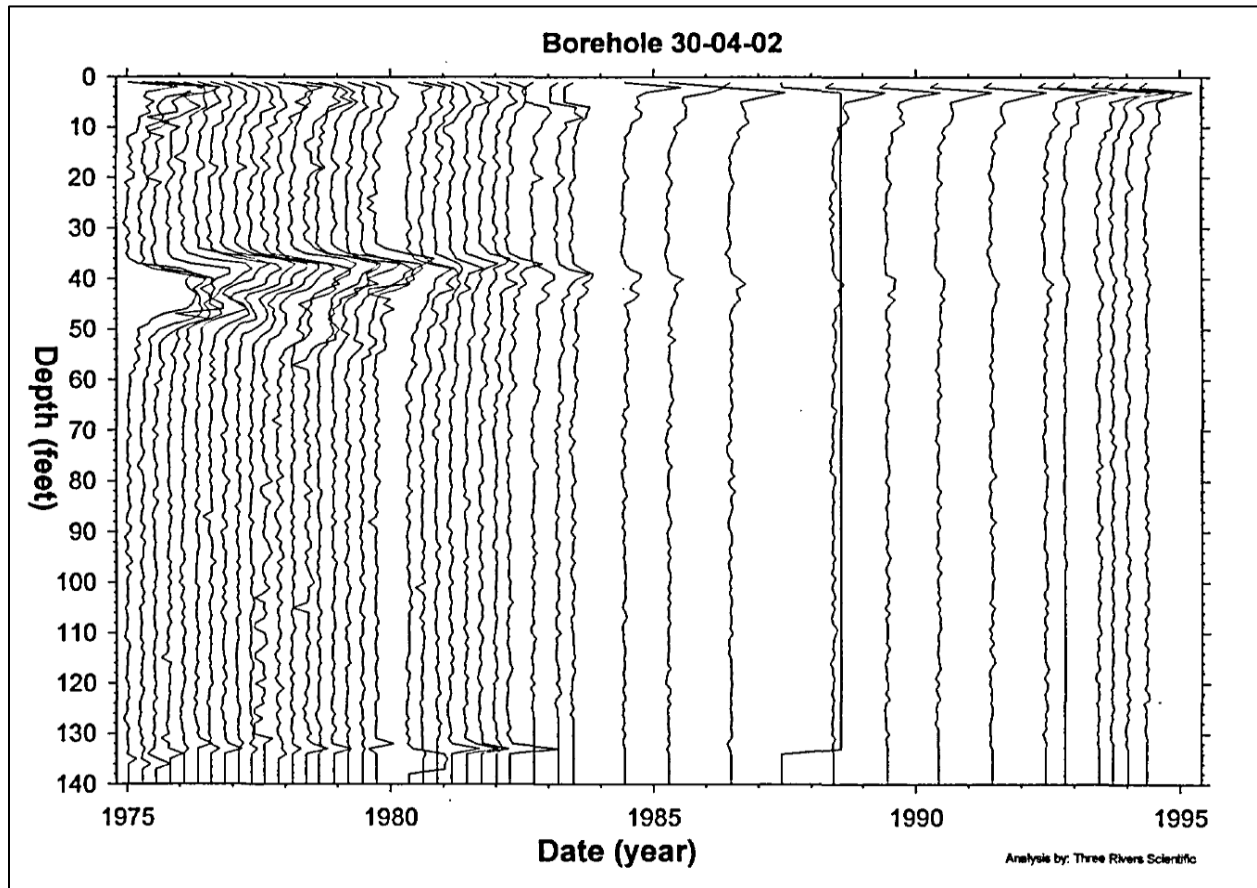
Figure 5-8. Tank C-105 Drywell 30-04-02 (RPP-8321)

In September 1997, Cs-137, Co-60, and U-235 were the only man-made radionuclides detected in drywell 30-04-02 (GJ-HAN-87). Moderate Cs-137 contamination extends from the surface to 2.5-ft BGS, then decreases to less than 20 pCi/g from 2.5 to 22-ft BGS, and below 22-ft BGS concentrations were less than 1 pCi/g. A thick zone of Co-60 contamination was detected from 38 to 58.5-ft BGS; however, concentrations were less than 1 pCi/g. A single occurrence of U-235 was detected at the ground surface (5.8 pCi/g). The activity peak identified in 1973 at 41-ft BGS correlates to the depth of the Co-60 contamination detected with SGLS (GJ-HAN-87). Document GJ-HAN-87 states the C-104-to-C-105 cascade line leak as the likely source of the Cs-137 and Co-60 detected in this drywell. However, a tank C-105 leak cannot be ruled out. Figure 5-8 shows the depths of radioactivity from 1975 to 1995 (RPP-8321).

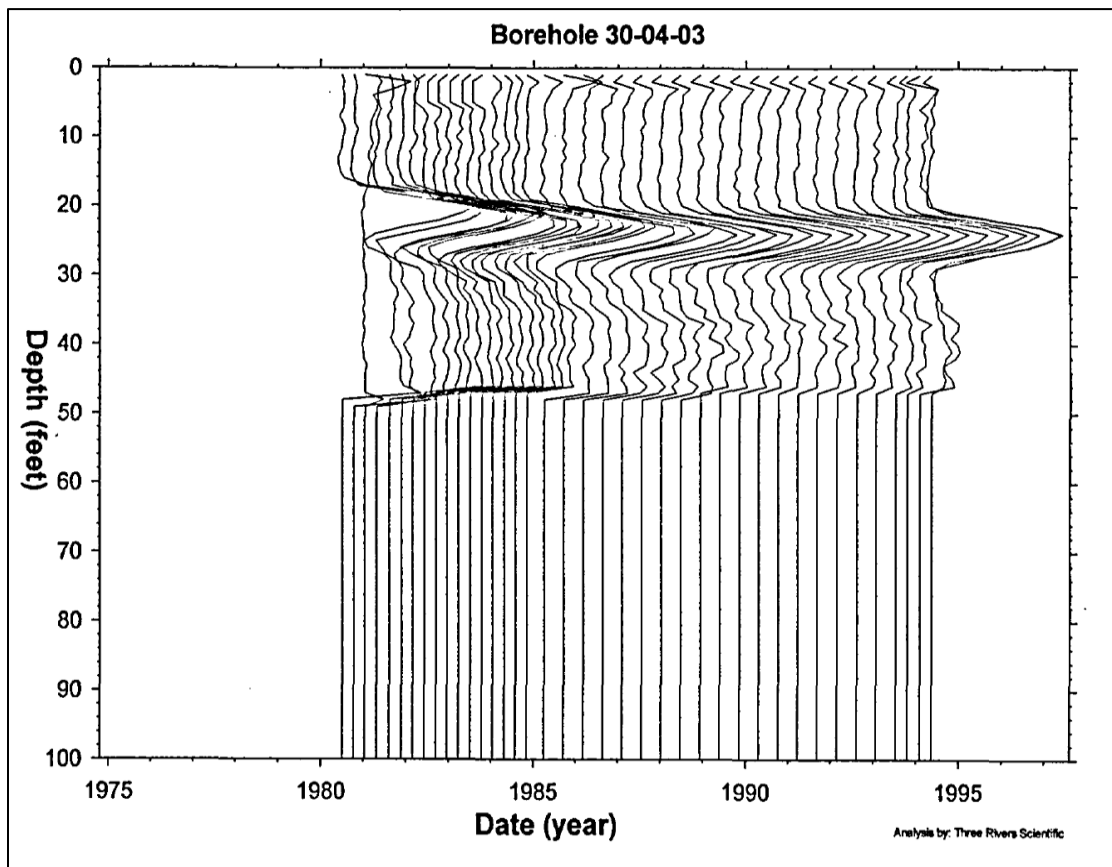
Figure 5-9. Tank C-105 Drywell 30-04-03 (RPP-8321)

In September 1997, Cs-137, Co-60, and U-235 were the only man-made radionuclides detected in drywell 30-04-03 (GJ-HAN-87). Moderate Cs-137 contamination (10 to 50 pCi/g) extends from the surface to 3-ft BGS, then decreases to less than 10 pCi/g below this zone and then to less than 3 pCi/g below 14-ft BGS. A very distinct zone of Cs-137 contamination occurs between 21 and 26-ft BGS with the highest Cs-137 concentration of 531 pCi/g detected at 23-ft BGS. Below the large Cs-137 plume, Co-60 was detected continuously from 26-ft BGS to the bottom of the logged interval (49-ft BGS) with concentrations ranging from 3 to 6 pCi/g. A single occurrence of U-235 (4.1 pCi/g) was detected at the ground surface. Document GJ-HAN-87 reports, "The distinct zone of high Cs-137 contamination detected between 21 and 26 ft and the extensive plume of Co-60 contamination that underlies it probably resulted from the C-104-to-C-105 cascade-line leak. The discrete nature of both contaminant plumes suggests that this borehole lies within proximity of the leak source." However, a tank C-105 leak cannot be ruled out. Figure 5-9 shows the depths of radioactivity from 1980 to 1995 (RPP-8321).

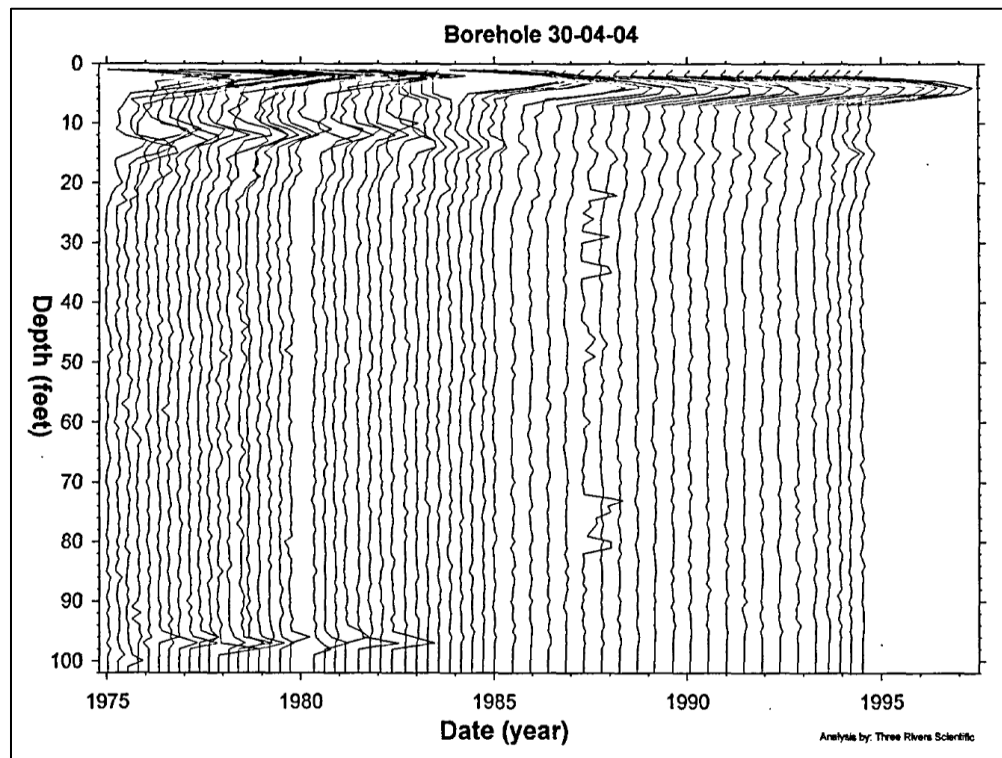
Figure 5-10. Tank C-105 Drywell 30-04-04 (RPP-8321)

Document GJ-HAN-87 reported, “The distinct zone of elevated Cs-137 contamination detected between 45 and 65 ft may have resulted from the cascade-line leak between tanks C-104 and C-105 or possibly from a leak in tank C-101. The contamination detected at this depth may also have migrated downward and laterally from the contaminant source.” However, a tank C-105 leak cannot be ruled out. Also, after further analyses it is unlikely the source of radioactivity is from tank C-101 (see tank C-101, Section 4.6). Figure 5-10 shows the depths of radioactivity from 1975 to 1995 (RPP-8321).

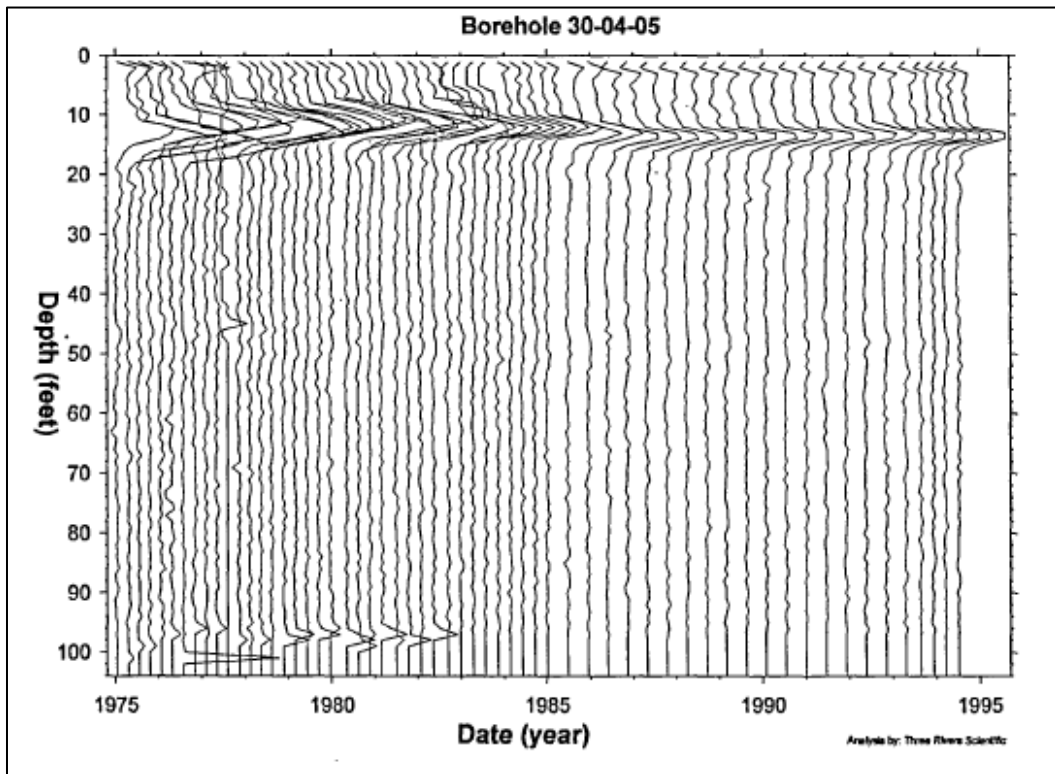
Figure 5-11. Tank C-105 Drywell 30-04-05 (RPP-8321)

In September 1997, Cs-137 was the only man-made radionuclides detected in drywell 30-04-05 (GJ-HAN-85). From the ground surface to 57.5-ft BGS and from 94.5 to 98.5-ft BGS, Cs-137 was detected almost continuously with the maximum concentration of 91.5 pCi/g measured at 12.5-ft BGS. From 69.5 to 91.5-ft BGS, Cs-137 was detected intermittently. Document GJ-HAN-85 reported, "The Cs-137 contamination from 11 to 38 ft is probably the result of a surface spill that migrated into the backfill material around the borehole" and "The Cs-137 contamination from 45 to 57.5 ft is probably from a tank leak that migrated into the Hanford formation sediments beneath the tank farm excavation." The Cs-137 contamination from 45 to 57.5-ft BGS is below 10 pCi/g and could be migration from the leak site near tank C-101 drywell 30-01-09. Also, there is no similar Cs-137 peak in drywell 30-04-04 and a leak from tank C-105 should have been detected in both drywells 30-04-04 and 30-05-04 (RPP-ASMT-39801). Therefore, drywell 30-04-05 is not being included as part of the leak location for tank C-105. Figure 5-11 shows the depths of radioactivity from 1975 to 1995 (RPP-8321).

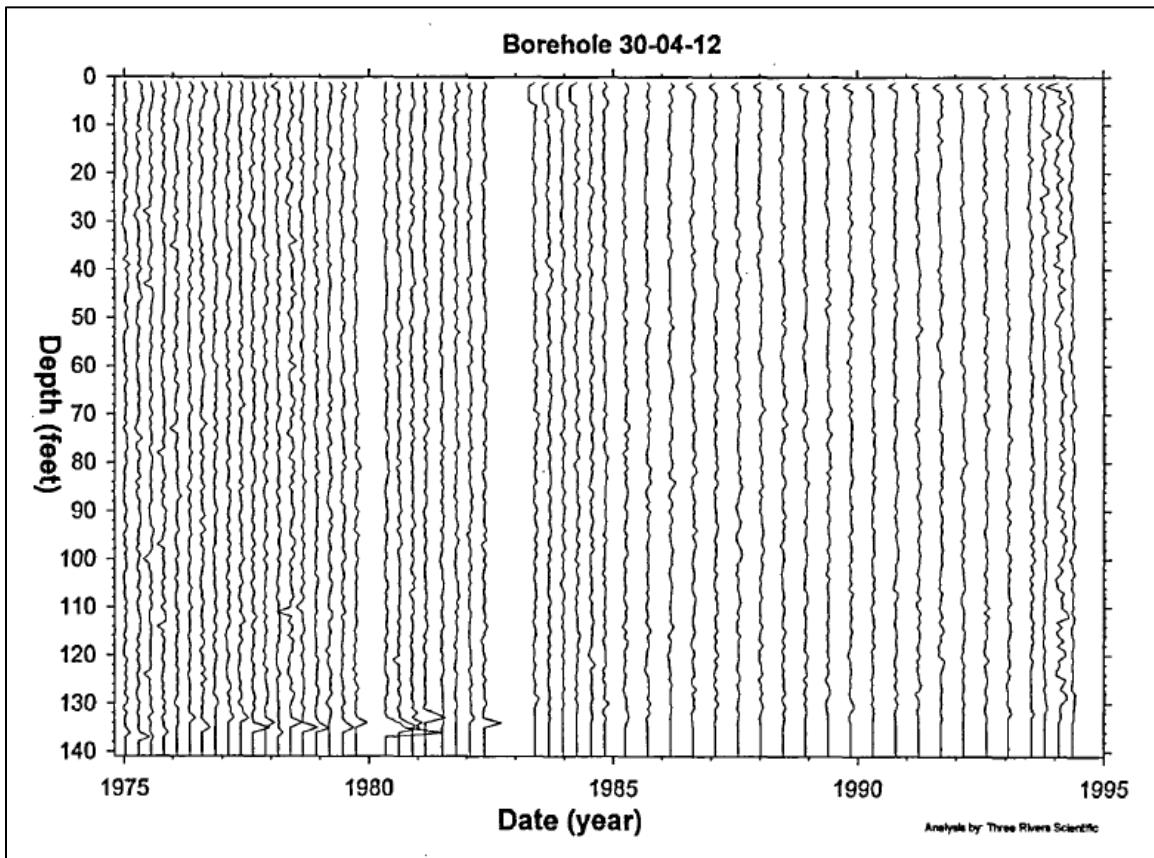
Figure 5-12. Tank C-105 Drywell 30-04-12 (RPP-8321)

In September 1997, Cs-137 and Co-60 were the only man-made radionuclides detected in drywell 30-04-12 (GJ-HAN-87). Very low level Cs-137 concentrations (from 0.2 to 0.7 pCi/g) were detected from the ground surface to 62-ft BGS with isolated occurrences at 66.5, 89, and 135-ft BGS. A few occurrences of Co-60 contamination were detected at very low concentrations (less than 0.1 pCi/g) between 43 and 47.5-ft BGS. Therefore, drywell 30-04-12 is not being included as part of the leak location for tank C-105. Figure 5-12 shows the depths of radioactivity from 1975 to 1995 (RPP-8321).

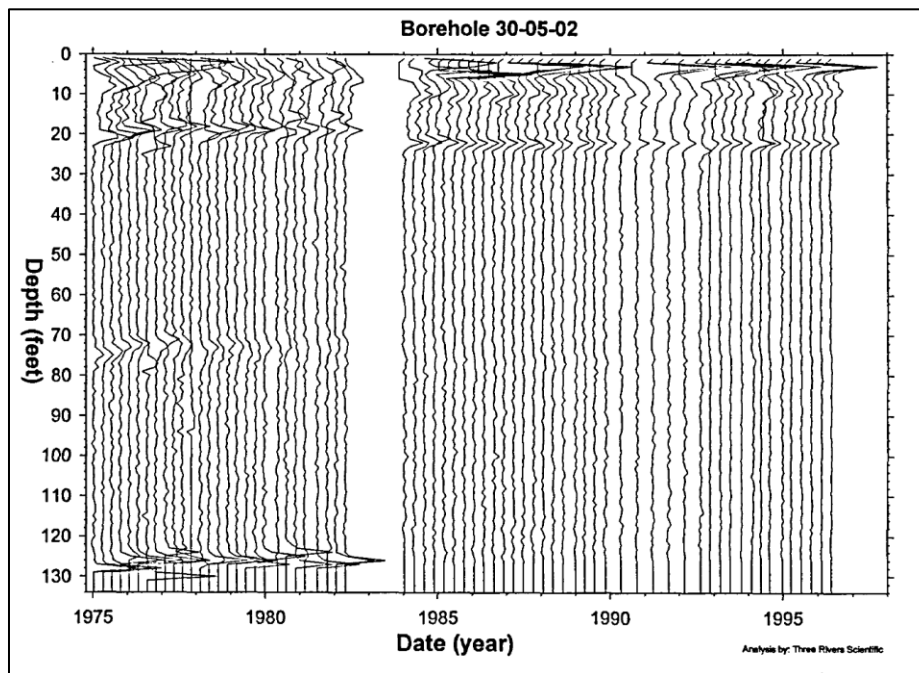
Figure 5-13. Tank C-105 Drywell 30-05-02 (RPP-8321)

The highest Cs-137 readings were encountered at the surface and very low levels were detected at the tank C-105 foundation level, there is no indication of a tank or pipeline leak at this drywell (RPP-ASMT-39801). Therefore, drywell 30-05-02 is not being included as part of the leak location for tank C-105. Figure 5-13 shows the depths of radioactivity from 1975 to 1995 (RPP-8321).

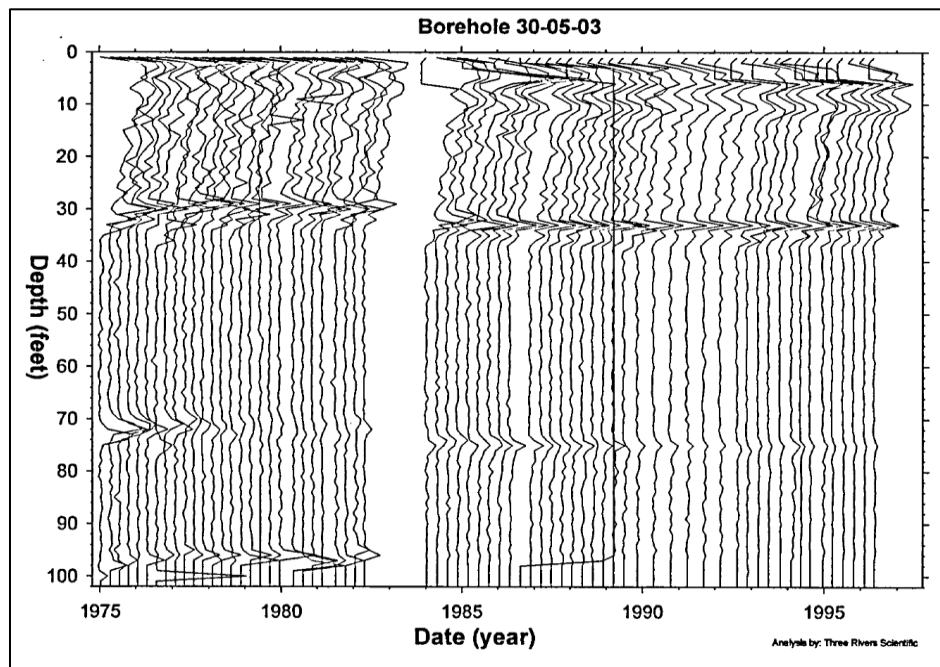
Figure 5-14. Tank C-105 Drywell 30-05-03 (RPP-8321)

Drywell 30-05-03 was discounted as being an indication of a tank or pipeline leak since the highest Cs-137 readings were encountered at the surface and very low levels were detected at the tank C-105 foundation level (RPP-ASMT-39801). However, a tank C-105 leak cannot be ruled out. Radioactivity could also be due to a leak from the nearby condenser at the surface followed by dragdown. Figure 5-14 shows the depths of radioactivity from 1975 to 1995 (RPP-8321).

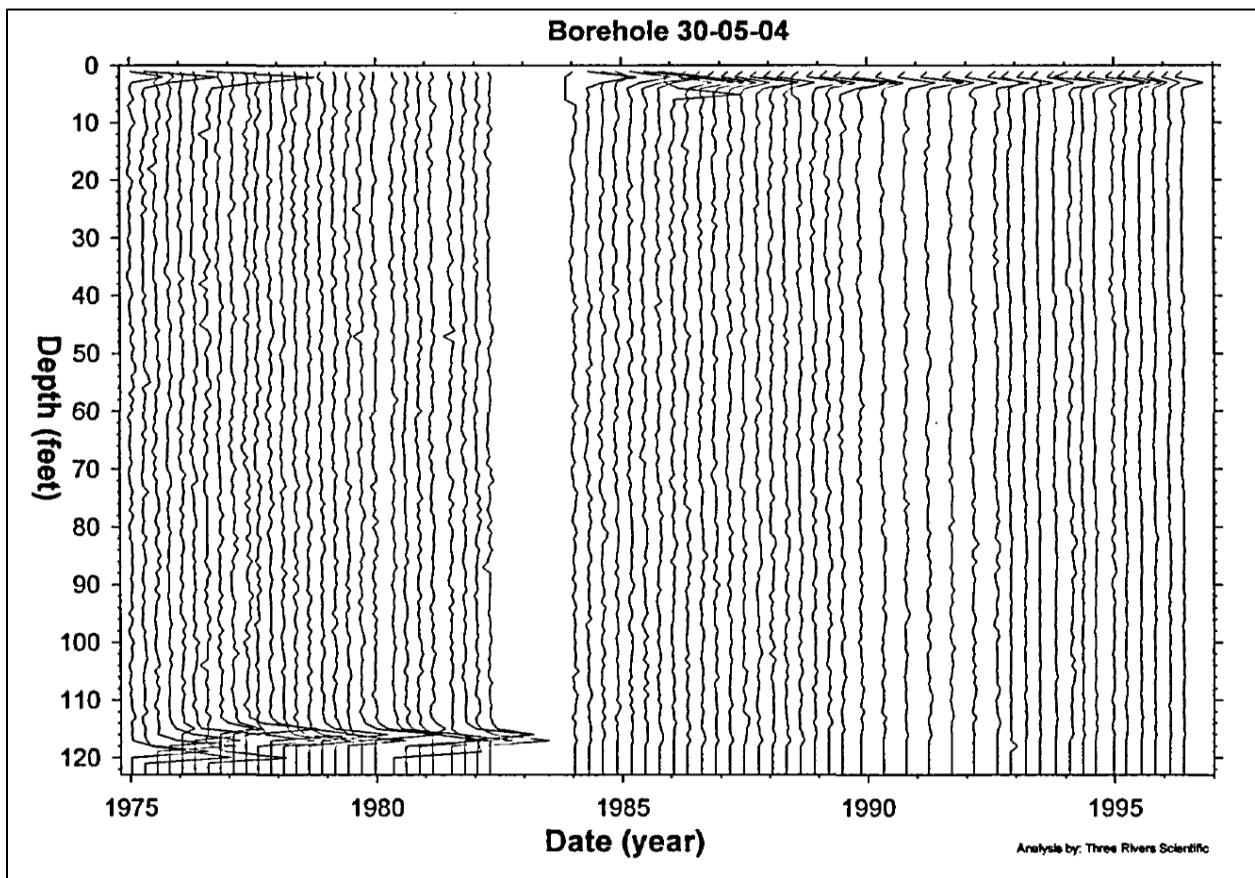
Figure 5-15. Tank C-105 Drywell 30-05-04 (RPP-8321)

In August 1997, Cs-137 and Co-60 were the only man-made radionuclides detected in drywell 30-05-04 (GJ-HAN-83). From the ground surface to 2-ft BGS, Cs-137 concentrations ranged from 25 to 45 pCi/g. The Cs-137 contamination decreases to less than 5 pCi/g between 5 and 16-ft BGS and then gradually decreases to 103-ft BGS. The Co-60 concentrations detected in this drywell were very low, ranging from 0.1 to 0.2 pCi/g. Document GJ-HAN-83 reported, “Much of the Cs-137 contamination detected below about 16 ft was probably carried down during the drilling of this borehole or later migrated down the outside of the borehole casing.” The highest Cs-137 readings were encountered at the surface and very low levels were detected at the tank C-105 foundation level, there is no indication of a tank or pipeline leak at this drywell (RPP-ASMT-39801). Therefore, drywell 30-05-04 is not being included as part of the leak location for tank C-105. Figure 5-15 shows the depths of radioactivity from 1975 to 1995 (RPP-8321).

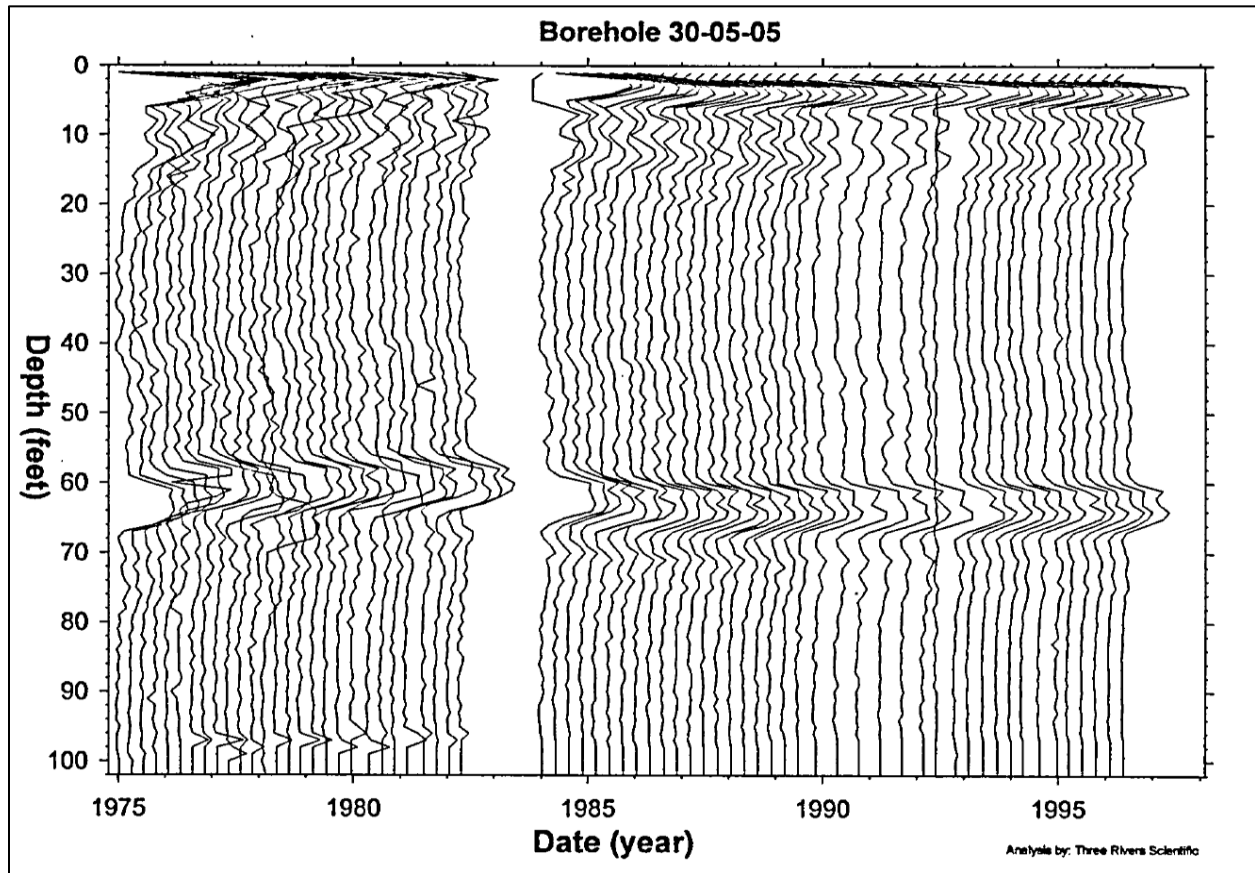
Figure 5-16. Tank C-105 Drywell 30-05-05 (RPP-8321)

In August 1997, Cs-137 and Co-60 were the only man-made radionuclides detected in drywell 30-05-05 (GJ-HAN-83). From the ground surface to 84.5-ft BGS, relatively higher Cs-137 concentrations were detected with the highest concentration (161 pCi/g) reported at the ground surface. The Cs-137 concentrations ranged from 30 to 70 pCi/g between 60 and 66-ft BGS. Continuous Co-60 contamination was detected from 69.5 to 74.5-ft BGS (as much as 1 pCi/g). A few Co-60 occurrences were detected at very low concentrations (0.1 pCi/g) at 79, 79.5, and 97-ft BGS. Document GJ-HAN-83 reported, "On the basis of an assessment of the RLS data, Brodeur (1993) concludes that there are two possible sources for the high Cs-137: lateral migration of the radionuclides released in the C-104-to-C-105 cascade-line leak, or a leak from tank C-105." However, radioactivity is detected at a much lower BGS level than the other nearby drywells and could be migration from an unknown source. Therefore, drywell 30-05-05 is not being included as part of the leak location for tank C-105. Figure 5-16 shows the depths of radioactivity from 1975 to 1995 (RPP-8321).

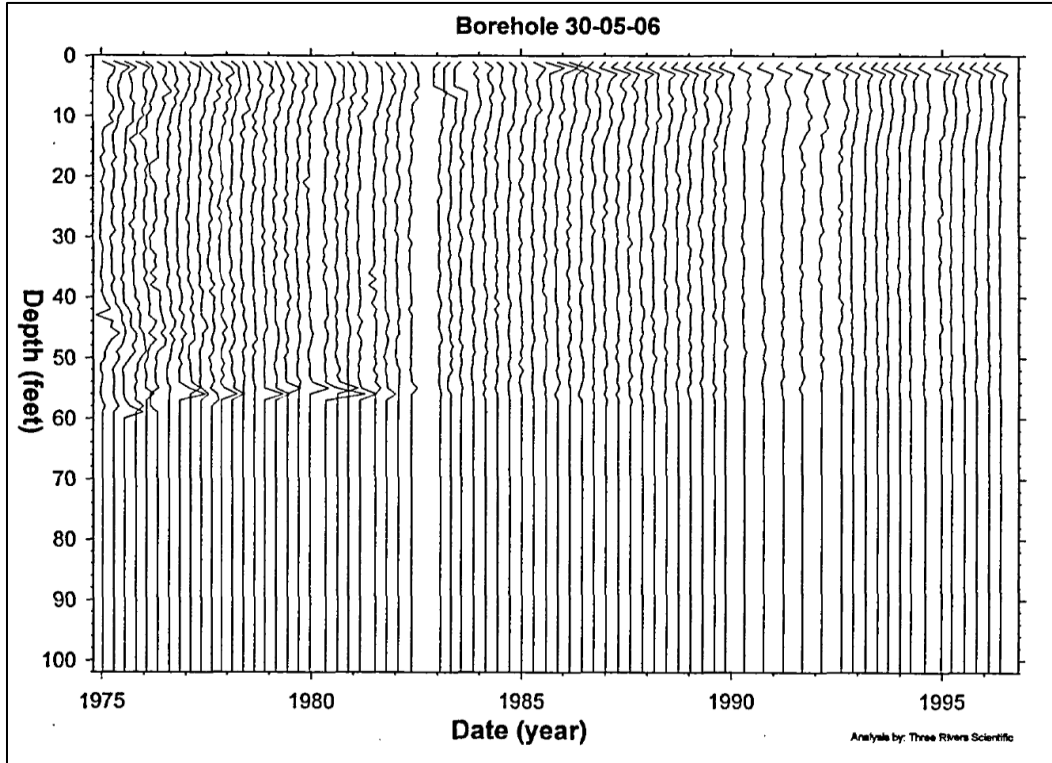
Figure 5-17. Tank C-105 Drywell 30-05-06 (RPP-8321)

In August 1997, Cs-137 and U-235 were the only man-made radionuclides detected in drywell 30-05-06 (GJ-HAN-83). From the ground surface to 2-ft BGS, Cs-137 concentrations ranged from 10 to 30 pCi/g. The Cs-137 contamination decreases to less than 10 pCi/g below this zone and continues to decrease to less than 1 pCi/g below 26-ft BGS. Between 41 and 52-ft BGS, Cs-137 concentrations ranged from 0.5 to 1 pCi/g and contamination was slightly above the minimum detection limit (MDL) at 35.5 and 36.5-ft BGS. A single occurrence of U-235 was detected at the ground surface with a concentration slightly above the MDL at 3.6 pCi/g. Document GJ-HAN-83 reported, "The zone of Cs-137 contamination between 41 and 52 ft may have resulted from the cascade-line leak between tanks C-104 and C-105."... "The low Cs-137 concentrations contamination detected below 26 and 52 ft were probably carried down during drilling of this borehole or later migrated down the outside of the borehole casing." Therefore, drywell 30-05-06 is not being included as part of the leak location for tank C-105. However, a pipeline leak cannot be ruled out. Figure 5-17 shows the depths of radioactivity from 1975 to 1995 (RPP-8321).

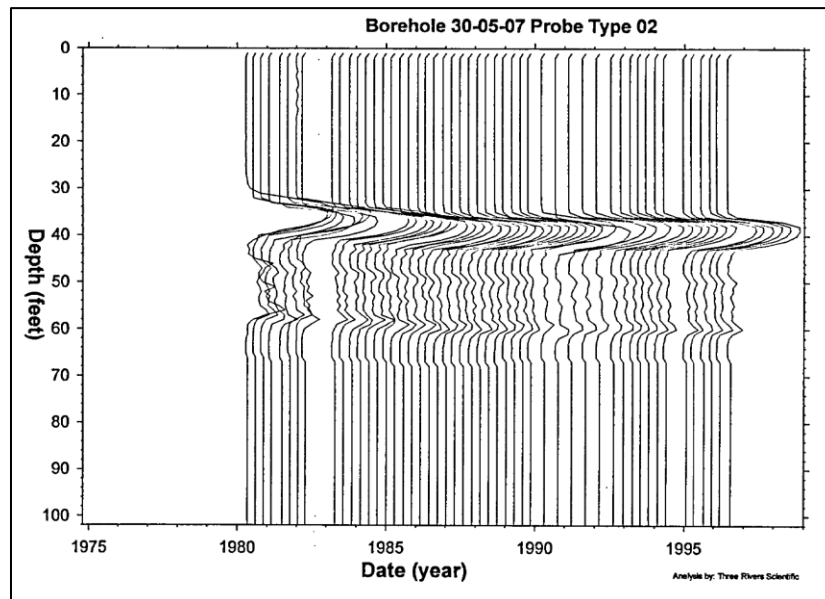
Figure 5-18. Tank C-105 Drywell 30-05-07 (RPP-8321)

The measured Cs-137 in this drywell was a factor of nearly 10^6 times higher than any other measurements from other tank C-104 or C-105 drywells with the highest concentrations at the tank footing. Historical gross gamma scans have interpreted the peak in drywell 30-05-07 as stable and decaying with a Cs-137 half-life; however, the validity of the interpretation that the peak is stable is affected by the radiation detector counting limitations (RPP-ASMT-39801, Section 7.7). Figure 5-18 shows the depths of radioactivity from 1980 to 1995 (RPP-8321).

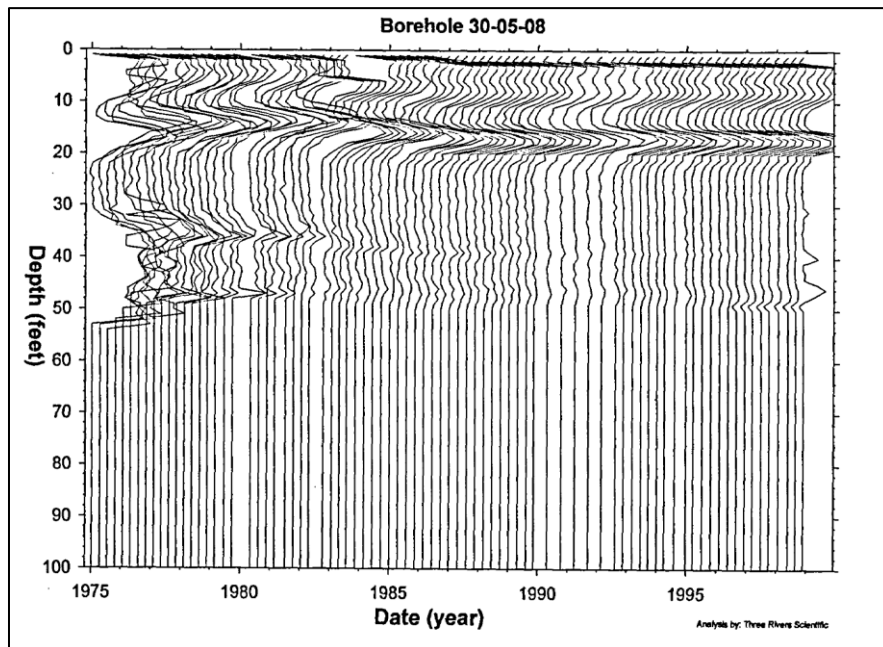
Figure 5-19. Tank C-105 Drywell 30-05-08 (RPP-8321)

Document GJ-HAN-83 reported, “A significant zone of Cs-137 and Eu-154 contamination combined with low levels of Co-60 contamination was detected between 14 and 20 ft. This contamination probably resulted from a transfer-line leak because it occurs at a relatively shallow depth above the level of the cascade line between tanks C-104 and C-105.” It was also stated that the Cs-137 and Co-60 detected deeper in the drywell were likely the result of subsurface contamination from the C-104-to-C105 cascade line leak. However, a tank C-105 leak cannot be ruled out. A leak from the capped spare nozzles was ruled out as source of radioactivity detected in drywell 30-05-08 (RPP-ASMT-46452). Figure 5-19 shows the depths of radioactivity from 1975 to 1995 (RPP-8321).

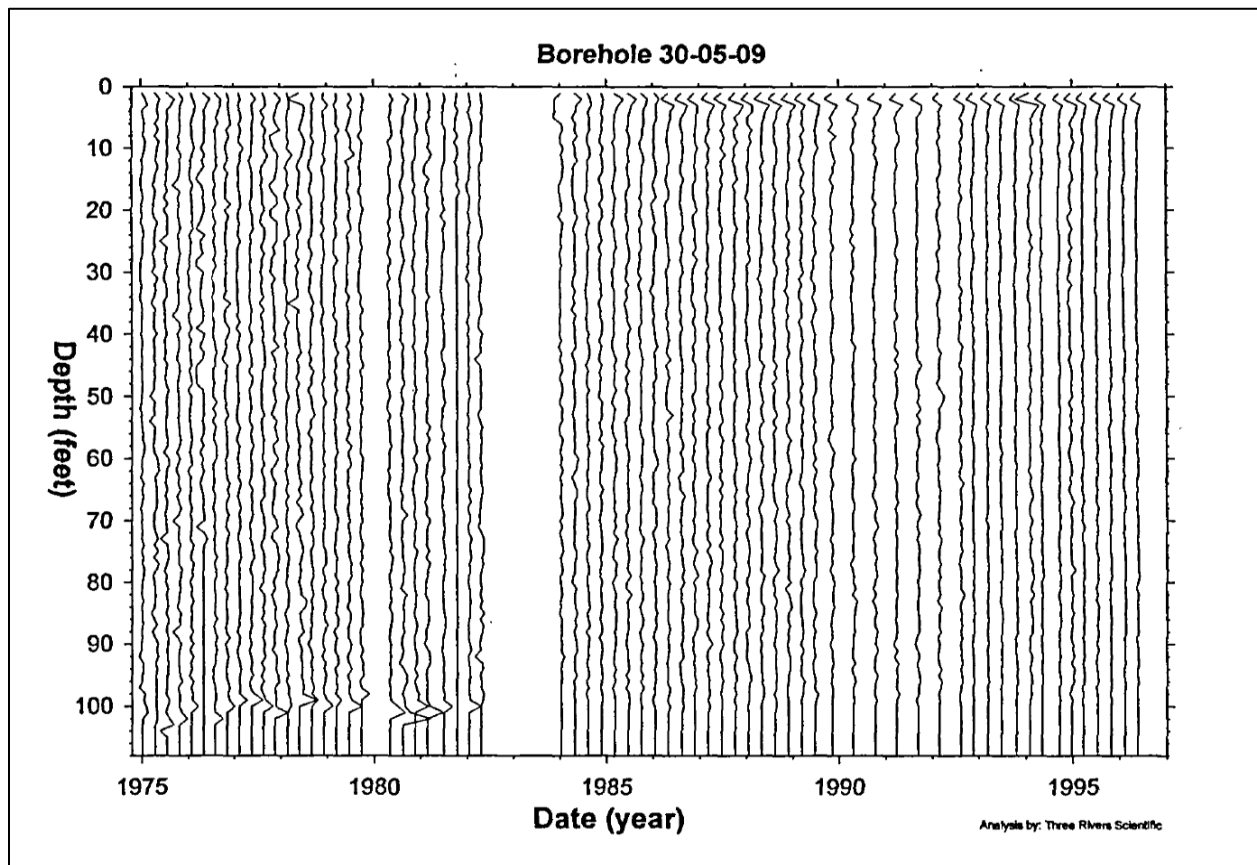
Figure 5-20. Tank C-105 Drywell 30-05-09 (RPP-8321)

In August 1997, Cs-137 was the only man-made radionuclides detected in drywell 30-05-09 (GJ-HAN-83). A thick zone of generally low Cs-137 contamination, with concentrations decreasing with depth (from 7 to 0.2 pCi/g), were reported from the ground surface to 32.5-ft BGS. From 48.5 to 77-ft BGS concentrations were less than 0.5 pCi/g, except from 57 to 64-ft BGS concentrations were greater than 1 pCi/g. Document GJ-HAN-83 reported, "The majority of the shallow Cs-137 contamination detected between the ground surface and 27 ft probably resulted from surface spills that have migrated down into the backfill surrounding the borehole. The region of elevated Cs-137 contamination detected from 58 to 63 ft suggests the possibility of a subsurface source, such as the C-104-to-C-105 cascade-line leak." Therefore, drywell 30-05-09 is not being included as part of the leak location for tank C-105. Figure 5-20 shows the depths of radioactivity from 1975 to 1995 (RPP-8321).
