Hanford Single-Shell Tank Leak Causes and Locations - 241-C Farm

C.L. Girardot, D.G. Harlow

Washington River Protection Solutions

Key Words: leak location, leak cause, tank, integrity assessment, C Farm, C-101, C-105, leak assessment

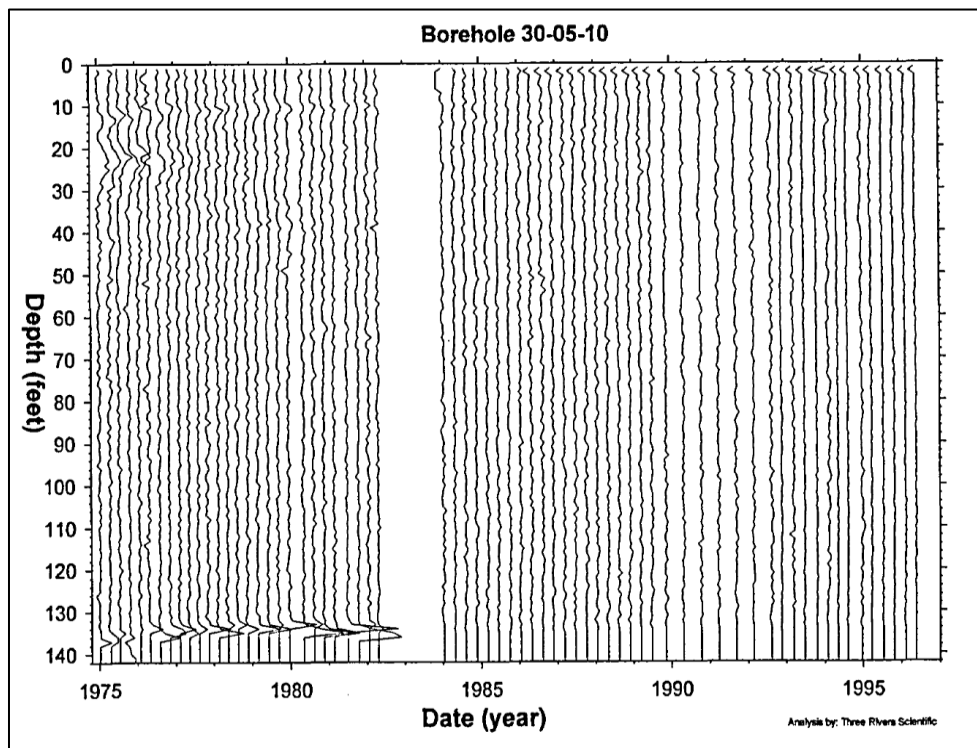
Figure 5-21. Tank C-105 Drywell 30-05-10 (RPP-8321)

In August 1997, Cs-137, Co-60, and U-235 were the only man-made radionuclides detected in drywell 30-05-10 (GJ-HAN-83). From the ground surface to 16-ft BGS, and concentrations decreasing with depth, Cs-137 concentrations ranged from 0.2 to 3 pCi/g. Small regions of very low Cs-137 contamination (less than 0.6 pCi/g) were reported from 26 to 30-ft and 114.5 to 116.5-ft BGS, and from 134.5 to 135.5-ft BGS concentrations were between 0.25 and 2.5 pCi/g. Several small zones of Co-60 contamination were detected between 13 and 53.5-ft BGS at concentrations less than 0.25 pCi/g. Document GJ-HAN-83 reported, "Most of the Cs-137 contamination detected below 20 ft was probably carried down during the drilling of this borehole or later migrated down the outside of the borehole casing." and "The zones of Co-60 contamination detected from 13 to 14.5 ft and 23 to 26 ft may have resulted from a nearby pipeline leak. The isolated region of minor Co-60 contamination detected from 47 to 53.5 ft may represent the remnant of a plume related to the cascade-line leak that occurred between tanks C-104 and C-105." Therefore, drywell 30-05-10 is not being included as part of the leak location for tank C-105. Figure 5-21 shows the depths of radioactivity from 1975 to 1995 (RPP-8321).

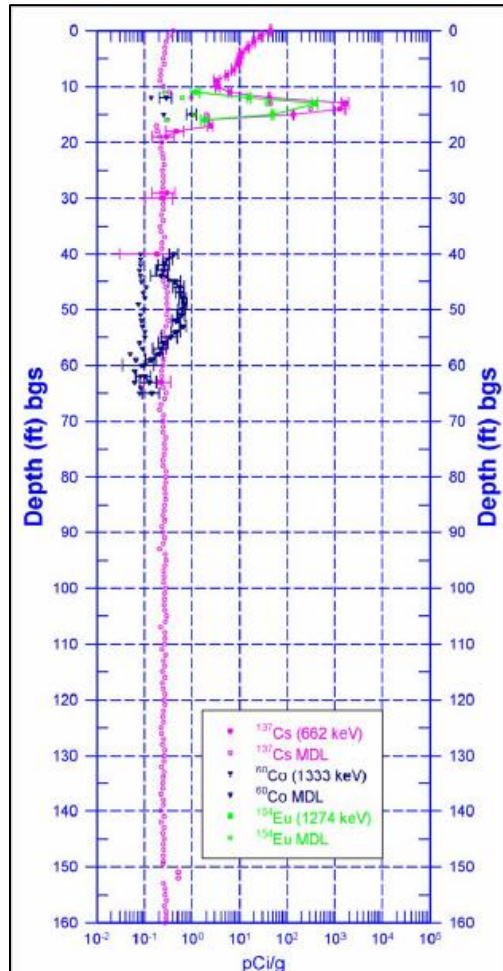
**Figure 5-22. Spectral Gamma Analyses of Drywell C4297
RPP-35484, Rev. 1**

In February 2004, drywell C4297 was installed to a total depth of 196.5-ft BGS between tanks C-104 and C-105 (see Figure 5-1). Results of the spectral gamma logging (see Figure 5-22) show elevated Cs-137 contamination between 10 and 20-ft BGS with a sharp peak at 14-ft BGS (~1000 pCi/g). A Eu-154 peak (~150 pCi/g) was also reported at 14-ft BGS which suggests a point source contamination, such as a pipeline. Line V103 that connects to tank C-105 lies less than 6-in from drywell C4297 at a depth of 13.6-ft BGS (RPP-ASMT-39801, Rev. 1). From 40 to 65-ft BGS, Co-60 is present at concentrations up to 0.5 pCi/g which is similar to drywell 30-05-08. It was reported in RPP-35484, Rev. 1, “At least two waste sources initiating at different starting depths and likely different times in the vadose zone are inferred from these observations, consistent with a tank leak event and at least one transfer line leak event.”

MDL= minimum detection limit
Note: Bottom of the tank footing is ~37-ft 5-in BGS

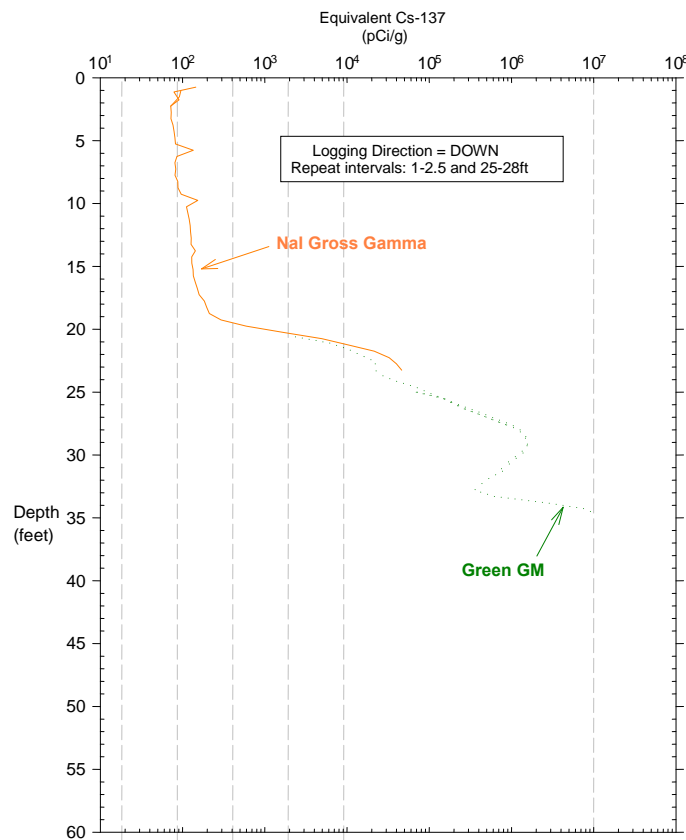
**Figure 5-23. Direct Push C7469 Small Diameter Gamma Survey
RPP-RPT-43725**

Direct push C7469 was installed in October 2009 and is located 3.8-ft from the inlet cascade line sidewall penetration, 2.3-ft from the tank sidewall, and pushed down to the tank footing (see Figure 5-1). A sodium iodide detector was used until the detector became saturated due to high count rates (about 23.5-ft BGS) and then a lower sensitivity green GM detector was used to complete the logging (see Figure 5-23). At 28-ft BGS, a peak concentration of $\sim 1 \times 10^6$ pCi/g was reported (see Figure 5-23) which is similar to concentrations reported beneath the spare inlet penetrations during the 1967 excavation for Line V103 (RPP-RPT-43725).

Note: Bottom of the tank footing is ~37-ft 5-in BGS

Below the 28-ft BGS peak, the soil contamination continued to decrease with depth before rising again in a second, much more intense contamination peak located at the base of the tank. The peak indicates that either the inlet cascade line penetration leak accumulated at the tank base, or else a second waste source is present at this depth. The direct push was terminated at the tank footing when resistance was met.

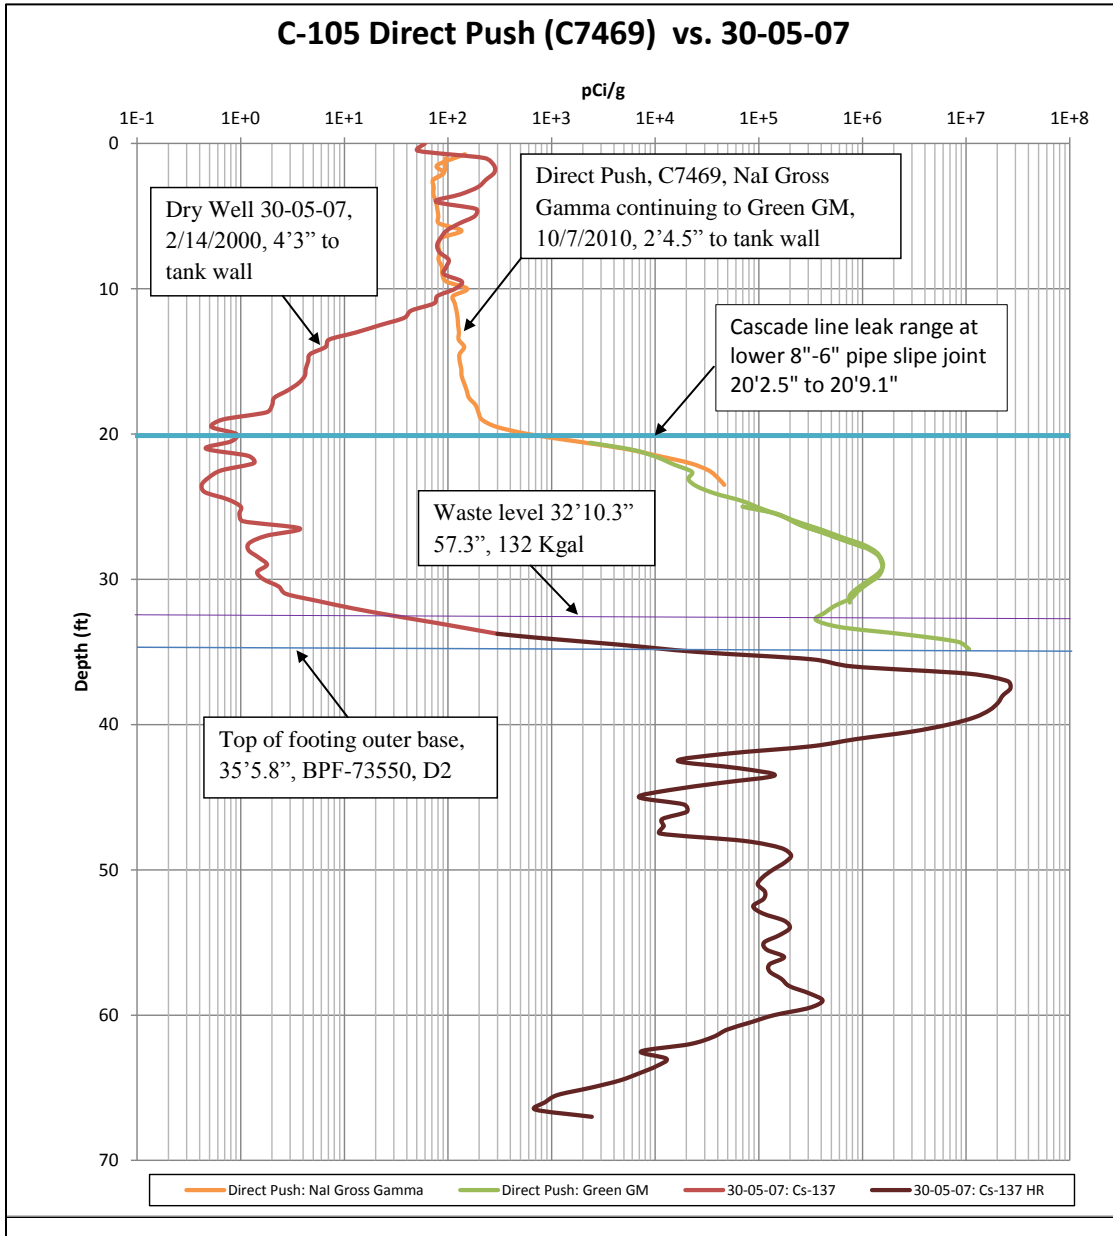
Figure 5-24. Direct Push C7469 and Drywell 30-05-07 Soil Contamination Profiles Comparison (RPP-ASMT-46452, Rev. 0)

During this period, drywell 30-05-07 was re-logged and a comparison of the radiation logs between direct push C7469 and drywell 30-05-07 is shown in Figure 5-24. Drywell 30-05-07 is located roughly twice the distance from the sidewall and cascade line penetration than direct push C7469. The drywell 30-05-07 log shows no evidence of the inlet cascade line penetration

leak detected by C7469. At the top of the tank C-105 footing, direct push C7469 recorded 1×10^7 pCi/g while drywell 30-05-07 recorded $\sim 1 \times 10^4$ pCi/g, an attenuation factor of 1000x over a horizontal distance of 3.9-ft. Immediately below the tank footing, the soil contamination detected in drywell 30-05-07 continued to increase to a maximum Cs-137 peak of $\sim 4 \times 10^7$ pCi/g. The concentration in this lower peak is 20 to 40 times higher than the upper peak detected at 28-ft BGS in direct push C7469 (RPP-ASMT-46452).

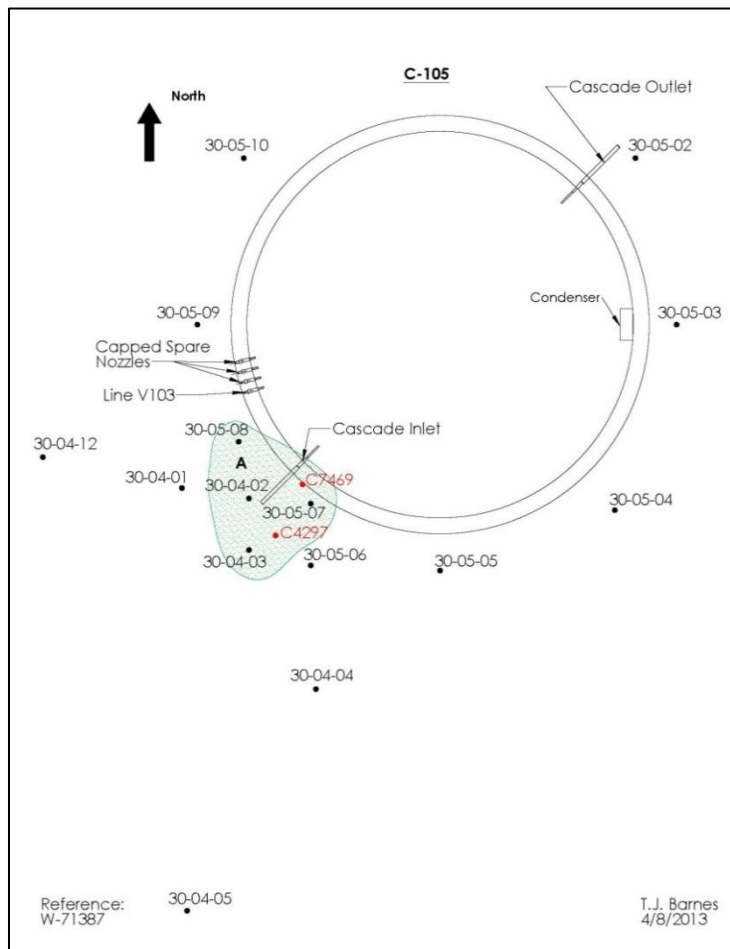
Figure 5-25. Tank C-105 Possible Leak Location (Before 1974)
 Tank inner ring is steel liner; outer ring is outer edge of tank footing

Tank C-105 was first suspected of leaking based on radioactivity detected in drywell 30-04-02; ten additional drywells were installed as a result. During this time liquid level decreases were reported to be normal due to evaporation. After further analyses, it was determined the tank was not actively leaking and tank C-105 was returned to service in October 1974. Tank C-105 continued to be kept in service with the last transfer out of the tank in June 1979 and water additions to allow for cooling continued until the mid-1990s.

The integrity of the tank was reassessed later and drywell C4297 and direct push C7469 were installed in 2004 and 2009, respectively. Drywells 30-04-02, 30-04-03, 30-05-08 and drywell C4297 all indicate radioactivity that could be the result of a tank leak and/or a line leak (C-104-to-C-105 cascade line and/or Line V103). Drywell 30-05-07 reported a peak at 37-ft BGS and concentrations were much greater than any other nearby drywell likely indicating a tank liner leak as shown in Figure 5-25. Direct push C7469 reported two separate peaks, one consistent with a cascade line leak, and the other peak either a continuation of the cascade line leak or a tank leak near the bottom of the tank.

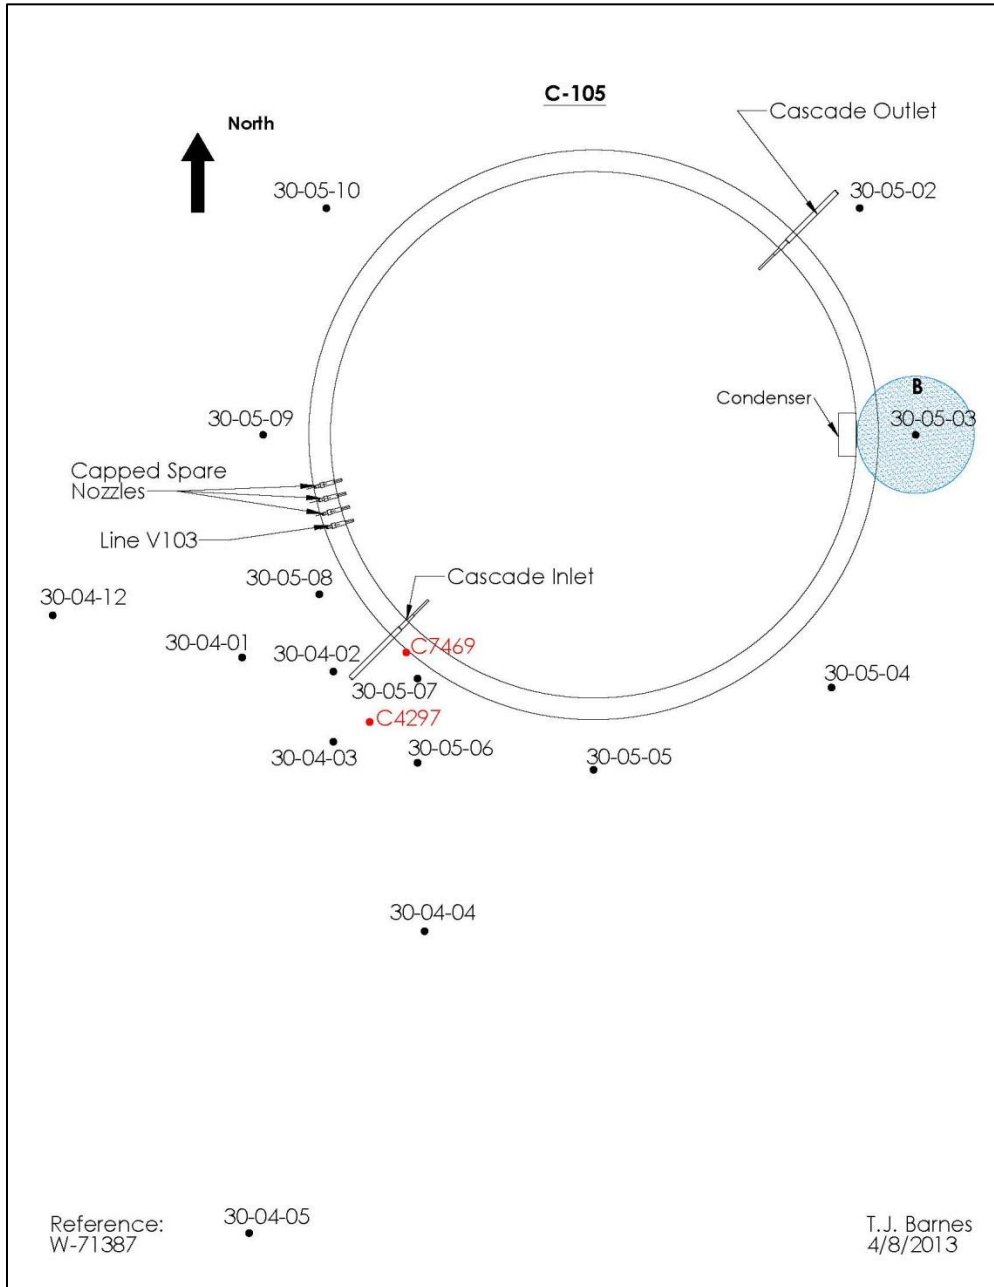
Figure 5-26. Tank C-105 Possible Leak Location (Before 1974)
 Tank inner ring is steel liner; outer ring is outer edge of tank footing

Drywell 30-05-03 reported low level radioactivity with a peak at approximately 32-ft BGS (see site B in Figure 5-26). Later SGLS data reports a thick zone of Cs-137 contamination from the ground surface to 38.5-ft BGS. This appears to be a separate site unrelated to the radioactivity detected in the southern portion of tank C-105 (see site A in Figure 5-25). The radioactivity reported in this drywell could be due to a tank leak and/or a leak from the nearby condenser.

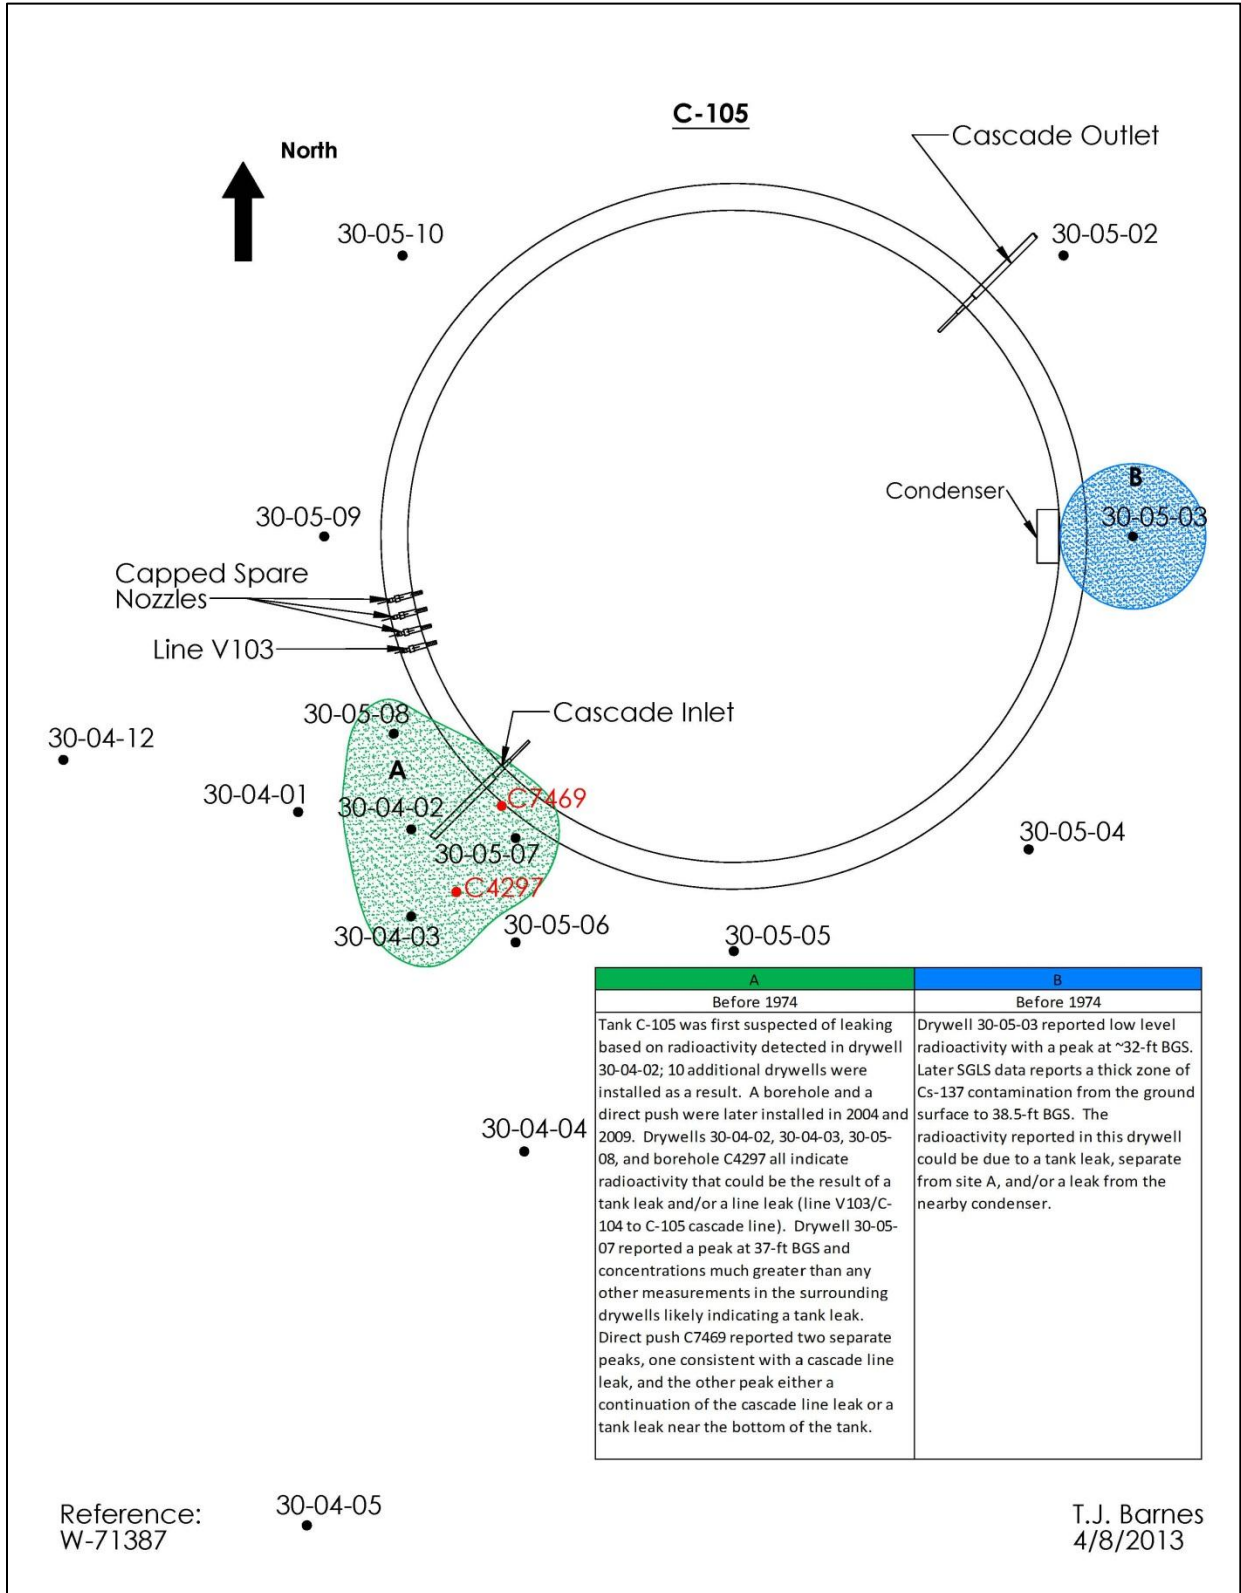
Figure 5-27. Tank C-105 Possible Radial Leak Locations
 Tank inner ring is steel liner, outer ring is outer edge of tank footing

Tank C-105 was first suspected of leaking based on radioactivity detected in drywell 30-04-02 in 1974, at which time ten additional drywells were installed. Drywell C4297 and direct push C7469 were installed later in 2004 and 2009, respectively. Drywells 30-04-02, 30-04-03, 30-05-08, and drywell C4297 all indicate radioactivity that could be the result of a tank leak and/or a line leak from the C-104-to-C-105 cascade line and/or Line V103 (see Figure 5-27). Drywell 30-05-07 reported a peak at the base of the tank (37-ft BGS) and concentrations reported were much greater than any readings from the other drywells likely indicating a tank leak. Direct push C7469, installed in 2009, reported two separate peaks, one consistent with a cascade line leak, and the other peak either a continuation of the cascade line leak or a tank leak near the bottom of the tank.

Also during the same time frame, drywell 30-05-03 reported low level radioactivity at approximately 32-ft BGS. Later SGLS data reports a thick zone of Cs-137 contamination from the ground surface to 38.5-ft BGS. Radioactivity reported in this drywell could be due to a tank leak, separate from site A (see Figure 5-27), and/or a leak from the nearby condenser.

Leak locations in Figure 5-27 are based on peak readings and are a representation of possible initial boundaries of radioactivity.
