241-AZ Farm Annulus Extent of Condition Baseline Inspection

Washington River Protection Solutions

Abstract: This report provides the results of the comprehensive annulus visual inspection for tanks 241-AZ-101 and 241-AZ-102 performed in fiscal year 2013. The inspection established a baseline covering about 95 percent of the annulus floor for comparison with future inspections. Any changes in the condition are also included in this document.

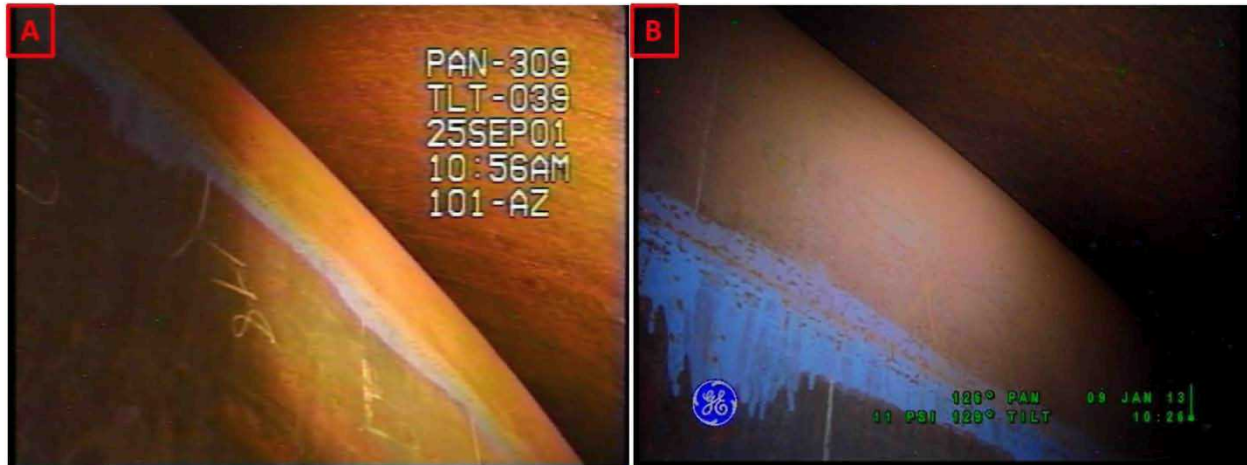
The tank dome and upper haunch area were not visible during the 1993 inspection. Figure 2-1 and Figure 2-2 show comparisons of the upper haunch area between inspections performed in 2001 and 2013. Since the camera was lower in the 2001 inspection, it is difficult to make any comparisons with the 2013 inspection of the top knuckle area. However, there appears to be no significant changes in the condition of this area from 2001 to 2013. No areas of interest were identified in the top knuckle region during the 2013 inspection.

Figure 2-2. Riser 78 Upper Haunch Comparisons Between Inspections on September 25, 2001 (A) and January 9, 2013 (B) Looking Towards Riser 90

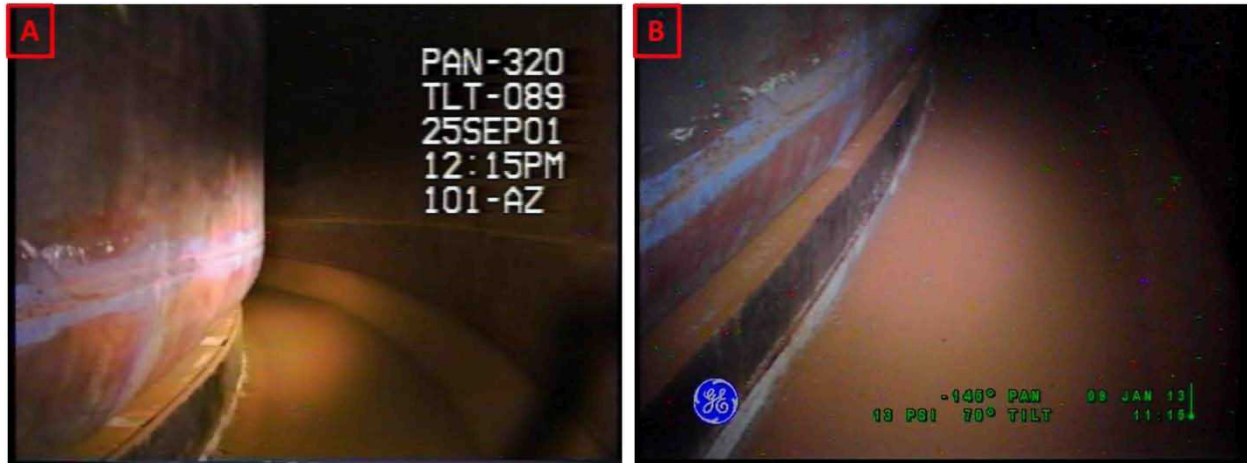
Figure 2-3 and Figure 2-4 show comparisons of the lower knuckle and annulus floor between inspections performed in 2001 and 2013. There appears to be no significant change in the condition of this area between 1993 and 2013. A beachline can also be seen along the annulus floor in Figure 2-3 and Figure 2-4 which is likely the result of evaporated couplant water used during UT examinations. Figure 2-5 shows the general condition of the refractory slots in 2013 and no anomalies were noted. No anomalies were identified on the lower knuckle of the primary tank, insulating refractory, refractory slots, stiffener ring, or annulus floor during the 2013 inspection.

Figure 2-4. Riser 78 Lower Knuckle and Annulus Floor Comparisons Between Inspections on September 25, 2001 (A) and January 9, 2013 (B) Looking Towards Riser 90

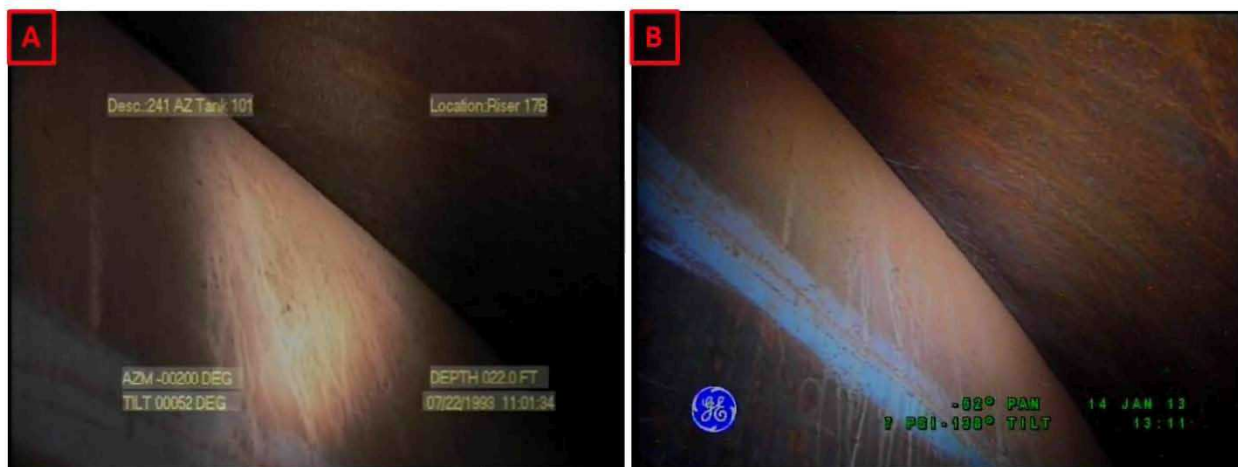
Figure 2-6 and Figure 2-7 show comparisons of the upper haunch area between inspections performed in 2001 and 2013. In both of these figures, white streaks can be seen on the primary tank. These white streaks, which are commonly seen among the DSTs, are referred to as laitance flow attributed to the pouring of the concrete dome during construction. There were no significant changes in the condition of this area from 2001 to 2013. No areas of interest were identified in the top knuckle region during the 2013 inspection.

Figure 2-7. Riser 79 Upper Haunch Comparisons Between Inspections on July 22, 1993 (A) and January 14, 2013 (B) Looking Towards Riser 99

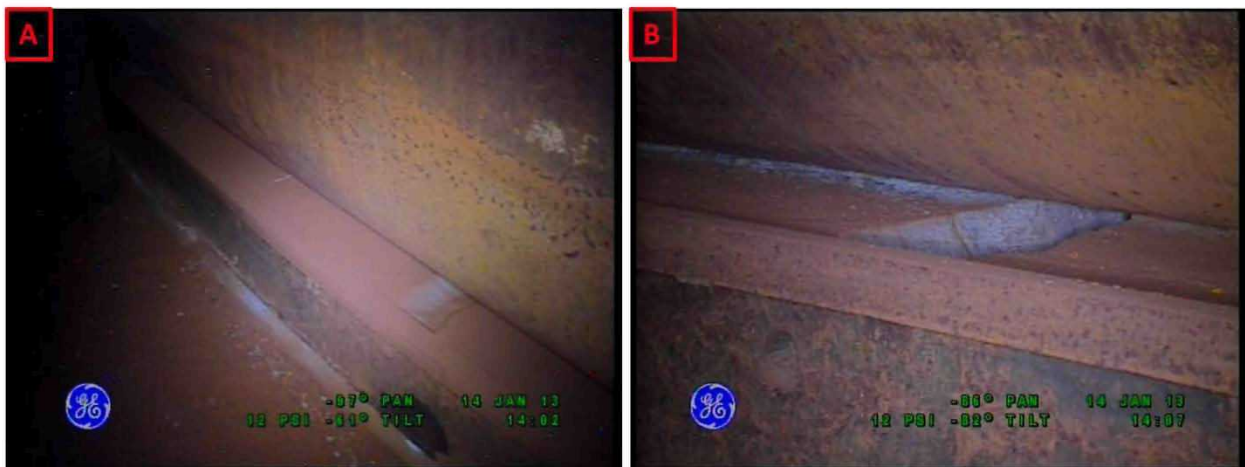
The lower knuckle and annulus floor were not visible during the 1993 inspection. Figure 2-8 shows the general condition of the lower knuckle and annulus floor in 2013. A beachline can be seen along the annulus floor in Figure 2-8 which is likely the result of evaporated couplant water used during UT examinations. Figure 2-9 shows the general condition of the refractory slots in 2013 and no anomalies were noted. No anomalies were identified on the lower knuckle of the primary tank, insulating refractory, refractory slots, stiffener ring, or annulus floor during the 2013 inspection.

Figure 2-9. Riser 79 General Condition of the Refractory Slots on January 14, 2013

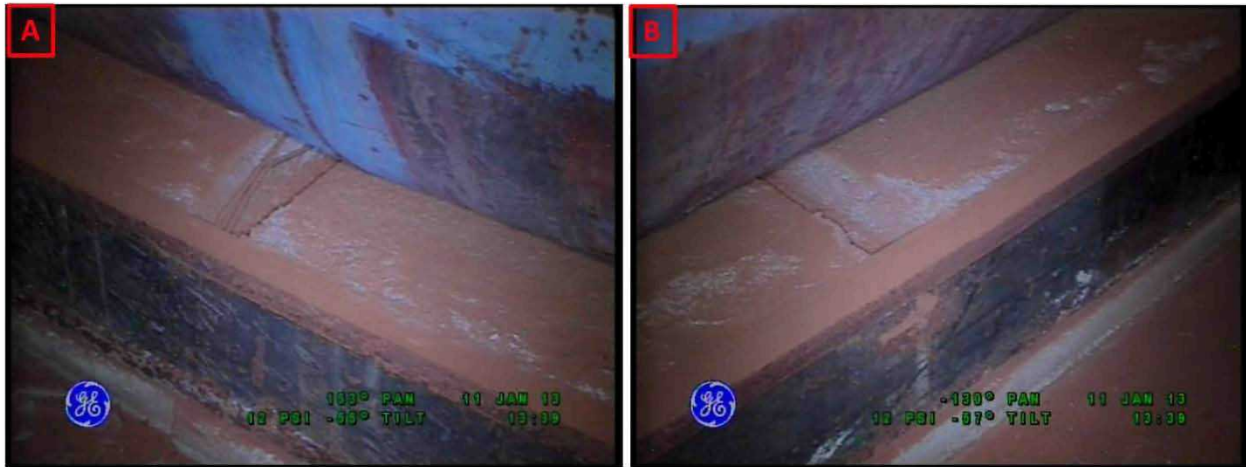
Figure 2-11 shows the general condition of the lower knuckle and annulus floor in January 2013. A beachline can also be seen along the annulus floor in Figure 2-11 which is likely the result of evaporated couplant water used during UT examinations. In Figure 2-11A, there appears to be signs of previous intrusion coming from Riser 105, the annulus pump pit. There is currently no pump installed in the AZ-101 annulus pump pit. The debris seen in Figure 2-11A is most likely remnants of past dirt and moisture which migrated into the pit and eventually into the annulus space. Figure 2-12 shows the general condition of the refractory slots in 2013 and no anomalies were noted. No anomalies were identified on the lower knuckle of the primary tank, insulating refractory, refractory slots, stiffener ring, or annulus floor during the 2013 inspection.

Figure 2-12. Riser 81 Lower Knuckle and Annulus Floor Condition on January 11, 2013

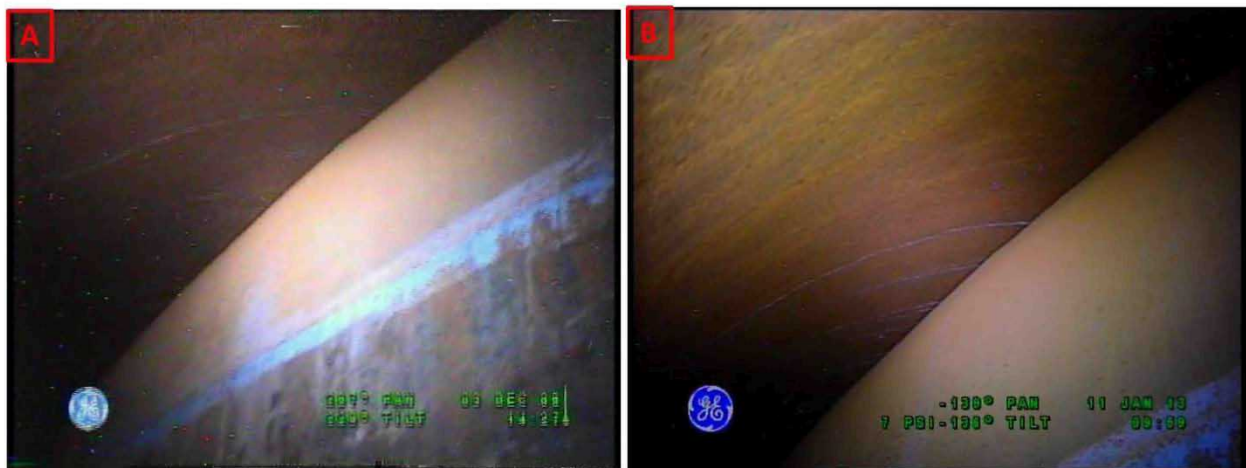
The tank dome and upper haunch area were not visible during the 2001 and 2007 inspections. Figure 2-13 and Figure 2-14 show comparisons of the upper haunch area between inspections performed in 2008 and 2013. There were no significant changes in the condition of this area from 2008 to 2013. No areas of interest were identified in the top knuckle region during the 2013 inspection.

Figure 2-13. Riser 82 Upper Haunch Comparisons Between Inspections on December 3, 2008 (A) and January 11, 2013 (B) Looking Towards Riser 95

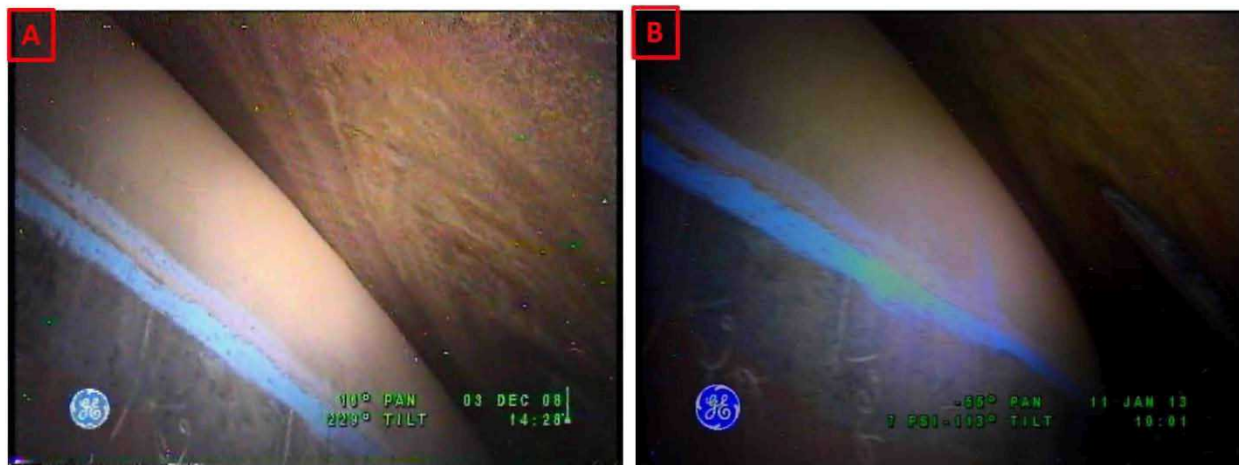
Figure 2-14. Riser 82 Upper Haunch Comparisons Between Inspections on December 3, 2008 (A) and January 11, 2013 (B) Looking Towards Riser 105

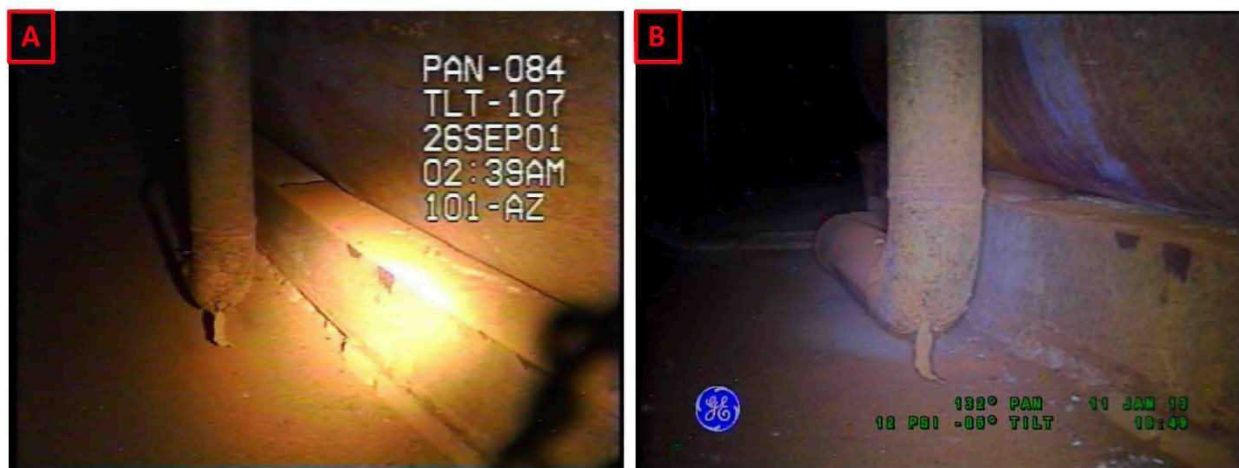
Figure 2-15 and Figure 2-16 show comparisons of the lower knuckle and annulus floor between inspections performed in 2001 and 2013. There appears to be no significant change in the condition of this area between 1993 and 2013. Figure 2-17 shows the general condition of the refractory slots in 2013 and no anomalies were noted. No anomalies were identified on the lower knuckle of the primary tank, insulating refractory, refractory slots, stiffener ring, or annulus floor during the 2013 inspection.

Figure 2-15. Riser 82 Lower Knuckle and Annulus Floor Comparisons Between Inspections on September 26, 2001 (A) and January 11, 2013 (B) Looking Towards Riser 95

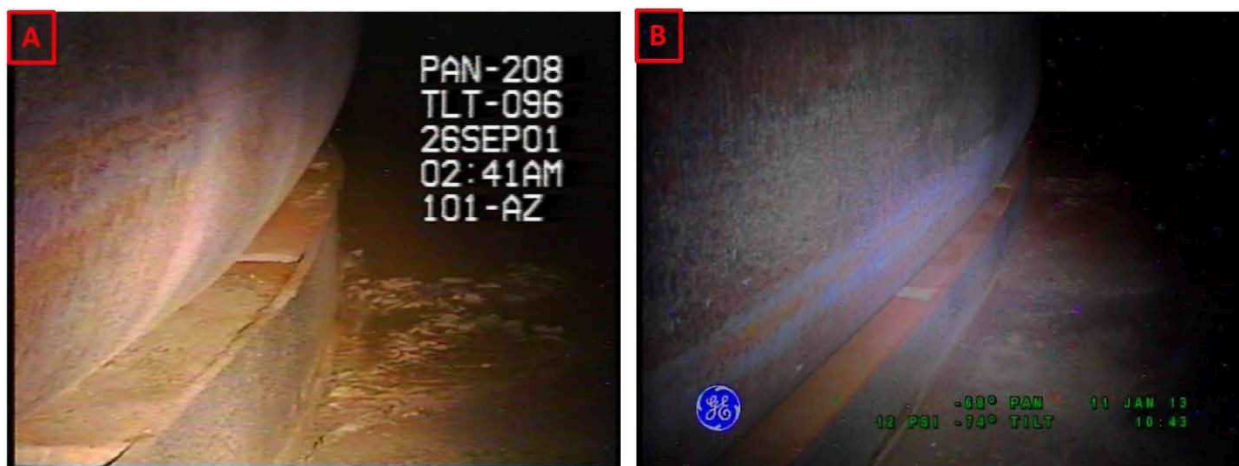
Figure 2-16. Riser 82 Lower Knuckle and Annulus Floor Comparisons Between Inspections on September 26, 2001 (A) and January 11, 2013 (B) Looking Towards Riser 105

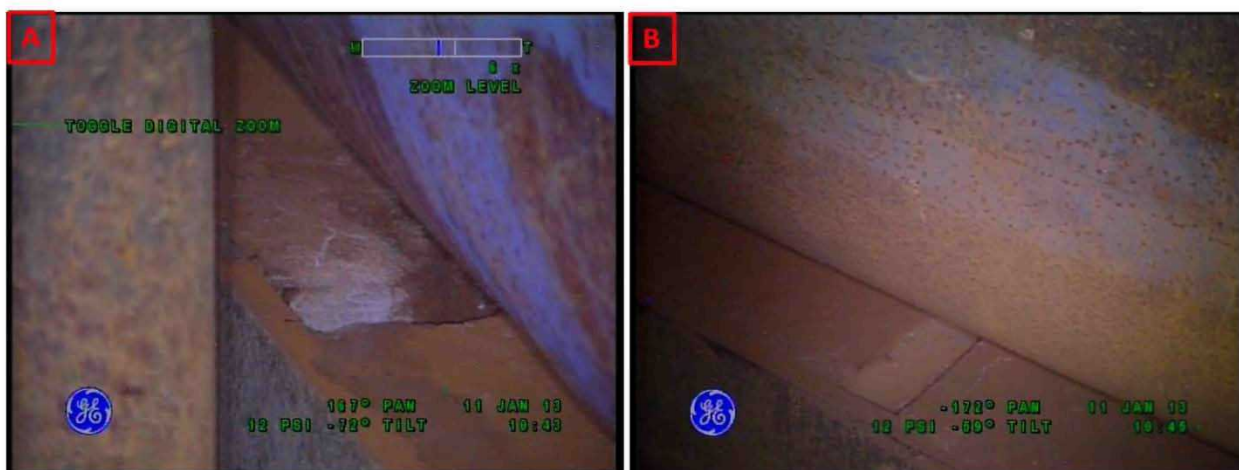
Figure 2-17. Riser 82 General Condition of the Refractory Slots on January 11, 2013

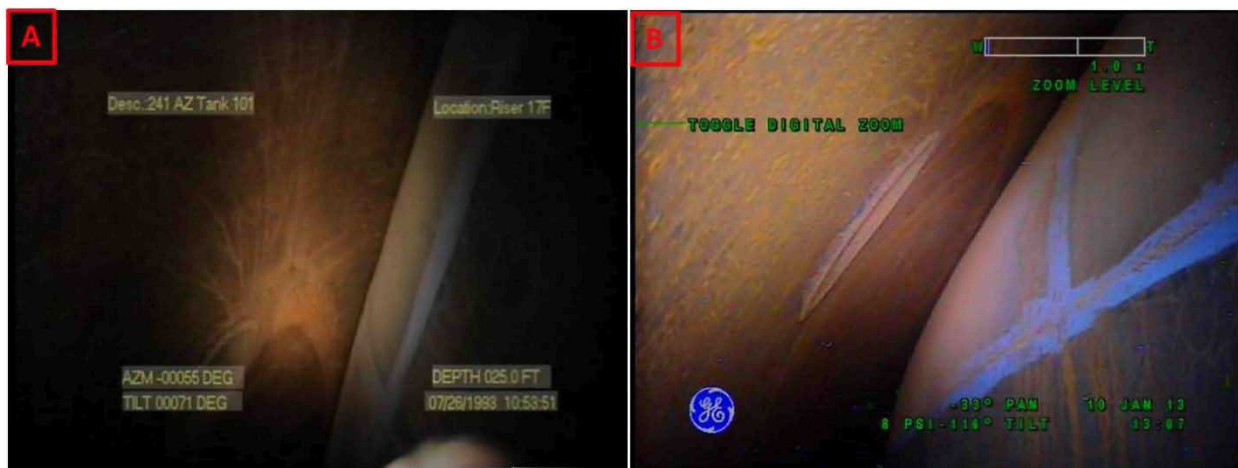
Figure 2-18 and Figure 2-19 show comparisons of the upper haunch area between inspections performed in 1993 and 2001, respectively, with the 2013 inspection. There were no significant changes in the condition of this area from 1993 or 2001 to 2013. No areas of interest were identified in the top knuckle region during the 2013 inspection.

Figure 2-18. Riser 83 Upper Haunch Comparisons Between Inspections on July 26, 1993 (A) and January 10, 2013 (B) Looking Towards Riser 96

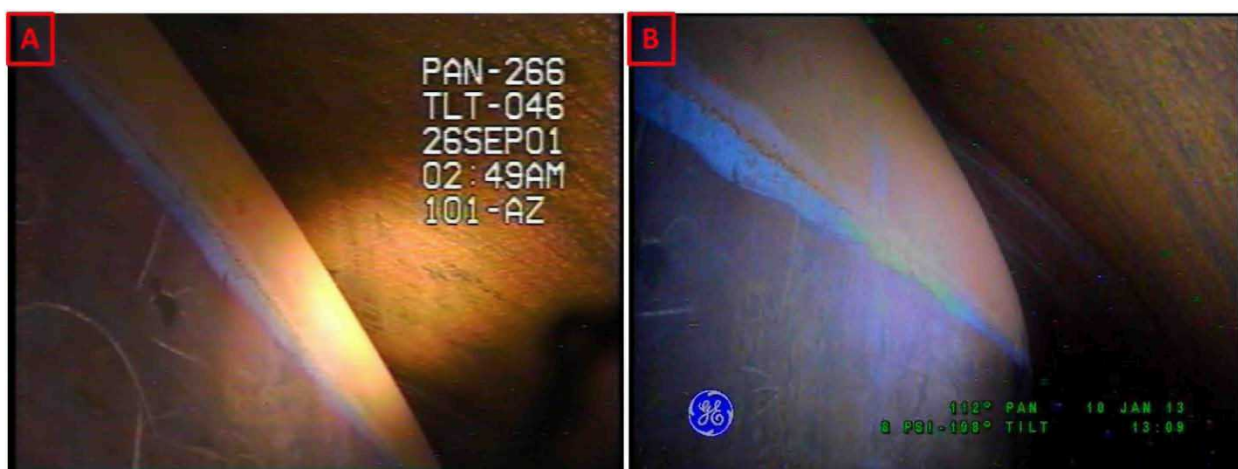
Figure 2-19. Riser 83 Upper Haunch Comparisons Between Inspections on September 26, 2001 (A) and January 10, 2013 (B) Looking Towards Riser 89

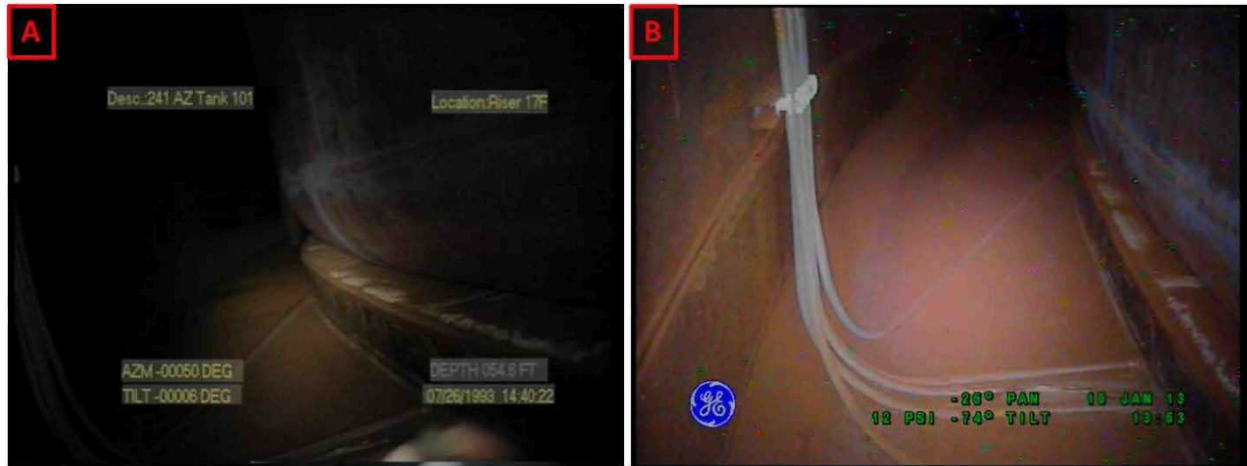
Figure 2-20 and Figure 2-21 show comparisons of the lower knuckle and annulus floor between inspections performed in 1993 and 2013. A beachline can also be seen along the annulus floor in Figure 2-20B which is likely the result of evaporated couplant water used during UT examinations. In Figure 2-21B, there appears to be more staining on the annulus floor when compared to the 1993 inspection which is likely the result of evaporated couplant water used in previous UT examinations performed in nearby Riser 89. There appears to be no significant change in the condition of this area between 1993 and 2013. Figure 2-22 shows the general condition of the refractory slots in 2013 and no anomalies were noted. No anomalies were

Figure 2-20. Riser 83 Lower Knuckle and Annulus Floor Comparisons Between Inspections on July 26, 1993 (A) and January 10, 2013 (B) Looking Towards Riser 96

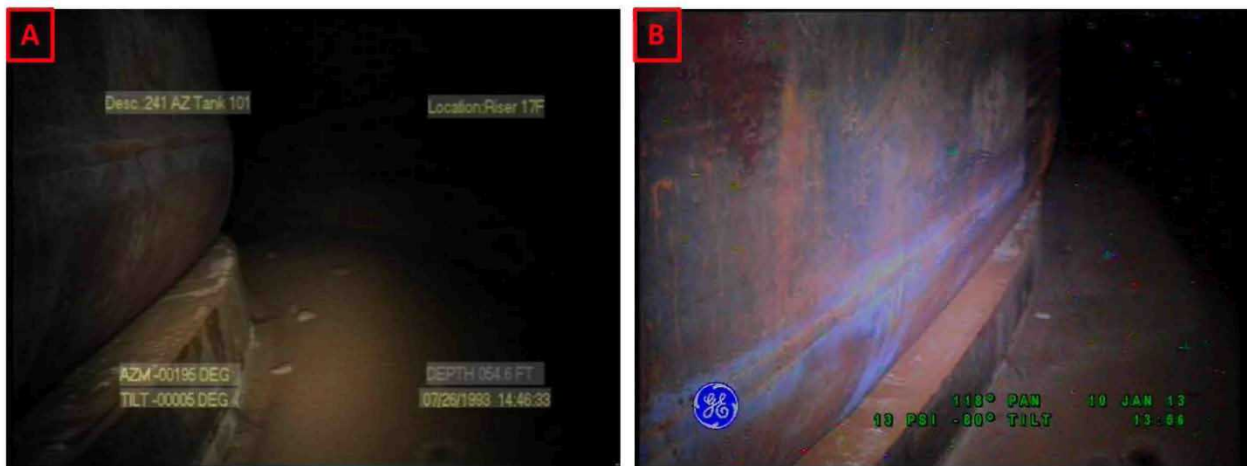
Figure 2-21. Riser 83 Lower Knuckle and Annulus Floor Comparisons Between Inspections on July 26, 1993 (A) and January 10, 2013 (B) Looking Towards Riser 89

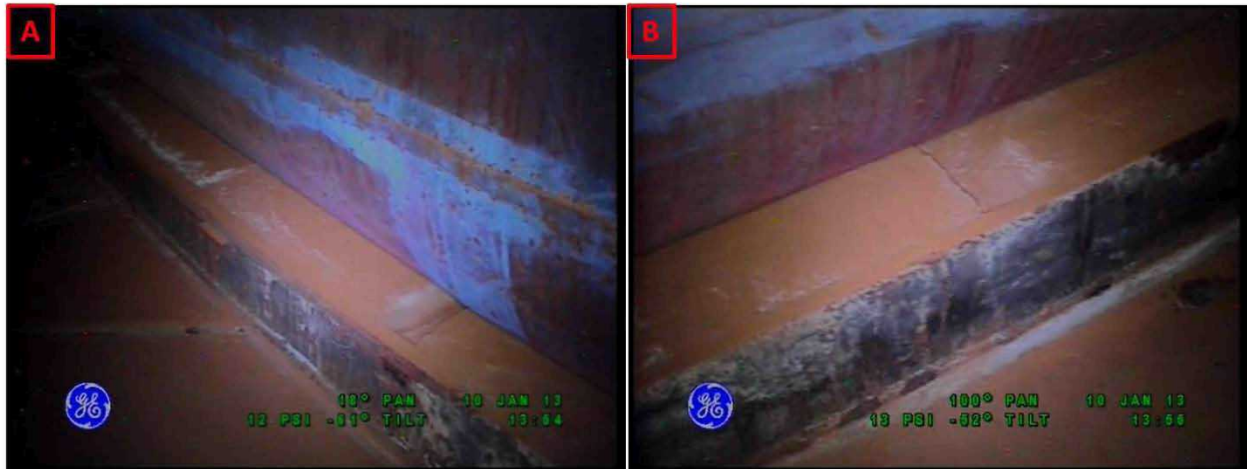
identified on the lower knuckle of the primary tank, insulating refractory, refractory slots, stiffener ring, or annulus floor during the 2013 inspection.

Figure 2-22. Riser 83 General Condition of the Refractory Slots on January 10, 2013

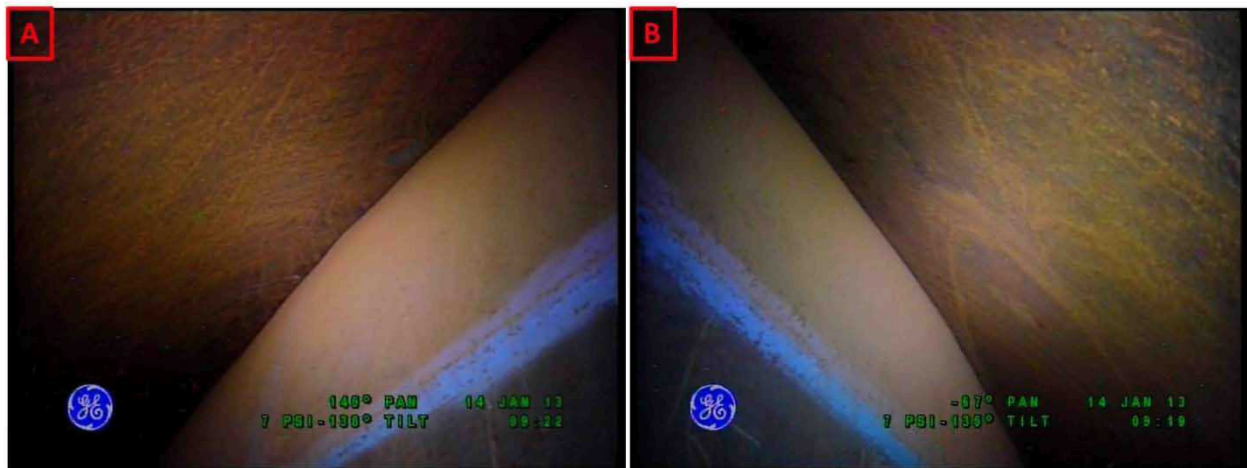
Figure 2-23 shows the general condition of the upper haunch area in January 2013. No areas of interest were identified in the top knuckle region during the 2013 inspection.

Figure 2-23. Riser 84 General Condition of the Upper Haunch on January 14, 2013
Looking Towards Riser 85 (A) and Looking Towards Riser 102 (B)

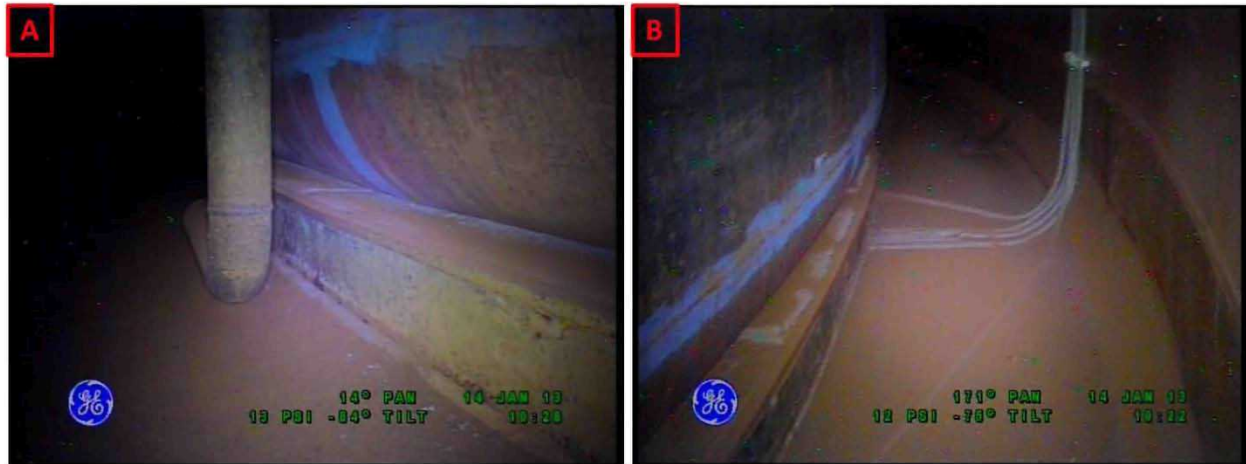
Figure 2-24 shows the general condition of the lower knuckle and annulus floor in January 2013. A beachline can also be seen along the annulus floor in Figure 2-24 which is likely the result of evaporated couplant water used during UT examinations. Figure 2-25 shows the general condition of the refractory slots in January 2013 and no anomalies were noted. No anomalies were identified on the lower knuckle of the primary tank, insulating refractory, refractory slots, stiffener ring, or annulus floor during the 2013 inspection.

Figure 2-24. Riser 84 Lower Knuckle and Annulus Floor Condition on January 14, 2013 Looking Towards Riser 85 (A) and Looking Towards Riser 102 (B)

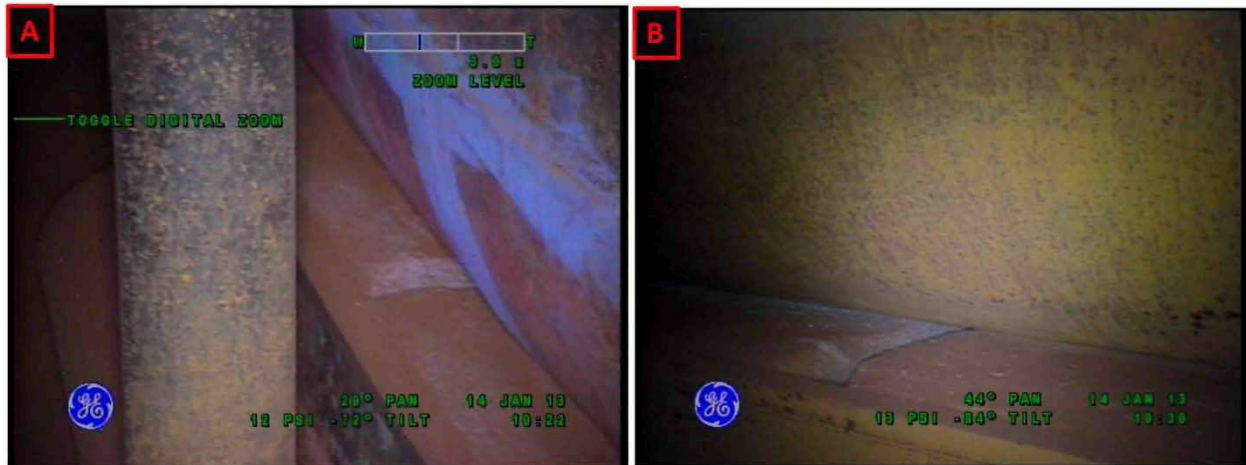
Figure 2-25. Riser 84 General Condition of the Refractory Slots on January 14, 2013

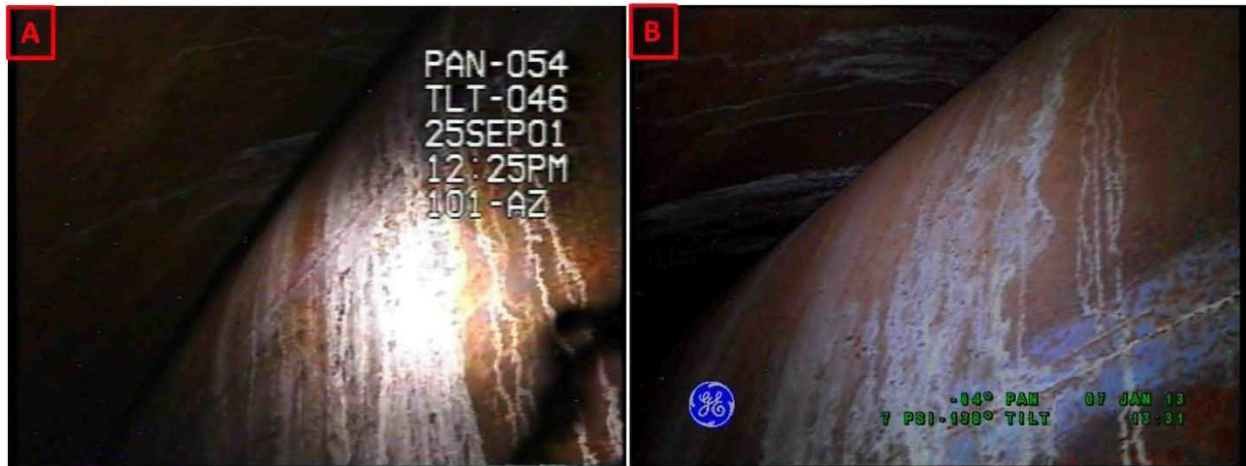
Figure 2-26 and Figure 2-27 show comparisons of the upper haunch area between inspections performed in 2001 and 2013. In both of these figures, white streaks can be seen on the primary tank and secondary liner. These white streaks, which are commonly seen among the DSTs, are referred to as laitance flow attributed to the pouring of the concrete dome during construction. There were no significant changes in the condition of this area from 2001 to 2013. No areas of interest were identified in the top knuckle region during the 2013 inspection.

Figure 2-26. Riser 86 Upper Haunch Comparisons Between Inspections on September 25, 2001 (A) and January 7, 2013 (B) Looking Towards Riser 87

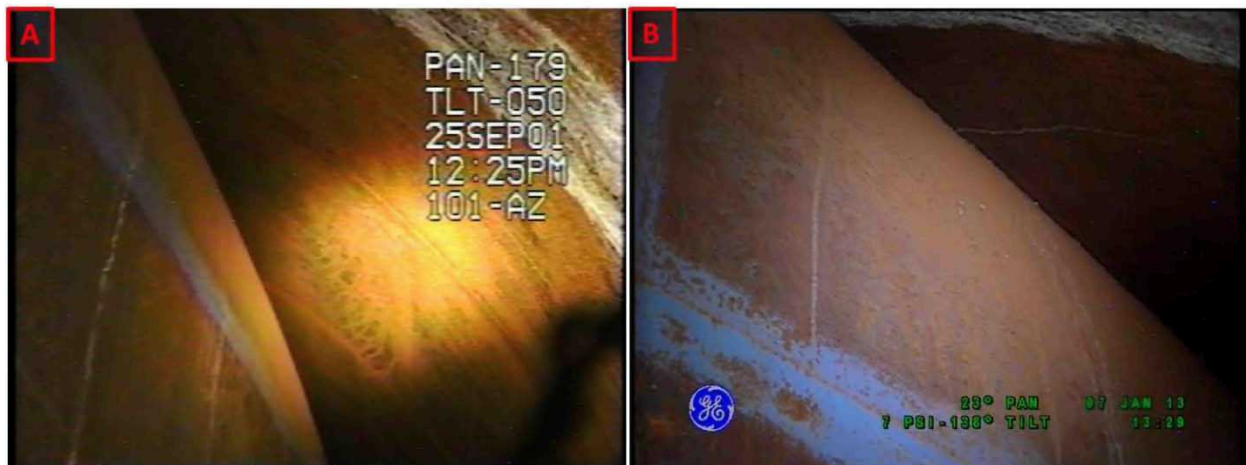
Figure 2-27. Riser 86 Upper Haunch Comparisons Between Inspections on September 25, 2001 (A) and January 7, 2013 (B) Looking Towards Riser 103

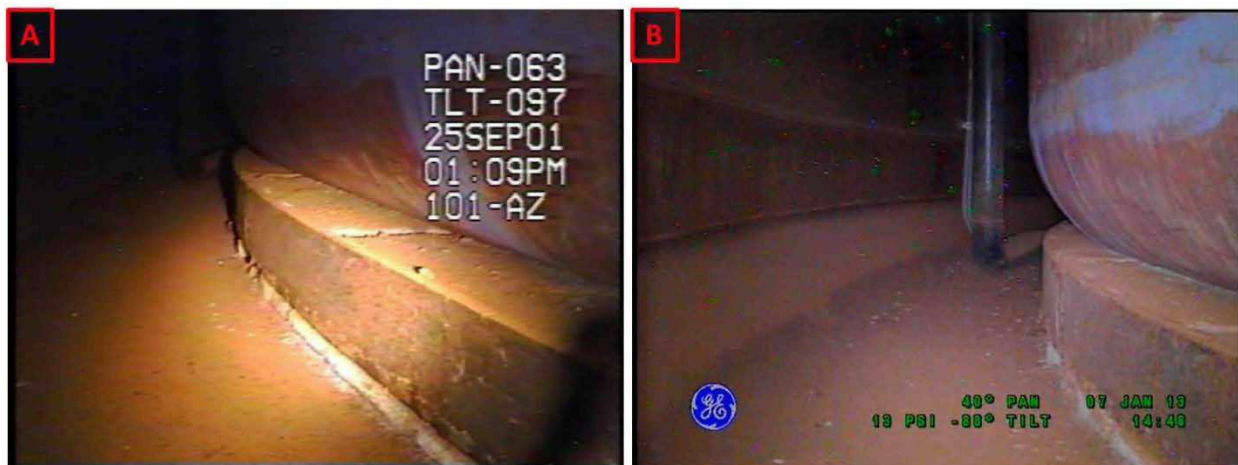
Figure 2-28 and Figure 2-29 show comparisons of the lower knuckle and annulus floor between inspections performed in 2001 and 2013. A beachline can also be seen along the annulus floor in Figure 2-28 and Figure 2-29 which is likely the result of evaporated couplant water used during UT examinations. There appears to be no significant change in the condition of this area between 2001 and 2013. Figure 2-30 shows the general condition of the refractory slots in 2013 and no anomalies were noted. No anomalies were identified on the lower knuckle of the primary tank, insulating refractory, refractory slots, stiffener ring, or annulus floor during the 2013 inspection.

Figure 2-28. Riser 86 Lower Knuckle and Annulus Floor Comparisons Between Inspections on September 25, 2001 (A) and January 7, 2013 (B) Looking Towards Riser 87

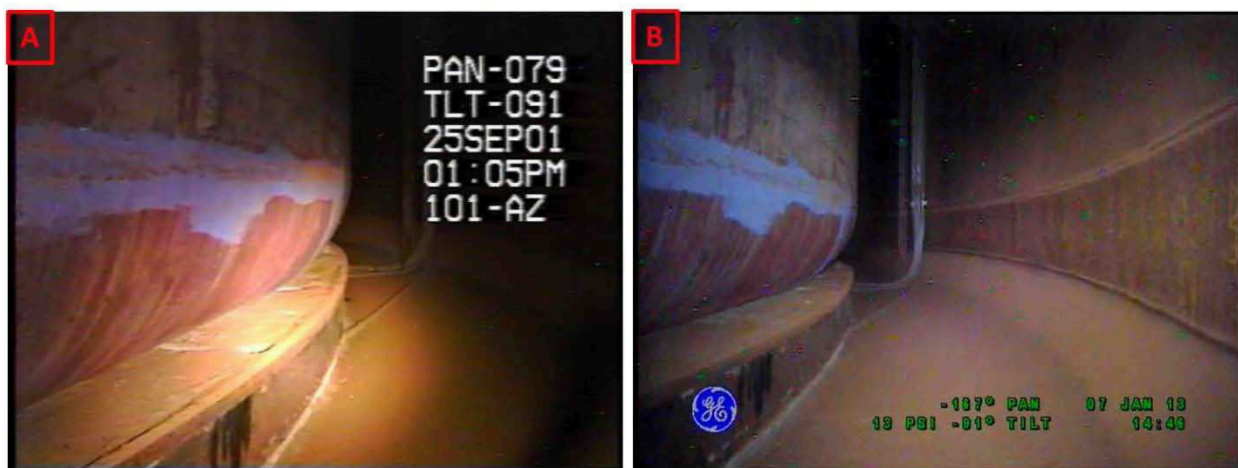
Figure 2-29. Riser 86 Lower Knuckle and Annulus Floor Comparisons Between Inspections on September 25, 2001 (A) and January 7, 2013 (B) Looking Towards Riser 103

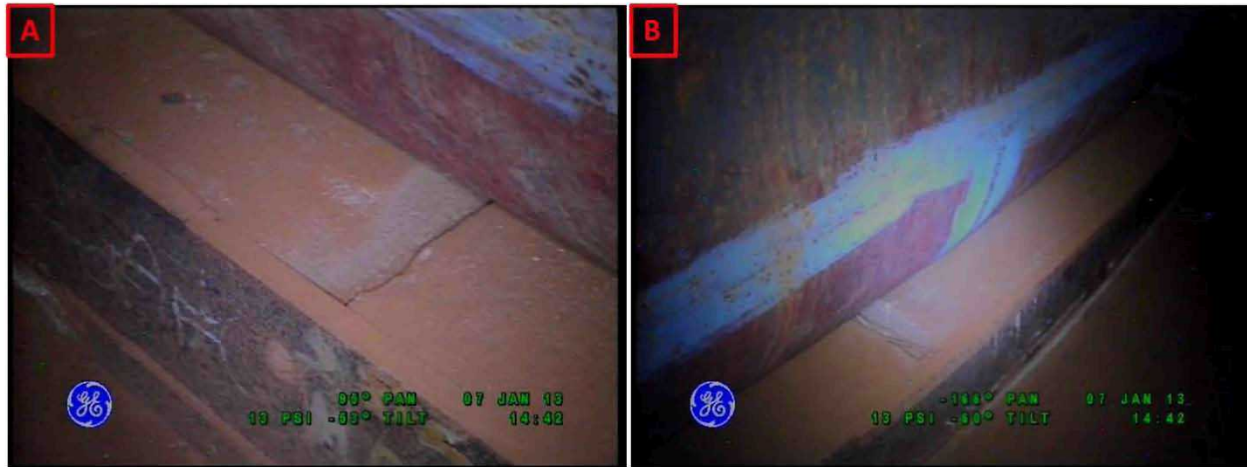
Figure 2-30. Riser 86 General Condition of the Refractory Slots on January 7, 2013

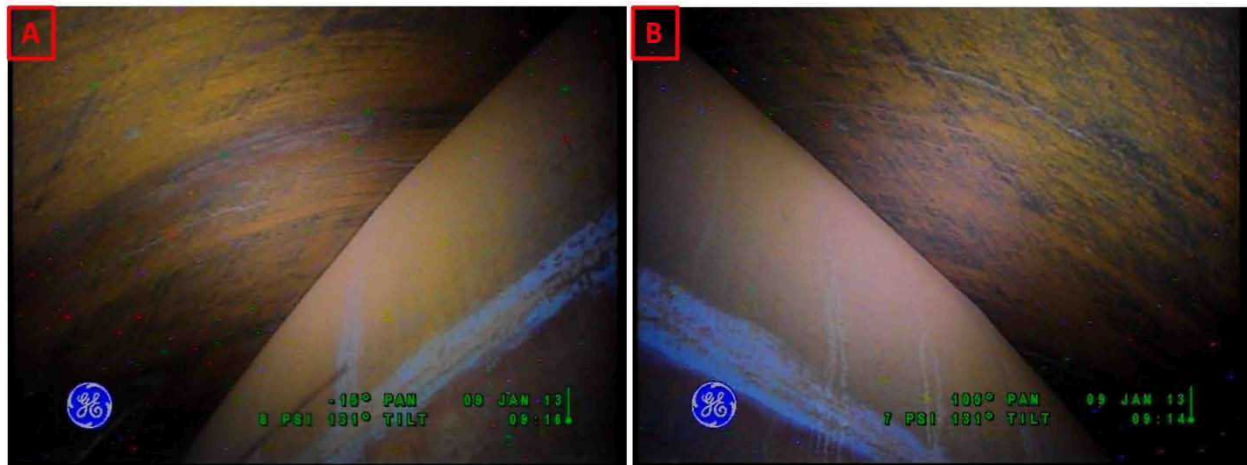
Figure 2-31 shows the general condition of the upper haunch area in January 2013. No areas of interest were identified in the top knuckle region during the 2013 inspection.

Figure 2-31. Riser 88 General Condition of the Upper Haunch on January 9, 2013 Looking Towards Riser 90 (A) and Looking Towards Riser 104 (B)

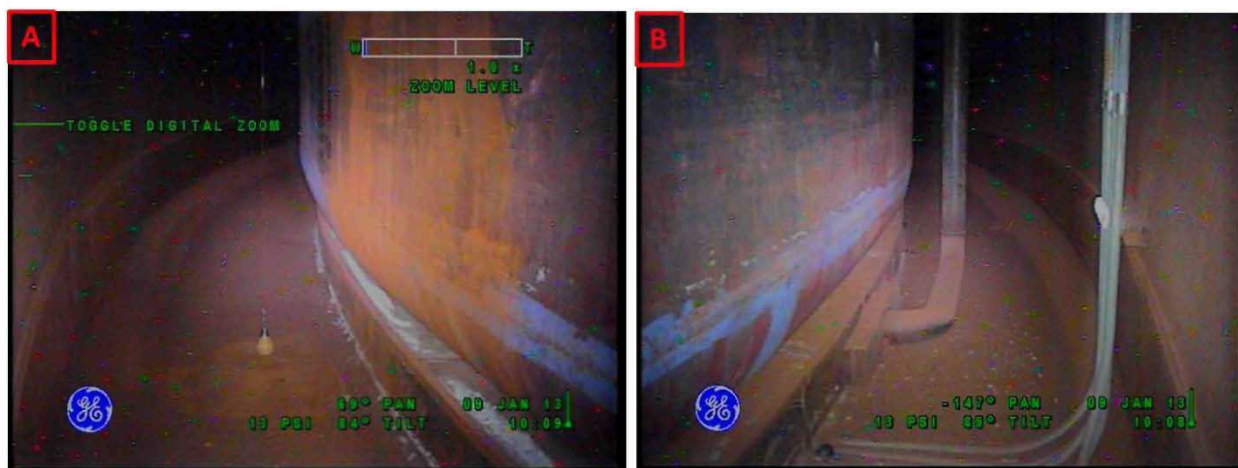
Figure 2-32 shows the general condition of the lower knuckle and annulus floor in January 2013. A beachline can also be seen along the annulus floor in Figure 2-32 which is likely the result of evaporated couplant water used during UT examinations. Figure 2-33 shows the general condition of the refractory slots in January 2013 and no anomalies were noted. No anomalies were identified on the lower knuckle of the primary tank, insulating refractory, refractory slots, stiffener ring, or annulus floor during the 2013 inspection.

Figure 2-32. Riser 88 Lower Knuckle and Annulus Floor Condition on January 9, 2013 Looking Towards Riser 90 (A) and Looking Towards Riser 104 (B)

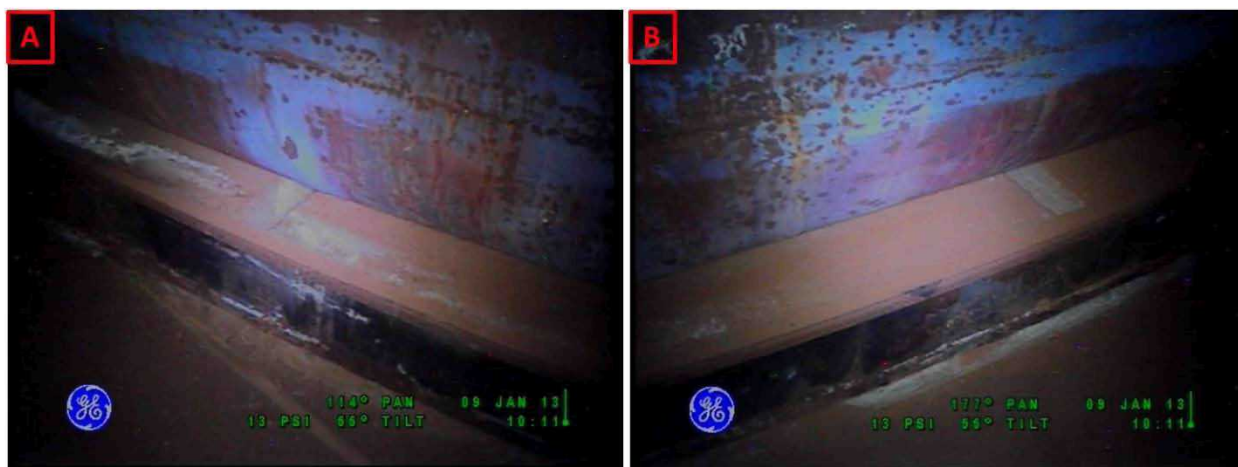
Figure 2-33. Riser 88 General Condition of the Refractory Slots on January 9, 2013

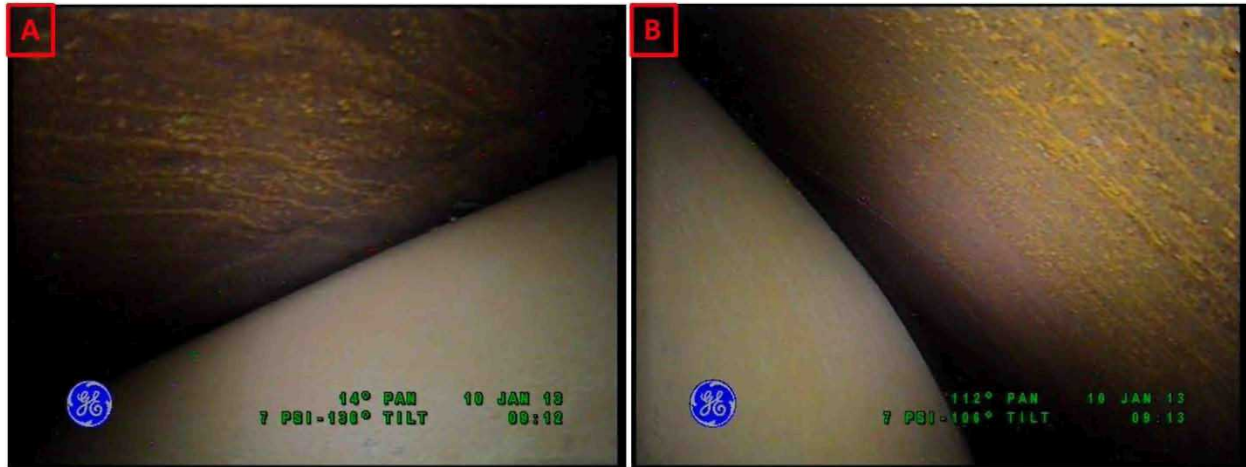
Figure 2-34 shows the general condition of the upper haunch area in January 2013. No areas of interest were identified in the top knuckle region during the 2013 inspection.

Figure 2-34. Riser 89 General Condition of the Upper Haunch on January 10, 2013 Looking Towards Riser 83 (A) and Looking Towards Riser 101 (B)

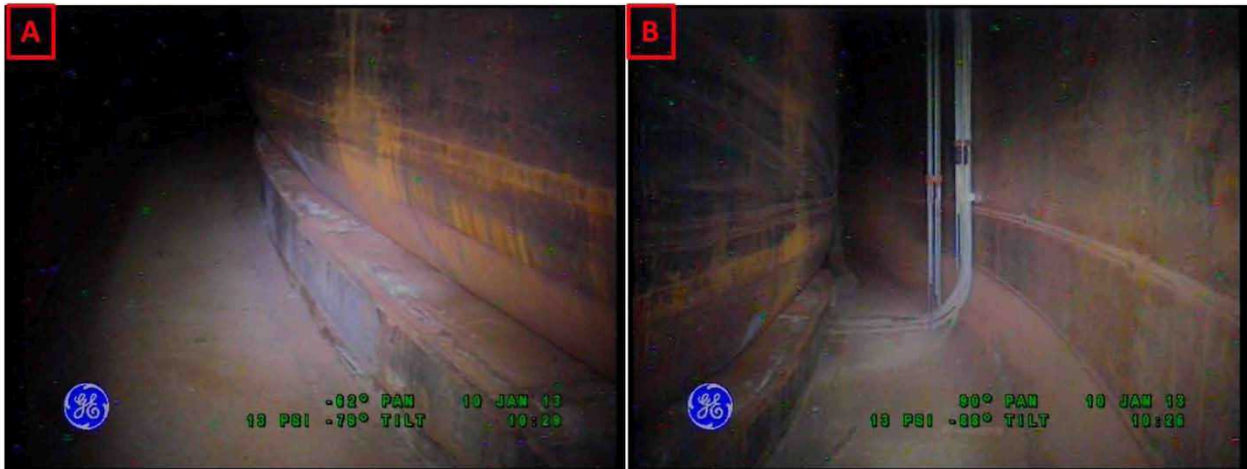
Figure 2-35 shows the general condition of the lower knuckle and annulus floor in January 2013. A beachline and can also be seen along the annulus floor in Figure 2-35 which is likely the result of evaporated couplant water used during UT examinations. Riser 89 is one of the risers that is utilized for UT examinations which explains why there is more areas of discoloration seen on the annulus floor compared with other risers of tank AZ-101. Figure 2-36 shows the general condition of the refractory slots in January 2013 and no anomalies were noted. No anomalies were identified on the lower knuckle of the primary tank, insulating refractory, refractory slots, stiffener ring, or annulus floor during the 2013 inspection.

Figure 2-35. Riser 89 Lower Knuckle and Annulus Floor Condition on January 10, 2013 Looking Towards Riser 83 (A) and Looking Towards Riser 101 (B)

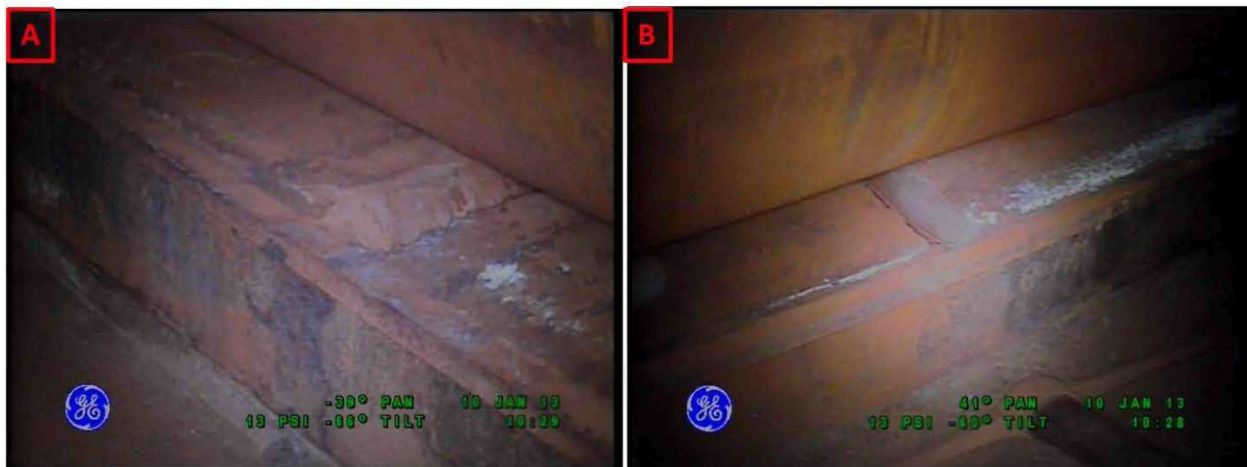
Figure 2-36. Riser 89 General Condition of the Refractory Slots on January 10, 2013

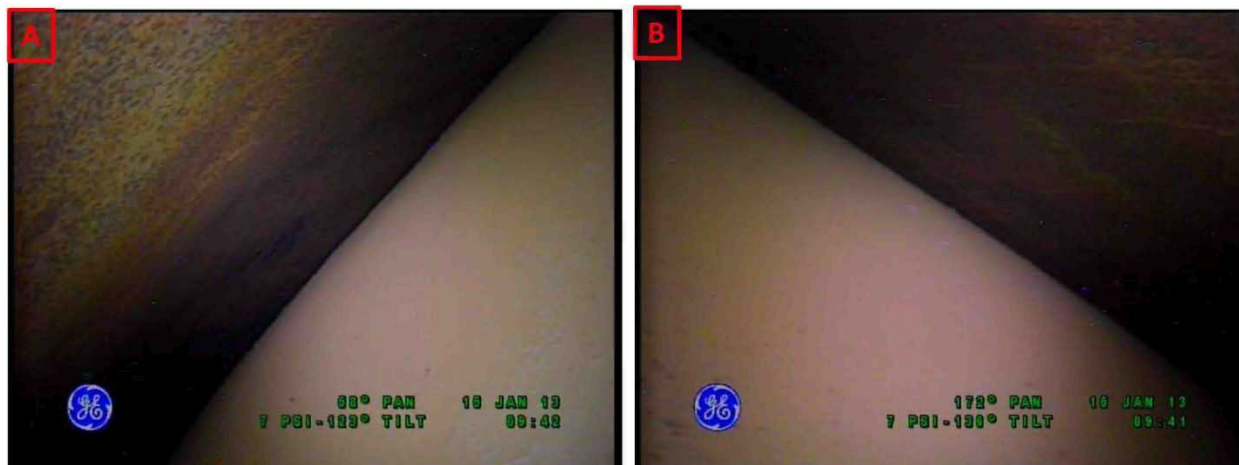
Figure 2-37. Riser 91 General Condition of the Upper Haunch on January 15, 2013 Looking Towards Riser 94 (A) and Looking Towards Riser 80 (B)

Figure 2-37 shows the general condition of the upper haunch area in January 2013. No areas of interest were identified in the top knuckle region during the 2013 inspection.

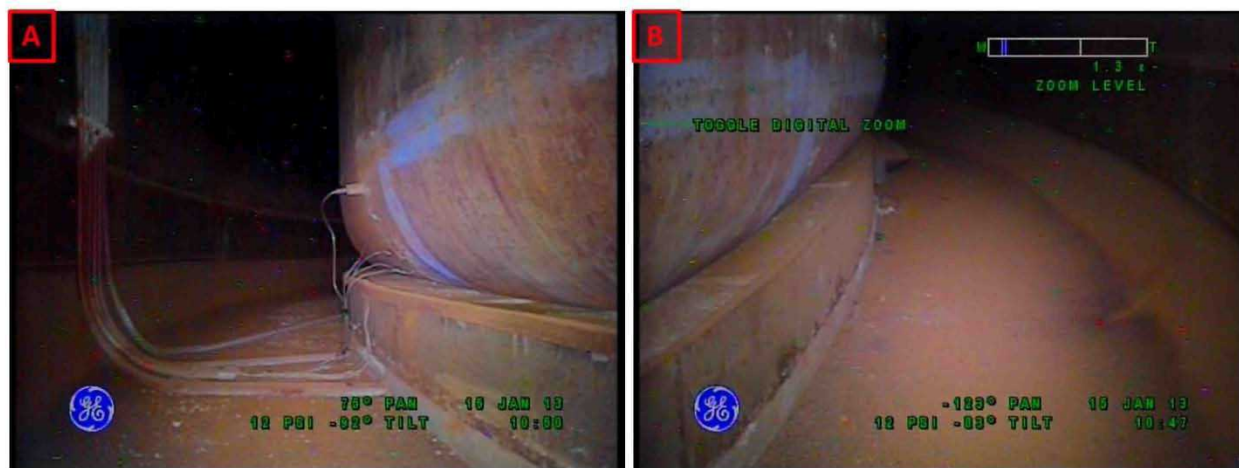
Figure 2-38. Riser 91 Lower Knuckle and Annulus Floor Condition on January 15, 2013 Looking Towards Riser 94 (A) and Looking Towards Riser 80 (B)

Figure 2-38 shows the general condition of the lower knuckle and annulus floor in January 2013. A beachline can also be seen along the annulus floor in Figure 2-38 which is likely the result of evaporated couplant water used during UT examinations. Figure 2-39 shows the general condition of the refractory slots in January 2013 and no anomalies were noted. No anomalies were identified on the lower knuckle of the primary tank, insulating refractory, refractory slots, stiffener ring, or annulus floor during the 2013 inspection.

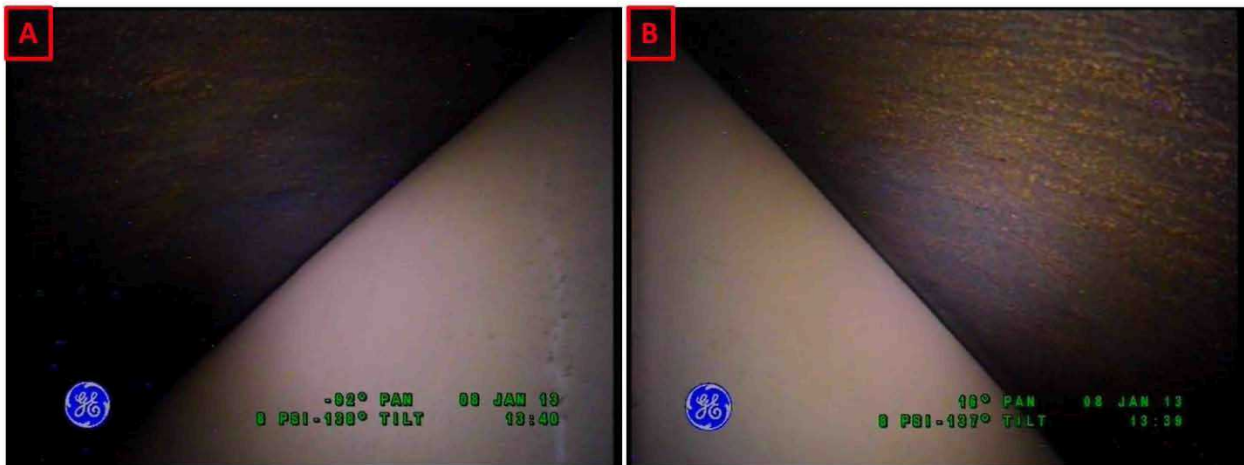
Figure 2-40. Riser 92 General Condition of the Upper Haunch on January 8, 2013 Looking Towards Riser 97 (A) and Looking Towards Riser 85 (B)

Figure 2-40 shows the general condition of the upper haunch area in January 2013. No areas of interest were identified in the top knuckle region during the 2013 inspection.
