241-AZ Farm Annulus Extent of Condition Baseline Inspection

Washington River Protection Solutions

Abstract: This report provides the results of the comprehensive annulus visual inspection for tanks 241-AZ-101 and 241-AZ-102 performed in fiscal year 2013. The inspection established a baseline covering about 95 percent of the annulus floor for comparison with future inspections. Any changes in the condition are also included in this document.

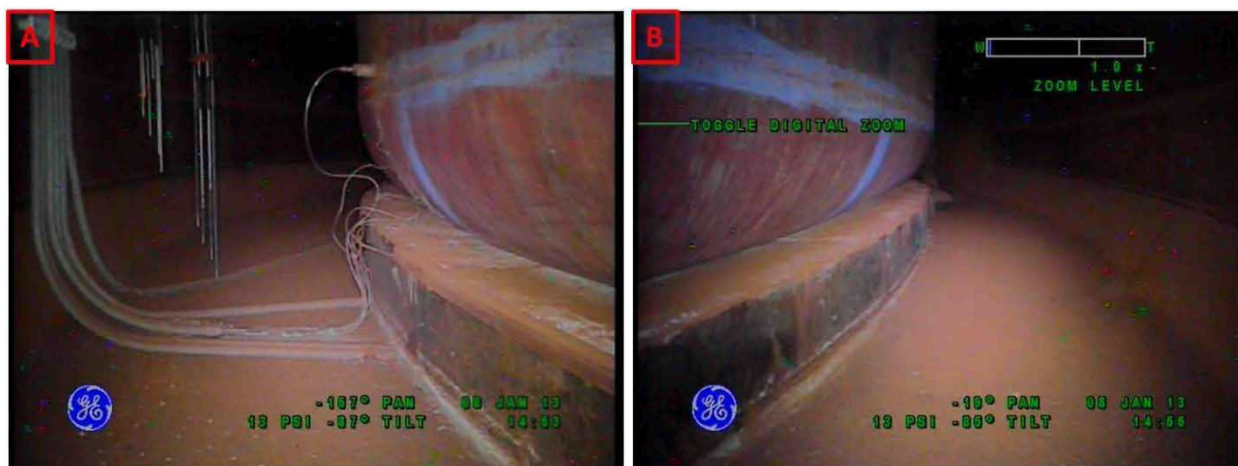
Figure 2-41. Riser 92 Lower Knuckle and Annulus Floor Condition on January 8, 2013 Looking Towards Riser 97 (A) and Looking Towards Riser 85 (B)

Figure 2-41 shows the general condition of the lower knuckle and annulus floor in January 2013. A beachline can also be seen along the annulus floor in Figure 2-41 which is likely the result of evaporated couplant water used during UT examinations. Figure 2-42 shows the general condition of the refractory slots in January 2013 and no anomalies were noted. No anomalies were identified on the lower knuckle of the primary tank, insulating refractory, refractory slots, stiffener ring, or annulus floor during the 2013 inspection.

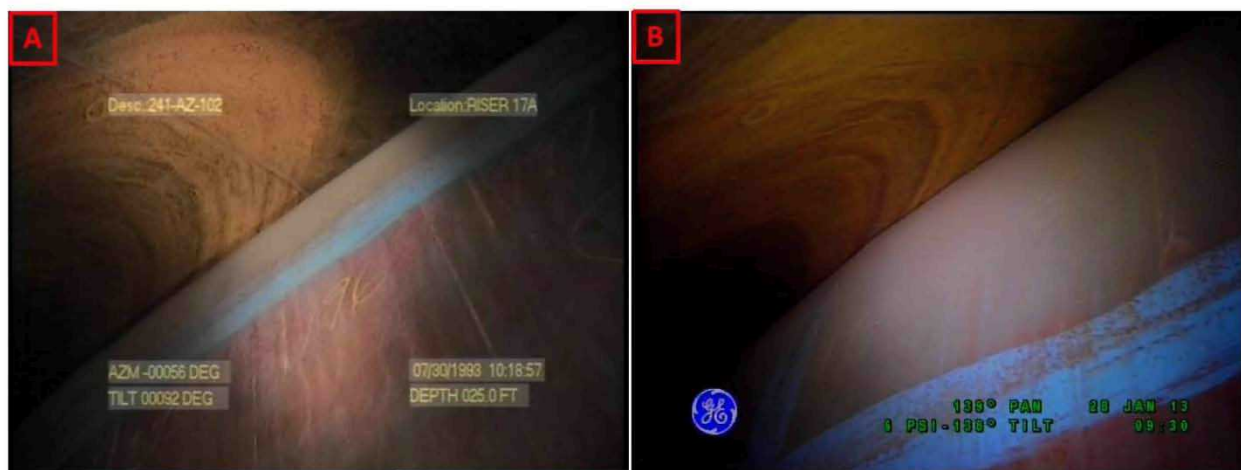
Figure 3-1. Riser 78 Upper Haunch Comparisons Between Inspections on July 30, 1993 (A) and January 28, 2013 (B) Looking Towards Riser 93

Figure 3-1 and Figure 3-2 show comparisons of the upper haunch area between inspections performed in 1993 and 2013. Since the camera was lower in the 1993 inspection, it is difficult to compare the top knuckle area with the 2013 inspection. However, there appears to be no significant changes in the condition of this area from 1993 to 2013. No areas of interest were identified in the top knuckle region during the 2013 inspection.

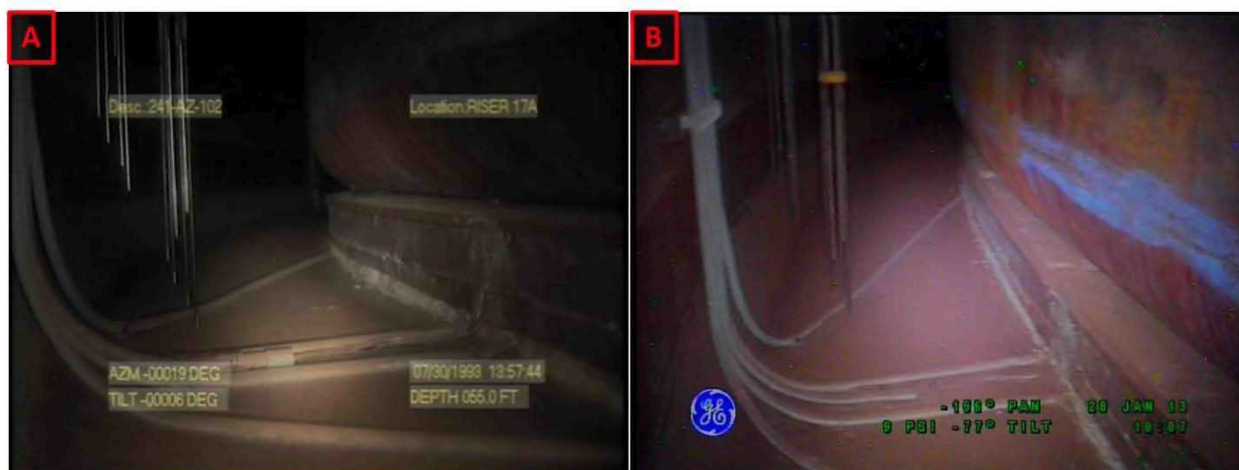
Figure 3-3. Riser 78 Lower Knuckle and Annulus Floor Comparisons Between Inspections on July 30, 1993 (A) and January 28, 2013 (B) Looking Towards Riser 93

Figure 3-3 and Figure 3-4 show comparisons of the lower knuckle and annulus floor between inspections performed in 1993 and 2013. There appears to be no significant change in the condition of this area between 1993 and 2013. However, in Figure 3-4B there appears to be more staining on the annulus floor in 2013 compared to 1993. This is attributed to the previous UT examinations performed in nearby Riser 90 of the lower knuckle weld. The scanner path can be seen on the tank wall in Figure 3-4B. A beachline can also be seen along the annulus floor in Figure 3-3 and Figure 3-4 which is likely the result of evaporated couplant water used during UT examinations. Figure 3-5 shows the 1993 and 2013 comparison of the condition of the refractory slot and no significant changes in the condition were noted. No anomalies were identified on the lower knuckle of the primary tank, insulating refractory, refractory slots, stiffener ring, or annulus floor during the 2013 inspection.

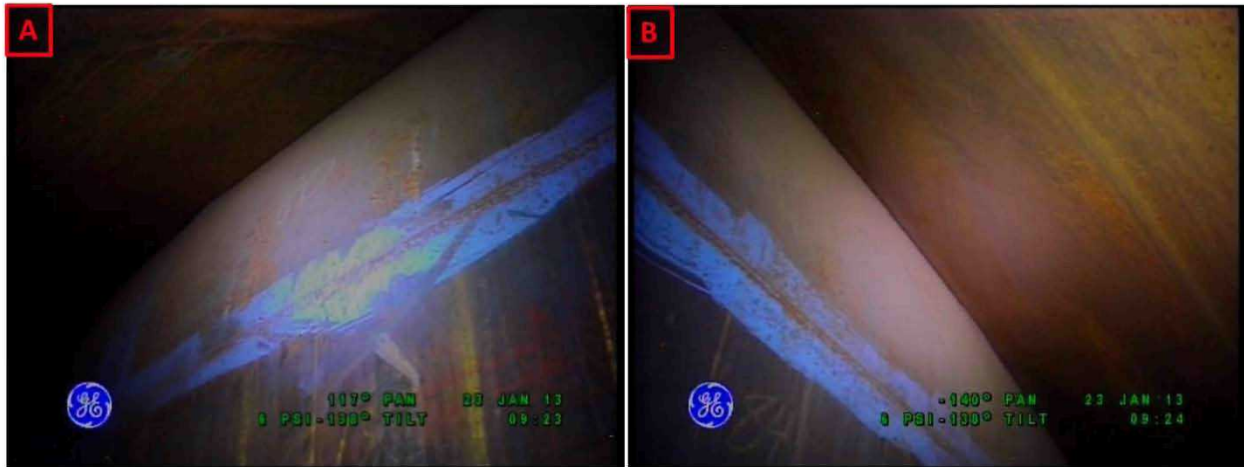
Figure 3-6. Riser 79 General Condition of the Upper Haunch on January 13, 2013 Looking Towards Riser 80 (A) and Looking Towards Riser 99 (B)

The tank dome and upper haunch area were not visible during the 2001 inspection. Figure 3-6 shows the general condition of the upper haunch area in January 2013. No areas of interest were identified in the top knuckle region during the 2013 inspection.

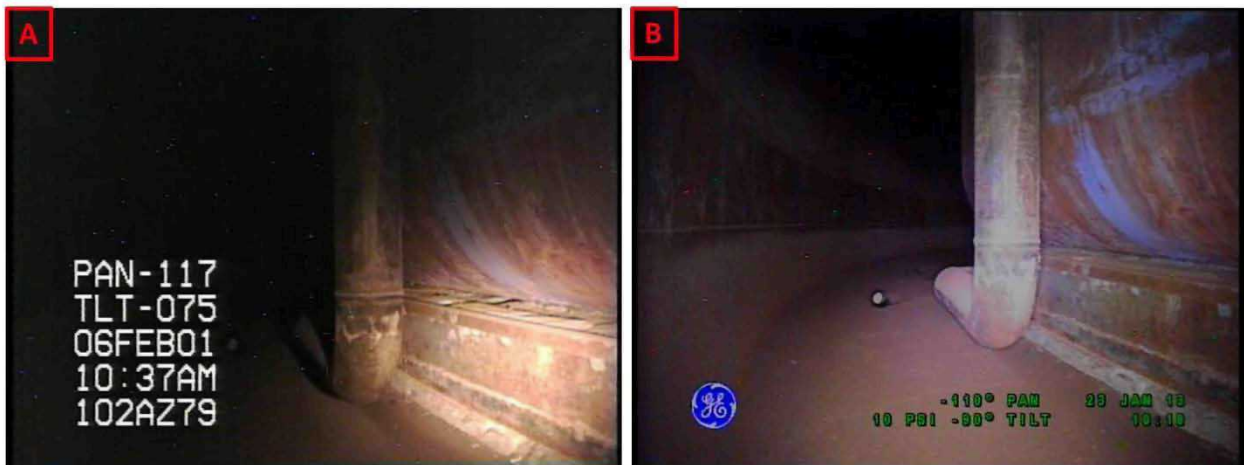
Figure 3-7. Riser 79 Lower Knuckle and Annulus Floor Comparisons Between Inspections on February 6, 2001 (A) and January 23, 2013 (B) Looking Towards Riser 80

Figure 3-7 and Figure 3-8 show comparisons of the lower knuckle and annulus floor between inspections performed in 2001 and 2013. There appears to be no significant change in the condition of this area between 2001 and 2013. Figure 3-9 shows the general condition of the refractory slots in 2013 and no anomalies were noted. No anomalies were identified on the lower knuckle of the primary tank, insulating refractory, refractory slots, stiffener ring, or annulus floor during the 2013 inspection.

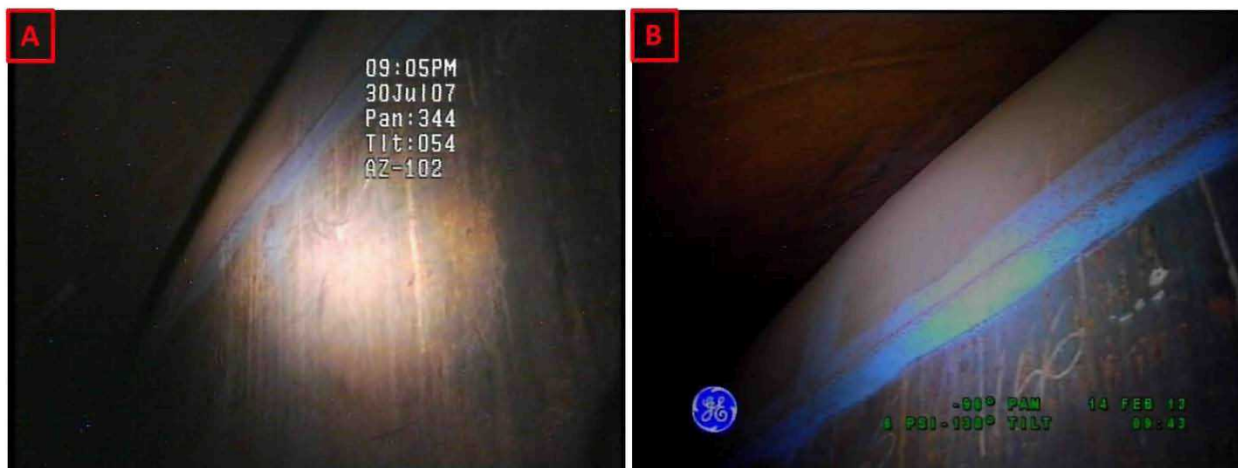
Figure 3-10. Riser 80 Upper Haunch Comparisons Between Inspections on July 30, 2007 (A) and February 14, 2013 (B) Looking Towards Riser 91

Figure 3-10 and Figure 3-11 show comparisons of the upper haunch area between inspections performed in 2007 and 2013. Since the camera was lower in the 2007 inspection, it is difficult to make any comparisons with the 2013 inspection of the top knuckle area. The camera was also at this lower position in the 2011 inspection. However, there appears to be no significant changes in the condition of this area from 2007 to 2013. No areas of interest were identified in the top knuckle region during the 2013 inspection.

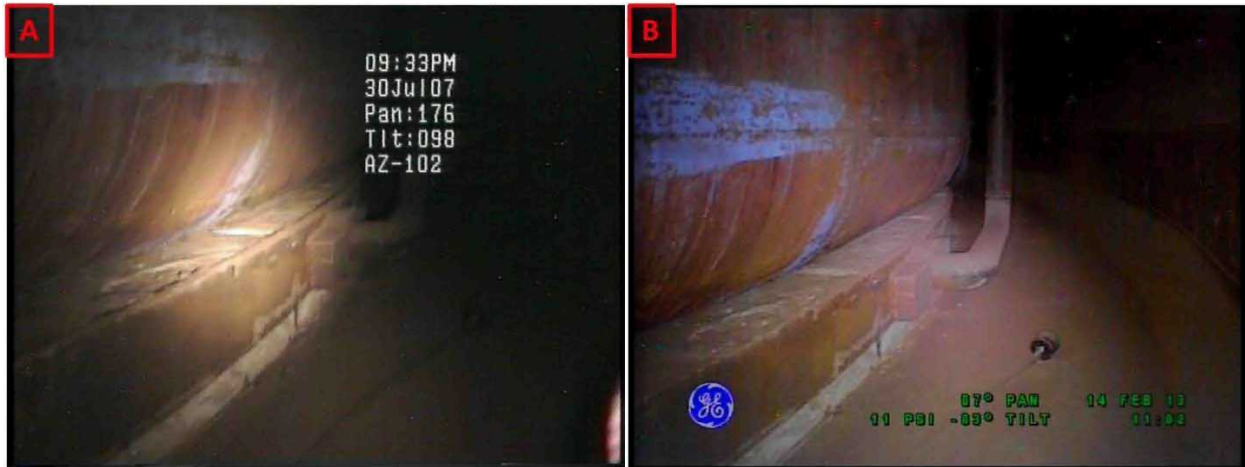
Figure 3-13. Riser 80 Lower Knuckle and Annulus Floor Comparisons Between Inspections on July 30, 2007 (A) and February 14, 2013 (B) Looking Towards Riser 79

Figure 3-12 and Figure 3-13 show comparisons of the lower knuckle and annulus floor between inspections performed in 2007, 2011, and 2013 and between 2007 and 2013, respectively. There appears to be no significant change in the condition of this area between 2007 and 2013. A beachline can also be seen along the annulus floor in Figure 3-12 and Figure 3-13 which is likely the result of evaporated couplant water used during UT examinations. In Figure 3-12, there is a distinct area on the annulus floor showing discoloration. This area is located under Riser 91, the location of the annulus leak detector ENRAF, which cannot be seen in this figure as the plummet was found to be suspended approximately 32 inches above the annulus floor (PER-2013-0274, *AZ-102 Annulus Leak Detector ENRAF*). This discoloration is likely to be the result of the

annulus ENRAF installation in December 2003 (see Section 4.0 for additional details). Unfortunately, no previous inspections viewed this area prior to 2007 to provide further insight. This anomaly does not appear to be a region of concern. Figure 3-14 shows the general condition of the refractory slots in 2007 and 2013 and no anomalies were noted. No anomalies were identified on the lower knuckle of the primary tank, insulating refractory, refractory slots, stiffener ring, or annulus floor during the 2013 inspection.

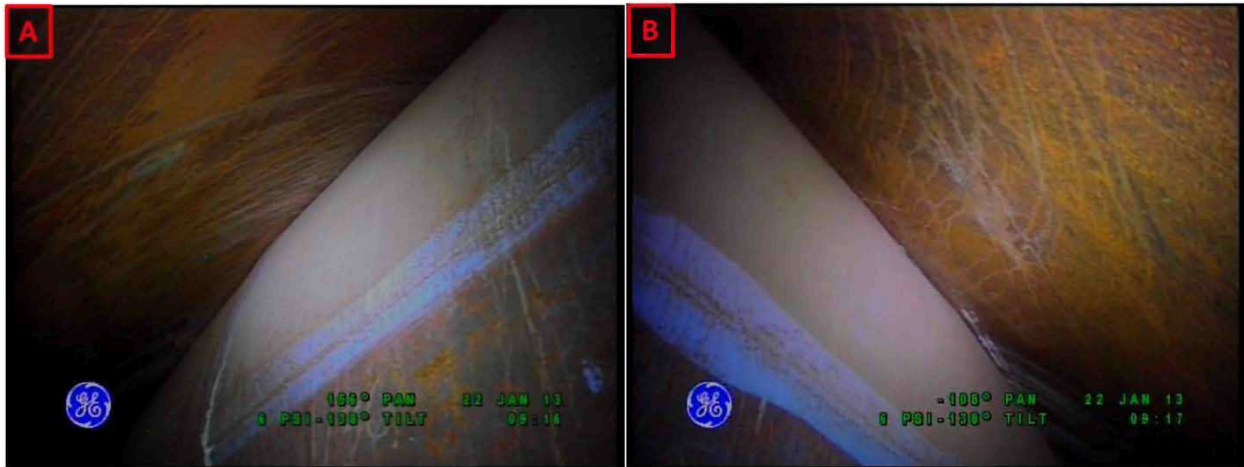
Figure 3-15. Riser 81 General Condition of the Upper Haunch on January 22, 2013 Looking Towards Riser 105 (A) and Looking Towards Riser 100 (B)

Figure 3-15 shows the general condition of the upper haunch area in January 2013. No areas of interest were identified in the top knuckle region during the 2013 inspection.

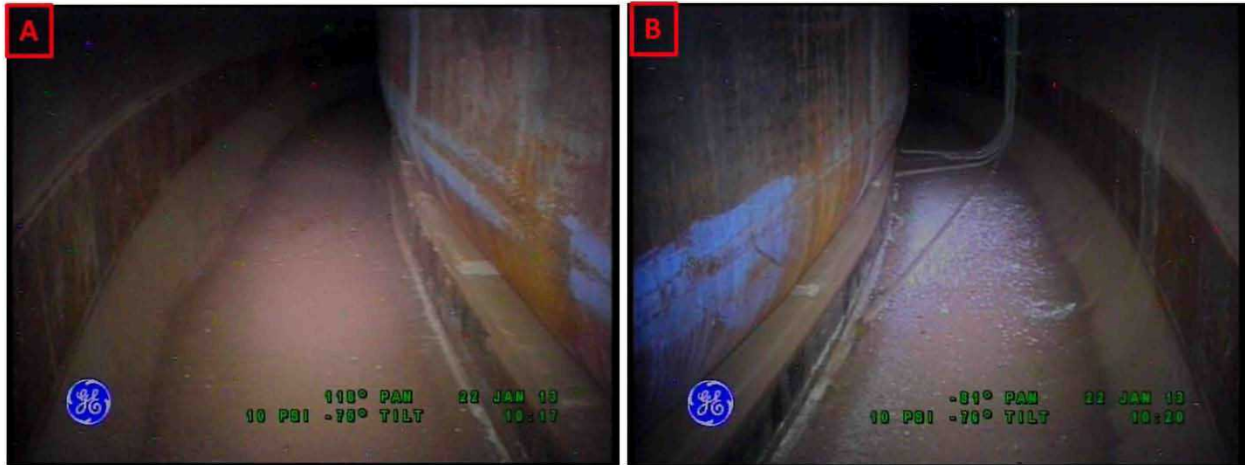
Figure 3-16. Riser 81 Lower Knuckle and Annulus Floor Condition on January 22, 2013 Looking Towards Riser 105 (A) and Looking Towards Riser 100 (B)

Figure 3-16 shows the general condition the lower knuckle and annulus floor in January 2013. In Figure 3-16B, there appears to be some unknown white debris along the annulus floor. The location of the white debris appears to match a small amount of white debris at the top of the secondary top knuckle. No previous inspections were performed in Riser 81 for comparison; however, white material does not appear to be coming from the primary tank. A beachline can also be seen along the annulus floor in Figure 3-16 which is likely the result of evaporated couplant water used during UT examinations. Figure 3-17 shows the general condition of the refractory slots in 2013 and no anomalies were noted. No anomalies were identified on the lower knuckle of the primary tank, insulating refractory, refractory slots, stiffener ring, or annulus floor during the 2013 inspection.

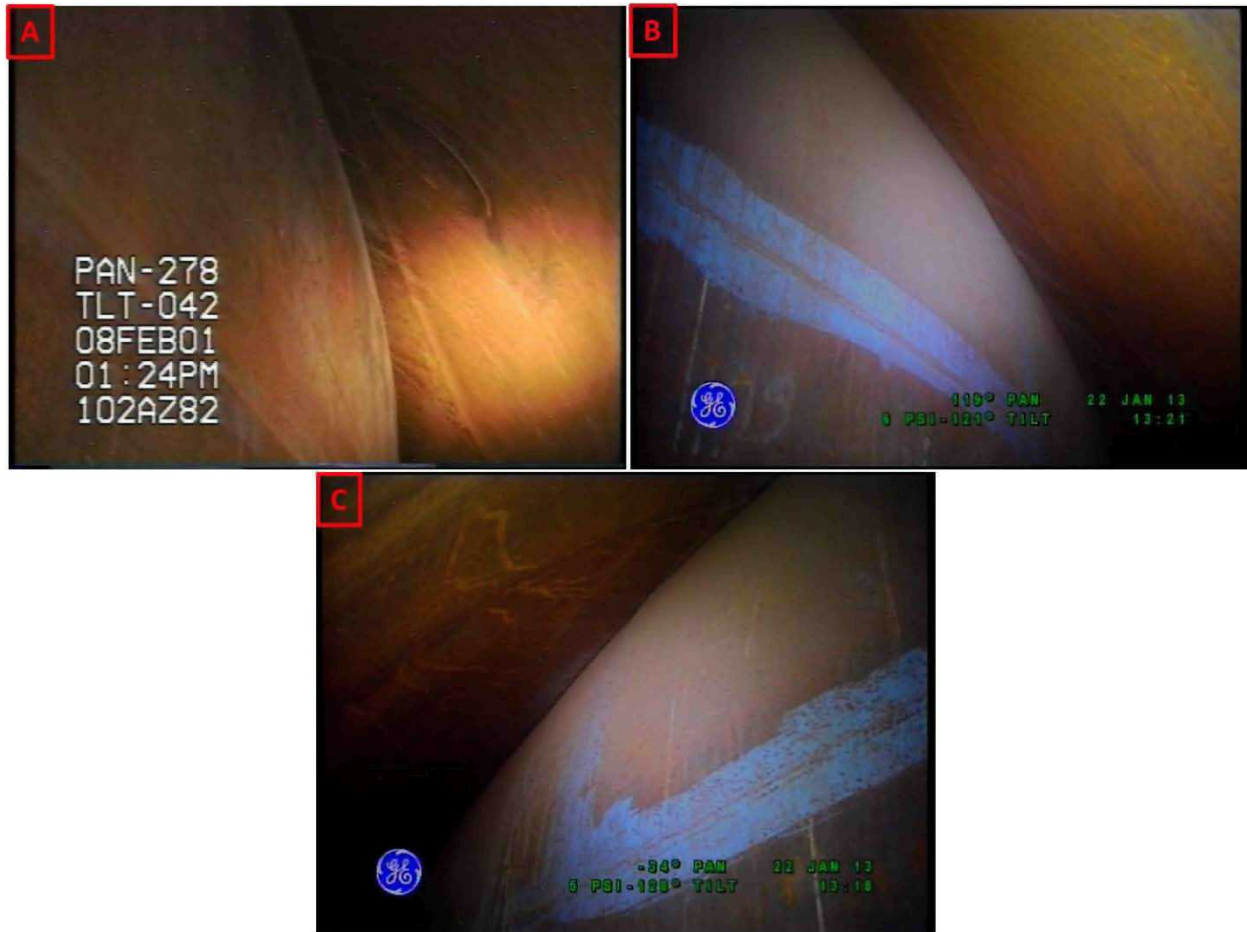
Figure 3-18. Riser 82 Upper Haunch Comparisons Between Inspections on February 8, 2001 (A) and January 22, 2013 (B) Looking Towards Riser 105 and on January 22, 2013 Looking Towards Riser 95 (C)

The tank dome and upper haunch area looking towards Riser 95 were not visible during the 2001 or 2011 inspection. Figure 3-18A and Figure 3-18B show comparisons of the upper haunch area looking towards Riser 105 between inspections performed in 2001 and 2013. There were no significant changes in the condition of this area from 2001 to 2013. No areas of interest were identified in the top knuckle region during the 2013 inspection.

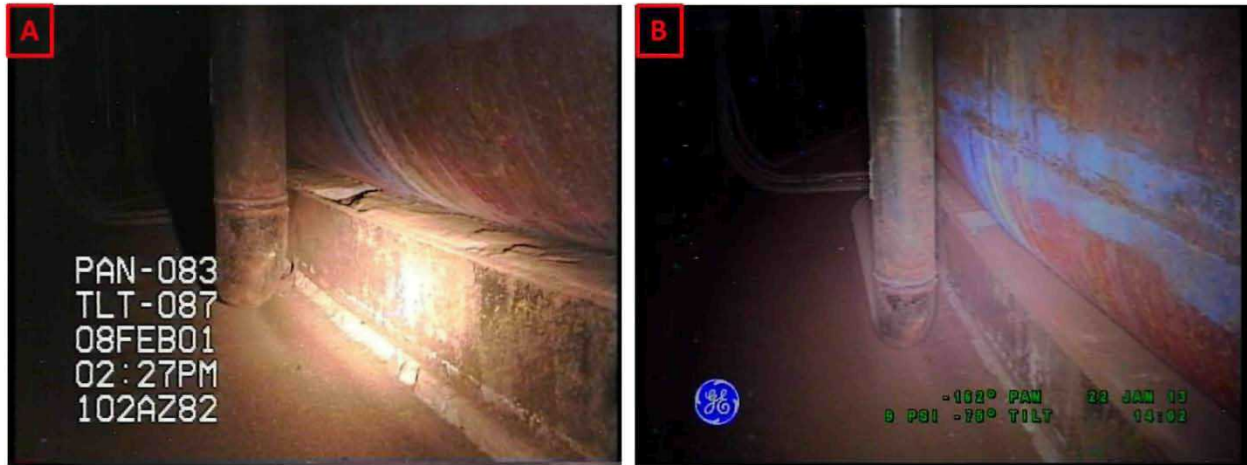
Figure 3-19. Riser 82 Lower Knuckle and Annulus Floor Comparisons Between Inspections on February 8, 2001 (A) and January 22, 2013 (B) Looking Towards Riser 95

Figure 3-19 and Figure 3-20 show comparisons of the lower knuckle and annulus floor between inspections performed in 2001 and 2013. There appears to be no significant change in the condition of this area between 2001 and 2013. Figure 3-21 shows the general condition of the refractory slots in 2013 and no anomalies were noted. No anomalies were identified on the lower knuckle of the primary tank, insulating refractory, refractory slots, stiffener ring, or annulus floor during the 2013 inspection.

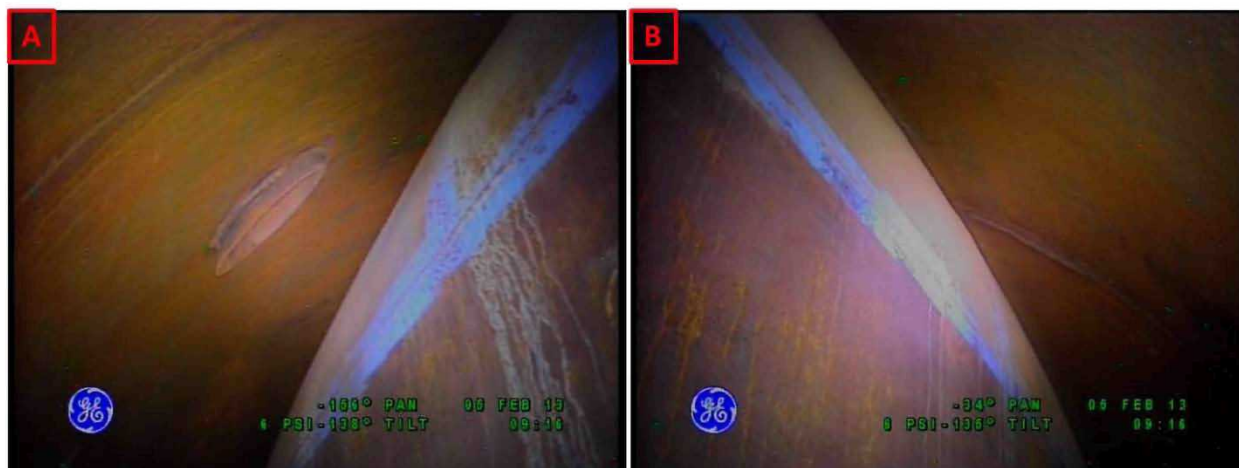
Figure 3-22. Riser 83 General Condition of the Upper Haunch on February 5, 2013 Looking Towards Riser 96 (A) and Looking Towards Riser 89 (B)

Figure 3-22 shows the general condition of the upper haunch area in January 2013. In Figure 3-22A, white streaks can be seen on the primary tank. These white streaks, which are commonly seen among the DSTs, are referred to as laitance flow which can be attributed to the pouring of the concrete dome during construction. No areas of interest were identified in the top knuckle region during the 2013 inspection.

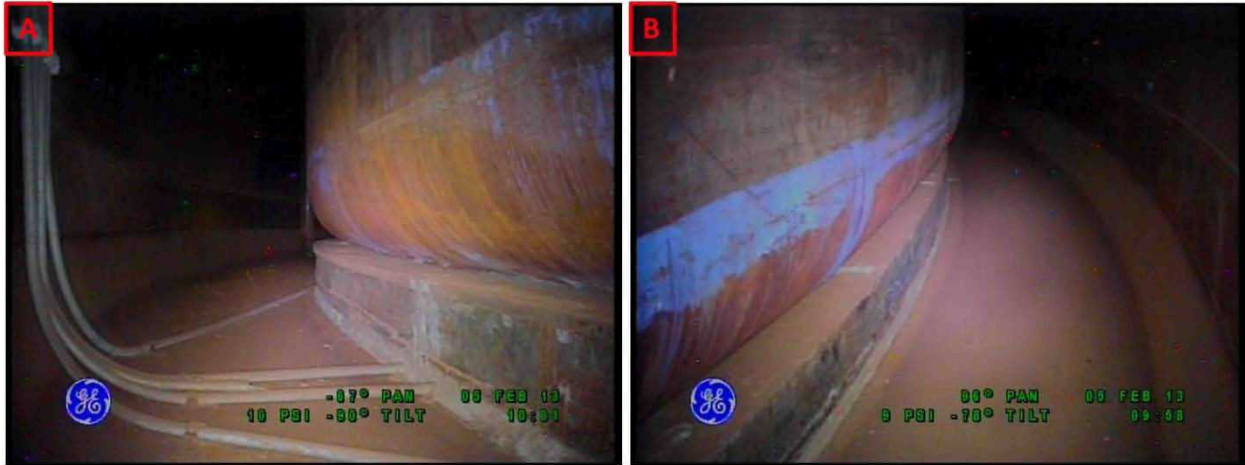
Figure 3-23. Riser 83 Lower Knuckle and Annulus Floor Condition on February 5, 2013 Looking Towards Riser 96 (A) and Looking Towards Riser 89 (B)

Figure 3-23 shows the general condition of the lower knuckle and annulus floor in January 2013. A beachline can also be seen along the annulus floor in Figure 3-23 which is likely the result of evaporated couplant water used during UT examinations. Figure 3-24 shows the general condition of the refractory slots in 2013 and no anomalies were noted. No anomalies were identified on the lower knuckle of the primary tank, insulating refractory, refractory slots, stiffener ring, or annulus floor during the 2013 inspection.

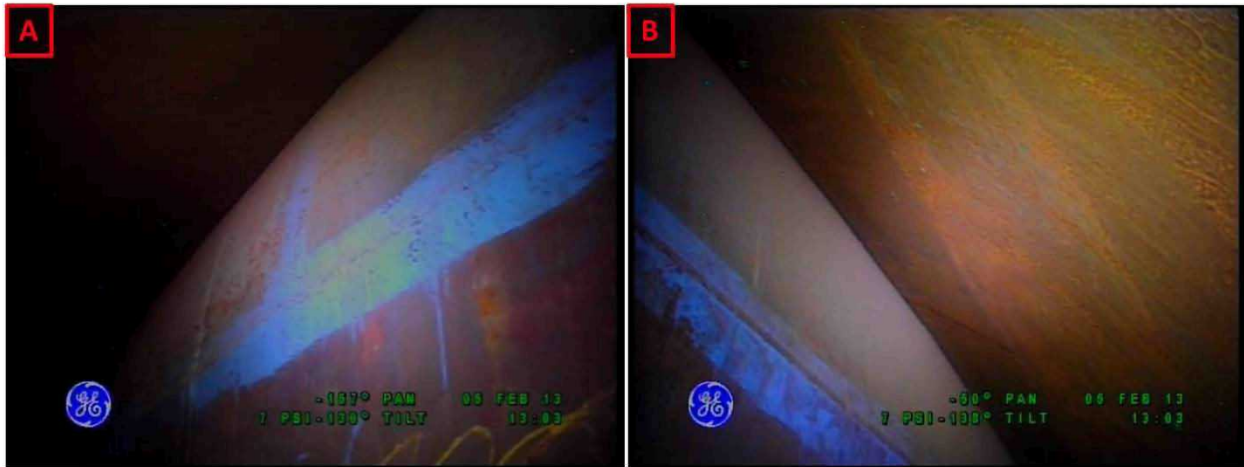
Figure 3-25. Riser 84 General Condition of the Upper Haunch on February 5, 2013 Looking Towards Riser 85 (A) and Looking Towards Riser 102 (B)

The tank dome and upper haunch area were not visible during the 1993 and 2001 inspections. Figure 3-25 shows the general condition of the upper haunch area in February 2013. No areas of interest were identified in the top knuckle region during the 2013 inspection.

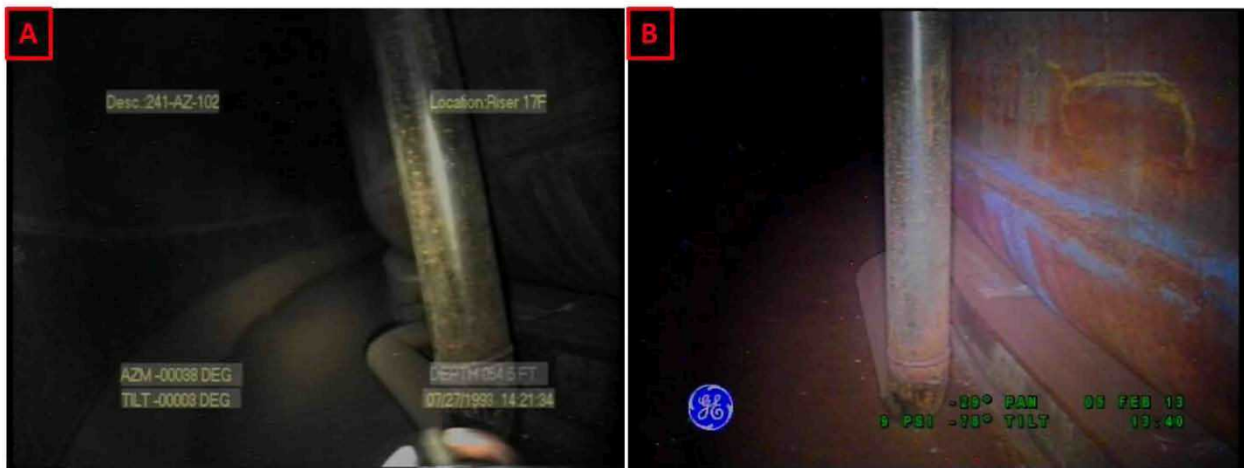
Figure 3-26. Riser 84 Lower Knuckle and Annulus Floor Comparisons Between Inspections on July 27, 1993 (A) and February 5, 2013 (B) Looking Towards Riser 85

Figure 3-26 and Figure 3-27 show comparisons of the lower knuckle and annulus floor between inspections performed in 1993 and 2013. There appears to be no significant change in the condition of this area between 1993 and 2013. A beachline can also be seen along the annulus floor in Figure 3-27 which is likely the result of evaporated couplant water used during UT examinations. Figure 3-28 shows the general condition of the refractory slots in February 2013 and no anomalies were noted. No anomalies were identified on the lower knuckle of the primary tank, insulating refractory, refractory slots, stiffener ring, or annulus floor during the 2013 inspection.

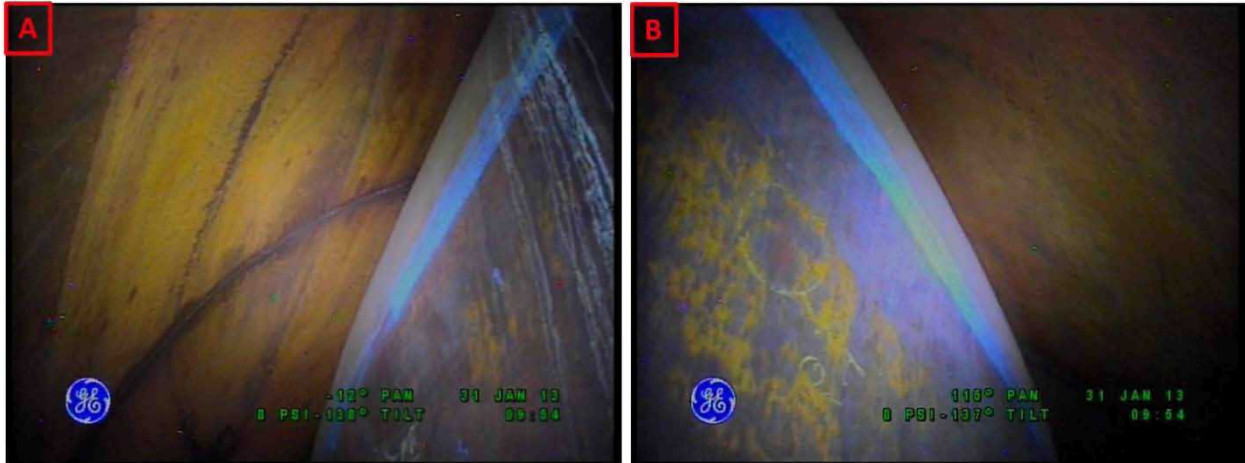
Figure 3-29. Riser 86 General Condition of the Upper Haunch on January 31, 2013 Looking Towards Riser 87 (A) and Looking Towards Riser 103 (B)

Figure 3-29 shows the general condition of the upper haunch area in January 2013. In Figure 3-29A, white streaks can be seen on the primary tank. These white streaks, which are commonly seen among the DSTs, are referred to as laitance flow attributed to the pouring of the concrete dome during construction. No areas of interest were identified in the top knuckle region during the 2013 inspection.

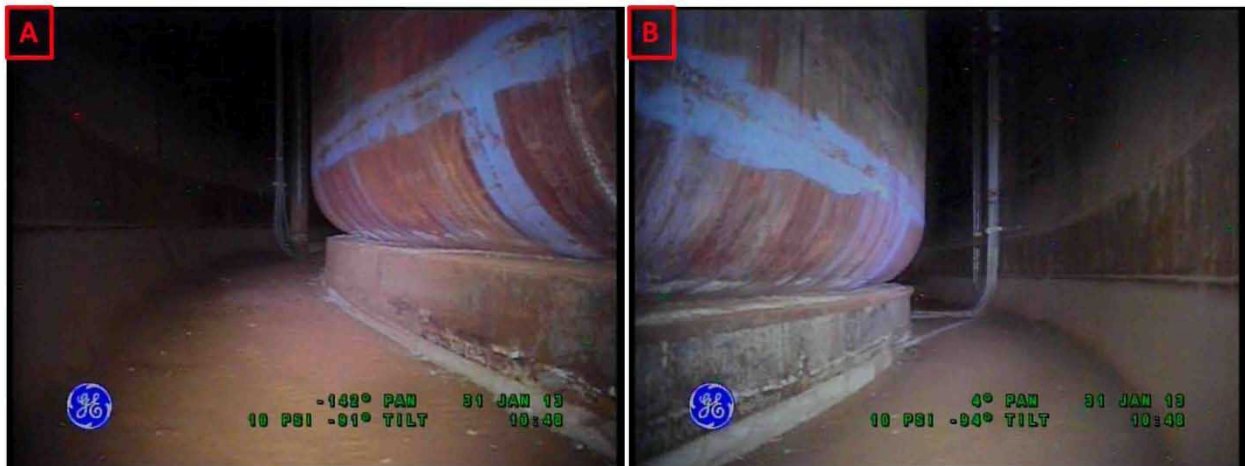
Figure 3-30. Riser 86 Lower Knuckle and Annulus Floor Condition on January 31, 2013 Looking Towards Riser 87 (A) and Looking Towards Riser 103 (B)

Figure 3-30 shows the general condition of the lower knuckle and annulus floor in January 2013. Figure 3-31 shows the general condition of the refractory slots in January 2013 and no anomalies were noted. No anomalies were identified on the lower knuckle of the primary tank, insulating refractory, refractory slots, stiffener ring, or annulus floor during the 2013 inspection.

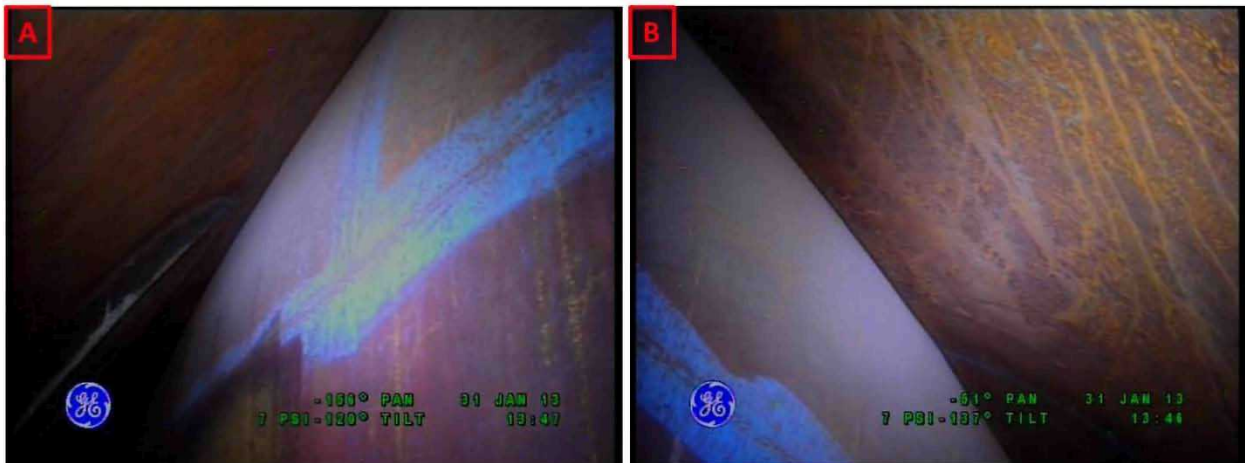
Figure 3-32. Riser 88 General Condition of the Upper Haunch on January 31, 2013 Looking Towards Riser 90 (A) and Looking Towards Riser 104 (B)

Figure 3-32 shows the general condition of the upper haunch area in January 2013. No areas of interest were identified in the top knuckle region during the 2013 inspection.

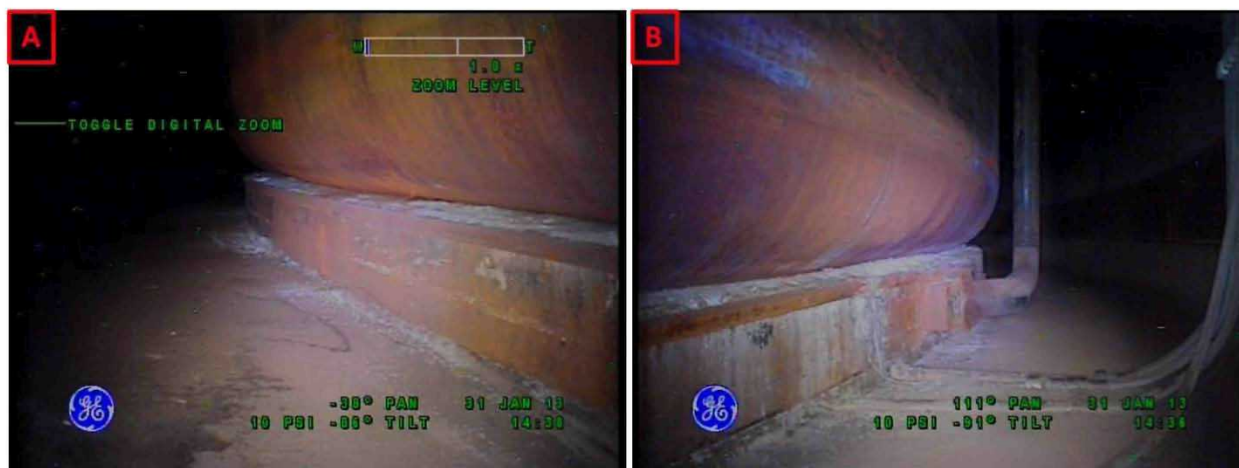
Figure 3-33. Riser 88 Lower Knuckle and Annulus Floor Condition on January 31, 2013 Looking Towards Riser 90 (A) and Looking Towards Riser 104 (B)

Figure 3-33 shows the general condition of the lower knuckle and annulus floor in January 2013. The stains on the annulus floor shown in Figure 3-33A are likely from the UT examinations that were performed in nearby Riser 90. Figure 3-34 shows the general condition of the refractory slots in January 2013 and no anomalies were noted. No anomalies were identified on the lower knuckle of the primary tank, insulating refractory, refractory slots, stiffener ring, or annulus floor during the 2013 inspection.

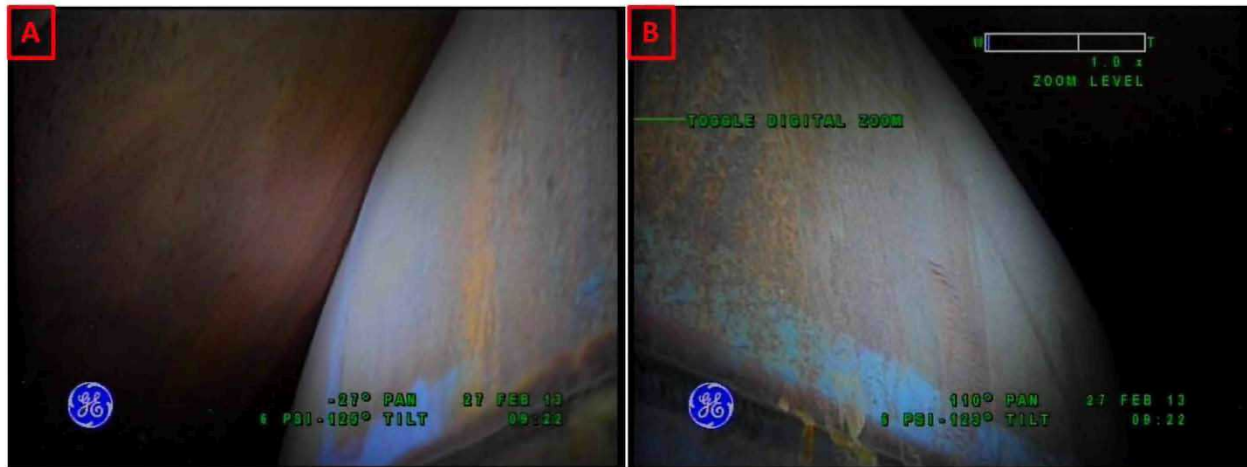
Figure 3-35. Riser 89 General Condition of the Upper Haunch on February 27, 2013 Looking Towards Riser 83 (A) and Looking Towards Riser 101 (B)

Figure 3-35 shows the general condition of the upper haunch area in February 2013. No areas of interest were identified in the top knuckle region during the 2013 inspection.

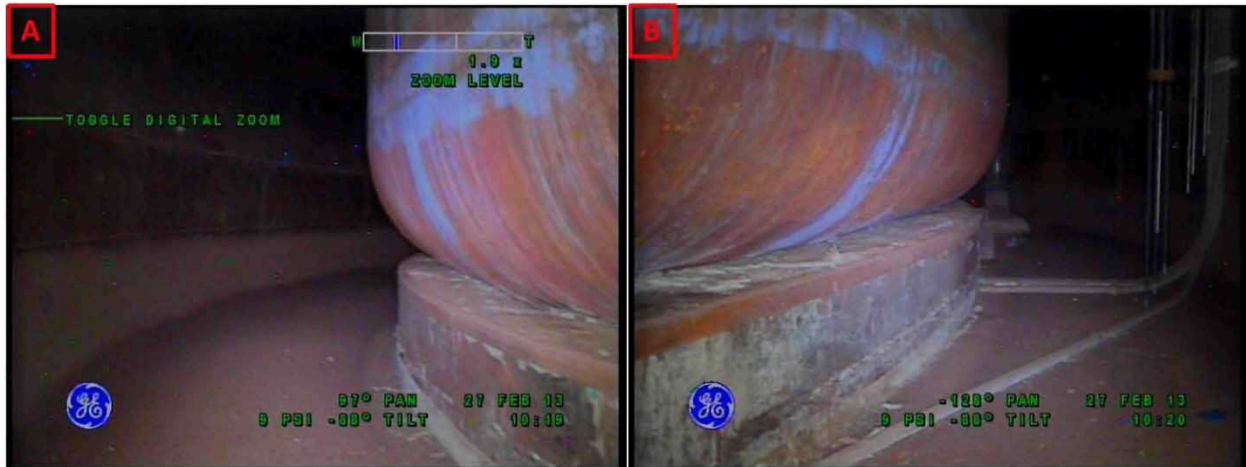
Figure 3-36. Riser 89 Lower Knuckle and Annulus Floor Condition on February 27, 2013 Looking Towards Riser 83 (A) and Looking Towards Riser 101 (B)

Figure 3-36 shows the general condition of the lower knuckle and annulus floor in February 2013. A beachline can also be seen along the annulus floor in Figure 3-36A which is likely the result of evaporated couplant water used during UT examinations. Figure 3-37 shows the general condition of the refractory slots in February 2013 and no anomalies were noted. No anomalies were identified on the lower knuckle of the primary tank, insulating refractory, refractory slots, stiffener ring, or annulus floor during the 2013 inspection.

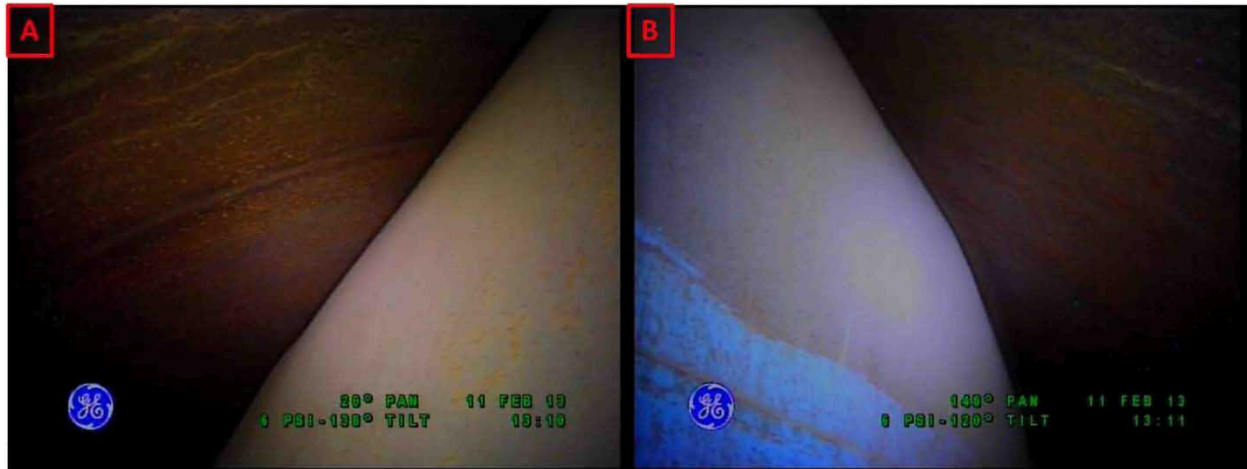
Figure 3-38. Riser 92 General Condition of the Upper Haunch on February 11, 2013 Looking Towards Riser 97 (A) and Looking Towards Riser 85 (B)

Figure 3-38 shows the general condition of the upper haunch area in February 2013. No areas of interest were identified in the top knuckle region during the 2013 inspection.

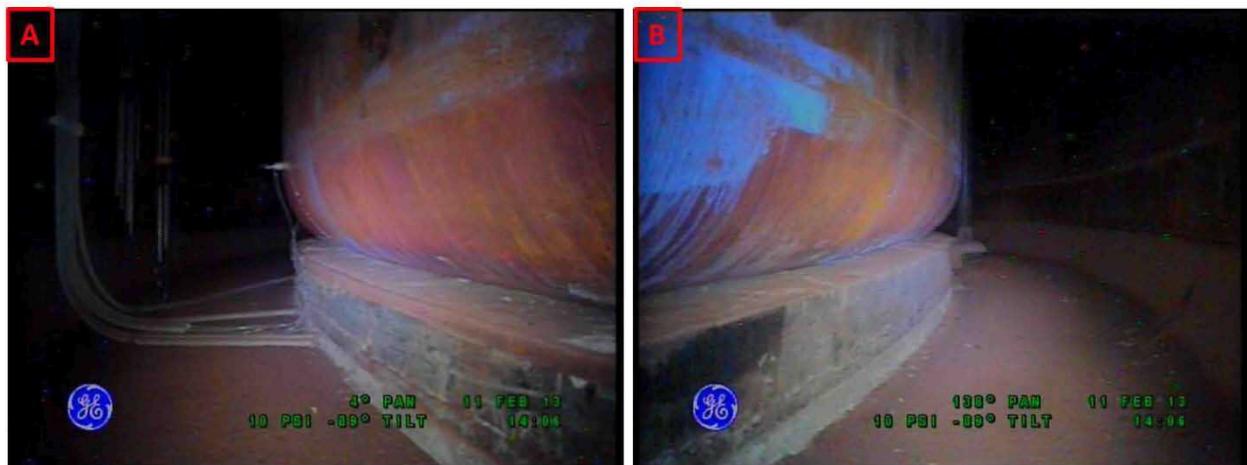
Figure 3-39. Riser 92 Lower Knuckle and Annulus Floor Condition on February 11, 2013 Looking Towards Riser 97 (A) and Looking Towards Riser 85 (B)

Figure 3-39 shows the general condition of the lower knuckle and annulus floor in February 2013. A beachline can also be seen along the annulus floor in Figure 3-39B which is likely the result of evaporated couplant water used during UT examinations. Figure 3-40 shows the general condition of the refractory slots in February 2013 and no anomalies were noted. No anomalies were identified on the lower knuckle of the primary tank, insulating refractory, refractory slots, stiffener ring, or annulus floor during the 2013 inspection.

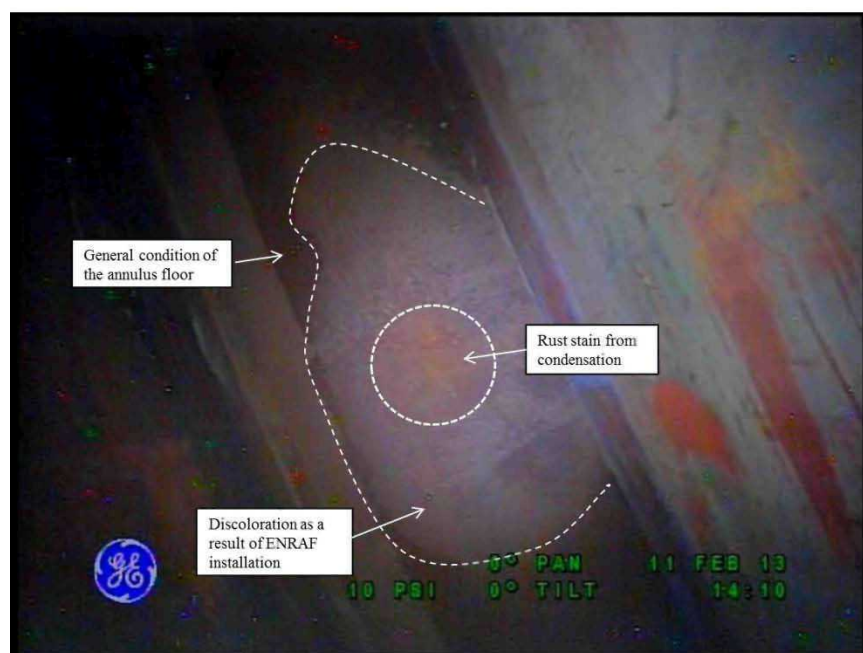
Figure 4-1. Top Down View of the Annulus Floor as seen from Riser 92 on February 11, 2013

In the risers where the annulus ENRAF is located, typically an area of discoloration can be seen on the annulus floor (see Figure 4-1 and Figure 4-2 for an example from tank AZ-102). The lighter area on the annulus floor is believed to be the result of the annulus ENRAF installation performed in 2003. During installation, compressed air was used to blow away any debris from the annulus floor at the bottom of the applicable riser (Work Package 2E-03-01479/M). After using compressed air, a mechanical grabber was then used to remove the debris. This lighter discoloration appears to be lower in elevation when compared to the darker annulus floor surrounding this area (see Figure 4-2D). The darker area appears to be corrosion product from the primary tank and secondary liner. In the center of the lighter region, there is typically a smaller rust stain which is located directly underneath the ENRAF plummet. This rust stain can be attributed to the accumulation of moisture resulting from air condensing in the ENRAF equipment located above grade. These anomalies seen in the ENRAF risers do not appear to be a region of concern.

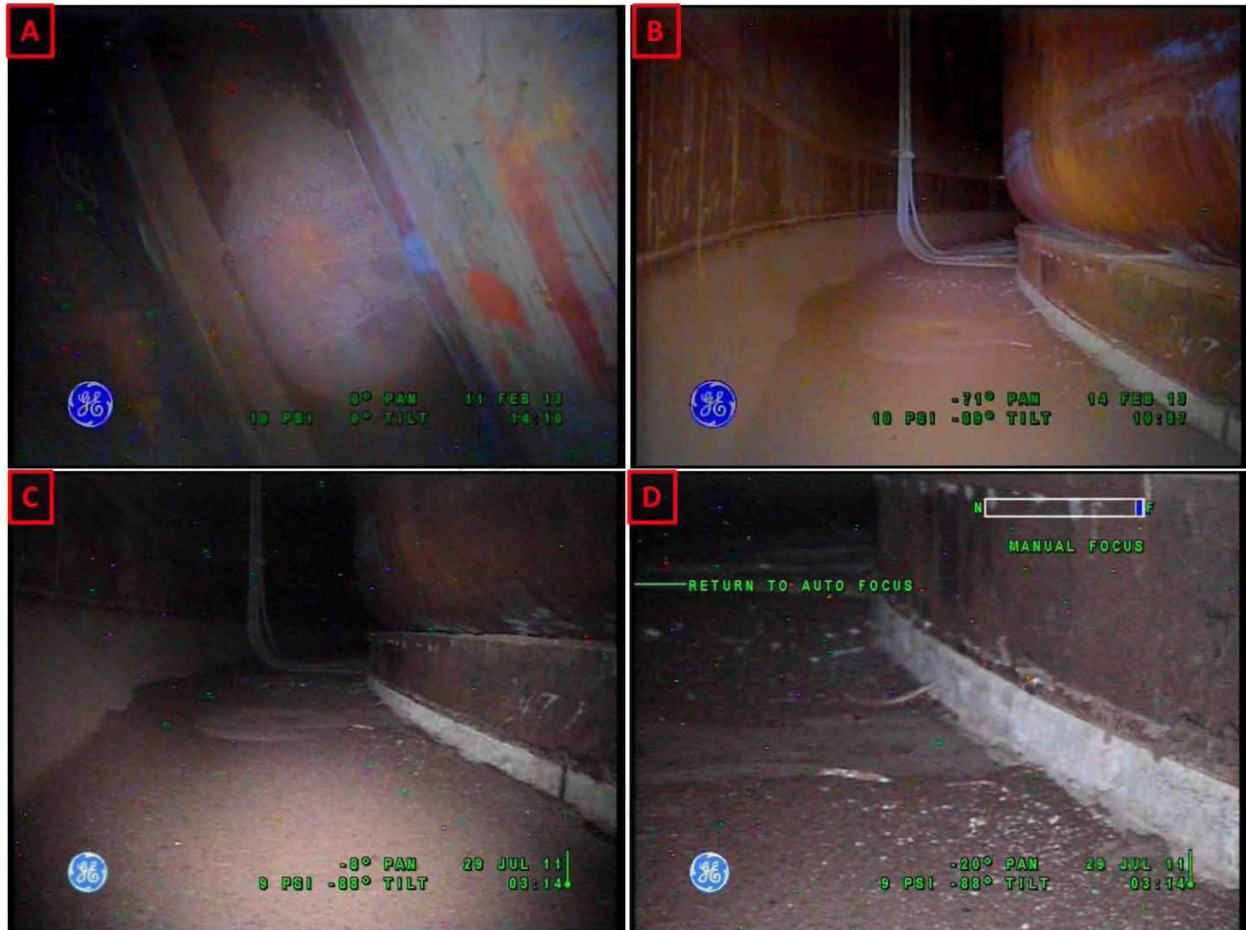
Figure 4-2. Annulus Floor Discoloration in Tank AZ-102 as seen from Riser 92 in 2013 (A), from Riser 80 in 2013 (B), from Riser 80 in 2011 (C), and Close Up View Showing Elevation Differences as seen from Riser 80 in 2011 (D)
