**Pacific Northwest
National Laboratory**

**Ultrasonic Examination of Double-Shell
Tank 241-AW-103 Examination
Completed September 2006**

AF Pardini
GJ Posakony

November 2006

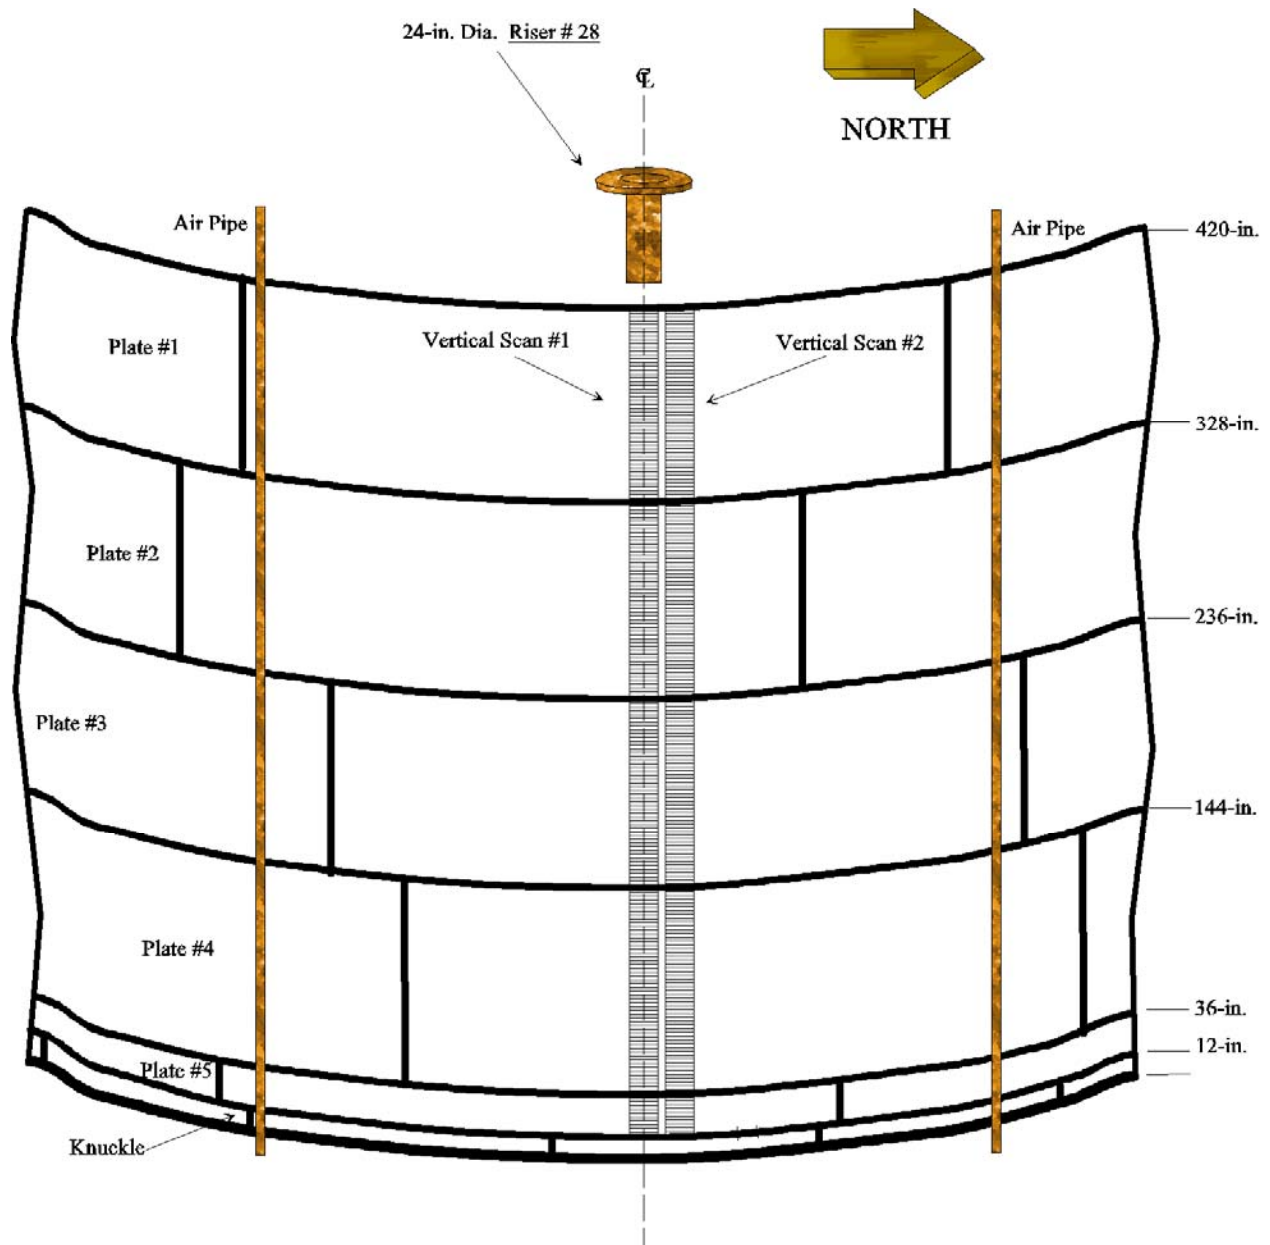
Figure 4.2. Sketch of Scan Paths on 241-AW-103 Primary Tank from Riser 28

Two 15-in.-wide vertical scan paths were performed on Plates #1, #2, #3, #4, and #5 from Riser 28. The plates were examined for wall thinning, pitting, and cracks oriented vertically on the primary tank wall. There were no areas of wall thinning that exceeded the reportable level of 10% of the nominal thickness. No pitting or vertical crack-like indications were detected in Plates #1, #2, #3, #4, or #5.

Figure 4.2 describes the areas on the primary wall of Tank 241-AW-103 that were ultrasonically examined from Riser 28 located on the east side of the tank. Two 15-in.-wide vertical scan paths were performed on Plates #1, #2, #3, #4, and #5 below the entrance to Riser 28.

Two 15-in.-wide vertical scan paths were performed on Plates #1, #2, #3, #4, and #5 from Riser 28. The plates were examined for wall thinning, pitting, and cracks oriented vertically on the primary tank wall. The results indicated that the minimum thicknesses in the areas that were scanned with nominal thickness of 0.500-in. are as follows; Plate #1 was 0.465-in., Plate #2 was 0.496-in., and Plate #3 was 0.497-in. The nominal thickness in Plate #4 is 0.750-in. and the minimum thickness in this area was 0.732-in. The nominal thickness in Plate #5 is 0.875-in. and the minimum thickness in this area was 0.848-in. There were no areas of wall thinning that exceeded the reportable level of 10% of the nominal thickness. No pitting or vertical crack-like indications were detected in Plates #1, #2, #3, #4, or #5.

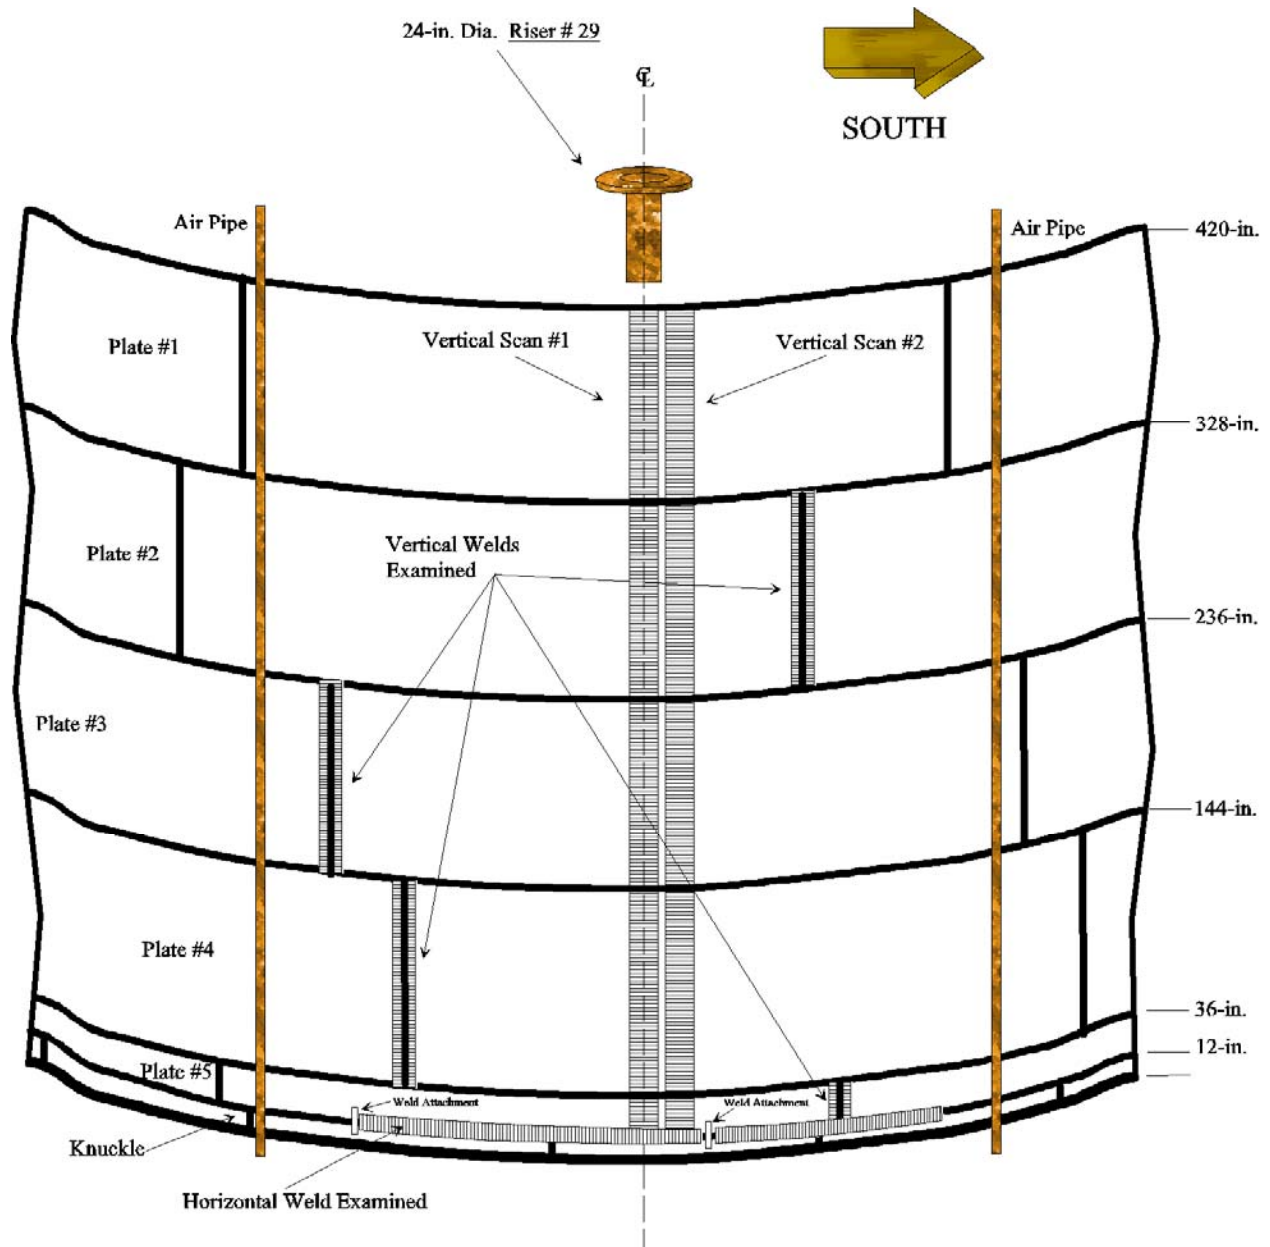
Figure 4.3. Sketch of Scan Paths on Tank 241-AW-103 Primary Tank from Riser 29

Two 15-in.-wide vertical scan paths were performed on Plates #1, #2, #3, #4, and #5 from Riser 29. The plates were examined for wall thinning, pitting, and cracks oriented vertically on the primary tank wall. There were no areas of wall thinning that exceeded the reportable level of 10% of the nominal thickness. No pitting or vertical crack-like indications were detected in Plates #1, #2, #3, #4, or #5.

Figure 4.3 describes the areas on the primary wall of Tank 241-AW-103 that were ultrasonically examined from Riser 29 located on the west side of the tank. Two 15-in.-wide vertical scan paths were performed on Plates #1, #2, #3, #4, and #5 below the entrance to Riser 29. Vertical weld HAZ examinations were done on Plates #2, #3, #4, and #5, and the horizontal weld HAZ examination was done on the transition Plate #5 to knuckle weld.

Two 15-in.-wide vertical scan paths were performed on Plates #1, #2, #3, #4, and #5 from Riser 29. The plates were examined for wall thinning, pitting, and cracks oriented vertically on the primary tank wall. The results indicated that the minimum thicknesses in the areas that were scanned with nominal thickness of 0.500-in. are as follows; Plate #1 was 0.470-in., Plate #2 was 0.489-in., and Plate #3 was 0.479-in. The nominal thickness in Plate #4 is 0.750-in. and the minimum thickness in this area was 0.718-in. The nominal thickness in Plate #5 is 0.875-in. and the minimum thickness in this area was 0.861-in. There were no areas of wall thinning that exceeded the reportable level of 10% of the nominal thickness. No pitting or vertical crack-like indications were detected in Plates #1, #2, #3, #4, or #5.

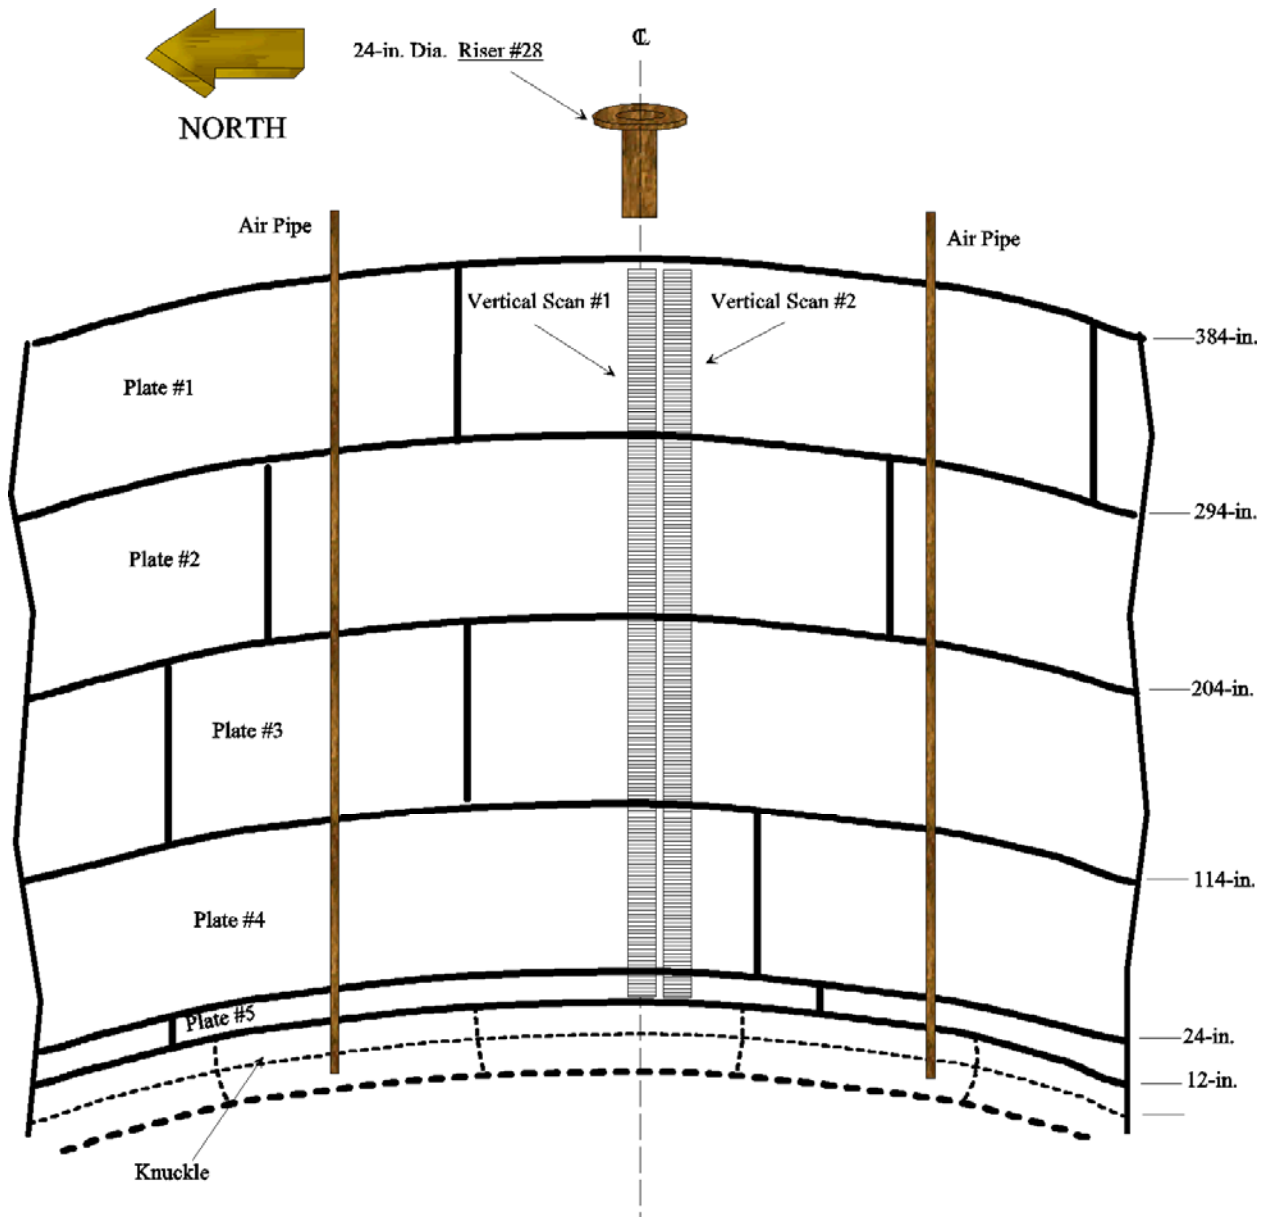
Figure 4.4. Sketch of Scan Paths on Tank 241-AW-103 Secondary Tank from Riser 28

Two 15-in.-wide vertical scan paths were performed on the secondary tank wall on Plates #1, #2, #3, #4, and #5 from Riser 28. The plates were examined for wall thinning, pitting, and cracks oriented vertically on the secondary tank wall. There were no areas of wall thinning that exceeded the reportable level of 10% of the nominal thickness. No pitting or vertical crack-like indications were detected in Plates #1, #2, #3, #4, or #5.

Figure 4.4 describes the areas on the secondary wall of Tank 241-AW-103 that were ultrasonically examined from Riser 28 located on the east side of the tank. Two 15-in.-wide vertical scan paths were performed on Plates #1, #2, #3, #4, and #5 below the entrance to Riser 28.

Two 15-in.-wide vertical scan paths were performed on the secondary tank wall on Plates #1, #2, #3, #4, and #5 from Riser 28. The plates were examined for wall thinning, pitting, and cracks oriented vertically on the secondary tank wall. The results indicated that the minimum thicknesses in the areas that were scanned with nominal thickness of 0.375-in. are as follows; Plate #1 was 0.359-in., Plate #2 was 0.362-in., Plate #3 was 0.363-in., and Plate #4 was 0.372-in. The nominal thickness in Plate #5 is 0.500-in. and the minimum thickness in this area was 0.455-in. There were no areas of wall thinning that exceeded the reportable level of 10% of the nominal thickness. No pitting or vertical crack-like indications were detected in Plates #1, #2, #3, #4, or #5.
