LAB-RPT-10-00011
Rev. 0

RESULTS OF THE EXAMINATION OF ELECTROCHEMICAL NOISE PROBE SPECIMENS REMOVED FROM TANK 241-AN-107, JUNE, 2010

G. A. Cooke
R. B. Wyrwas
J. B. Duncan
Washington River Protection Solutions LLC

Date Published
October 2010

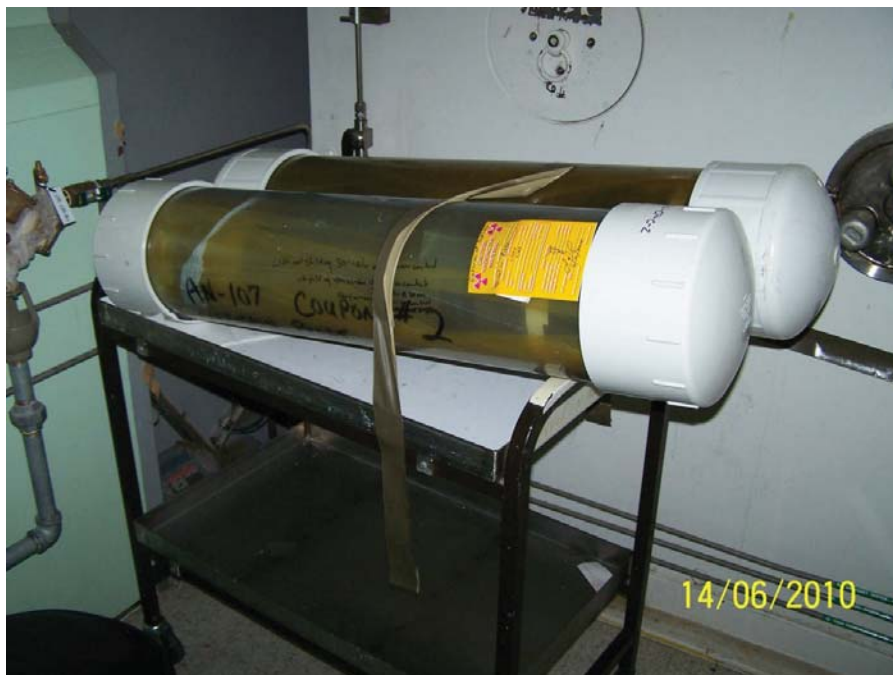
Figure 2. Detector Sections 1 and 2 with Outer Bags Removed.

The two detector sections were loaded into hot cell 1 in Room 1-E at the 222-S Laboratory on June 14 without any difficulties (Figure 2). The package was placed in the airlock after removing the end cap that was closest to the door between the airlock and the hot cell (Figure 3). The manipulators were used to pull the inner package into the hot cell (Figure 4), leaving the outer polycarbonate package in the airlock. The outer packaging was disposed.

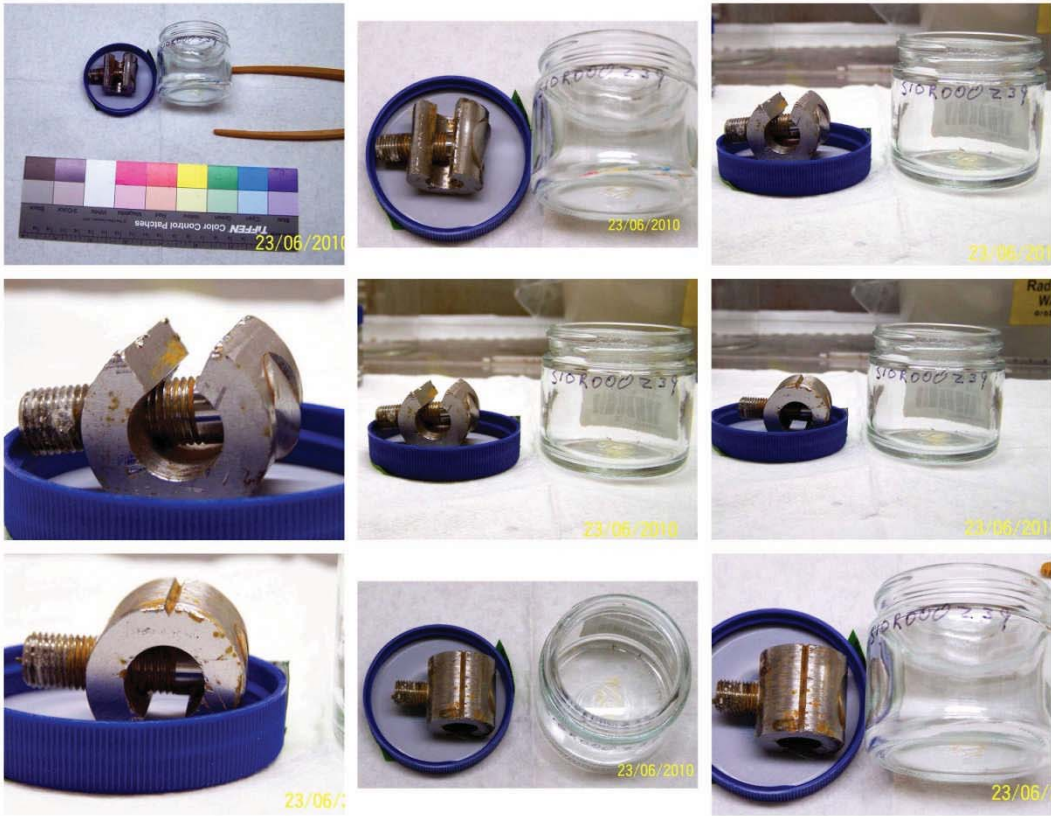
Plate I. Sample VS-ENC-R (S10R000239).

- 4) The C-rings recovered from the vapor space show the slight corrosion (dominantly crevice corrosion) that has been seen in the past (RPP-RPT-32425, *Final Analytical Results from the Examination of Corrosion on Sections of Corrosion Probe Removed from Tank 241-AN-107 on August 10, 2006* and 7S110-GAC-06-087, “Results of the Examination of Electrochemical Noise Probe Specimens Removed from Tank 241-AN-107”). The one stressed C-ring still shows the characteristic bulge in the polished surface indicating that the stress that was imparted during pre-cracking has not been relieved by further cracking (Figure 11). We do not have pictures of the crack before deployment, but every indication is that the crack has not progressed any further.

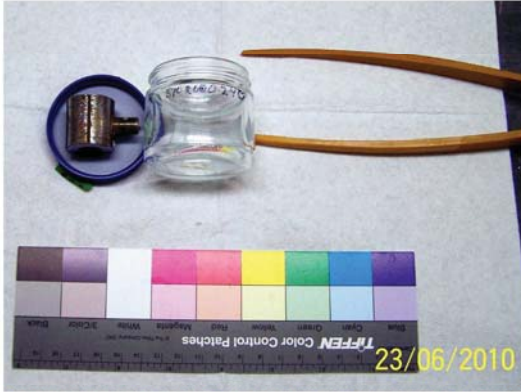
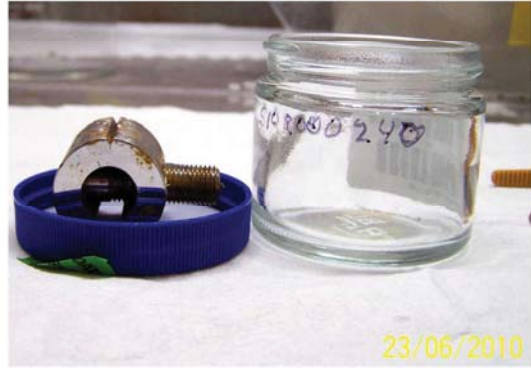
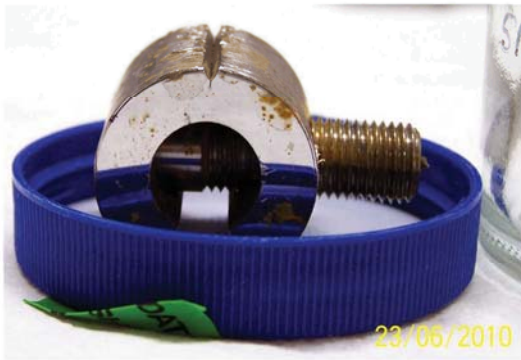
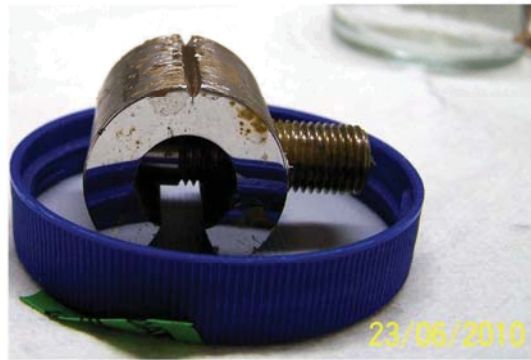
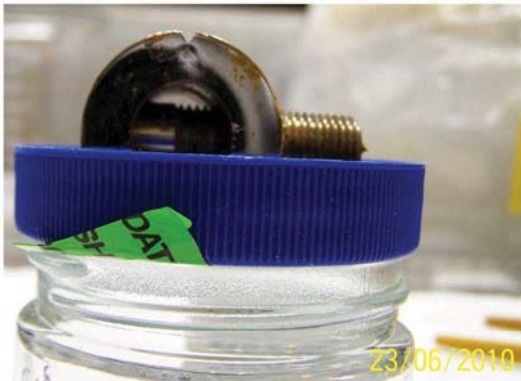
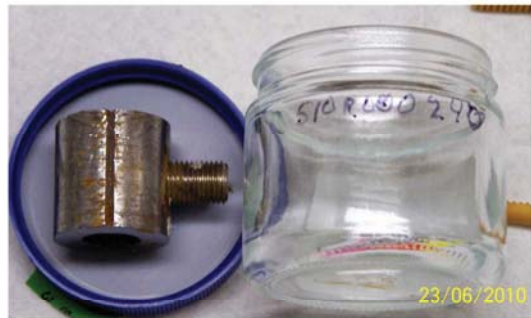
Plate IIa. Sample VS-ENC-W (S10R000240).

The one pre-cracked C-ring recovered from the vapor space still had the stress bulge visible on the polished surface, indicating that crack propagation had not occurred in the tank. No photographs were taken of the C-ring before deployment. No further analysis was conducted on this specimen. A detailed discussion and photographic documentation are provided in this report.

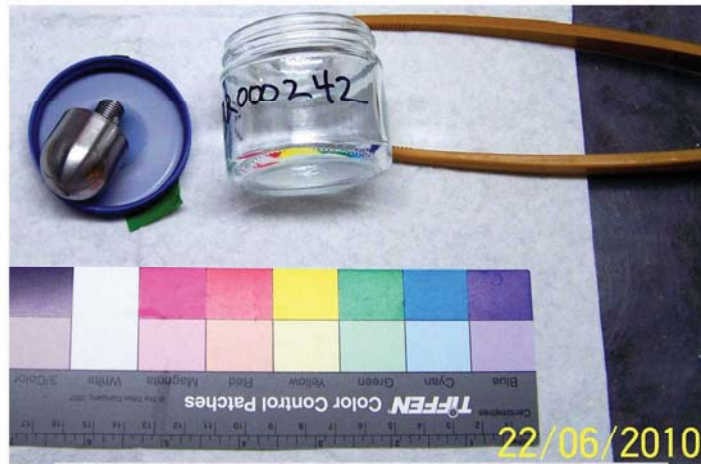
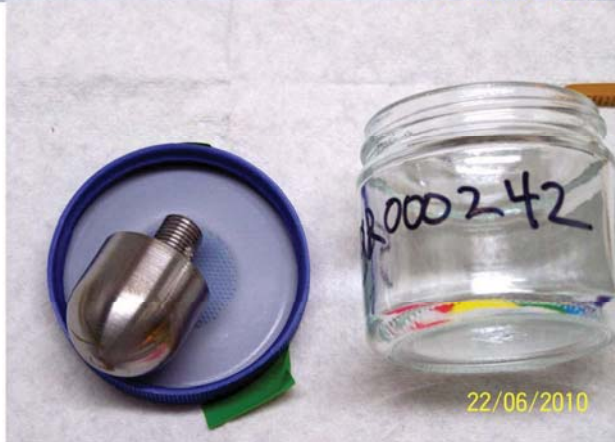
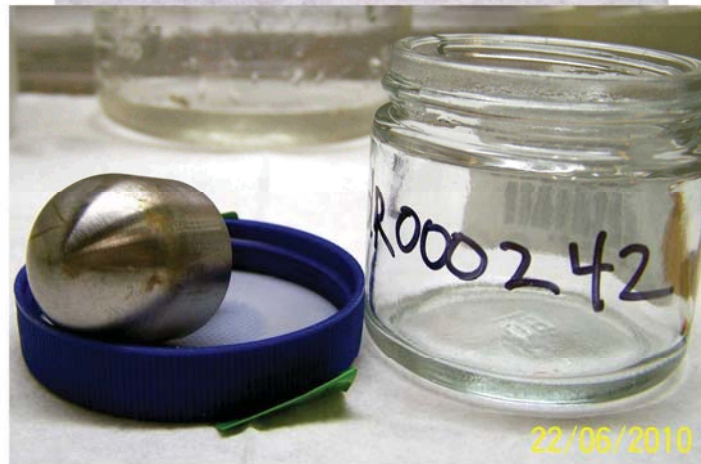
Plate IV. Sample SP-ENB-R (S10R000242).

Metrology of the bullets has been corrupted by the use of glue and by the design of the bullets prohibiting the measurement of an exposed surface area. Macrophotography shows an overall low level of corrosion. Visible evidence for corrosion is slightly more evident on the vapor section C-rings than on the bullets suspended in the supernatant of Tank AN-107. These observations are consistent with previous studies, referenced above. The macrophotographs also demonstrate that the pre-cracked C-ring still retains its stress bulge at the tip of the crack, on the polished end of the C-ring (Figure 11).
