RFP-1557

November 6, 1970

GLOVEBOX FIRE TESTS

THE DOW CHEMICAL COMPANY
ROCKY FLATS DIVISION
P. O. BOX 888
GOLDEN, COLORADO 80401

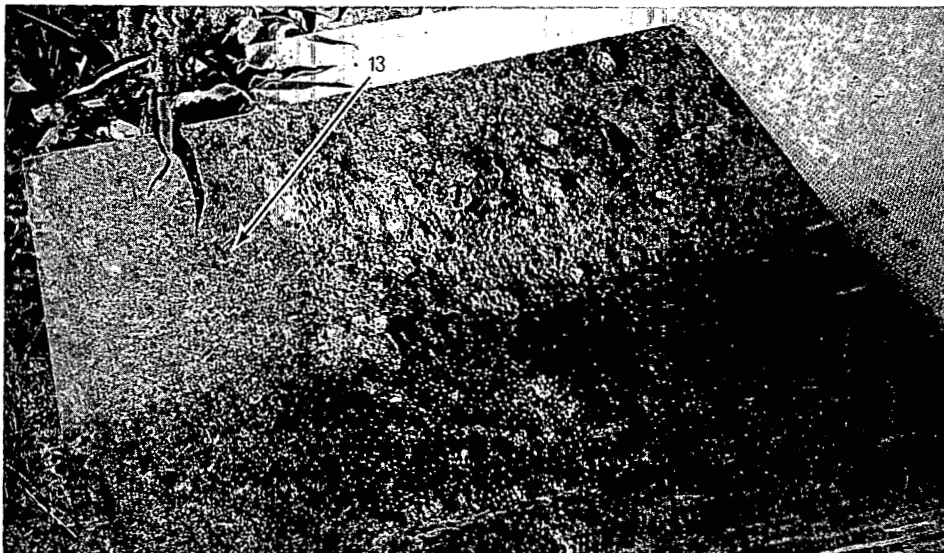
Figure 21. Shielding Panel after Experiment No. 2. (See Table X for added description of reference number.)

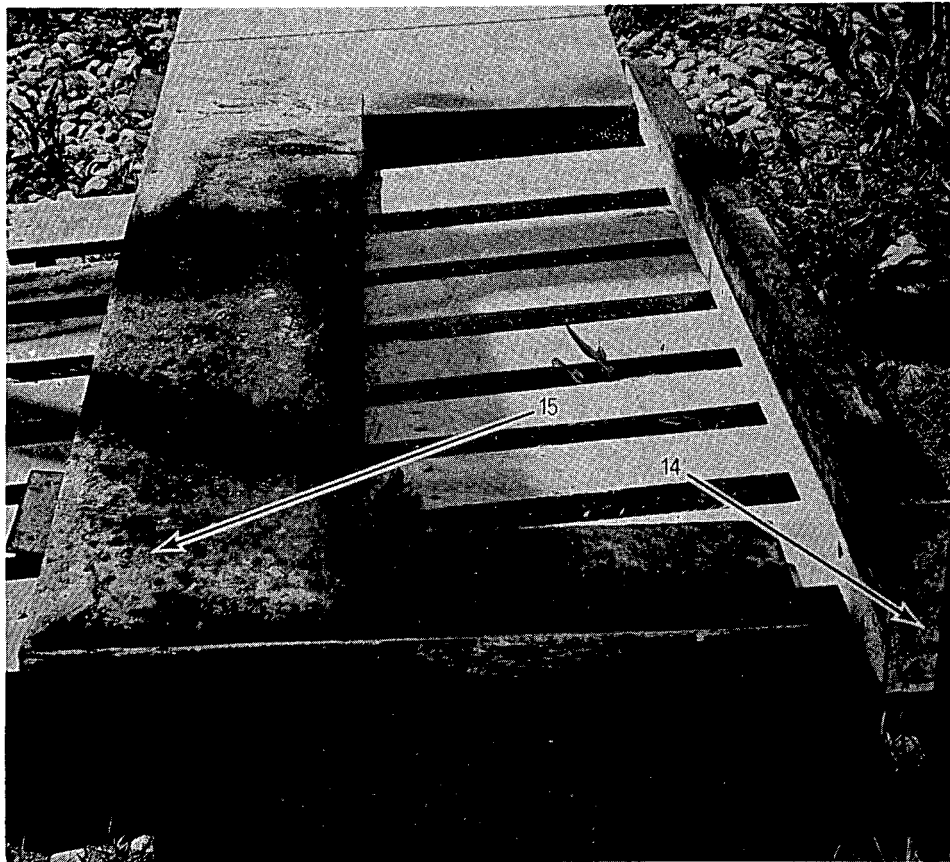
Figure 22. Shielding Panels after Experiment No. 2. (See Table X for description of reference numbers.)

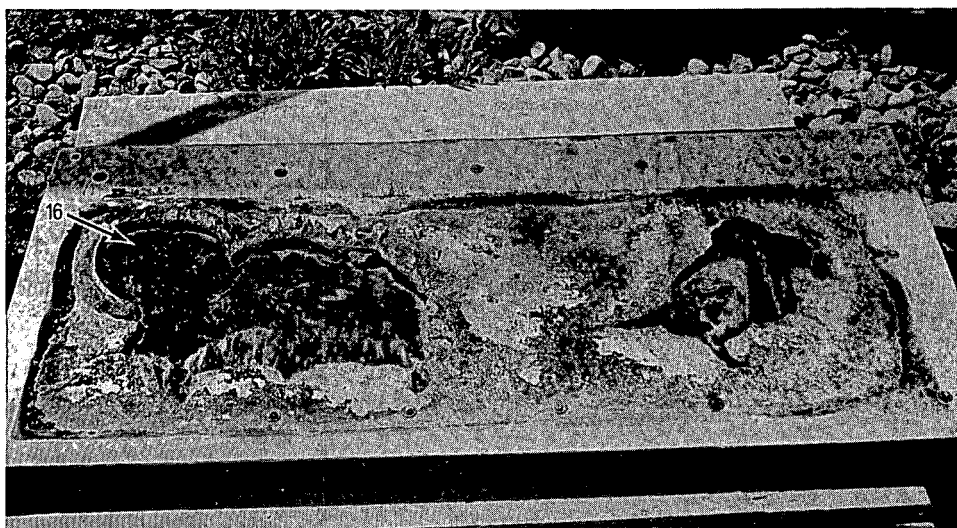
Figure 23. Shielding Panel after Experiment No. 2. (See Table X for added description of reference number.)

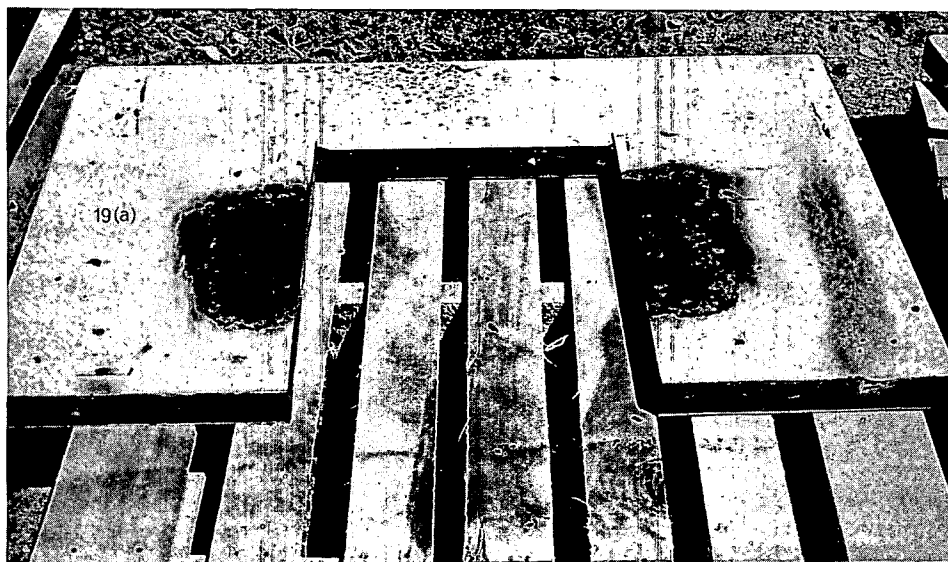
19.	Two-inch Benelex panel in two sections. Both sides of Benelex were painted with fire-retardant paint (Albi). Sheet lead, also painted with fire-retardant paint, was applied to one side. (a) The top section was placed with the Benelex side facing the box; (b) the bottom section was placed with the lead facing the box.	Figures 6 and 7 Panel 19	(a) Paint around exhaust pipe on top section was expanded. Also some blistering of Benelex surface was noted in certain areas. Lead was unaffected. See Figure 25. (b) Paint on surface of lead sheet was expanded although no lead was melted from the surface. See Figure 26.

Figure 25. Shielding Panel after Experiment No. 2. (See Table XI for added description of reference number.)

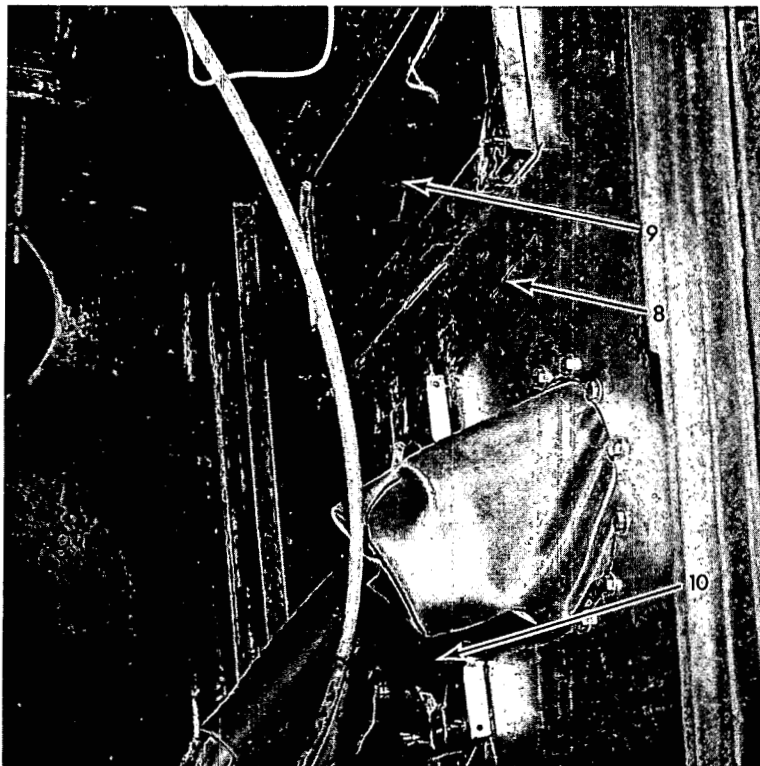
Figure 33. View of Interior of Glovebox Showing Frame for Protection of Los Alamos-Style Window Gasket. (See Table XIV for added description of reference numbers.

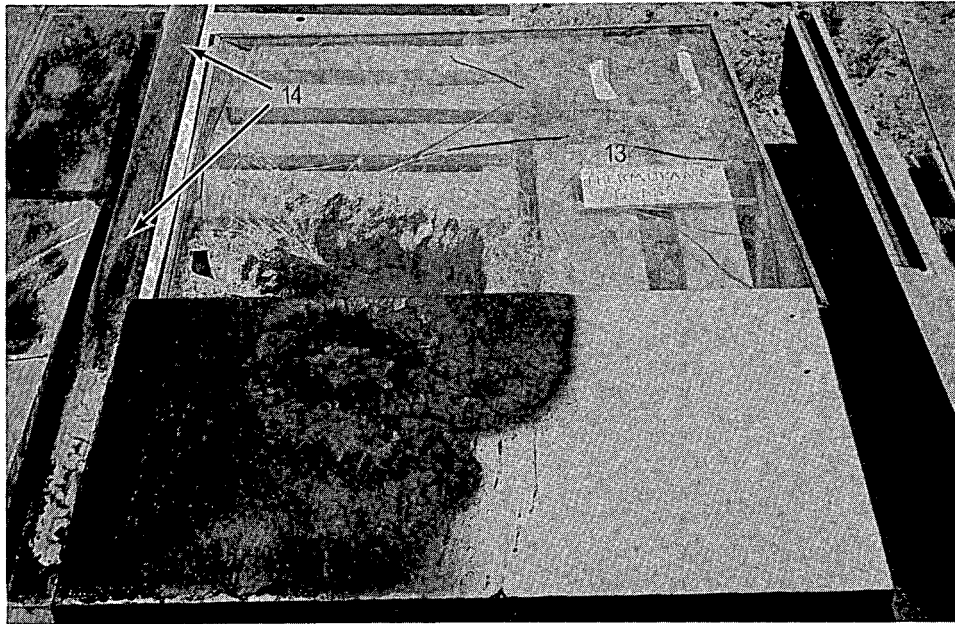
14.	Wedge-shaped piece for transition from vertical to sloped shielding. Painted with fire-retardant paint.	Figure 7 Panel 14	Only slight effect from fire was noted. See Figure 35.

Figure 35. Shielding Panels after Experiments No. 3. (See Table XV for added description of reference number.)

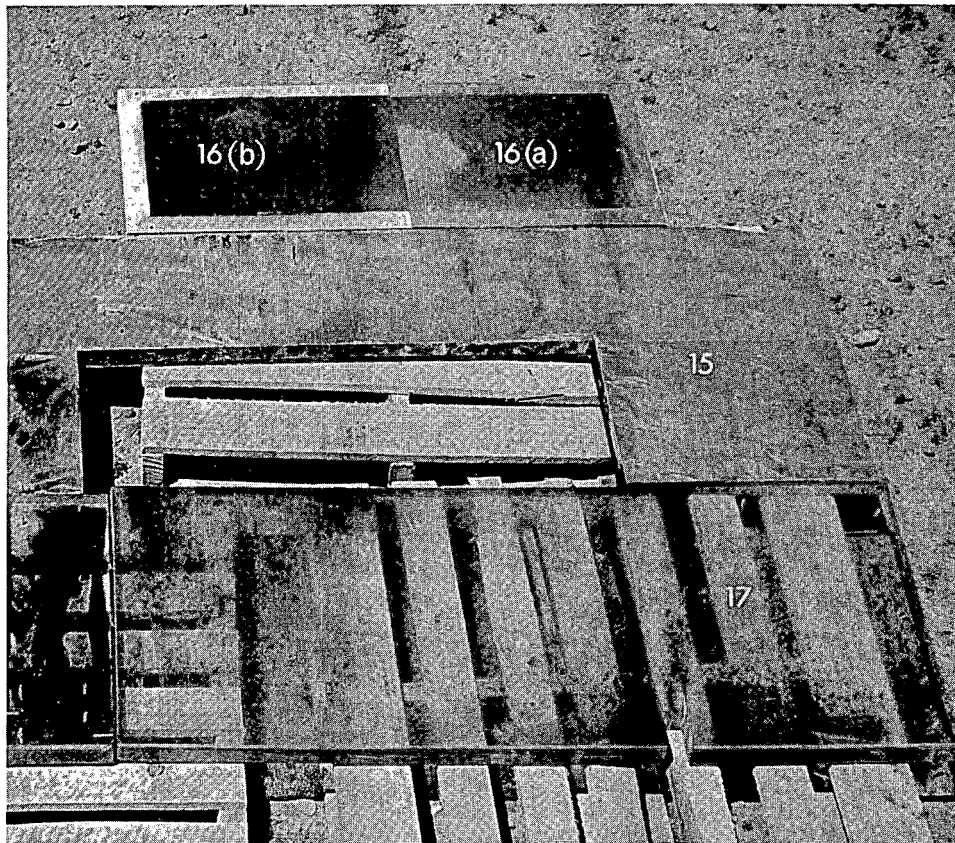
15.	Benelex panel (2 in.) painted with two coats of fire-retardant paint and then covered with aluminum foil.	Figure 7 Panel 15	No significant fire damage was noted. Aluminum foil was still intact. See Figure 36.

Figure 36. Shielding Panels after Experiment No. 3. (See Table XV for added description of reference numbers.)
