EVALUATION OF IRRADIATED
EXPERIMENTAL OMR FUEL ELEMENTS

J. H. WALTER
E. E. GARRETT
J. M. DAVIS

ATOMICS INTERNATIONAL

CONTRACT: AT(11-1)-GEN-8
ISSUED: APRIL 1, 1960

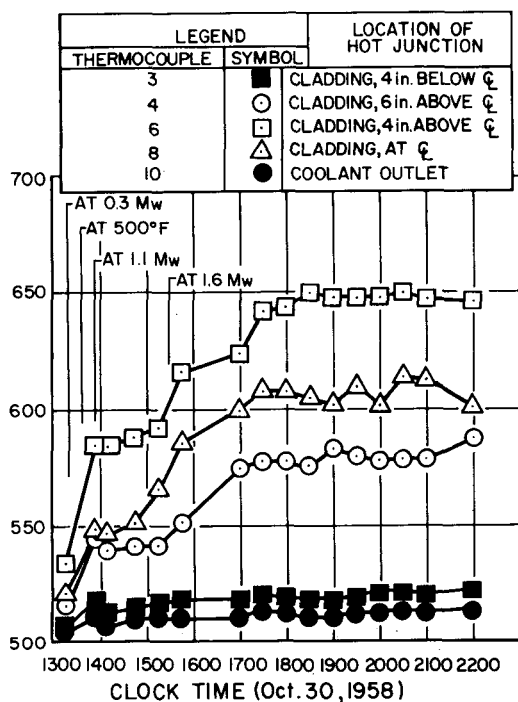
Figure 9. Temperatures in HB-1 After the Fission Product Release

indications from HB-1 were significantly higher than expected from previous experience. As operation continued, the temperatures continued to increase and showed pronounced fluctuations. Figure 9 shows the temperatures from HB-1 during the 6-hr run. The temperatures scattered more than is shown by the relatively few points plotted; for example, Thermocouple 8 increased from 615 to 645°F between 21:15 and 21:32, and then dropped down to 600°F within 1 min. During this run none of the temperatures in HT-1 exceeded 550°F. Based upon the above data, it was decided to remove HB-1 for hot cell examination.

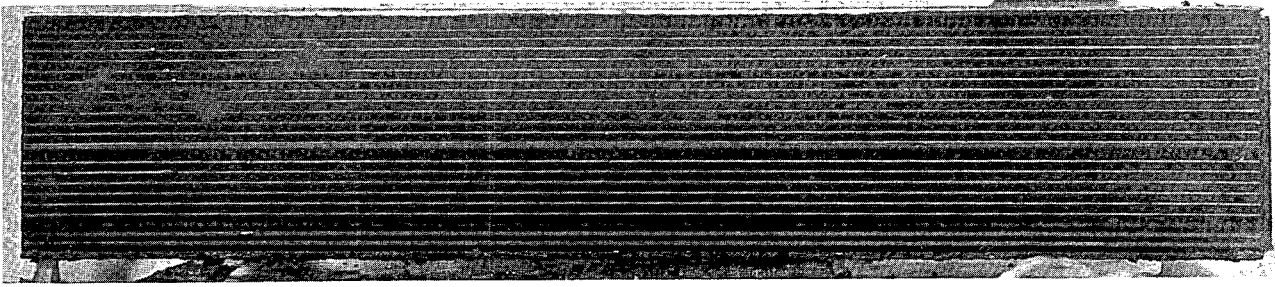
a. Plate 348-3 — Plate From Center Section of HT-1, Closest Plate to the Center of the Core

and was the second plate from the edge of the element closest to the center of the reactor core. The center plate from the center section evidenced some distortion of the cladding fins in the same location as the blister on adjacent Plate 347-1, but the area had not raised, as on Plate 347-1. The only other deformed areas noted were small blisters on the center plate from the lower fueled section. These blisters had been noted during fabrication, and appeared to be the same size as before irradiation. The deposits on the finned cladding surfaces were most pronounced on fuel plates from the lower and center sections. The five plates from the upper section were noticeably more free from deposits. The deposits on the finned surfaces were relatively soft and could be readily removed. Part of some of the deposits had a matted, fibrous appearance.

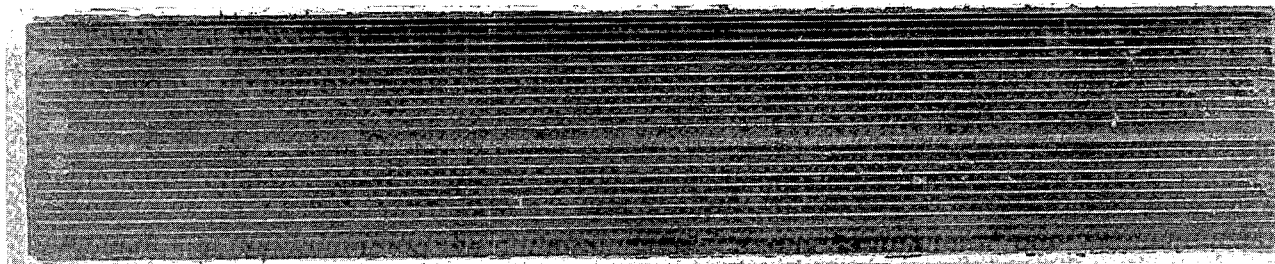
c. Plate 344-1 — Plate From Upper Section of HT-1

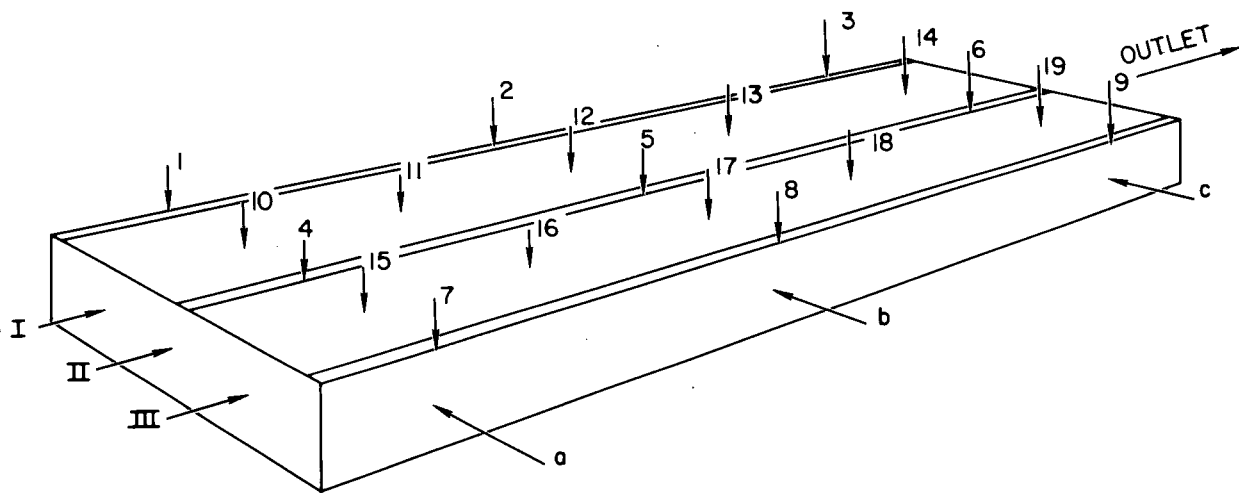
Figure 17. Location of Plate Measurements

to the spread in preirradiation measurements. The only significant changes were small increases in plate lengths for all three plates and increases in thickness on the blistered area of Plate 347-1.

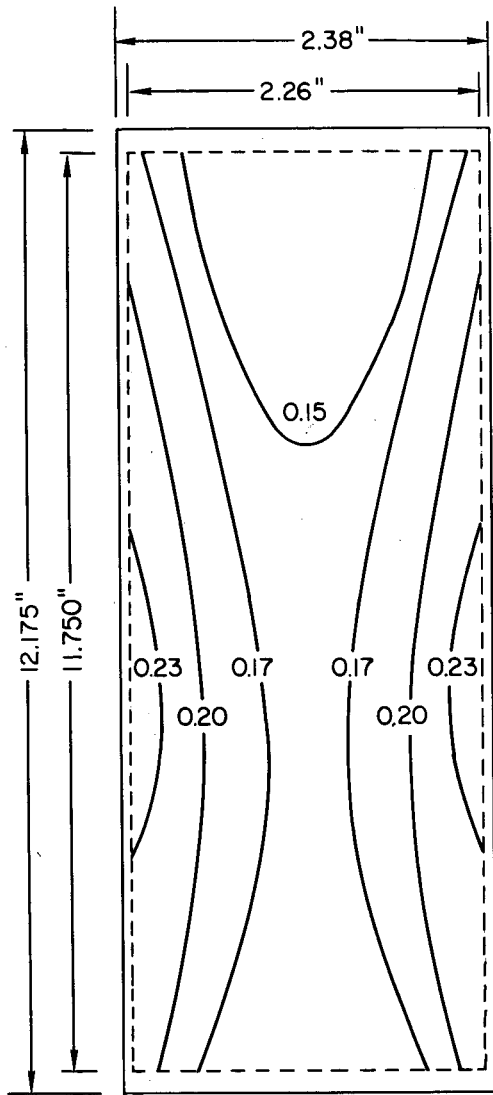
a. Plate 341-1, U - 3.5% Mo, from HB-1 - Plate Closest to Center of Reactor Core

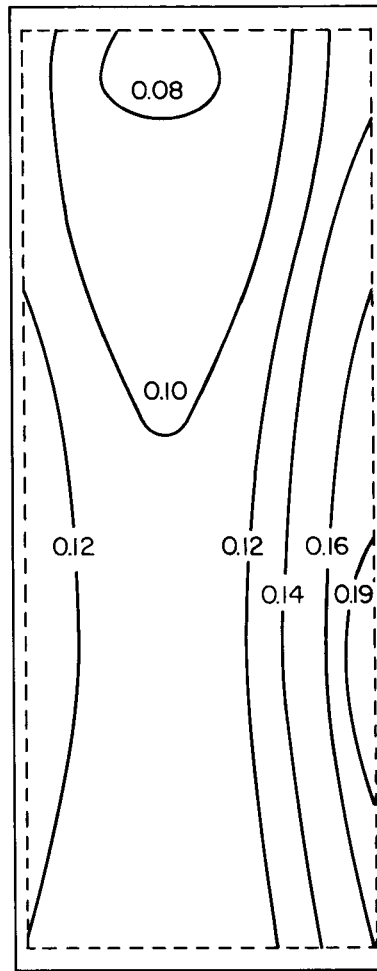
b. Plate 348-3, U - 3.5% Mo - 0.5% Si, from Center Section of HT-1 - Plate Closest to Center of Reactor Core

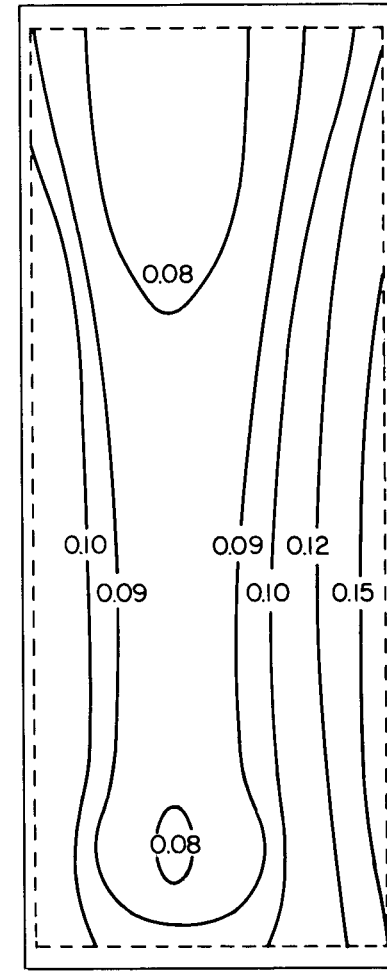
c. Plate 347-1, U - 3.5% Mo - 0.5% Si, from Center Section of HT-1 - Plate Adjacent to 348-3

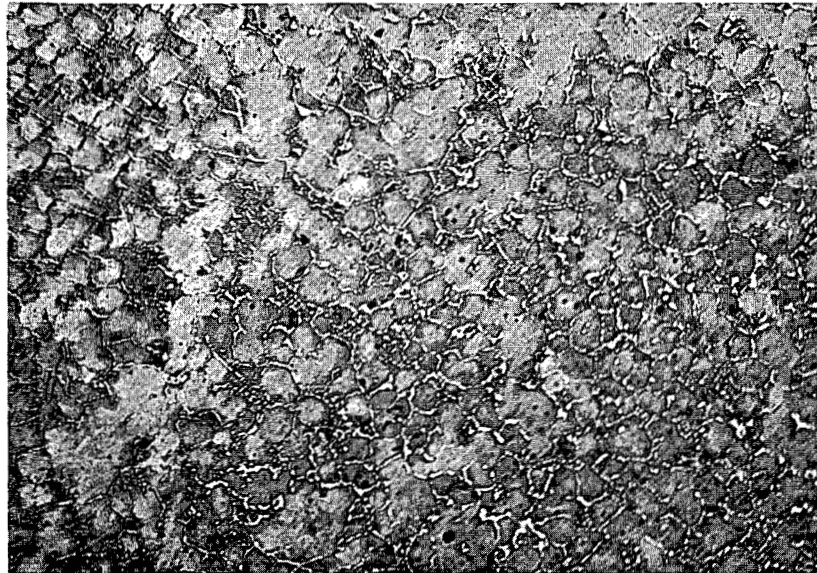
Figure 21 is a photomicrograph of the unblistered region. The bond between the core and cladding was intact, except for a small split at one edge, which probably occurred during sectioning. The microstructure of the bond area showed almost complete consumption of the nickel bond by the aluminum, to form brittle Al-Ni intermetallic compounds. Some diffusion of aluminum into the uranium core was evident. Figure 22 is a typical photomicrograph of an unirradiated "as-fabricated" bond. Figure 23 is a photomicrograph of a typical bond area from the unblistered specimen, with the probable components identified. Identification of the compounds was based on previous experience with Al-Ni-U diffusion bonds.⁸ The dark band due to relief polishing contained no cracks or voids. The microstructure of the core alloy in the unblistered section was very similar to the unirradiated structure, and is shown in Figure 24.

Electropolished 270X
 Figure 24. Microstructure of Fuel Core Alloy in Unblistered Area of Plate 347-1
