Spray Foam in Accessible Spaces: Best Practices and Case Studies for Retrofit in Mixed-Humid Climates

October 2011

**Prepared by
Jeffrey E. Christian
Kathy S. Gant**

Prepared by
OAK RIDGE NATIONAL LABORATORY
Oak Ridge, Tennessee 37831-6283
managed by
UT-BATTELLE, LLC
for the
U.S. DEPARTMENT OF ENERGY
under contract DE-AC05-00OR22725

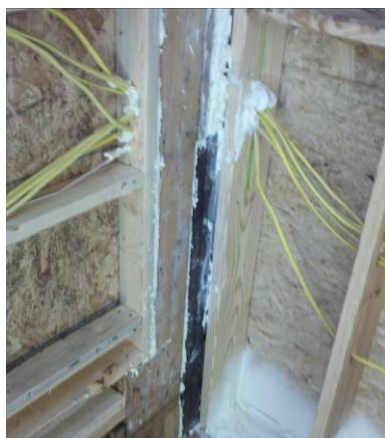
The balloon framing, combined with many penetrations (Fig. 37), allowed a lot of airflow, enough infiltration to have about the same effect as leaving a window open all the time.

Fig. 37. Spray foam used to seal band joist, openings in framing, and electrical penetrations.

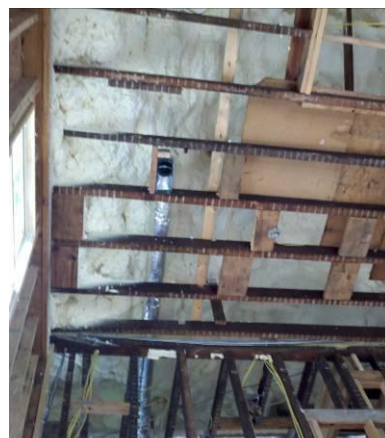
The most significant use of spray foam in this house was its application to the underside of the roof (Fig. 38). The biggest innovation here is that the house is designed with all closed soffits and rakes. The air barrier on the walls is the weather wrap fabric. This fabric is extended into the closed soffits and rakes, which were blown full of open-cell, low-density foam. The confirmed thickness of the

Fig. 38. Spray foam applied to underside of roof.

foam in the roof produced a thermal resistance of R-38. These measures sealed and insulated the top of the attic and enclosed the upstairs ductwork within the conditioned envelope.

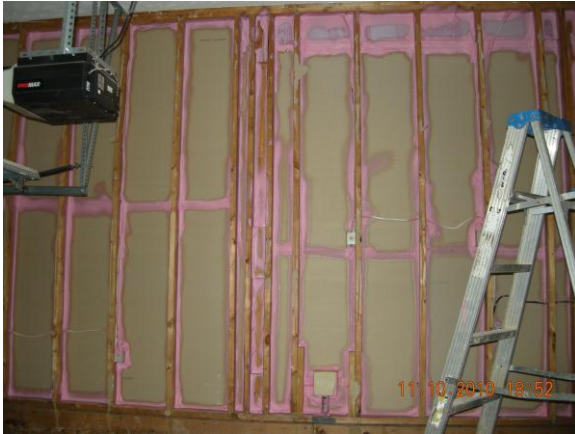
Figures 42 and 43 show the EnergyComplete™ system applied to the floor of the attic and the wall between the conditioned space and the unconditioned garage. The installation was confirmed by the blower door tests to have been very successful in these two applications. A different crew returned and tried to seal the accessible spaces in the walkout basement with the same product. However, that crew was apparently not trained on the how to properly install the EnergyComplete™ system. Some valuable lessons learned from this application are summarized below:

Fig. 42. Owens Corning EnergyComplete™ is used to improve the air barrier between the garage and the conditioned space.

1. Larger cracks need to be identified, and properly sized backer rod (a flexible foam rope of varying diameter that fits snugly into cracks wider than 1/4 in.) or equivalent needs to be installed to provide foam backing.

2. The oval spray pattern needs to always be applied with the longer axis of the oval perpendicular to the crack, even in corners.
3. The homeowner removed all old attic insulation and even vacuumed the attic. The manufacturer states that vacuuming is not necessary, since the air pressure of the foam nozzle will push the loose particles away prior to the foam hitting the substrate.

5. Obviously all non-insulation-contact-rated canned down lights should be replaced, but if not, follow proper insulation damming practices of providing at least 3 inches clearance on all sides and check local codes for how much area needs to be isolated above the non-insulation-contact-rated cans. In some jurisdictions the can must remain open to the attic space. The insulation-contact-rated cans are much better because they have an on-board temperature sensor that shuts off the light when the temperature of the light fixture gets too high, avoiding the ignition of surrounding combustible materials.

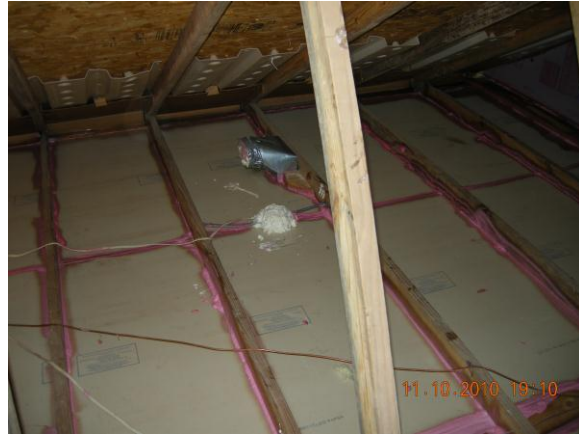
Fig. 43. Sealed and reinsulated attic. (The fiberglass batts were removed and used in the crawl space under the office. The attic was vacuumed, the electric outlets were foamed with GREAT STUFF™, and the remaining cracks sealed with the pink EnergyComplete™ latex foam.) Then new insulation was blown in to create an R-value of 60.

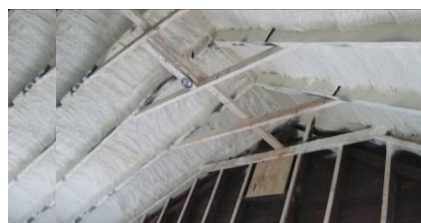
ceiling in the study on the right side of the house, shown in Figure 45. Ridge and soffit vents were stuffed with fiberglass batts and sealed over with closed-cell foam. One inch of closed-cell foam was sprayed on the underside of the roof and then topped with 8 in. of open-cell foam (Fig. 46). Low-rise foam was used to seal around windows and doors (Fig. 47). The typical minimum thickness of closed-cell foam always applied first by the manufacturer selected by the homeowner for this job is 1 in., so that is what was used on this deep retrofit as well.

Fig. 46. SPF shortly after application to underside of roof.

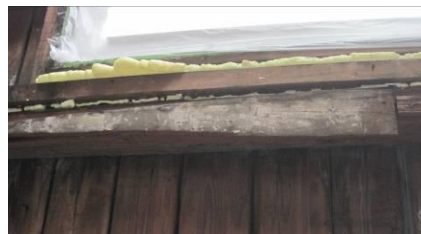
Fig. 47. Low-expansion foam around window.

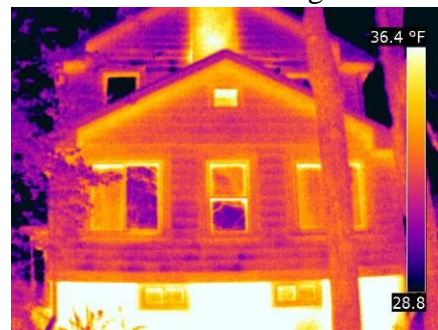
Figure 49 shows the west side of the house. The area around the gable vent in the sun room is particularly bright. Figure 50 shows a close-up of the area, which is warmer than the surrounding air. The sunroom is a converted porch, which once had an attic over it. The ceiling had been converted to a cathedral ceiling, with the insulation sprayed on the inside of the roof, and the gable vent had been covered with ½ in. plywood and foamed.

Fig. 49. Infrared image of west end of Gaiter house.

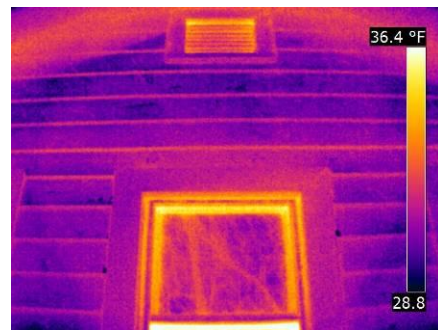
Fig. 50. Gable vent in sunroom area of the west façade.

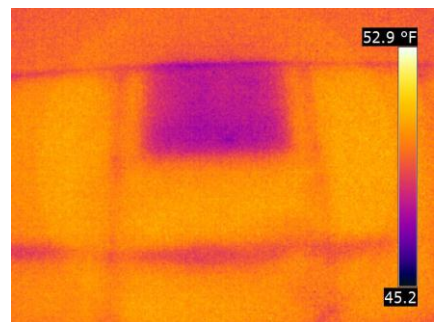
Images taken of the same area from the inside show the vent area as cooler (Fig. 51). In Fig. 52, the house was partially evacuated using the blower door set at 40 Pa. Colder air would be drawn into the house through any openings, and the purplish area is deepening and increasing in size. Notice the bulging dark area in Fig. 52, indicating that the colder air is leaking into the home from the poorly sealed gable vent.

Fig. 51. Gable vent from inside sunroom.

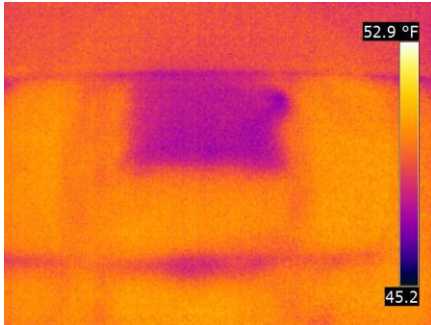
Fig. 52. Cooler air being drawn in through vent area by blower door.

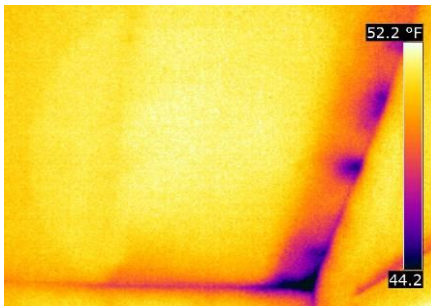
Fig. 54. Ceiling at roof line of sun room without blower door.

Figures 54 and 55 show the ceiling of the sun room at the northwest corner. There are some cooler spots along the junction in Fig. 55, and these areas expand with characteristic wispy finger-like features indicating air intrusions when the blower door is used to lower the air pressure inside the house.

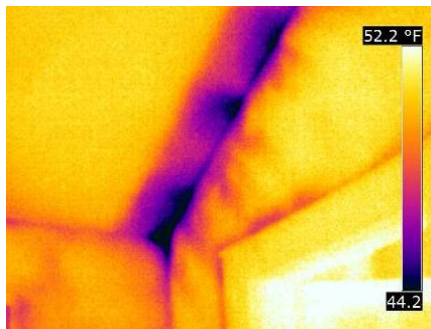
Fig. 55. Ceiling at roof line of sun room with blower door at 40 Pa.

It would be good to have the blower door and IR on site toward the end of the foam application and to agree in advance on a depth-sampling method that will be used to meet the depth specification. The IR camera identified a few spots where the insulation needed to be redone, locations that would not have been found by visual inspection. (Note that the IR camera is not very useful unless there is a large difference between the inside and outside temperatures.) Call-backs are costly because the spray rig needs to be hauled back to the site and the heated hoses dragged back into the house, all for what is generally not much added spraying.

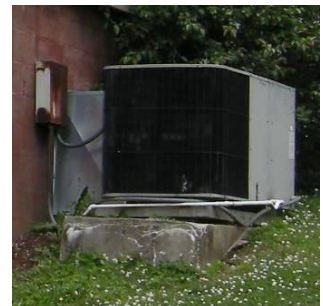
Fig. 61. Older, inefficient HVAC unit.

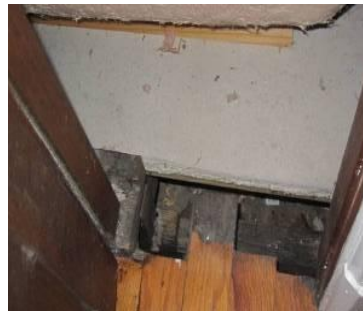
The first step was to reduce the infiltration rate. The whole-house fan (Fig. 65) creates a sizable hole between the conditioned living space and the unconditioned attic. There is also a gap around the chimney that is open to the living area. The soot and dirt on the flooring shows a lot of air movement in the walls and outside of the ductwork (Fig. 66). Some of the recommendations included sealing the electrical and plumbing penetrations, sealing the laundry chute, and removing the fan. The laundry chute is a classic attic by-pass. One can look up and see the roof sheathing and look down into the basement laundry room. SPF could be applied under the roof deck to incorporate the attic into the conditioned space.

Fig. 66. Soiled flooring from air movement in wall.

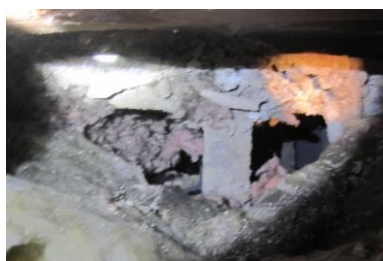
Fig. 69. Opening to interior walls in attic.

After sealing the electrical and plumbing penetrations and the leaks, the auditors suggested sealing and insulating the crawl space to R-15. The attic is another accessible area in which spray foam could be used for sealing and insulation. A target R-value of 50 would be appropriate for the attic floor.
