# Final Report on PCRV Thermal Cylinder Axial Tendon Failures

FINAL REPORT ON PCRV THERMAL CYLINDER  
AXIAL TENDON FAILURES

D. A. Canonico, J. C. Griess, and G. C. Robinson

JANUARY 1976

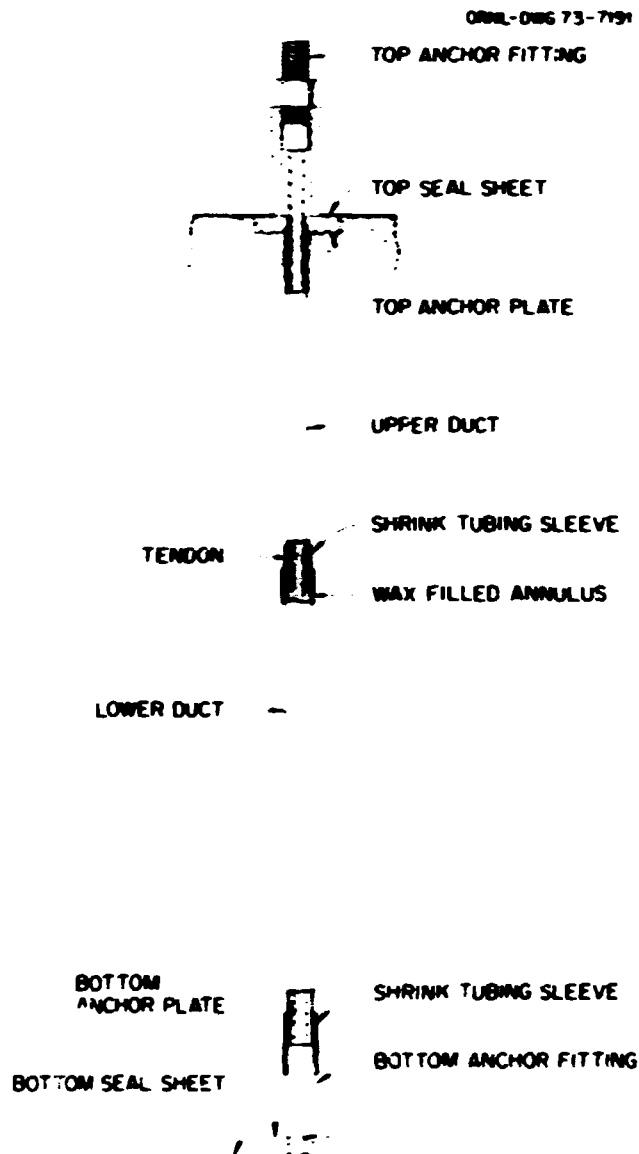
Figure 1 is a sketch of the axial tendon assemblies. The tendons were enclosed within the duct as shown. The wires (ASTM A 424) were coated with NO-OX-ID "A" by the manufacturer of the tendons,<sup>2</sup> and the ducts were filled with Mobilwax 2300-T5L6 during the assembly of the thermal cylinder experiment. Tendon failures occurred randomly during the lifetime of the experiment, as shown by the load-time curves obtained with instrumented tendons (see Figs. 9 thru 16 of Ref. 2). An example of a typical fracture is shown in Fig. 2. All the wire failures contained a flat semi-elliptical initiation site and a ductile cup-cone fracture when the net area of the wire was not able to withstand the stressing load. (The initiation site in the wire shown in Fig. 2 contained sulfur, but this was not necessarily true of all of the failures.) The wax in the ducts of the disassembled thermal cylinder test was chemically analyzed, and the results are given in Table 1. For comparison, the as-received NO-OX-ID "A" Special and Mobilwax 2300-T5L6 are included. It is evident that the wax in the tendon ducts contained large quantities of nitrogen. Although the chemical form of nitrogen was not determined,

Fig. 1. Axial Tendon Subassembly.

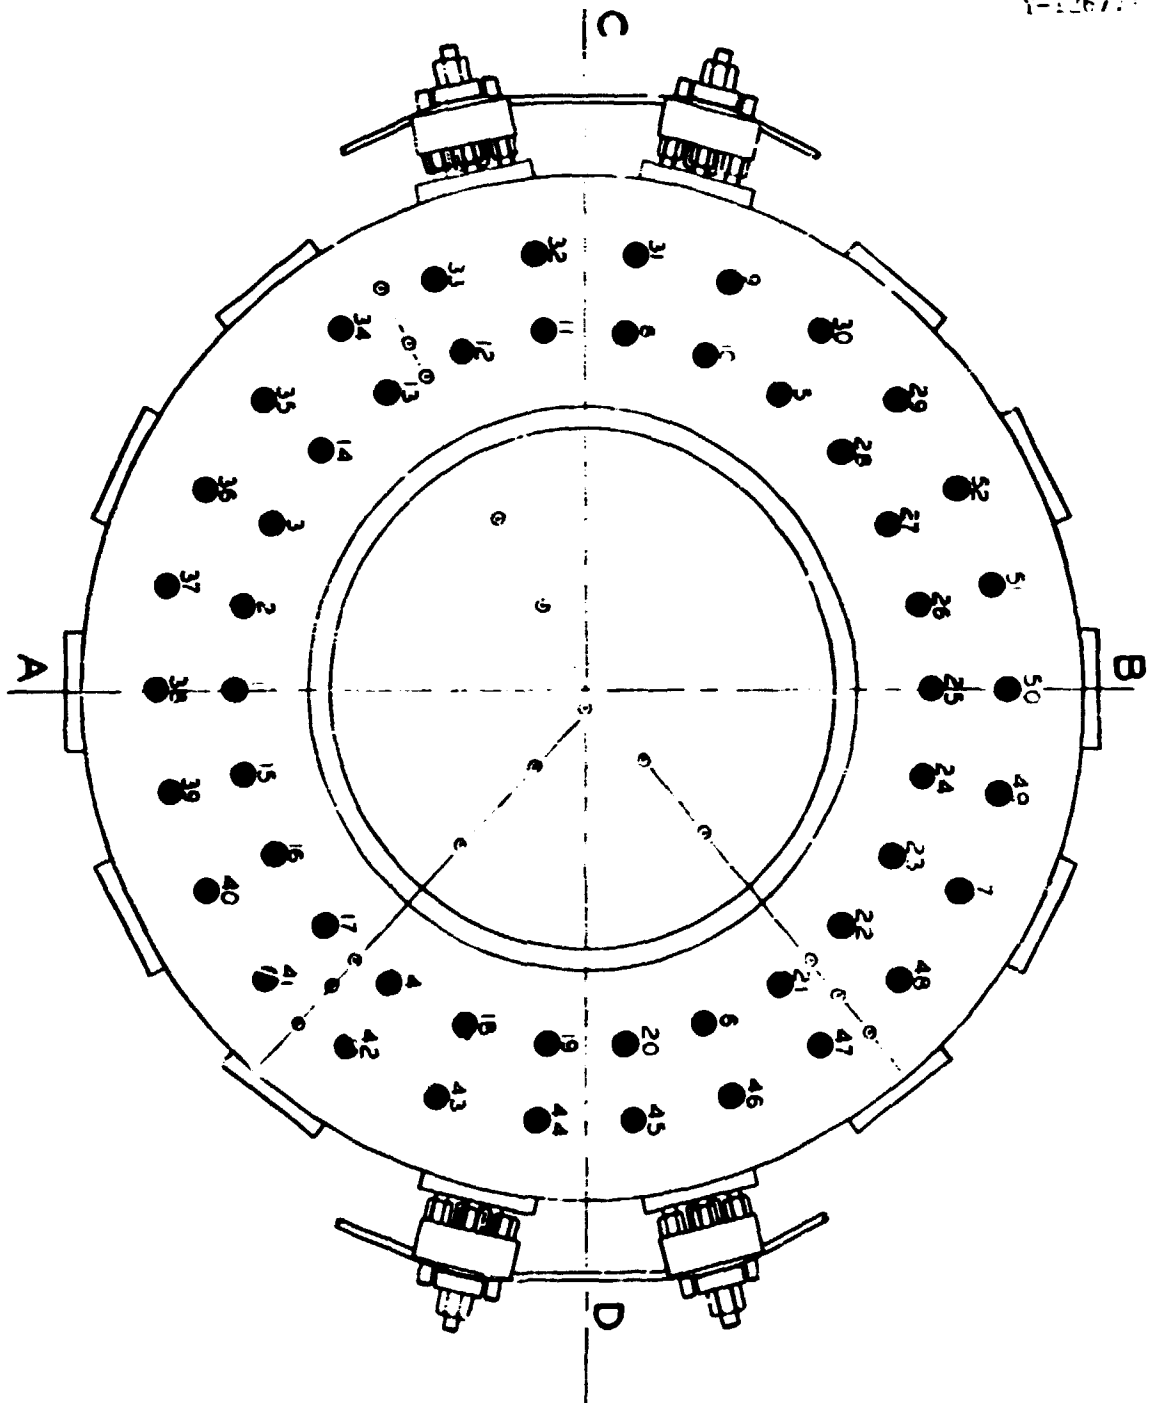
As previously noted, the observed failures were associated with the inner row of tendons. This implies either a preferential location for the corrodent(s) or a sensitivity to the slight difference in temperature experienced by the outer and inner row of tendons [ $52$  vs  $38^\circ\text{C}$  ( $125$  vs  $100^\circ\text{F}$ )]. A test was prepared to examine sensitivity to temperature. We assumed that the corrodent(s) was still present in the ducts and that a reversal in the radial temperature gradient would, in time, result in a failure of an outer-row tendon. On these premises, two pie-shaped segments were removed from the PCRV thermal cylinder test, one including tendons 15 and 39, the other tendons 20 and 45 (see Fig. 5).

Fig. 5. Location of Tendon Assemblies in the Prestressed Concrete Reactor Vessel Thermal Cylinder Test.
