**Ultrasonic Examination of
Double-Shell Tank 241-AN-101
Examination Completed November 2005**

AF Pardini
GJ Posakony

November 2005

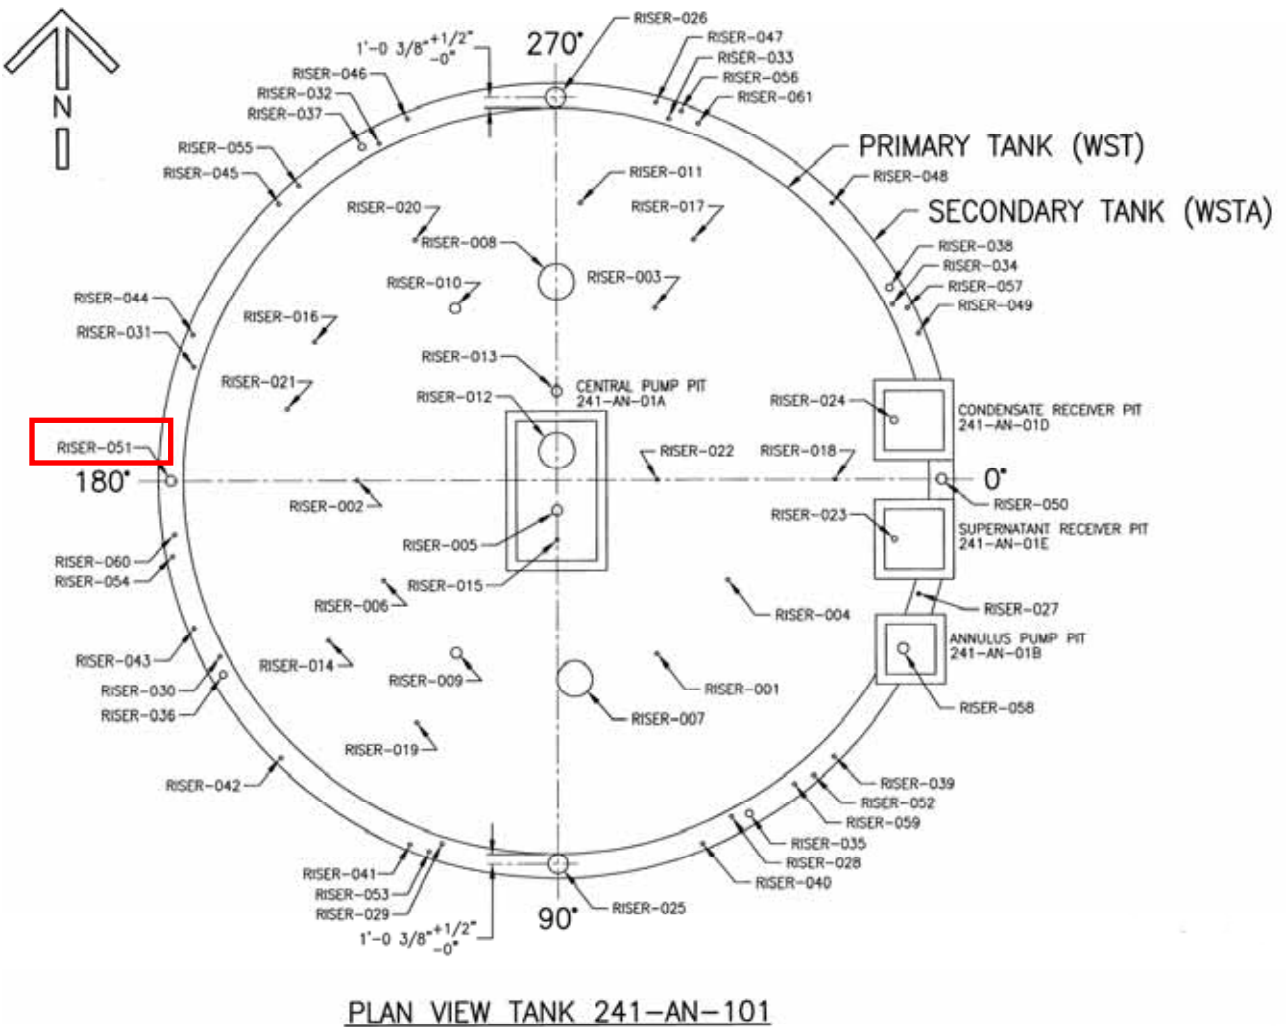
Figure 4.1. UT of 241-AN-101 Riser 51

Tank 241-AN-101 is located in the Hanford 200 East area in AN Tank Farm. The crawler and associated scanner were lowered into the 12-in. riser located on the west side of 241-AN-101 and designated as Riser 51. Figure 4.1 provides a graphic of the location of this riser.
