**Pacific Northwest
National Laboratory**

**Ultrasonic Examination of Double-Shell
Tank 241-AN-103
Examination Completed October 2005**

AF Pardini
GJ Posakony

January 2006

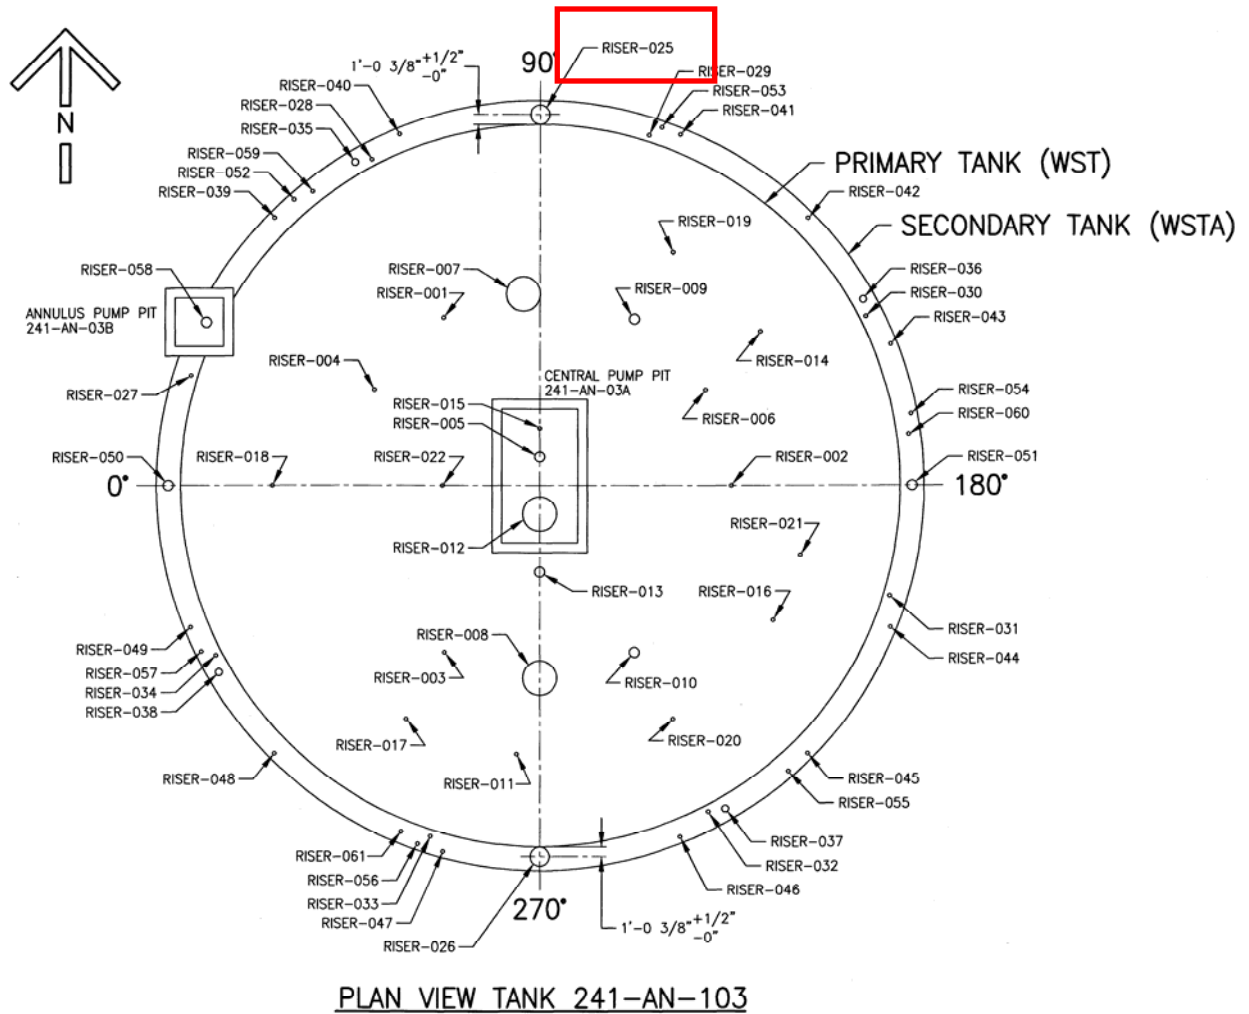
Figure 4.1. UT of Tank 241-AN-103 from Riser 25

Tank 241-AN-103 is located in the Hanford 200 East area in AN Tank Farm. The crawler and associated scanner that hold the transducers were lowered into the 24-in. riser located on the north side of 241-AN-103 and designated as Riser 25. Figure 4.1 provides a graphic of the location of this riser.
