## Pacific Northwest National Laboratory

# Ultrasonic Examination of Double-Shell Tank 241-AY-101 Examination Completed March 2007

AF Pardini  
DR Weier

June 2007

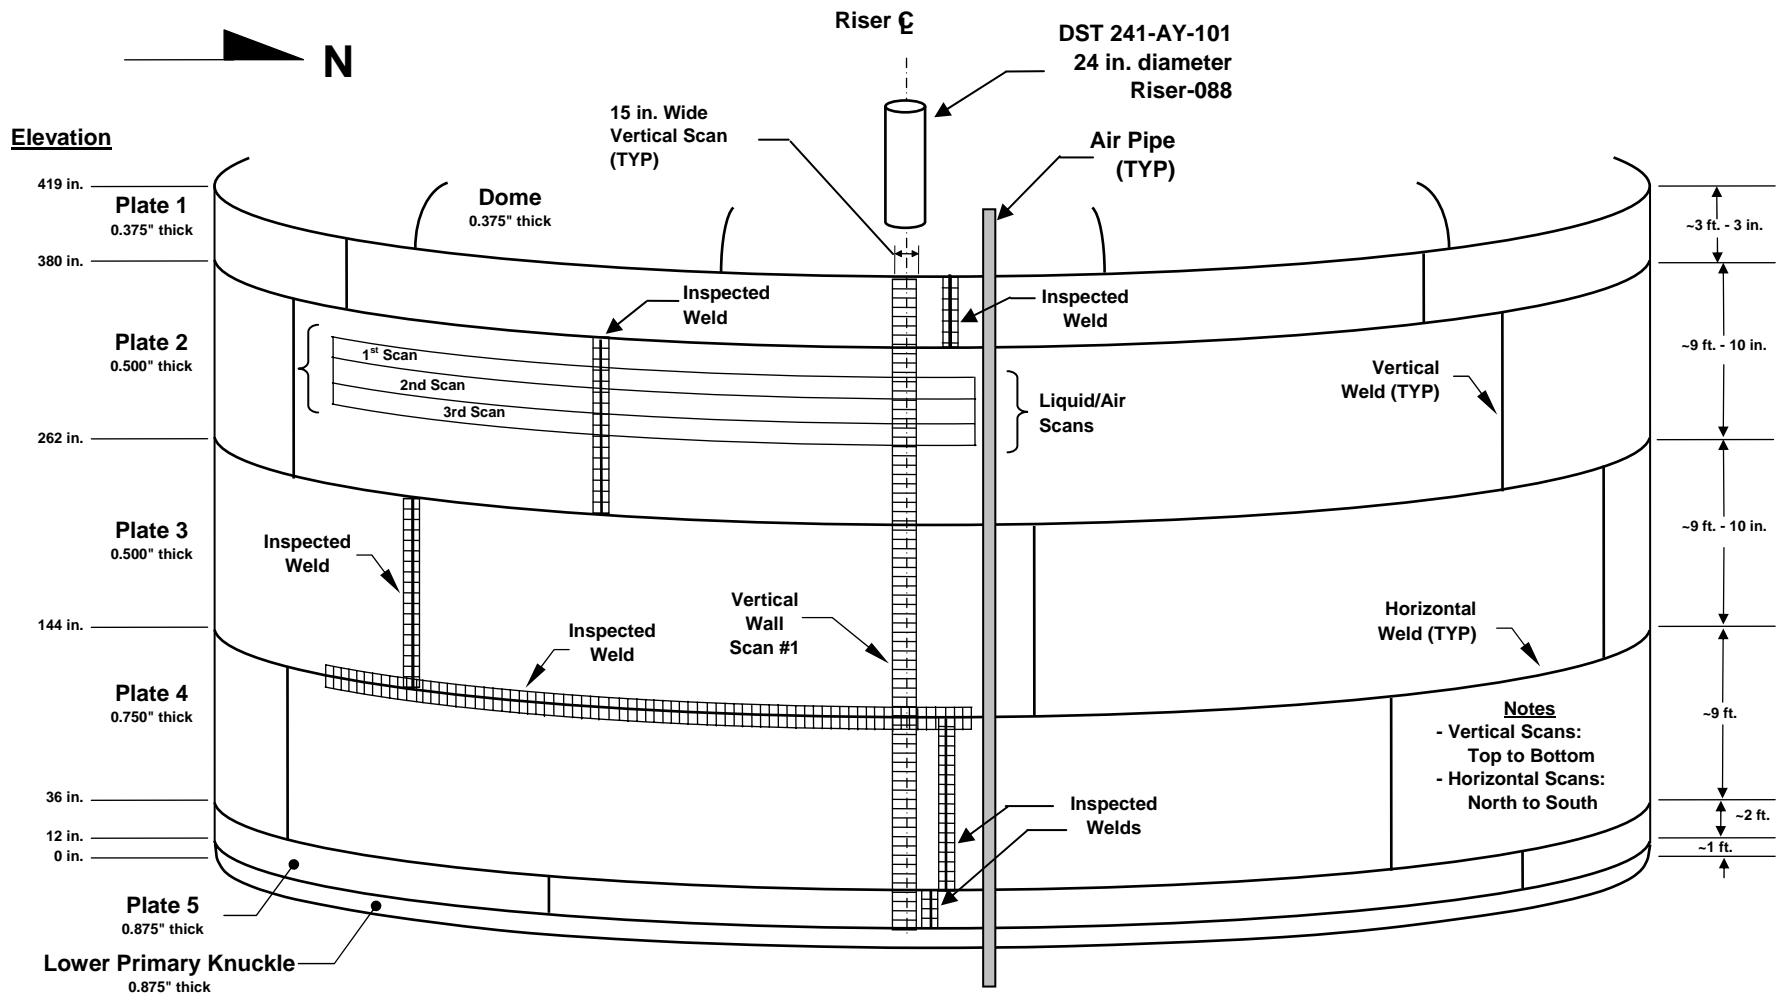
**Figure 4.2.** Sketch of Scan Paths on 241-AY-101 Primary Tank from Riser 88

Figure 4.2 describes the areas on the primary wall of Tank 241-AY-101 that were ultrasonically examined from Riser 88 located on the east side of the tank. One 15-in.-wide vertical scan path was performed on Plates #1, #2, #3, #4, and #5 below the entrance to Riser 88. Vertical weld HAZ examinations were done on Plates #1, #2, #3, #4, and #5, and the horizontal weld HAZ examination was done between Plate #3 and Plate #4. Additionally three 15-in.-wide horizontal scans were performed in the liquid-air interface (LA) region on Plate #2.

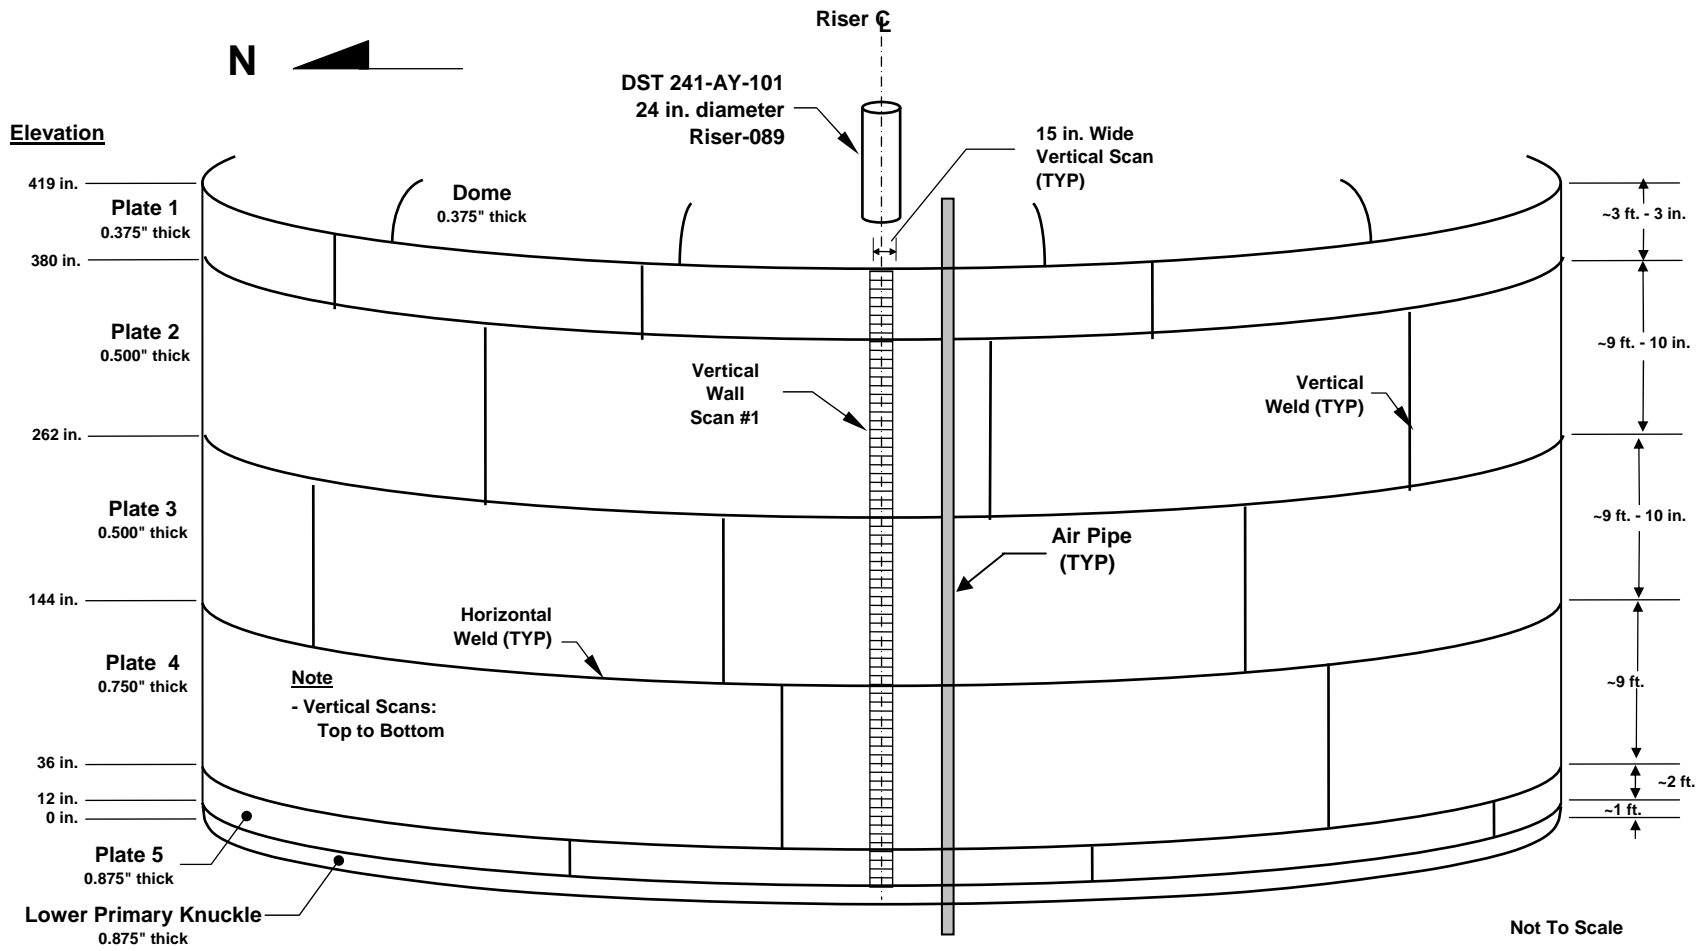
**Figure 4.3.** Sketch of Scan Paths on Tank 241-AY-101 Primary Tank from Riser 89

Figure 4.3 describes the areas on the primary wall of Tank 241-AY-101 that were ultrasonically examined from Riser 89 located on the west side of the tank. One 15-in.-wide vertical scan path was performed on Plates #1, #2, #3, #4, and #5 below the entrance to Riser 89.
