# Ultrasonic Examination of Double-Shell Tank 241-AY-102 Examination Completed January 2007

AF Pardini  
DR Weier

May 2007

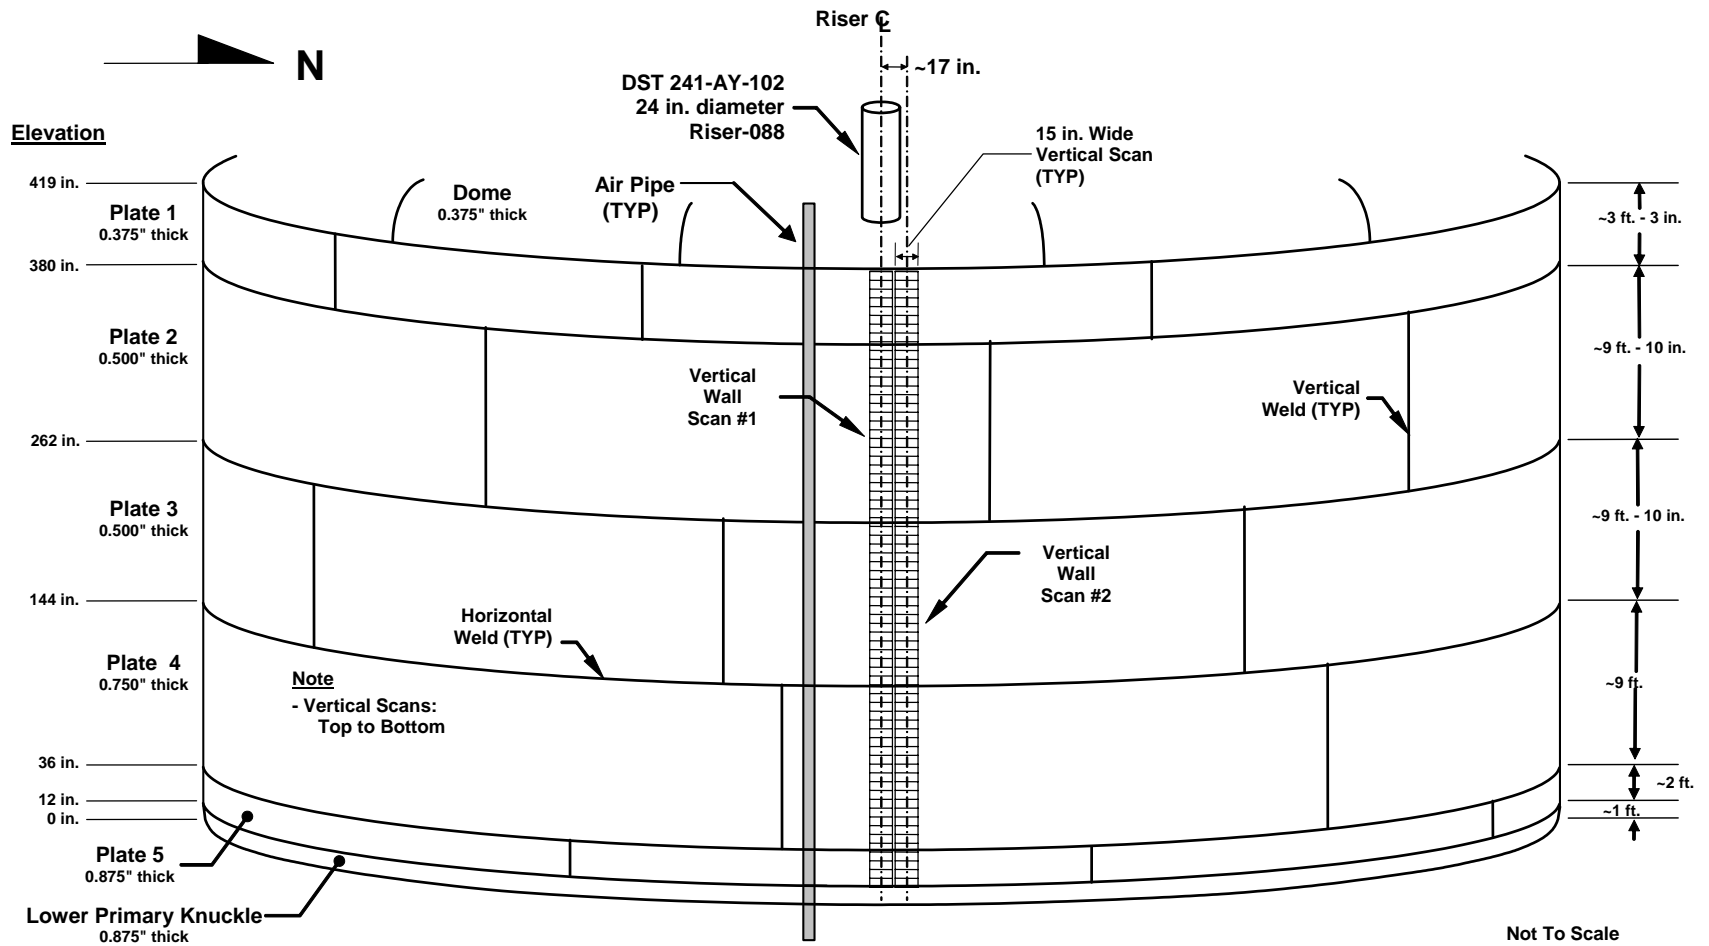
**Figure 4.2.** Sketch of Scan Paths on 241-AY-102 Primary Tank from Riser 88

Figure 4.2 describes the areas on the primary wall of Tank 241-AY-102 that were ultrasonically examined from Riser 88 located on the east side of the tank. Two 15-in.-wide vertical scan paths were performed on Plates #1, #2, #3, #4, and #5 below the entrance to Riser 88.

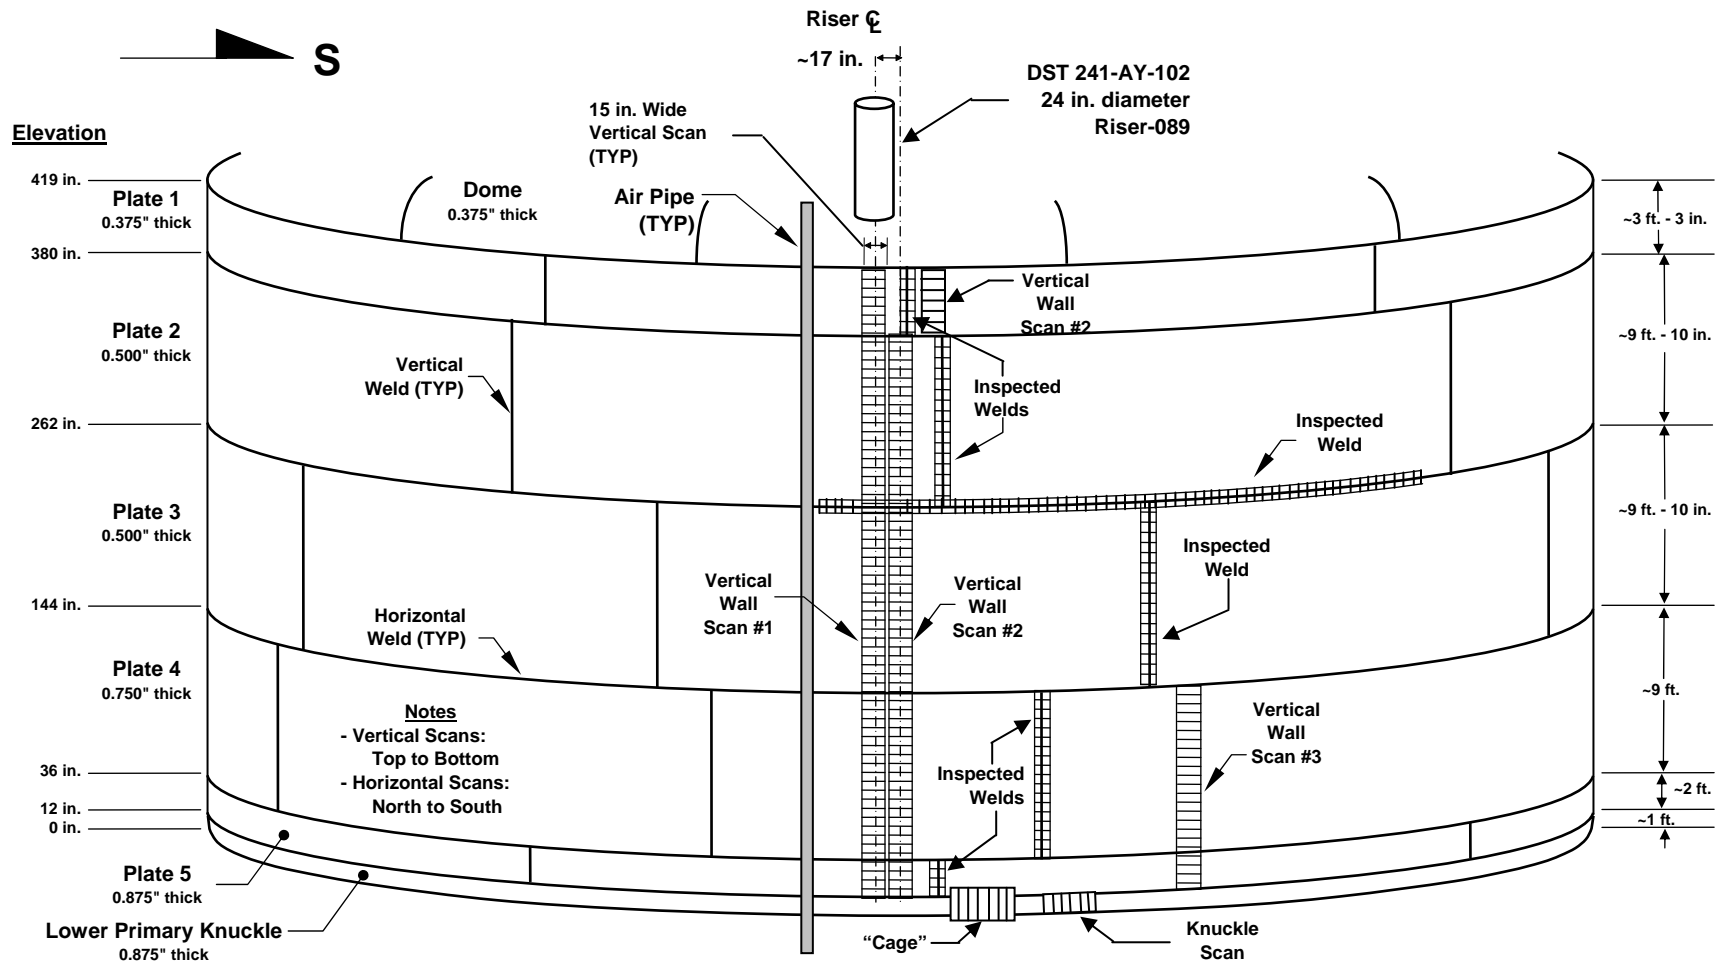
Figure 4.3. Sketch of Scan Paths on Tank 241-AY-102 Primary Tank from Riser 89

- Plate #4 results indicate five areas that exceed the minimum thinning reportable level of 10% of the nominal thickness. However, two of these areas (with remaining ligament of 0.666-in., and 0.670-in.) were analyzed by the UT Level III and were considered pit-like and therefore do not exceed the reportable pitting level of 25% of the nominal thickness. Three of the five areas were evaluated by the UT Level III and were considered wall thinning with minimum thicknesses of 0.648-in., 0.670-in., and 0.672-in. and do exceed the reportable level of 10% of the nominal thickness. No vertical crack-like indications were detected in Plate #4.

- Plate #5 results indicate two areas that exceed the minimum thinning reportable level of 10% of the nominal thickness. However, one of these areas (with remaining ligament of 0.759-in.) was analyzed by the UT Level III and was considered pit-like and therefore does not exceed the reportable pitting level of 25% of the nominal thickness. One of the two areas was evaluated by the UT Level III and was considered wall thinning with minimum thicknesses of 0.775-in., and does exceed the reportable level of 10% of the nominal thickness. No vertical crack-like indications were detected in Plate #5.

Plate 4 results indicate one area with a minimum thickness of 0.656-in. that exceeded the minimum thinning reportable level of 10% of the nominal thickness. No pitting or crack-like indications were detected in the weld areas in Plate #4

The HAZ of the horizontal weld between Plate #2 and Plate #3 from Riser 89 was examined for wall thinning, pitting and cracks oriented either perpendicular or parallel to the weld. There were no areas of wall thinning that exceeded the reportable level of 10% of the nominal thickness. No pitting or crack-like indications were detected in the weld HAZ areas on Plate #2 side or on Plate #3 side of the horizontal weld.

The upper portion of the knuckle area of the primary tank was scanned utilizing the Y-arm scanner attached to the AWS-5D crawler. The Y-arm scans the transducer down around the knuckle approximately 9-in. from a starting position 2-in. below the upper knuckle weld joining Plate #5 to the knuckle. The knuckle was examined for wall thinning, pitting, and cracks oriented circumferentially around the primary tank. There were no areas that exceeded the reportable level of 10% of the nominal thickness. No pitting or circumferentially oriented crack-like indications were detected in the upper portion of the knuckle area.

Figure 4.3 describes the areas on the primary wall of Tank 241-AY-102 that were ultrasonically examined from Riser 89 located on the west side of the tank. Two 15-in.-wide vertical scan paths were performed on Plates #1, #2, #3, #4, and #5 below the entrance to Riser 89 an additional short scan on Plates #4 and #5 was performed just south of these two. Vertical weld HAZ examinations were done on Plates #1, #2, #3, #4, and #5, and the horizontal weld HAZ examination was done on the Plate #2 to Plate #3 weld. A short section of the knuckle was also scanned from Riser 89.
