ORNL/TM-2005/34

Field Testing of Energy-Efficient Flood-Damage- Resistant Residential Envelope Systems Summary Report

June 2004

Buildings Technology Center, Residential Buildings Group

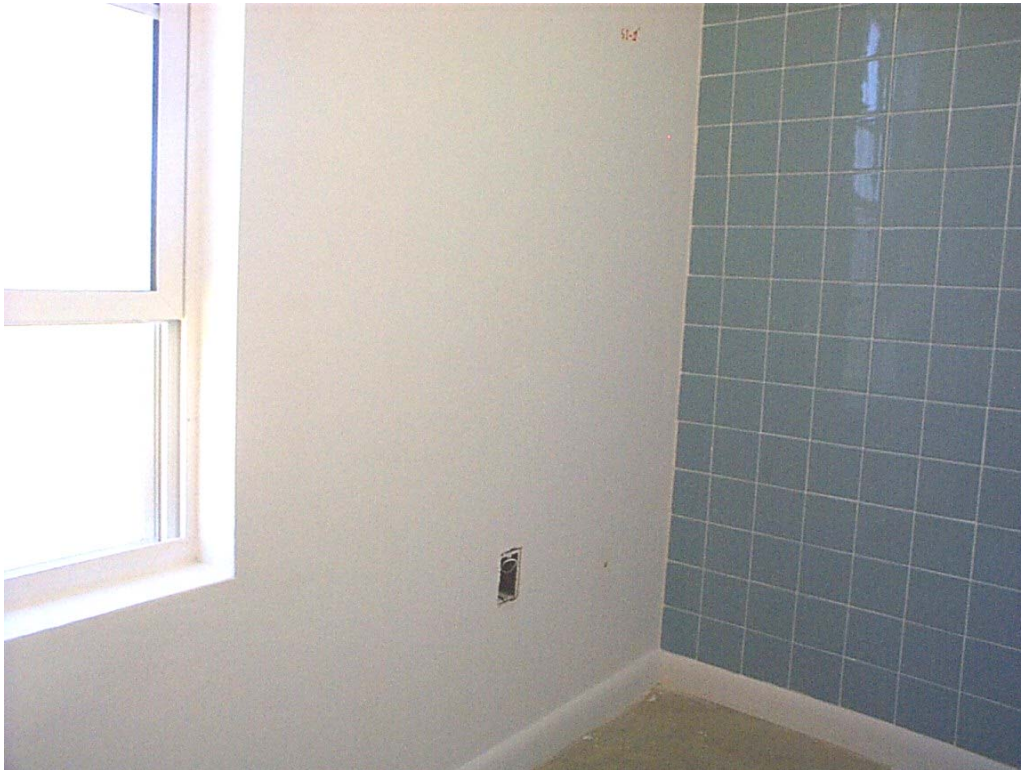
Figure 4-4 Module S-1 (Walls 1 & 2) Pre-flood. Walls, window, floor are in new condition.

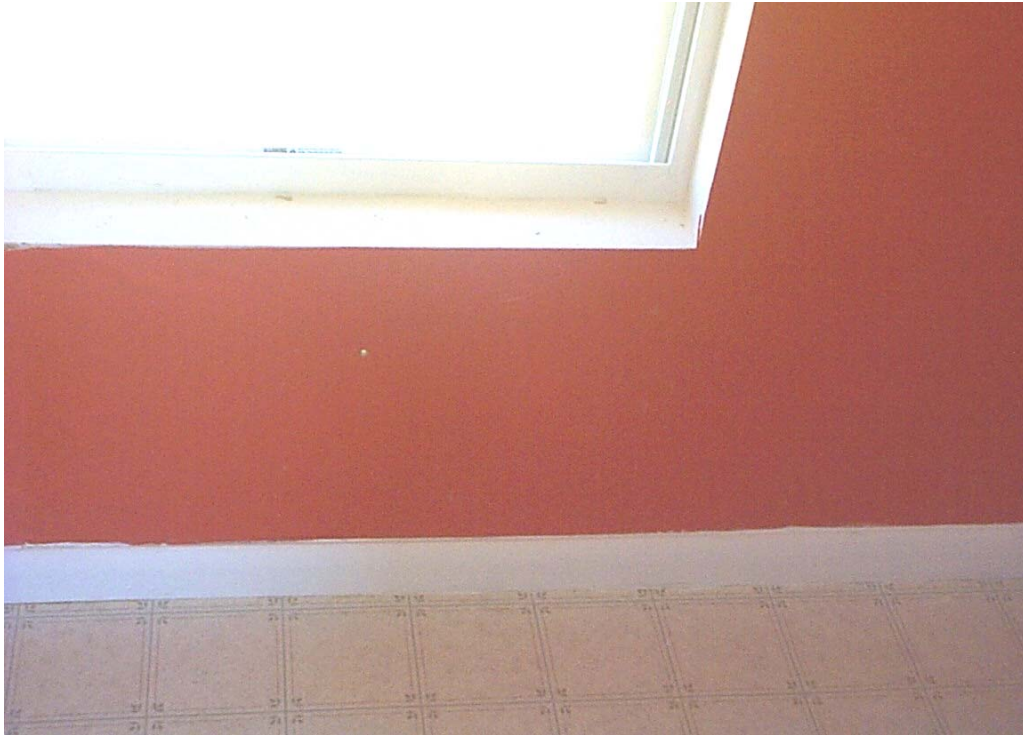
Figure 4-9 Module C-1 (Wall 1) Pre-flood. Vinyl wall covering, vinyl floor cover, and window are in new condition.

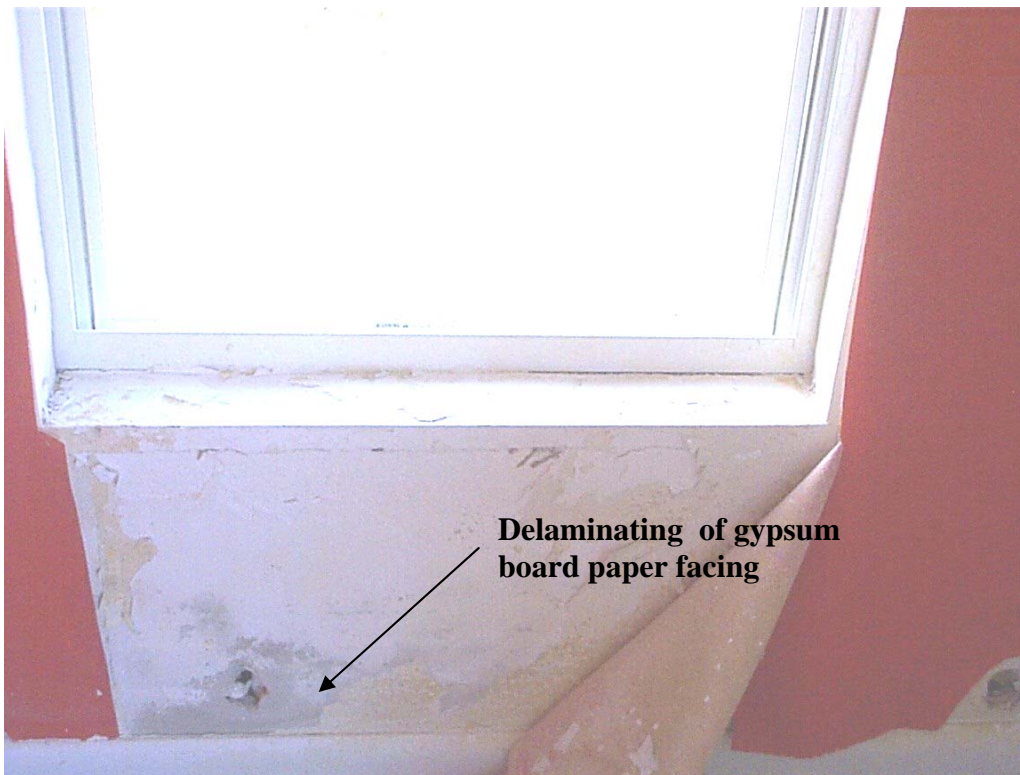
In the Module C-1 no mold growth was observed. The vinyl applied to Wall 1 suffered the most damage in the area under the window, where it was almost completely immersed during flooding. Wall 4 also exhibited a considerable amount of damage. The interior plastic door showed stains and paint deterioration on the Day 20 at the two lower corners of the door facing Room C-102. No further changes were observed during the remainder of the drying period.

Figure 4-11 Module C-1 (Wall 1) Post-flood, Day 15. No change from Day 8.

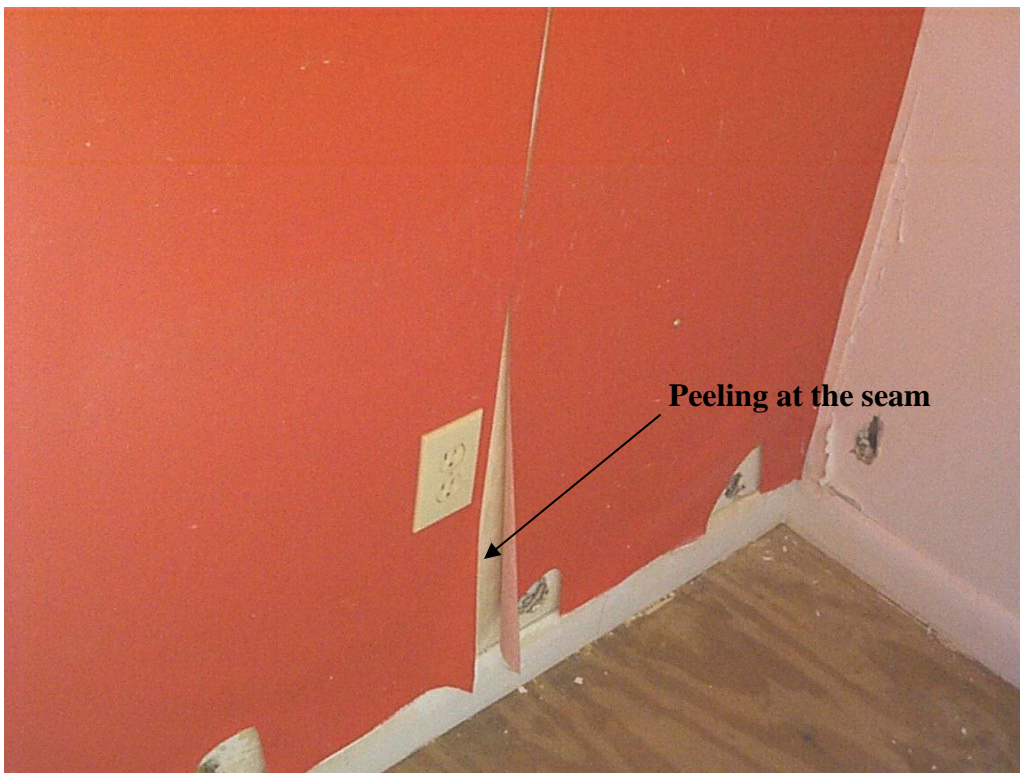
Figure 4-12 Module C-1 (Wall 1) Post-flood, Day 29. Vinyl wall covering is peeling at seams.

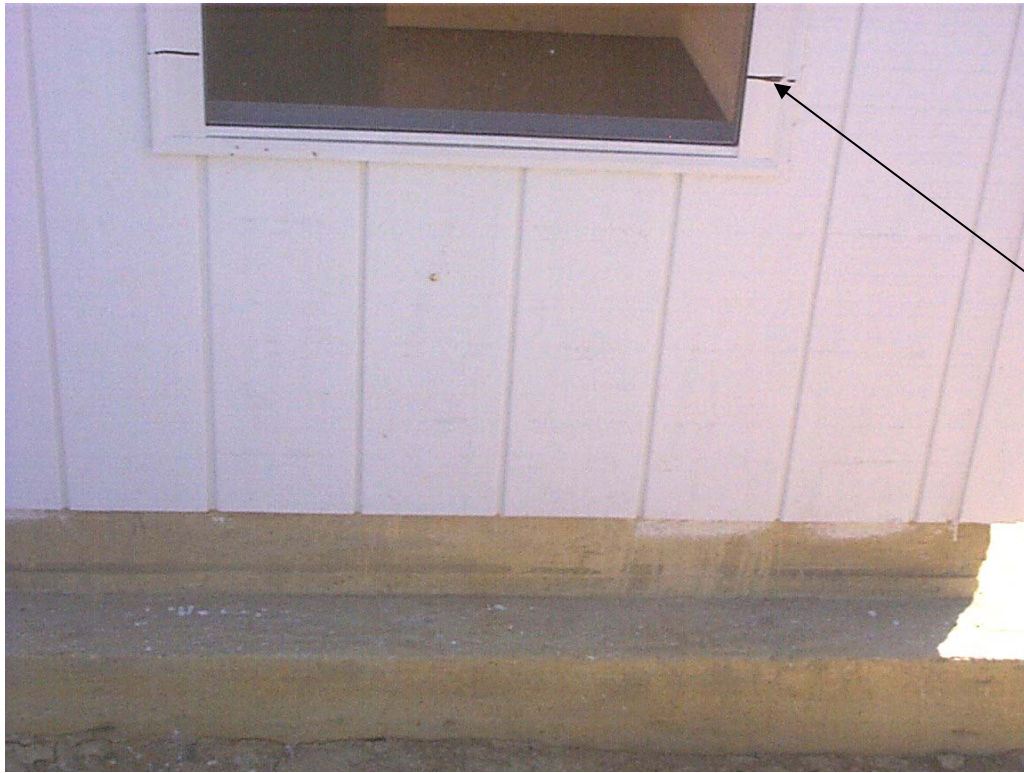
Figure 4-13 Module S-1 (Wall 1, North Exterior Wall) Pre-flood. Wall is clean and in new condition.

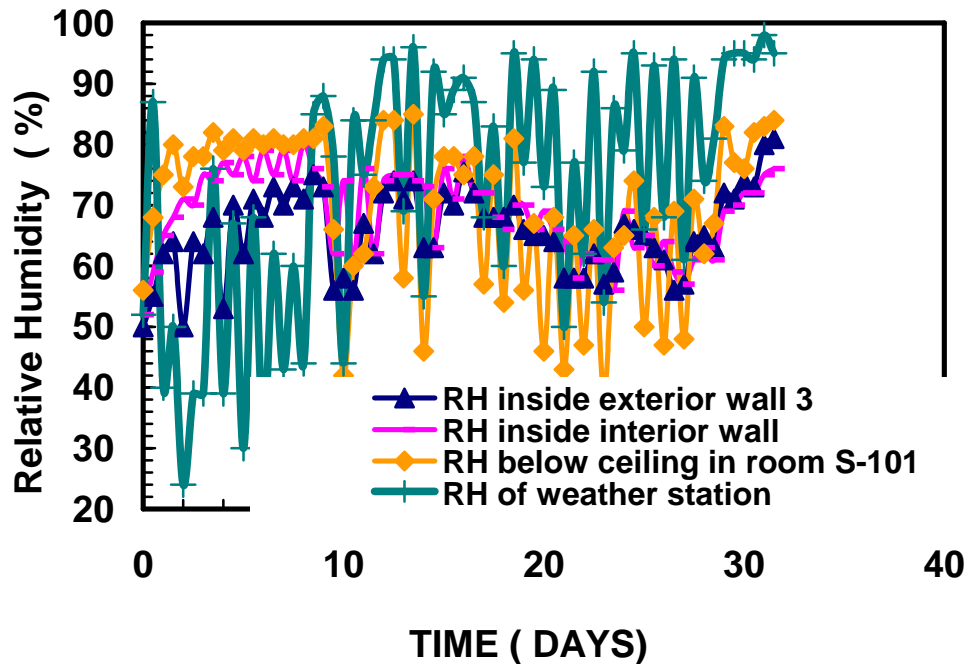
The relative humidity readings from Module S-1, along with the exterior relative humidity obtained from the weather station, are shown in Figure 4-17. The relative humidity readings in Modules S-1 and C-1 were similar. The relative humidity measured just below the ceiling went up rapidly during flooding and remained relatively constant until the door and window were opened after draining on Day 8. After that the pattern of the indoor relative humidity resembled that of the weather station, only it maintained a lower absolute value.

At the very end of the drying period the relative humidity of the exterior wall slightly exceeds that of the interior wall. The exterior wall is subject to sun exposure and would be expected to dry more quickly than the interior wall. The exterior wall cavity temperature consistently exceeded the interior wall cavity temperature. However, the exterior wall contained fiberglass insulation which appears to have retained moisture on its fibers and kept the RH elevated in this wall throughout the drying period. It appears that there is little correlation between relative humidity in the cavity of the interior and exterior walls with that of the weather station.

Figure 4-17 Relative humidity versus time at three different locations in Module S-1. Day 1 is the time at which the basins were completely filled. The basins were drained by Day 4 and the door and window were opened on Day 9.

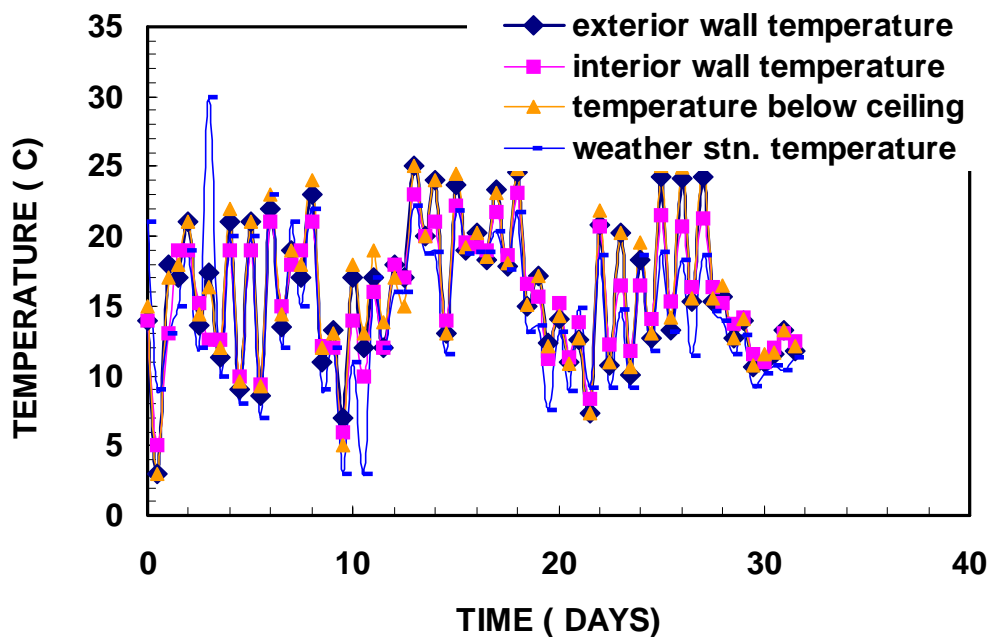
The temperature in the cavity of the exterior Wall 3, the cavity of the internal wall and Room 101 were monitored continuously. The relationship between temperatures and time for these locations as well as the outdoor temperature profile are shown in Figure 4-18. Temperature readings were the same for both modules. The exterior temperature profiles are based on two readings per day; one at 12:00 noon and the other at 12:00 midnight. As shown in Figure 4-18, the three readings follow that of the outside temperature. The difference in the temperature between the three readings in the module varies by at the most 6°C. These profiles are influenced by other factors such as fluctuation in the daily average outdoor temperature, wall orientation, wind-speed, rain etc.

Figure 4-18 Temperature profiles for three different locations in Module S-1 and the outdoor air temperature. Day 1 is the time at which the basins were completely filled. The basins were drained at Day 4 and the door and window were opened on Day 9.

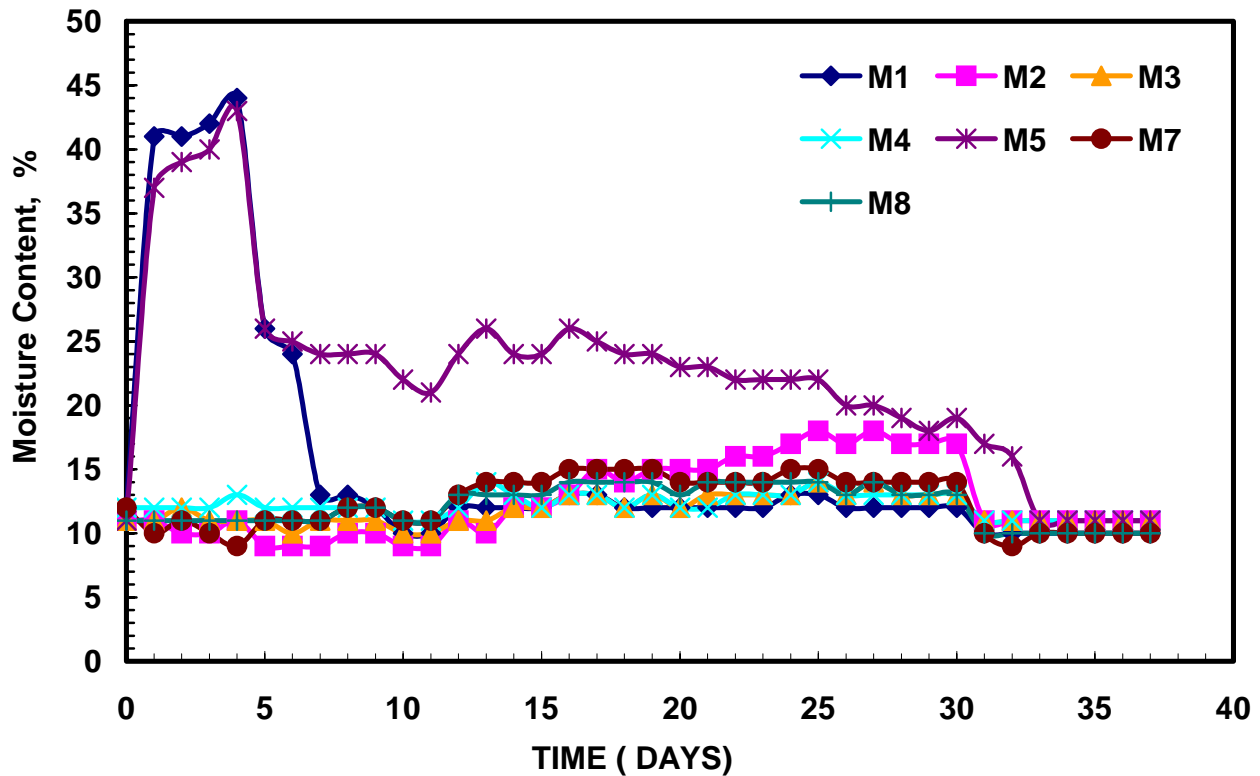
The relationship between the moisture content and time for Module S-1 is given in Figure 4-19 for the entire flood and drying period. Module C-1, Figure 4-20, was very similar, except there were two additional sensors. For sensors M1 through M8 in Module C-1, the measurements of moisture content and rates of wetting and drying were similar. Only sensors M1 and M5 (below the water level) had a significant change in the moisture content and this moisture content rose sharply at flooding. Day 1 represents the reading after the basin was completely filled. The rate of moisture absorption in the studs below water level, during flooding, is slightly higher for the stud in the exterior wall. The moisture content remained slightly higher during the entire flooding period as indicated from the reading of sensor M1. After draining, which occurred at Day 4 on Figure 4-19, both M1 and M5 have the same drying rate for about 1 day and then the drying rate at the location of sensor M1 in the exterior wall is faster than sensor M5. This indicates that the studs in the exterior walls dry faster than the studs in the interior walls. The remaining sensors appear to have a similar pattern throughout the flooding and drying period.

Figure 4-19 The relationship between the moisture content and time of exterior and interior wall studs in Module S-1 for 37 days. Day 1 through Day 4 is the period of flooding. The drying period begins with Day 4. The designation of the moisture sensors is as follows:

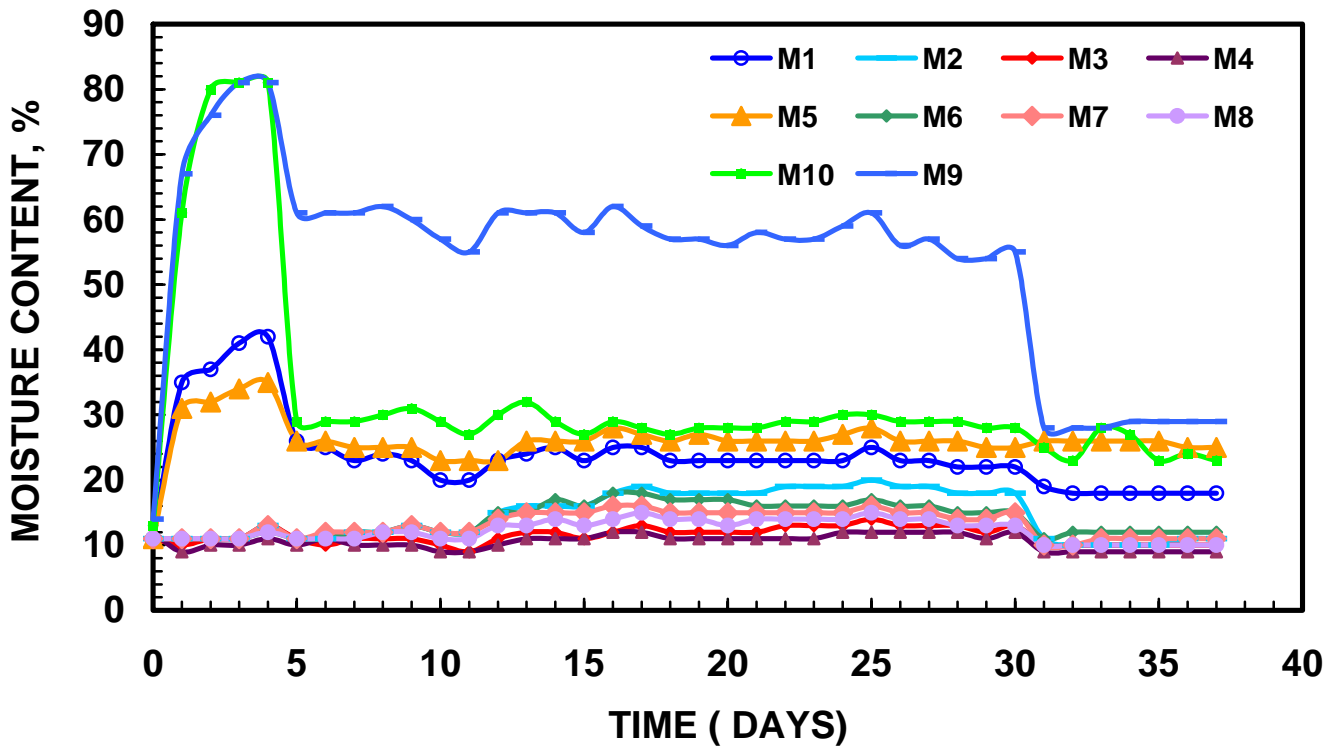
In Module C-1, two additional sensors (M9 and M10) were installed. (See Figure 4-20.) After draining, the reading of sensor M10 (joist in Module C-1) dropped rapidly from 80% to about 30% in one day. After this day it remained constant at about 30% moisture content throughout the drying period. The reading of M9 however, (subflooring in Module C-1) dropped slowly from the 80% at Day 4 to about 60% at Day 5. It remained at around 60% for almost 30 days from the start of the flood. At that time it was decided to remove the insulation underneath the subfloor at the location underneath the sensor. The reading after this point dropped to about 30%, which is in line with sensors M1, M5, and M10. It appears that the insulation under the subflooring kept the moisture content in the sub-flooring high.

Figure 4-20 The relationship between the moisture content and time of exterior and interior wall studs for Module C-1 during the 37 days. Day 1 through Day 4 is the period of flooding. The drying period begins with Day 4. The designation of the moisture sensors is as follows:

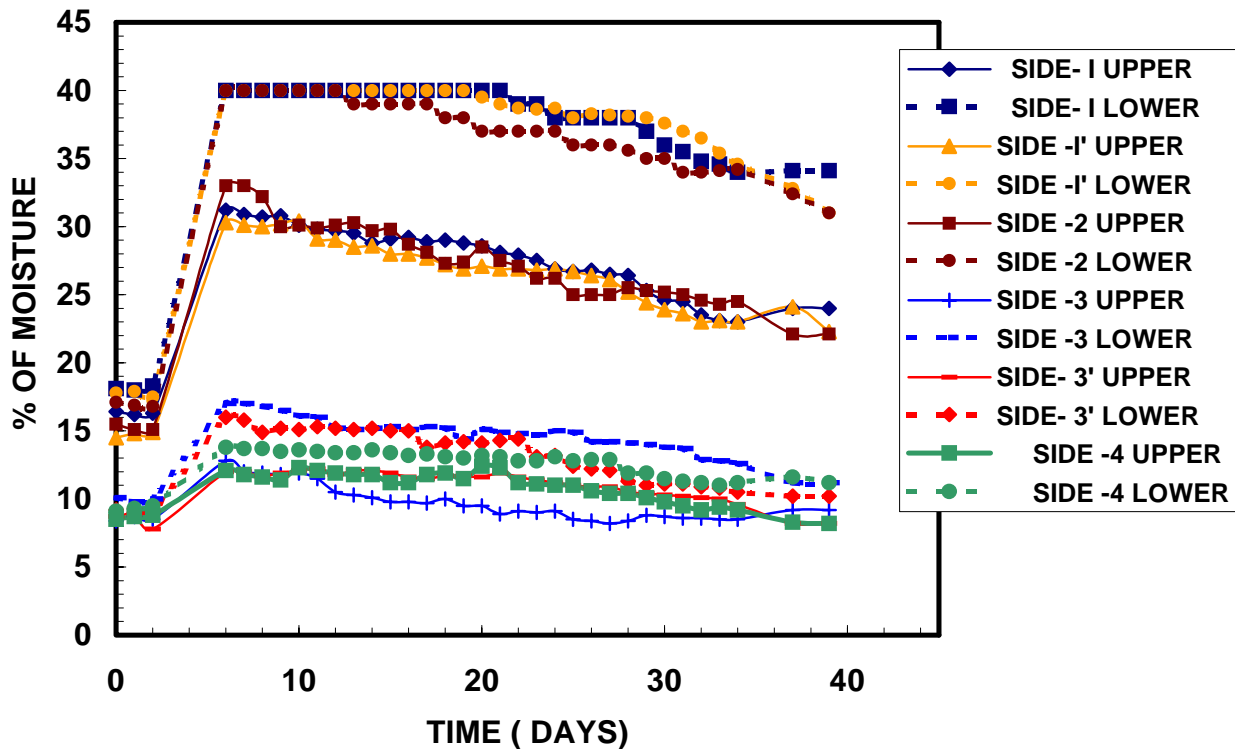
The relationship between the moisture content and time for Module S-1 is shown on Figure 4-21. (The readings were similar for Module C-1.) The data are clustered in three groups. The drying rate for each group appears to be similar. Group 1, which has the highest moisture content consists of: Wall 1 lower, Wall 1' lower, and Wall 2 lower. The moisture content in this group started at about 40% after draining the basin. Group two consists of: Wall 1 upper, Wall 1' upper and Wall 2 upper. The moisture content in this group started at about 30%. Group 3 consists of: Wall 3 and 3' upper and lower, and Wall 4 upper and lower. Although the moisture content in Wall 3 upper and lower at the two locations are in this group there is a difference of about 8% between the above and below water level readings. In the case of Wall 4 the difference between the readings at the upper and lower locations is only a few percent. The moisture content for Walls 3 and 4 probably remained lower after flood exposure and dried closer to their original value due to the material they were covered with. Walls 3 and 4 were covered with hard board lap siding, while Walls 1 and 2 were covered with a plywood siding.

Plywood is more porous and contains a grainy structure that will hold and transport moisture. Hardboard siding is more dense and homogeneous, which tends to slow the penetration of moisture. The hardboard siding used in the test modules was new and had well-sealed edges. Older siding with less well-sealed edges may absorb significantly more moisture than the present tests reflect. The orientation of the walls did not appear to play a significant factor in the rate of drying in either Module S-1 or C-1. Wall 3 faces south, while Wall 4 faces west; however since these walls did not absorb as much water during flooding, during which time orientation would not have a significant effect.

Figure 4-21 Moisture content versus time for the siding on Module S-1. Day 2 through Day 5 is the period of flooding. The drying period begins with Day 5.

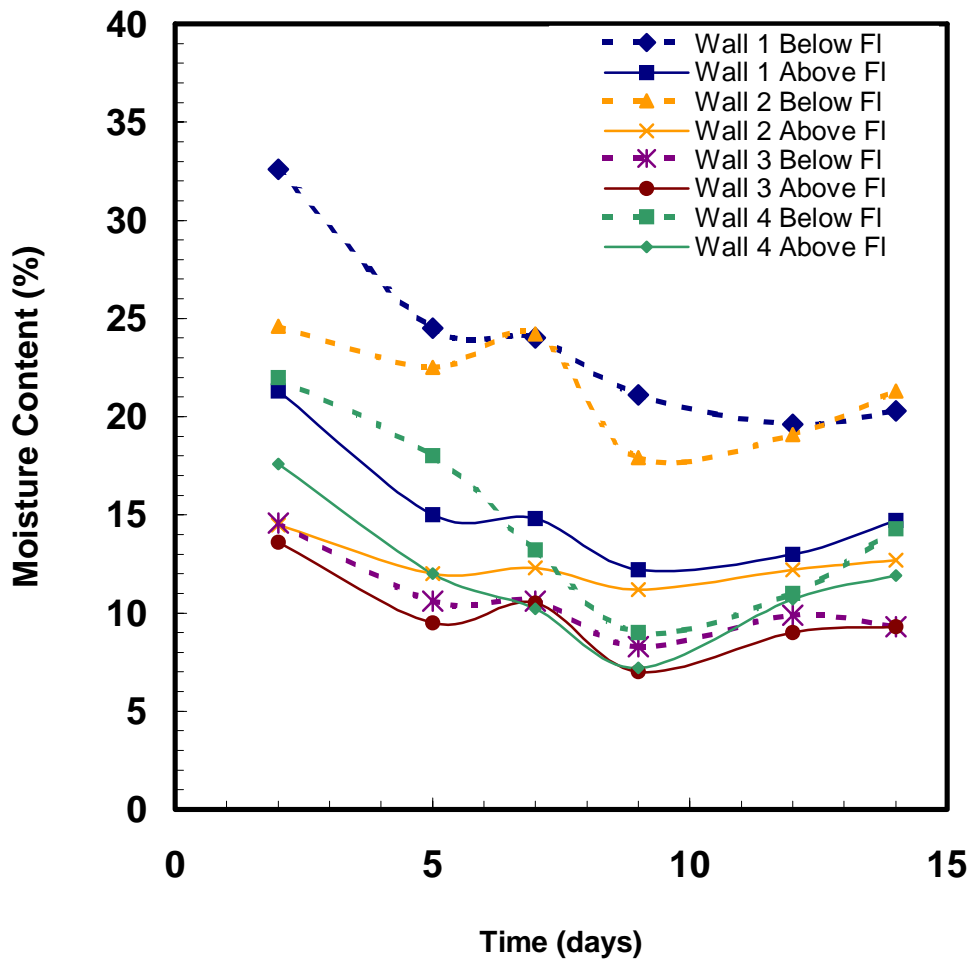
The exterior siding was removed on the 21st of December, which was 2 days after the end of the drying period. The moisture content was measured below and above the water level on all 4 exterior walls. This was done for 12 days. The relationship between the moisture content and time is shown in Figure 4-22. The moisture content of the points below the water level is higher than those above the water level for all test locations. There is a significant difference in the moisture content for Wall 1 and Wall 2, for readings above and below the flood level. Wall 3 displays the lowest difference in moisture content. A slight increase in moisture content seen at 7 days was believed to be due to rain.

Readings taken from the sheathing on all the walls (above and below the water level) nine weeks after the final drying period reading were taken and showed that all locations on all walls have dried back to a moisture content of between 6-9%. These readings were made in areas where the siding had been removed for an extended period, and it is doubtful that this level of drying would have occurred had the siding remained in place.

Figure 4-22 Relationship between the moisture content and time for the plywood sheathing. Measurements were taken after removal of the exterior siding at the end of the drying period 28 days after draining the basins.

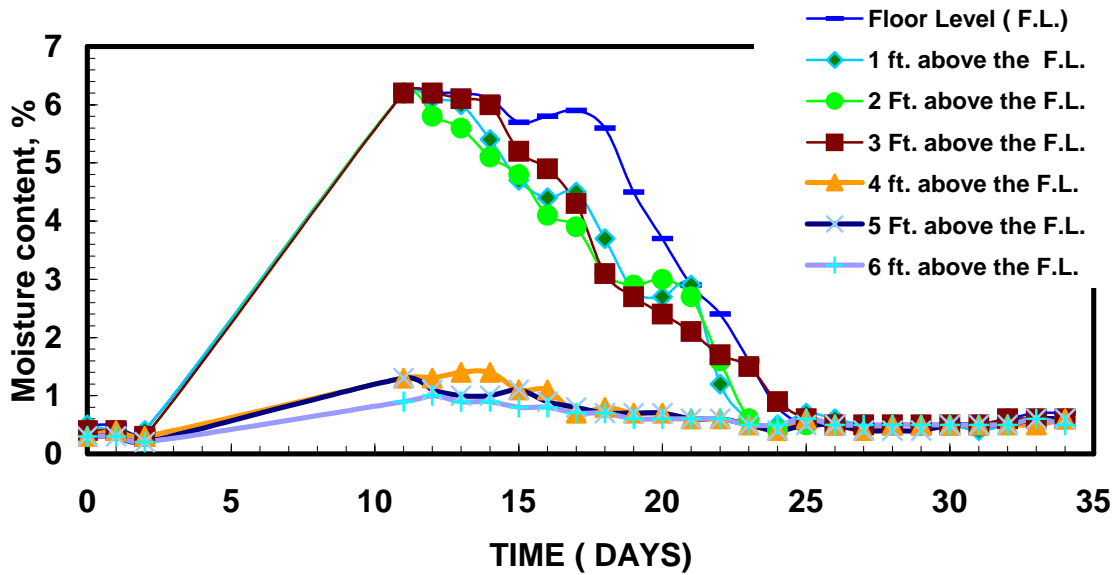
The relationship between the moisture content and time for the gypsum board on the interior wall in Module S-1 is shown in Figure 4-23 for the various heights. Figure 4-25 shows the relationship between the moisture content and time for the gypsum board on the interior wall in Module C-1. The maximum moisture content was about 6% for floor level, 1 foot, 2 feet and 3 feet above floor level. The moisture content at heights 4 feet and above was about 1 percent and reached the pre-flood conditions at the end of the drying period. It took about 15 days from the opening of the house for the moisture content at these levels to reach the pre-flood condition. The moisture content for the gypsum board cannot be compared with that of wood products because of a difference in instrument calibration. All moisture contents given are relative to their original readings and not absolute values. The measurements taken at the floor level remained higher for about 10 days and then dropped rapidly.

The difference in drying rate between the interior and exterior walls at floor level is attributed to the impact of the fiberglass insulation in the exterior walls. The insulation retains more moisture at floor level. This increased moisture within the exterior wall cavity caused the exterior wall gypsum board to dry more slowly at the floor level. The drying rate at one foot above floor level is similar for both walls. At locations 2 and 3 feet above floor level, Wall 3 dried faster. This is attributed to the fact that Wall 3 is facing south and absorbs heat from the sun.

Figure 4-23 Moisture content versus time for the gypsum board on the interior wall of Module S-1. Day 2 is the beginning of flooding, Day 5 is the draining of the basin, Day 10 is the reentry into the module and the beginning of observation and measurement, Day 33 is the end of the drying period. *All moisture contents should be considered relative to their original readings and not absolute values.*

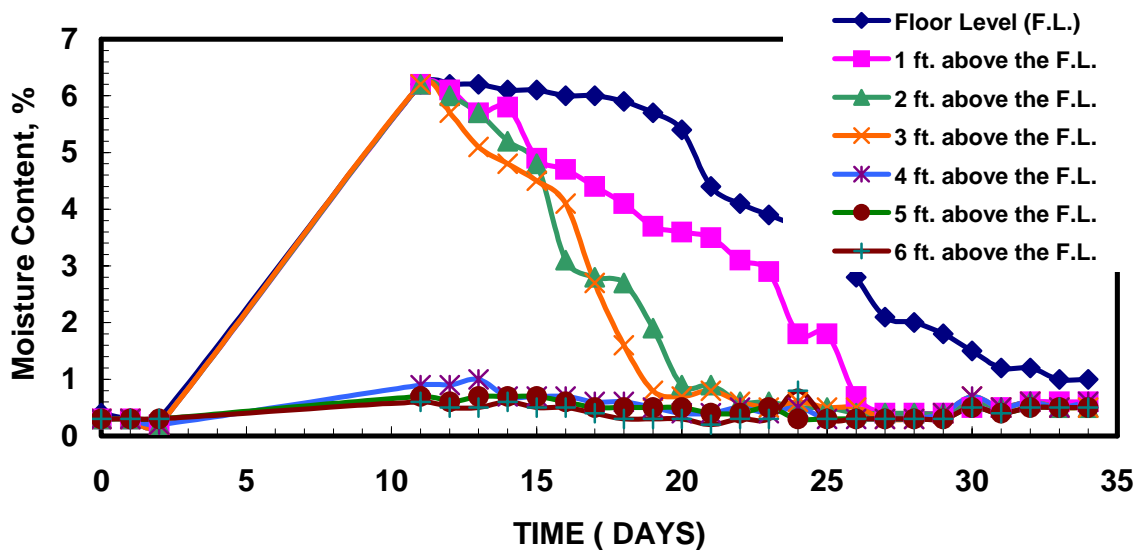
The relationship between the moisture content and time for the gypsum board on Wall 3 of Module S-1, an exterior wall facing south, is shown in Figure 4-24 below. Moisture content versus time for the gypsum board on Wall 3 was similar for Module C-1, as seen in Figure 4-26 below. Similar to the interior wall, the highest moisture content was about 6 % for the floor level, 1, 2 and 3 feet above the floor level. The moisture content at heights 4 feet and above was just under 1 percent after opening the door and window and it reached the pre-flood condition at the end of the drying period. Also the floor level moisture resembled that of the interior wall; however, it had a slower drying rate. This was the case for the floor level measurements and at 1 foot above the floor. For 2 and 3 feet above the floor the drying rate was faster in Wall 3.

Figure 4-24 Moisture content versus time for the gypsum board in Module S-1 on the interior of Wall 3. Day 2 is the beginning of flooding, Day 5 is the draining of the basin, Day 10 is the reentry into the module and the beginning of observation and measurement, and Day 33 is the end of the drying period. *All moisture contents should be considered relative to their original readings and not absolute values.*

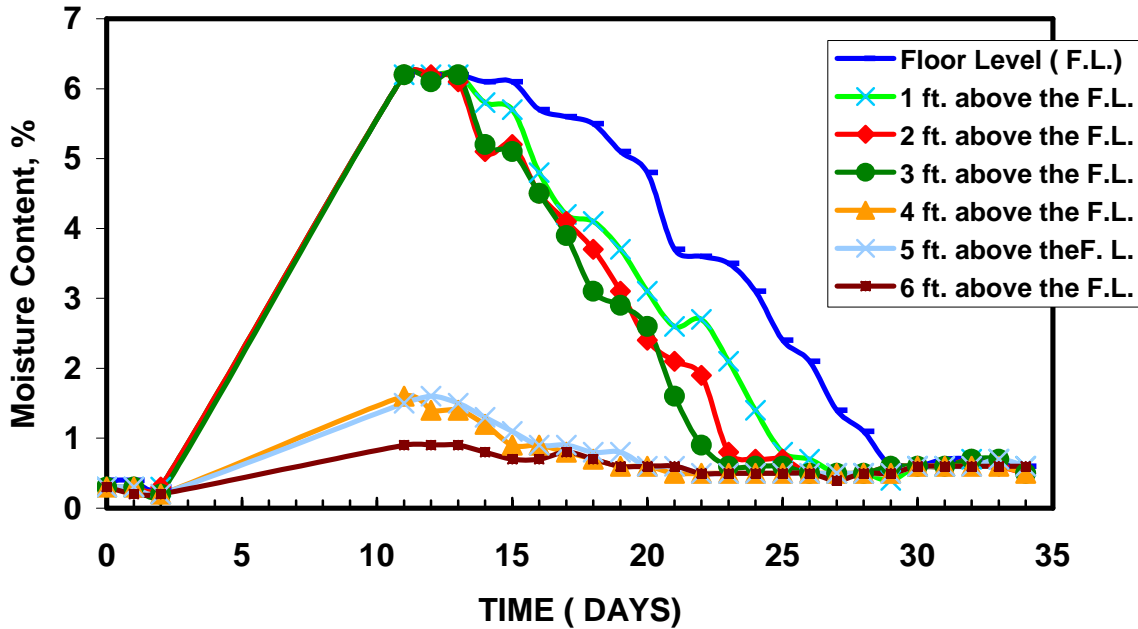
The values in S-1 were similar to C-1 except for the floor level reading as seen in Figure 4- below. At floor level the gypsum board on the interior wall in Module C-1 dried slower than in S-1. In C-1, it took about 20 days from the opening of the house to reach the pre-flood condition, while in S-1 it only took about 15 days. This may be due to the plywood flooring and insulation in the crawl space under the flooring, which retained moisture; this slowed the drying process near the floor.

Figure 4-25 Moisture content versus time for the gypsum board on the interior wall of **Module C-1**. Day 2 is the beginning of flooding; Day 5 is the draining of the basin; Day 10 is the reentry into the module and the beginning of observation and measurement; Day 33 is the end of the drying period. *All moisture contents should be considered relative to their original readings and not absolute values.*

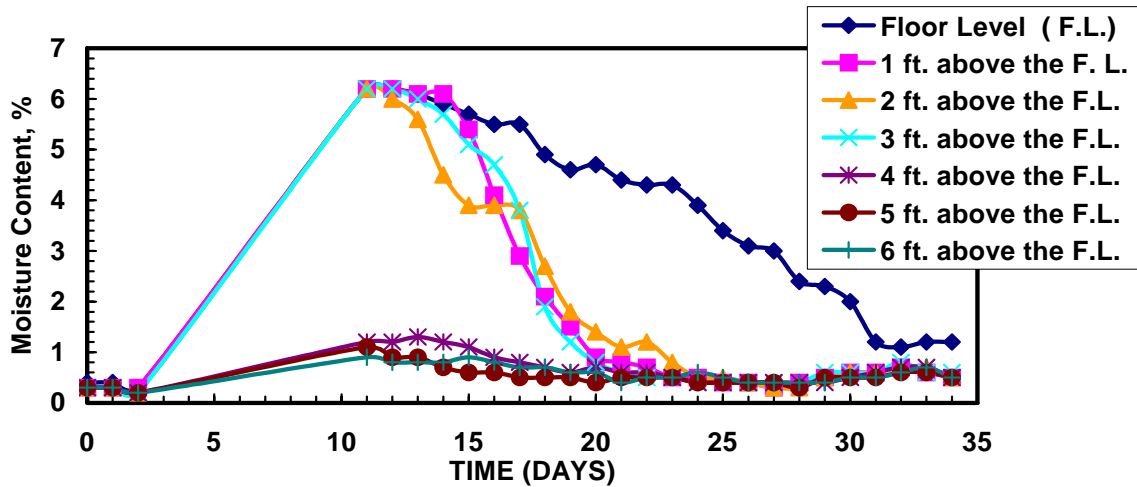
Figure 4-26 Moisture content versus time in the gypsum board on the interior of **Wall 3** (south wall) in **Module C-1**. Day 2 is the beginning of flooding, Day 5 is the draining of the basin, Day 10 is the reentry into the module and the beginning of observation and measurement, Day 33 is the end of the drying period. *All moisture contents should be considered relative to their original readings and not absolute values.*

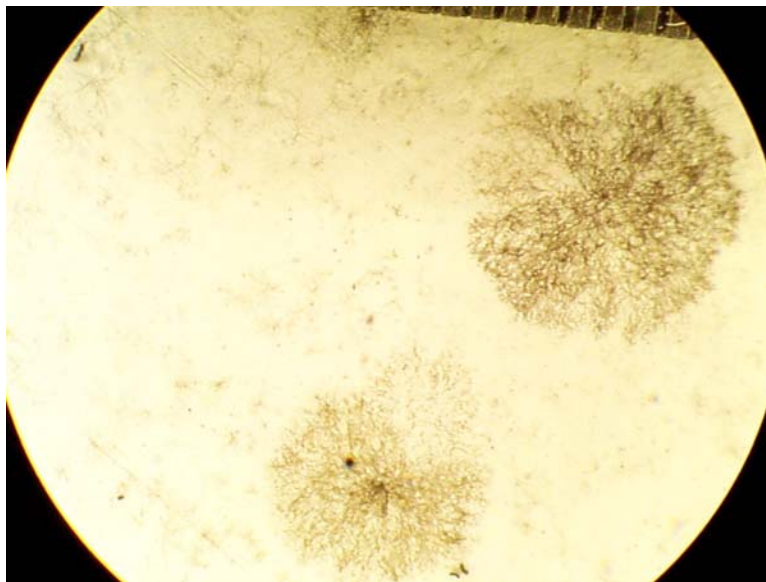
Mold growth is a major problem associated with floods. No mold was observed on any part of the building components prior to flooding. One day after draining, there was no visible mold found on the outside surface of the modules. However, a strong musty smell of moisture and mud was present in the interior. Upon reentering the modules (Day 8) no mold traces were seen. At no time throughout the testing was mold growth visible in the crawl space unit, Module C-1. Beginning on the Day 13, dark-yellowish mold spots were observed in Module S-1. A series of optical micrographs were recorded to show the morphology of such contaminants and mold spots. An example of these is shown in Figure 4-27.

Mold was only found in the slab-on-grade module mainly on the walls of Room S-101. This room differed from S-102 (very little mold) in that the walls were painted with flat latex paint as opposed to latex enamel and the room had carpet on the floor during the flood. The wet carpet was removed at reentry (Day 8). Mold growth was present on the gypsum board walls only above the water line and was concentrated in areas between the studs.

Figure 4-27 Optical micrograph at 5X, showing the size of typical molds. Diameters are from 0.8 mm to 15 mm (3 feet above floor level, Module S-1, Wall 3 in Room S-101).

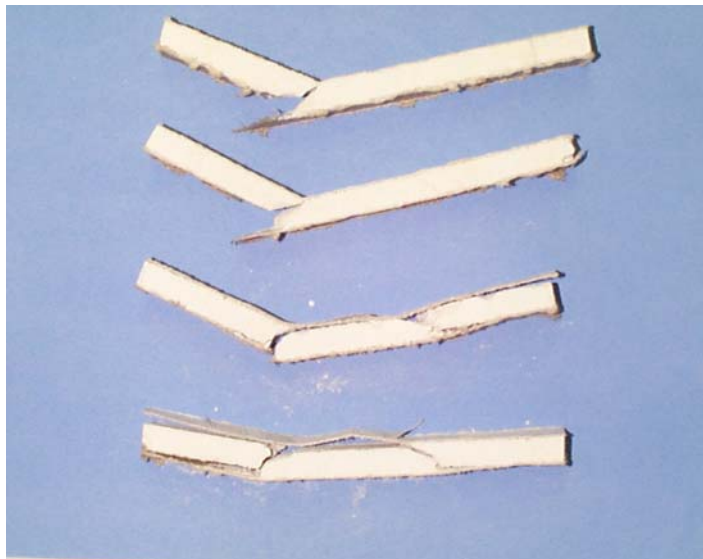
Four point bending tests on gypsum board were also performed (Figure 4-28) to examine the flexural strength change due to the flooding. It was found that the flexural strength of the gypsum board on the exterior walls dropped by about 50% below the water line compared to that above the water line. The gypsum board on the interior wall of the unit showed no significant decrease in strength. It appears that the reason for the decreased flexural strength in the exterior wall gypsum board is that the fiberglass insulation in the interior cavities of the walls caused them to stay wet longer. The interior wall was hollow and thus dried quicker. The detailed test results are listed in Table 4-5. Results were virtually the same in Module C-1.

Figure 4-28 Four point bending samples from the gypsum board of Module C-1. Samples are taken from interior side of outside wall, below the water line.

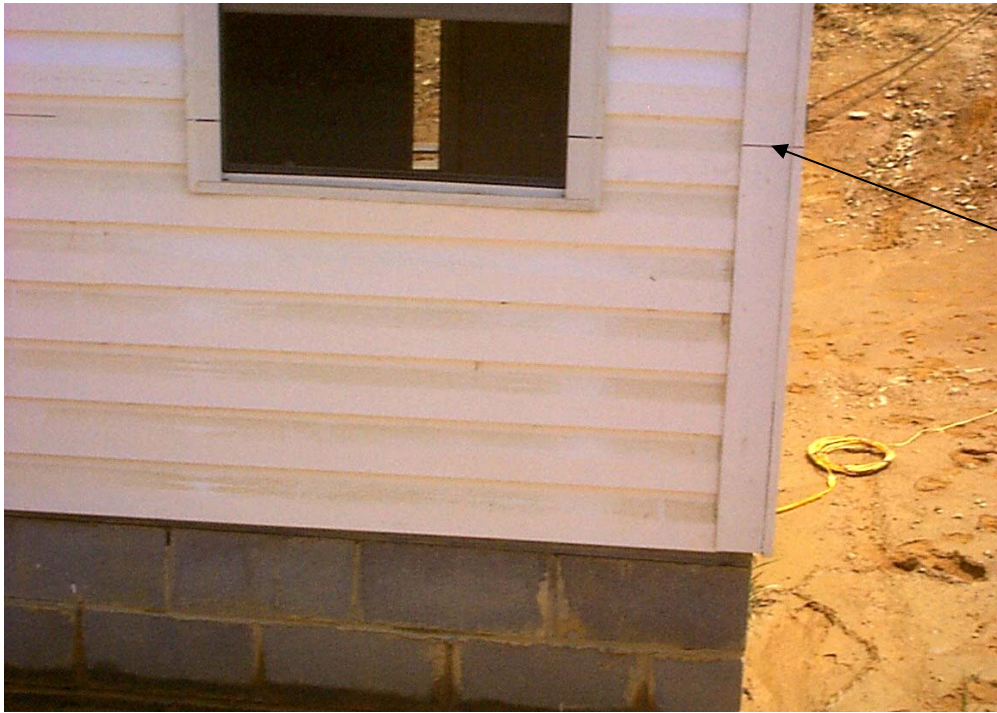
Depth to which unit was flooded

Figure 5-16 Module C-2 (Wall 1) Day 8 before washing. Wall is discolored

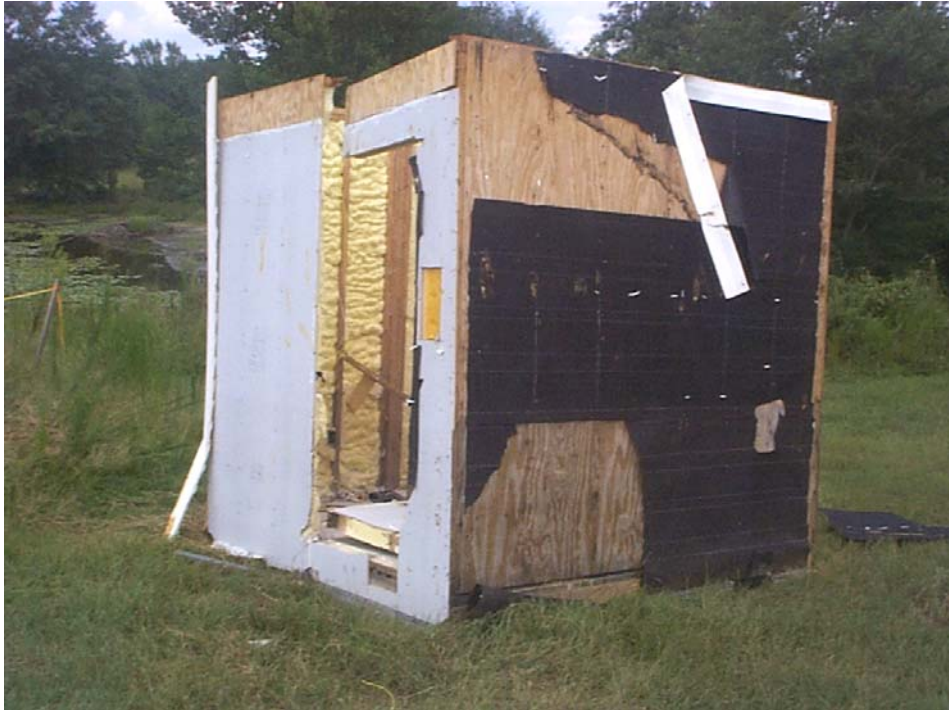
At the end of the drying period and following the completion of the restoration, an autopsy was performed on selected walls. In both Modules S-2 and C-2, Wall 1 exterior and Wall 2 exterior, as well as the interior wall were autopsied. The autopsy revealed no mold on the inside surfaces. The polyurethane foam appears to be intact with no discoloration or staining. On the exterior side, the cement and vinyl siding as well as the gypsum sheathing material were intact with no apparent mold or permanent damage.

Figure 5-18 Module C-2 - Body of module at final autopsy and demolition

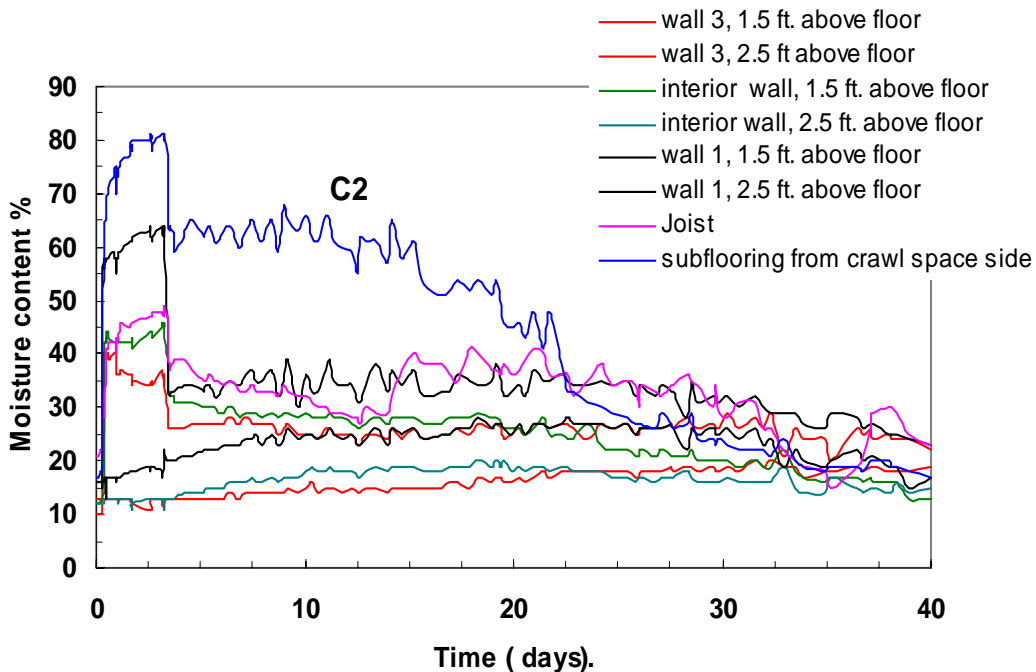
The relationship between moisture content and time for the entire 40 days is given in Figure 5-24. The rate of moisture absorption during flooding is higher for the subfloor and it took a longer time to dry. It reached about 80% during the flooding period and it took more than 22 days to drop to 30%. After draining, which occurred on Day 3, the readings of all other sensors dropped suddenly reaching a range of 25-35% on Day 5. All sensors above the water level appear to have a very similar pattern throughout the flooding and drying period.

The moisture content of the studs inside Wall 3 of Module C-2 is very similar to that of the studs inside Wall 3 of Module S-2. Both of these walls face south. The moisture content of the studs inside the interior wall of both modules is similar, also. The moisture content at 1.5 ft. from the floor in the stud in Wall 1 facing north was much higher during flooding and remained higher during the drying period in comparison with Wall 3 and the interior wall.

Figure 5-24 Relationship between the moisture content and time for exterior and interior wall studs, subflooring and joist in Module C-2. Days 1- 4 is the period of flooding. The drying period begins with Day 4.

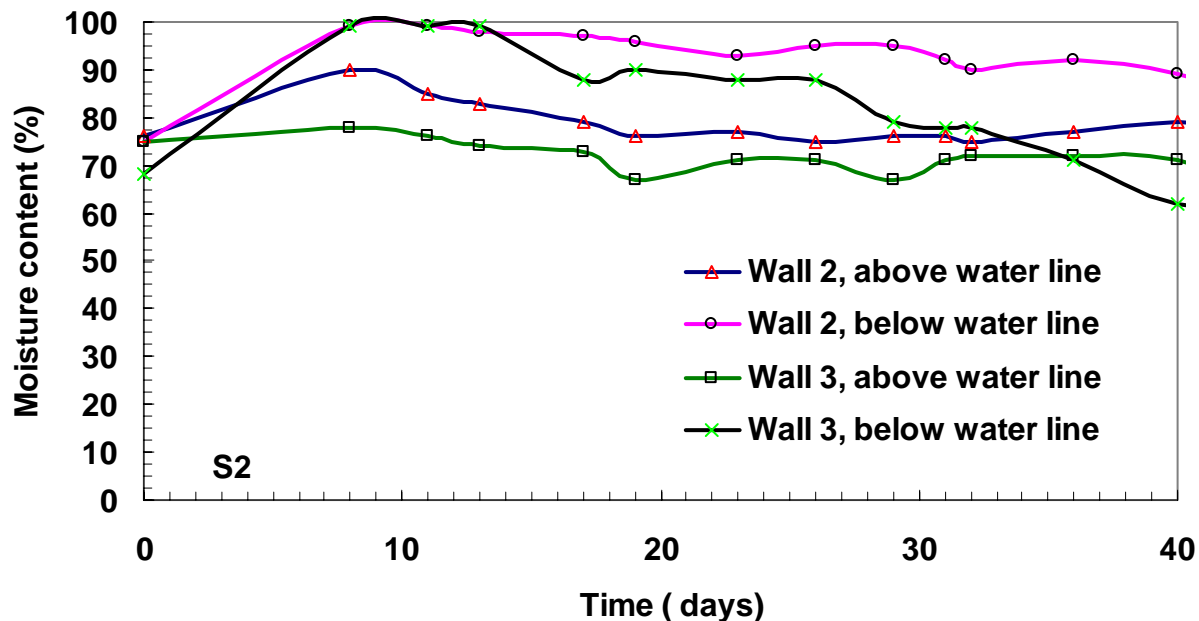
The moisture content was measured for the cement board siding on Walls 2 and 3 in Module S-2 using the hand held moisture meter. The results in Figure 5-25 are for Walls 2 (east wall) and 3 (south wall), since these walls have the cement board siding. (Results for Module C-2 are similar.) The moisture content below the flood level was at maximum wetness from Day 8 to Day 14. Then, Wall 3 experienced a faster drying rate than Wall 2 due to its orientation to the south. In the time period from Day 0, which is pre-flood, to Day 8, no measurements were taken. Measurements started on Day 8, once the module had been drained and was open for inspection. Above flood level there was no significant change in the moisture content.

Figure 5-25 Moisture content of the cement siding, Walls 2 and 3 versus time for Module S-2. All moisture contents should be considered relative to their original readings and not absolute values.

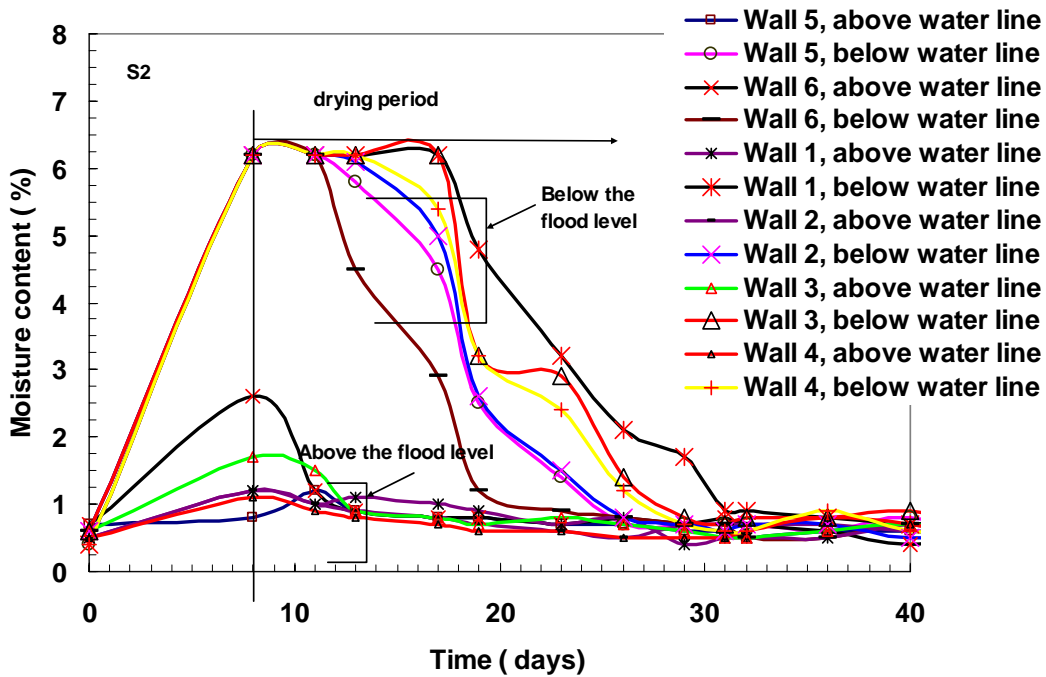
In Module S-2, the relationship between the moisture content and time for all walls is shown in Figure 5-26 for the two locations on each wall. The maximum moisture content was about 6% for all locations below the water line (2 feet from floor). The maximum moisture content at heights 4 feet had a range between 1 and 2.5% and reached the pre-flood conditions at the end of the drying period. It took about 24 days from the opening of the unit for the moisture content below the water line for all walls to reach the pre-flood condition. *The moisture content for the interior fiber reinforced gypsum panels cannot be compared with that of wood products because of a difference in the instrument calibration. All moisture contents should be considered relative to their original readings and not absolute values.*

Examination of the relationship between the moisture content and time for all walls below the water line in Module S-2 reveals that Wall 6 (interior wall in Room S-201) has the fastest drying rate. It reached pre-flood conditions in about 20 days from flooding. This wall had a south exposure when the main door was kept open, which may explain the faster drying rate. Both Walls 2 and 5 took about 26 days to dry while Walls 3 and 4 took about 29 days to dry. Wall 1 had the slowest drying rate of about 32 days. Only Wall 6 had a noticeable moisture content of about 2.5% above flood line upon reentry on the 8th day of flooding. All other walls had a moisture range between 0.6 and 1.7%. The difference in drying rate between the four walls appears to be independent of the orientation. This difference in drying rate could be attributed to the impact of the spray foam insulation in the exterior walls. Unlike fiberglass insulation, the spray foam insulation did not retain significant moisture.

Figure 5-26 Moisture content vs. time, fiber reinforced gypsum panel interior walls in Module S-2. Day 0 is the beginning of flooding, Day 3 is the draining of the basin, and Day 8 is the reentry into the module and the beginning of observation and measurements. *All moisture contents should be considered relative to their original readings and not absolute values.*

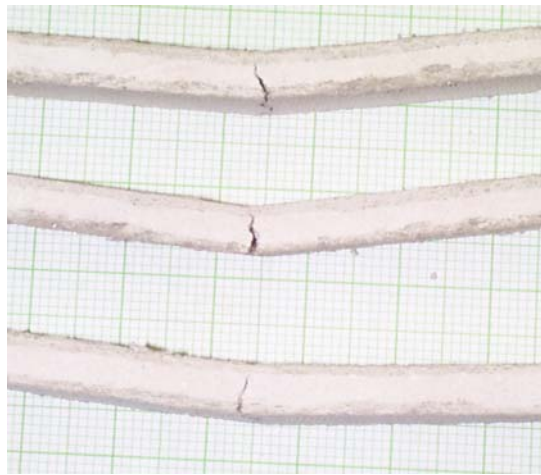
The failure of the fiber reinforced interior wall board under 3-point bend tests is shown in Figure 5-31. The failure initiated from the tension side of the specimen at the outer fibers.

Figure 5-31 Fractured specimens from fiber reinforced gypsum wall panels in Module S-2

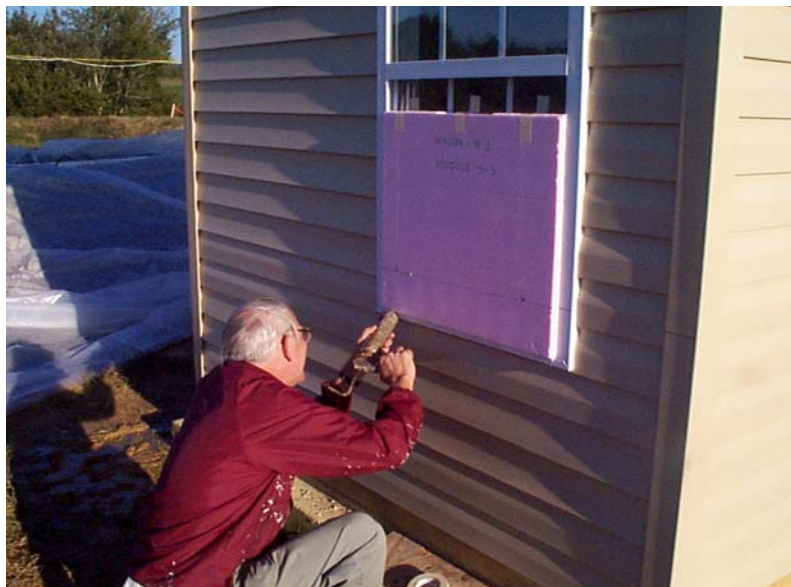
Figure 6-1 Module S-3 Placement of flood proofing dam over window. Two beads of adhesive sealant were applied to seal the Styrofoam dam and then additional caulking was placed around all the sides.
