ORNL/TM-2005/34

Field Testing of Energy-Efficient Flood-Damage- Resistant Residential Envelope Systems Summary Report

June 2004

Buildings Technology Center, Residential Buildings Group

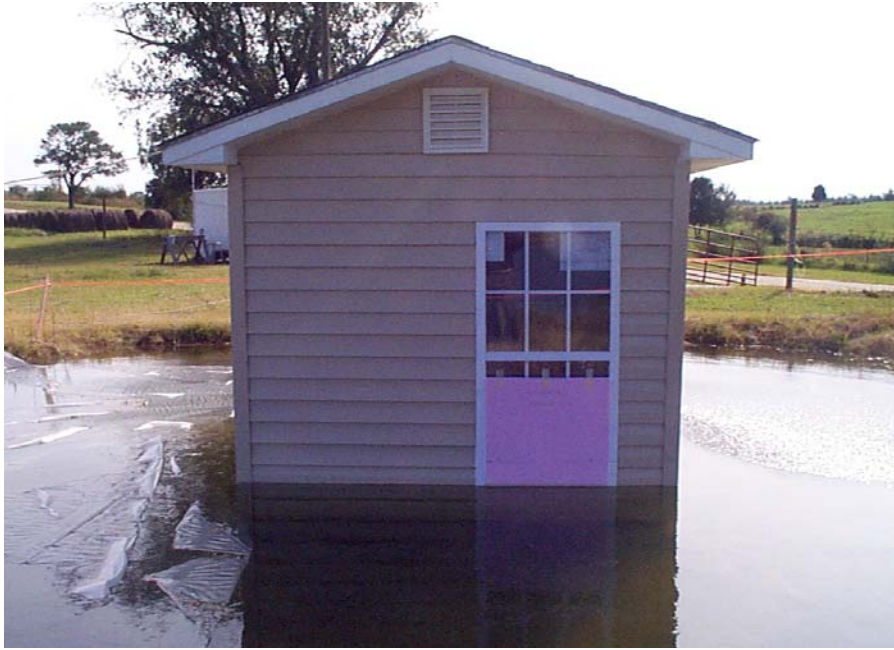
Figure 6-2 Module S-3 Wall 1. Dam on window during flooding is staying in place.

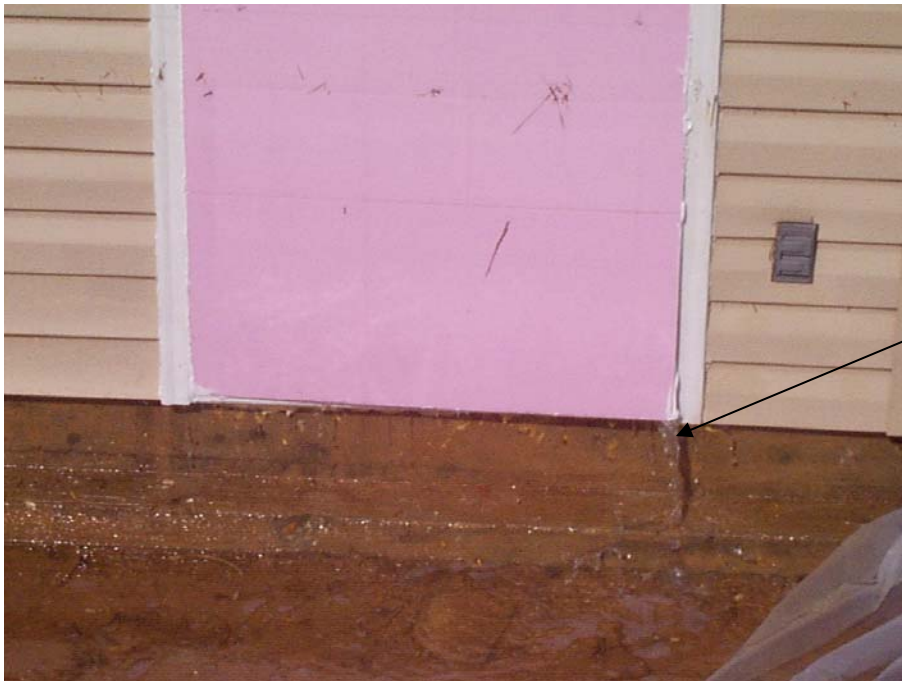
Figure 6-3 Module S-3 Exterior door dam. Dam on door is leaking at right lower corner where it has been pushed out from the force of the retained water. Leakage was also observed at the corners of the test module as well as at the intersection of the interior partition and exterior walls along the slab foundation.

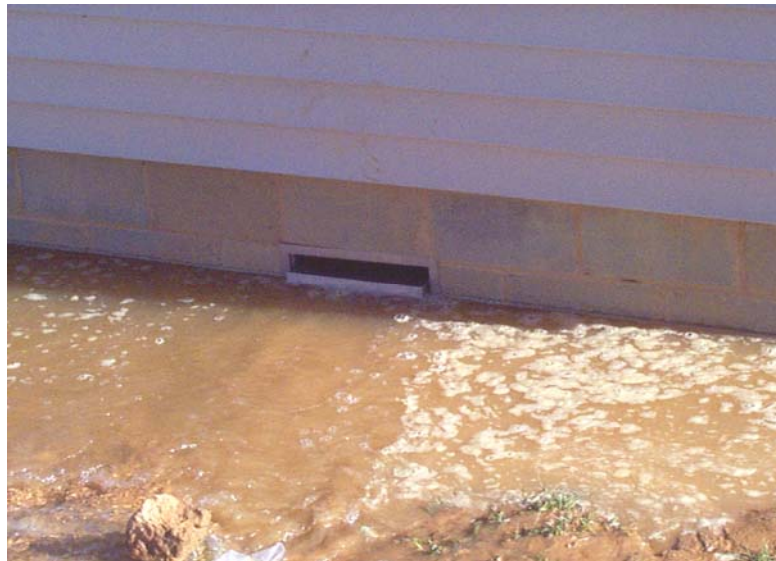
Figure 6-5 Module C-3. Water draining out of open crawlspace flood vents

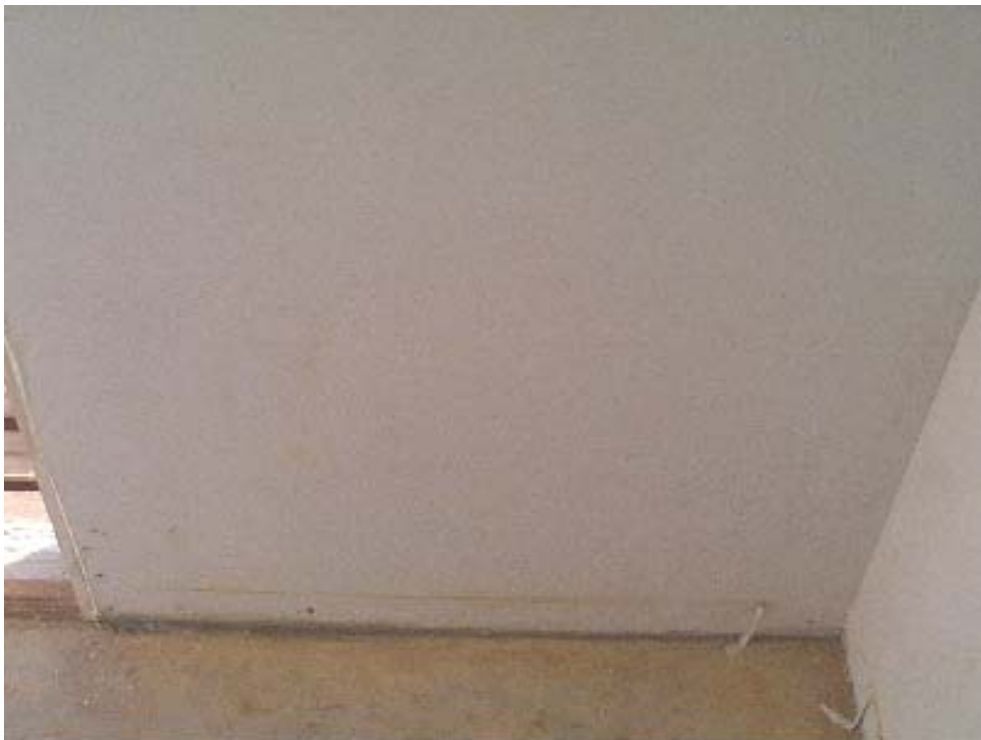
In Module S-3, mold was observed upon reentry to the unit. Views of the mold in Module S-3 are shown in Figures 6-8 and 6-9. In Module C-3, no mold was visible during the entire testing and drying period. Module S-3 was treated for mold growth in accordance with the protocol, but, since there was no mold observed, Module C-3 was not treated for mold growth.

Figure 6-10 Module S-3 (Wall 3) Day 15 - After sanitizing. No mold visible

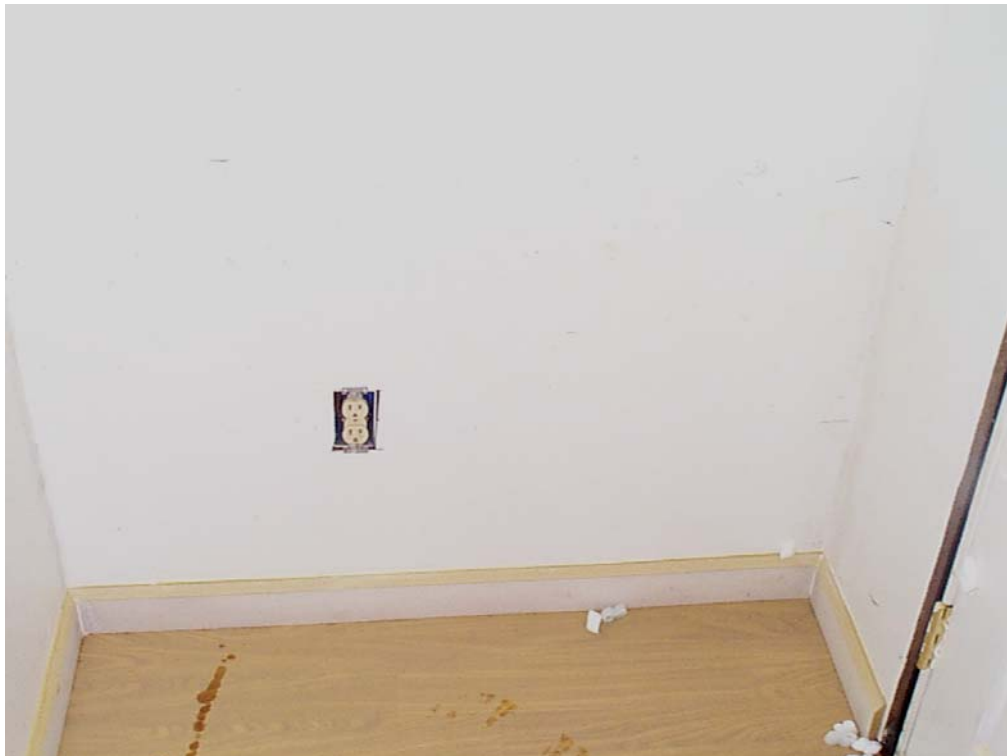
Figure 6-12 Module C-3 (Wall 2) Day 8 – Before washing. *Note: “Pellets” on the floor at right bottom are Styrofoam which was placed on the floor of the unit prior to flooding. As floodwater rose, the pellets floated, and cameras could record locations where water appeared to flow into the unit.*

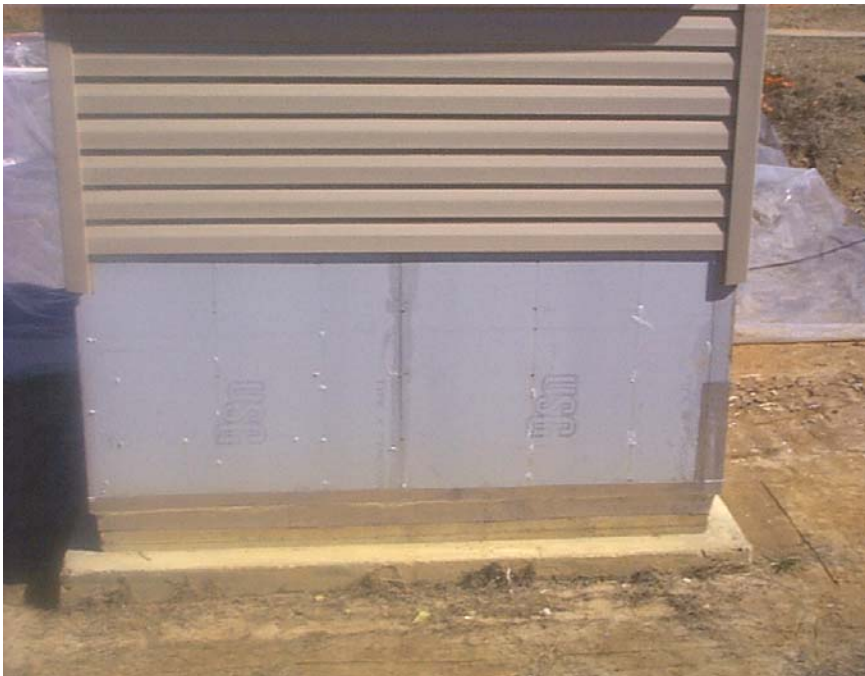
Figure 6-30 Module S-3a, west wall with adhesive sealant tape installed. Prior to flooding

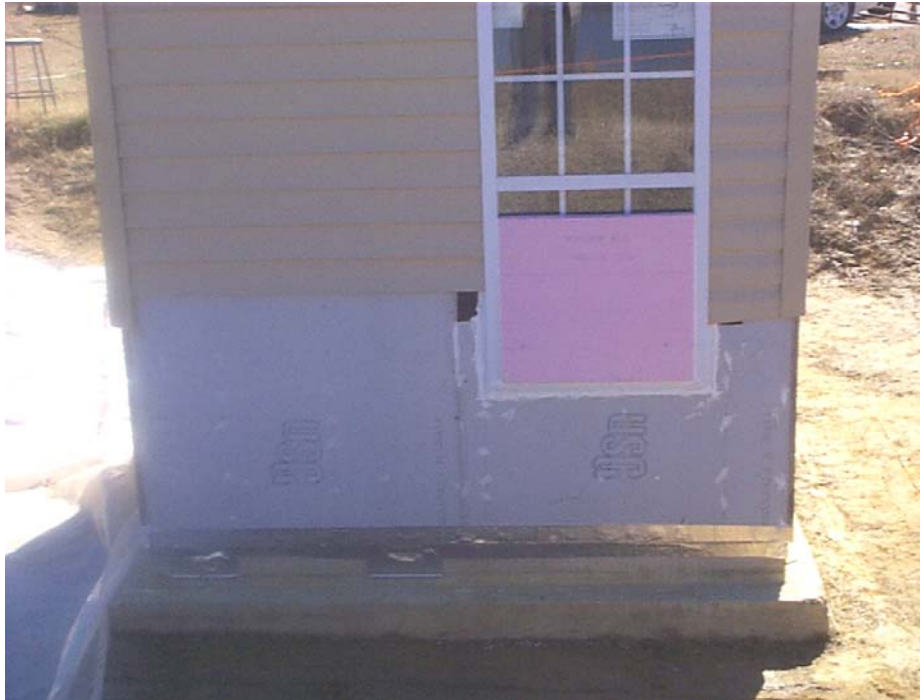
Figure 6-31 Module S-3a, north wall with window dam and adhesive sealant tape installed. Prior to flooding

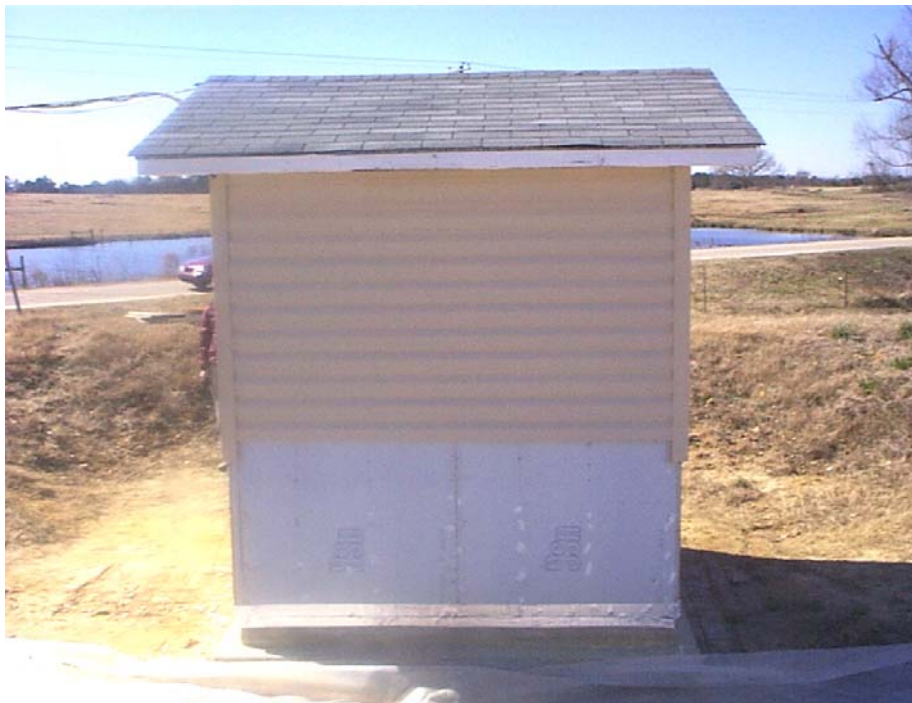
Figure 6-32 Module S-3a, east wall with adhesive sealant tape installed. Prior to flooding

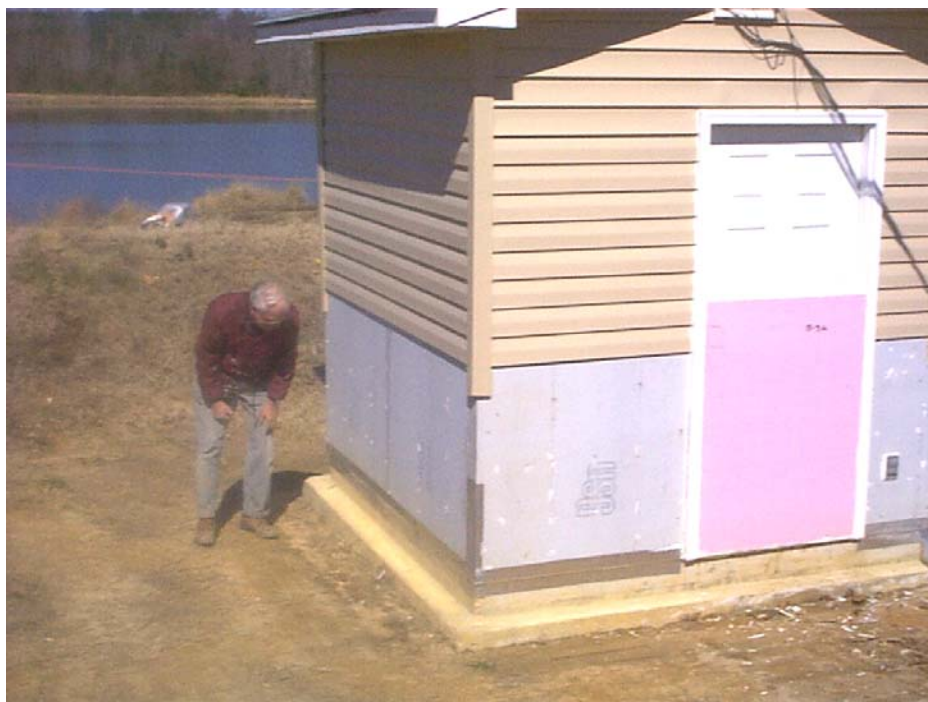
Figure 6-33 Module S-3a, south and west walls being inspected. Before flooding

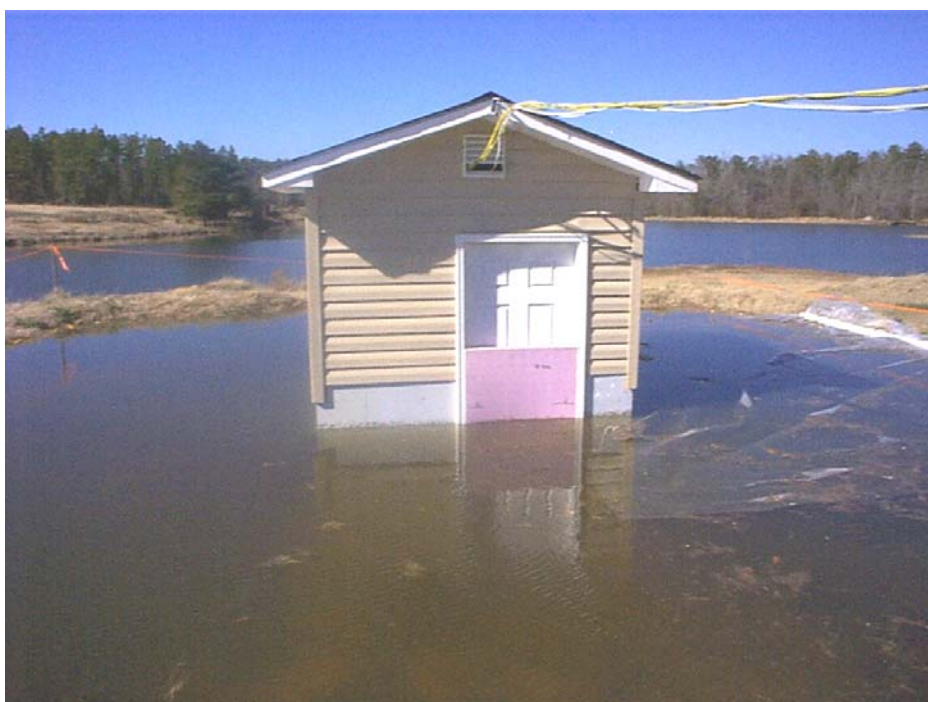
Figure 6-34 Module S-3a South wall during flooding. Note the inward deflection of the flood dam at the door. This indicates a significant differential in water level (outside to inside) at the time of the photograph.

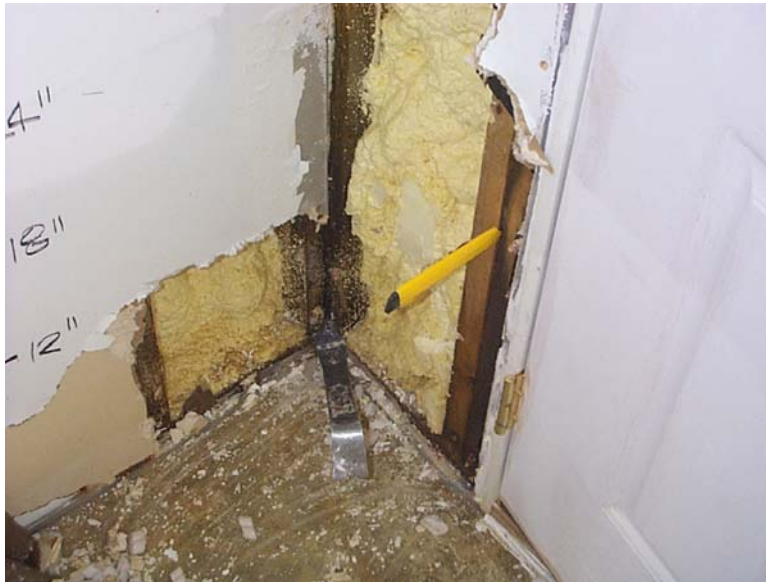
Figure 6-35 Module S-3a Interior southeast corner of Room S-301 after second dry flood proof test. Water entered the module during flooding through the crack between the doubled studs (yellow knife) that form the door rough framing. It also entered through the crack between the corner studs and the sill plate (grey pry bar).

2. Water entered the unit from the corners and underneath the door frame in spite of the efforts to seal these areas. Places where the concrete foundation was chipped appeared to be the problem areas based on observations at draining of water exiting from these locations.

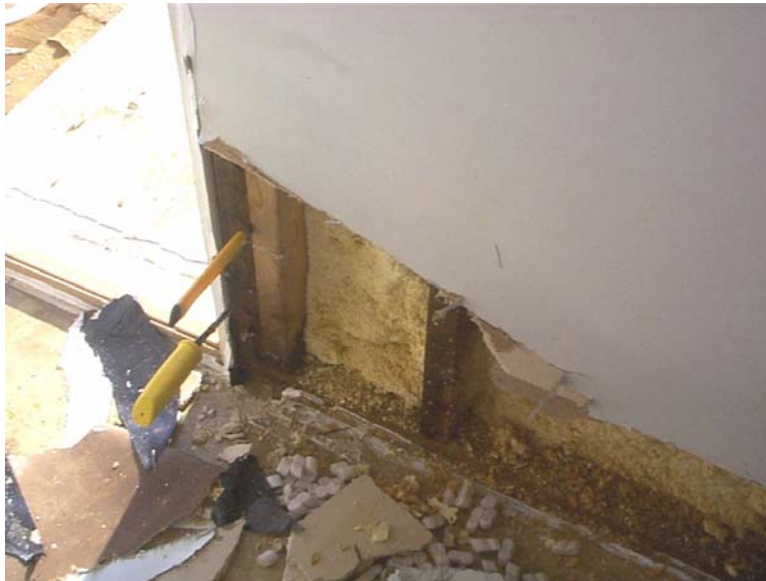
Figure 6-36 Module S-3a Interior south wall after second dry flood proof test. Water entered the module during flooding through the crack between the doubled studs (yellow knife and saw) that form the door rough framing.

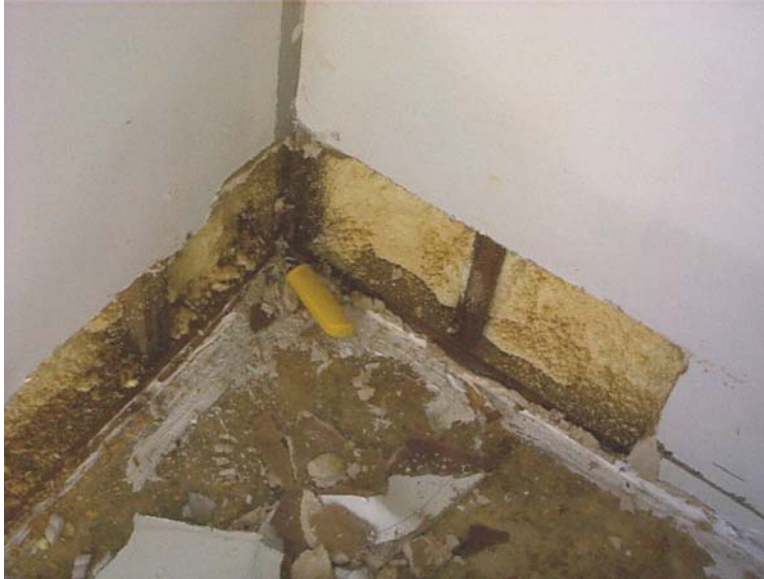
Figure 6-37 Module S-3a Interior southwest corner of Room S-301 after second dry flood proof test. Water entered the module during flooding through the crack between the corner studs and the sill plate (yellow saw).

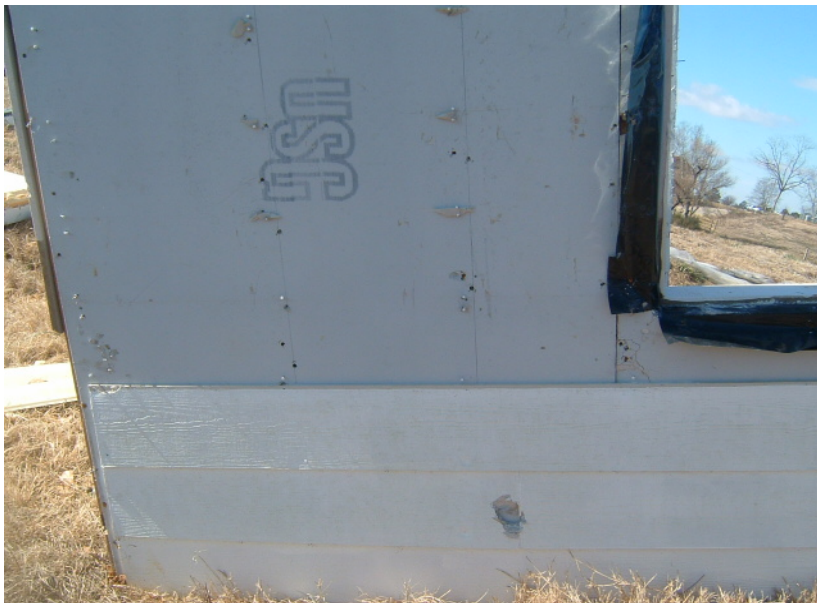
Figure 6-38 Module C-3, Wall 1, Exterior. No mold or severe staining was observed at autopsy which occurred 15 months after the flood test. The flood level was about 6” above the windowsill in this photograph.

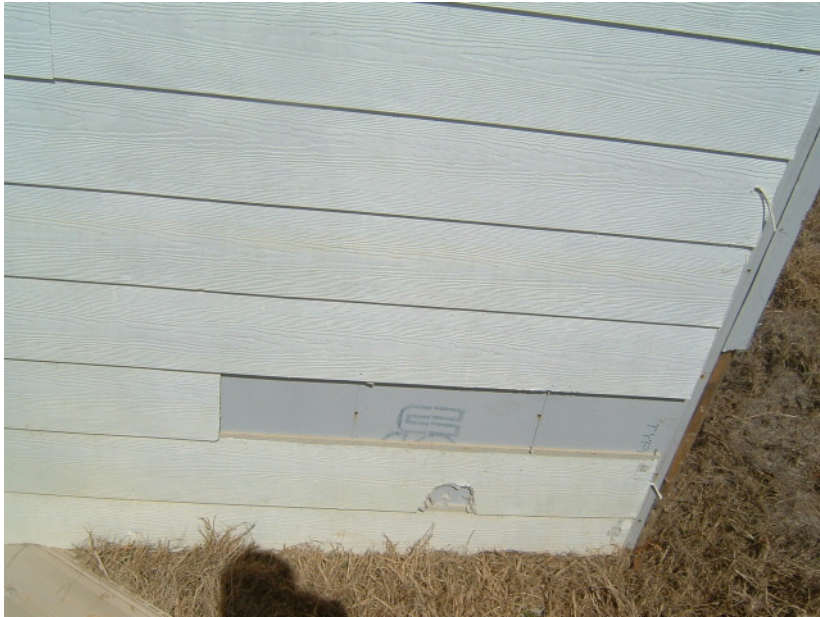
Figure 6-39 Module C-3, Wall 2, Exterior. No mold or severe staining was observed at autopsy which occurred 15 months after the flood test.

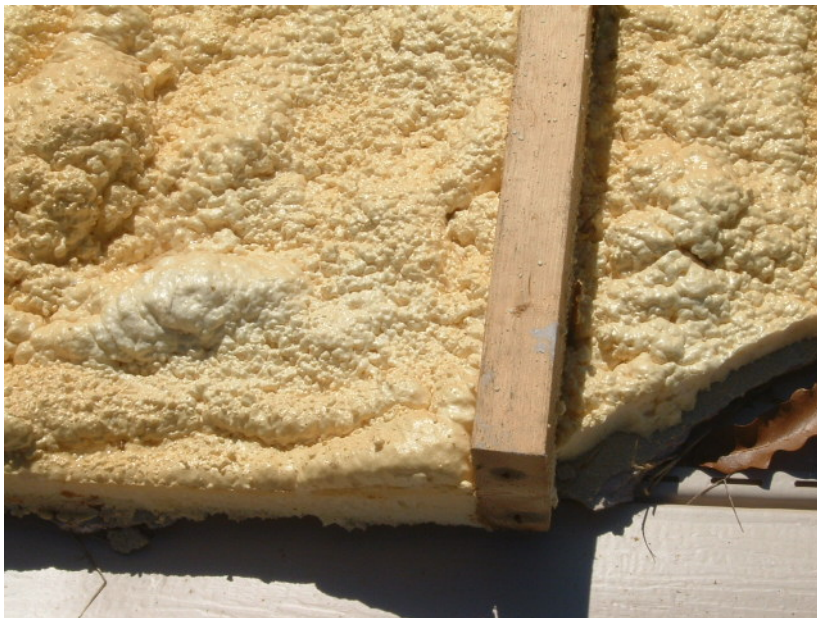
Figure 6-40 Module C-3, Wall 3, Interior. No mold or severe staining was observed at autopsy which occurred 15 months after the flood test.

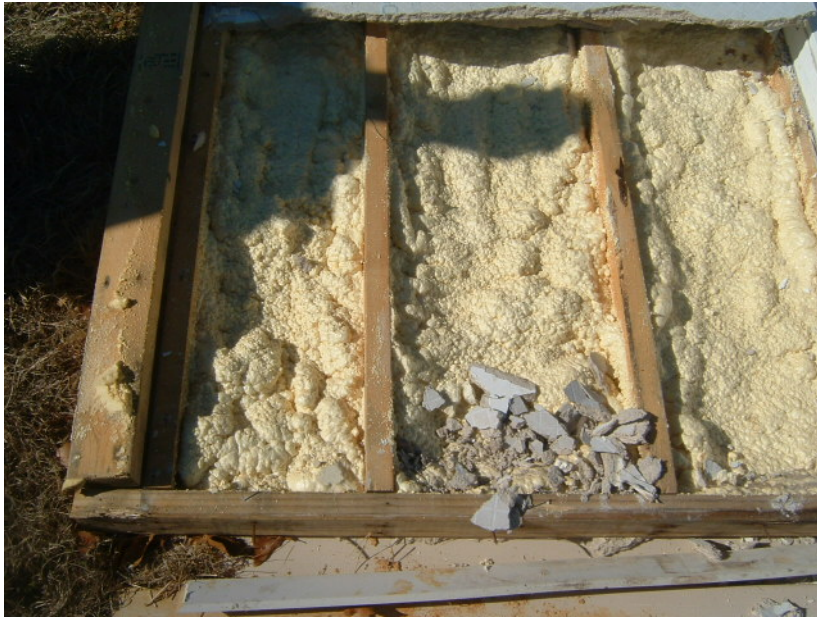
Figure 6-41 Module C-3, Wall 4, Interior. No mold or severe staining was observed at autopsy. The grey debris in the lower portion of the photo is the remains of the interior wall board.

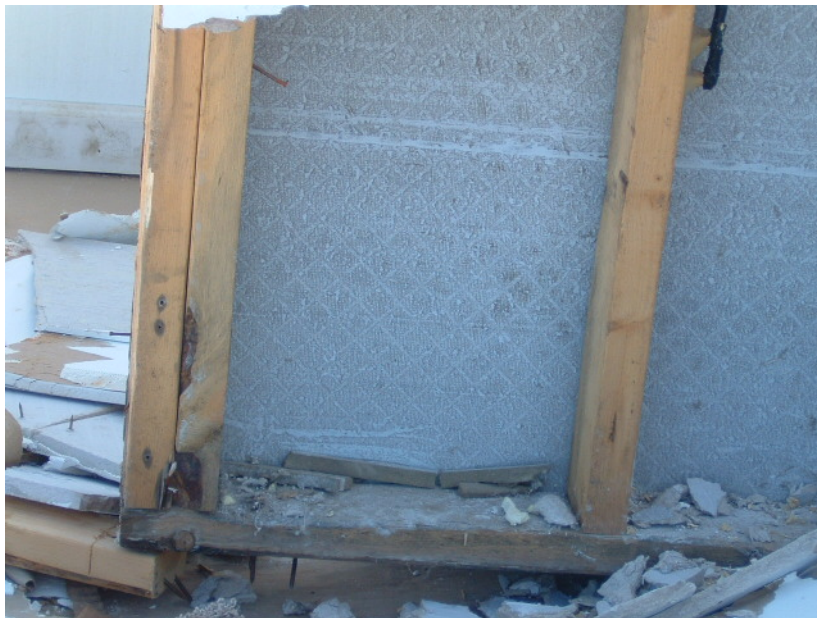
Figure 6-42 Module C-3, Wall 5, Interior. No mold or severe staining was observed at autopsy which occurred 15 months after the flood test.
