WSRC-STI-2008-00228

L-Area Wastewater Storage Drum Evaluation

P. R. Vormelker, D. Z. Nelson, C. N. Foreman, D. J. Hathcock, and D. W. Vinson
Savannah River National Laboratory
Materials Science and Technology

Publication Date: November 2007

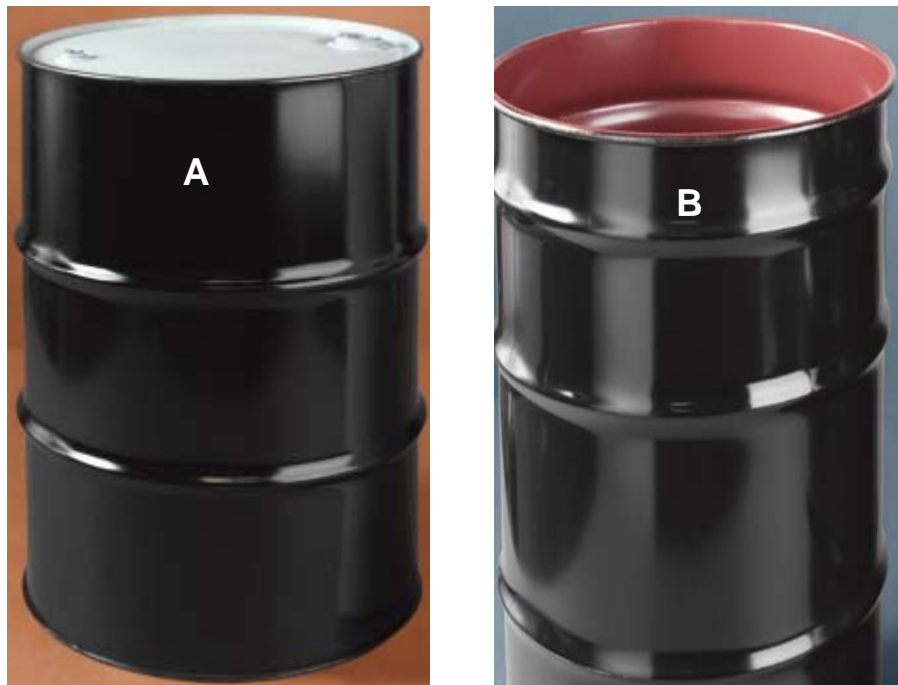
The 55 gallon drums were manufactured by Skolnik Industries out of carbon steel with an epoxy phenolic coating on the interior as shown in Figure 5. The drums are approximately 35 inches tall and 23 inches in diameter. The epoxy phenolic coating (1 mil nominal thickness), applied by Skolnik, is produced by Delta Coatings.

Figure 5. Exterior view of new 55 gallon carbon steel tight head drum (A) in left photo with red epoxy phenolic lined drum (B) shown in right photo (Vendor photographs). Note that the B drum has an extra rolled hoop near the top. SRS drums have two roll hoops as shown in A.

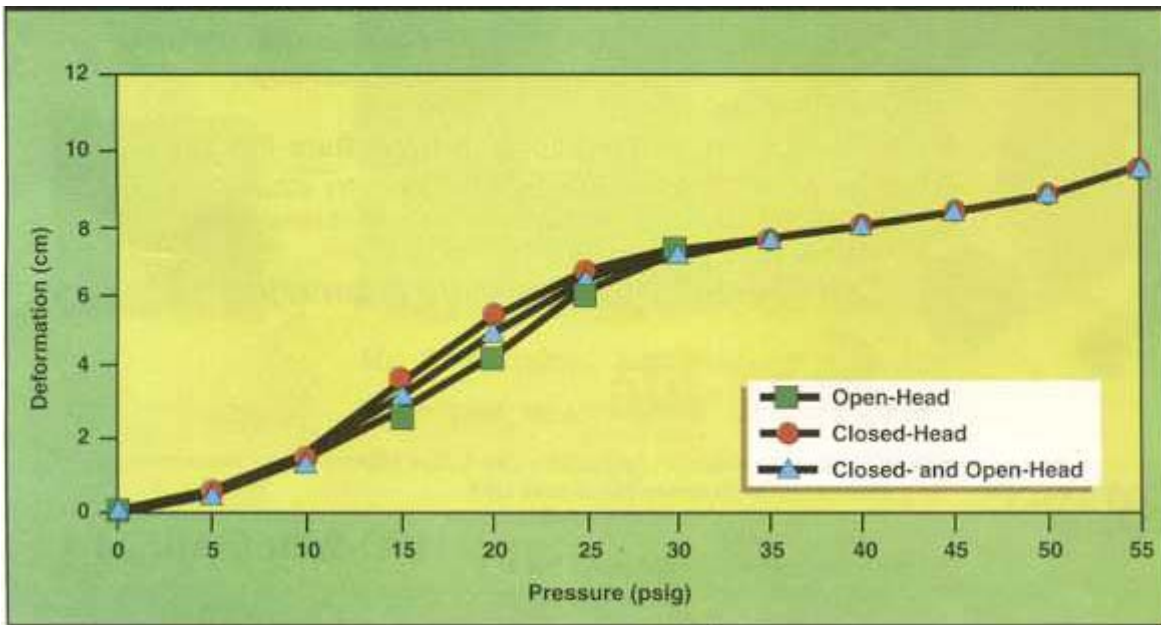
Figure 18. Open-head vs. closed-head drum top deformation averages versus pressure curve (upper graph) for 55 gallon steel drums.[10] The curves overlap each other at low and high pressures, except between 10 and 30 psi.
