Title: **The U. S. NHMFL 60 T Long Pulse Magnet Failure**

¹Abstract—The 60 T long pulse magnet operated by the U. S. National High Magnetic Field Laboratory at Los Alamos National Laboratory, Los Alamos, New Mexico failed catastrophically on July 28, 2000. The failure was investigated and the cause was determined to be unusually low toughness in the nitrogen strengthened manganese stainless steel (Nitronic-40™) reinforcing material. The source of the reduced toughness condition was a sigma phase conversion in the microstructure. The magnet failure, failure investigation and results of the investigation are described. Plans for the construction of the successor magnet, the 60 tesla long pulse Mark II, are described.

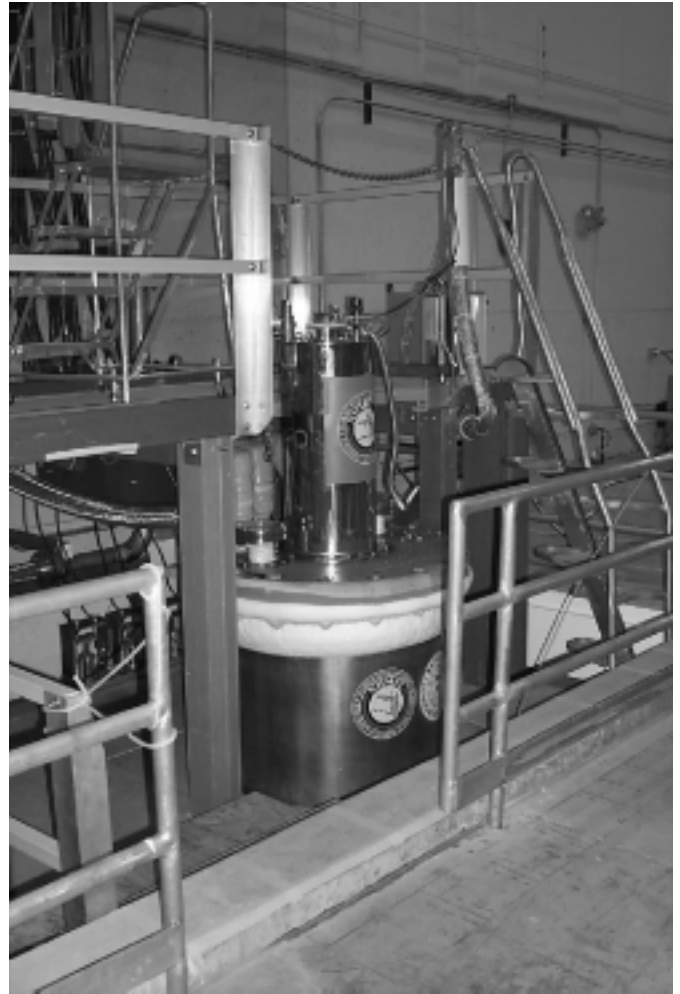
Fig. 1: Photograph of magnet before failure.

correlation energy gap above 40T in a Kondo insulator. These are the first specific heat measurements above 35T and the first ever taken in a pulsed magnet. Fig. 1 is a photograph of the 60 T LP magnet system installed in its pit.
