**Pacific Northwest
National Laboratory**

**Ultrasonic Examination of
Double-Shell Tank 241-AN-102
Examination Completed July 2008**

AF Pardini
DR Weier
KK Anderson

August 2008

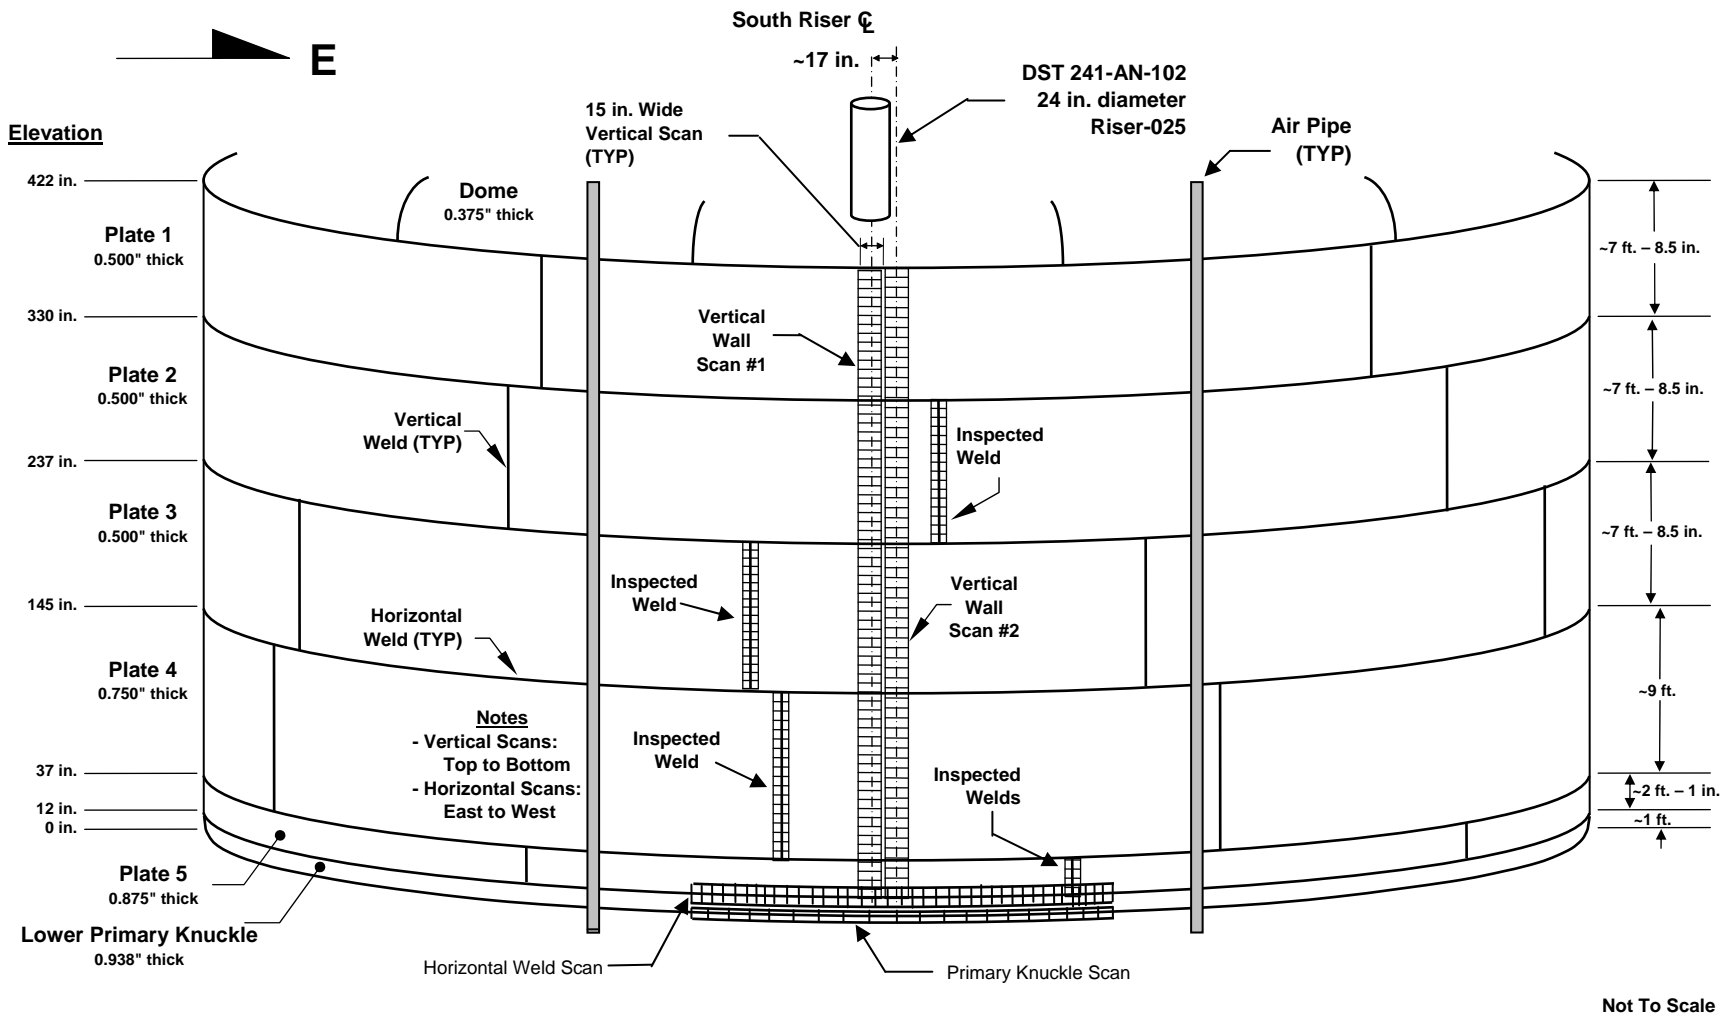
Figure 4.2. Sketch of Scan Paths on 241-AN-102 Primary Tank from Riser 25

Two 15-in.-wide vertical scan paths were performed on Plates #1, #2, #3, #4, and #5 from Riser 25. The plates were examined for wall thinning, pitting, and cracks oriented vertically on the primary tank wall. There were no areas of wall thinning that exceeded the reportable level of 10% of the nominal thickness. No pitting or vertical crack-like indications were detected in Plates #1, #2, #3, #4, or #5.

The HAZ of vertical welds in Plates #2, #3, #4, and #5 from Riser 25 were examined for wall thinning, pitting, and cracks oriented either perpendicular or parallel to the weld. There were no areas of

wall thinning that exceeded the reportable level of 10% of the nominal thickness. No pitting or crack-like indications were detected in the weld HAZ areas in Plates #2, #3, #4, and #5.

The HAZ of the horizontal weld between Plate #5 and the tank knuckle from Riser 25 was examined for wall thinning, pitting and cracks oriented either perpendicular or parallel to the weld. There were no areas of wall thinning that exceeded the reportable level of 10% of the nominal thickness. No pitting or crack-like indications were detected in the weld HAZ areas on Plate #5 side or on the knuckle side of the horizontal weld.

Figure 4.2 describes the areas on the primary wall of Tank 241-AN-102 that were ultrasonically examined from Riser 25 located on the south side of the tank. Two 15-in.-wide vertical scan paths were performed on Plates #1, #2, #3, #4, and #5 below the entrance to Riser 25. Vertical weld HAZ examinations were done on Plates #2, #3, #4, and #5, and the horizontal weld HAZ examination was done on the transition Plate #5 to knuckle weld. The upper and lower portions of the knuckle were also examined.

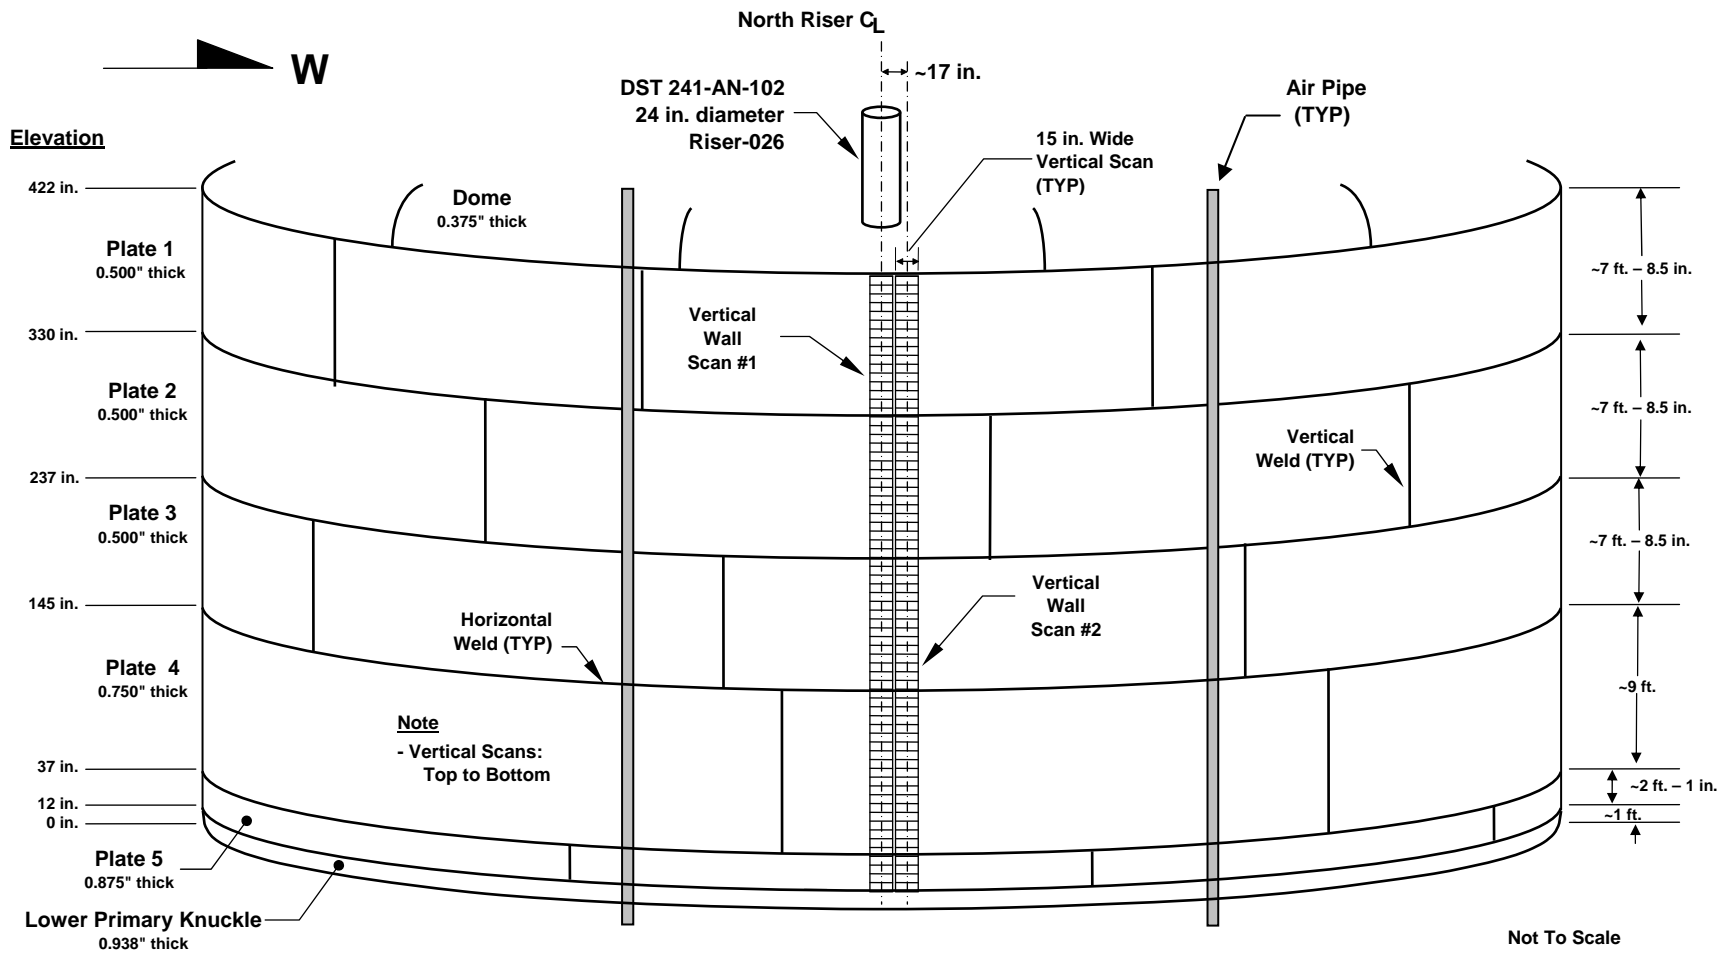
Figure 4.3. Sketch of Scan Paths on Tank 241-AN-102 Primary Tank from Riser 26

Two 15-in.-wide vertical scan paths were performed on Plates #1, #2, #3, #4, and #5 from Riser 26. The plates were examined for wall thinning, pitting, and cracks oriented vertically on the primary tank wall. There was two areas in Plate #3 with minimum thicknesses of 0.446-in. and 0.448-in. that exceeded the reportable level of 10% of the nominal thickness. There were no areas of wall thinning that exceeded the reportable level of 10% of the nominal thickness in Plates #1, #2, #4, or #5. No pitting or vertical crack-like indications were detected in Plates #1, #2, #3, #4, or #5.

Figure 4.3 describes the areas on the primary wall of Tank 241-AN-102 that were ultrasonically examined from Riser 26 located on the north side of the tank. Two 15-in.-wide vertical scan paths were performed on Plates #1, #2, #3, #4, and #5 below the entrance to Riser 26.
