COAL ASH CORROSION RESISTANT MATERIALS TESTING

Topical Report: Removal of Section "C"

THE BABCOCK & WILCOX COMPANY

The “Coal Ash Corrosion Resistant Materials Testing Program” is being conducted by The Babcock & Wilcox Company (B&W), the U.S. Department of Energy (DOE) and the Ohio Coal Development Office (OCDO) at Reliant Energy’s Niles plant in Niles, Ohio to provide full-scale, in-situ testing of recently developed boiler superheater materials. Fireside corrosion is a key issue for improving efficiency of new coal fired power plants and improving service life in existing plants.

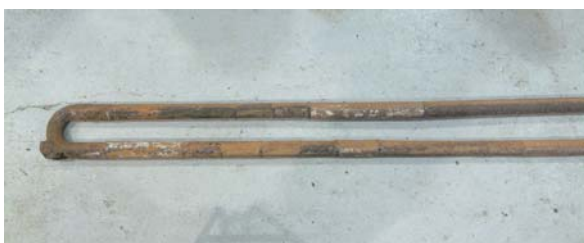
Section B – As Removed

In August 2003, both sections were removed and visually evaluated. This examination revealed that Section C had become distorted due to field maintenance difficulties while Section B was relatively unaffected, see figures below for comparison.

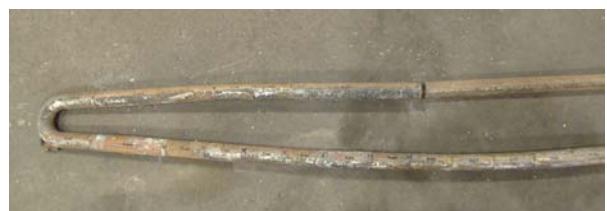
Section C – As Removed

Furthermore, inspection of both sections revealed evidence of tube wastage that suggested that additional tube samples would need to be replaced if either section were to survive to the completion of the program. Based on this, it was decided to remove and replace all of the questionable samples from Section B, then, to put it back into service. It further was decided to use the samples from Section C for the current evaluation. It should be noted that Section B was re-installed into the boiler at the location previously occupied by Section C.

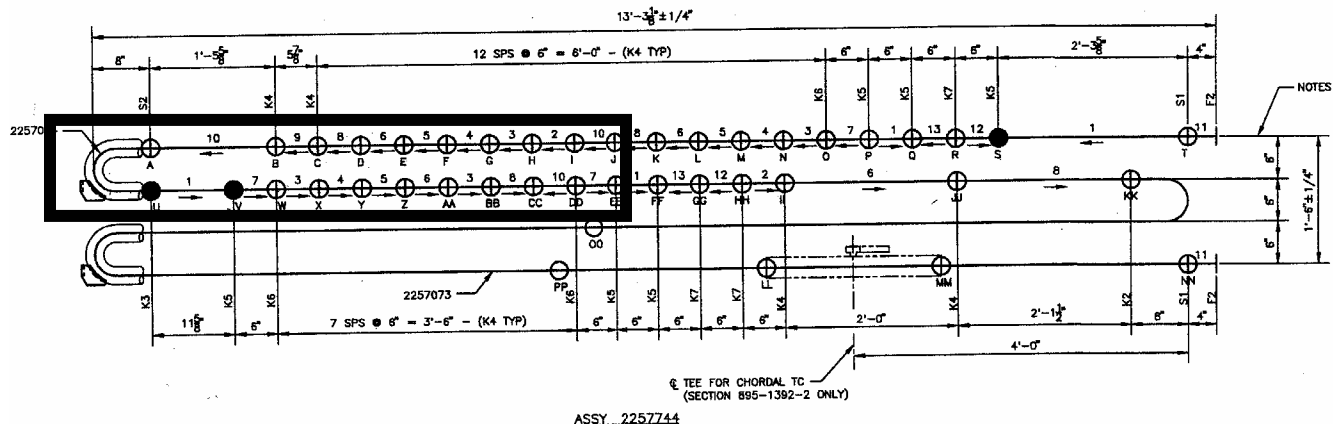
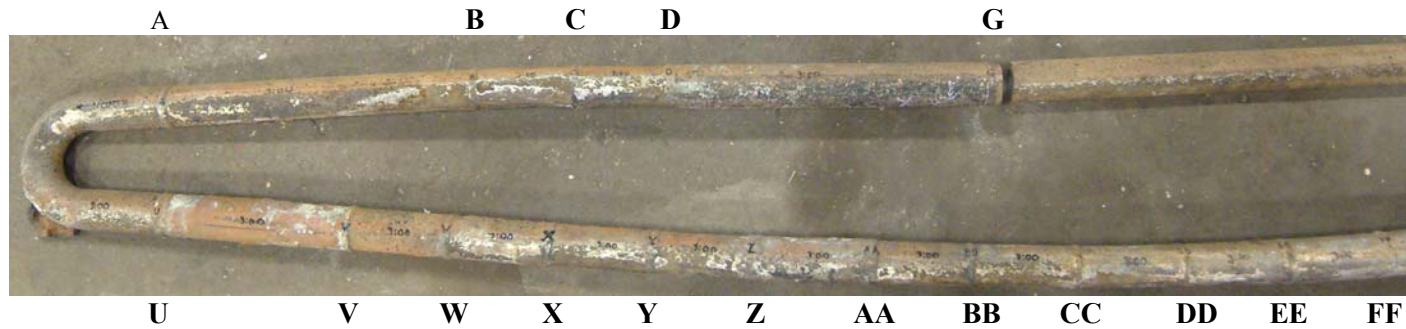
Figure 3: Appearance of Test Section C After Removal From Service (Part 1)

Test Section Appearance Upon Receipt After Exposure: Figures 3 and 4 show the appearance of Test Section C when it was received at the Research Center. Two figures were needed to document the entire length of the test section; however, there is some overlap between them. The weld lettering designations are noted in these figures. The schematic provides a representation of how each tube sample was originally situated within the test section.

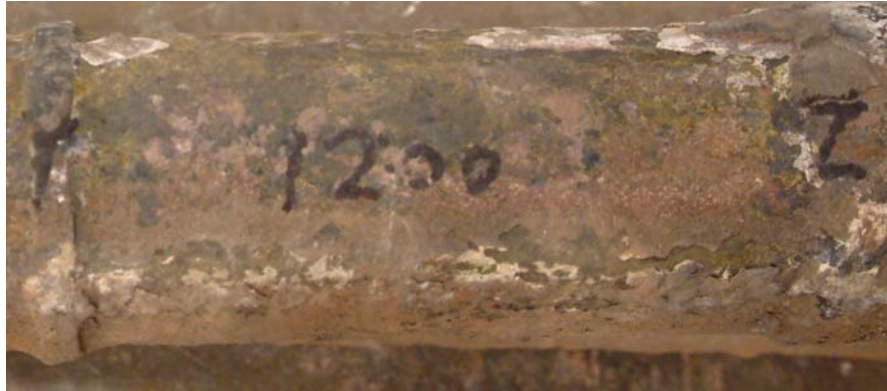
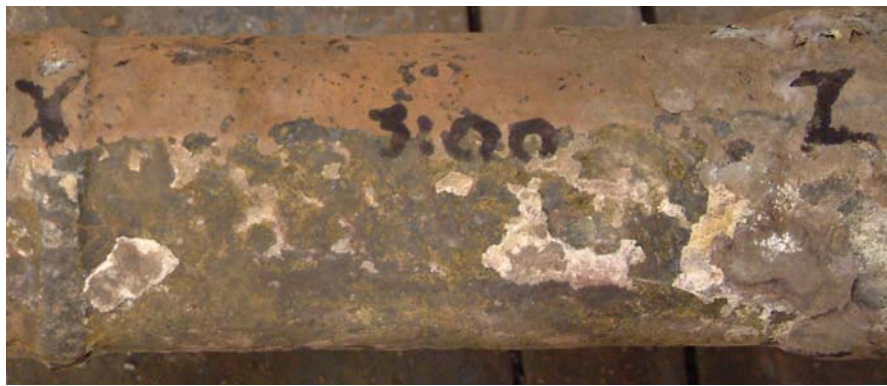
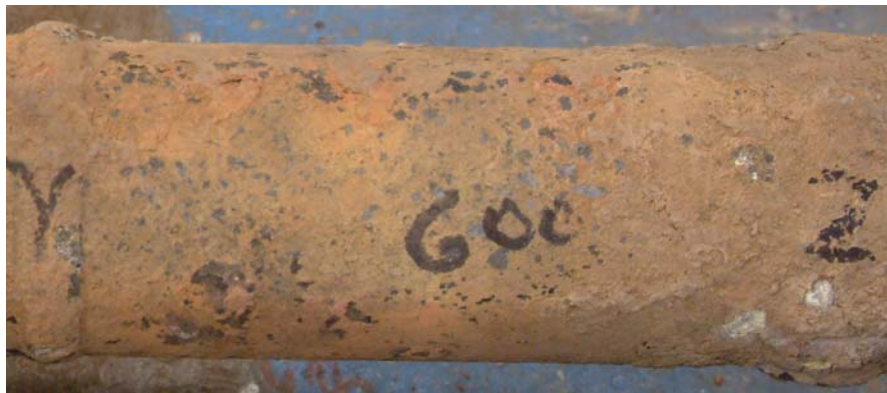
Figure 5: Typical Documentation of As-Received Appearance for Tube Sample Y-Z (Modified 800H)

Note: The chalky alkali-iron trisulfate scale is noted in all three orientations. Differences in coloration are primarily due to lighting effects, with the 3 o'clock orientation being the most accurate in this regard.

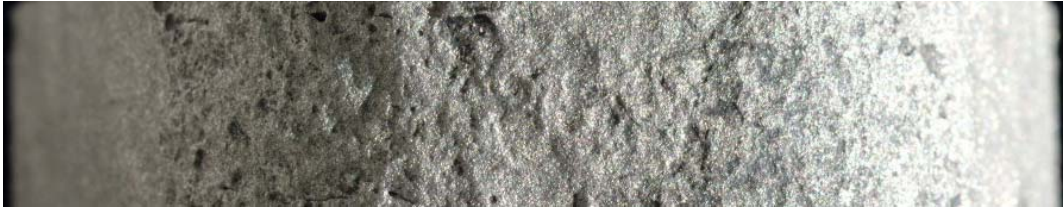
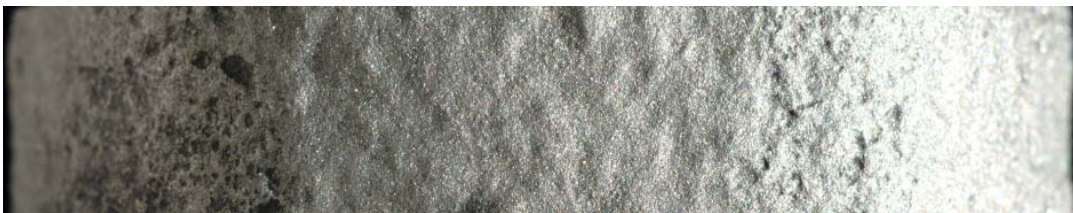
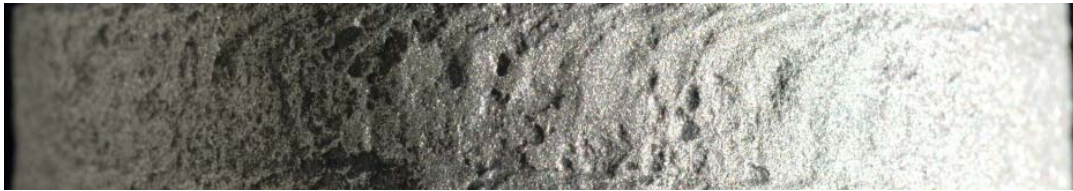
Figure 9: Typical Example of OD Surface Appearance After Grit Blast

12 O'Clock
(N/A mils lost)

3 O'Clock
(106 mils lost)

6 O'Clock
(0 mils lost)

Note: This particular example is for IN52 Weld Overlay, Sample GG-HH.

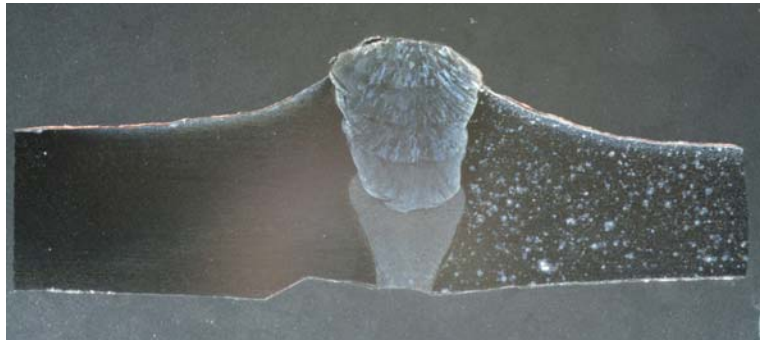
Note: Fe₃Al material to the right of the weld in this image and 347 HFG to the left.

Figure 11: Weld Profile Through Tube Sample Showing Good Corrosion Resistance in the Vicinity of the Weld

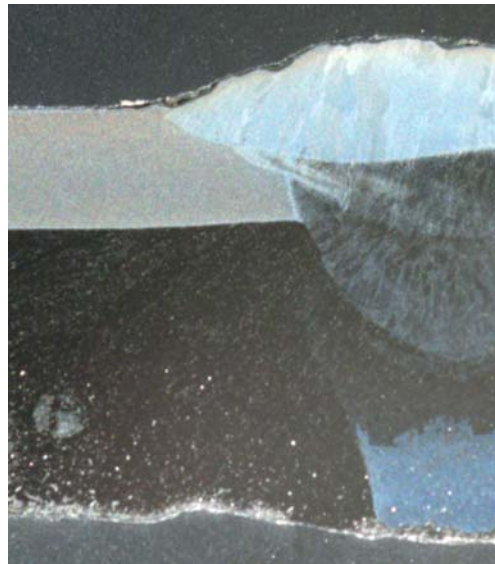
**Figure 12: Weld Profile Through Clad Tube Sample
Incoclad 671 Adjacent to Weld "V" in Section C (at 1121 F)**

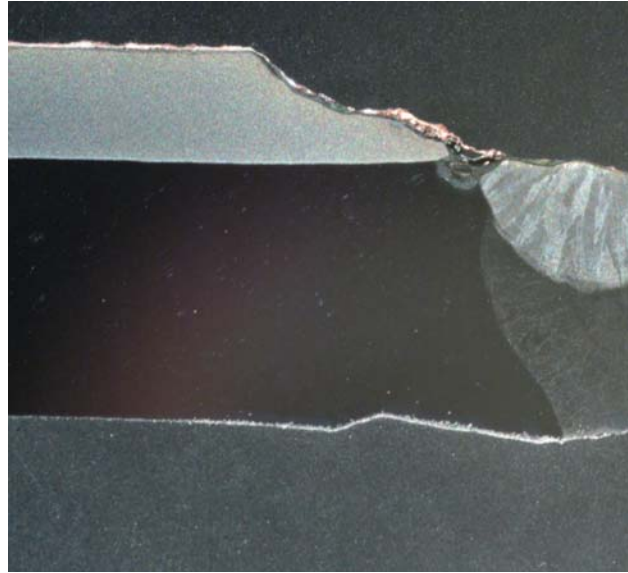
**Figure 13: Weld Profile Through Clad Tube Sample
Incoclad 671 Adjacent to Weld "P" (at 1203 F) in Section C**

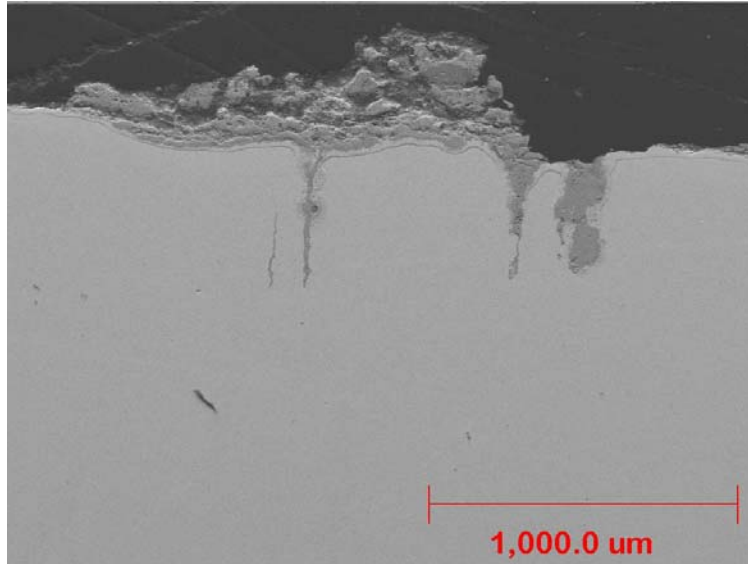
Finally, based on calculated wastage rates, the IN 72 Weld Overlay tube segments consistently have demonstrated excellent corrosion resistance, see Table 8. However, this material appears also concurrently to be suffering from a time-dependent cracking problem. The cracking problem does not appear related to the hot-side corrosion mechanism for this material; however, in at least one case, corrosion had removed enough material to reveal and penetrate along an underlying crack. If this additional loss of wall thickness had been taken into account, the calculated corrosion rate would have increased by more than fifty percent. The extent of the IN 72 Weld Overlay cracking problem was first discovered when the material was examined in the SEM along with the other eleven candidate materials. Figure 18 shows an SEM image of one region where underlying cracks intersected the tube surface.

Figure 18: Weld Cracks Intersecting External Corrosion for 72 WO Test Segment

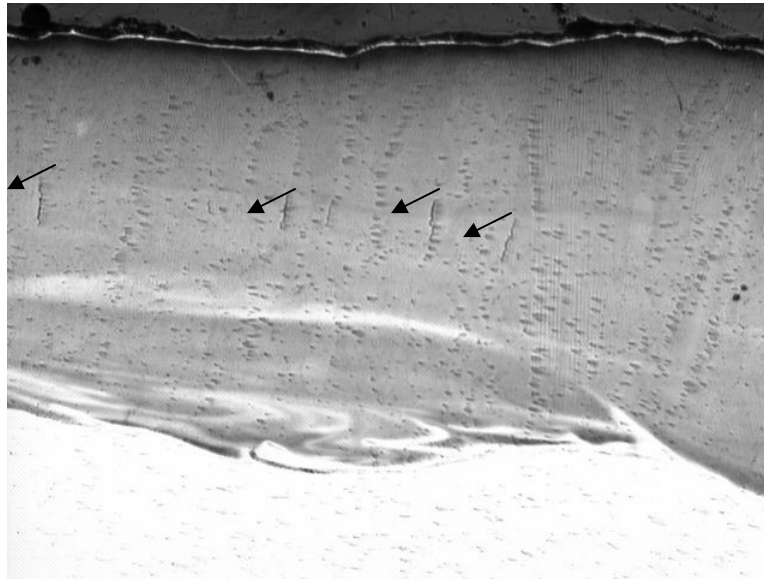
The cracking shown in Figure 18 spurred further investigation. Figure 19 shows evidence of cracking at other locations in this tube segment. Note that the cracking appears to be at roughly the mid-point of the 72 Weld Overlay cladding, and does not contain a corrosion product. Similar cracking was found for both 72 Weld Overlay test segments in Section C. Closer examination of Section A samples revealed the same sort of sub-surface cracking, but to a somewhat lesser extent. Finally, examination of an archive 72 Weld Overlay tube sample revealed a few similar internal cracks, see Figure 20.

Figure 19: Internal Cracking in 72 Weld Overlay Test Segment from Section C

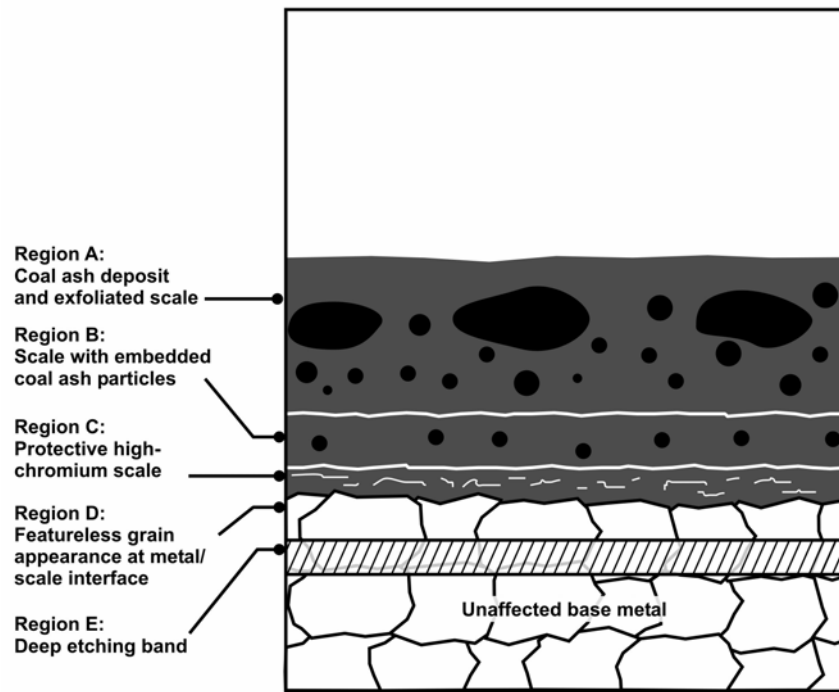
Figure 24: Common Characteristics at External Scale/Metal Interface

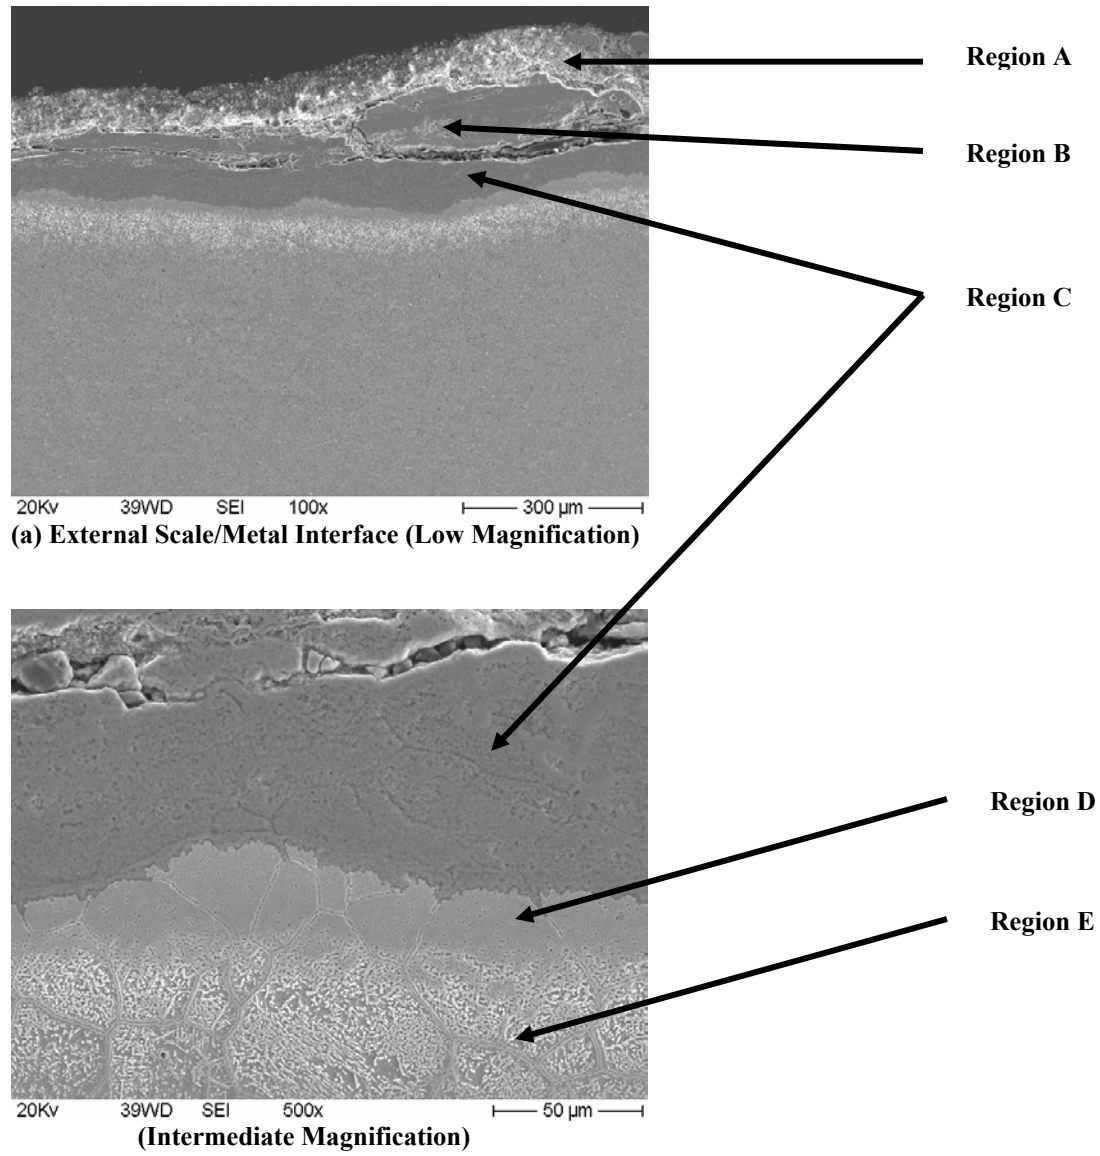
Figure 25: Illustrates the Characteristic Microstructural Regions Found at the External Scale/Metal Interface for Many of the Candidate Materials.

Note: These photographs are of the scale/metal interface for NF 709.

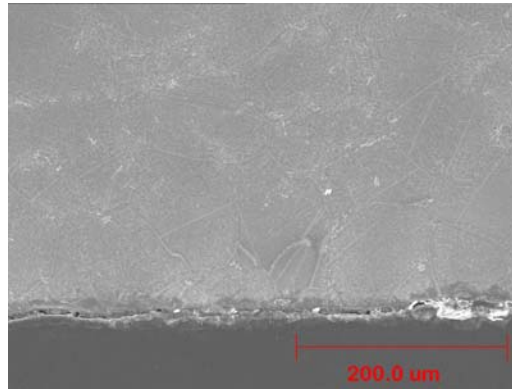
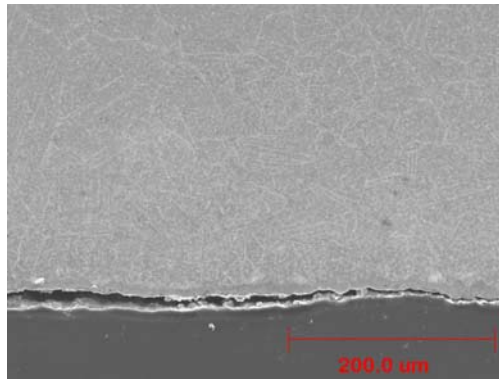
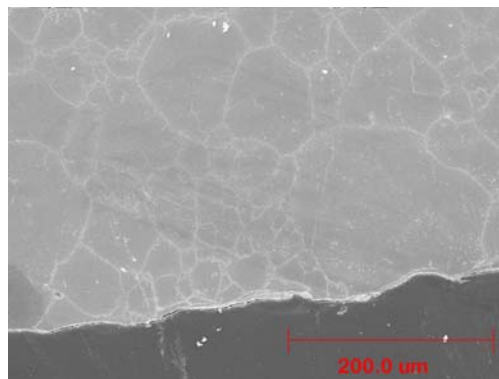
Internal Scale/Metal Interface for Type 310 Ta

Internal Scale/Metal Interface for HR 120

Internal Scale/Metal Interface for Save 25

Figure 27 Typical Examples of the Condition of the Internal Scale/Metal Interface after Service

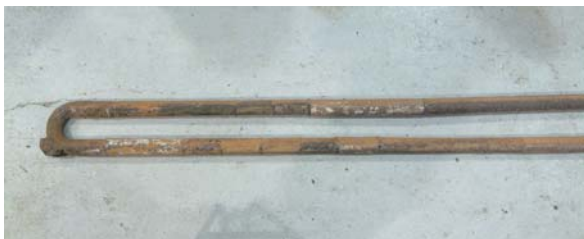
Section B – As Removed

The system ran through July with the control valves locked open to keep the sections cool and minimize further corrosion. As planned, the top two rows of both of the remaining sections (B&C) were removed in August during a brief unscheduled outage and replaced with the bends sent in early July. Both Sections were transported to the B&W Research Center (BWRC) and metal loss was preliminarily assessed using calipers. Based on those measurements the remaining life of each specimen was considered in regard to operating an additional 18 months. Since the Section taken from the C position (farthest from the boiler sidewall) was badly distorted but the one from the B (middle) location is in good condition, it was decided to replace the specimens in Section B whose remaining life would not be expected to achieve 18 more months and reinstall it in the boiler in the C location during the fall outage to obtain additional operating time.

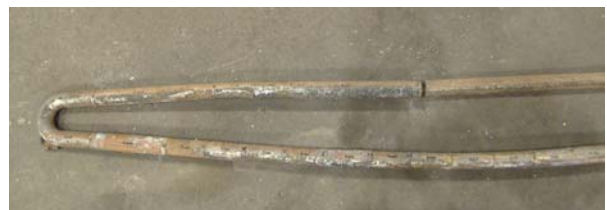
Section C – As Removed

A visit was made to the plant on June 19 to inspect the existing tubes in more detail. Both supports on the baffle wall of all three Sections had moved off the support lugs. The lower test row of Section C was bowed downward and was touching the adjacent 3rd row (from the top). The upper row of Section C had significant wastage in two of the samples (310Ta and 310HCbN). Most of the unclad samples in Section B showed significant wastage as well. There was concern that the thinning walls of Sections B and C would not last until the fall outage so two bends were weld prepped and plans were made so the plant could remove the top two rows of both Sections, ship them to Alliance, Ohio for evaluation, and install the bends to connect the top two rows. Once the top two rows were removed the valves would be left open (run cool) until the fall outage when the two new Sections will be installed for the USC Materials Project (DE-FG26-01NT41175 and OCDO D-00-20). If Section B could be sufficiently 'repaired' by replacing the corroded samples with new ones to be confident it could operate for another 1.5 to 2 years it would be reinstalled.

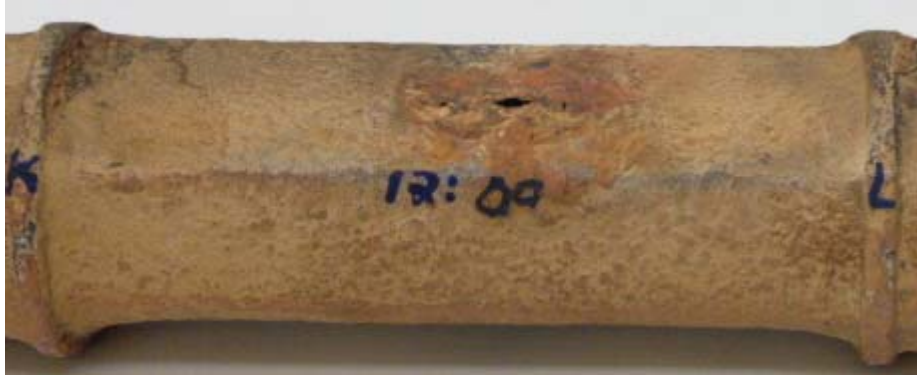
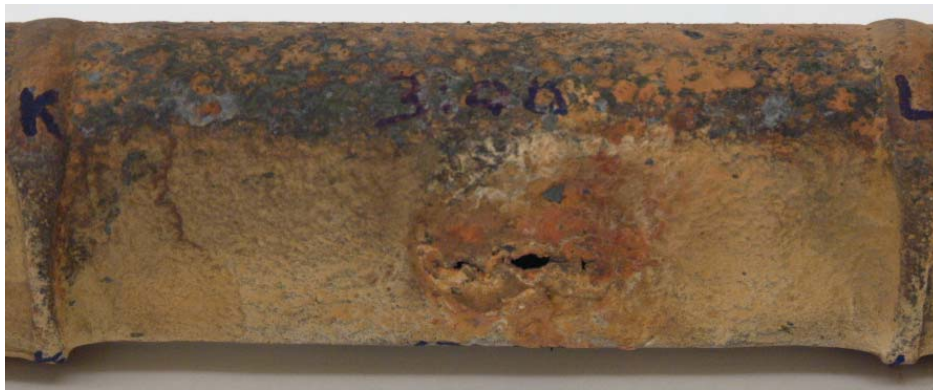
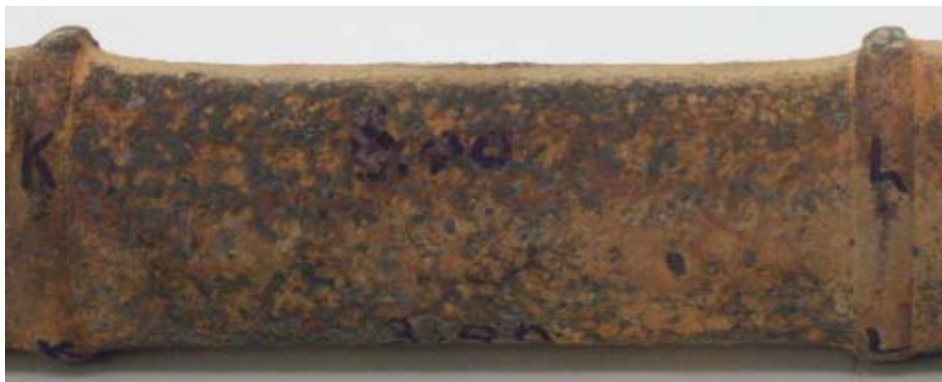
Figure A-4: As-Received Appearance of Sample K-L (Save 25)

12 O'Clock – Facing Gas Flow
(Note: 3 o'clock is up in this image)

3 O'Clock
(Note: 6 o'clock is up in this image)

6 O'Clock – Opposite Gas Flow

(Average metal temperature: 1180 F)

Note: this tube sample was removed from service on 11/6/01

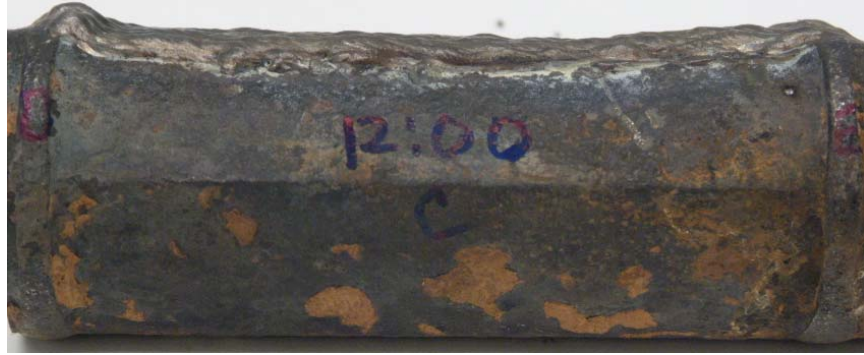
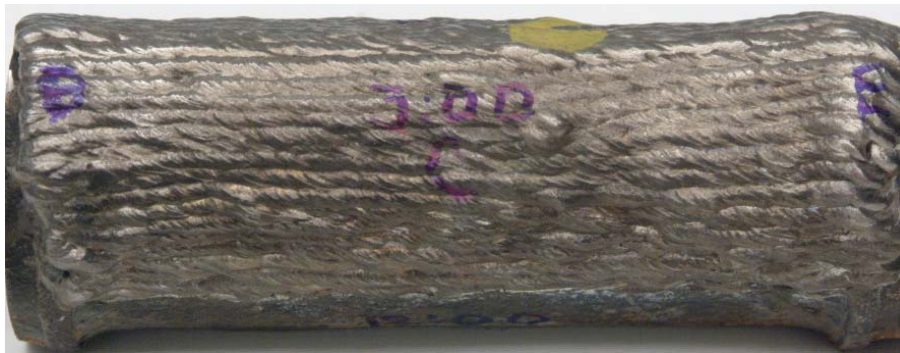
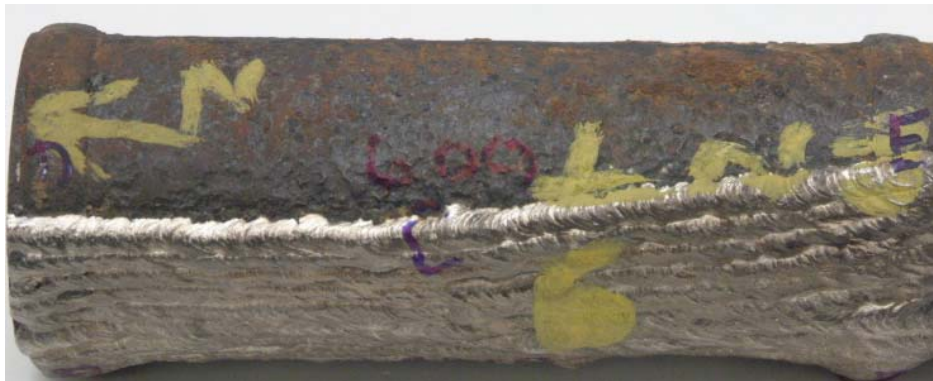
Figure A-5: As-Received Appearance of Sample D-E (Save 25)

12 O'Clock – Facing Gas Flow
(Note: 3 o'clock is up in this image)

3 O'Clock
(Note: 6 o'clock is up in this image)

6 O'Clock – Opposite Gas Flow

(Average metal temperature: 1158 F)

Note: this tube sample was surface clad to extend life.
This tube sample was removed from service on 6/10/02

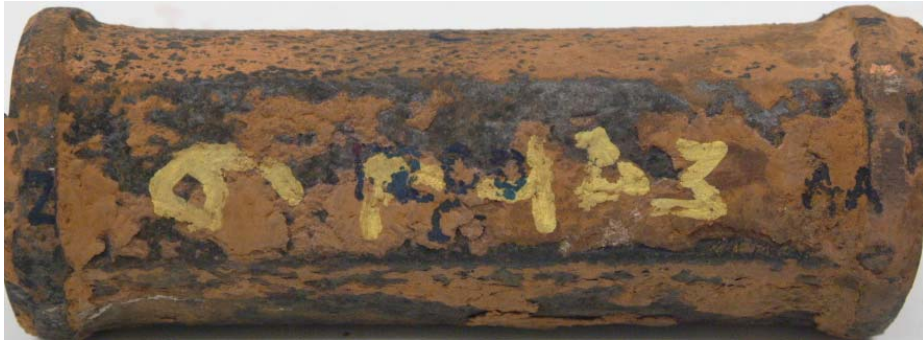
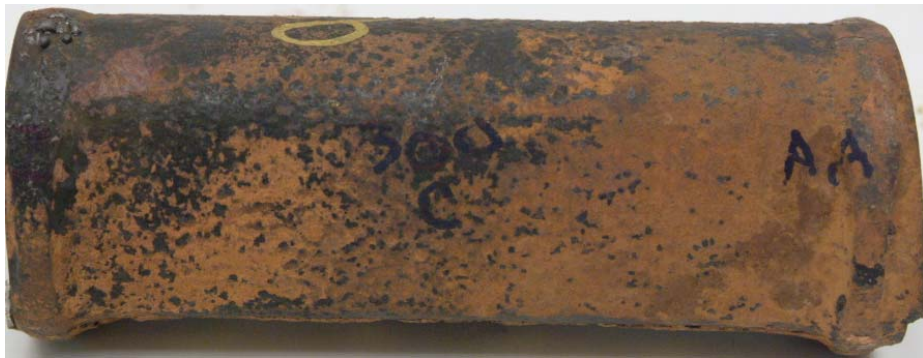
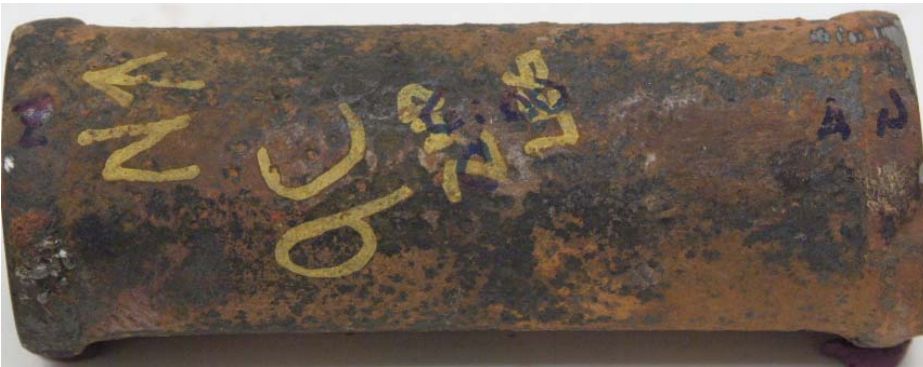
Figure A-6: As-Received Appearance of Sample Z-AA (Save 25)

12 O'Clock – Facing Gas Flow
(Note: 3 o'clock is up in this image)

3 O'Clock
(Note: 6 o'clock is up in this image)

6 O'Clock – Opposite Gas Flow

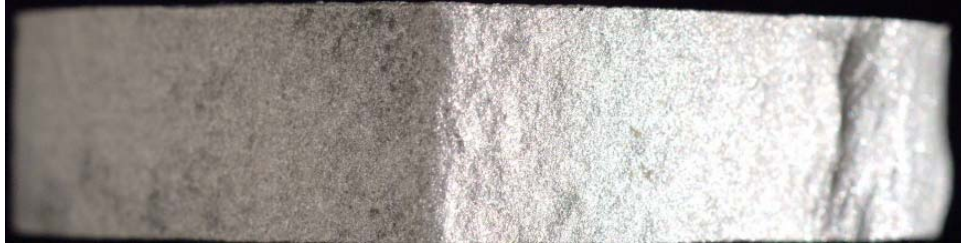
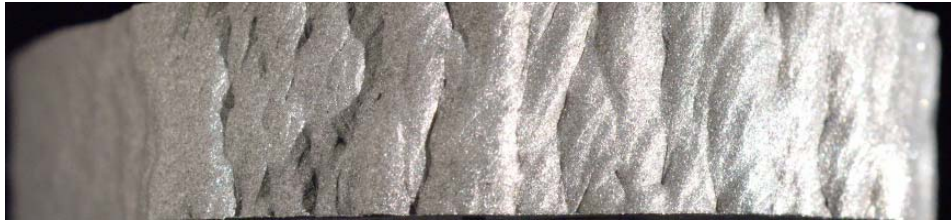
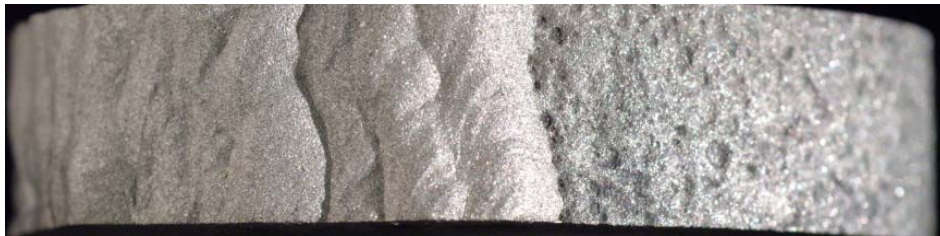
Figure A-9: OD Surface Appearance After Grit Blast

Grit-Blasted Surface Appearance	<ul style="list-style-type: none"> • Figures A-8 through A-11 show the appearance of the external surface of the Save 25 tube samples after grit-blasting to remove deposit and scale. The 12 o'clock and 3 o'clock positions for all four samples show the appearance of general wastage due to fireside corrosion. • With the exception of Sample II-JJ, all of the Save 25 samples showed significant pitting at the 6 o'clock position.
Wall Thickness Loss Determined	<ul style="list-style-type: none"> • Tube cross-sections were prepared to allow for measurement of wall thickness to determine metal loss due to exposure. These are shown in silhouette in Figures A-12 through A-15. • The same relative "o'clock" positions were maintained as discussed earlier. Measurements were taken at eight evenly spaced locations about the tube circumference. These were then compared with measurements taken at these same locations prior to exposure. • The before and after measurements were documented in the table that accompanies each figure. These form the basis for the "delta" calculation to determine the amount of wall thickness lost. • In some cases, the minimum wall thickness in the cross section was not at one of the eight predetermined locations, (Samples K-L and II-JJ are examples). In these cases, there was no "before" measurement for comparison. So, the average "before" wall thickness was used to calculate the wall thickness lost at these off locations. • For Sample K-L, the wall was completely perforated, so, it was not possible to determine an accurate maximum rate of metal loss.

3 O'Clock
(Not this shows the condition of the weld overlay build-up, not the original surface.)

6 O'Clock
(The weld overlay can be seen to the left in this image. The original surface is to the right.)

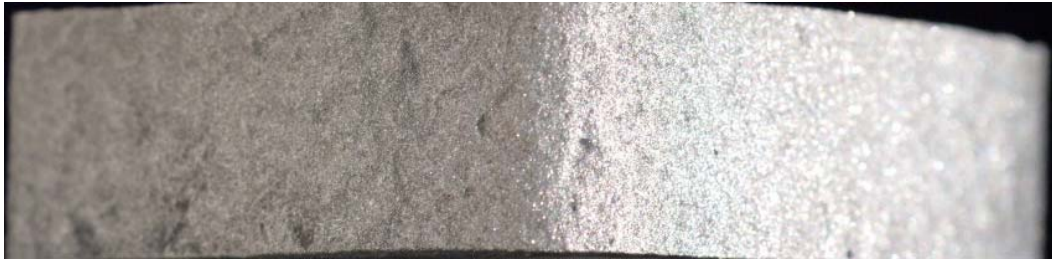
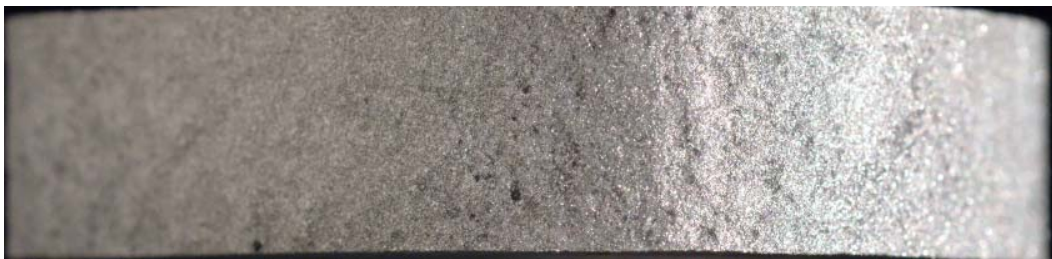
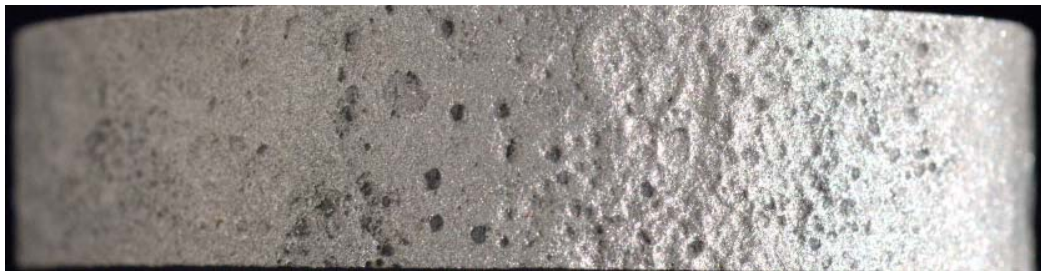
Figure A-10: OD Surface Appearance After Grit Blast

12 O'Clock
(253 mils lost)

3 O'Clock
(207 mils lost)

6 O'Clock
(0 mils lost)

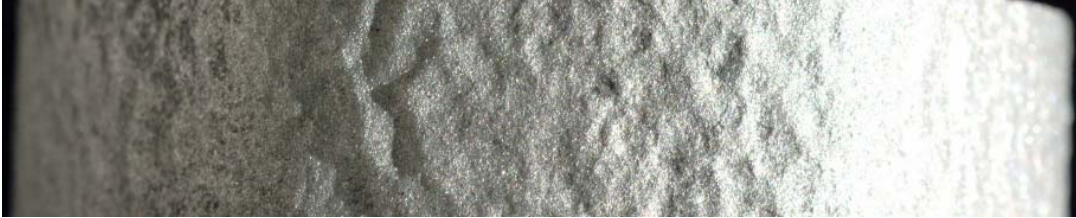
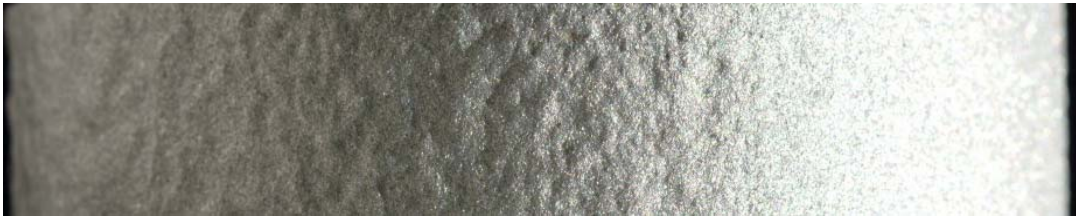
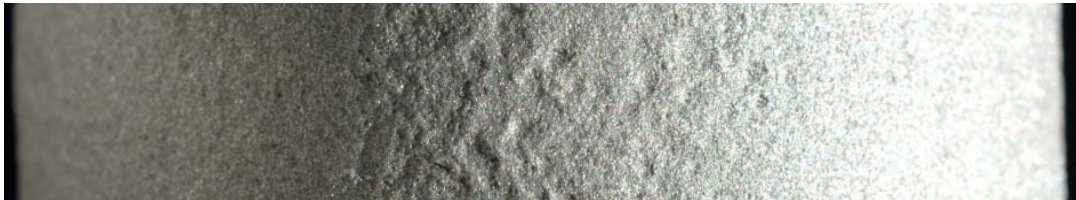
Figure A-11: OD Surface Appearance After Grit Blast

12 O'Clock
(106 mils lost)

3 O'Clock
(74 mils lost)

6 O'Clock
(6 mils lost)

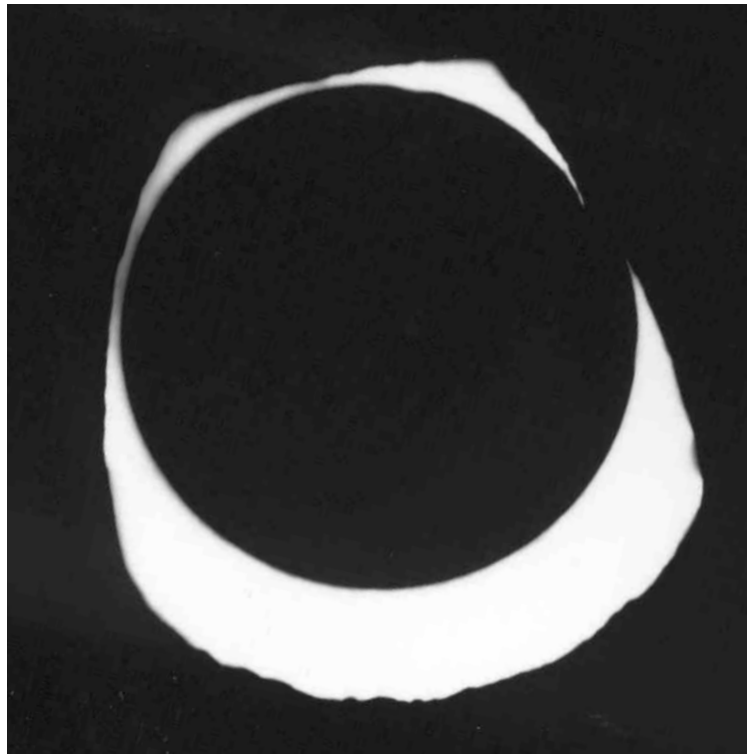
Sample Location: K-L
Maximum Rate: >259 mils/yr
Maximum Loss Orientation: Approx. 2:30 o'clock
Average metal Temperature: 1180 F

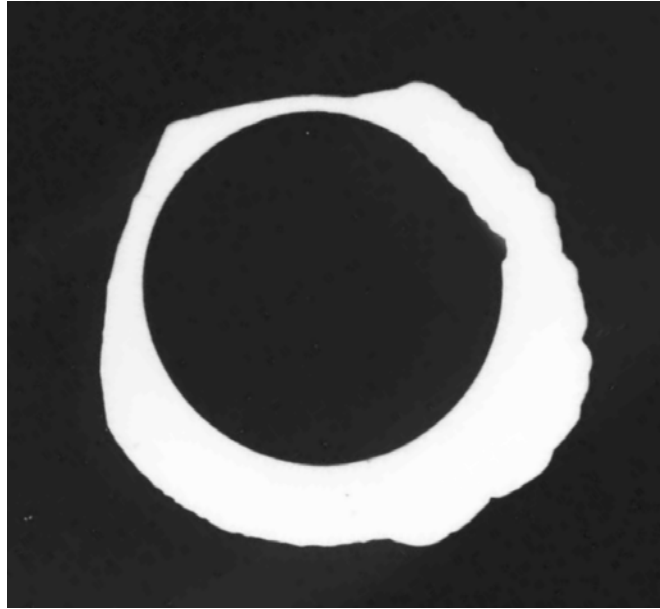
Material: SAVE 25
Sample Location: D-E
Maximum Rate: N/A mils/yr
Maximum Loss Orientation: N/A
Average metal Temperature: 1158 F

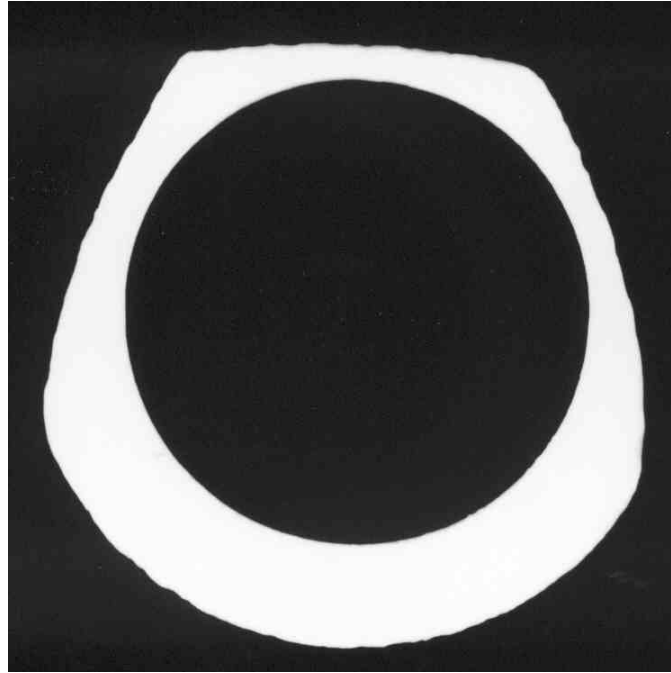
Material: SAVE 25
Sample Location: Z-AA
Maximum Rate: 148 mils/yr
Maximum Loss Orientation: Approx. 2:30 o'clock
Average metal Temperature: 1096 F

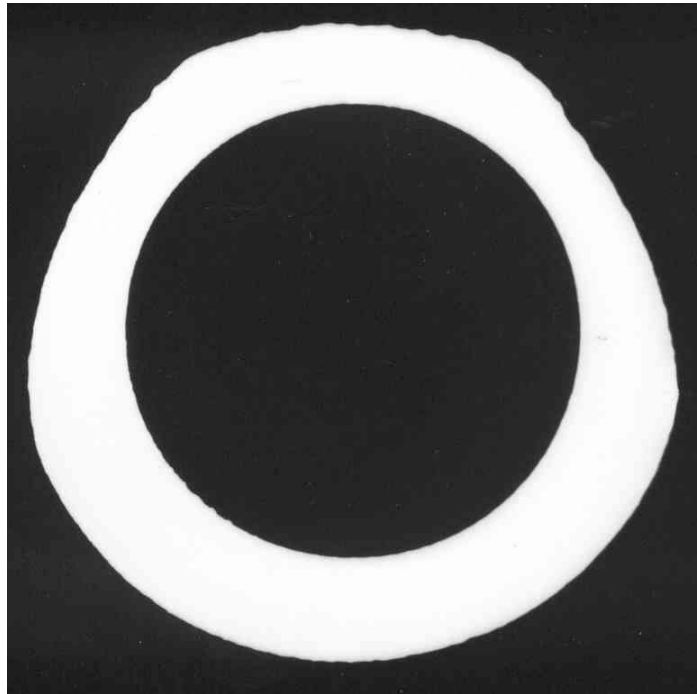
Figure A-15: Silhouette and Wall Thickness Measurements for Sample II-JJ

Material: SAVE 25
Sample Location: II-JJ
Maximum Rate: 56 mils/yr
Maximum Loss Orientation: Approx. 2:30 o'clock
Average metal Temperature: 1058 F

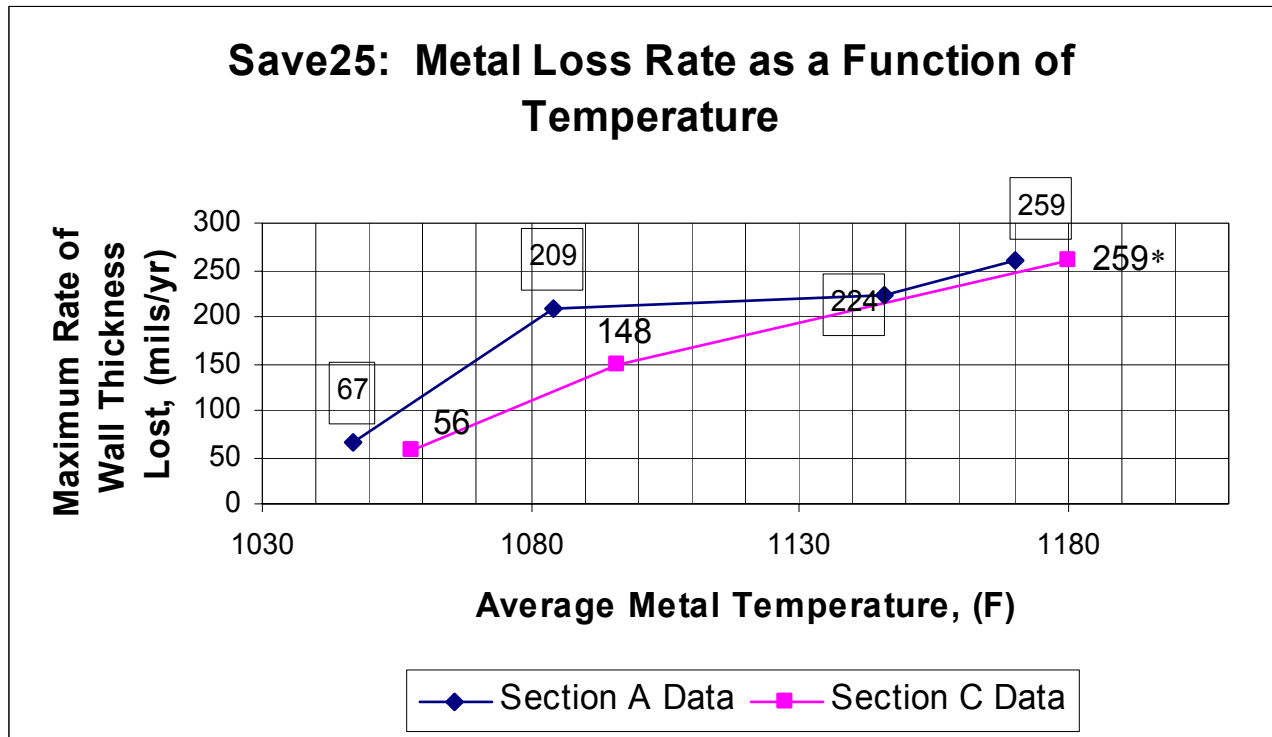
Figure A-16: Metal Loss Rate as a Function of Temperature

The metal loss rate for the Save 25 samples increased with average surface metal temperature over the range of exposure for Section C, i.e. from 1058 F to 1180 F. The rate of metal loss at the highest temperature, in excess of 259 mils per year*, was adequate to perforate the tube wall within 18.6 months of exposure. This was the highest rate of metal loss for any of the candidate alloys. Save 25 continued to demonstrate poor resistance to corrosion down to an average surface metal temperature of about 1096 F. Sample II-JJ, which saw exposure at 1058 F, experienced a moderate rate of metal loss of 58 mils per year. More than half of the wall thickness remained at the end of the Section C exposure period for this sample.

Issue	Discussion
Wall Thickness Loss Versus Average Metal Temperature	<ul style="list-style-type: none"> • The chart in Figure A-16 plots the maximum wall thickness lost against the calculated average surface metal temperature for each of the four Save 25 samples. • As a general trend, it is apparent that the rate of attack increases continuously as the temperature is raised over the interval of roughly 1040 F to 1180 F. • It also was noted that Save 25 suffers minimal wall reduction at 1040 F, but that the rate of metal loss increases dramatically when the temperature is raised to 1080 F. • The observed high rate of metal loss provides the reason that all of the Save 25 samples that saw an exposure of 1080 F and above have been removed from service. At this point only the II-JJ sample (at 1040 F) remains in service for Section B.
Wall Thickness Loss as a Function of Time and Location	<ul style="list-style-type: none"> • The chart in Figure A-17 plots metal loss as a function of time for three of the four sample locations Sections A and C. with samples from Section C having experienced generally longer exposure times. Note: Sample D-E data was not plotted because this sample had been overlain with weld metal in Section C, so, no data was available for this sample. • The (401 mils) data point for Sample K-L represents complete penetration of the wall. • While the data is very limited, data for Sample Z-AA suggest that the corrosion rate slowed with time after an initial rapid loss of wall thickness.

Note: In analyzing these data it is important to understand that the three of the four Section C samples were removed early due to excessive corrosion losses. Sample K-L (1180 F) was removed in November 2001, shortly after the Section A samples. At the same time, Sample D-E (1158 F) had its' wall thickness built-up using a weld overlay. It then was removed from service at the same time as Sample Z-AA in June 2002. The weld overlay destroyed wall thickness data for Sample D-E and accounts for the fact that no data is plotted for this sample for Section C. Sample II-JJ (1058 F) was removed with the remaining Section C samples in May 2003.

* - The wall thickness for this sample was completely penetrated; therefore, this data point represents a minimum rate of loss.

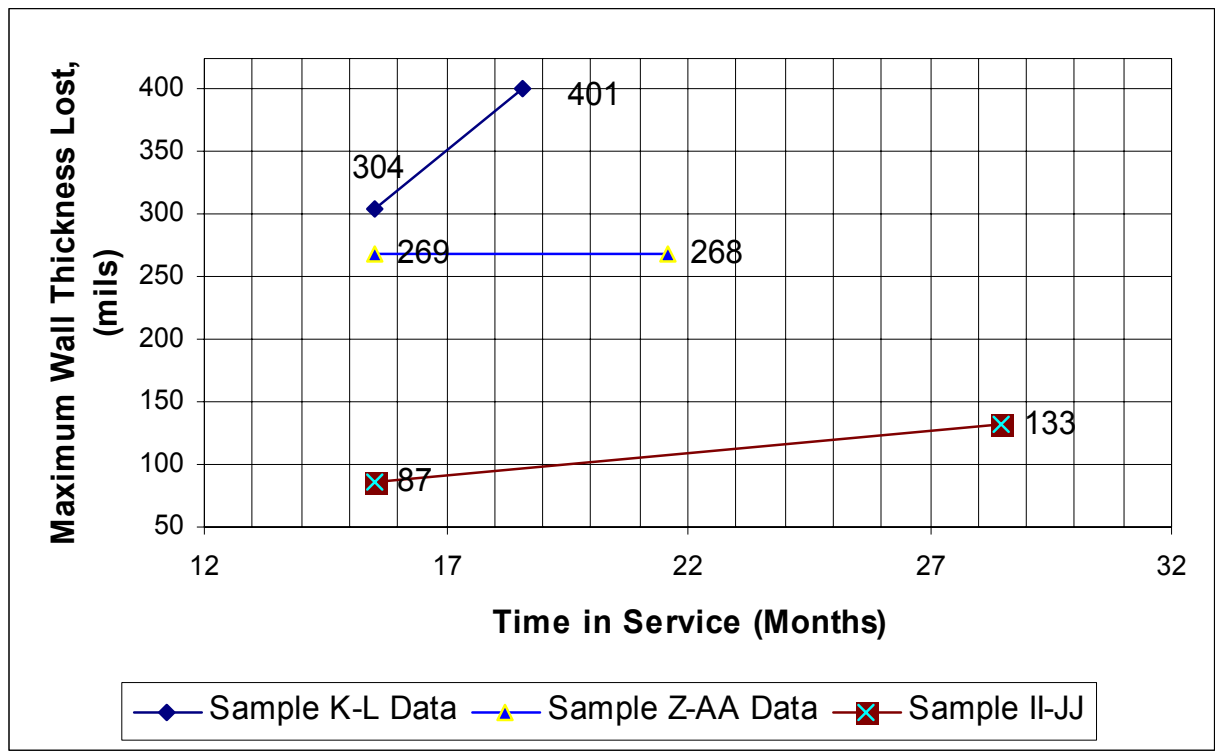
Figure A-17: Metal Loss as a Function of Time

Note: From the plot above it can be seen that Sample K-L from Section C, which was completely perforated, had somewhat more exposure than the Section A samples, even though it was removed at roughly the same time, i.e. November 2001. There was no data for the D-E sample from Section C due to the fact that it was overlain with weld metal. Sample Z-AA from Section C was removed in June 2002. Sample II-JJ experienced the full exposure life for both Sections A and C.

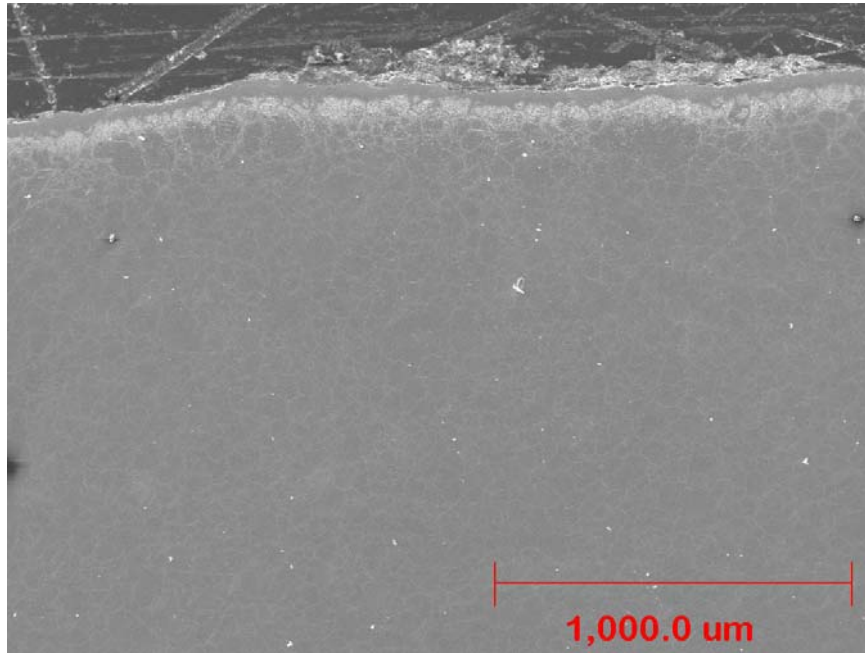
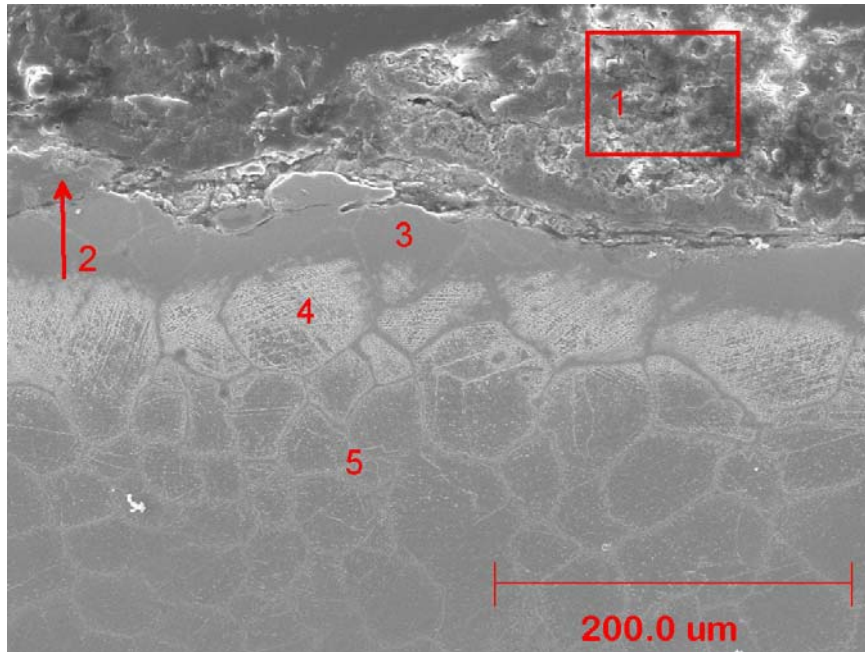
Figure A-18: SEM Microstructure: Save 25

(a) External Scale/Metal Interface (SEI - Low Magnification)

(b) External Scale/Metal Interface (SEI - Intermediate Magnification)

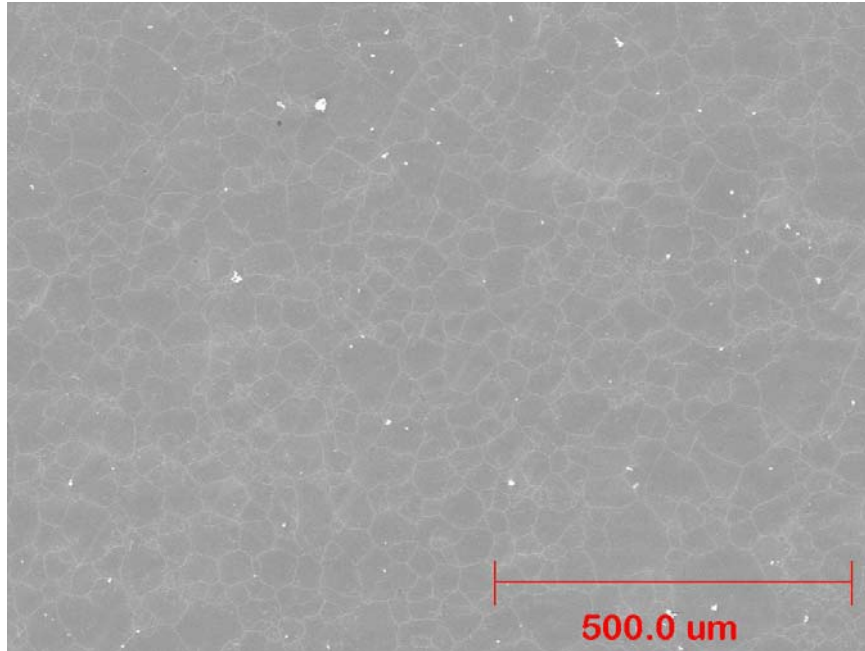
Figure A-19: SEM Mid-Wall Microstructure: Save 25

Issue	Discussion
Metallurgical Analysis – SEM, Continued.	<ul style="list-style-type: none"> • Figure A-19 shows the appearance of the microstructure at mid-wall. • Figure A-20 shows the appearance of the internal surface for Sample II-JJ. Little evidence of an oxide scale was found. While it cannot be stated conclusively without further investigation, the irregular surface contour at the internal surface suggest that this surface had experienced metal loss due to steam-side oxidation, but that the scale subsequently had spalled away from the surface.
EDS Analysis Results	<ul style="list-style-type: none"> • The table in Figure A-21 provides a summary of the EDS analyses of the locations numbered in Figure A-18b. Also shown in this table is a summary of the spectrographic analysis reported earlier, in Figure A-2. • Review of this table suggests the following: <ul style="list-style-type: none"> • <u>Area 1: Bulk deposit/scale analysis</u> – Alkali metals are present. Sulfur and phosphorous are present in an increased amount compared to the base metal. An iron oxide is likely, as are aluminum, silicon and titanium oxides. Carbon content is relatively high, however, EDS is reliable qualitatively but not quantitatively for light elements such as carbon. This suggests that carbon is present, but the exact amount is unknown. • <u>Area 2: Adherent scale</u> – This appears to be comprised of an chromium-, iron-, and nickel-rich oxide. Again of significance here is the presence of sulfur and carbon. • <u>Area 3: Diffusion zone – dark etching</u> - This is leading edge of the metal adjacent to the scale/metal interface. This region is depleted in chromium. Oxygen and perhaps carbon ingress are suggested by this analysis. • <u>Area 4: Diffusion zone – light etching</u> – The analysis here is practically indistinguishable from that of the bulk tube alloy. • <u>Area 5: Tube metal composition</u> – Given its limitations this EDS analysis compares favorably with that of the reference spectrographic analysis below it.
