COAL ASH CORROSION RESISTANT MATERIALS TESTING

Topical Report: Removal of Section "C"

THE BABCOCK & WILCOX COMPANY

The “Coal Ash Corrosion Resistant Materials Testing Program” is being conducted by The Babcock & Wilcox Company (B&W), the U.S. Department of Energy (DOE) and the Ohio Coal Development Office (OCDO) at Reliant Energy’s Niles plant in Niles, Ohio to provide full-scale, in-situ testing of recently developed boiler superheater materials. Fireside corrosion is a key issue for improving efficiency of new coal fired power plants and improving service life in existing plants.

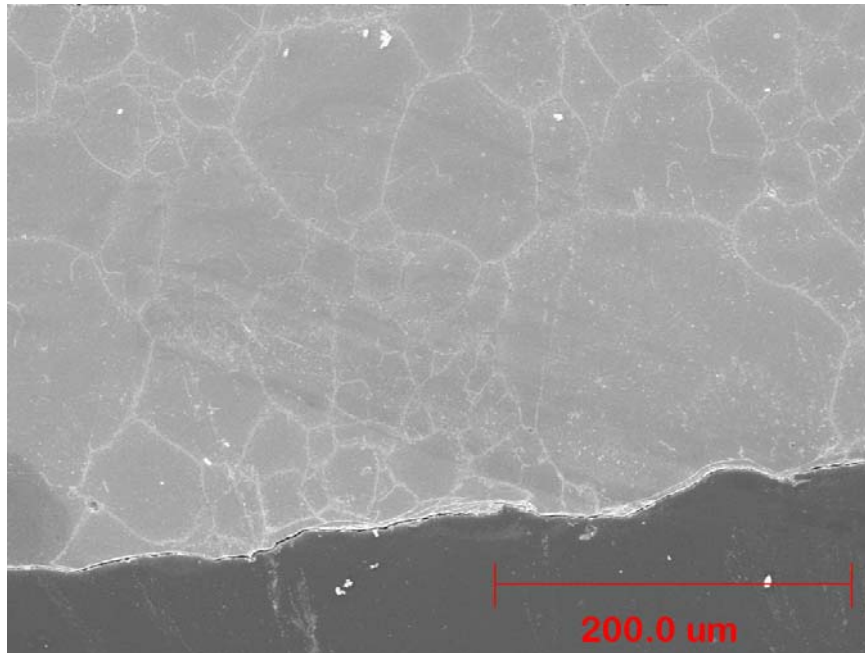
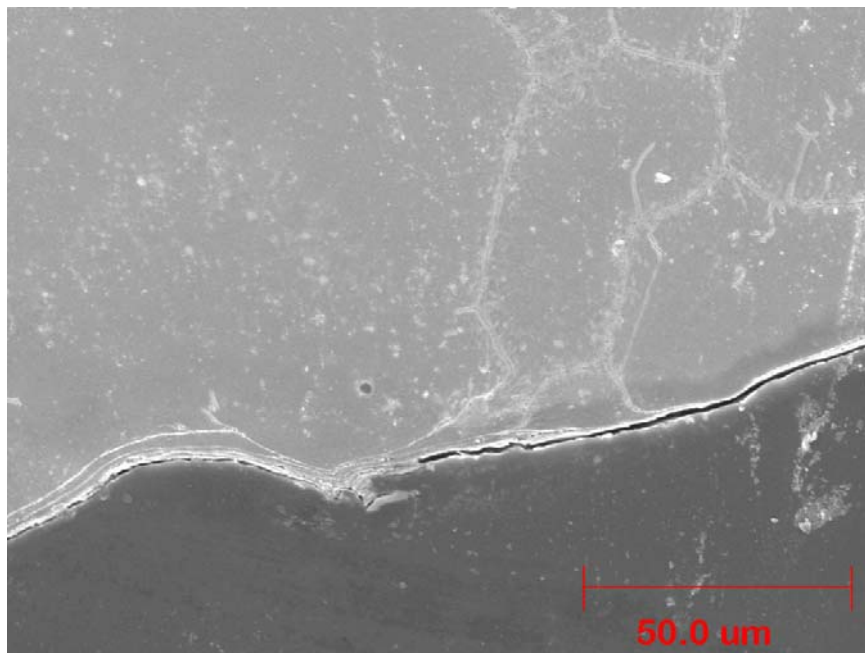
Figure A-20: SEM Microstructure: Save 25

Issue	Discussion
Metallurgical Analysis – SEM, Continued.	<ul style="list-style-type: none"> • Figure A-19 shows the appearance of the microstructure at mid-wall. • Figure A-20 shows the appearance of the internal surface for Sample II-JJ. Little evidence of an oxide scale was found. While it cannot be stated conclusively without further investigation, the irregular surface contour at the internal surface suggest that this surface had experienced metal loss due to steam-side oxidation, but that the scale subsequently had spalled away from the surface.
EDS Analysis Results	<ul style="list-style-type: none"> • The table in Figure A-21 provides a summary of the EDS analyses of the locations numbered in Figure A-18b. Also shown in this table is a summary of the spectrographic analysis reported earlier, in Figure A-2. • Review of this table suggests the following: <ul style="list-style-type: none"> • <u>Area 1: Bulk deposit/scale analysis</u> – Alkali metals are present. Sulfur and phosphorous are present in an increased amount compared to the base metal. An iron oxide is likely, as are aluminum, silicon and titanium oxides. Carbon content is relatively high, however, EDS is reliable qualitatively but not quantitatively for light elements such as carbon. This suggests that carbon is present, but the exact amount is unknown. • <u>Area 2: Adherent scale</u> – This appears to be comprised of an chromium-, iron-, and nickel-rich oxide. Again of significance here is the presence of sulfur and carbon. • <u>Area 3: Diffusion zone – dark etching</u> - This is leading edge of the metal adjacent to the scale/metal interface. This region is depleted in chromium. Oxygen and perhaps carbon ingress are suggested by this analysis. • <u>Area 4: Diffusion zone – light etching</u> – The analysis here is practically indistinguishable from that of the bulk tube alloy. • <u>Area 5: Tube metal composition</u> – Given its limitations this EDS analysis compares favorably with that of the reference spectrographic analysis below it.

(a) Internal Surface (SEI - Intermediate Magnification)

(b) Internal Surface (SEI - High Magnification)

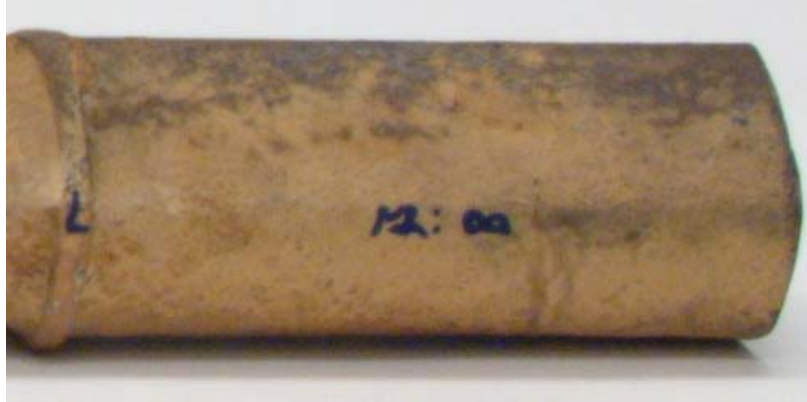
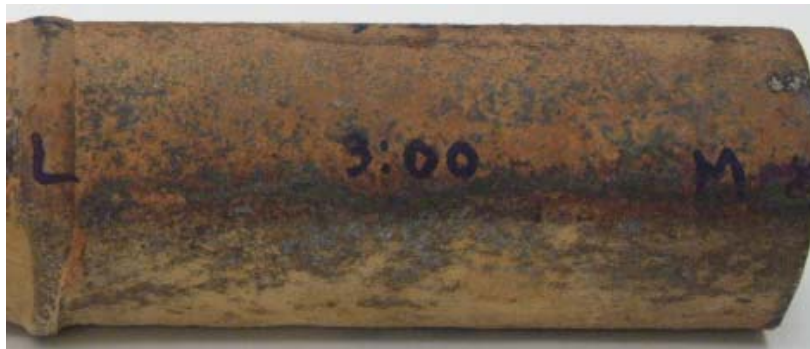
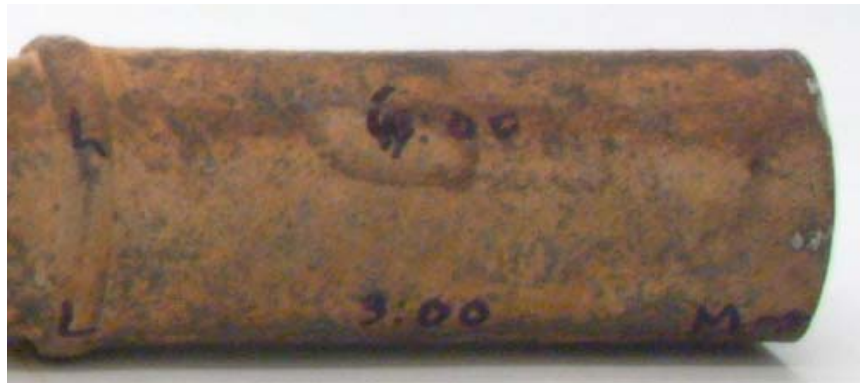
Figure B-4 As-Received Appearance of Sample L-M (Modified 800H)

12 O'Clock – Facing Gas Flow
(Note: 3 o'clock is up in this image)

3 O'Clock
(Note: 6 o'clock is up in this image)

6 O'Clock – Opposite Gas Flow

(Average metal temperature: 1185 F)

Note: this tube sample was removed from service on 11/6/01

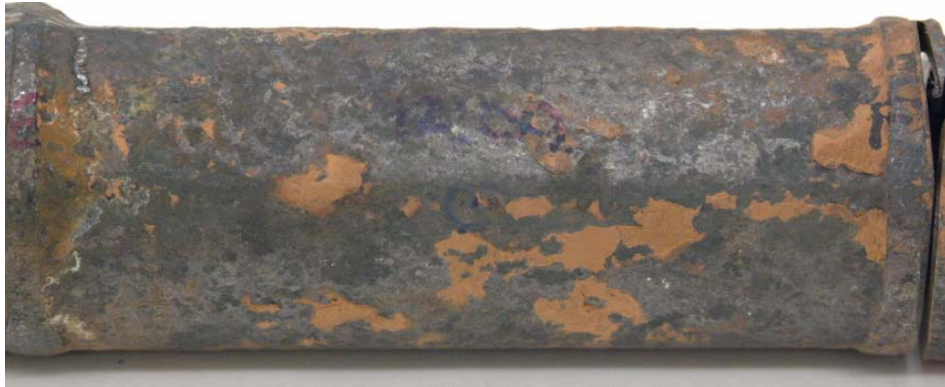
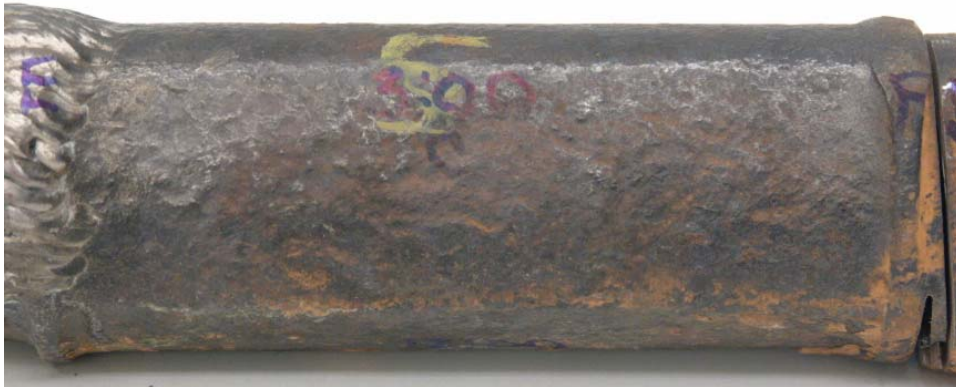
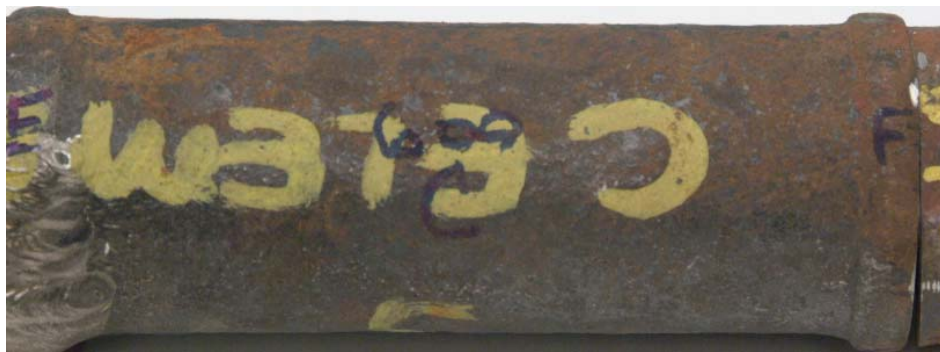
Figure B-5 As-Received Appearance of Sample E-F (Modified 800H)

12 O'Clock – Facing Gas Flow
(Note: 3 o'clock is up in this image)

3 O'Clock
(Note: 6 o'clock is up in this image)

6 O'Clock – Opposite Gas Flow

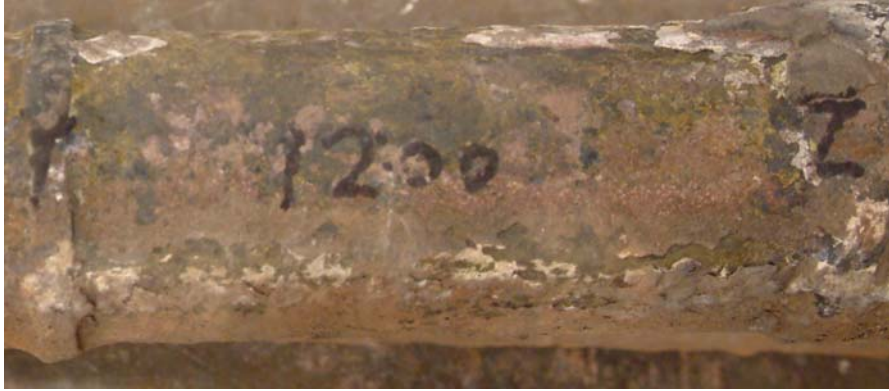
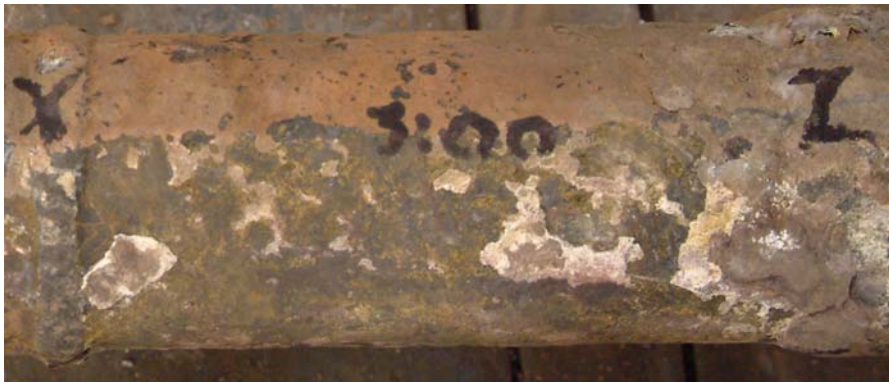
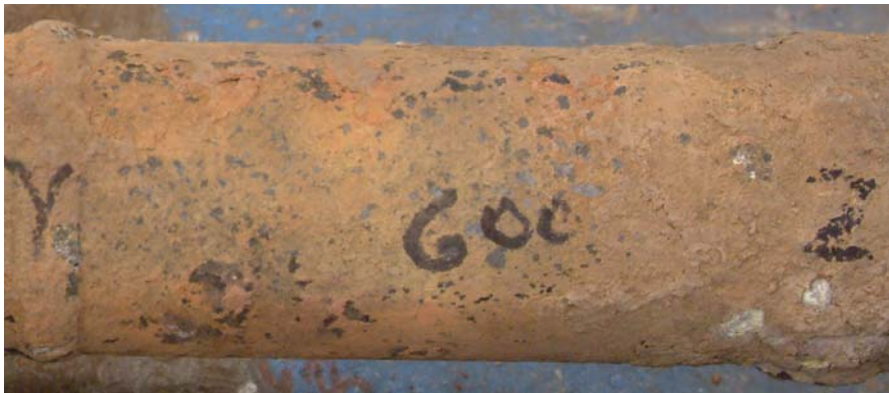
(Average metal temperature: 1162 F)

Note: this tube sample was removed from service on 6/10/02)

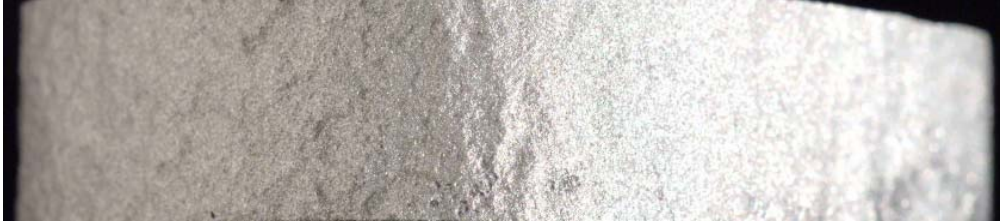
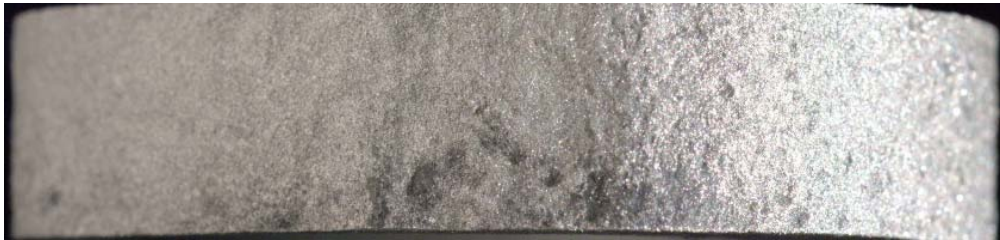
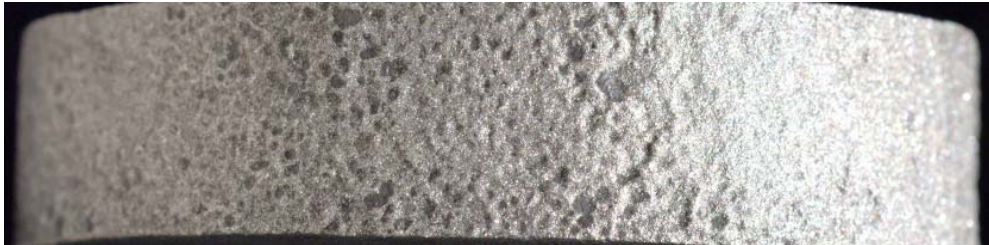
Figure B-8 OD Surface Appearance After Grit Blast

Grit-Blasted Surface Appearance	<ul style="list-style-type: none"> • Figures B-7 through B-9 show the appearance of the external surface of the Modified 800H tube samples after grit-blasting to remove deposit and scale. The 12 o'clock and 3 o'clock positions for all three samples show the appearance of general wastage due to fireside corrosion. • The 6 o'clock position for all three tube samples shows that evidence of shallow but extensive pitting on the back-side.
Wall Thickness Loss Determined	<ul style="list-style-type: none"> • Tube cross-sections were prepared to allow for measurement of wall thickness to determine metal loss due to exposure. These are shown in silhouette in Figures B-10 through B-12. • The same relative "o'clock" positions were maintained as discussed earlier. Measurements were taken at eight evenly spaced locations about the tube circumference. These were then compared with measurements taken at these same locations prior to exposure. • The before and after measurements were documented in the table that accompanies each figure. These form the basis for the "delta" calculation to determine the amount of wall thickness lost. • For all three tube samples, the minimum wall thickness in the cross section was not at one of the eight predetermined locations. In these cases, there was no "before" measurement for comparison. So, the average "before" wall thickness was used to calculate the wall thickness lost at these off locations.

12 O'Clock
(198 mils lost)

3 O'Clock
(200 mils lost)

6 O'Clock
(5 mils lost)

Material: Modified 800H
Sample: L-M

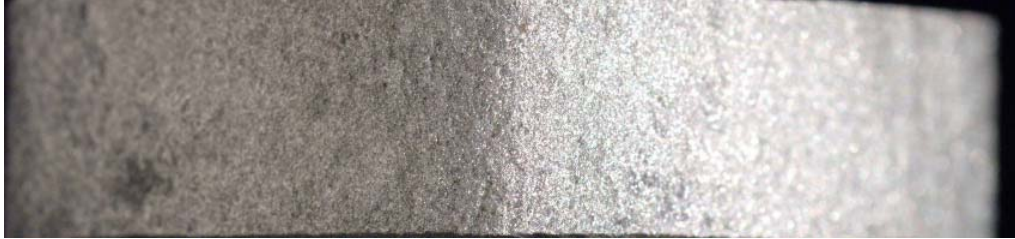
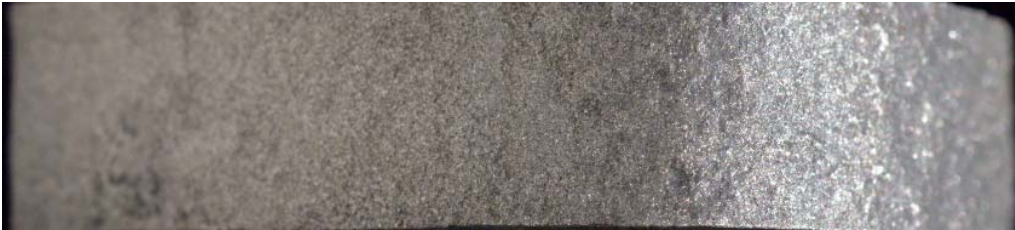
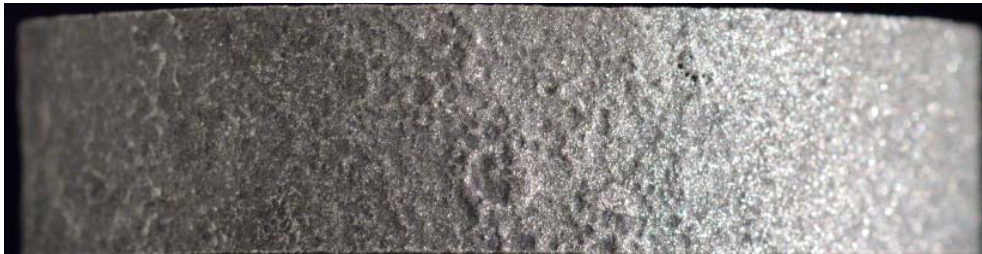
Figure B-8 OD Surface Appearance After Grit Blast

12 O'Clock
(220 mils lost)

3 O'Clock
(251 mils lost)

6 O'Clock
(12 mils lost)

Material: Modified 800H
Sample: E-F

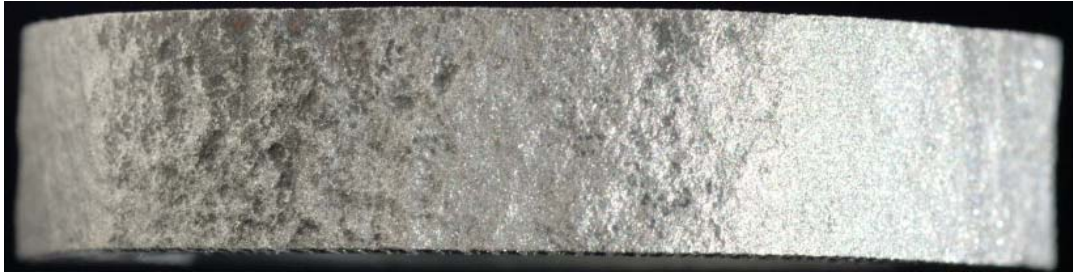
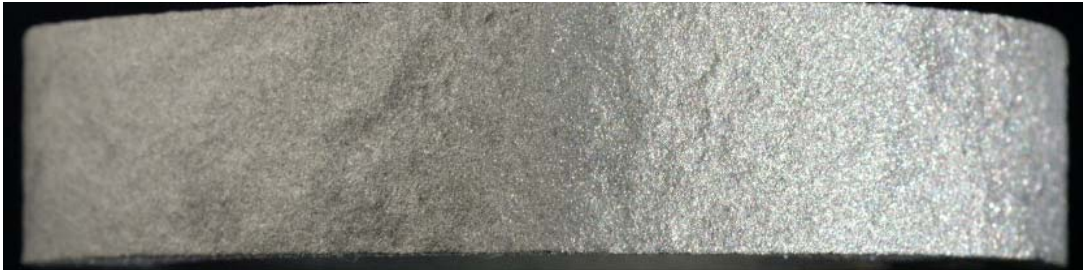
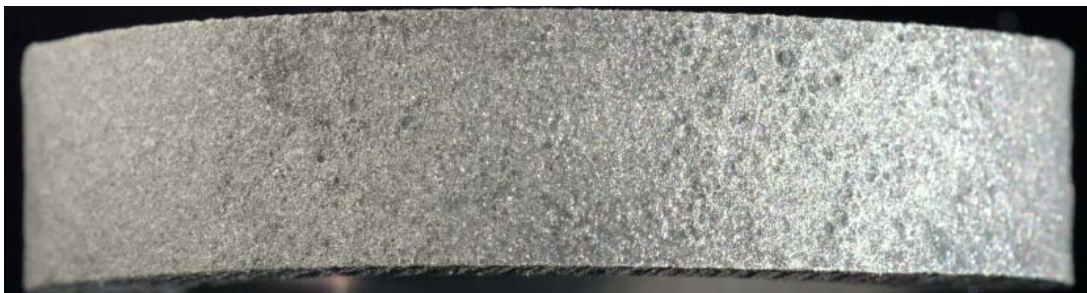
Figure B-9 OD Surface Appearance After Grit Blast

12 O'Clock
(149 mils lost)

3 O'Clock
(107 mils lost)

6 O'Clock
(10 mils lost)

Material: Modified 800H
Sample: Y-Z

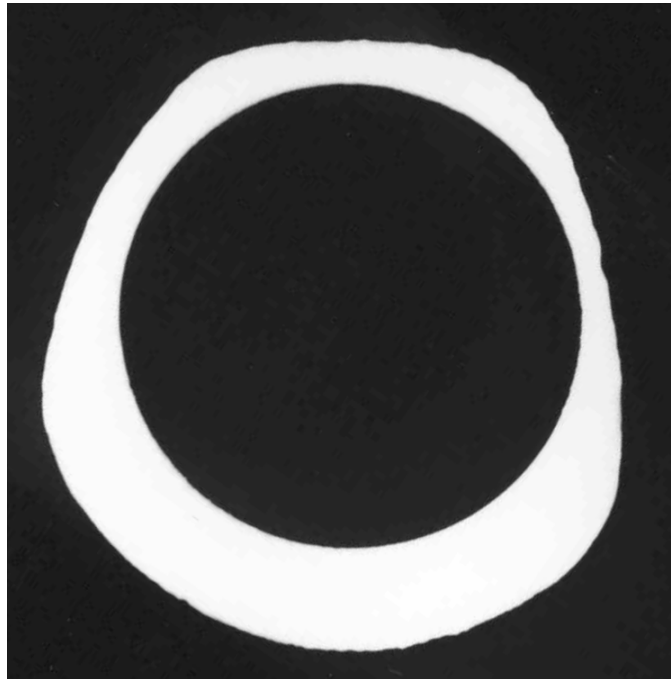
Average metal Temperature: 1185 F

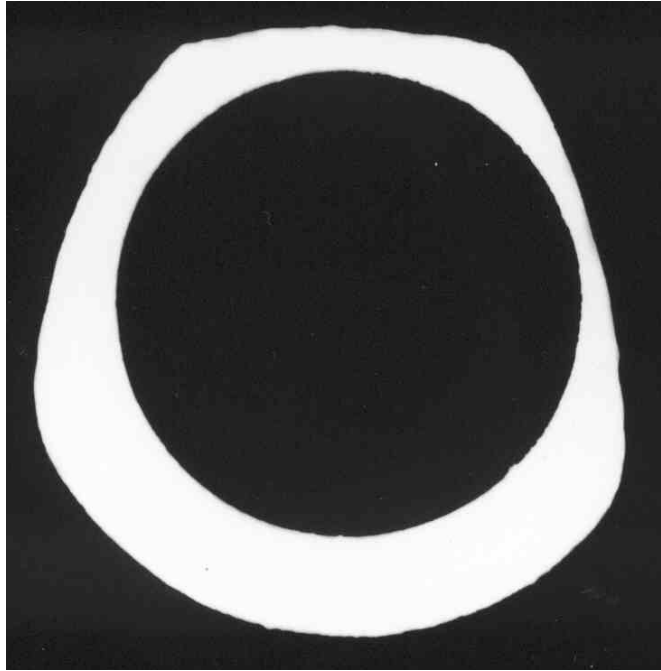
Material: Modified 800H
Sample Location: E-F
Maximum Rate: 176 mils/yr
Maximum Loss Orientation: Approx. 2:30 o'clock
Average metal Temperature: 1162 F

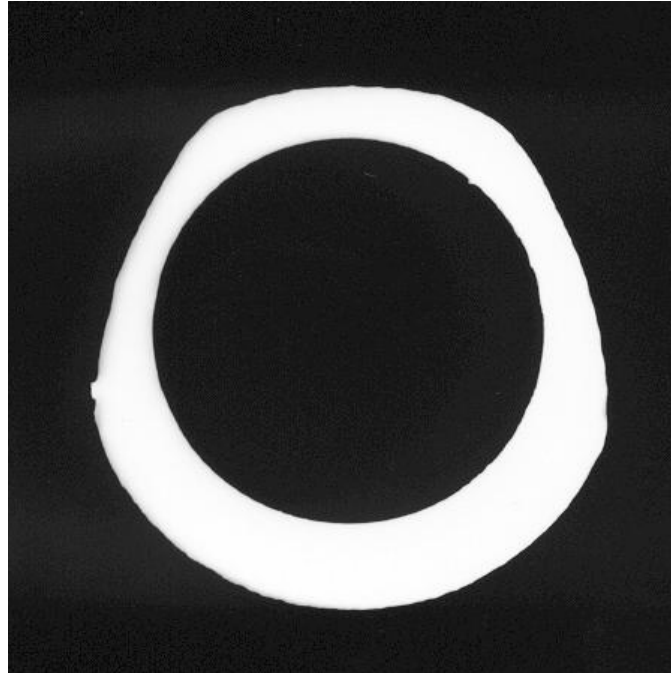
Figure B-12: Silhouette and Wall Thickness Measurements for Sample Y-Z

Material:	Modified 800H
Sample Location:	Y-Z
Maximum Rate:	79 mils/yr
Maximum Loss Orientation:	Approx. 9:30 o'clock
Average metal Temperature:	1099 F

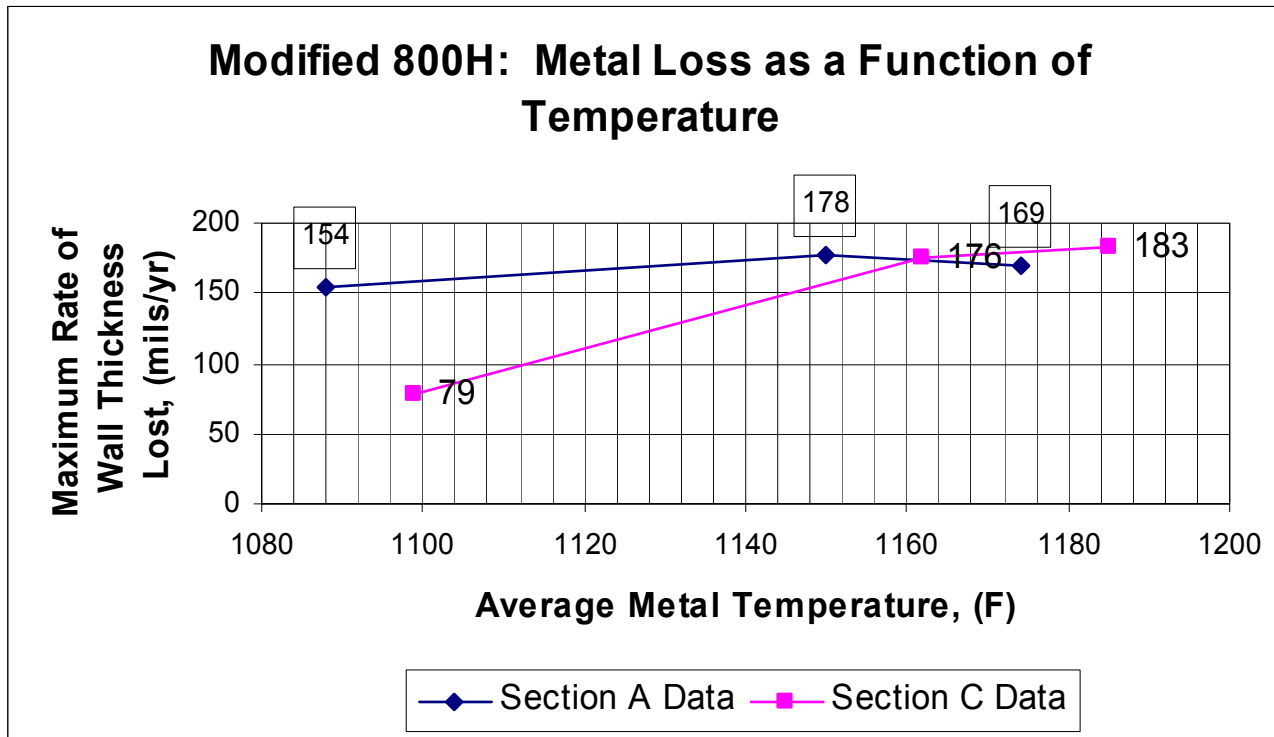
Figure B-13: Metal Loss Rate as a Function of Temperature

Analysis of Section A revealed that Modified 800H had sustained a maximum rate of 178 mils per year* of exposure to the corrosion-inducing service conditions within the Niles boiler. This resulted in a maximum measured wall reduction of 0.230 inches after 1.29 years of exposure within Section A. Time of exposure is based on time above a minimum average surface metal temperature of 1000F, not calendar time. So, given an initial wall thickness of about 0.400 inches, Section A results showed that one Modified 800H tube sample had lost almost 60 percent of its initial wall thickness after a relatively short exposure time. Consistent with this observation, shortly after Section A was removed from the boiler, the Modified 800H samples at location L-M were removed from both Sections B and C and replaced with a more corrosion resistant material. The Modified 800H samples at location E-F were replaced for both sections approximately six months later. For Section C, only one Modified 800H tube sample survived for the full length of time until the section was removed for evaluation, that was the sample at location Y-Z. This corresponded to the location within Section C having lowest average surface metal temperature for a Modified 800H sample.

Note: In analyzing these data it is important to understand that the three Section C samples were removed at different times, and so they experienced different lengths of exposure. Sample L-M (1185 F) was removed November 2001, shortly after the Section A samples. Sample E-F (1162 F) was removed in June 2002. Sample Y-Z (1099 F) saw was removed with the remaining Section C samples in May 2003.

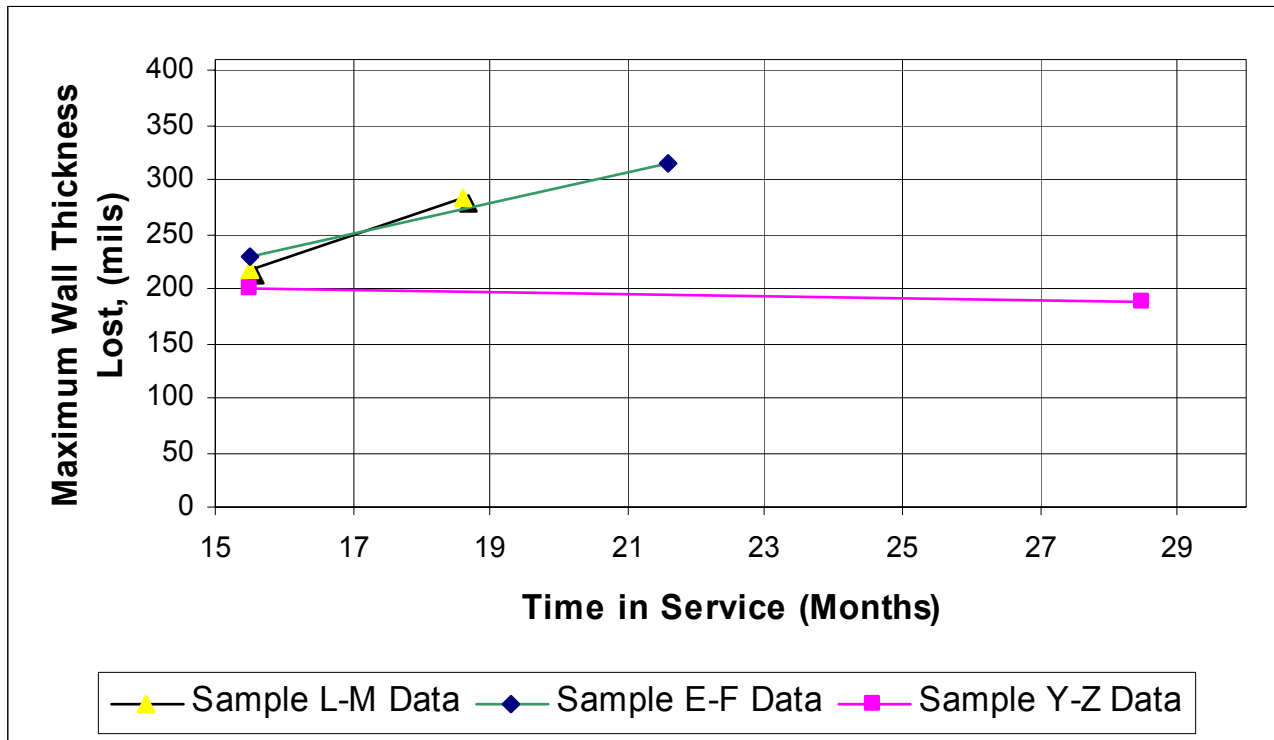
Figure B-14: Metal Loss as a Function of Time

Wall Thickness Loss as a Function of Time and Location	<ul style="list-style-type: none">• The chart in Figure B-14 plots metal loss as a function of time for each sample location for Sections A and C. with samples from Section C having experienced generally longer exposure times.• Shortly after Section A was removed for analysis, the tube Sample L-M was also removed and replaced in Section C due to excessive metal loss.• Metal losses in Sample E-F as a function of time provide the reason that it was removed early from Section C.• In Section C, Sample Y-Z lost less wall thickness in 28.5 months of exposure, than it did in Section A in 18.6 months. This was in spite of the fact that the average surface metal temperature for Sample Y-Z in Section C exceeded that of the same sample location in Section A (1099 F vs 1088 F).
Metallurgical Analysis – SEM	<ul style="list-style-type: none">• Sample E-F was selected for a detailed SEM/EDS assessment of the constituents and structure in the vicinity of the external and internal surfaces. This sample was selected based on the fact that it had lost the most wall thickness of all of the Modified 800H samples. The focus of this investigation was in the region of the tube where the maximum amount of material was lost.

Note: Sample L-M was removed from Section C shortly after the Section A samples were removed. For Section C, Sample E-F was removed early due to excessive wall thickness losses (316 mils). Sample Y-Z experienced the full exposure life for both Sections A and C.

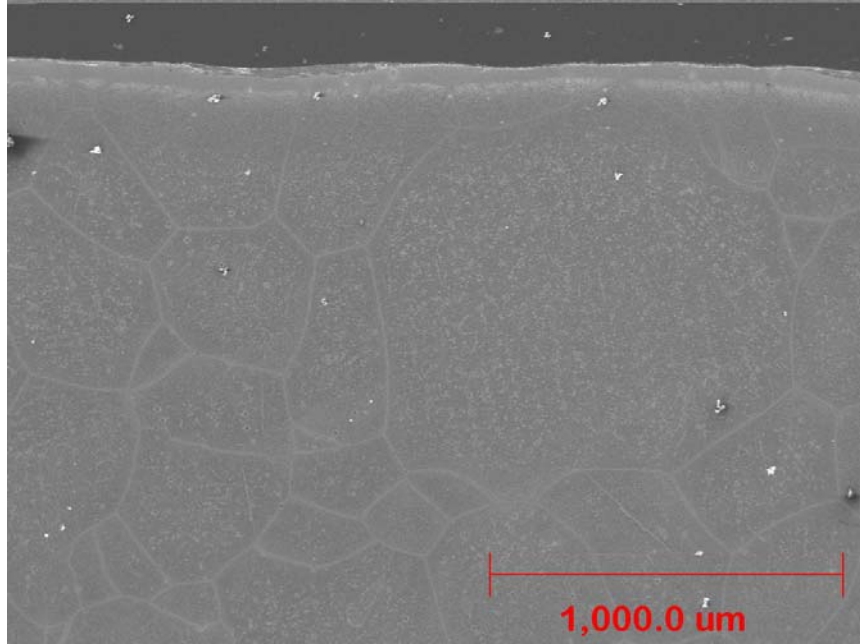
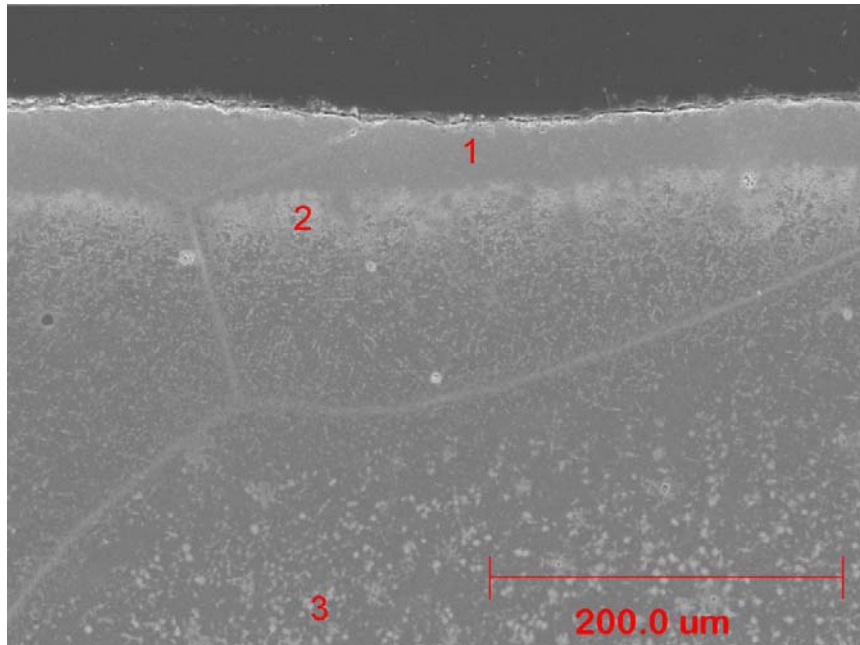
Figure B-15: Microstructure: Modified 800H

Evaluation of the microstructure at the external scale/metal interface revealed that Modified 800H had developed a continuous adherent chromium-oxide scale covering the external surface of the tube. Similar results were found during the evaluation of the Modified 800H sample removed from Section A. The results of this assessment suggested that this material suffered rapid general metal loss that may be related to the degree of chromium depletion in the vicinity of the metal surface (as low as 9%). The evidence suggested also that progressive spalling of the chromium oxide scale that adheres to the surface may also have played an important role in influencing the poor performance of this material.

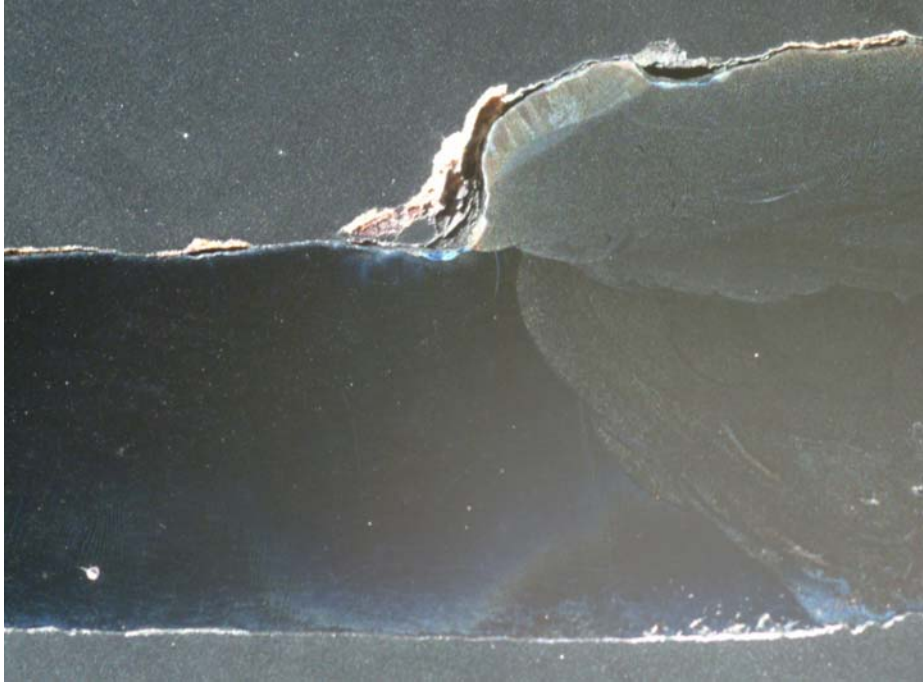
Figure B-18: Longitudinal Cross-Section: Modified 800H Adjacent to Weld

Modified 800H Adjacent to Weld "Z"

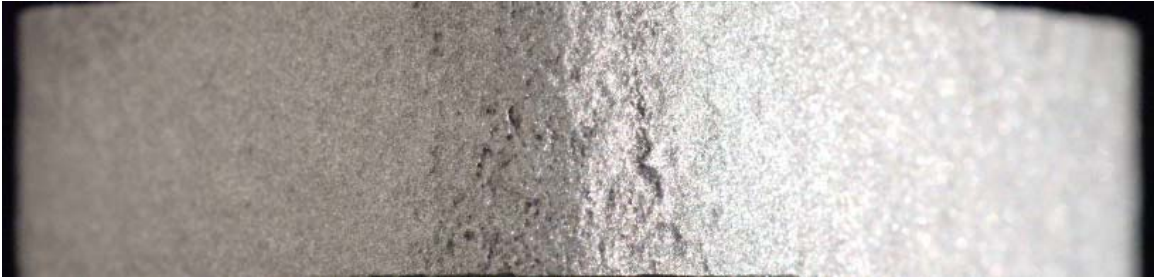
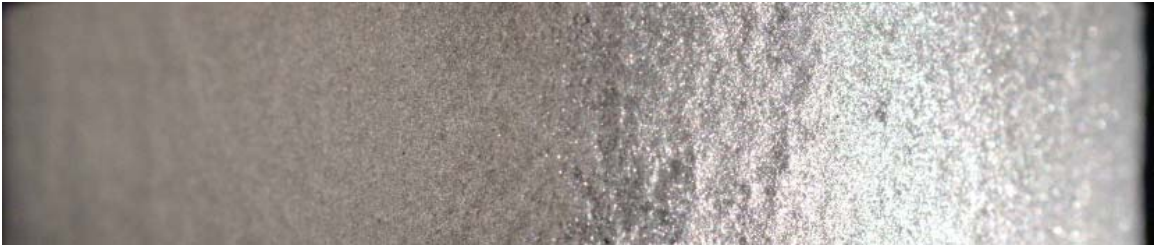
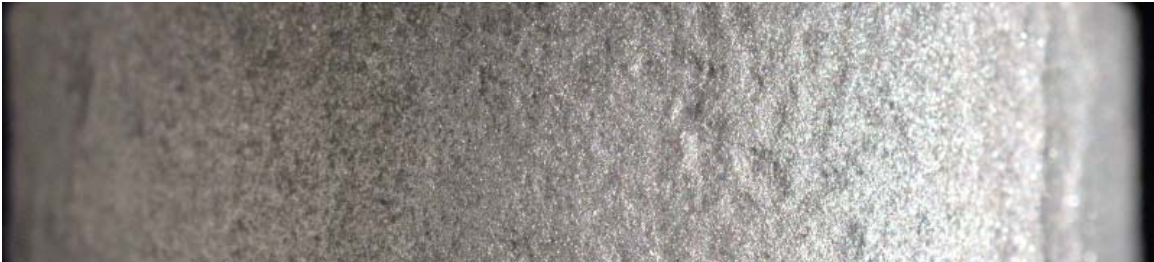
Figure C-7: OD Surface Appearance After Grit Blast

Grit-Blasted Surface Appearance	<ul style="list-style-type: none"> • Figures C-7 through C-9 show the appearance of the external surface of the 347 HFG tube samples after grit-blasting to remove deposit and scale. The 12 o'clock and 3 o'clock positions for all three samples show the appearance of general wastage due to fireside corrosion. • No significant pitting was found on the back-side of these samples.
Wall Thickness Loss Determined	<ul style="list-style-type: none"> • Tube cross-sections were prepared to allow for measurement of wall thickness to determine metal loss due to exposure. These are shown in silhouette in Figures C-10 through C-12. • The same relative "o'clock" positions were maintained as discussed earlier. Measurements were taken at eight evenly spaced locations about the tube circumference. These were then compared with measurements taken at these same locations prior to exposure. • The before and after measurements were documented in the table that accompanies each figure. These form the basis for the "delta" calculation to determine the amount of wall thickness lost. • For all three samples, the minimum wall thickness in the cross section was not at one of the eight predetermined locations. In these cases, there was no "before" measurement for comparison. So, the average "before" wall thickness was used to calculate the wall thickness lost at these off-locations.

12 O'Clock
(205 mils lost)

3 O'Clock
(281 mils lost)

6 O'Clock
(15 mil lost)

Material: 347 HFG
Sample: I-J

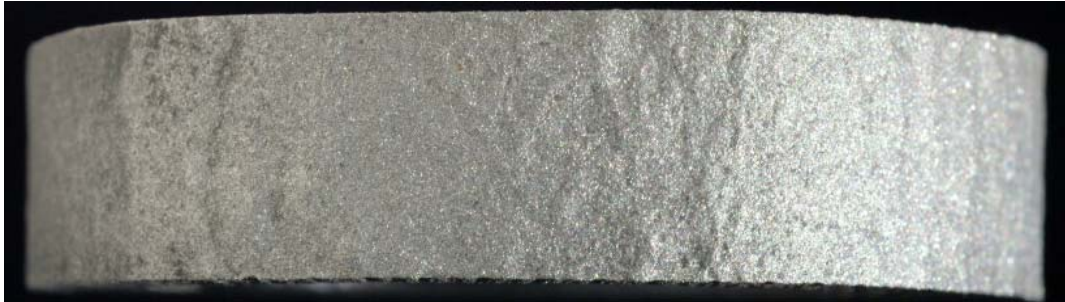
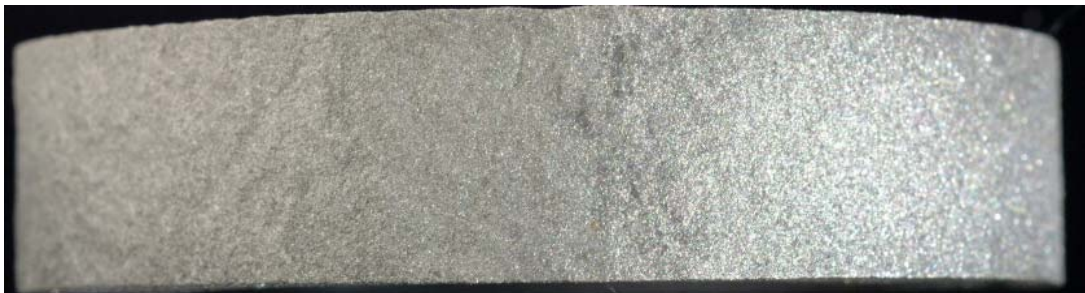
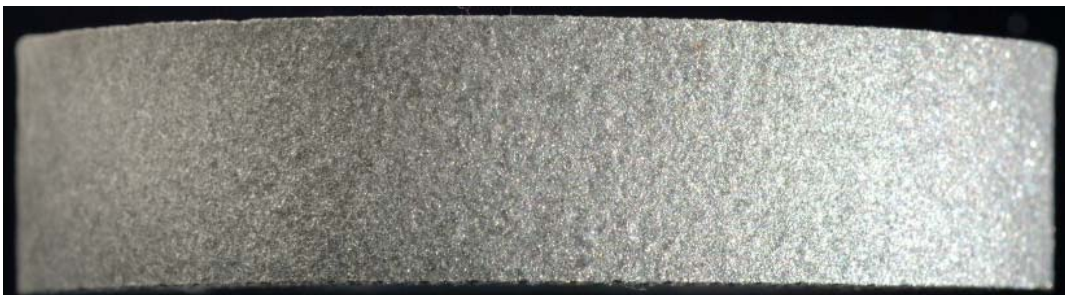
Figure C-8: OD Surface Appearance After Grit Blast

12 O'Clock
(142 mils lost)

3 O'Clock
(60 mils lost)

6 O'Clock
(15 mil lost)

Material: 347 HFG
Sample: A-B

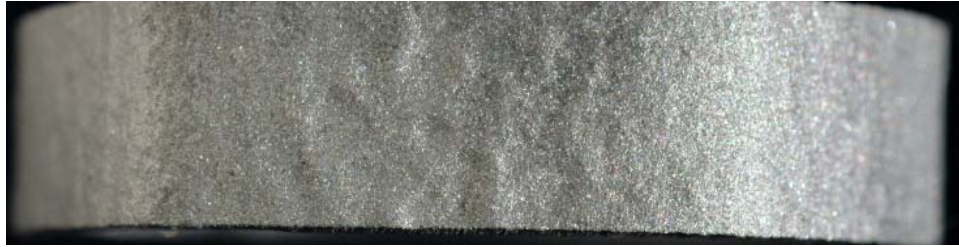
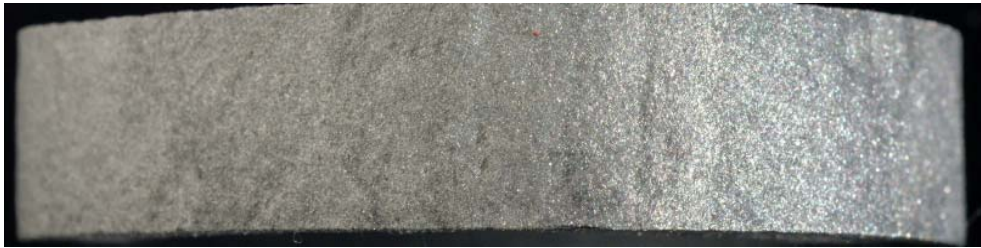
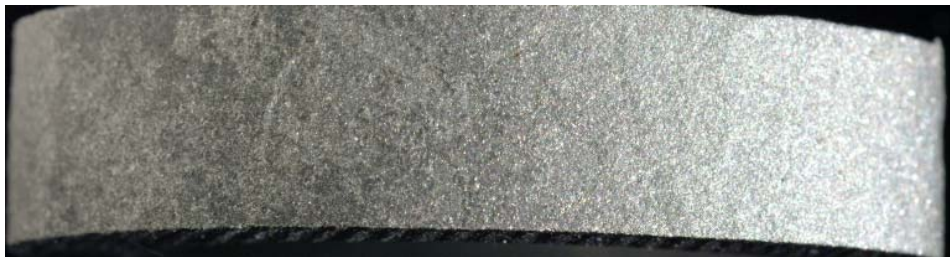
Figure C-9: OD Surface Appearance After Grit Blast

12 O'Clock
(205 mils lost)

3 O'Clock
(229 mils lost)

6 O'Clock
(8 mils lost)

Material: 347 HFG
Sample: CC-DD

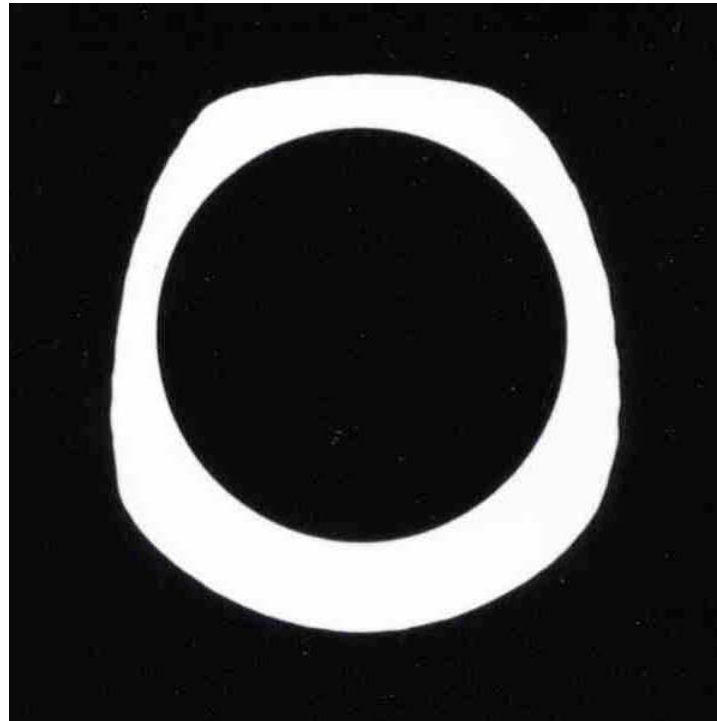
Material: 347 HFG
Sample Location: I-J
Maximum Rate: 204 mils/yr
Maximum Loss Orientation: Approx. 2:30 o'clock
Average metal Temperature: 1174 F

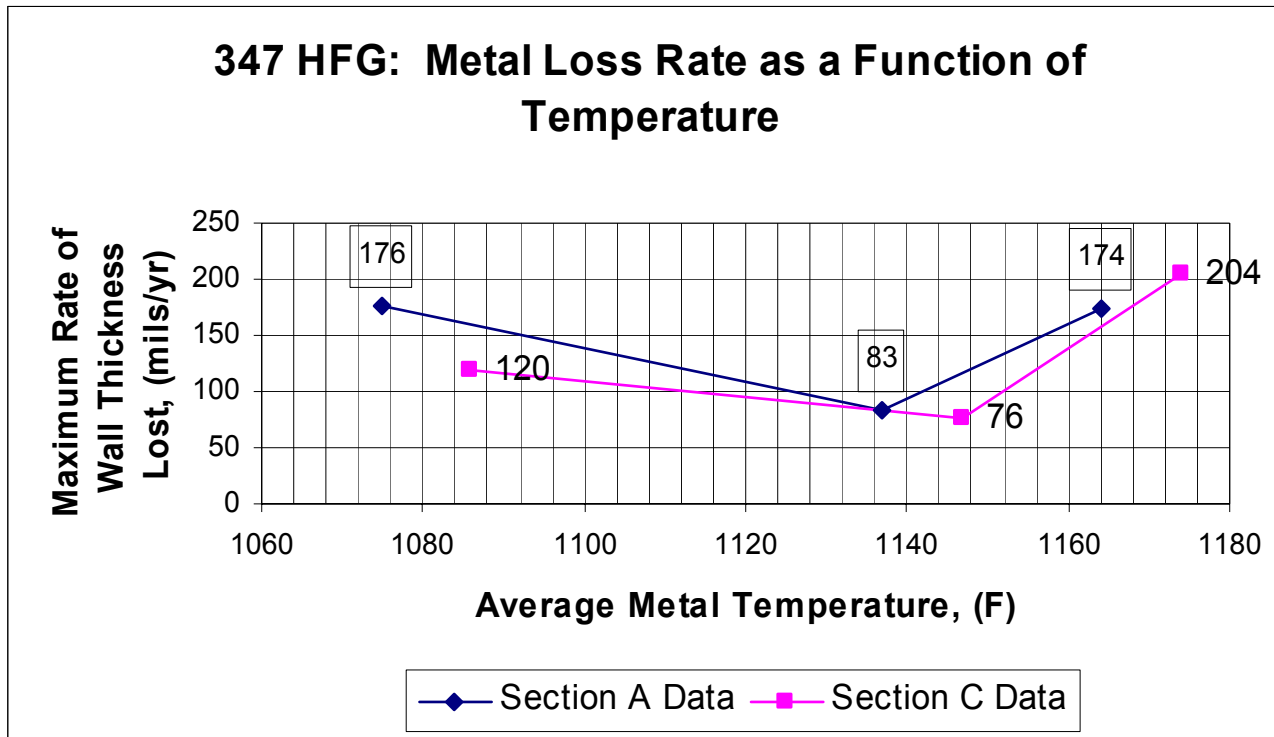
Figure C-13: Metal Loss Rate as a Function of Temperature

Issue	Discussion
Rate of Wall Thickness Loss Versus Average Metal Temperature	<ul style="list-style-type: none">• The chart in Figure C-13 plots the maximum wall thickness lost against the calculated average surface metal temperature for each of the three 347 HFG samples in Section C. Similar data for Section A also are plotted on this chart.• It was noted that, for both sections, the maximum rate of metal loss was greater at the low and high temperatures, and dipped significantly at an intermediate temperature. The reason for this is not clear; however, it may suggest the role of different corrosion mechanisms.• It should be noted that, given an initial wall thickness of 400 mils, then given the measured maximum rate of metal loss of between 204 and 174 mils per year, the samples at the highest exposure temperature (i.e. the samples at position I-J) would not be expected to survive for three years of exposure. This provides further justification as to why these samples were removed early from all three sections.

Note: In analyzing these data it is important to understand that one of the three Section C samples was removed at an earlier date than the other two., and so they experienced different lengths of exposure. Sample I-J (1175 F) was removed in November 2001, at about the same time as the Section A samples. Sample A-B (1147 F) and Sample CC-DD were removed with the remaining Section C samples in May 2003.

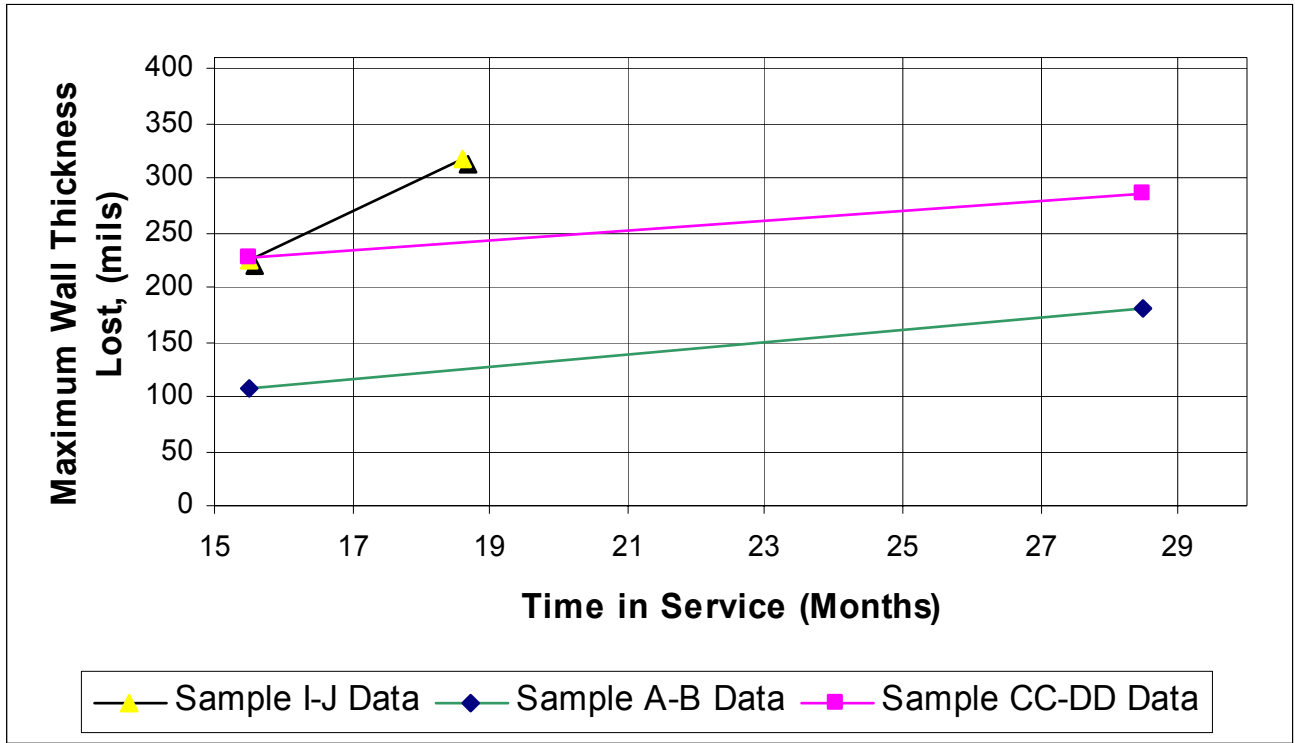
Figure C-14: Metal Loss as a Function of Time

Wall Thickness Loss as a Function of Time and Location	<ul style="list-style-type: none">• The chart in Figure C-14 plots metal loss as a function of time for each sample location for both Sections A and C, with samples from Section C having experienced generally longer exposure times.• Sample I-J was removed from Section C and replaced at about the same time that Section A was removed for analysis, i.e. November 2001. It was noted that the rate of metal loss appears to be greater for the Sample I-J from Section C as compared with the same sample in Section A. This may have been due to the somewhat higher temperatures for the I-J position in Section C (1174 F vs 1164 F), but due to limited sampling it is difficult to draw this conclusion with certainty.• The chart shows a straight line fit to the maximum metal loss data points for Samples A-B and CC-DD for both Sections A and C. Evaluation of the rate of metal loss data depicted in Figure C-13 suggests that a straight line fit might well be appropriate for the samples at position A-B in that the rate of metal loss was the same at this location for both Section A and Section C.• For the samples at position CC-DD, the rate of metal loss drops off between Section A (176 mils/yr) and Section C (120 mils/yr), so, a straight-line fit would likely be less appropriate.

Note: From the plot above it can be seen that, for Section C, Sample I-J was removed from service due to excessive metal losses at about the same time that Section A was removed for evaluation. Samples CC-DD and A-B both experienced the full exposure life for both Sections A and C.

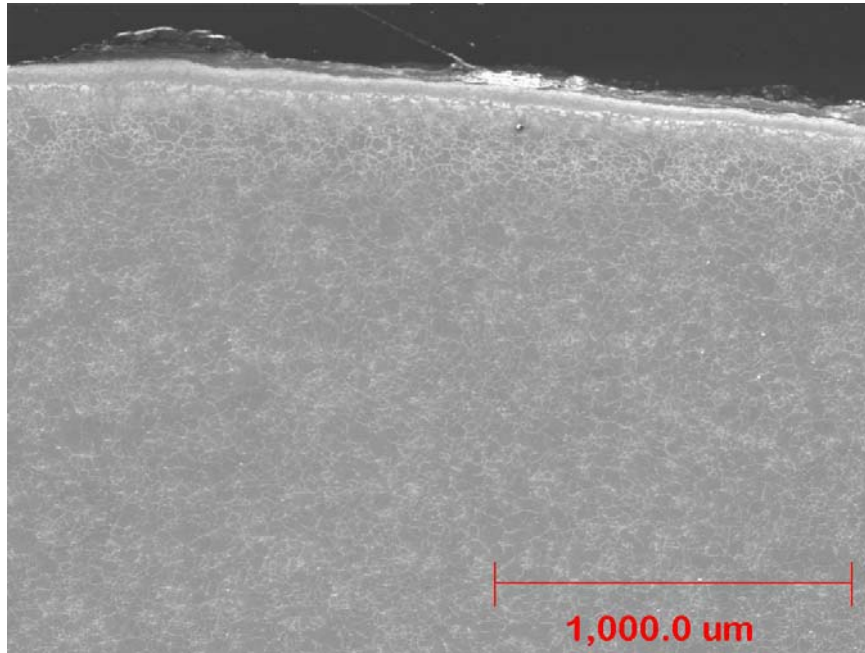
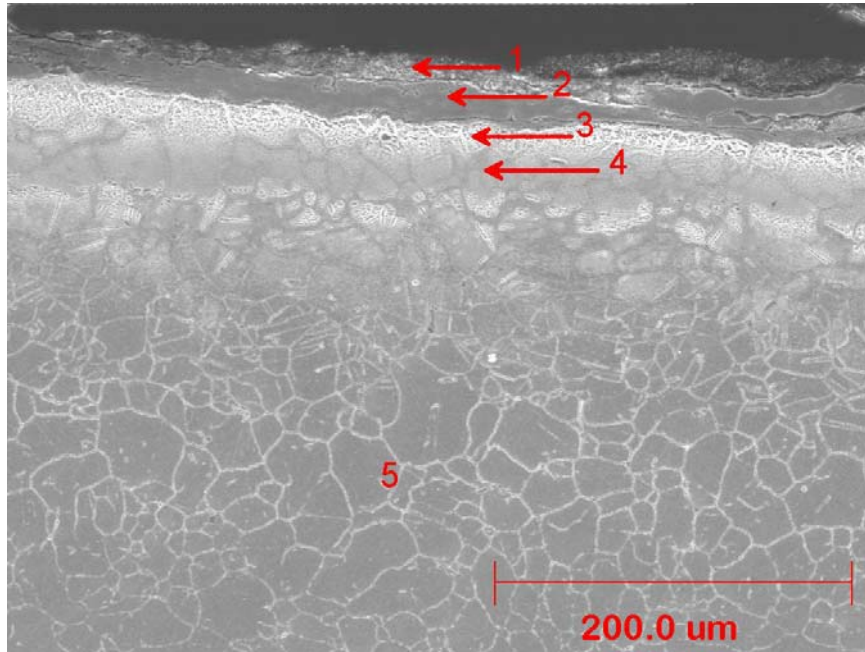
C-15: Microstructure: 347 HFG

(a) External Scale/Metal Interface (SEI - Low Magnification)

(b) External Scale/Metal Interface (SEI - Intermediate Magnification)

Note: 1) Numbers on photos indicate distinct areas characterized by the visual assessment and EDS analyses that follow.
