COAL ASH CORROSION RESISTANT MATERIALS TESTING

Topical Report: Removal of Section "C"

THE BABCOCK & WILCOX COMPANY

The “Coal Ash Corrosion Resistant Materials Testing Program” is being conducted by The Babcock & Wilcox Company (B&W), the U.S. Department of Energy (DOE) and the Ohio Coal Development Office (OCDO) at Reliant Energy’s Niles plant in Niles, Ohio to provide full-scale, in-situ testing of recently developed boiler superheater materials. Fireside corrosion is a key issue for improving efficiency of new coal fired power plants and improving service life in existing plants.

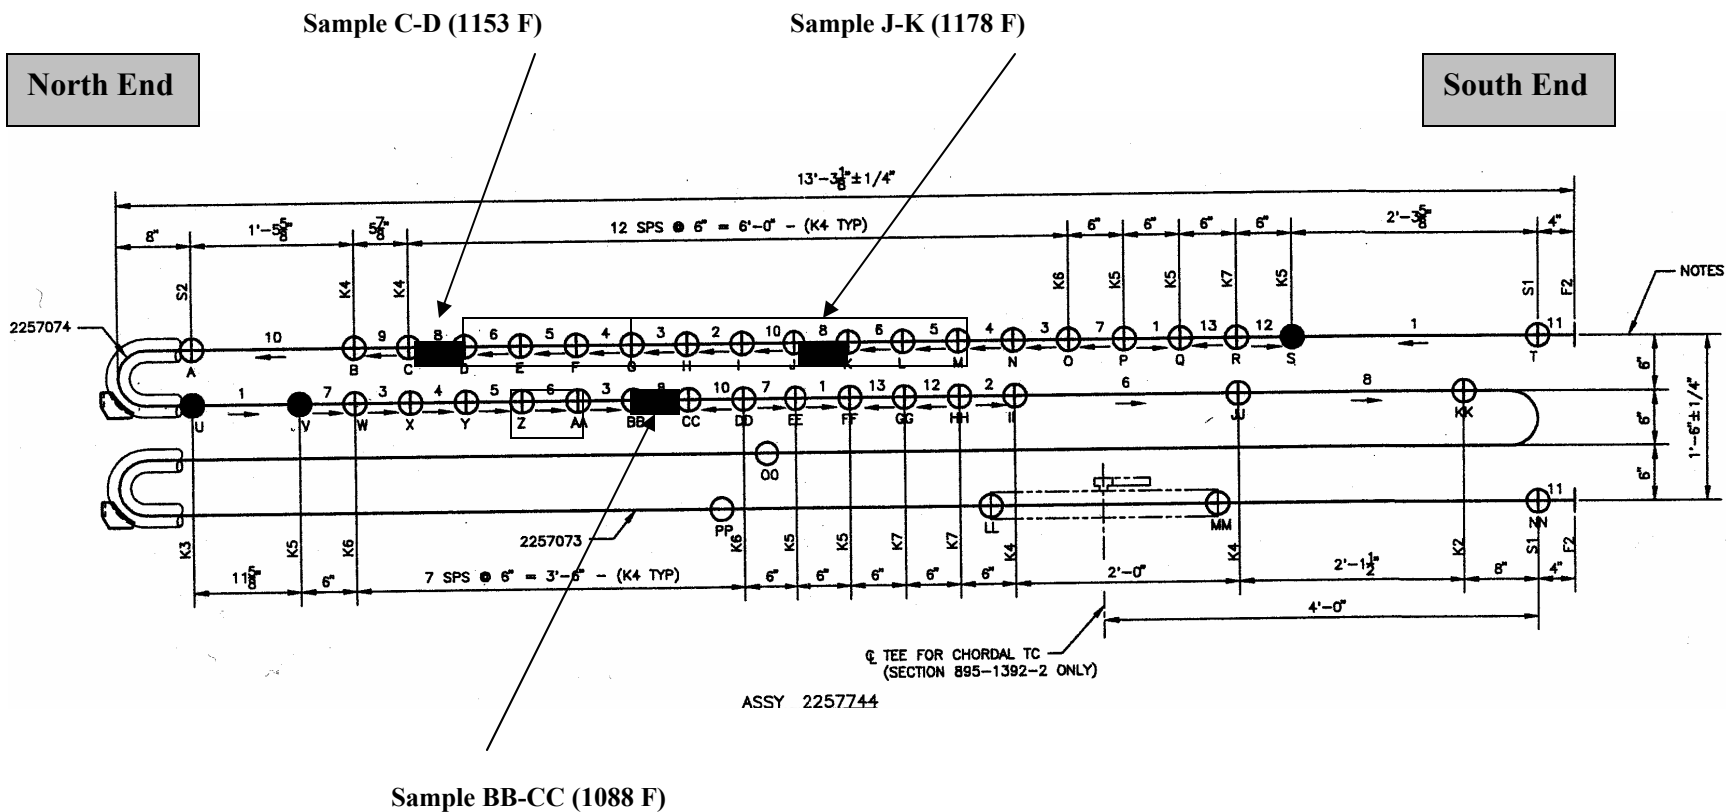
Figure D-1: Schematic Drawing Showing Position of NF 709 Tube Samples Within Section C

Issue	Discussion
Sample Location and Orientation.	<ul style="list-style-type: none">• In assessing the data for Section C, it is important to understand that some tube samples had to be removed from the section early due to excessive thinning. The schematic in Figure D-1 shows the relative positions of the NF 709 samples in all three sections. Also, shown are the positions of all of the excessively thinned tubes that were removed and replaced in order to extend the life of Section C.• One NF 709 sample was removed early. Sample J-K was removed in November 2001, (i.e. shortly after Section A was removed from service for evaluation). The other two NF 709 samples survived for the full Section C exposure period.• The sample that was removed early was set aside for later analysis, and has been included in the current evaluation along with the other tube samples that made up Section C.• Also shown in this figure is the calculated average surface metal temperature at each location.

1. Drawing shown in same relative orientation as per the actual installation.
2. This group of tube samples was removed from service in November 2001 - highlighted in red.
3. This group of tube samples was removed from service in June 2002 - highlighted in yellow.

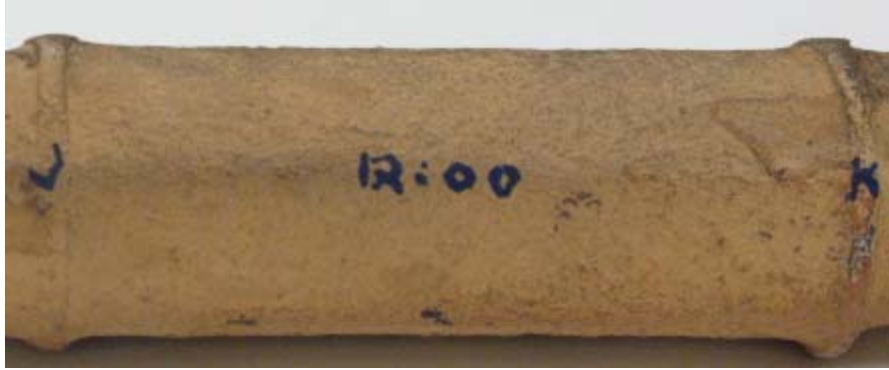
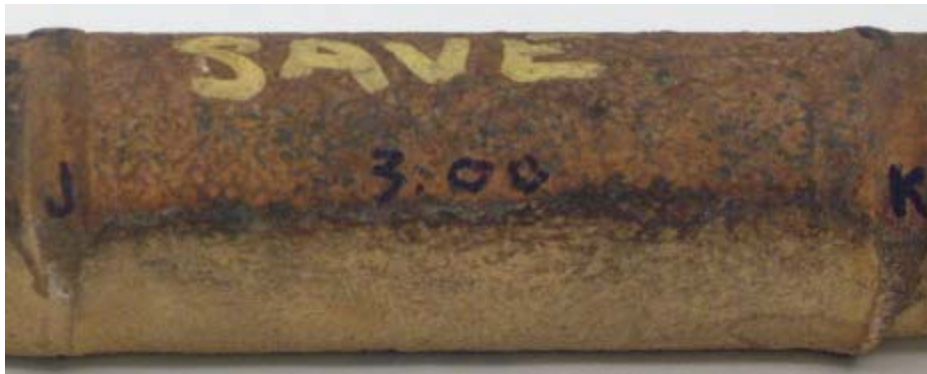
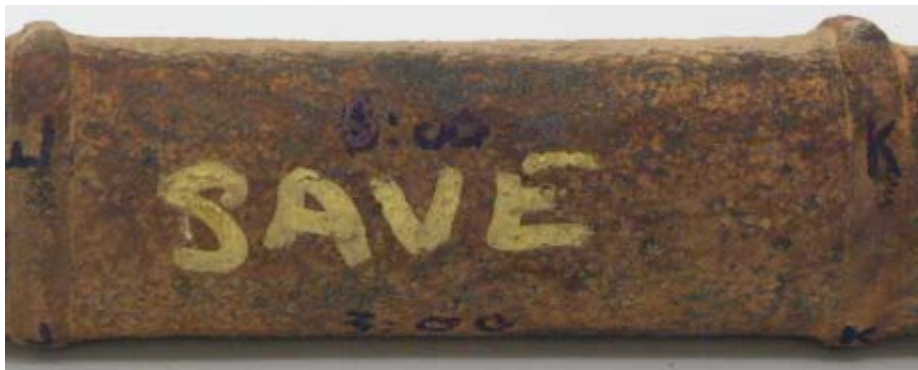
Figure D-4 As-Received Appearance of Sample J-K (NF 709)

(Average metal temperature: 1178 F)

Note: this tube was removed from service on 11/6/01.

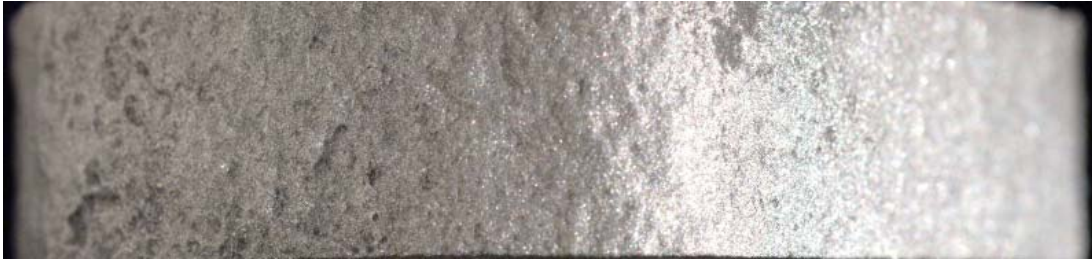
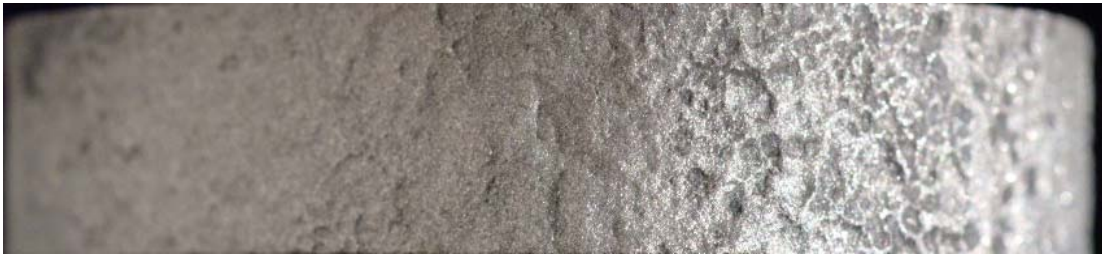
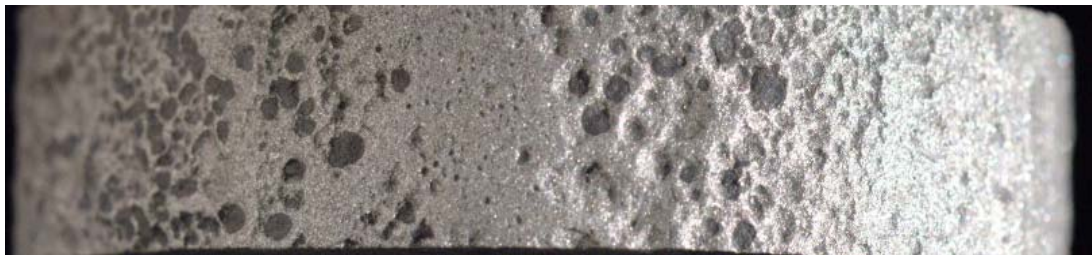
Figure D-7: OD Surface Appearance After Grit Blast

Grit-Blasted Surface Appearance	<ul style="list-style-type: none"> • Figures D-7 through D-9 show the appearance of the external surface of the NF 709 tube samples after grit-blasting to remove deposit and scale. The 12 o'clock and 3 o'clock positions for all three samples show the appearance of general wastage due to fireside corrosion. • The 6 o'clock position for Samples J-K and C-D show the pitting that occurred on the back-side of these samples. Only minimal pitting was noted at the 6 o'clock position for Sample BB-CC.
Wall Thickness Loss Determined	<ul style="list-style-type: none"> • Tube cross-sections were prepared to allow for measurement of wall thickness to determine metal loss due to exposure. These are shown in silhouette in Figures D-10 through D-12. • The same relative "o'clock" positions were maintained as discussed earlier. Measurements were taken at eight evenly spaced locations about the tube circumference. These were then compared with measurements taken at these same locations prior to exposure. • The before and after measurements were documented in the table that accompanies each figure. These form the basis for the "delta" calculation to determine the amount of wall thickness lost. • For all three samples, the minimum wall thickness in the cross section was not at one of the eight predetermined locations. In these cases, there were no "before" measurement for comparison to determine the "delta". So, the average "before" wall thickness was used to calculate the wall thickness lost at these off-locations.

12 O'Clock
(201 mils lost)

3 O'Clock
(224 mils lost)

6 O'Clock
(1 mil lost)

Material: NF 709
Sample: J-K

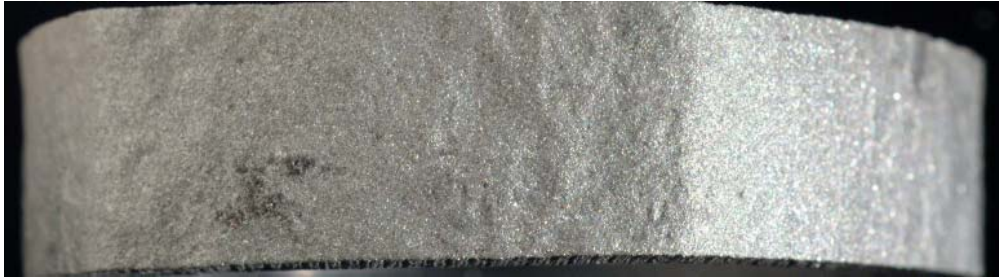
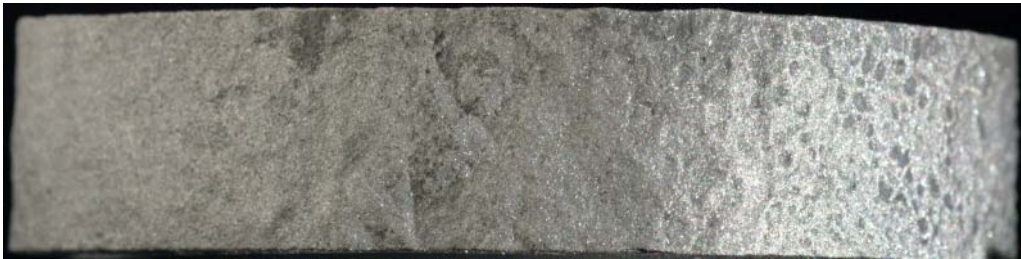
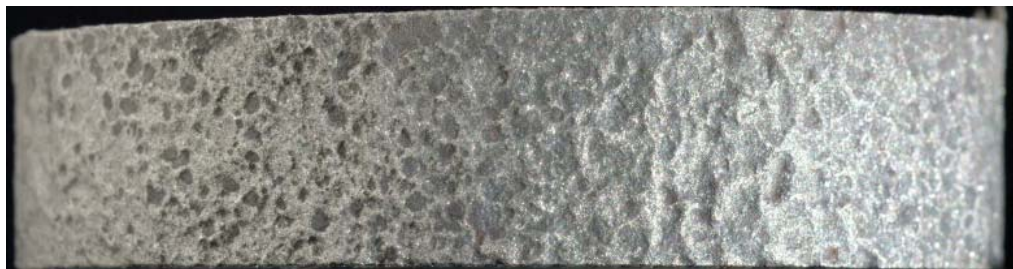
Figure D-8: OD Surface Appearance After Grit Blast

12 O'Clock
(208 mils lost)

3 O'Clock
(204 mils lost)

6 O'Clock
(13 mils lost)

Material: NF 709
Sample: C-D

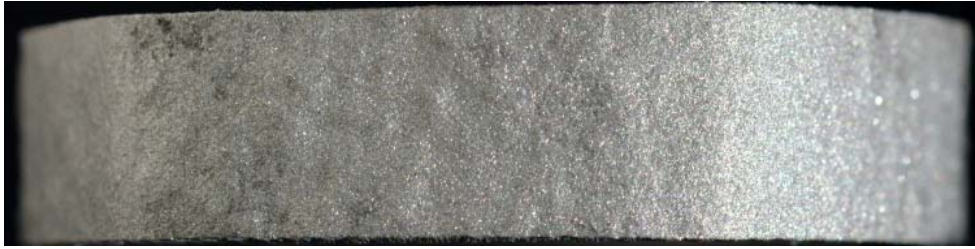
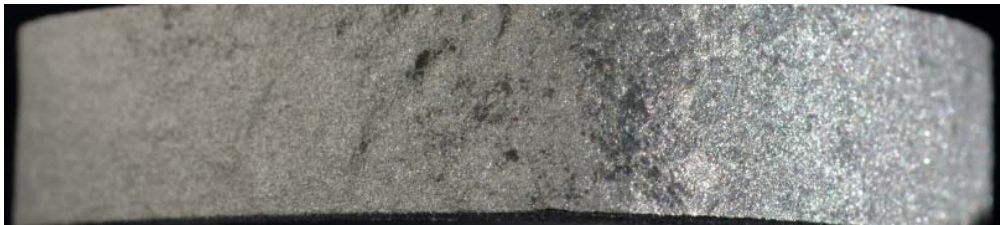
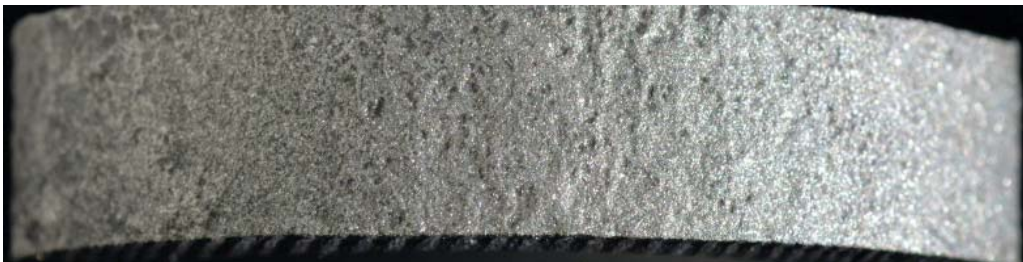
Figure D-9: OD Surface Appearance After Grit Blast

12 O'Clock
(188 mils lost)

3 O'Clock
(207 mils lost)

6 O'Clock
(2 mils lost)

Material: NF 709
Sample: BB-CC

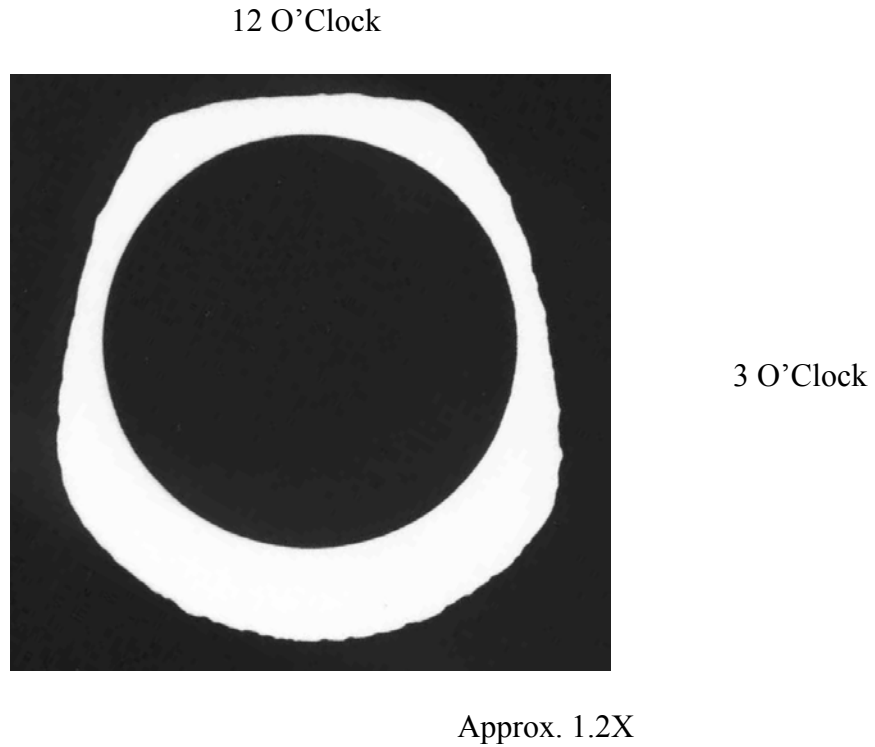
Material: NF 709
Sample Location: J-K
Maximum Rate: 181 mils/yr
Maximum Loss Orientation: Approx. 9:30 o'clock
Average metal Temperature: 1178 F

12 o'clock	1:30	3:00	4:30	6:00	7:30	9:00	10:30	AVG	Max Loss*
Before	0.400	0.398	0.398	0.396	0.395	0.395	0.395	0.399	0.397	0.397
After	0.199	0.160	0.174	0.378	0.394	0.365	0.146	0.254		0.116
Delta	0.201	0.238	0.224	0.018	0.001	0.030	0.249	0.145		0.281

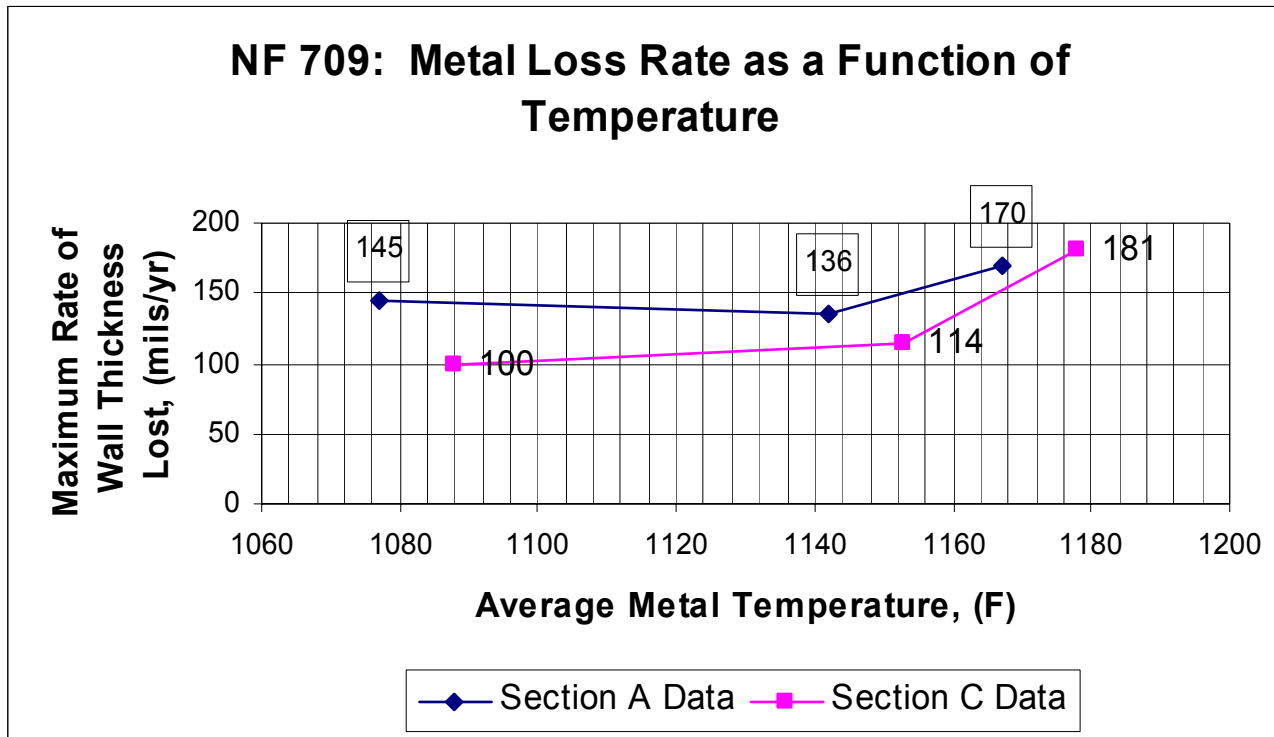
Figure D-13: Metal Loss Rate as a Function of Temperature

Issue	Discussion
Rate of Wall Thickness Loss Versus Average Metal Temperature	<ul style="list-style-type: none">• The chart in Figure D-13 plots the maximum wall thickness lost against the calculated average metal temperature for the three NF 709 samples. Similar data for Section A also are plotted on this chart.• For both sections, it was noted that there appears to be a “knee” in the plotted curve that comes about due to a significant increase in the rate of metal loss above an exposure temperature of about 1160 F.• As was mentioned earlier, Sample J-K was removed early due to excessive metal losses.
Metal Loss as a Function of Time at Each Location	<ul style="list-style-type: none">• The chart in Figure D-14 plots metal loss as a function of time for each sample location for both Sections A and C, with samples from Section C having experienced generally longer exposure times.• Shortly after Section A was removed for analysis, the tube Sample J-K was also removed and replaced in Section C.• The chart shows a straight line fit to the maximum metal loss data points for Samples C-D and BB-CC for both Sections A and C. Evaluation of the rate of metal loss data depicted in Figure D-13 suggests that a straight line fit might well be appropriate for these data in that the rate of metal loss was similar for both locations for both Section A and Section C.

Note: In analyzing these data it is important to understand that the one of the three Section C samples was removed early due to excessive corrosion losses. Sample J-K (1178 F) was removed in November 2001, shortly after Section A was removed for analysis. Sample C-D (1153 F) and Sample BB-CC (1088 F) were removed with the remaining Section C samples in May 2003.

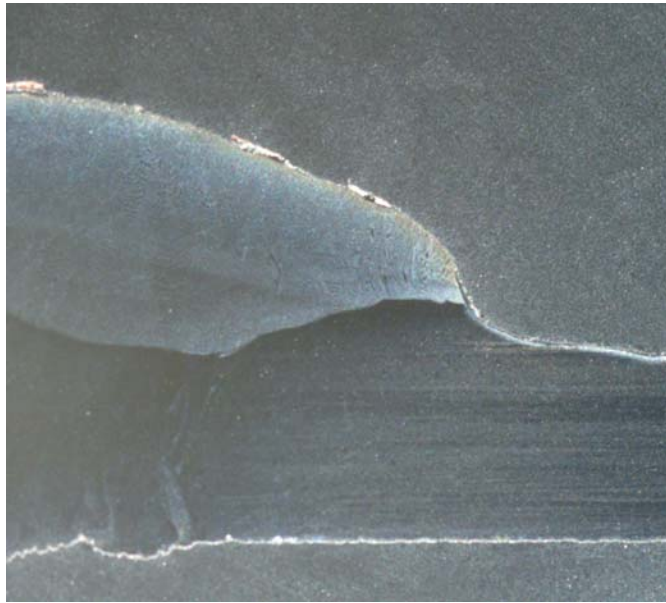
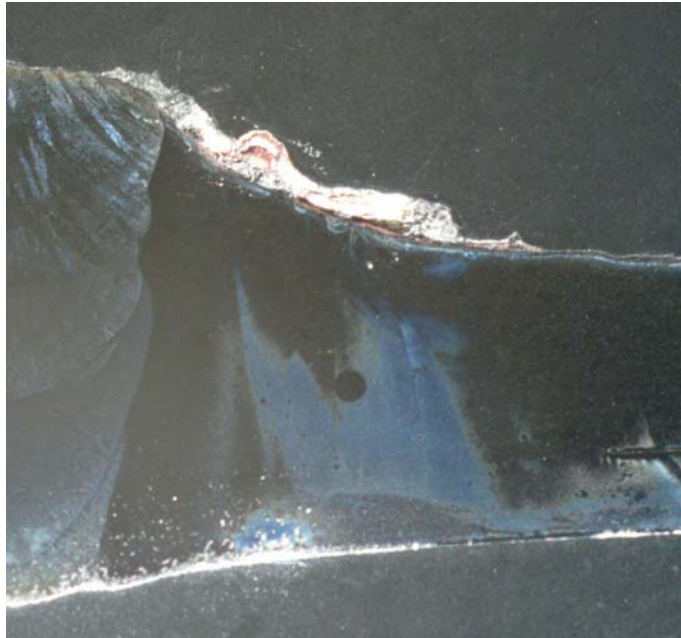
Figure D-18: Longitudinal Cross-Section: NF 709 Adjacent to Welds

Metallurgical Analysis – Weld Cross Section.	<ul style="list-style-type: none"> ● Figure D-18 shows a longitudinal profile (at the 12 o’clock orientation) of the NF 709 samples adjacent to the welds in Section C. The welds in question are those identified as welds “D” and “BB”, see Figure F-1 for locations ● An Inconel 625 weld metal was used throughout Section C. The cross sections show that the TP 310 Ta heat affected zones are not preferentially attached, in fact, the wall thickness for the tube sample tapers from the weld toward the middle of the tube length.
EDS Analysis Results	<ul style="list-style-type: none"> ● The table in Figure D-19 provides a summary of the EDS analyses of the locations numbered in Figure D-15b. Also shown for reference in this table are the results the spectrographic analysis that was performed during the assessment of Section A. ● Review of this table suggests the following: <ul style="list-style-type: none"> ● <u>Area 1: For the bulk deposit analysis</u> – Alkali metals are present. Sulfur and phosphorous are present in an increased amount compared to the base metal. An iron oxide is likely, as are aluminum, silicon and titanium oxides. Carbon content appears to be relatively high, however, EDS is not reliable for carbon. ● <u>Area 2: Adherent scale</u> – This layer is comprised primarily of a chromium-rich oxide, although oxides of iron and nickel also are present. ● <u>Area 3: Diffusion zone – dark etching</u> – this area is depleted in chromium, suggestive of a diffusion zone. ● <u>Area 4: Diffusion zone – light etching</u> – this is depleted in nickel and enriched in chromium and iron relative to the base metal ● <u>Area 5: Bulk EDS analysis</u> – compares well with optical spectrograph results.

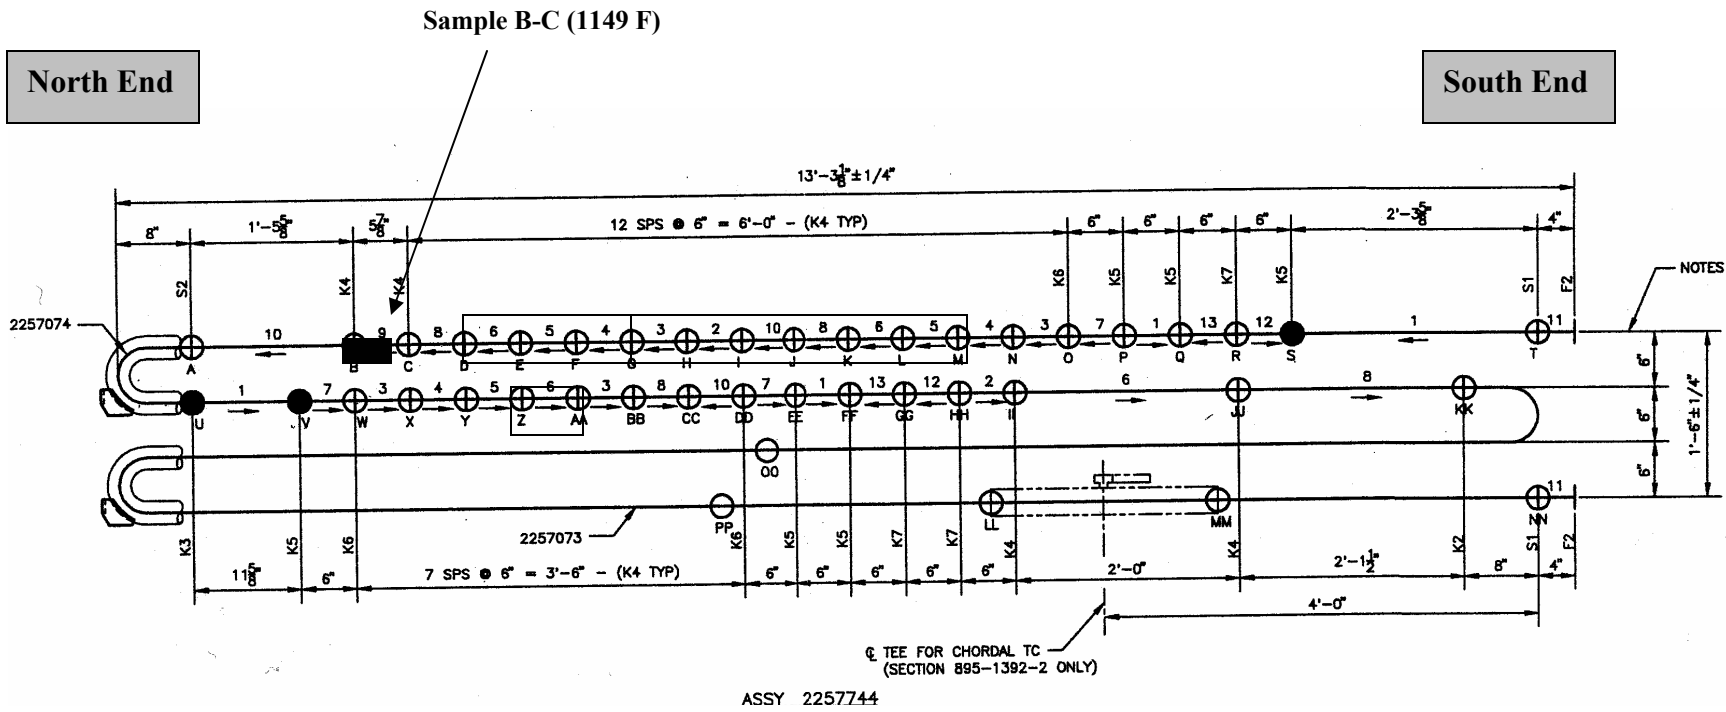
Figure E-1: Schematic Drawing Showing Position of Fe₃Al / TP 304H Tube Sample Within Section C

Issue	Discussion
Sample Location and Orientation.	<ul style="list-style-type: none"> • The schematic in Figure E-1 shows the position of the one Fe₃Al / TP 304H sample in Section C. Also, shown is the calculated average metal temperature at this location.
Composition Verification.	<ul style="list-style-type: none"> • The table in Figure E-2 provides the composition of tube Sample B-C after exposure. An attempt was made to find and analyze the composition of the iron-aluminide coating on the “after service” samples, but none could be found. It is assumed that the coating either spalled or was corroded away from the surface at some point during the 2.38 years of exposure in Section C. This is consistent with similar results for Section A, after 1.55 years of exposure. • The table in Figure E-2 provides EDS analyses of the Fe₃Al coating prior to service. Numerous samplings were made and found to be highly variable. The reported results are for material at the extreme outer surface. A bulk analysis was also attempted and reported. The significance of deviations from the target chemistry is unclear. • EDS semi-quantitative analysis at mid-wall for Sample B-C confirms that this material is consistent with TP 304H, thus it verifies that the correct sample was located at position B-C.

1. Drawing shown in same relative orientation as per the actual installation.
2. This group of tube samples was removed from service in November 2001 - highlighted in red.
3. This group of tube samples was removed from service in June 2002 - highlighted in yellow.

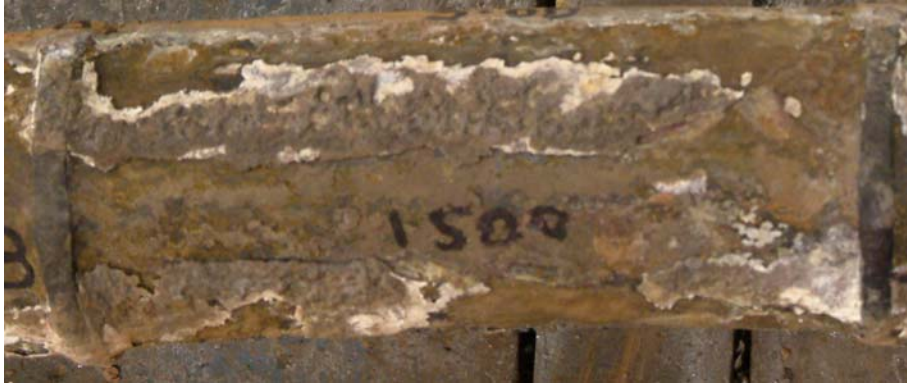
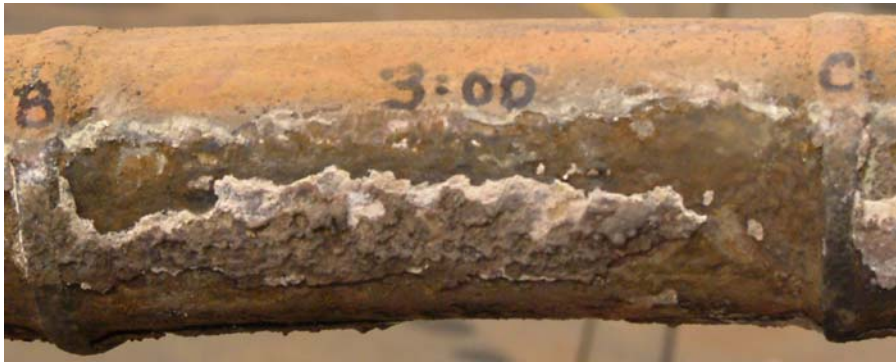
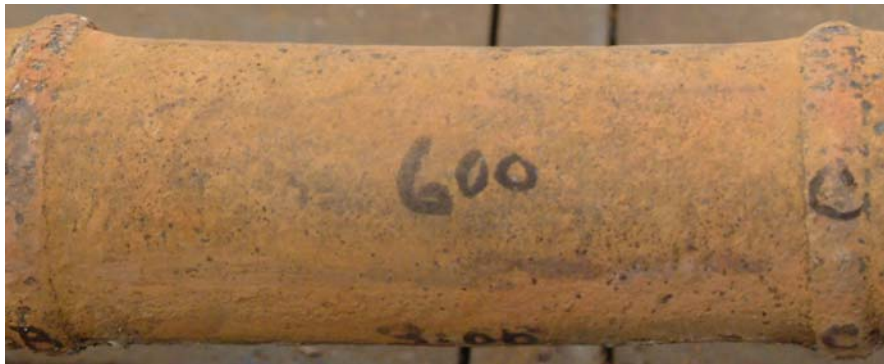
Figure E-4 As-Received Appearance of Sample B-C (Fe_3Al / TP 304H)

(Average metal temperature: 1149 F)

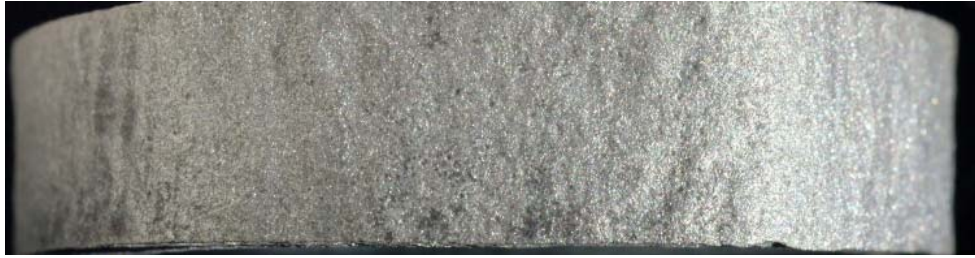
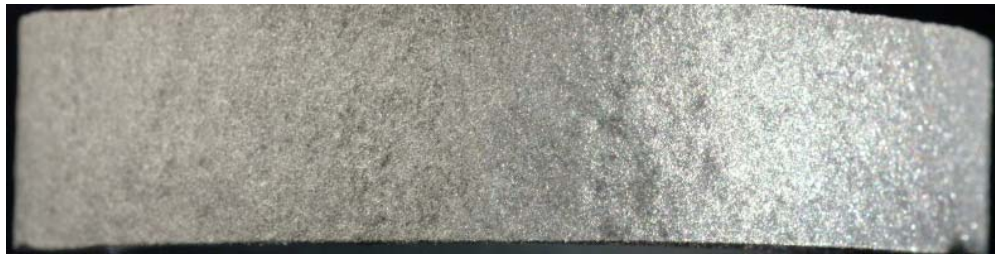
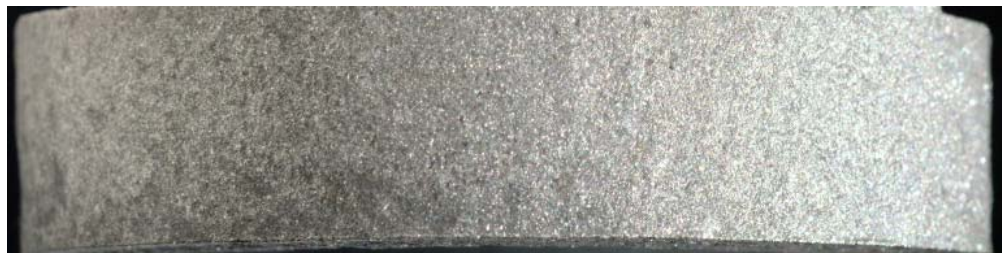
Figure E-5: OD Surface Appearance After Grit Blast

12 O'Clock
(227 mils lost)

3 O'Clock
(194 mils lost)

6 O'Clock
(27 mils lost)

Material: Fe₃Al / TP 304H
Sample: B-C

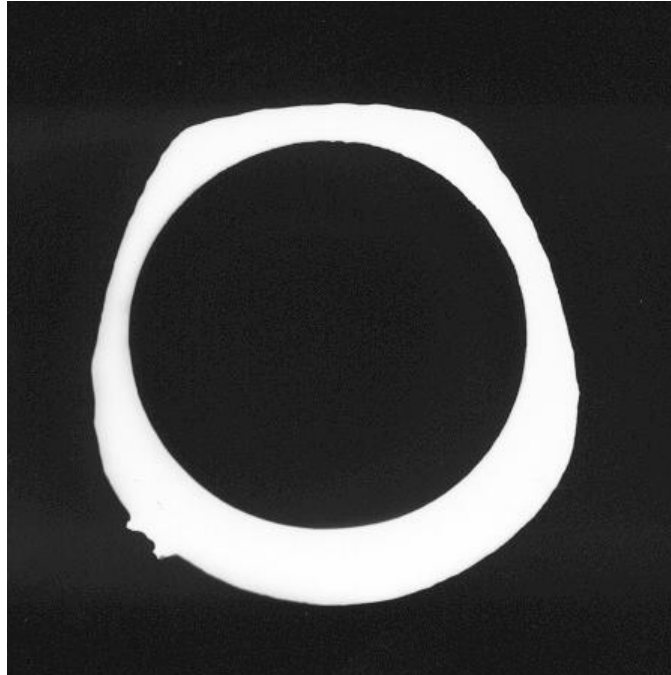
Material: Fe₃Al / TP 304H
Sample Location: B-C
Maximum Rate: 100 mils/yr
Maximum Loss Orientation: Approx. 2:30 o'clock
Average metal Temperature: 1149 F

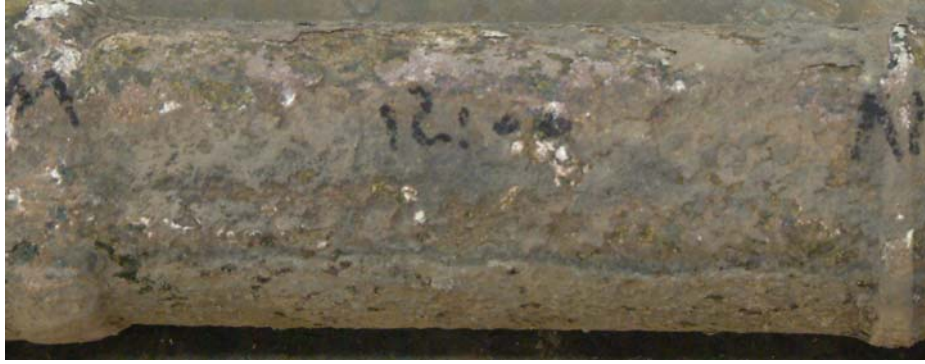
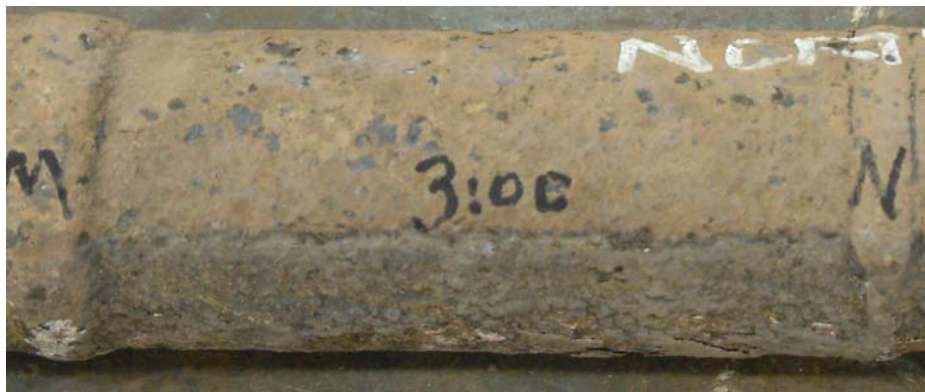
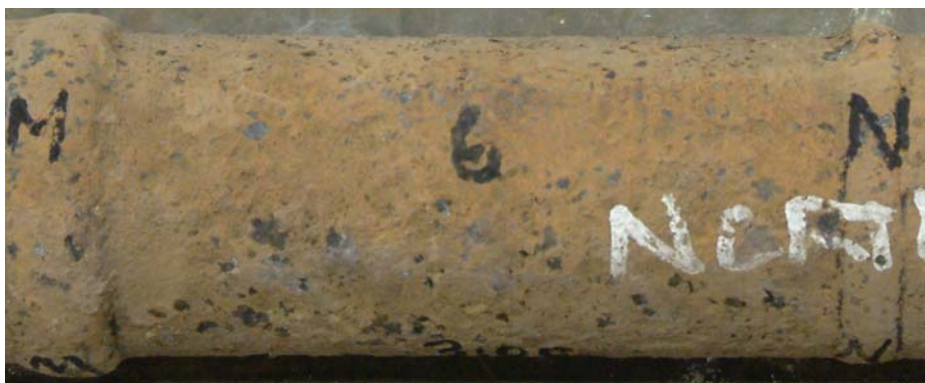
Figure F-4 As-Received Appearance of Sample M-N (310 Ta)

(Average metal temperature: 1188 F)

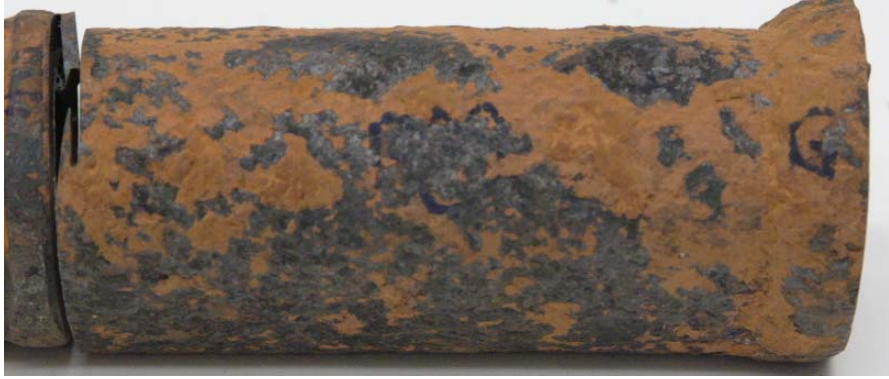
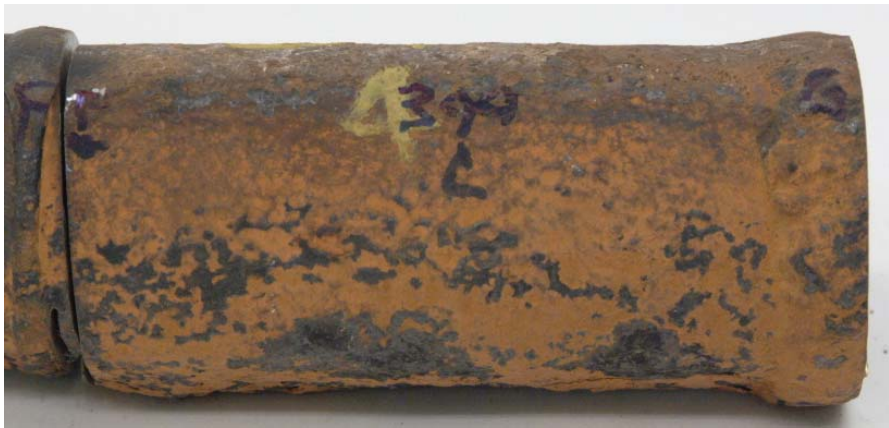
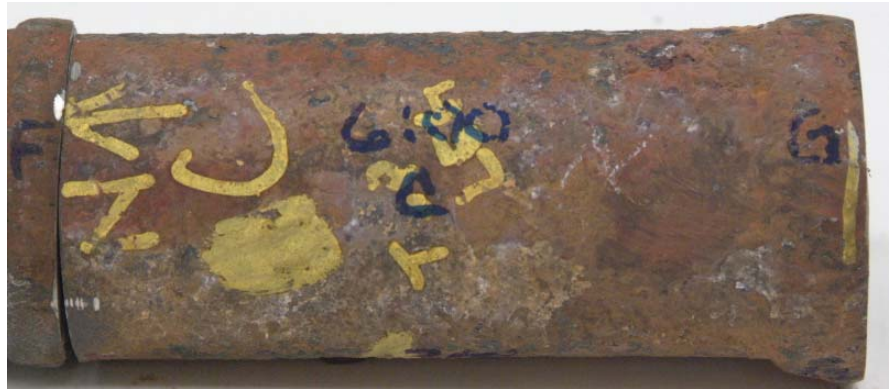
Figure F-5 As-Received Appearance of Sample F-G (310 Ta)

(Average metal temperature: 1166 F)

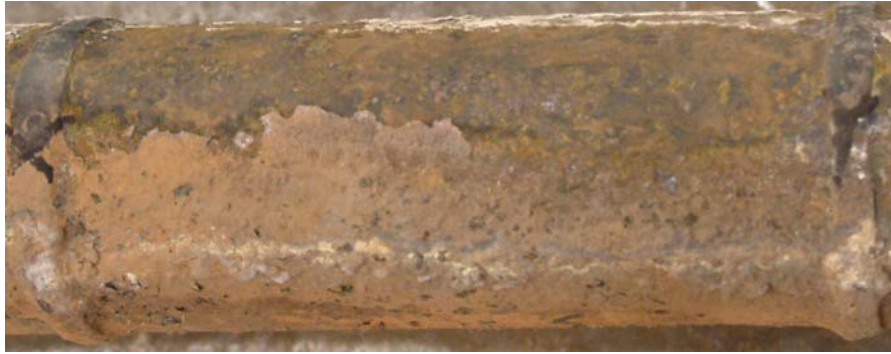
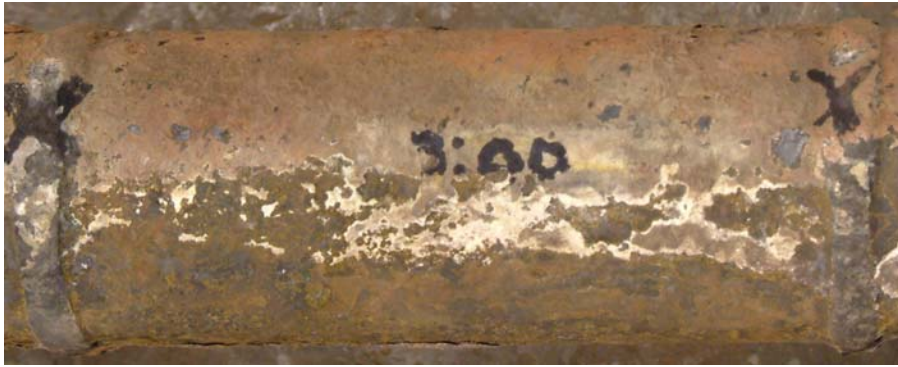
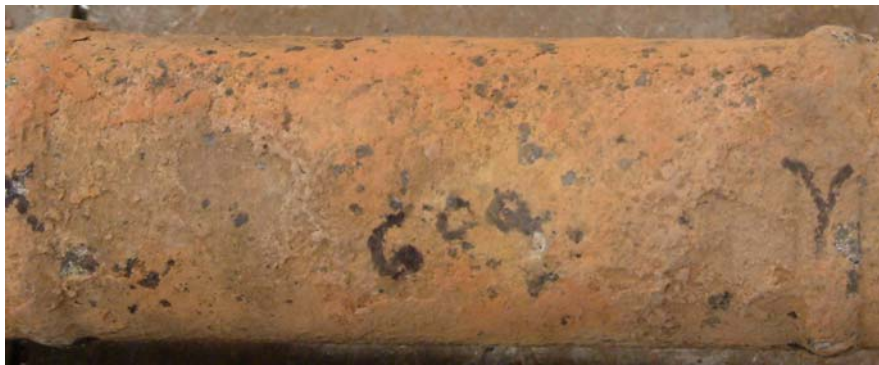
Figure F-6 As-Received Appearance of Sample X-Y (310 Ta)

(Average metal temperature: 1103 F)

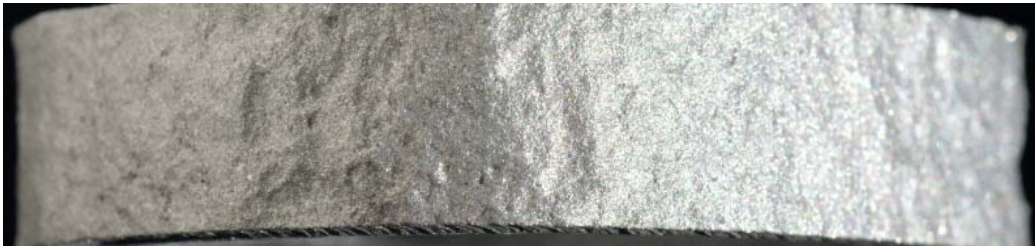
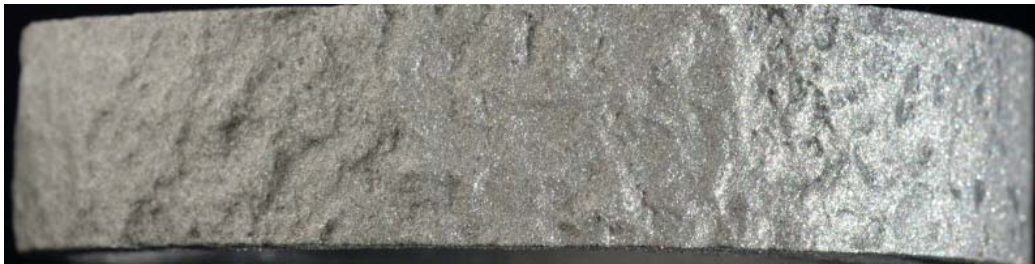
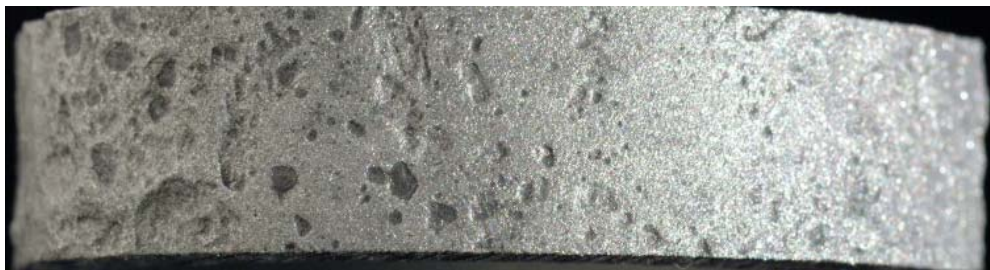
Figure F-7: OD Surface Appearance After Grit Blast

Grit-Blasted Surface Appearance	<ul style="list-style-type: none">• Figures F-7 through F-9 show the appearance of the external surface of the 301 Ta tube samples after grit-blasting to remove deposit and scale. The 12 o'clock and 3 o'clock positions for all three samples show the appearance of general wastage due to fireside corrosion.• The 6 o'clock position for Samples M-N shows that significant pitting occurred on the back-side (i.e. the side of the tube opposite the gas flow direction).
Wall Thickness Loss Determined	<ul style="list-style-type: none">• Tube cross-sections were prepared to allow for measurement of wall thickness to determine metal loss due to exposure. These are shown in silhouette in Figures F-10 through F-12.• The same relative "o'clock" positions were maintained as discussed earlier. Measurements were taken at eight evenly spaced locations about the tube circumference. These were then compared with measurements taken at these same locations prior to exposure.• The before and after measurements were documented in the table that accompanies each figure. These form the basis for the "delta" calculation to determine the amount of wall thickness lost.• For all three tube samples, the minimum wall thickness in the cross section was not at one of the eight predetermined locations. In these cases, there were no "before" measurements for comparison. So, the average "before" wall thickness was used to calculate the wall thickness lost at these off-locations.

12 O'Clock
(212 mils lost)

3 O'Clock
(255 mils lost)

6 O'Clock
(0 mils lost)

Material: 310 Ta
Sample: M-N

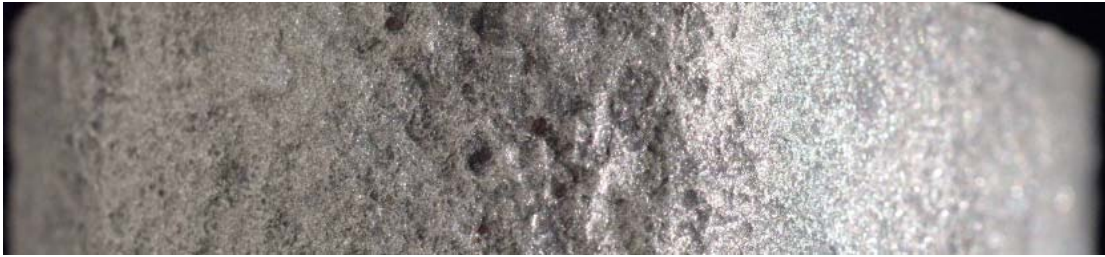
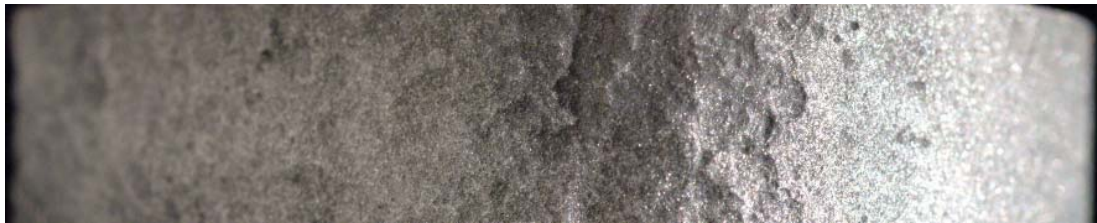
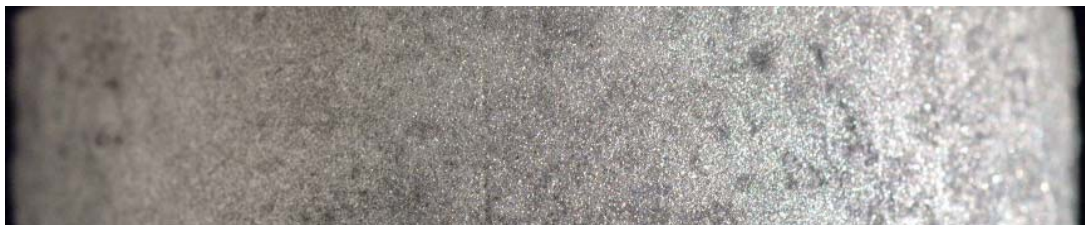
Figure F-8: OD Surface Appearance After Grit Blast

12 O'Clock
(119 mils lost)

3 O'Clock
(188 mils lost)

6 O'Clock
(2 mils lost)

Material: 310 Ta
Sample: F-G

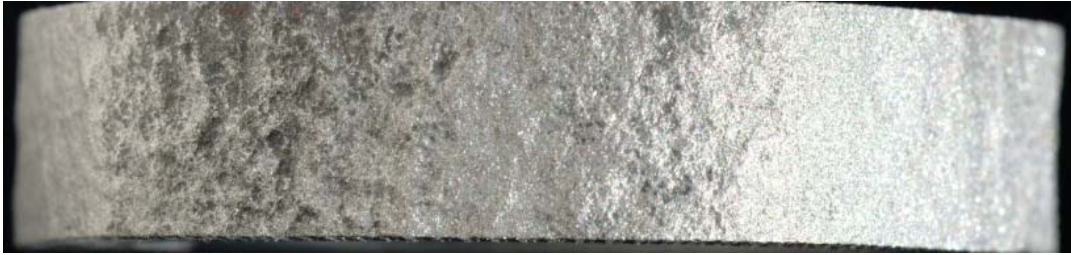
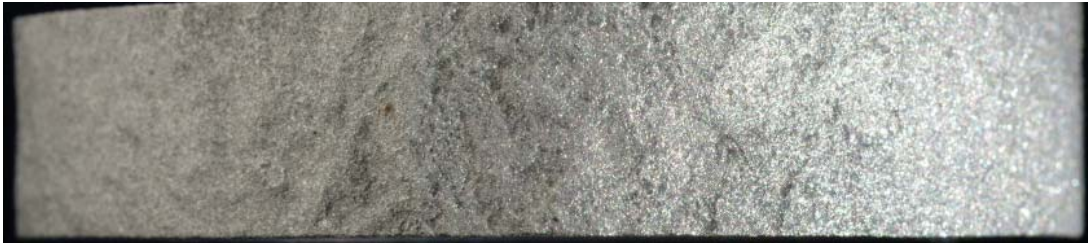
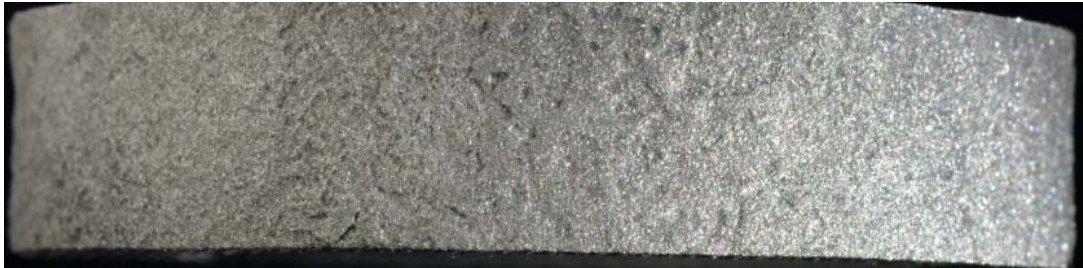
Figure F-9: OD Surface Appearance After Grit Blast

12 O'Clock
(105 mils lost)

3 O'Clock
(61 mils lost)

6 O'Clock
(0 mils lost)

Material: 310 Ta
Sample: X-Y

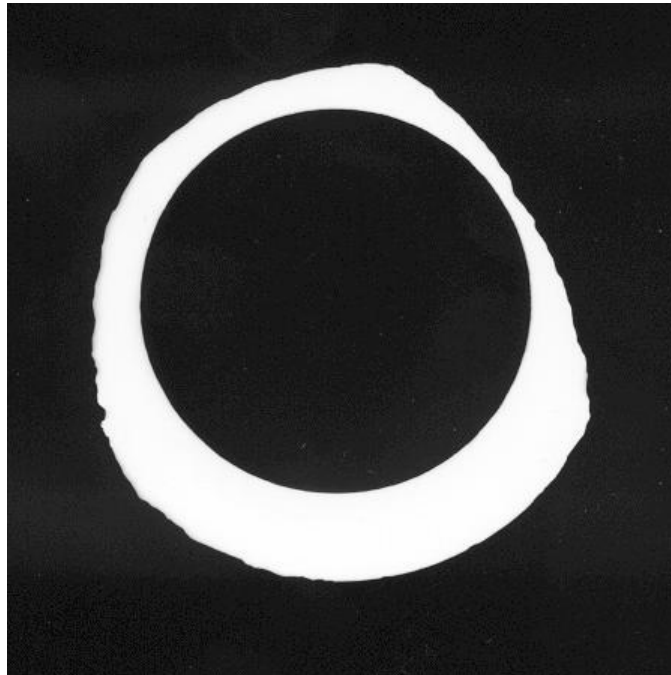
Type 310 Ta experienced a high rate of metal loss at two of the three locations in Section C. The metal loss rates for Samples M-N and F-G were 131 and 127 mils per year* respectively. These rates were very similar to those determined for the samples from Section A which had metal loss rates that ranged from 120 mils per year to 136 mils per year. This suggests a linear rate of metal loss for samples at these locations. It was noted that Sample F-G needed to be removed early from Section C due to concerns about excessive metal loss. This poor performance of TP 310 Ta is consistent with that of those other alloys having approximately 20% to 25% chromium.

Material: 310 Ta
Sample Location: M-N
Maximum Rate: 131 mils/yr
Maximum Loss Orientation: Approx. 2:30 o'clock
Average metal Temperature: 1188 F

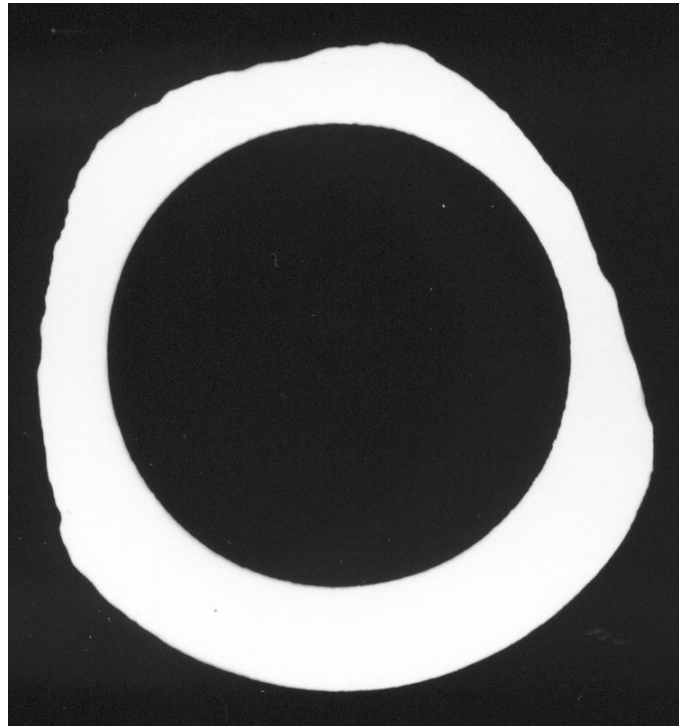
Material: 310 Ta
Sample Location: F-G
Maximum Rate: 127 mils/yr
Maximum Loss Orientation: Approx. 2:30 o'clock
Average metal Temperature: 1166 F

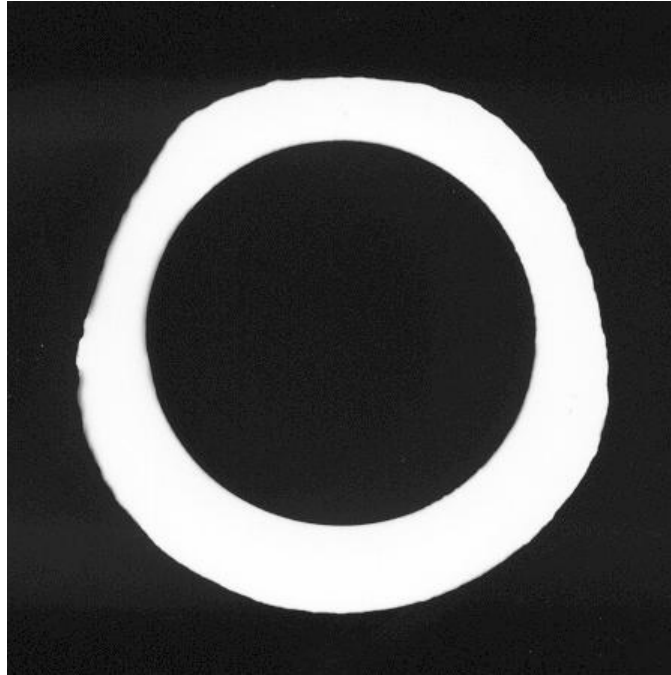
Figure F-12: Silhouette and Wall Thickness Measurements for Sample X-Y

The sample at the lowest temperature location, Sample X-Y, had a metal loss rate of 120 mils per year for Section A and 64 mils per year for Section C. The reason for this reduced rate is not clear, particularly given the fact that the average surface metal temperature for tube Sample X-Y is somewhat higher (calculated to be 11 °F) in Section C than in Section A, and otherwise the corrosion rate appears to increase with temperature over the temperature range in question.

Material: 310 Ta
Sample Location: X-Y
Maximum Rate: 64 mils/yr
Maximum Loss Orientation: Approx. 9:30 o'clock
Average metal Temperature: 1103 F

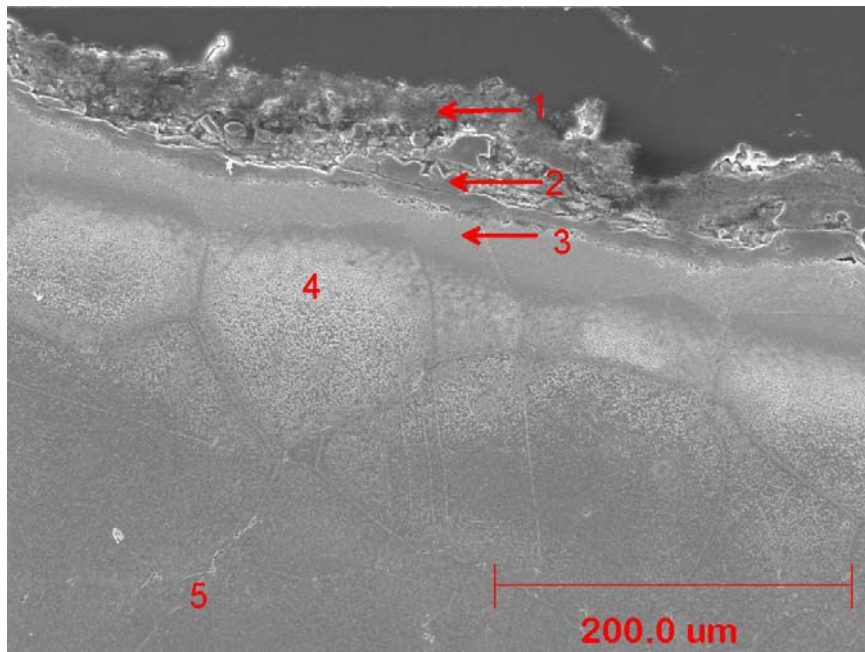
Figure F-15: Microstructure: 310 Ta

Issue	Discussion
Metallurgical Analysis – SEM, Continued.	<ul style="list-style-type: none"> • Figure F-15b shows numbered positions where EDS analyses were performed to characterize the materials in the vicinity of the scale/metal interface. • Figure F-16 shows the appearance of the microstructure at mid-wall in the specimen. • Figure F-17 internal metal surface for Sample M-N. An extremely thin oxide scale is noted to cover the surface.
Metallurgical Analysis – Weld Cross Section.	<ul style="list-style-type: none"> • Figure F-18 shows a longitudinal profile (at the 12 o'clock orientation) of the TP 310 Ta samples adjacent to the welds in Section C. The welds in question are those identified as welds “N” and “X”, see Figure F-1 for locations • An Inconel 625 weld metal was used throughout Section C. The cross sections show that the TP 310 Ta heat affected zones are not preferentially attacked, in fact, the wall thickness for the tube sample tapers from the weld toward the middle of the tube length.

(b) External Scale/Metal Interface (SEI - Intermediate Magnification)
